NANT YR EIRA MINE

HAFREN FOREST

PHOTOGRAPHIC SURVEY

PAT FROST
ARCHAEOLOGICAL
CONSULTANT
REPORT NO. 111
APRIL 2001

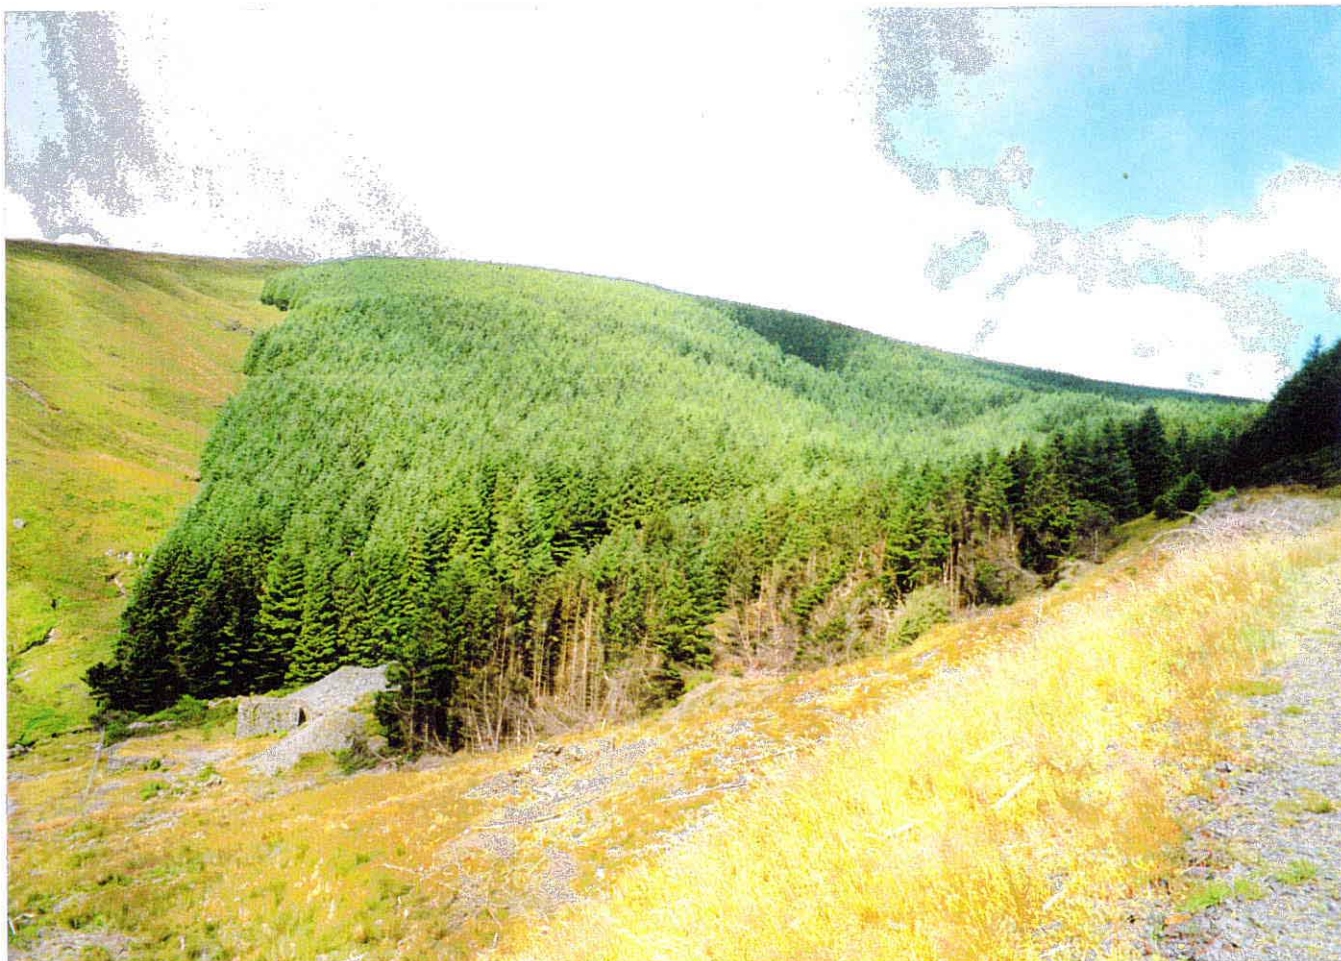
Plate 1 *above*: View to west, from forestry track towards Nant yr Eira Mine site, prior to harvesting operations. The crusher house wheelpit (18536) and the platform to the south of it (18538) together with two spoil tips can be seen to the left of the clearfell. (August 2000)

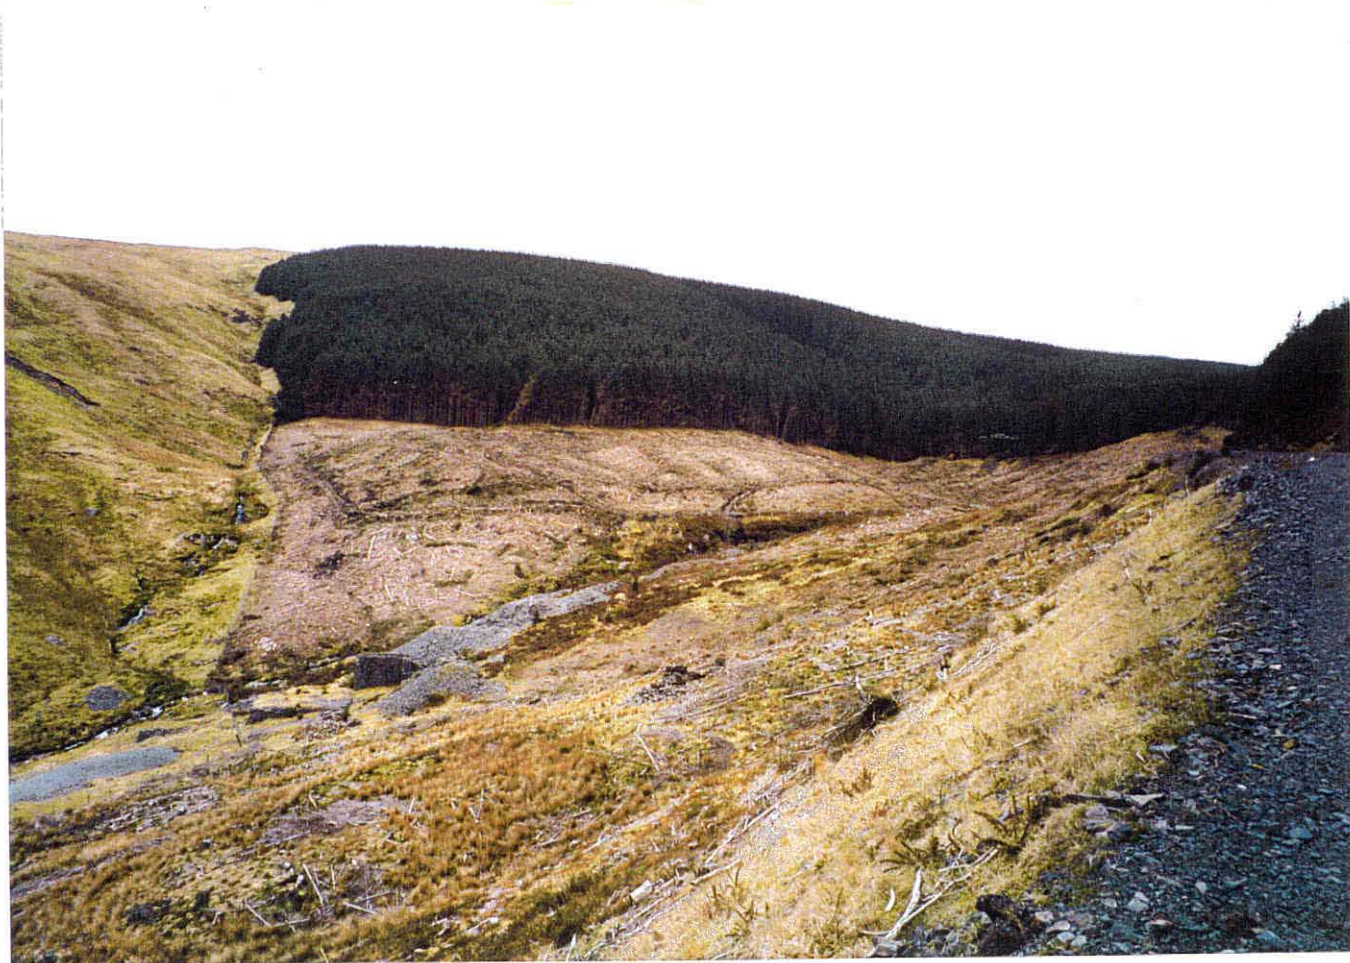
Plate 2 *below*: View west following harvesting operations (April 2001)

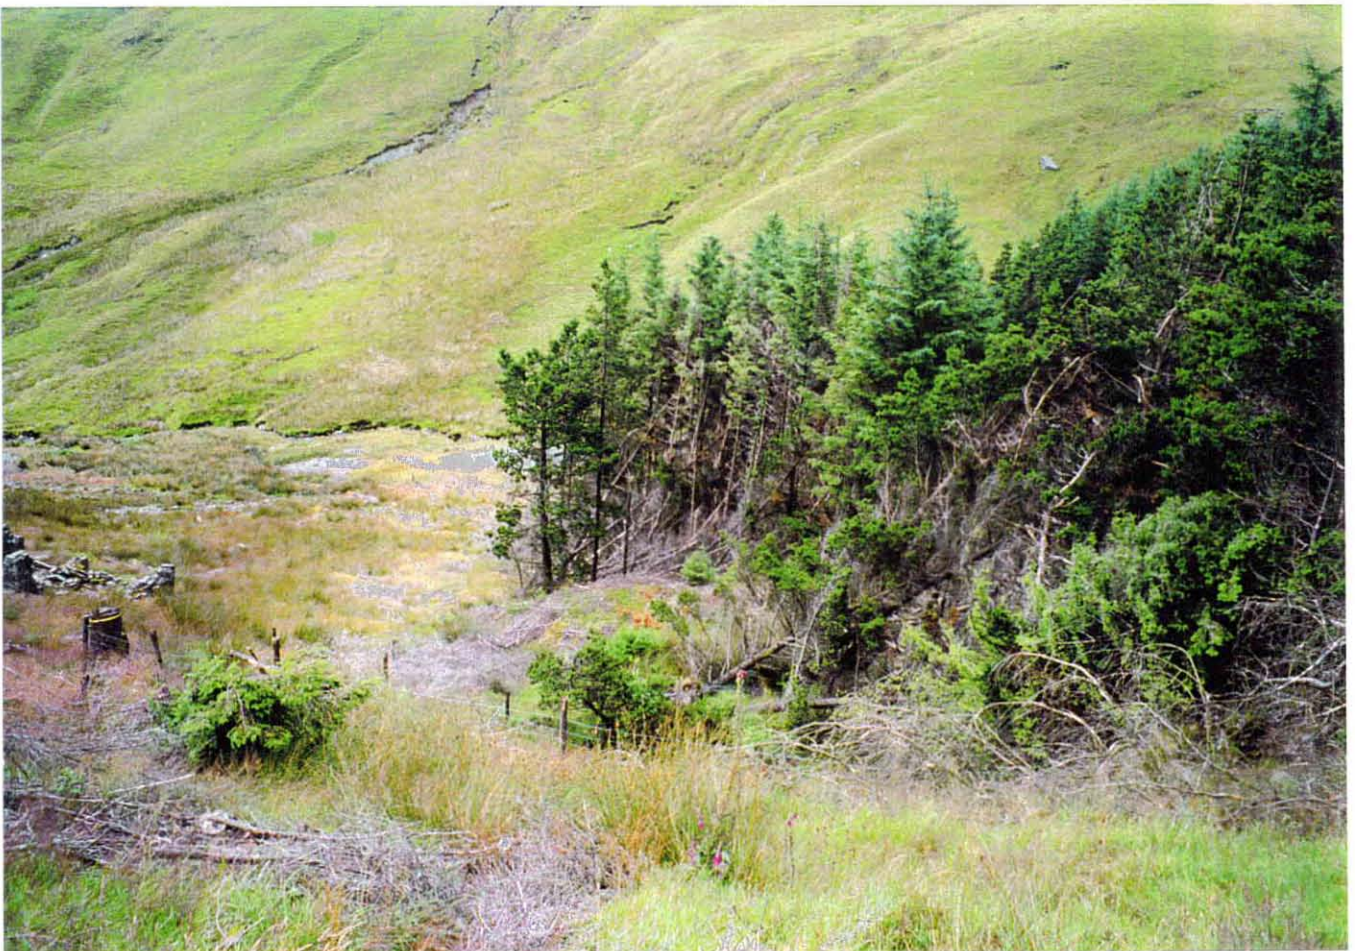
Plate 3 *above*: View west of lower mine area prior to harvesting. The building on the left of the photograph is the mine building (15118) located east of the main site, located following previous felling operations.
(August 2000)

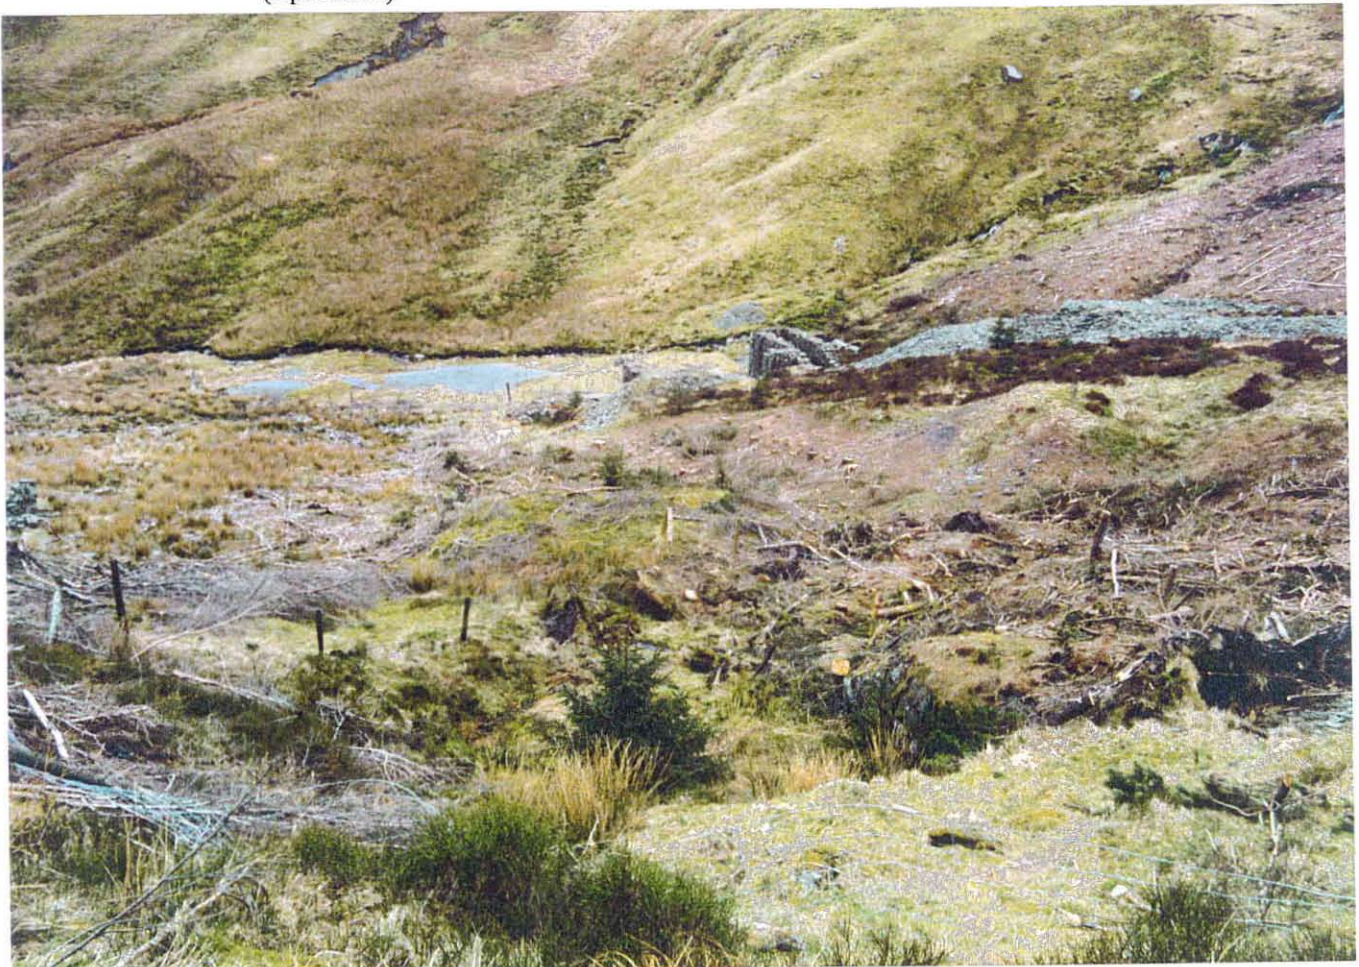
Plate 4 *below*: View west following harvesting operations. Harvesting has opened up clear views from the east towards the crusher house complex.
(April 2001)

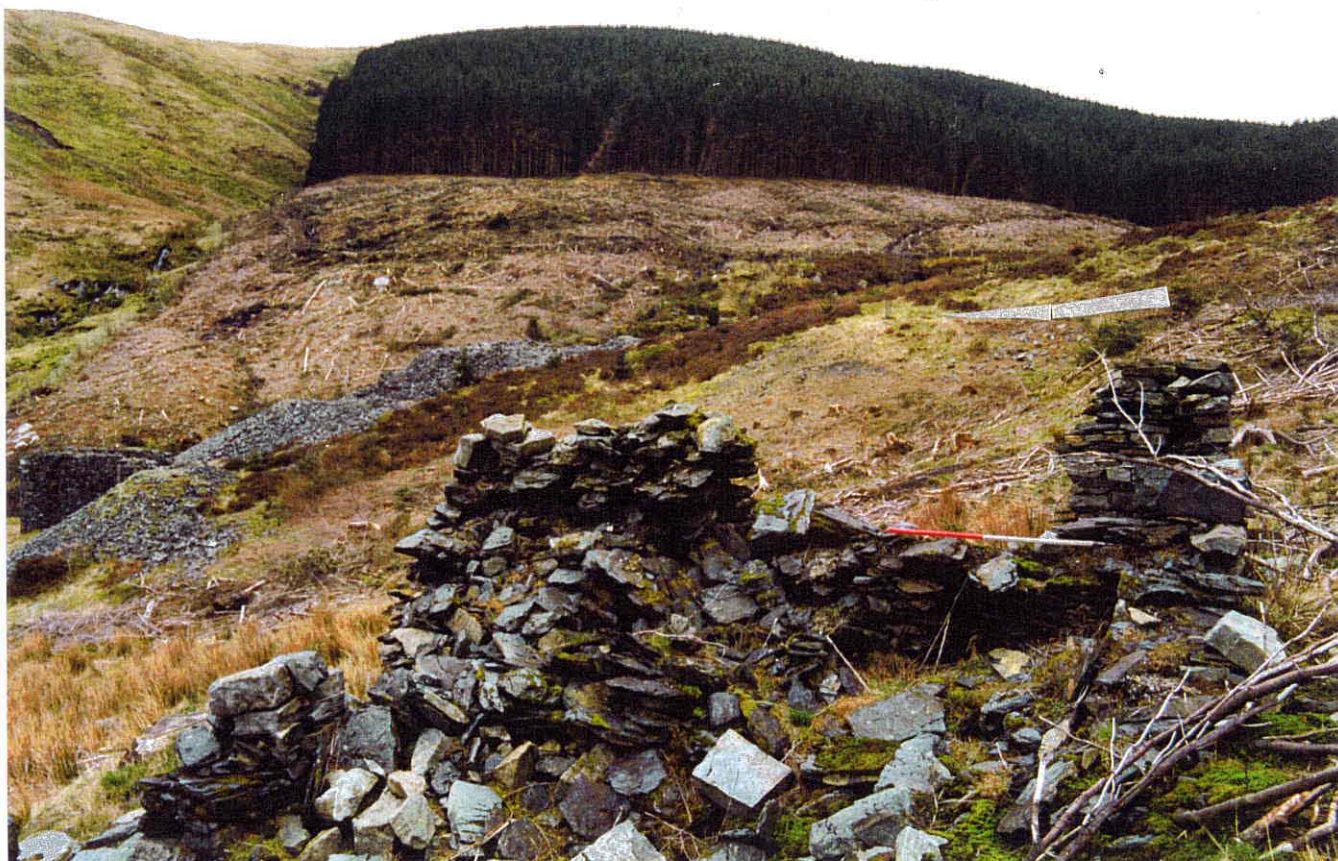
Plate 5 *above*: View west following harvesting operations from mine building 15118 towards the main site. Harvesting has opened up views towards the earthworks of a spoil tip tramway which extended in a north / south direction. Route of tramway indicated by white line. (April 2001)

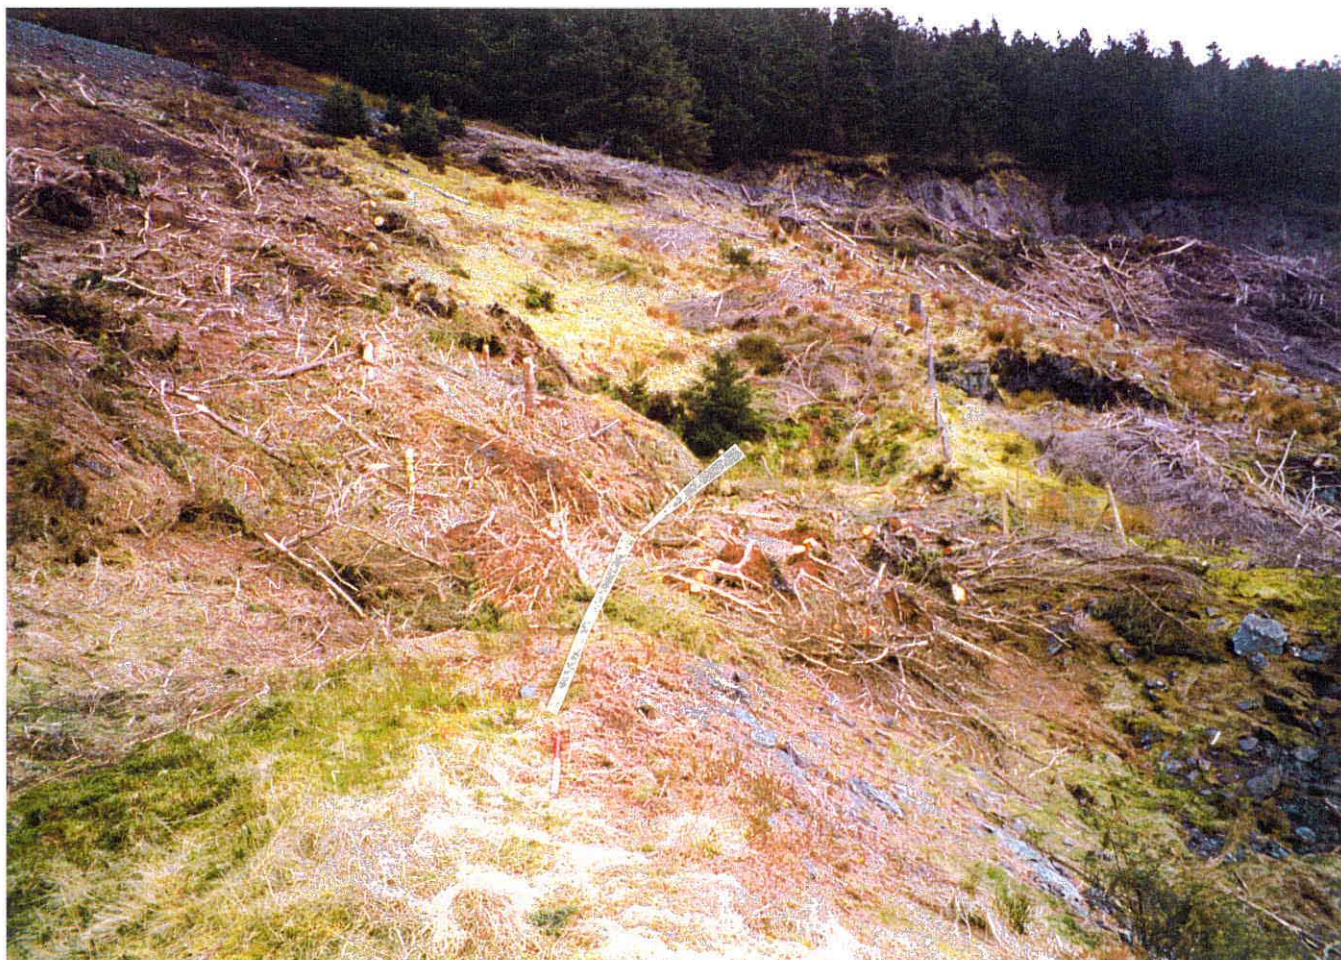
Plate 6 *below* View northwards over the tramway; route indicated by 2m scale and white line. (April 2001)

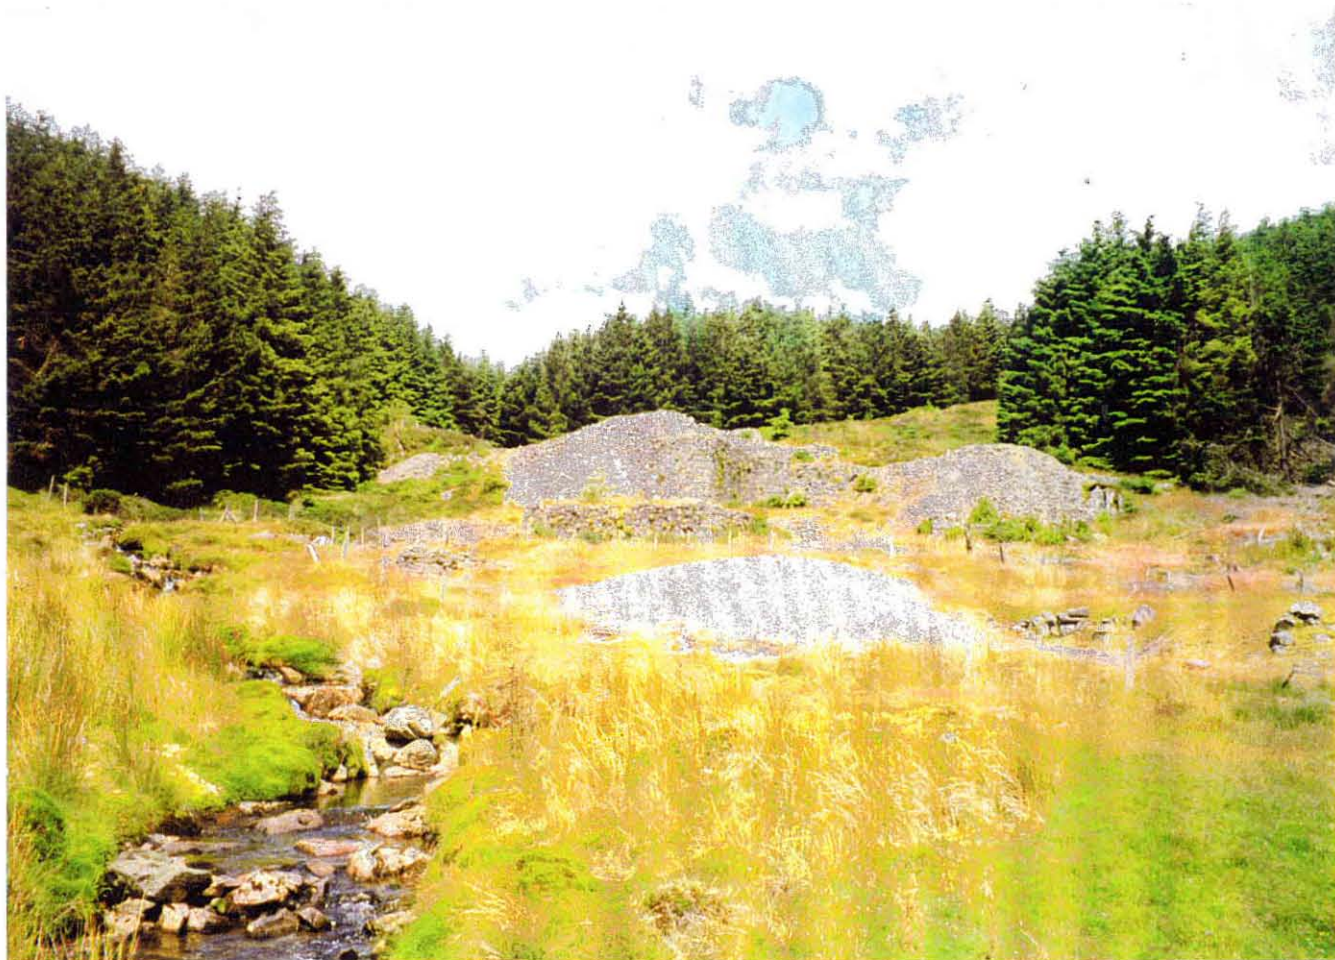
Plate 7 *above*: View north over Nant yr Eira stream to main mine site, prior to harvesting. Spoil relating to jigging operations can be seen in the foreground and the crusher house, wheelpit and platform area are north of the fenceline, between 2 areas of tipping. The tip on the west side includes ore-bins 18535. (August 2000)

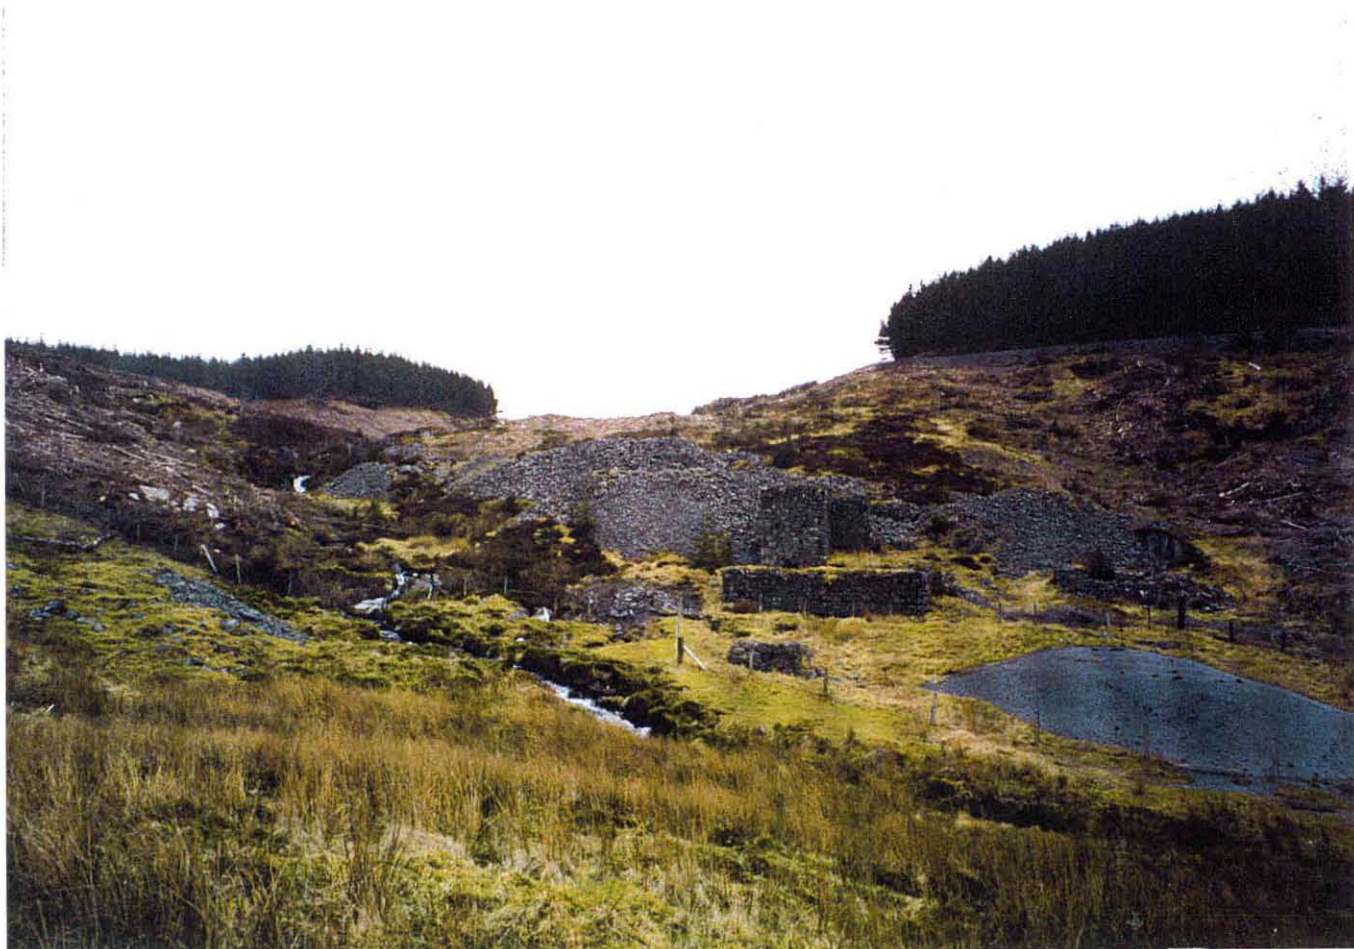
Plate 8 *below* View following harvesting. (April 2001)

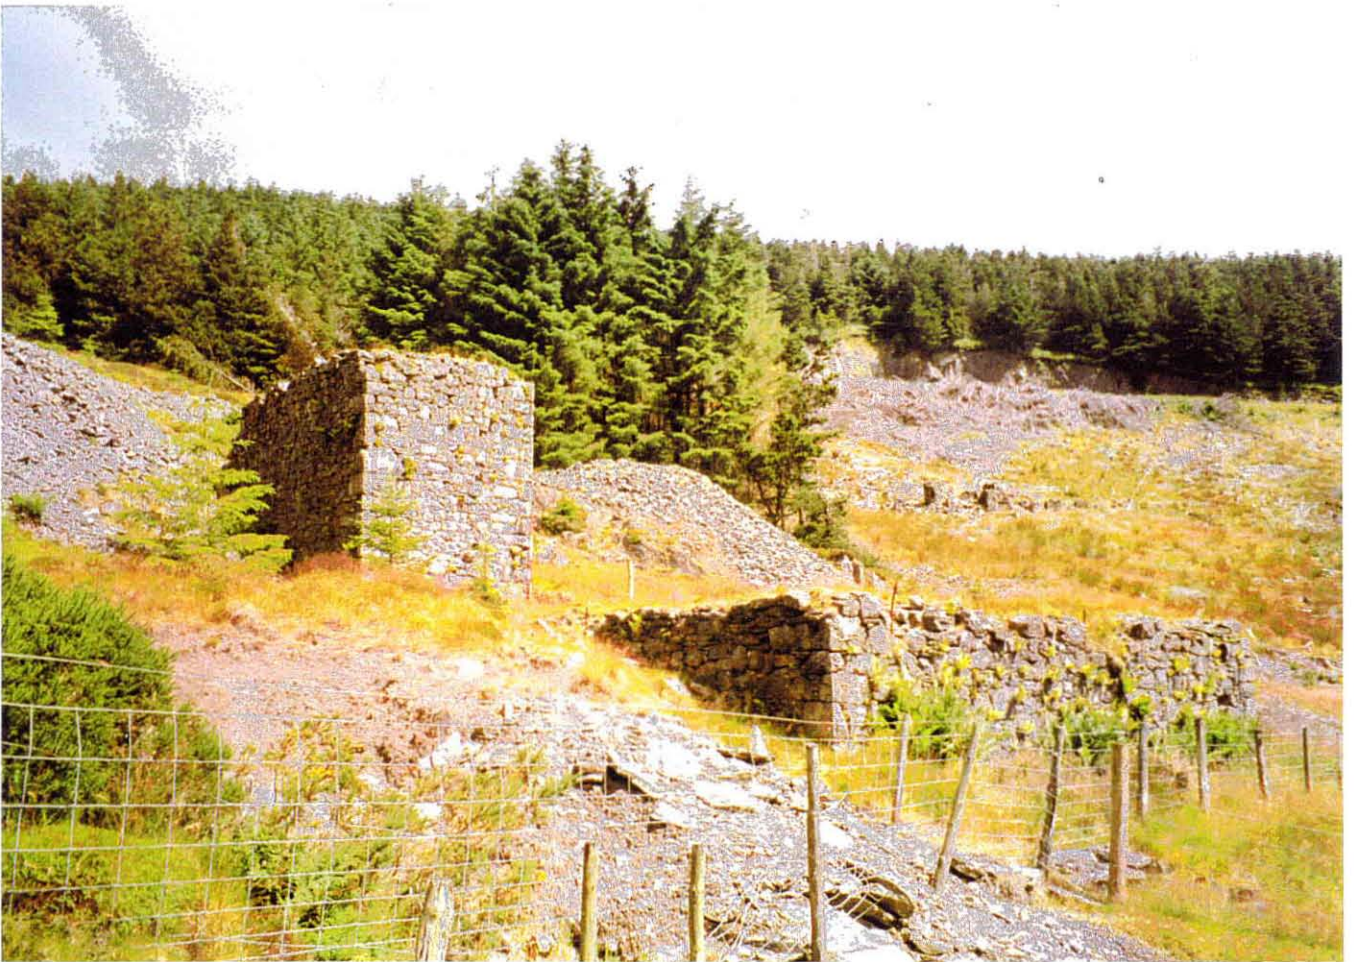
Plate 9 *above*: View north-east towards crusher house wheelpit (18536) and the platform to the south of it (18538). Mine building 15118 can be seen in the distance to the right of the conifers, prior to harvesting. (August 2000)

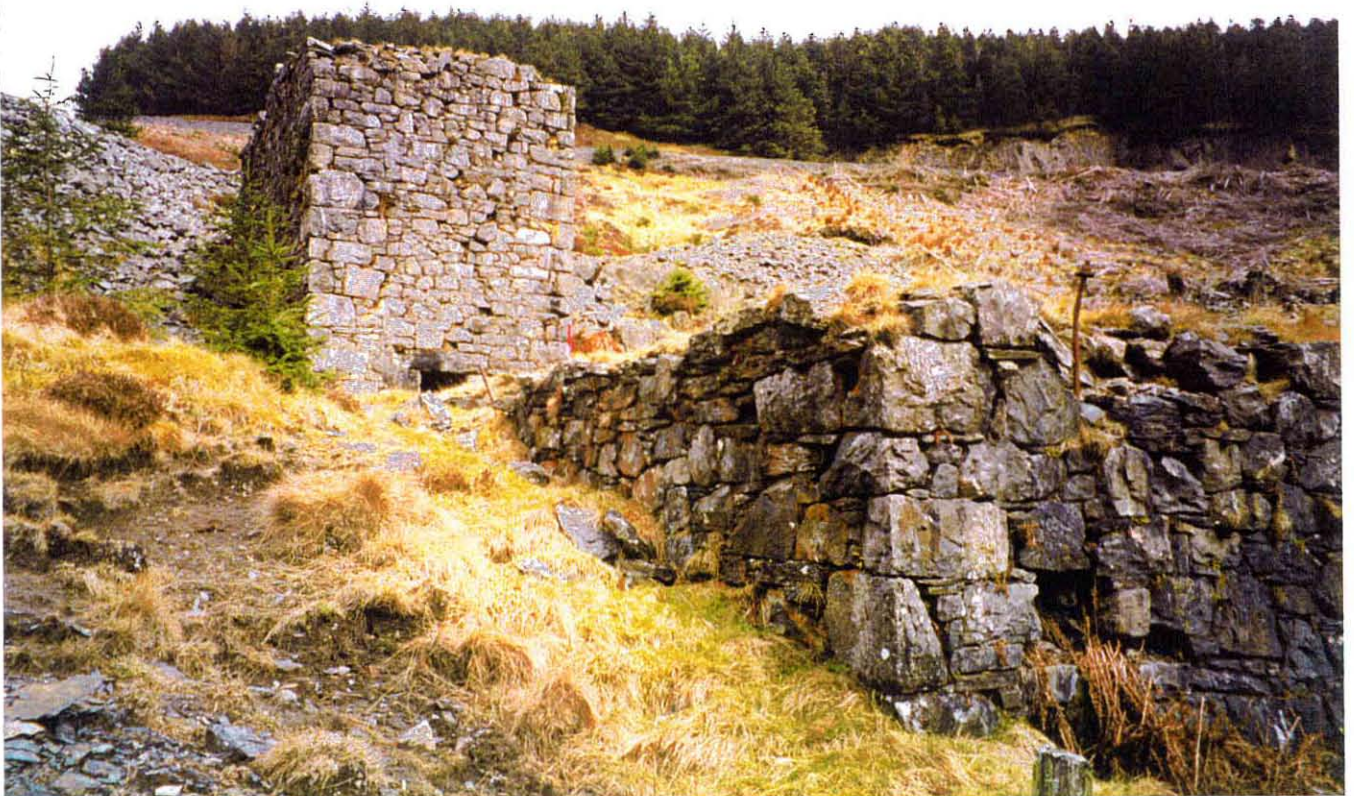
Plate 10 *below*: View following harvesting operations. (April 2001)

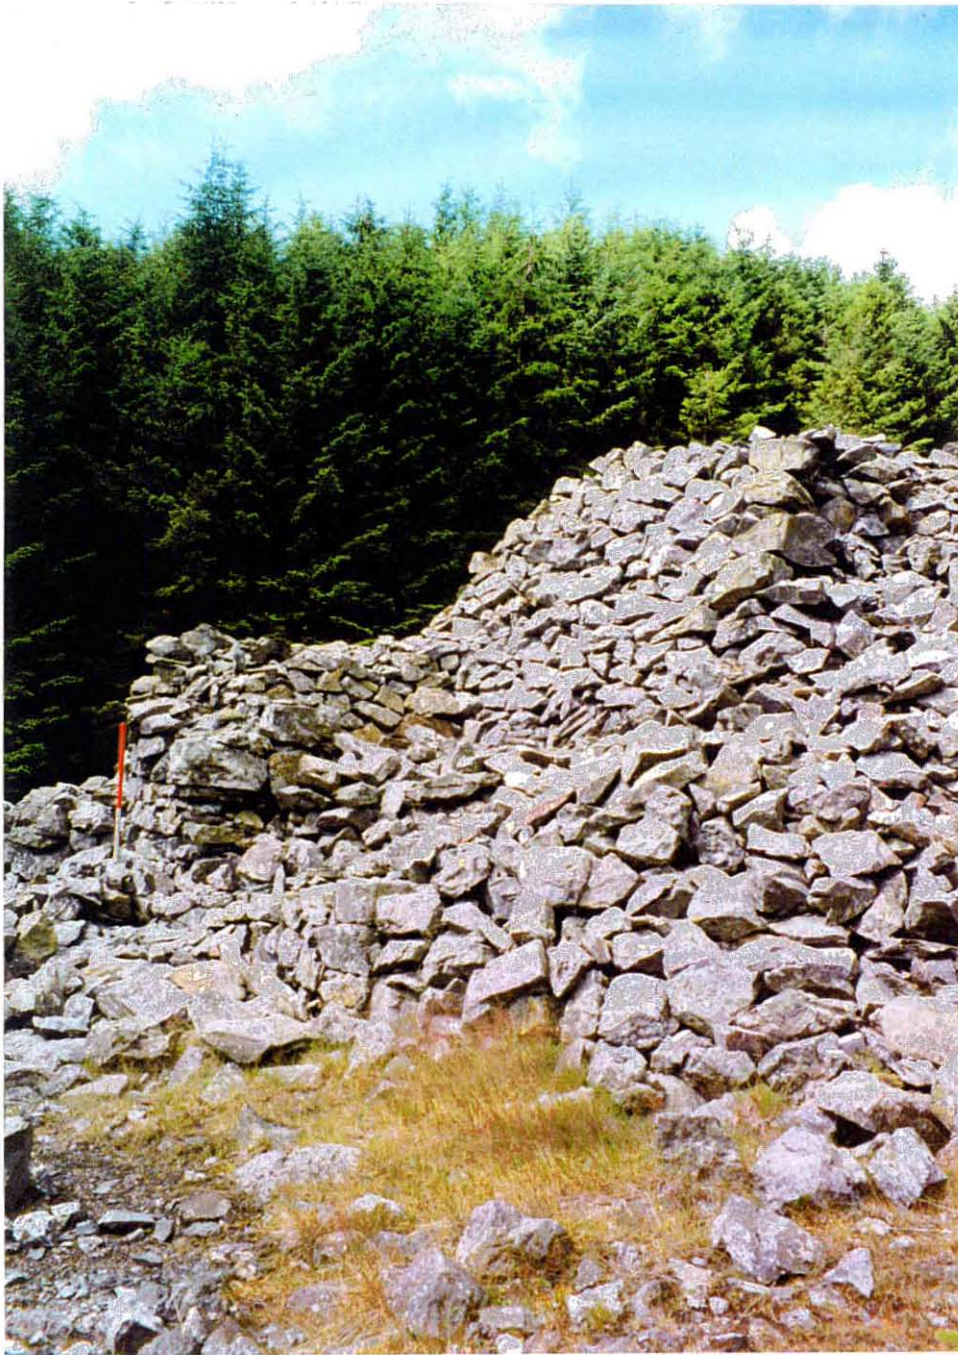
Plate 11: View west to bank of ore-bins 18535, prior to harvesting. (August 2000)

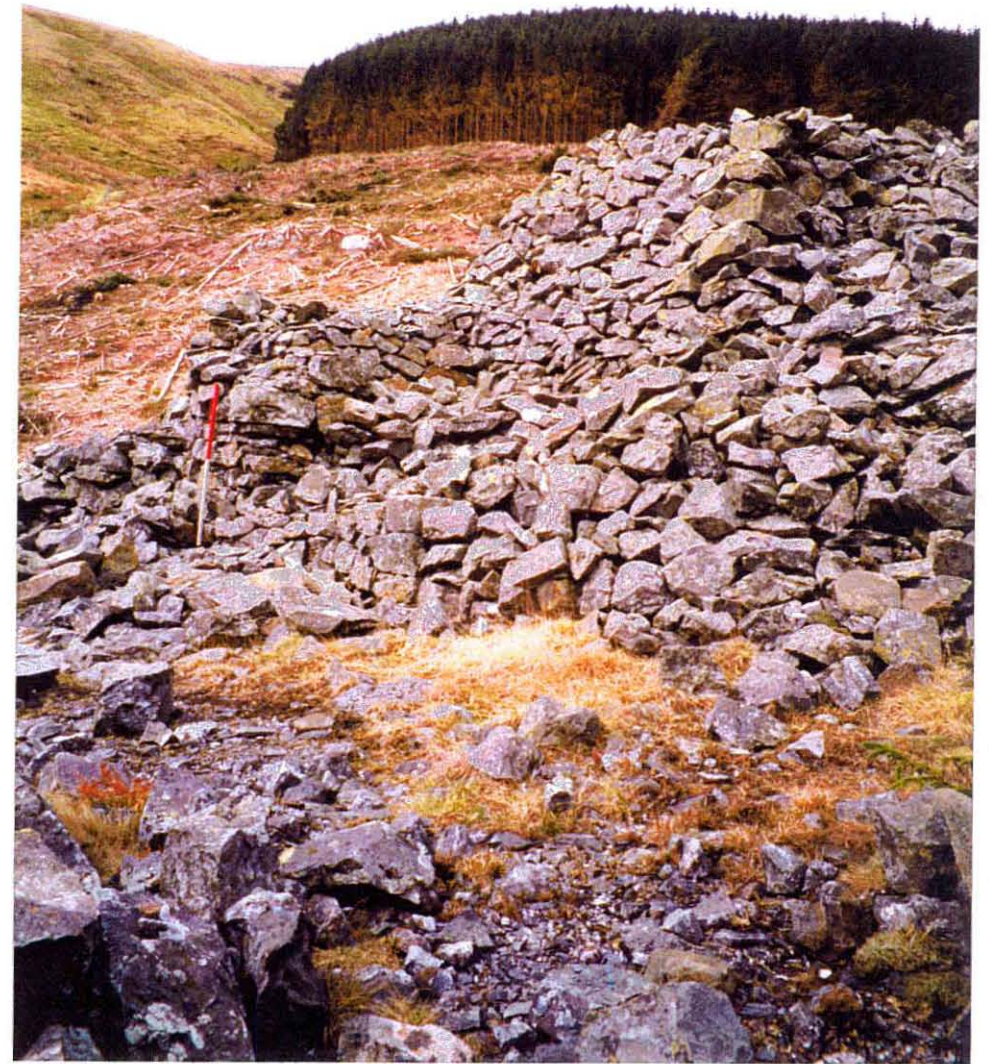
Plate 12: View of ore-bins 18535, following harvesting. (April 2001)

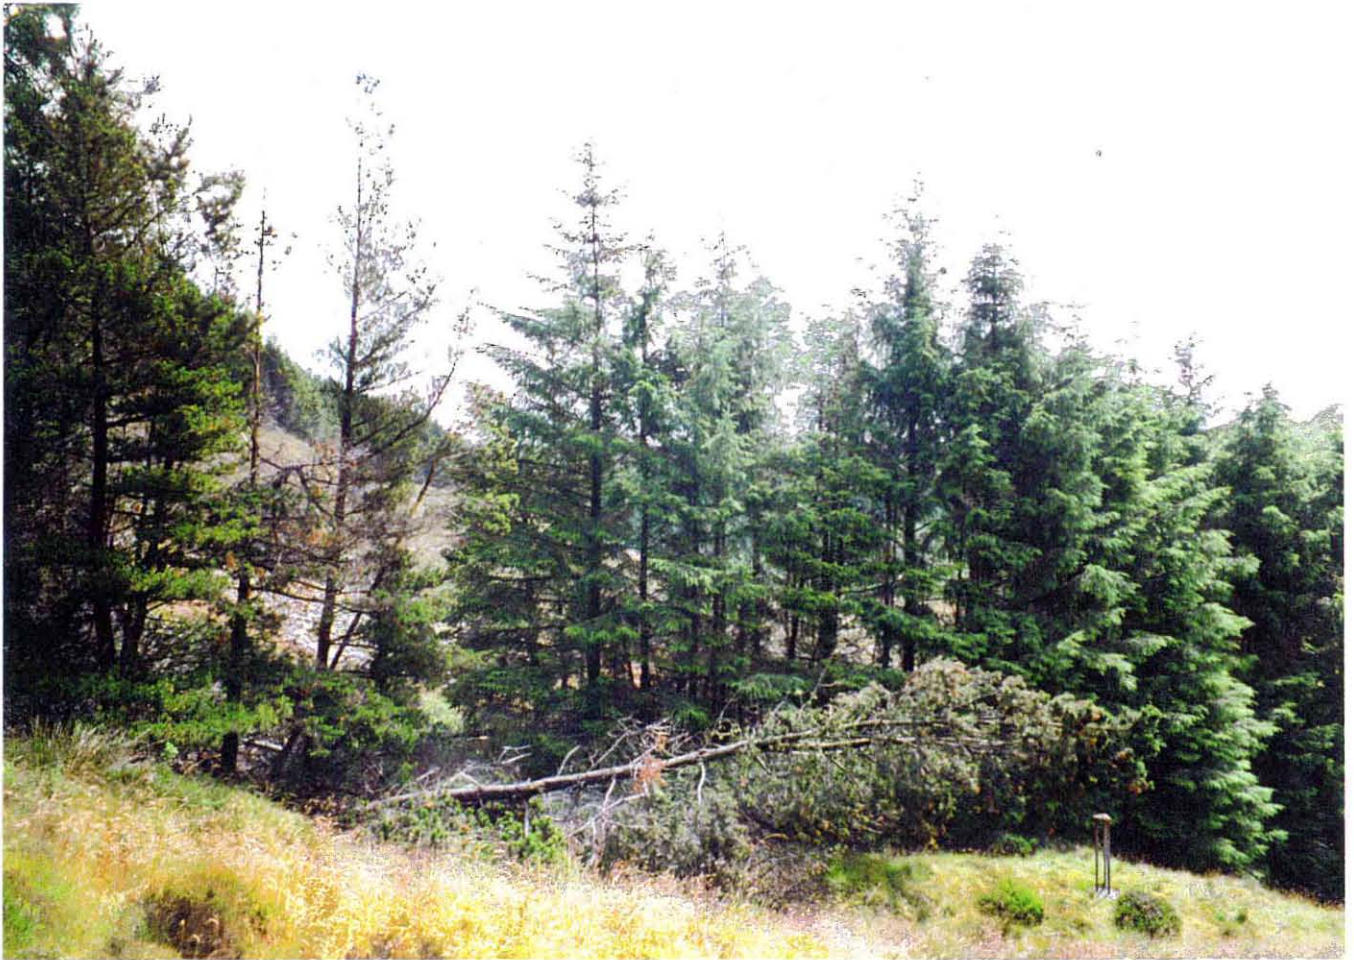
Plate 13 *above*: View east towards mine building 15118, obscured by conifer crop, prior to harvesting. (August 2000)

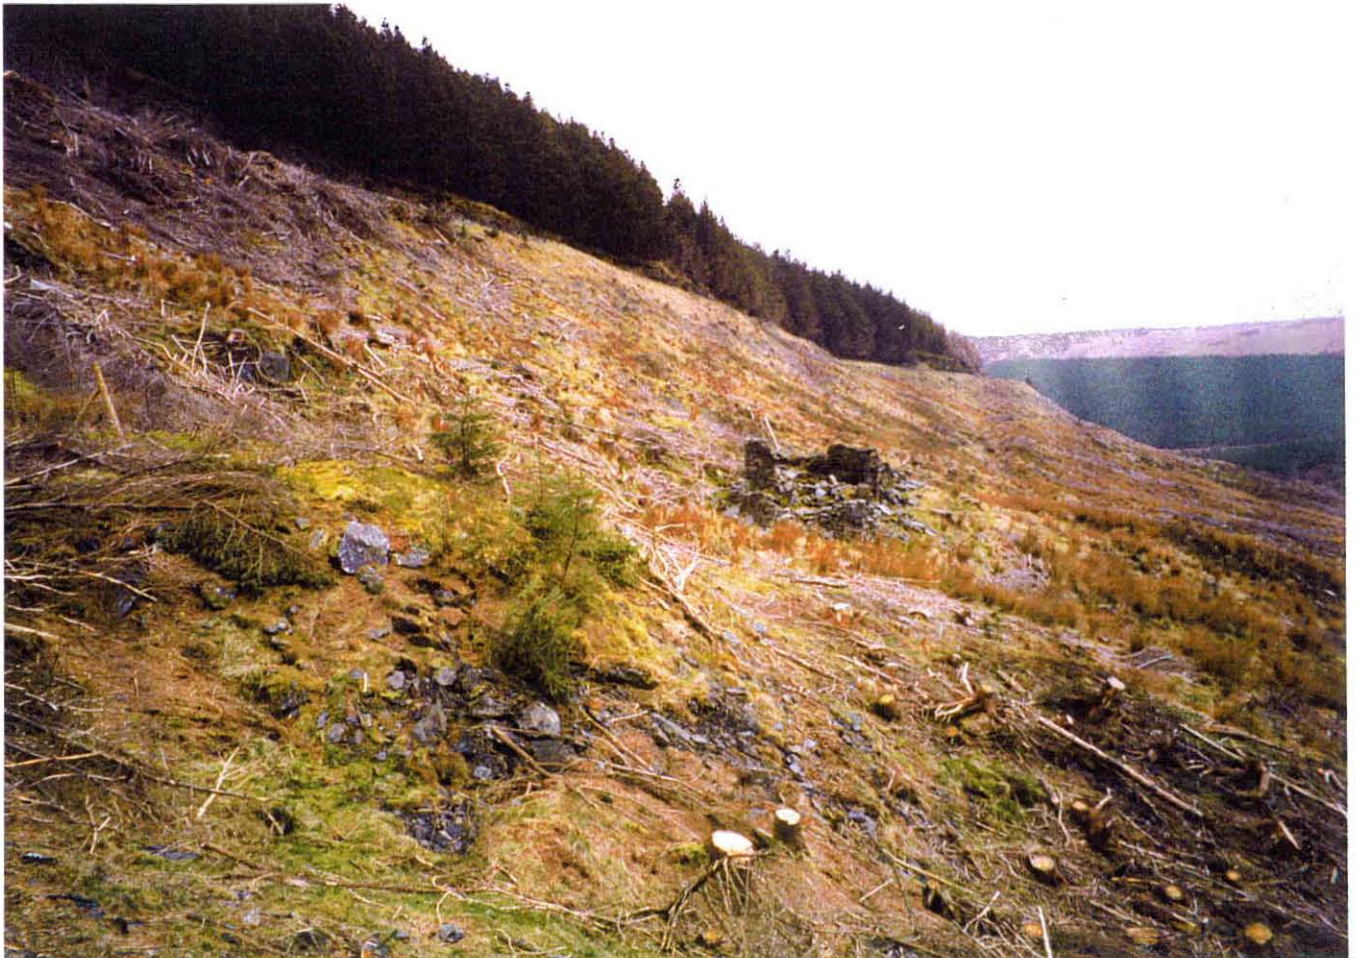
Plate 14 *below*: View east following harvesting, which has opened up a clear view from the main mine site. (April 2001)

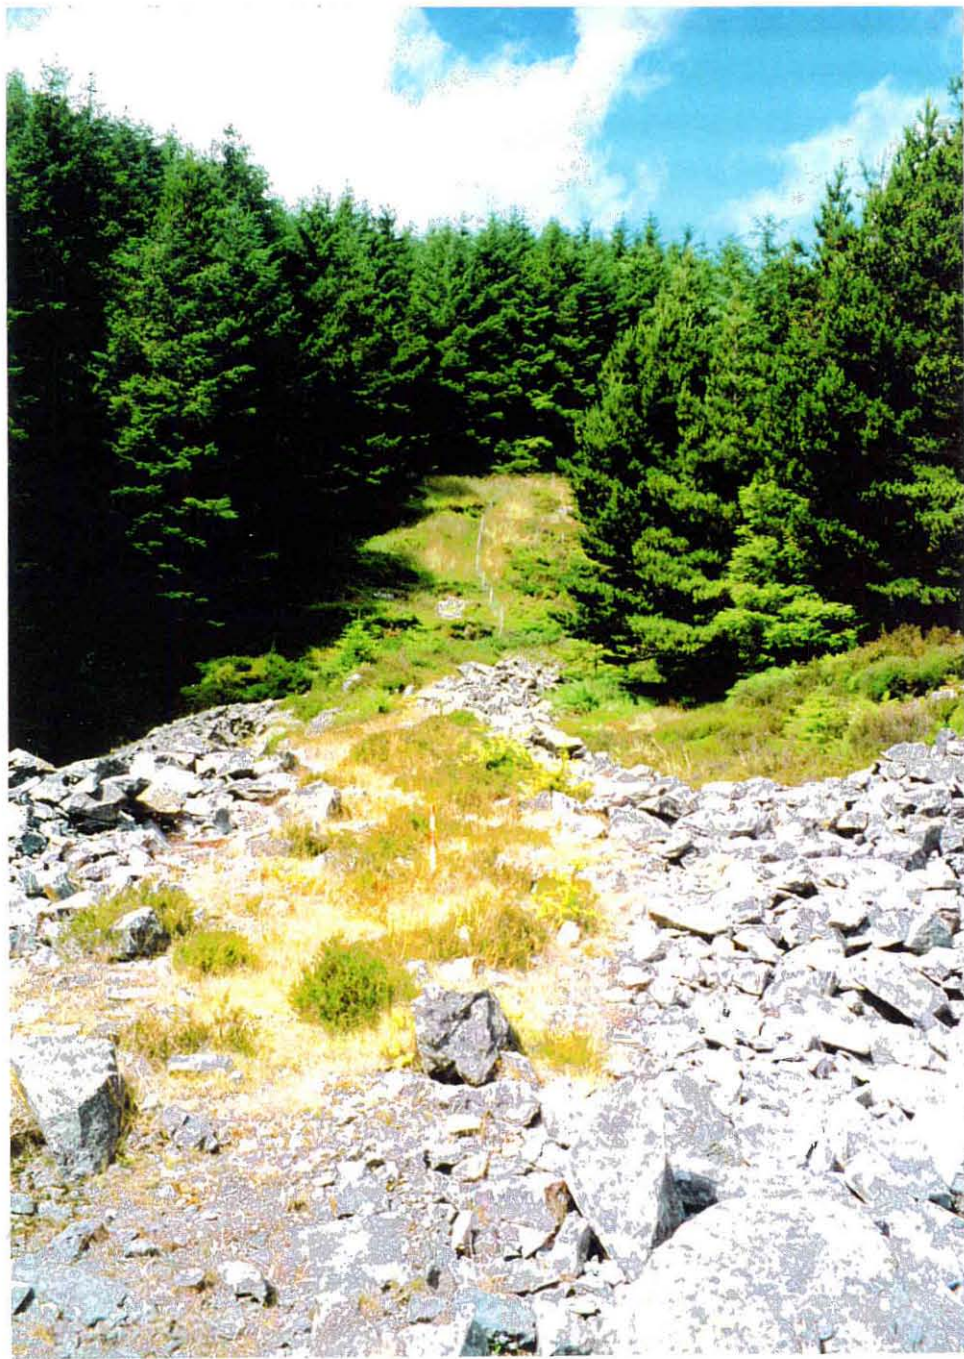
Plate 15: View to north-west along tramway 18534, towards the Bronze Age open-cut (18531) obscured by conifer crop. (August 2000)

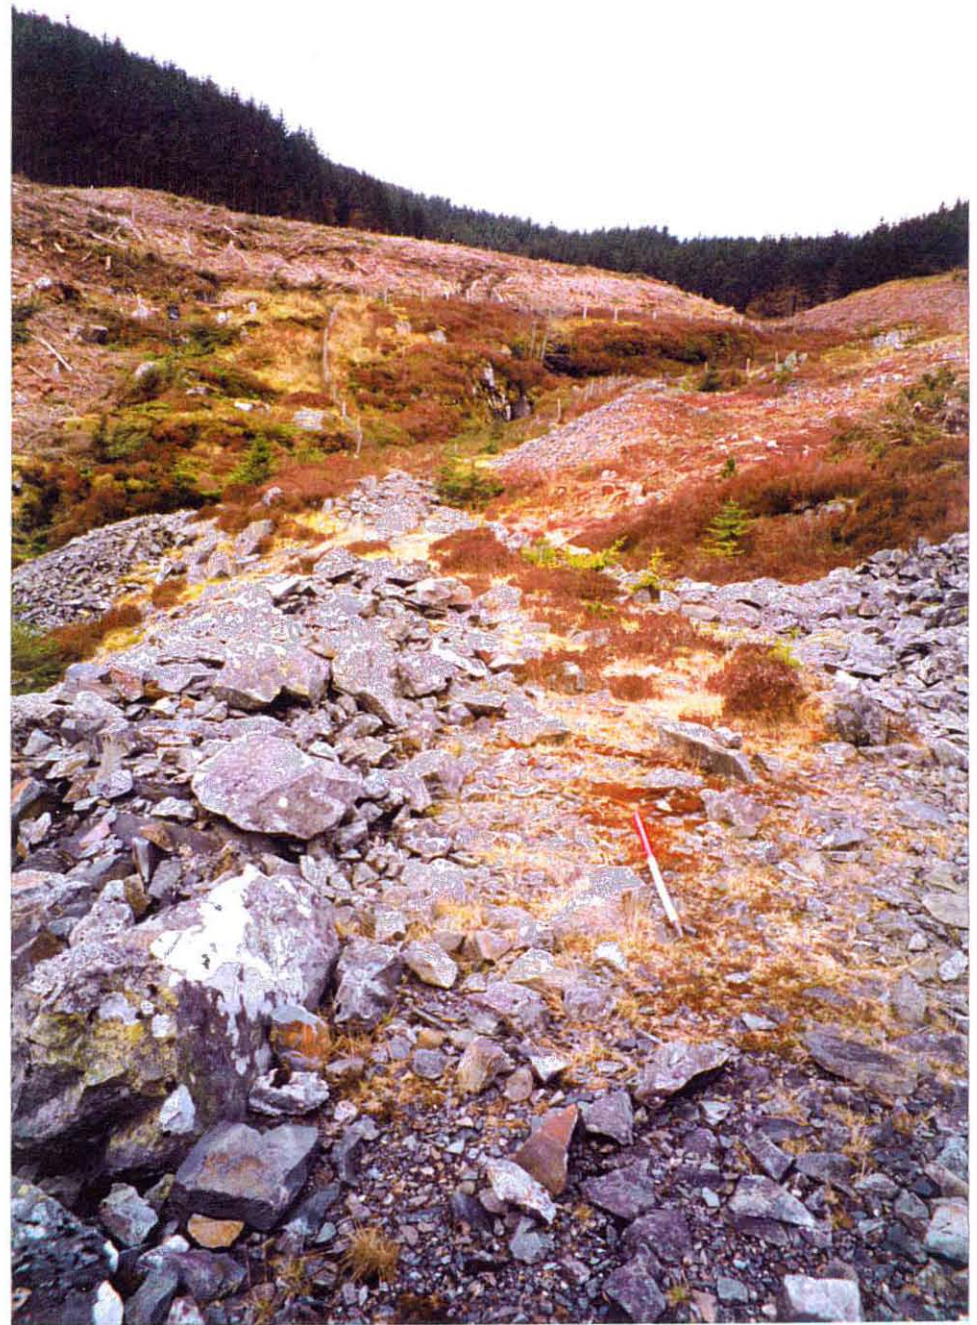
Plate 16: View north-west following harvesting, which has opened up a clear view towards the open-cut. (April 2001)

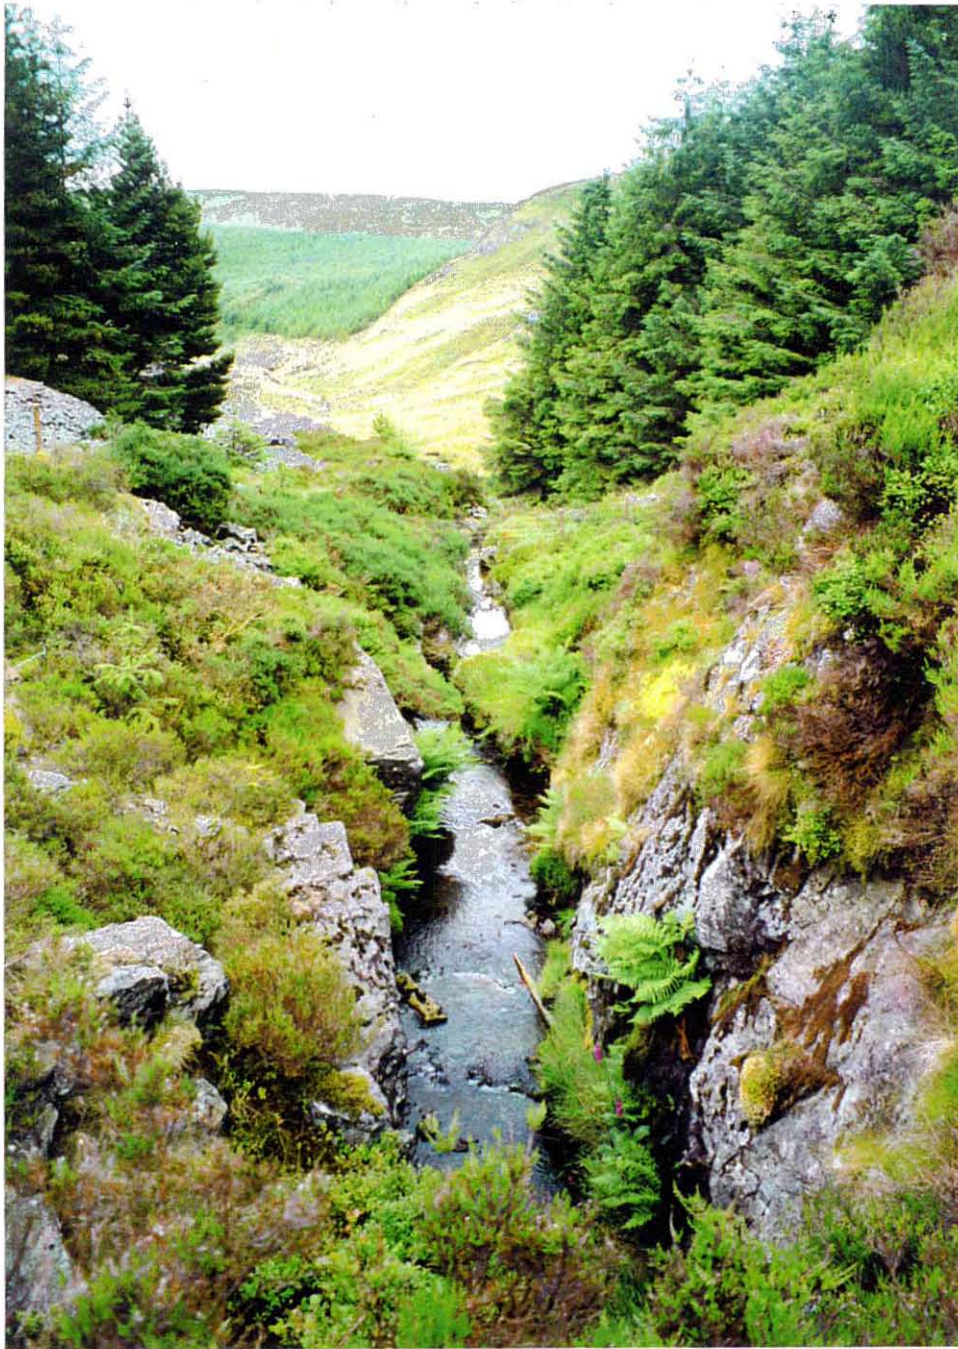
Plate 17: View south down Nant yr Eira from the open-cut workings, prior to harvesting. (August 2000)
