NANT YR EIRA MINE

HAFREN FOREST

PHOTOGRAPHIC SURVEY

PAT FROST
ARCHAEOLOGICAL
CONSULTANT
REPORT NO. 111
APRIL 2001

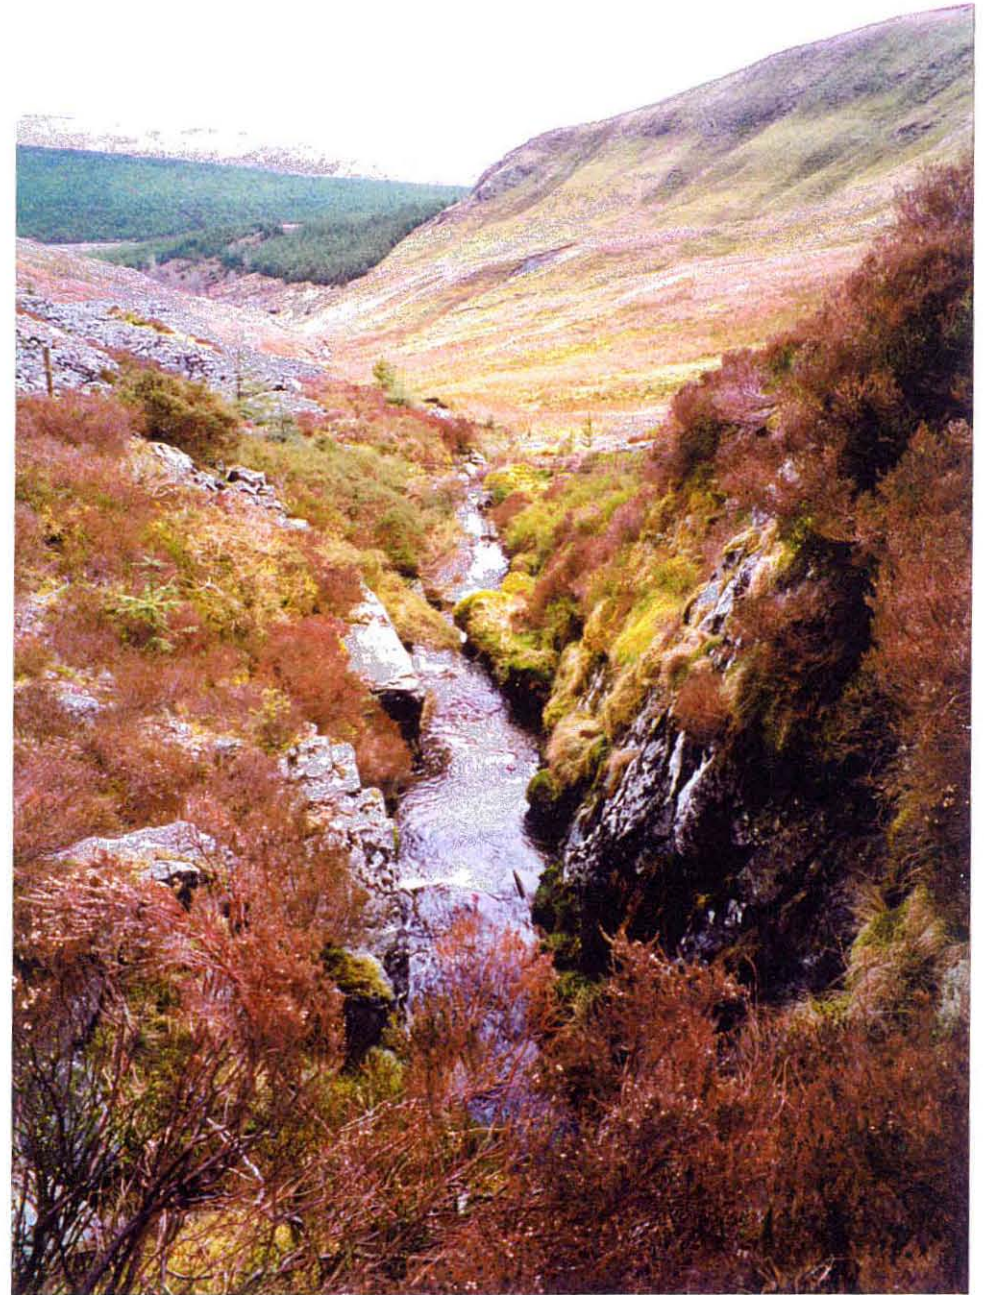
Plate 18: View south following harvesting operations. (April 2001)

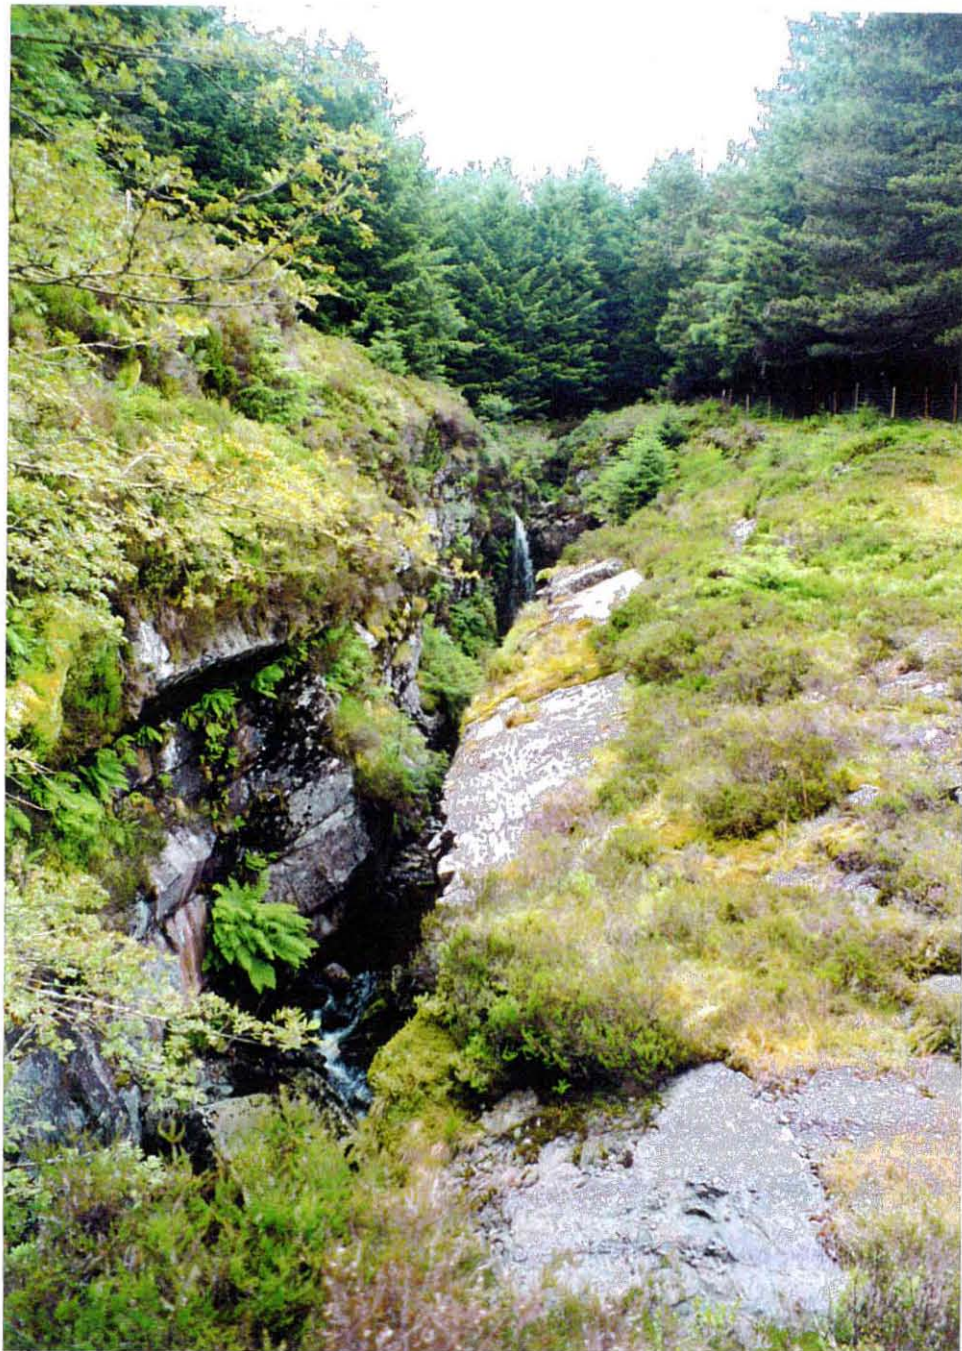
Plate 19: View north of the open-cut workings, prior to harvesting. (August 2000)

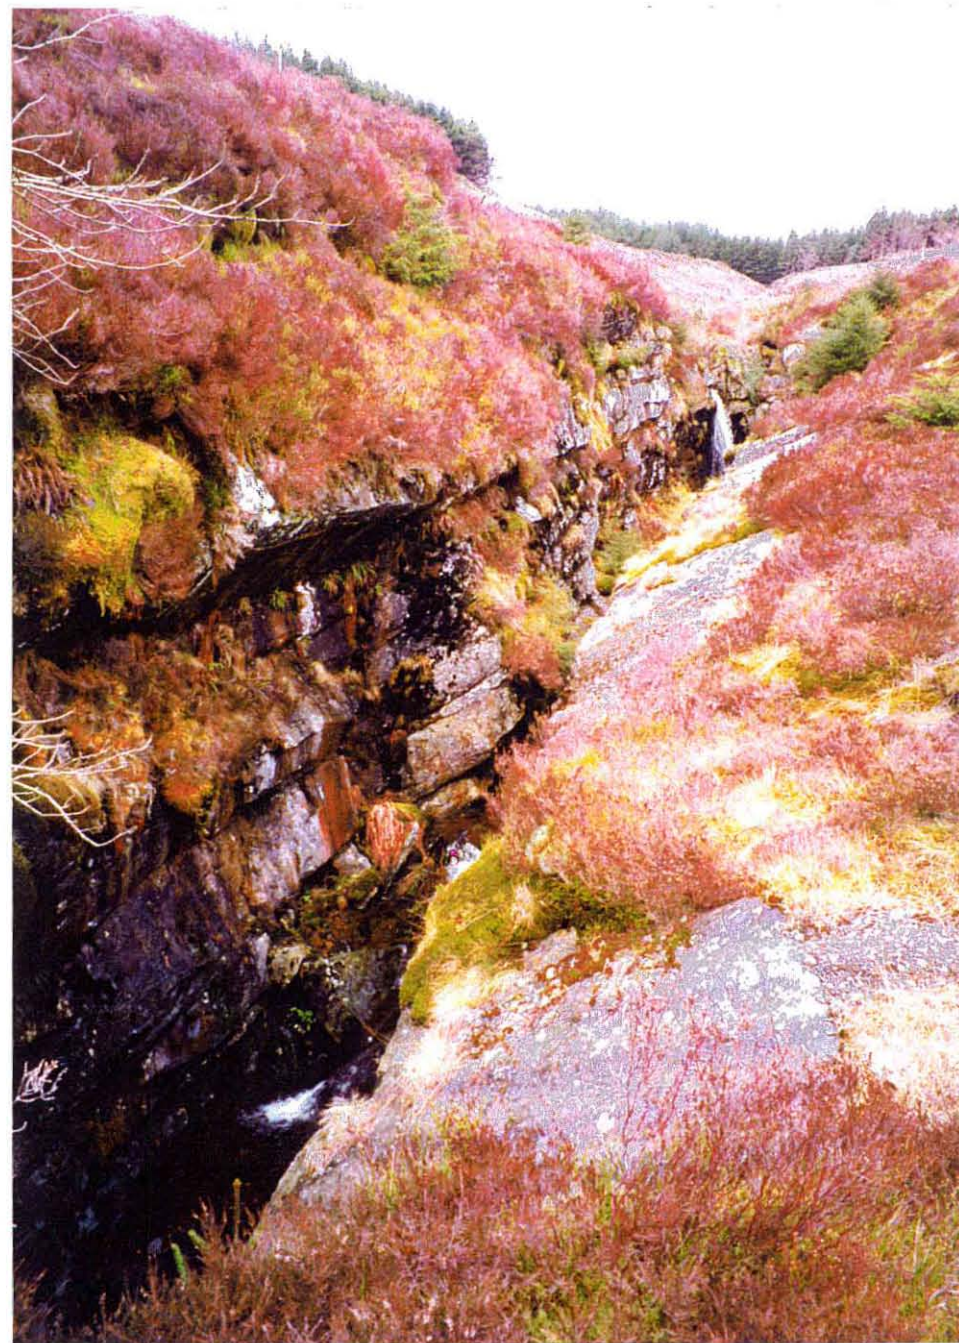
Plate 20: View north following harvesting operations. (April 2001)

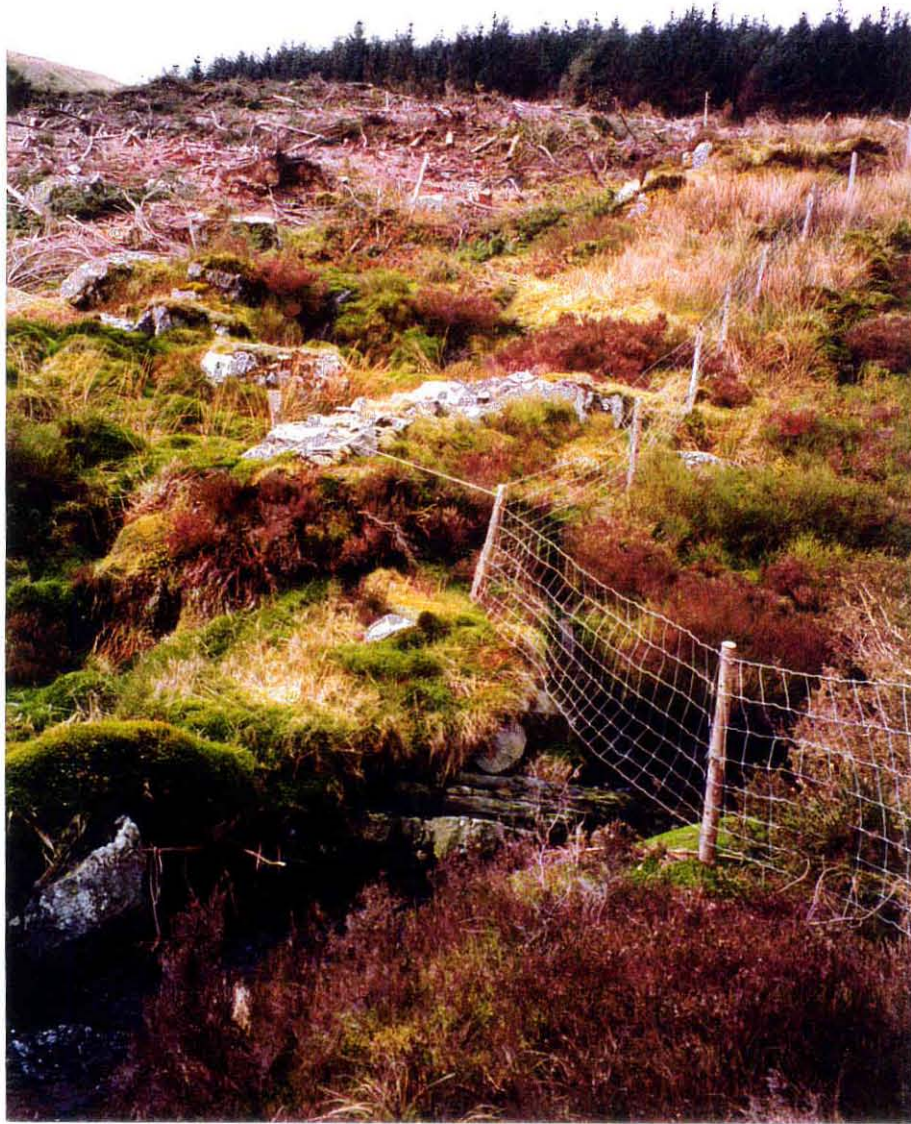
Plate 21: View west to pier base 18696, which presumably helped Transport the diverted stream across the bottom of the open cut to feed the crusher house leat. Pier base no longer overshadowed by conifers. (April 2001)

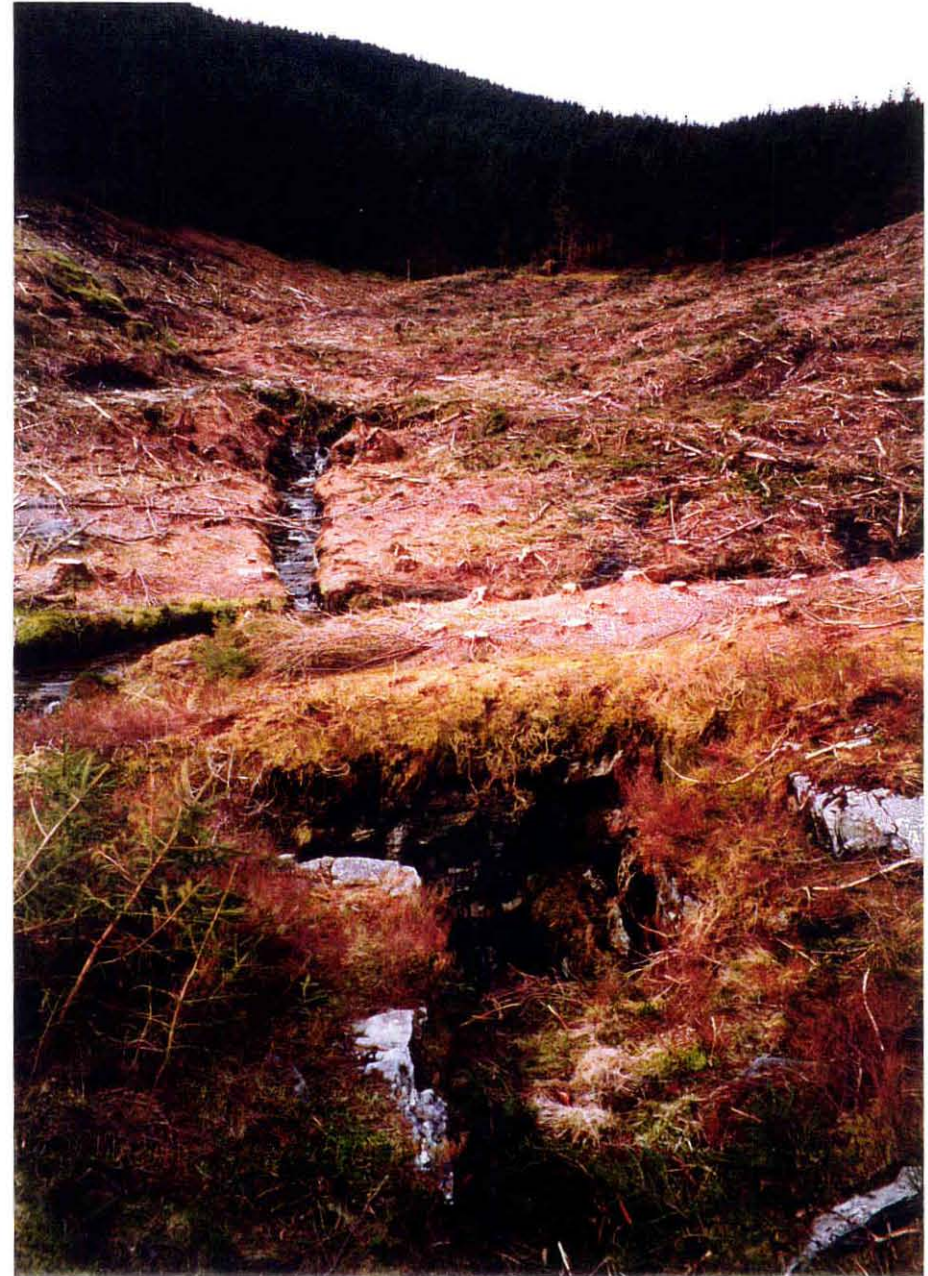
Plate 22: View west from north end of open-cut shows confluence of north-south and west-east flowing streams in area of 'rock bridge' (April 2001)

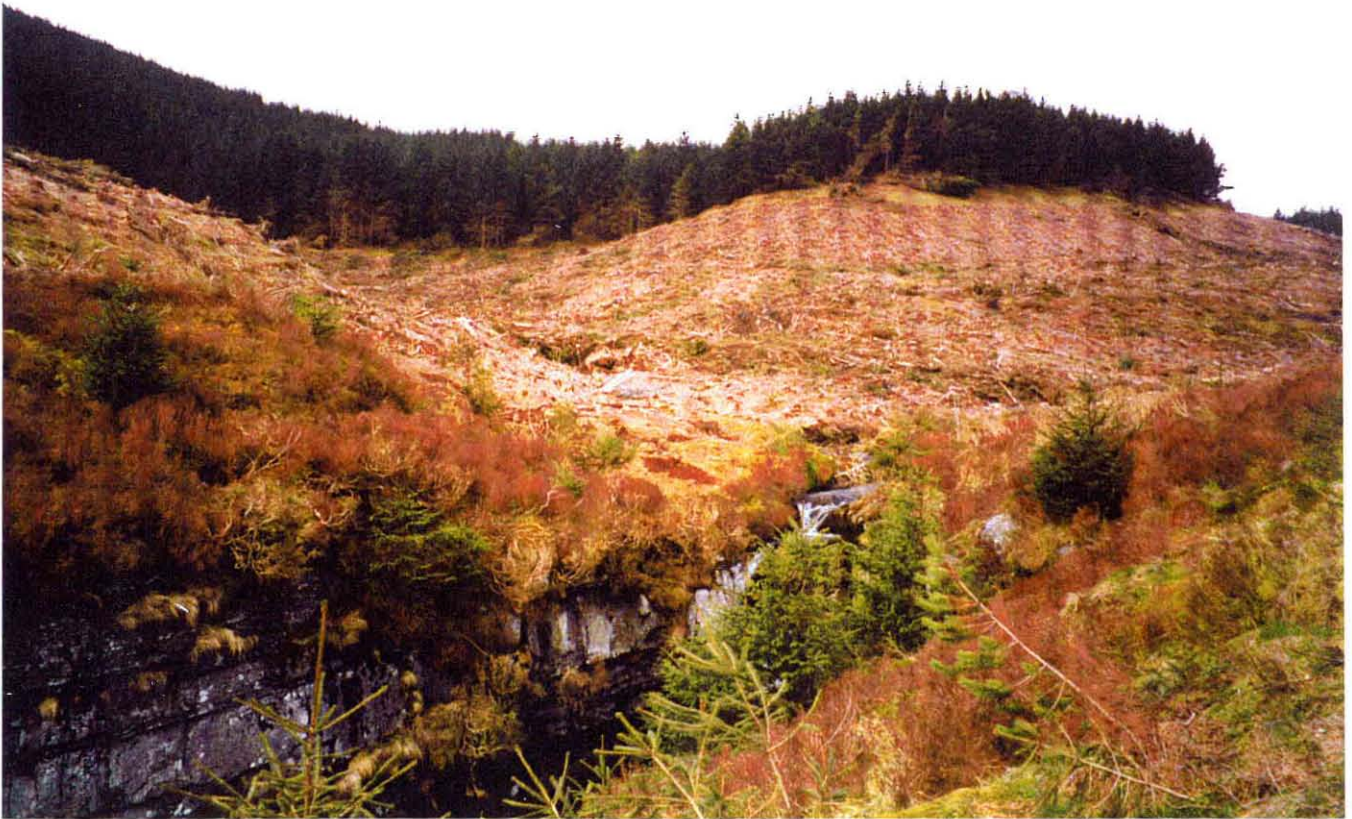
Plate 23: View to north-west over top of open-cut towards the large area of clearfell.

The clearfell operations have opened up in particular the area around the Bronze Age open-cut (18531) and the reservoir (20899). The north side of the cut was previously obscured from view.
(April 2001)

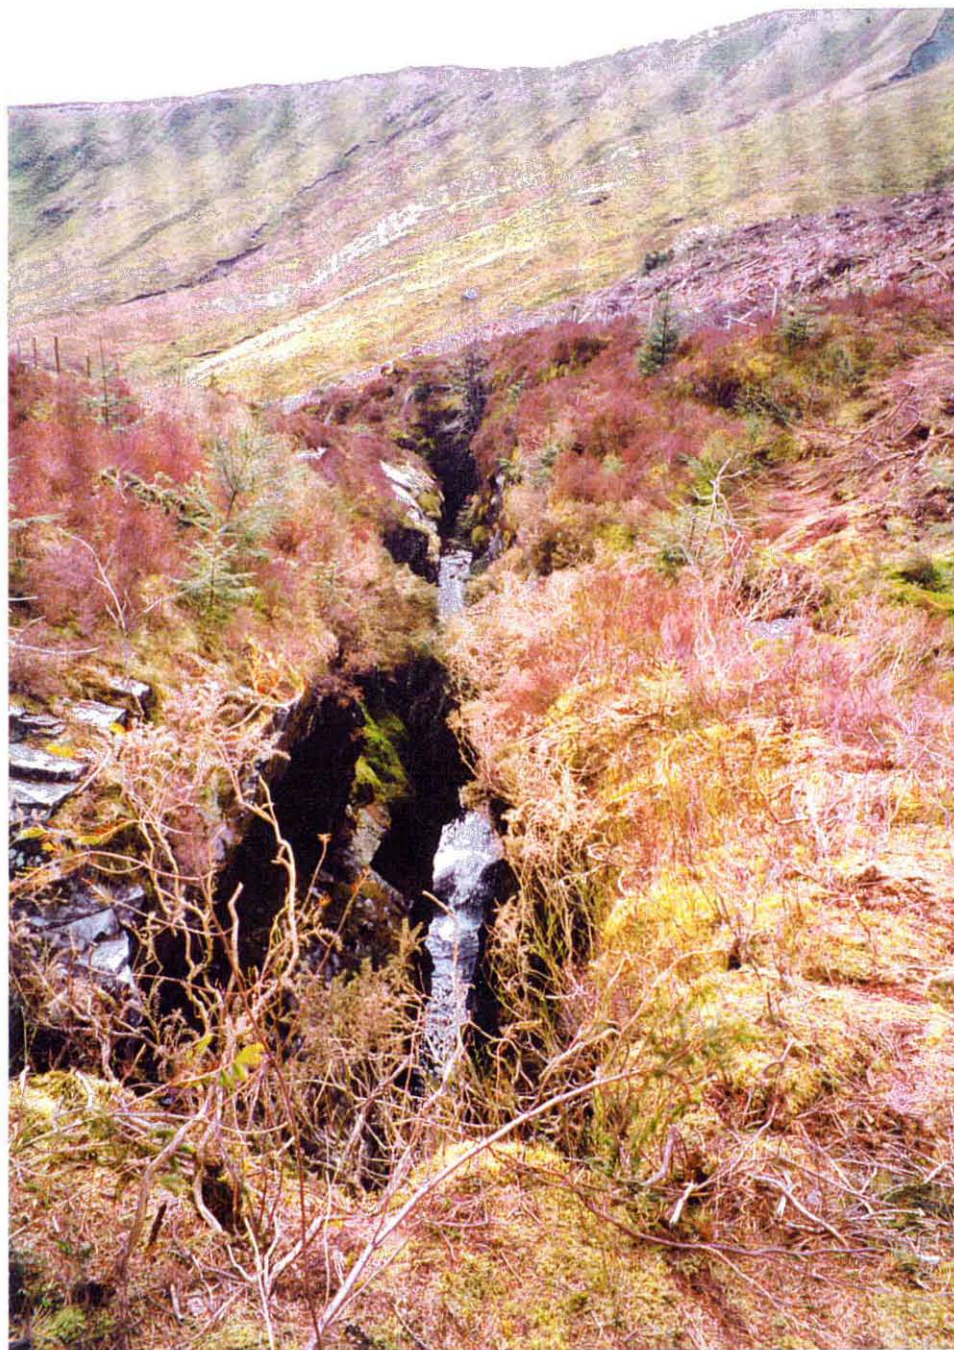
Plate: 24

View to south into north end of Bronze Age open-cut workings (18521), following harvesting. View had previously been obscured by the overhanging conifer crop.

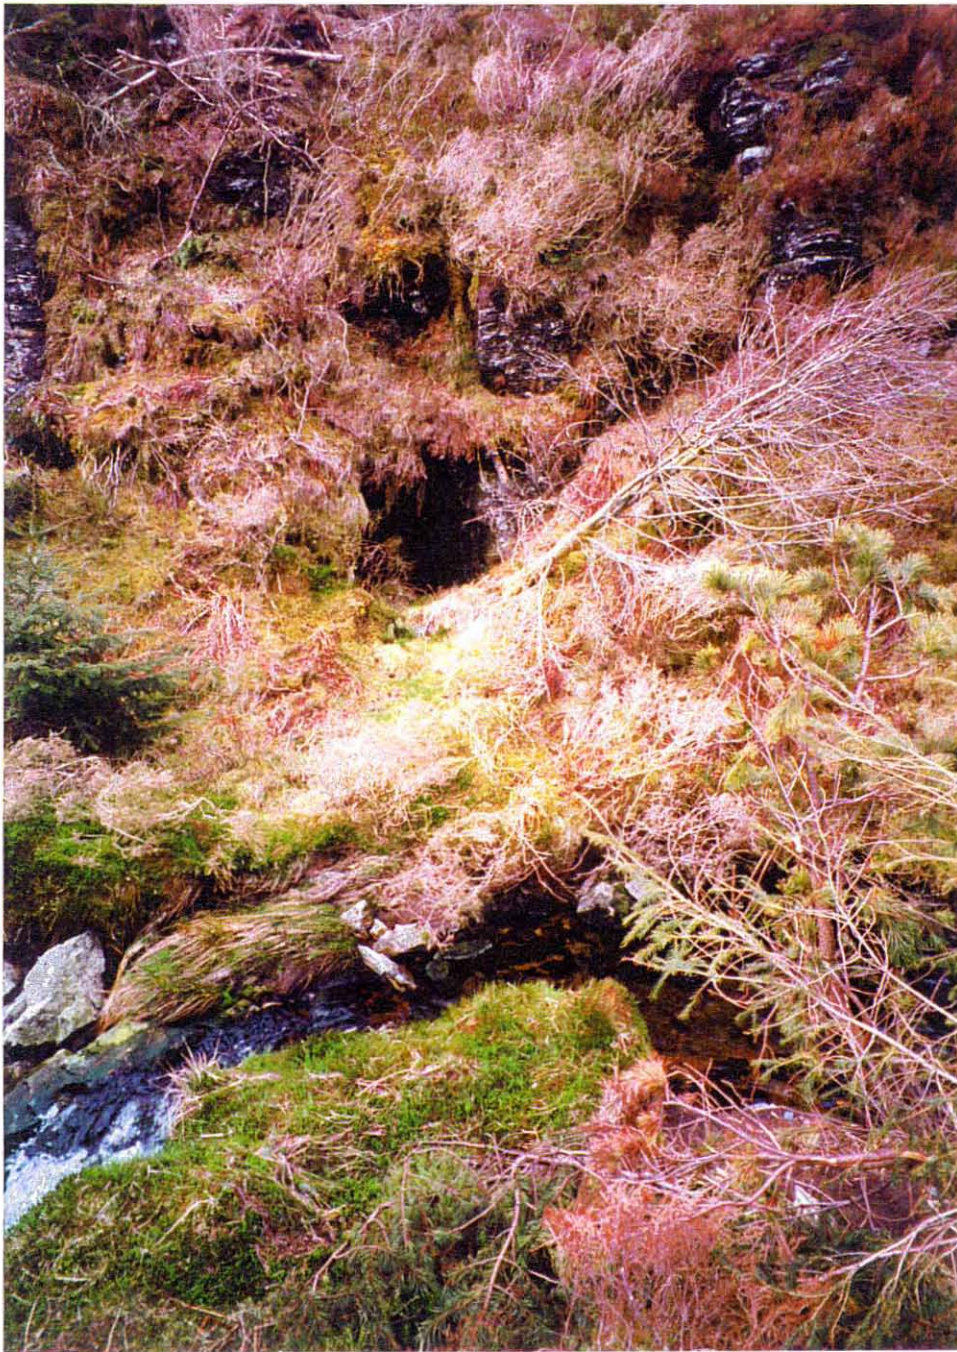
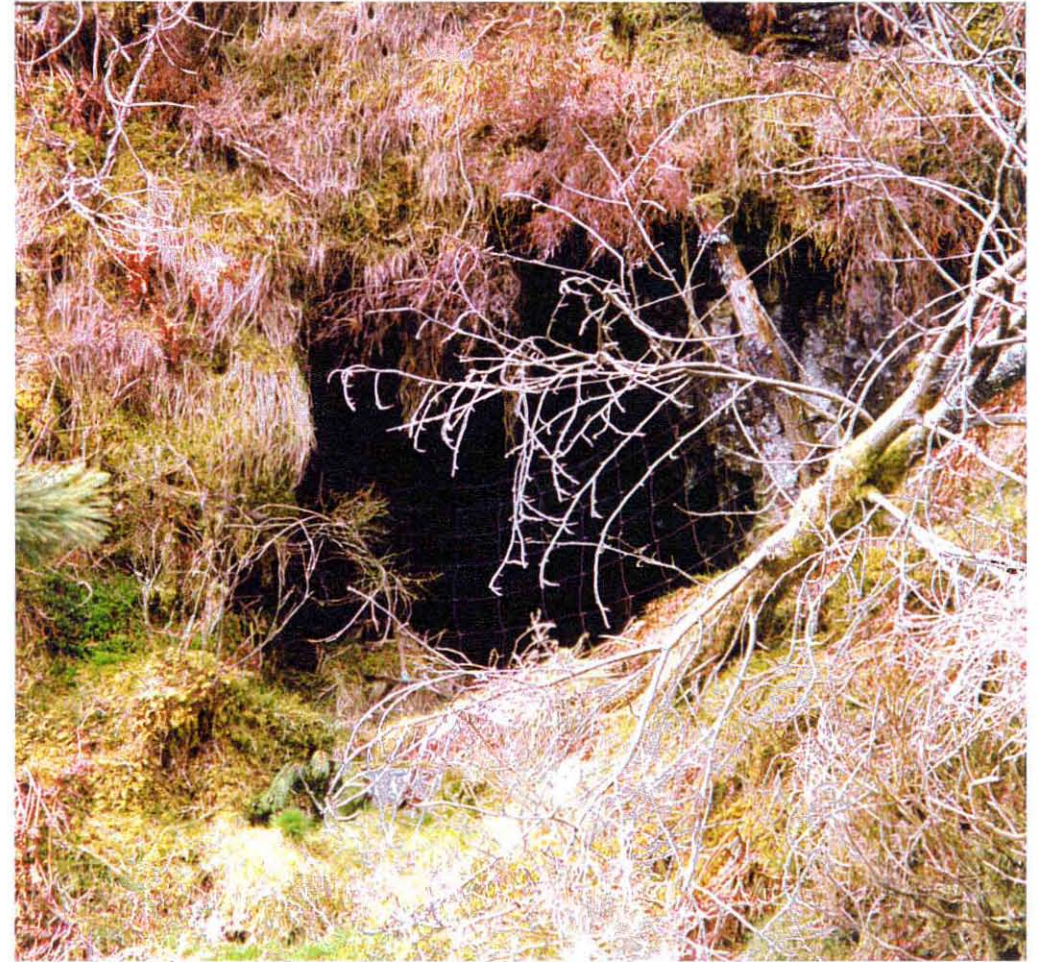
Plates 25 & 26: View west to rock-cut level 15117; cut in west on the right bank of the stream, following removal of overhanging conifer crop. Level located downstream of the dam wall. (April 2001)

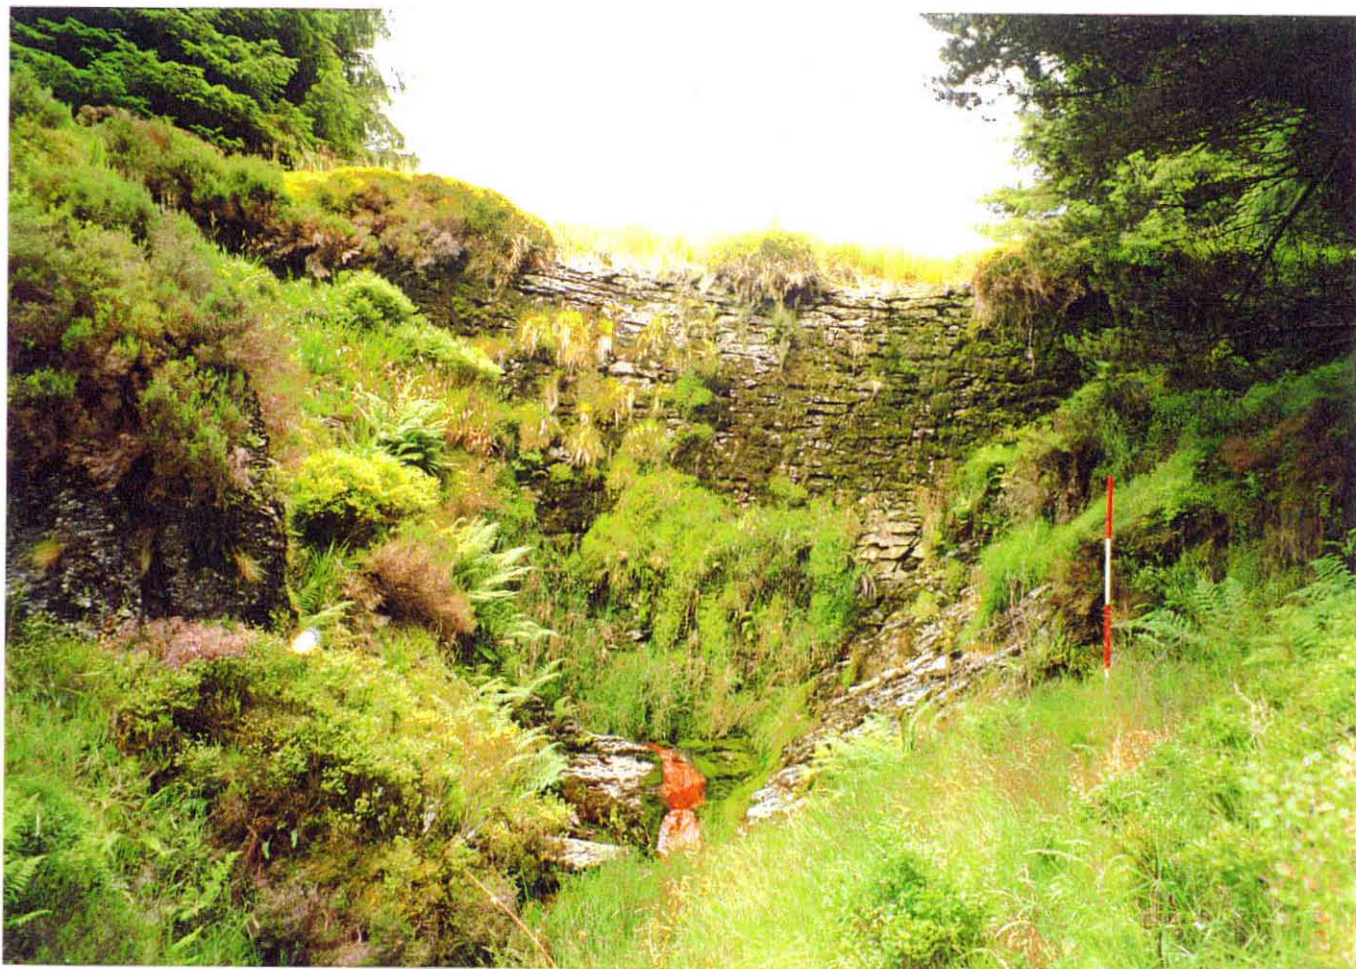
Plate 27 *above*: View north of Reservoir dam wall (20899), prior to harvesting. (August 2000)

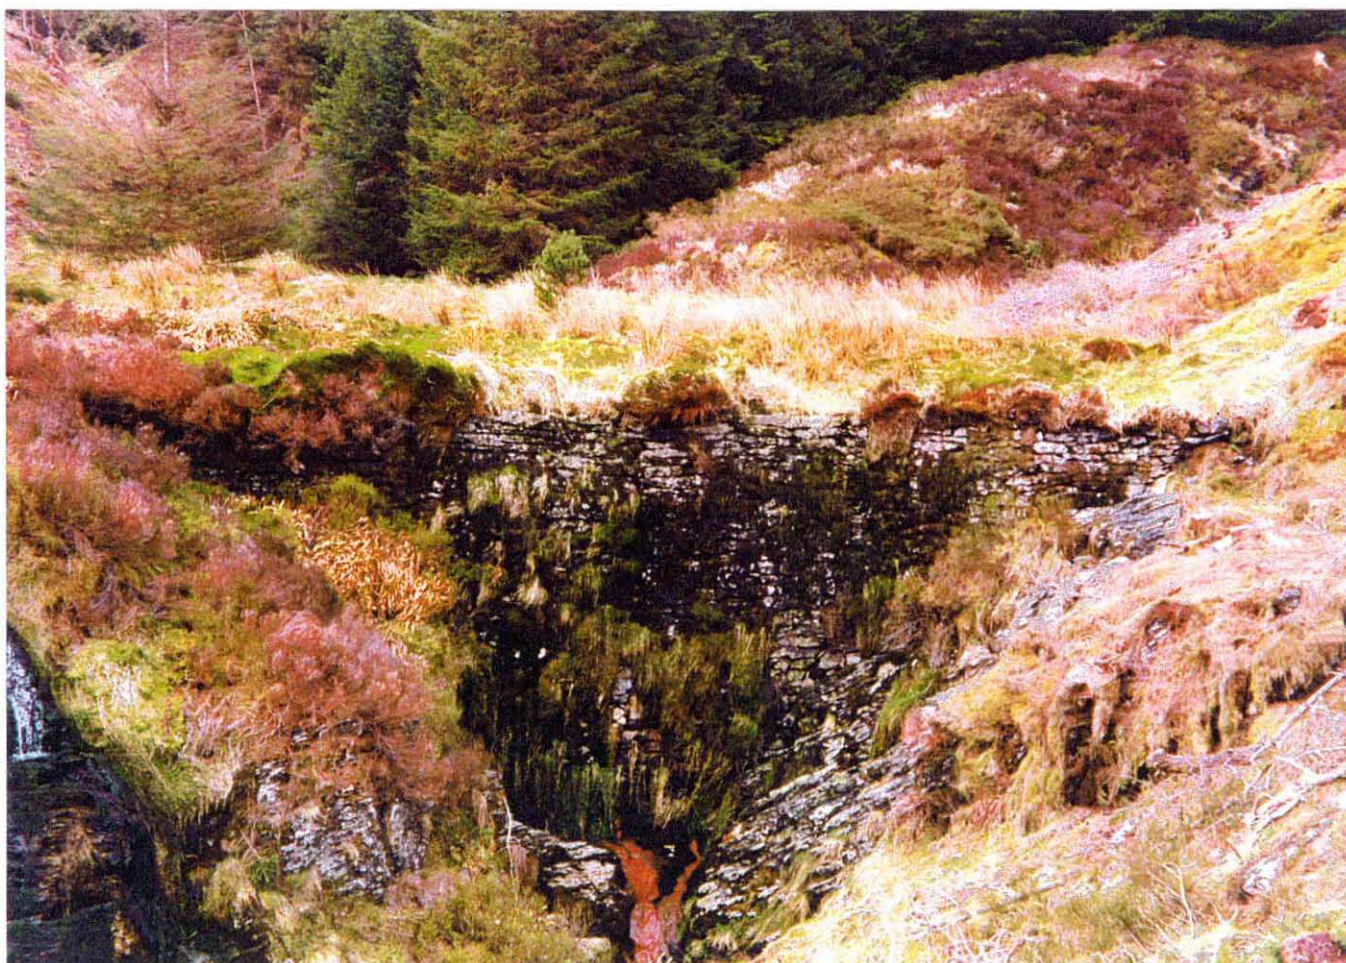
Plate 28 *below*: View following harvesting, which has removed the crop which was threatening the structure of the dam. (April 2001)

- 5.4 The prevention of damage to the dam wall has been aided by the removal of the conifer crop, which was threatening the structure.
- 5.5 Hafren Forest is a popular recreational area. The mine site is depicted on the picnic area notice board and a trail is planned to include a visit to the mine site, which had already been on the route of a forest trail, although access had become extremely difficult through the mature crop. Cadw had considered that the proposed plan to clear the trees from the site would be of long term benefit to the monument. Following harvesting, the site will be maintained on open ground.

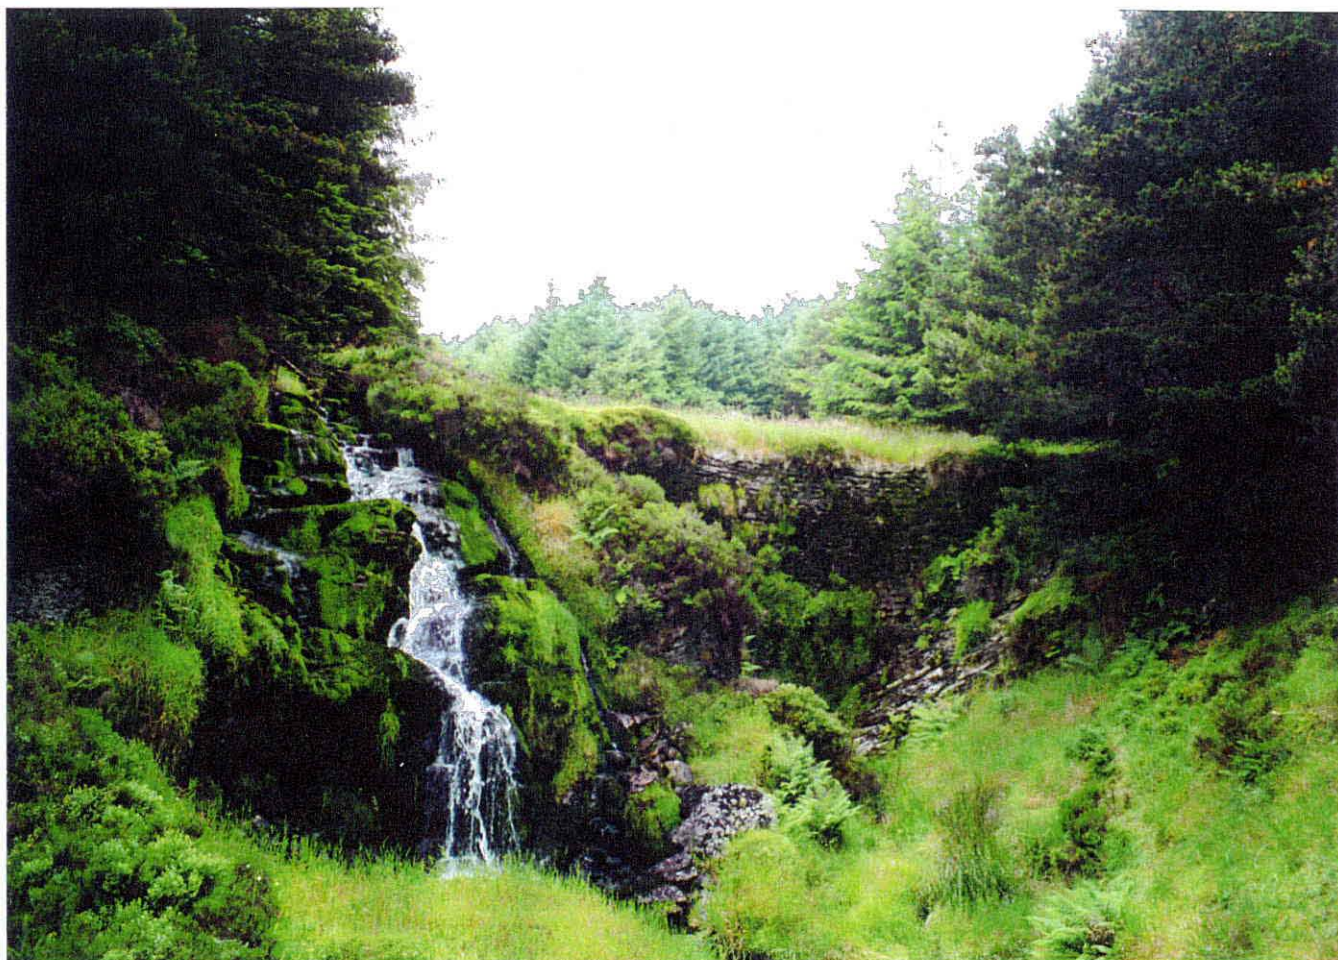
Plate 29 *above*: View north to reservoir dam wall (20899), prior to clearfell. Conifer crop can be seen to be in close proximity to the structure, particularly on the right (east side). (August 2000)

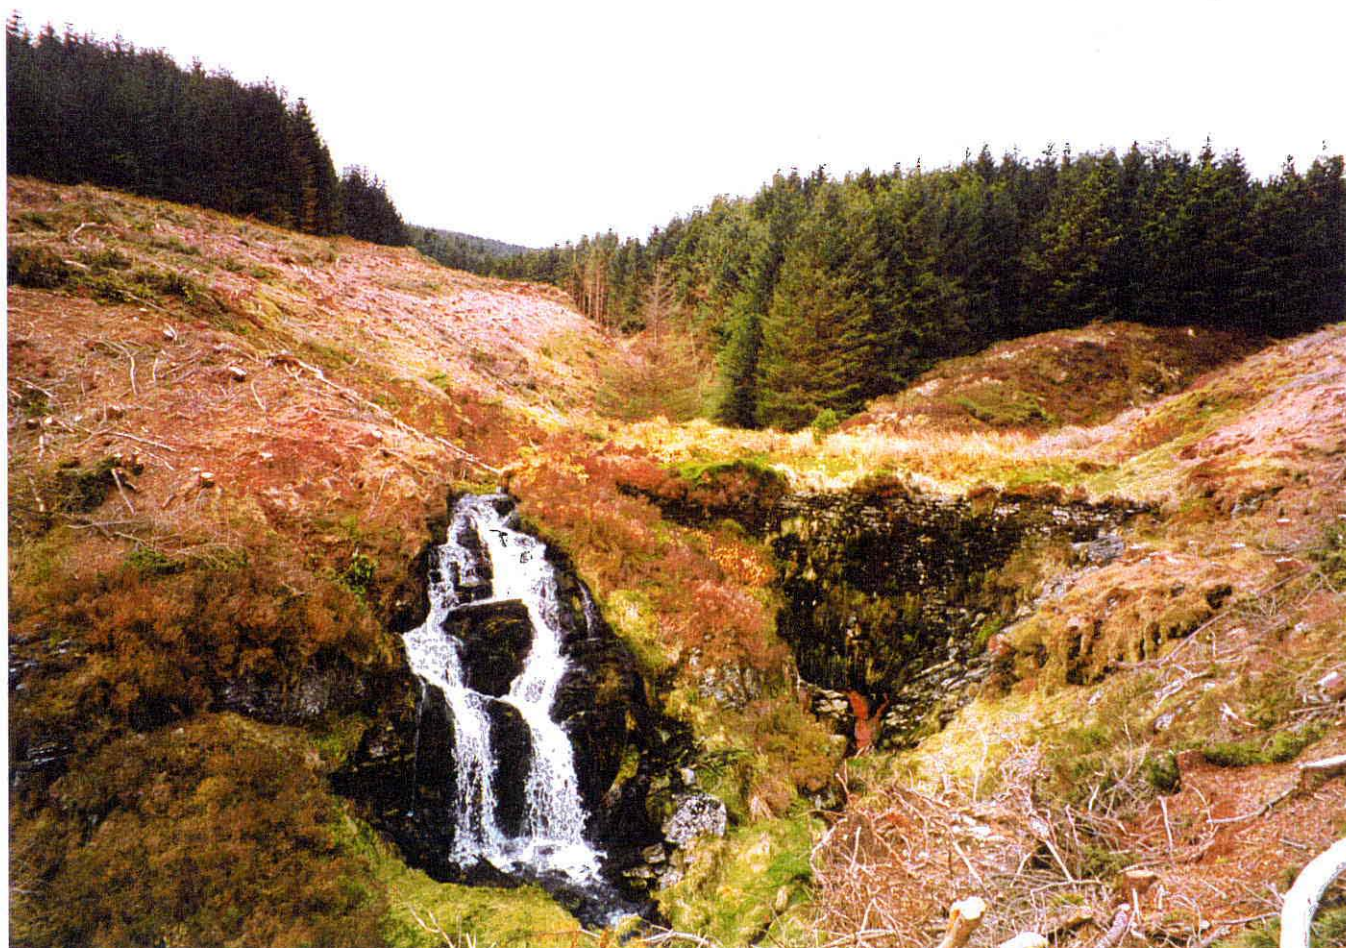
Plate 30 *below*: View north, as above, following harvesting operations. (April 2001)

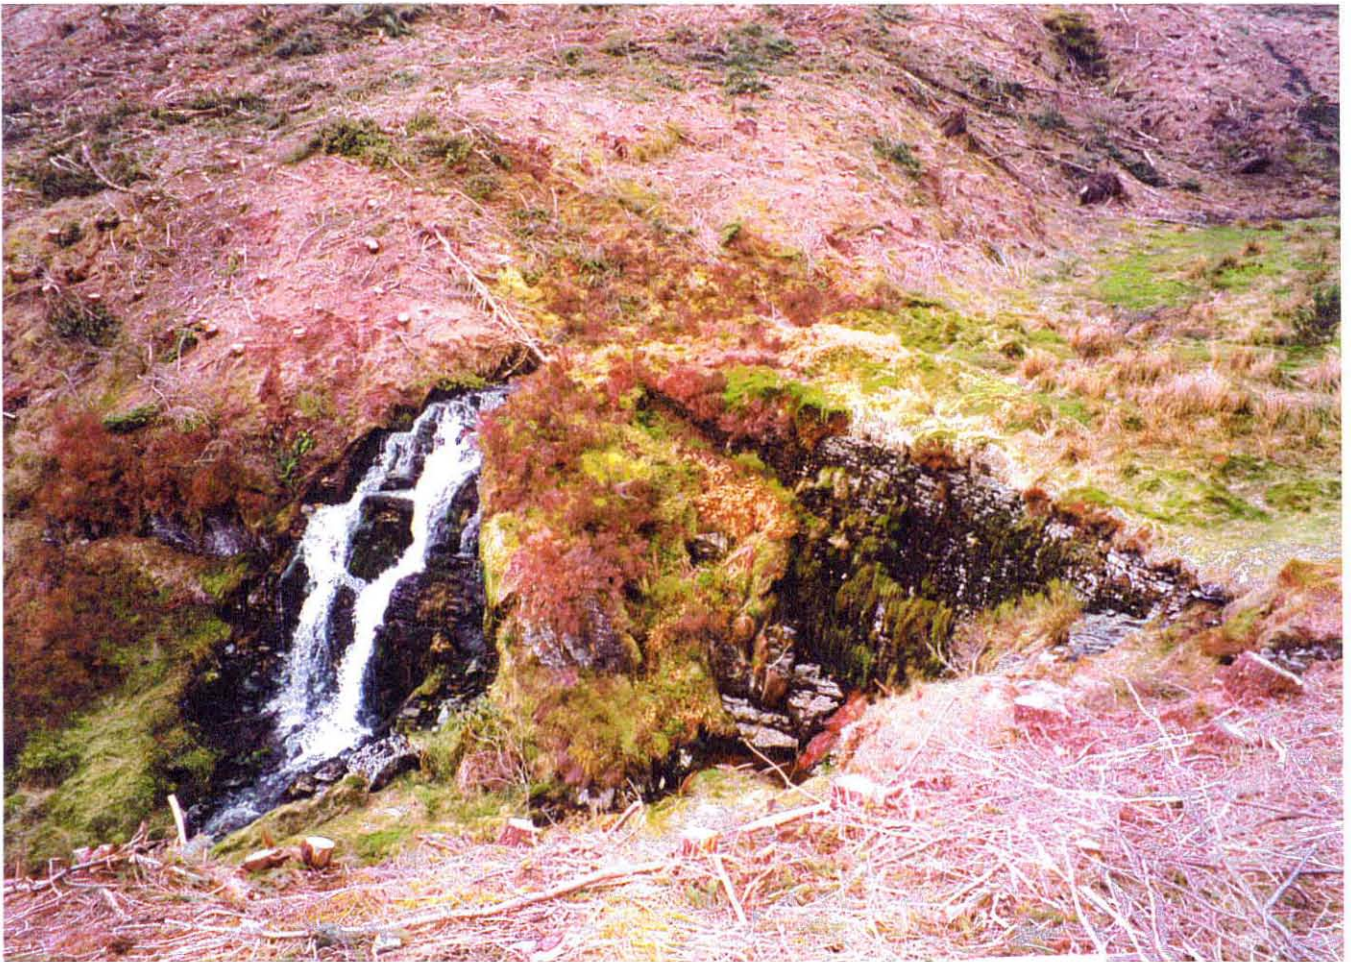
Plate 31 *above*: View west across the reservoir and dam wall (20899), following harvesting operations, which have removed the threat to the structure of the dam. (April 2001)

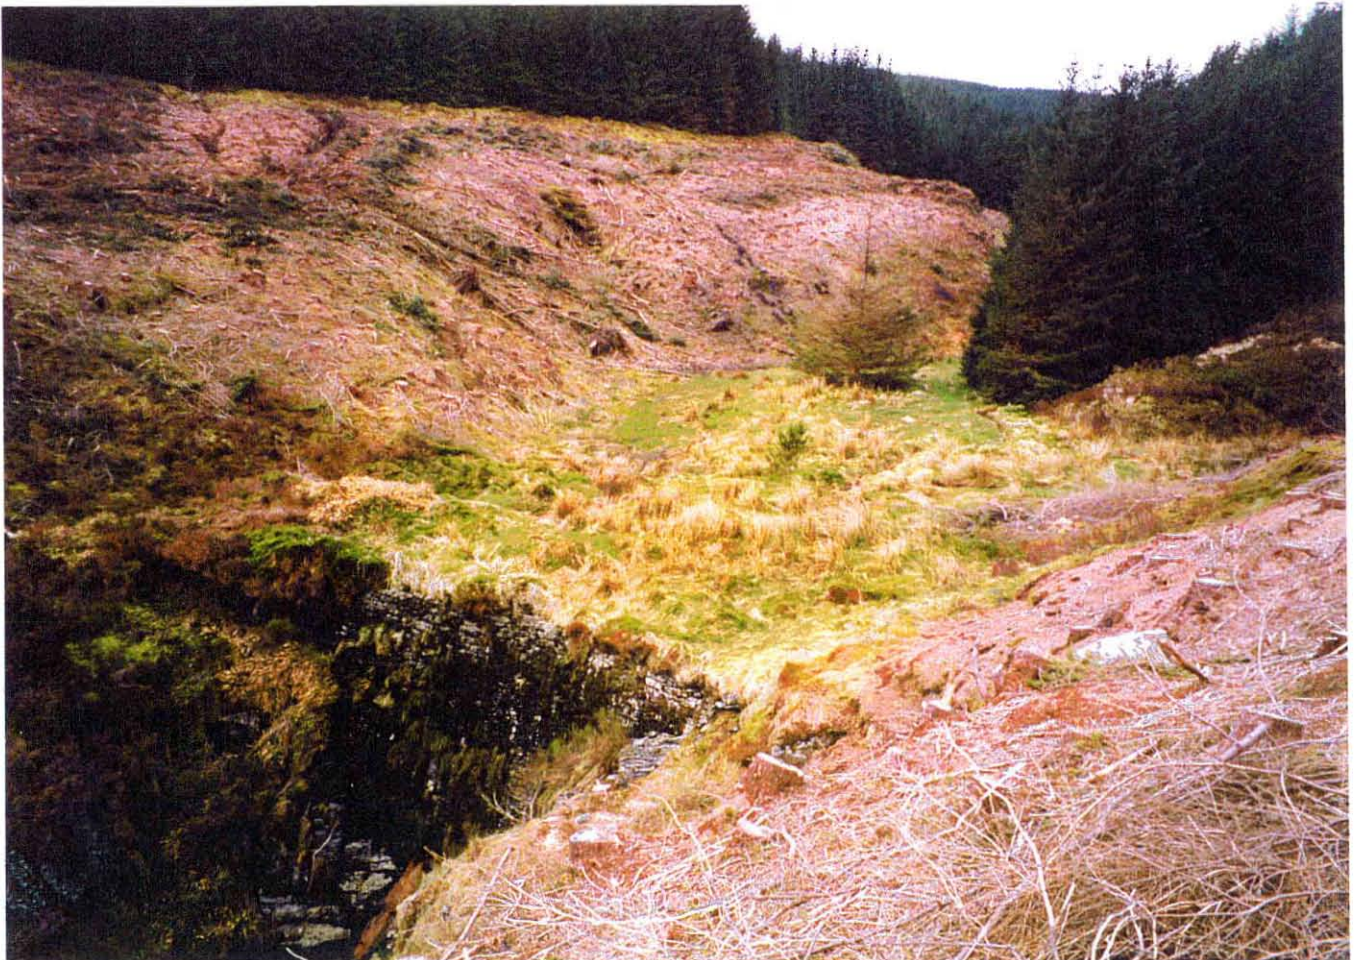
Plate 32 *below*: View west, following harvesting operations, showing reservoir now displayed on open ground. (April 2001)
