CAMBRIAN MOUNTAINS ESA, HISTORIC MONITORING

BASELINE 1995

OS 1:10000 SHEET: ~~SO/SH~~/SN 75	GRID REF: ~~SO/SH~~/SN 7770 5380
PRN: 9112 SITE NAME: Bryn – Brith	
AIR PHOTO No 650 – 120	LANDSCAPE TYPE: Ic
No GROUND PHOTOS: 8	
DATE SURVEYED: 29/11/95	SURVEYED BY: G A HOPWOOD
ACCESS: Land owned by Jones bros, Nant Llwyd. Access via forest Enterprise track from Soar - y- Mynydd.

PRN 9112

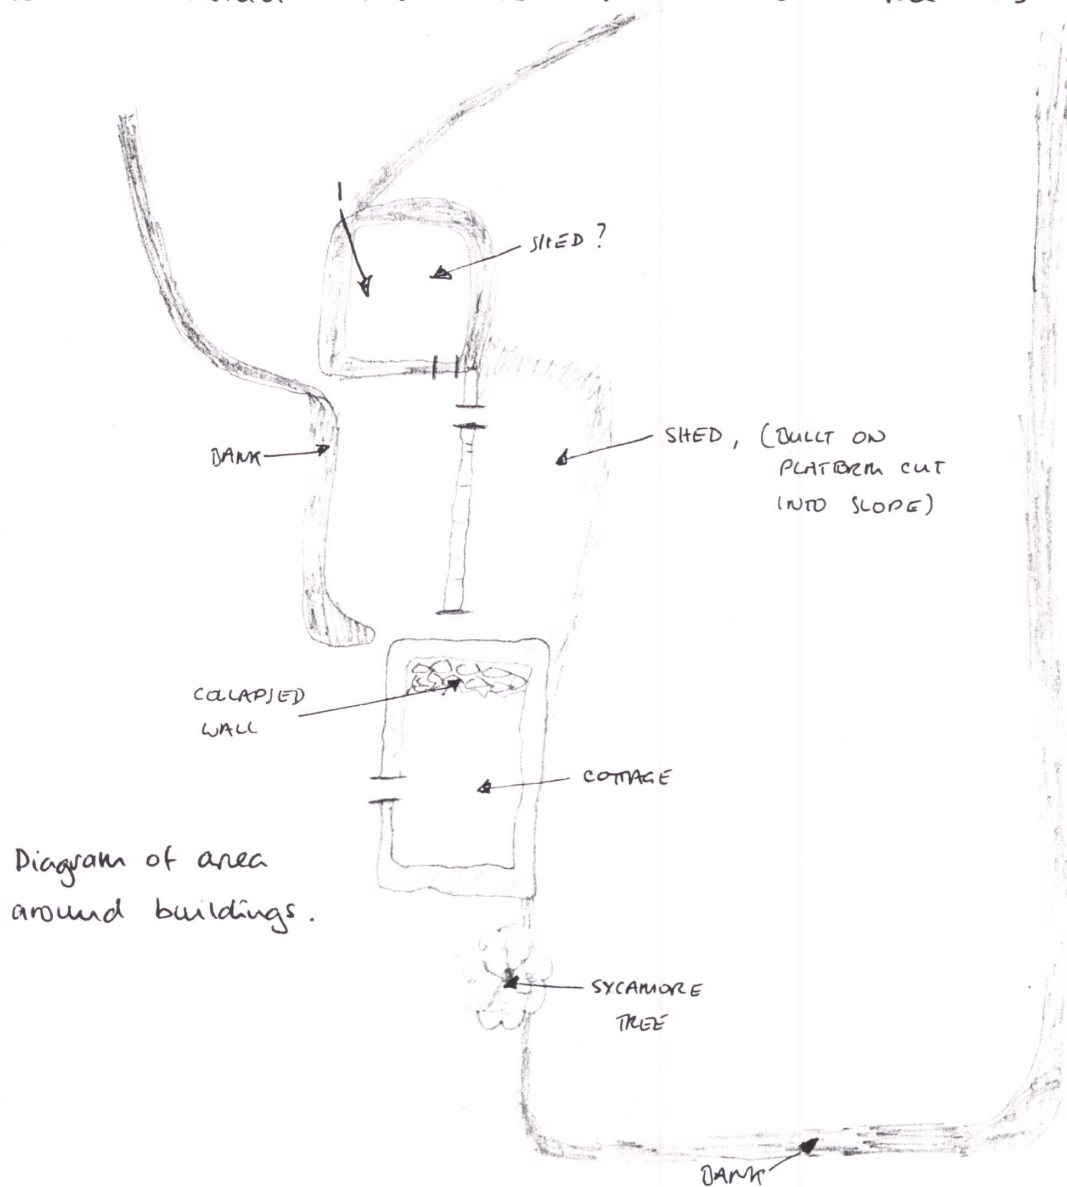
Diagram of area around buildings.

Walls of cottage still visible and up to 1.5m in height. Entrance still obvious but no other internal/external features have survived. Dry stone construction. Remains of shed? next to cottage with obvious

2 doorways still ₀ visible. Walls no longer standing but foundations visible. Remains of other building approx 25m ESE, not shown on OS map. Banks around fields in surprisingly good condition, not stockproof but up to 1m high in places. Coniferous plantation has encroached onto part of the site. Line of banks not obvious in wetter areas but the enclosures appear to be intact and as shown on the OS detail.
