Historic Environment Feature Management Report:

Treginnis Isaf, Well Head

Customer Reference Number: A0029530

UID: 303,431

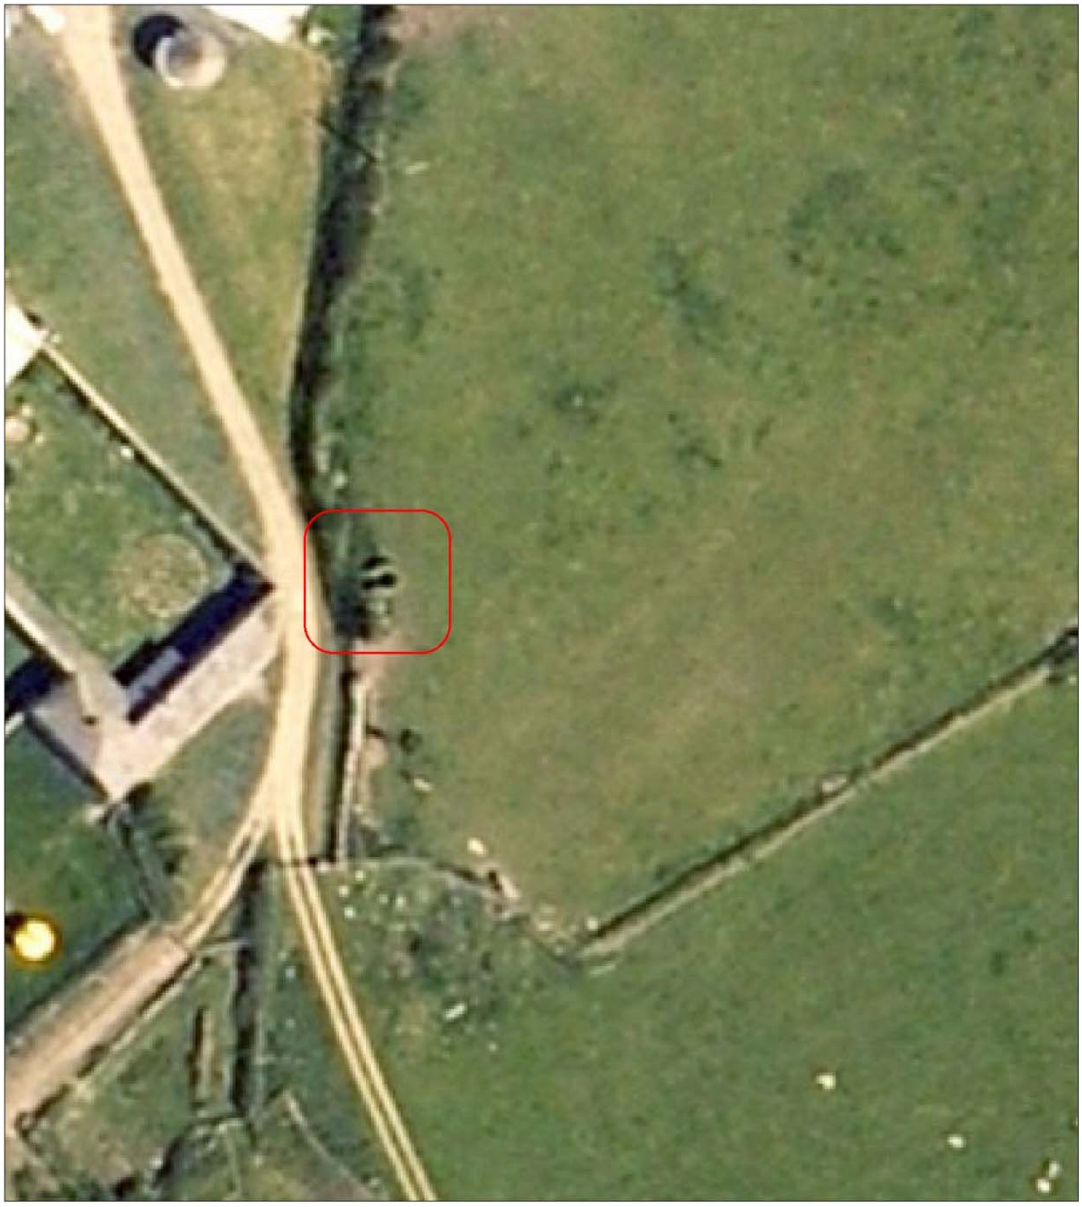
Aerial Photograph

Site Description
A well head shown on the 1st edition Ordnance Survey map (1889). It is stone built keyhole shaped structure. The most recent aerial photographs (Next Perspectives, 2009) show the structure survives in good condition. It is located at the edge of a pasture field close to a thick hedgerow which is encroaching onto the tail of the structure.

Management Issues
The main management issue is the control of invasive vegetation from the adjacent hedge which has the potential to damage built structural remains by the intrusive action of roots and the prising apart of masonry bonds. Excessive vegetation cover can also obscure the remains from view.

- Remove by hand any invasive vegetation from the structure in order to retain the visibility and stability of the structure.
- Spot treat to prevent regrowth.
- Clear and maintaina zone between the structure and the hedge line to prevent further vegetation spread
