THE SISTERS' HOUSE
MINWEAR, PEMBS
PRN 3594

AN HISTORICAL SUMMARY AND STRUCTURAL DESCRIPTION

AUGUST 1997

Report prepared for Pembrokeshire County Council
by
Neil Ludlow

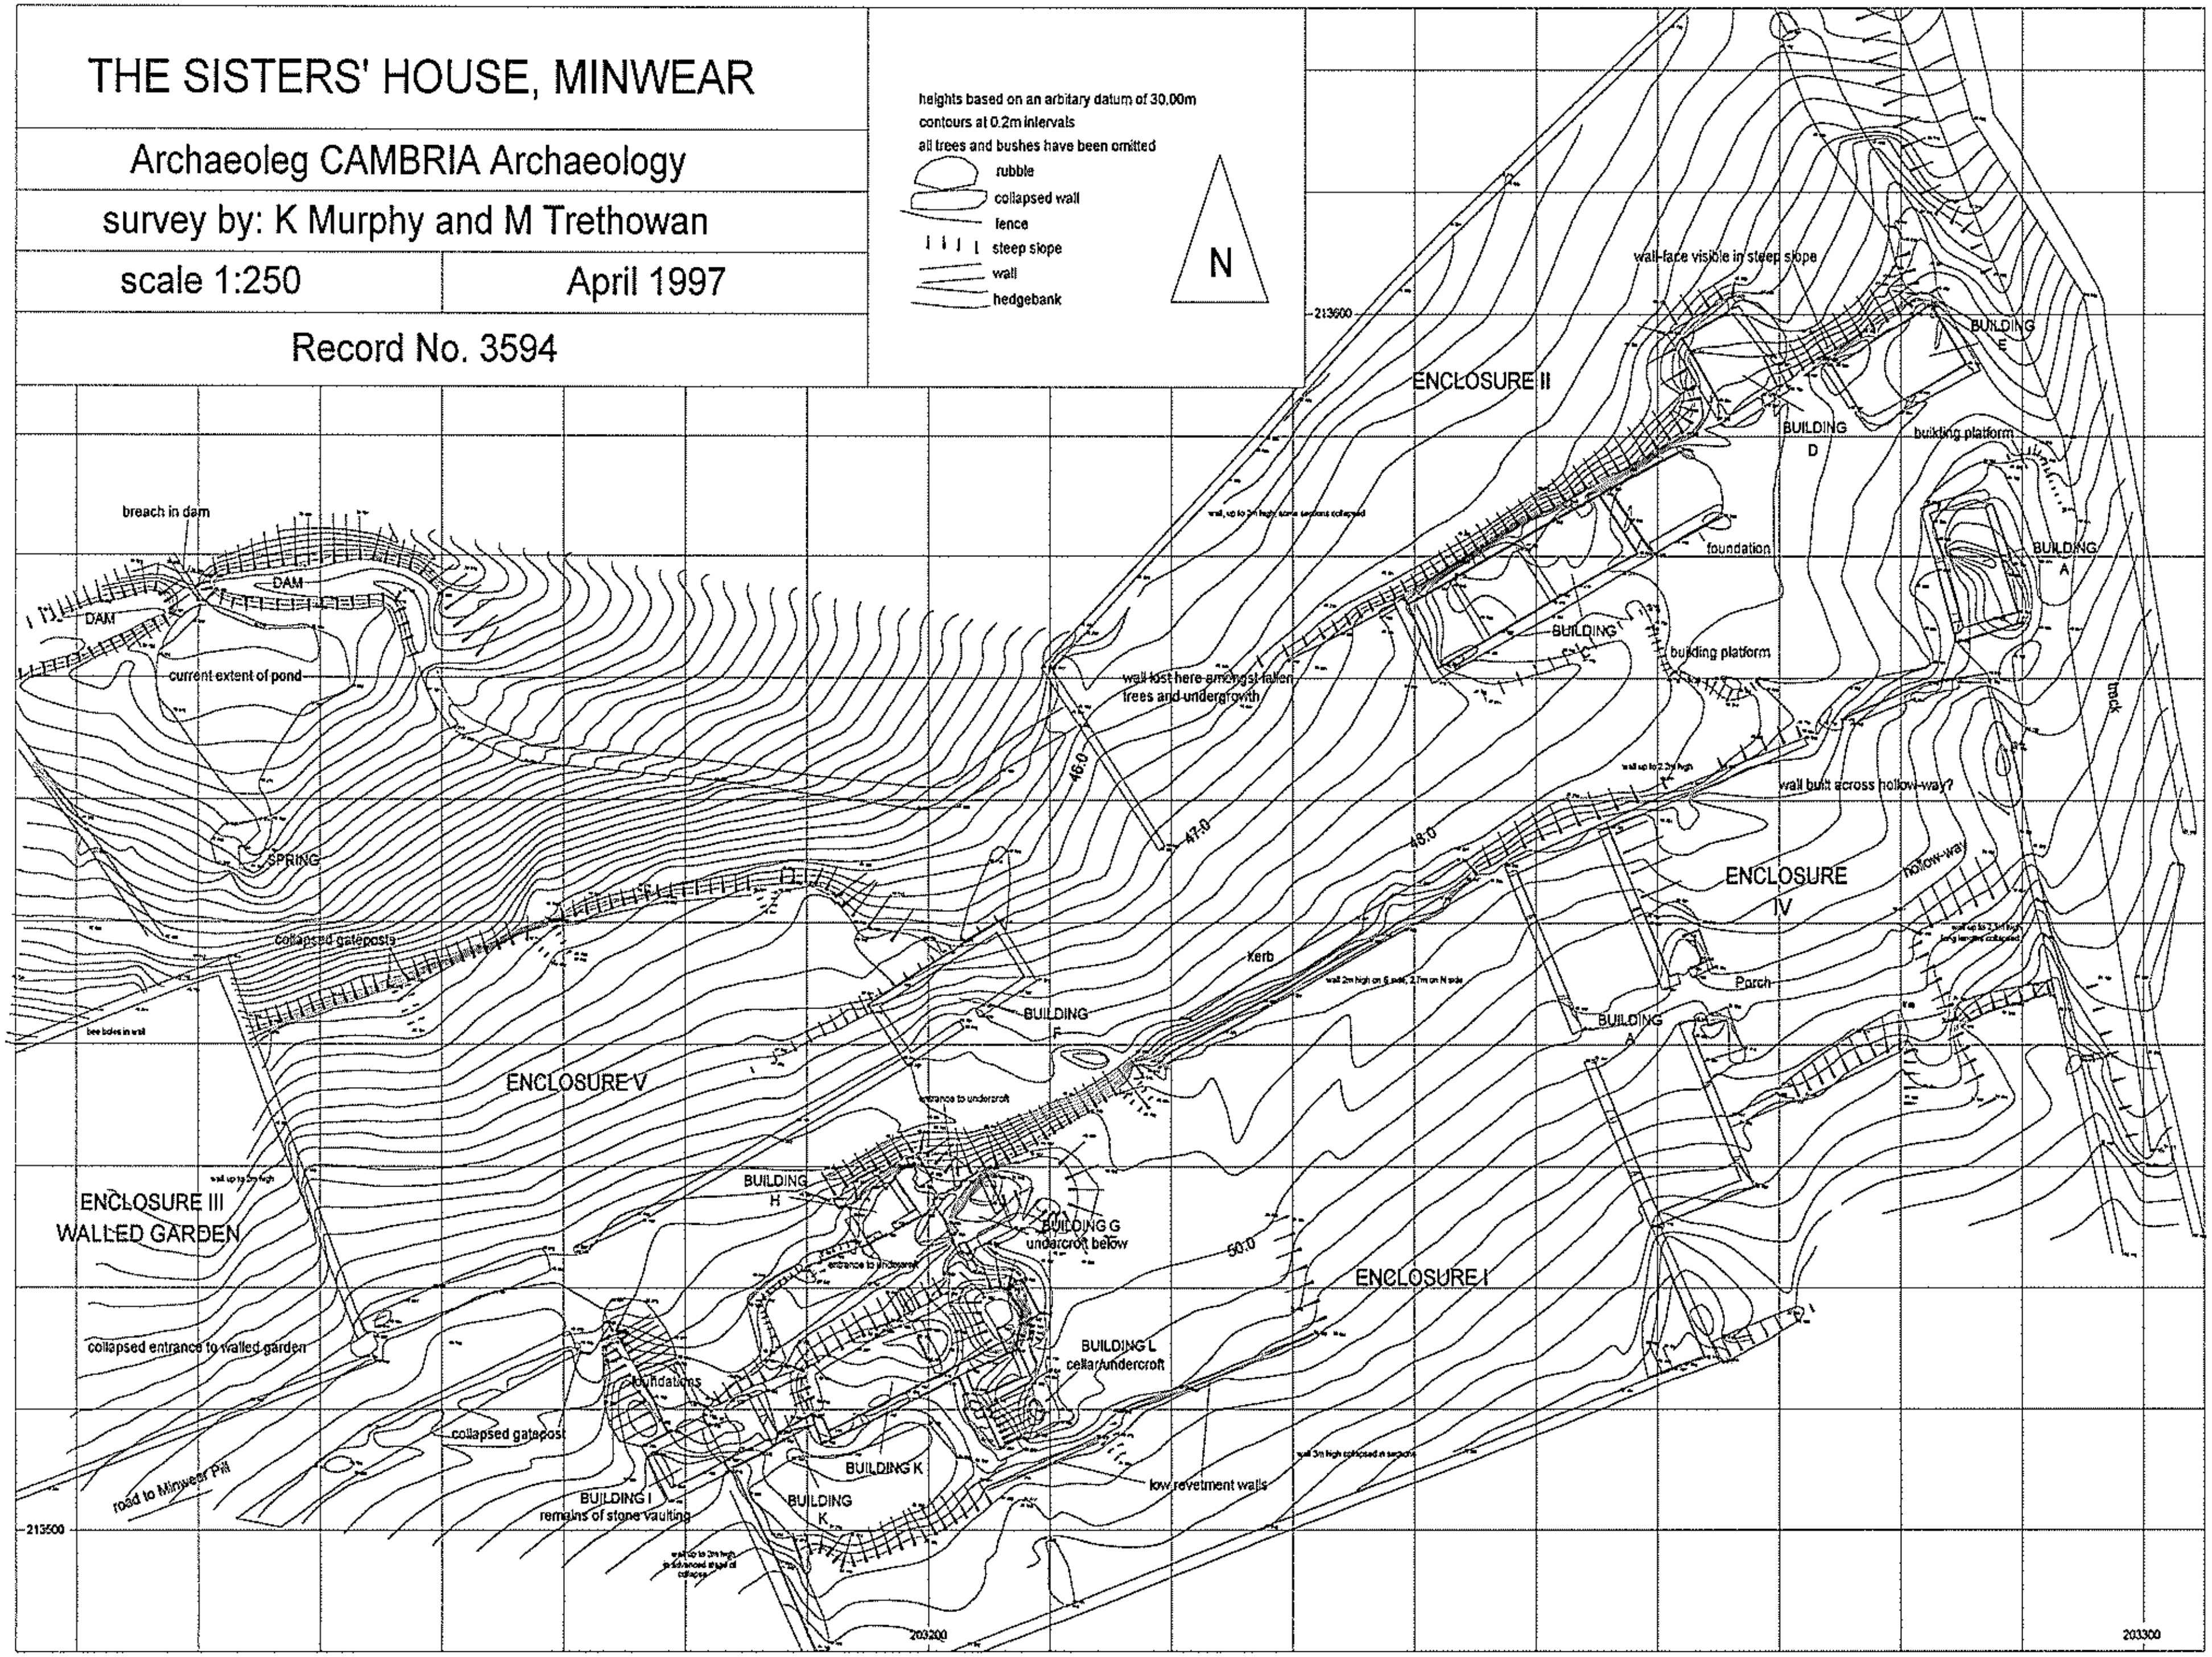
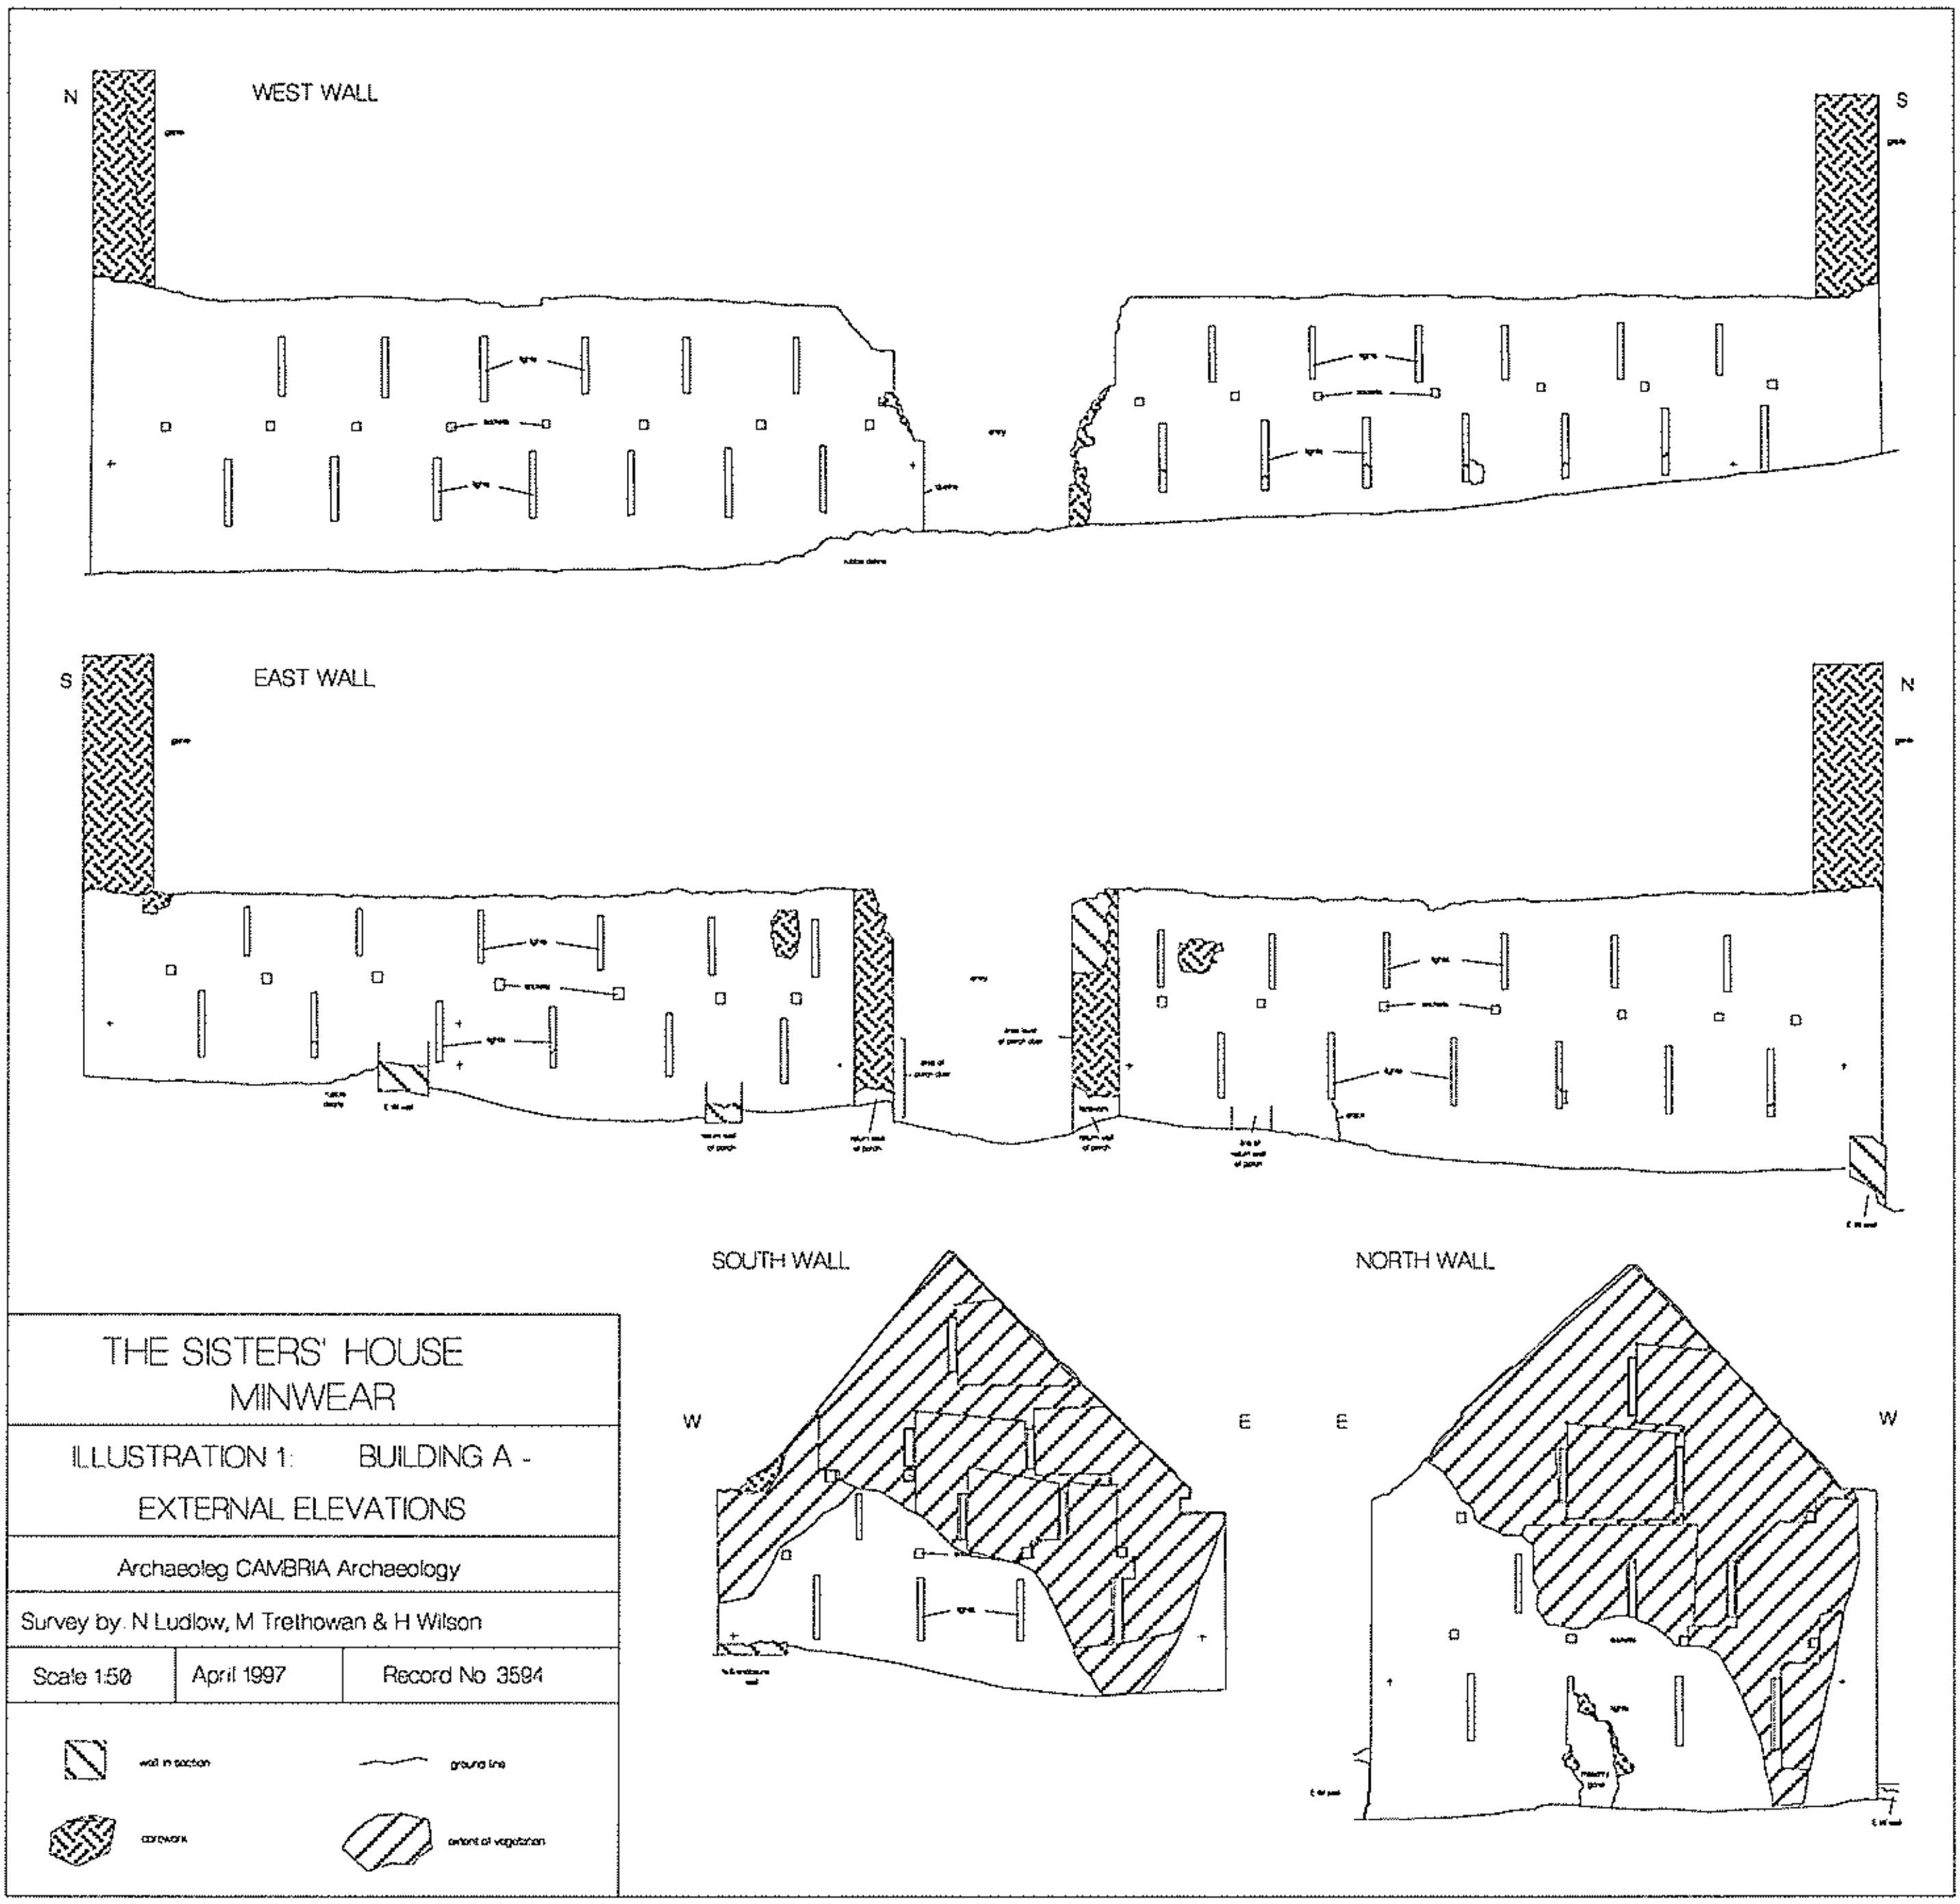
WEST WALL
N
S
EAST WALL
S
N
SOUTH WALL
W
E
NORTH WALL
E
W
THE SISTERS' HOUSE
MINWEAR
ILLUSTRATION 1: BUILDING A -
EXTERNAL ELEVATIONS
Archaeoleg CAMBRIA Archaeology
Survey by: N Ludlow, M Trethowan & H Wilson
Scale 1:50
April 1997
Record No 3594

The walls are fairly free from cracks, except within the porch, and the building consolidable. The areas of masonry above the two doorways have gone, as has masonry below the sill of one of the lower embrasures in the north wall.

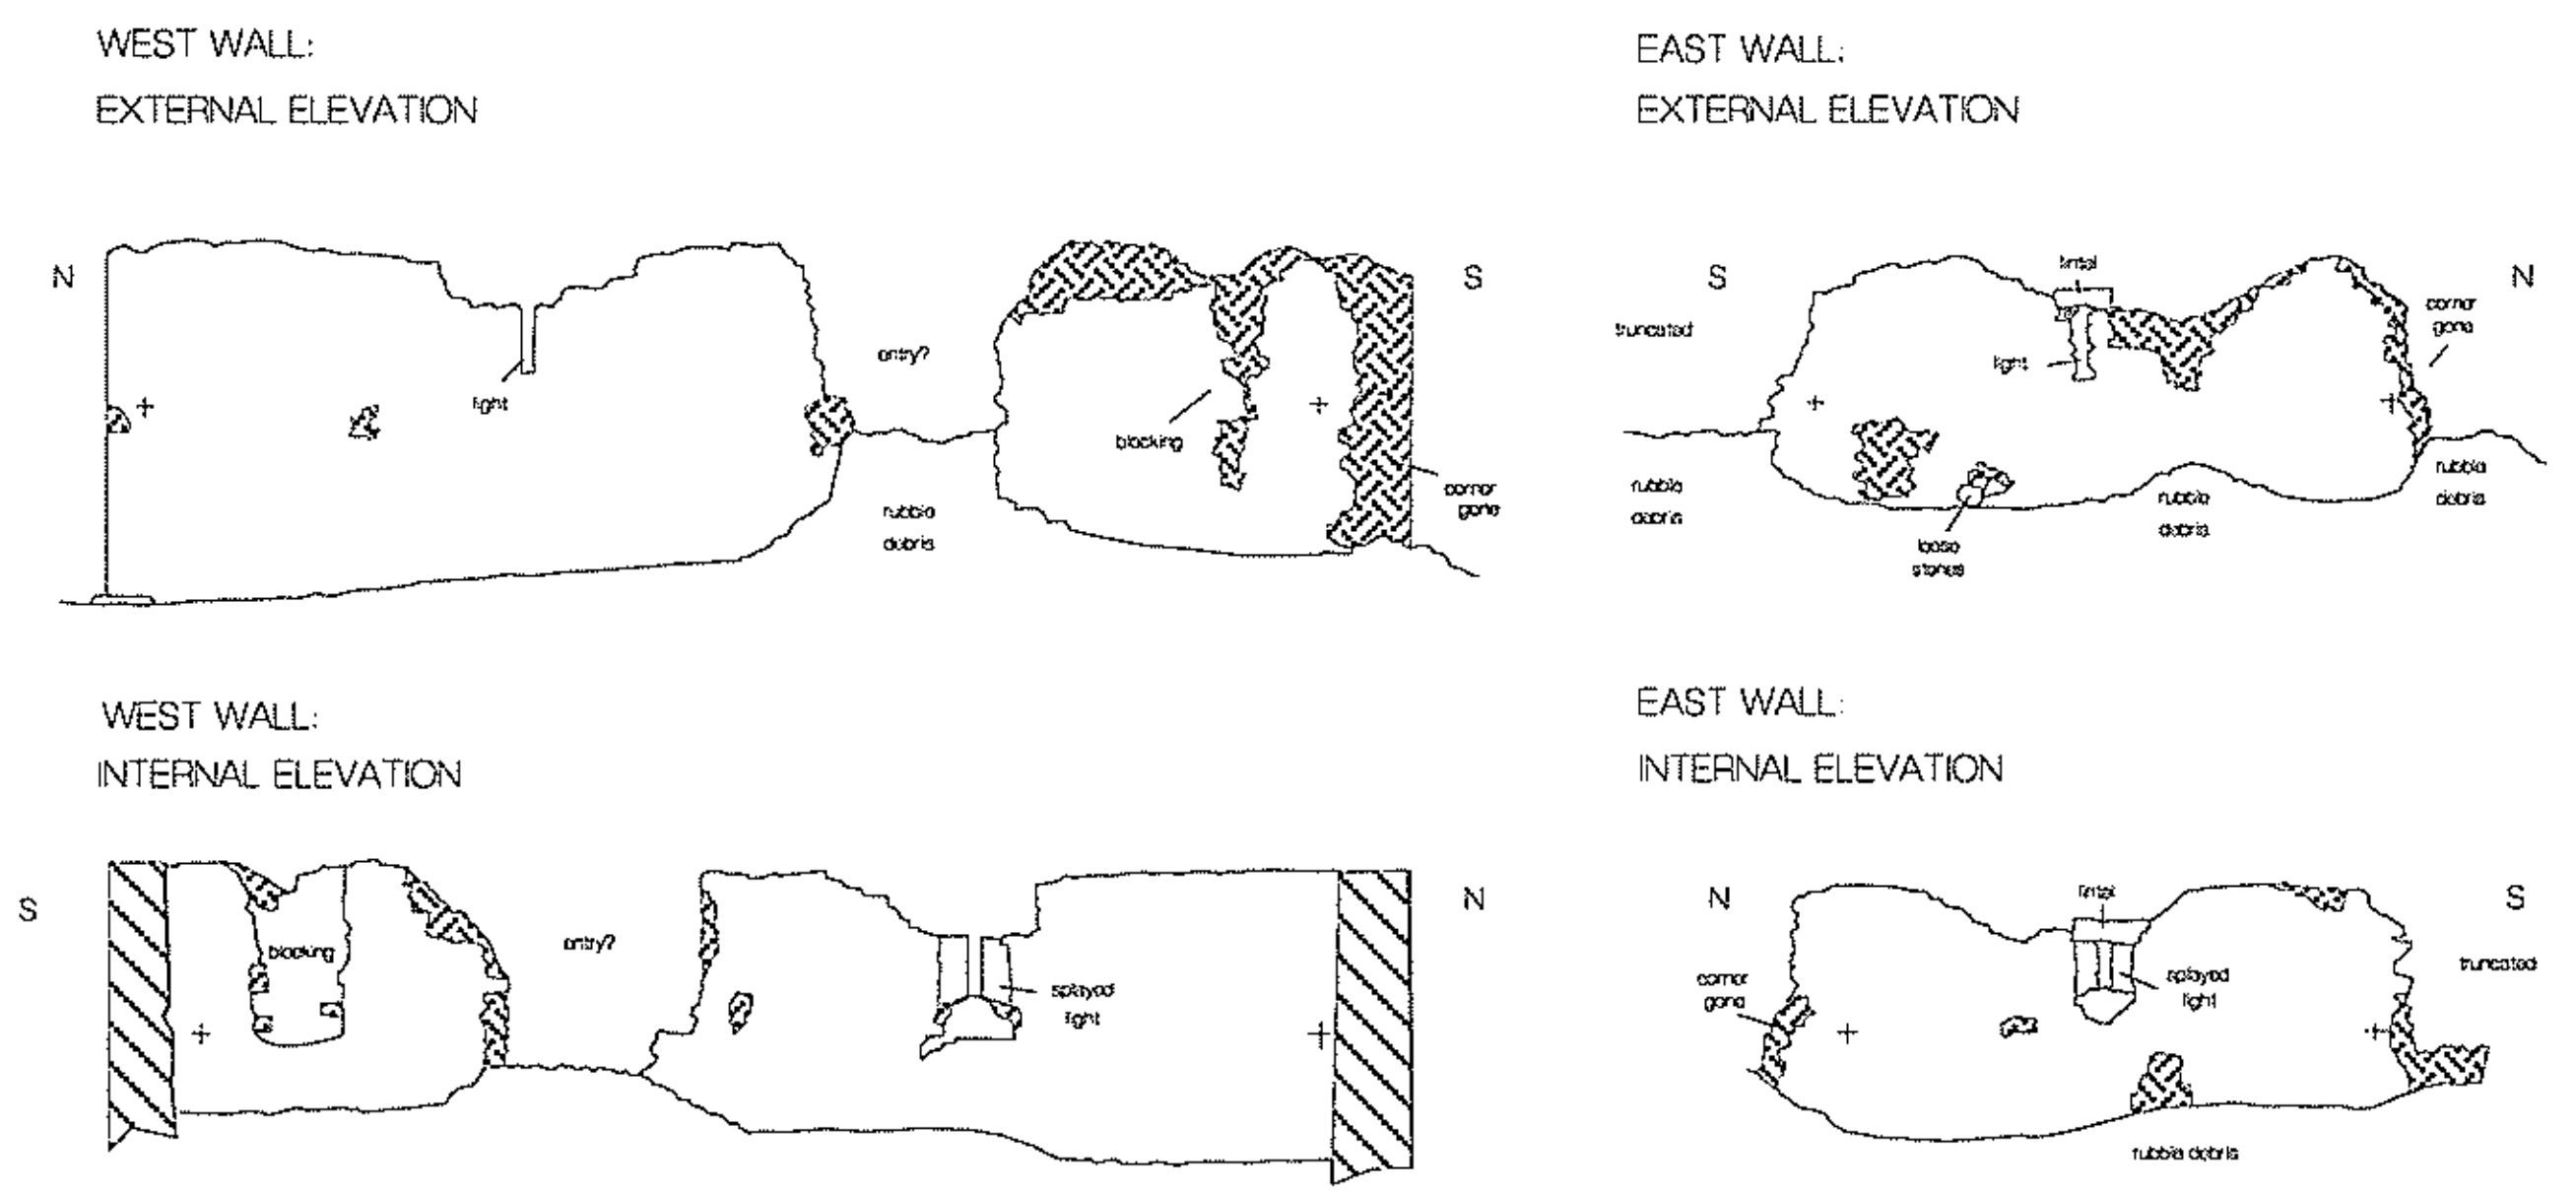
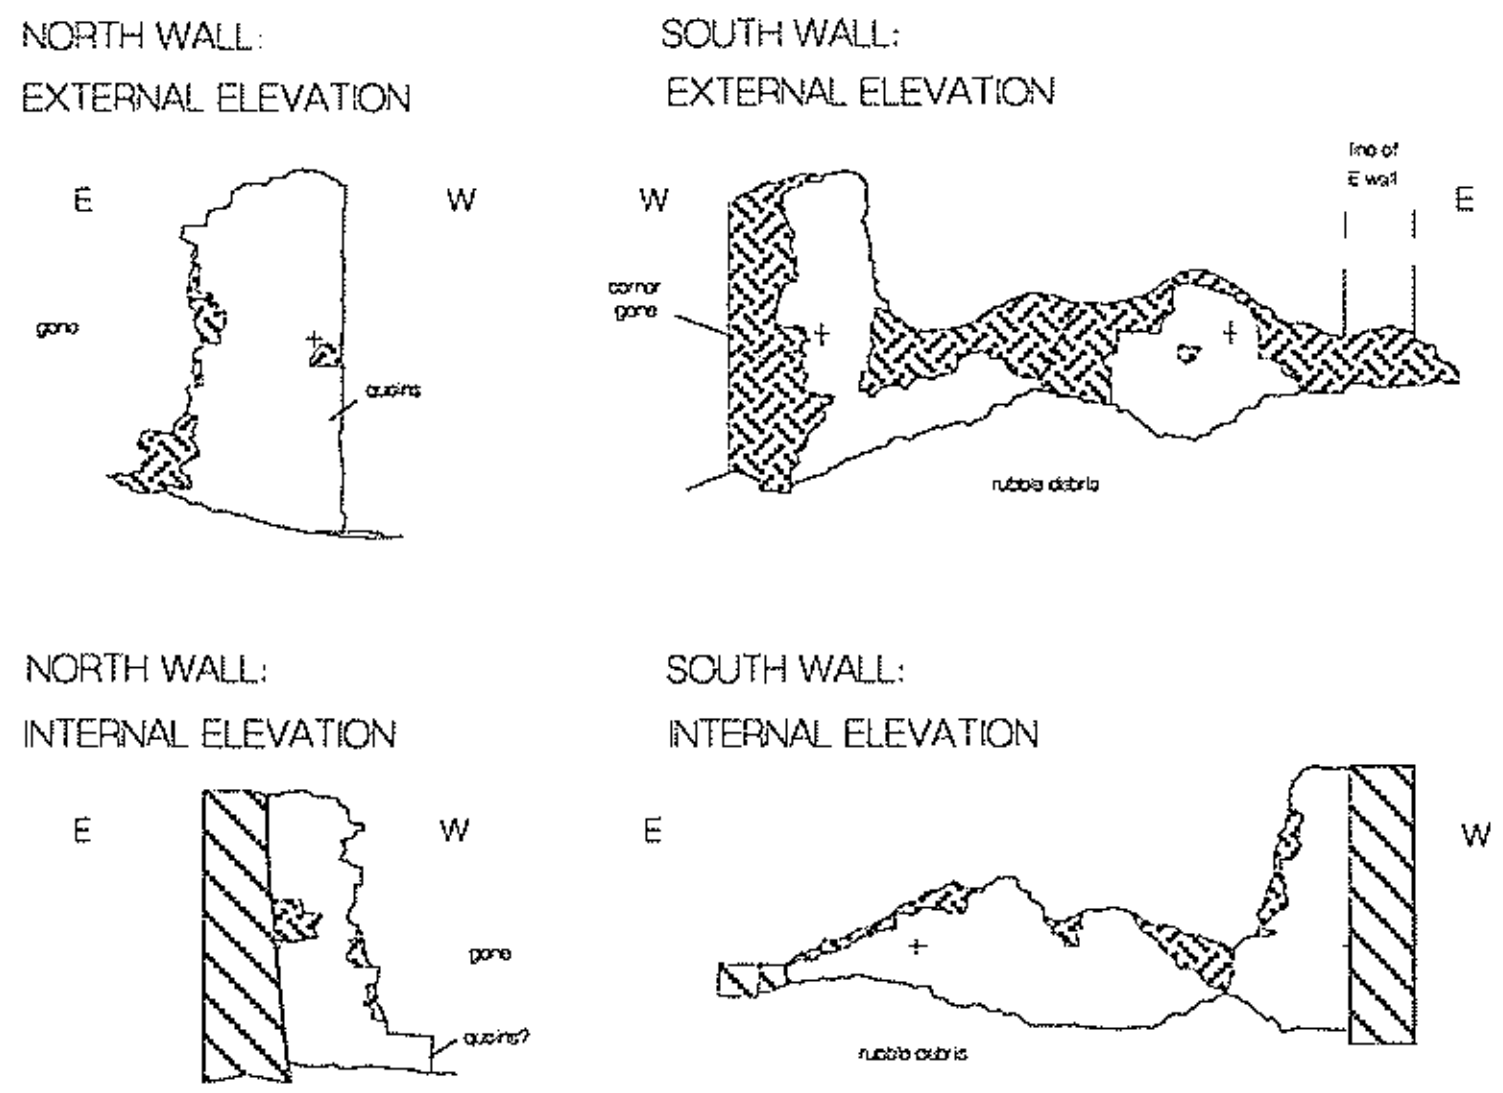
ILLUSTRATION 3: BUILDING B - ELEVATIONS

The building is now in very poor condition, the north wall and north-east corner having been completely truncated, and the south wall with the south-east corner in little better condition. Rubble derived from their collapse occupies much of the interior and obscures the lower parts of the external walls. However, the west wall survives to a height of 3.2m. The building was certainly formerly gabled. A footings stone is exposed on the north-west corner.

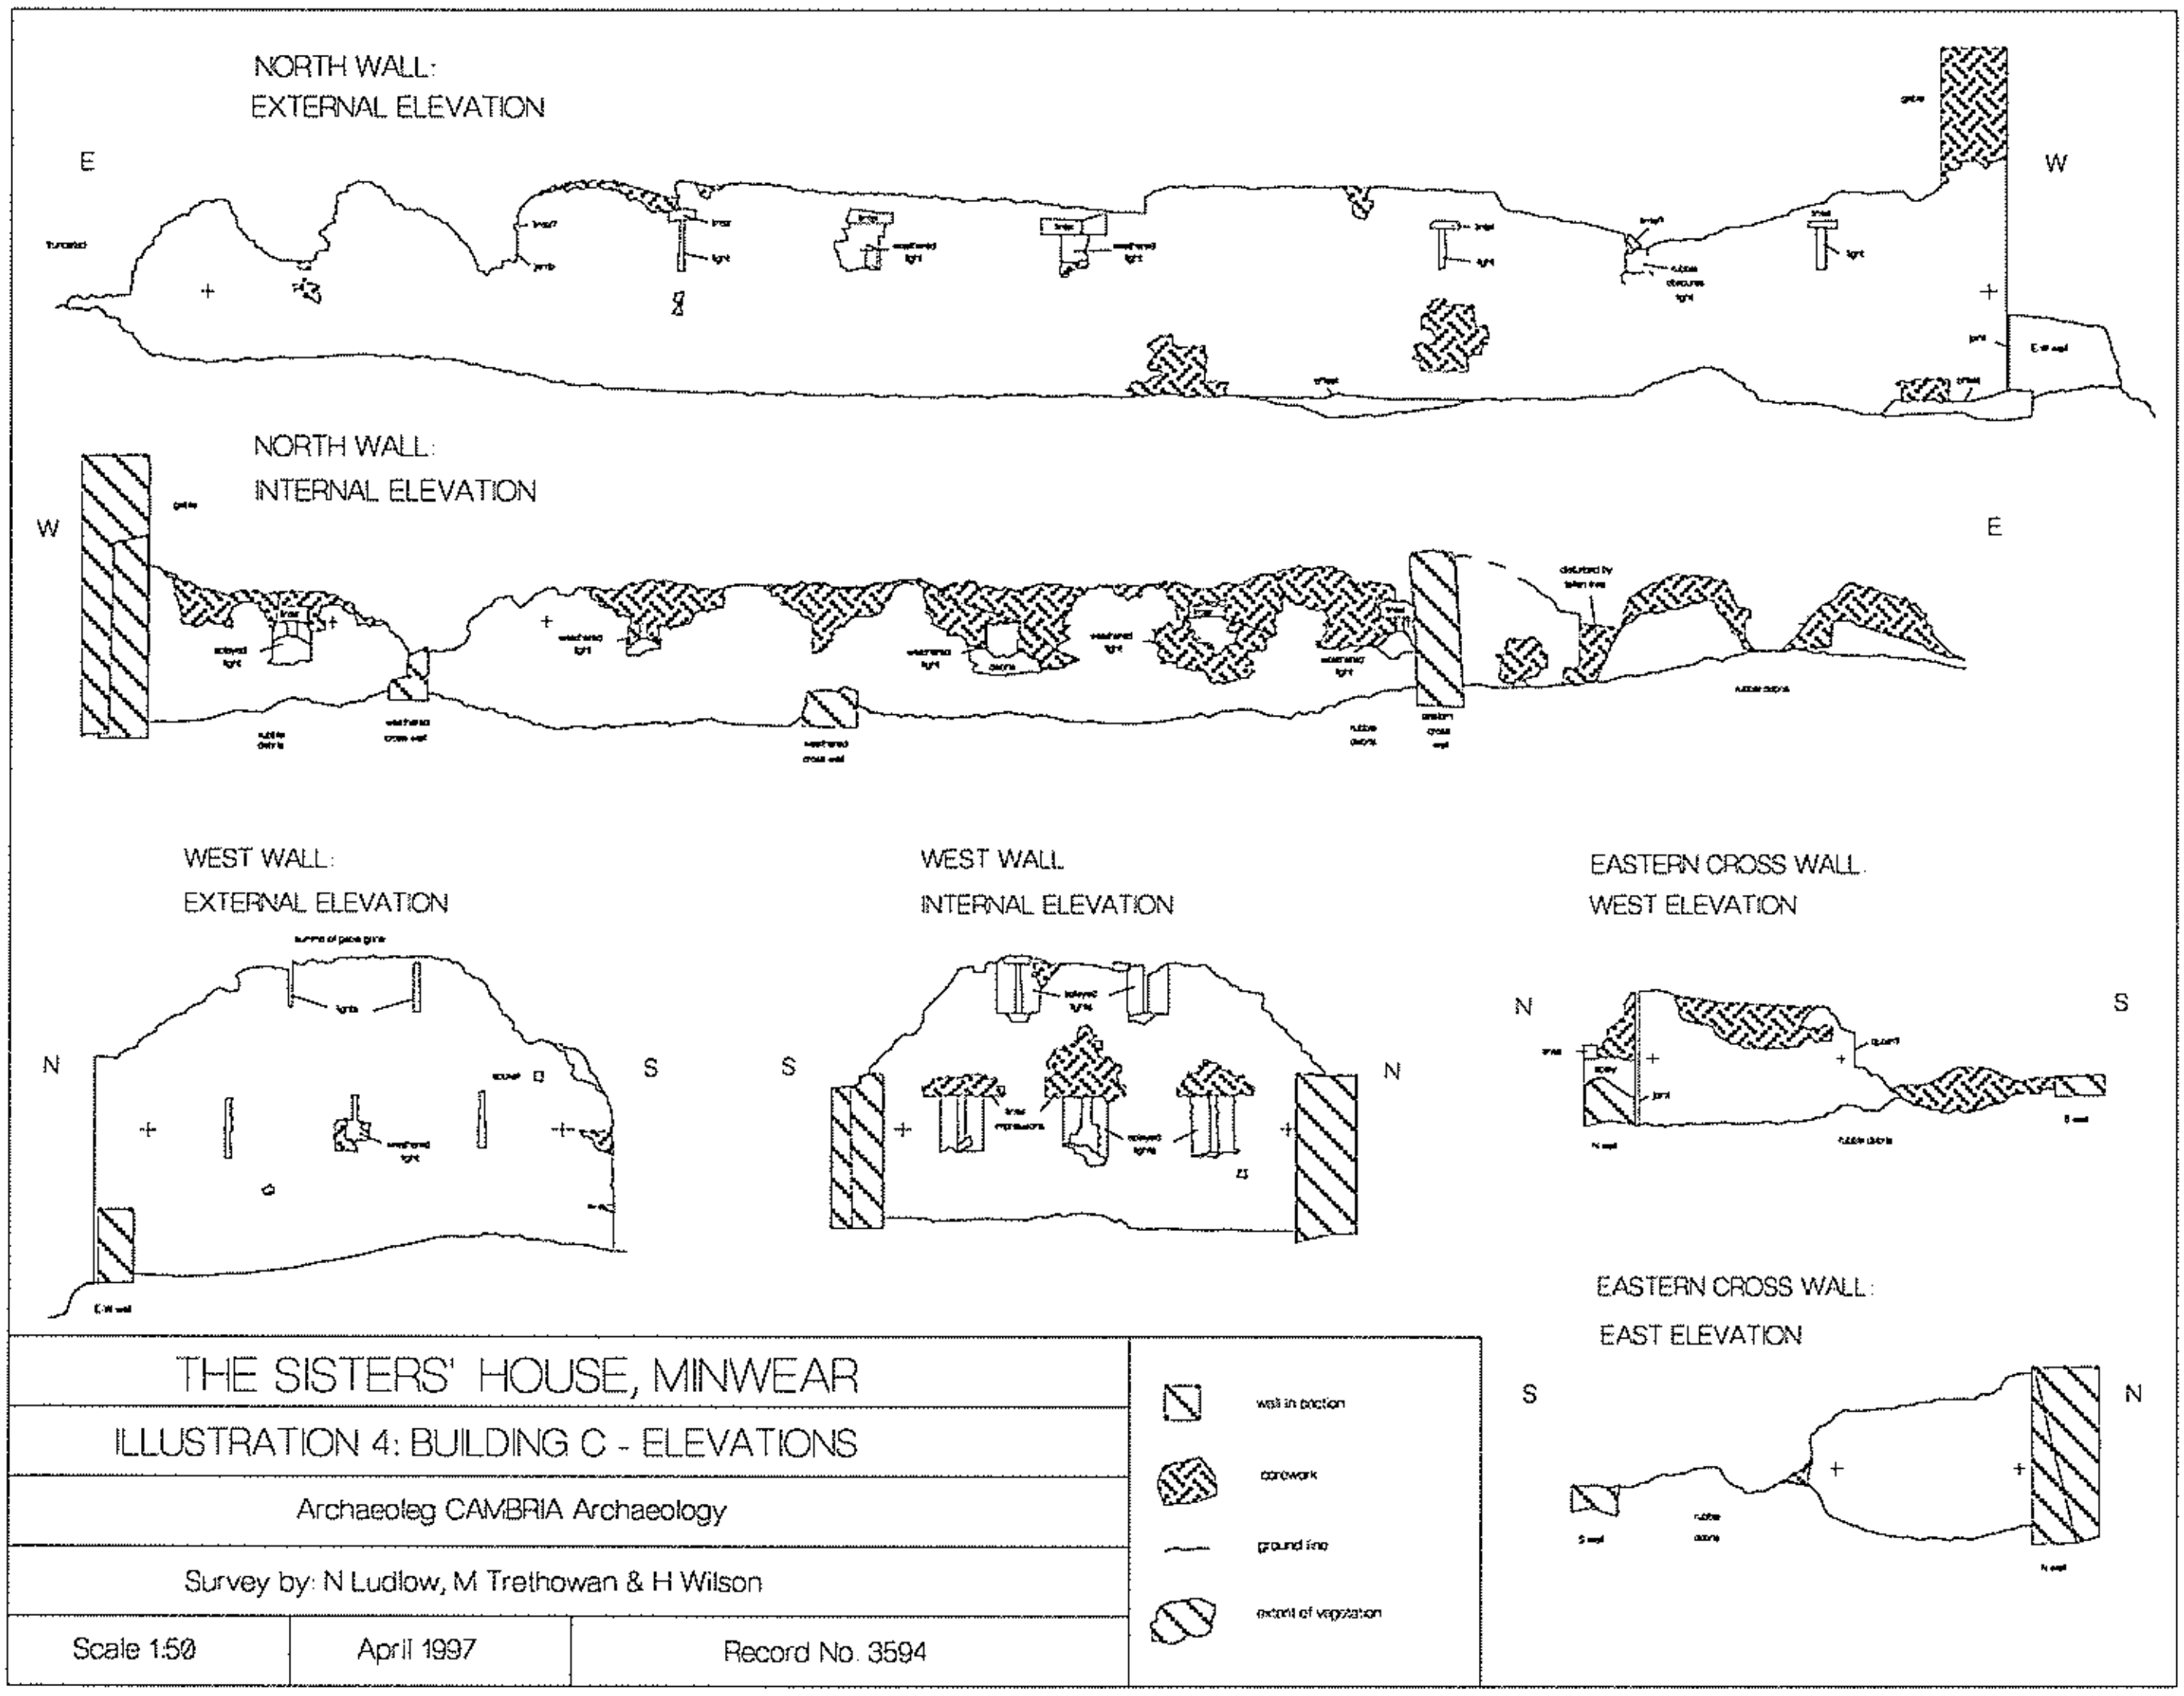
ILLUSTRATION 4: BUILDING C - ELEVATIONS

Building C occupies an east-west position on the north side of the main axial trackway towards the east of the complex. It is a long, narrow, rectangular, single-storey gabled building with at least three internal cross walls, none of which are bonded into the side walls. Superficially it is of similar form to Building A but its limestone rubble is of cruder construction, crudely quoined, and its preservation accordingly worse, the building now being in poor condition. The north wall survives to an average of 3m which, in part at least, represents the wall top level, and the western gable wall is complete with the exception of its apex. The south wall, however, has been truncated, while the loss of the east end renders the internal dimensions difficult to ascertain. The eastern limit of the building is now represented by the easternmost internal cross-wall which, while the best preserved of the three, only stands to a height of 2.3m; the remainder average 1m and rubble derived from their collapse occupies much of the interior of the building. An overall E-W measurement of 27m is suggested by the limit of the rubble debris; the internal north-south dimension is 5.5m. There are no remains of any finishes, either externally or internally.

The side- and end walls all appear to be of one build, but exhibit rather dissimilar openings. In the surviving northern side wall is a single tier of slit-lights/vents, at irregular intervals, in splayed embrasures 0.5m square. Both the plain, square external heads, and the internal lintels (where they survive) are of stone. Much the internal facework has weathered above those lintels which are missing.

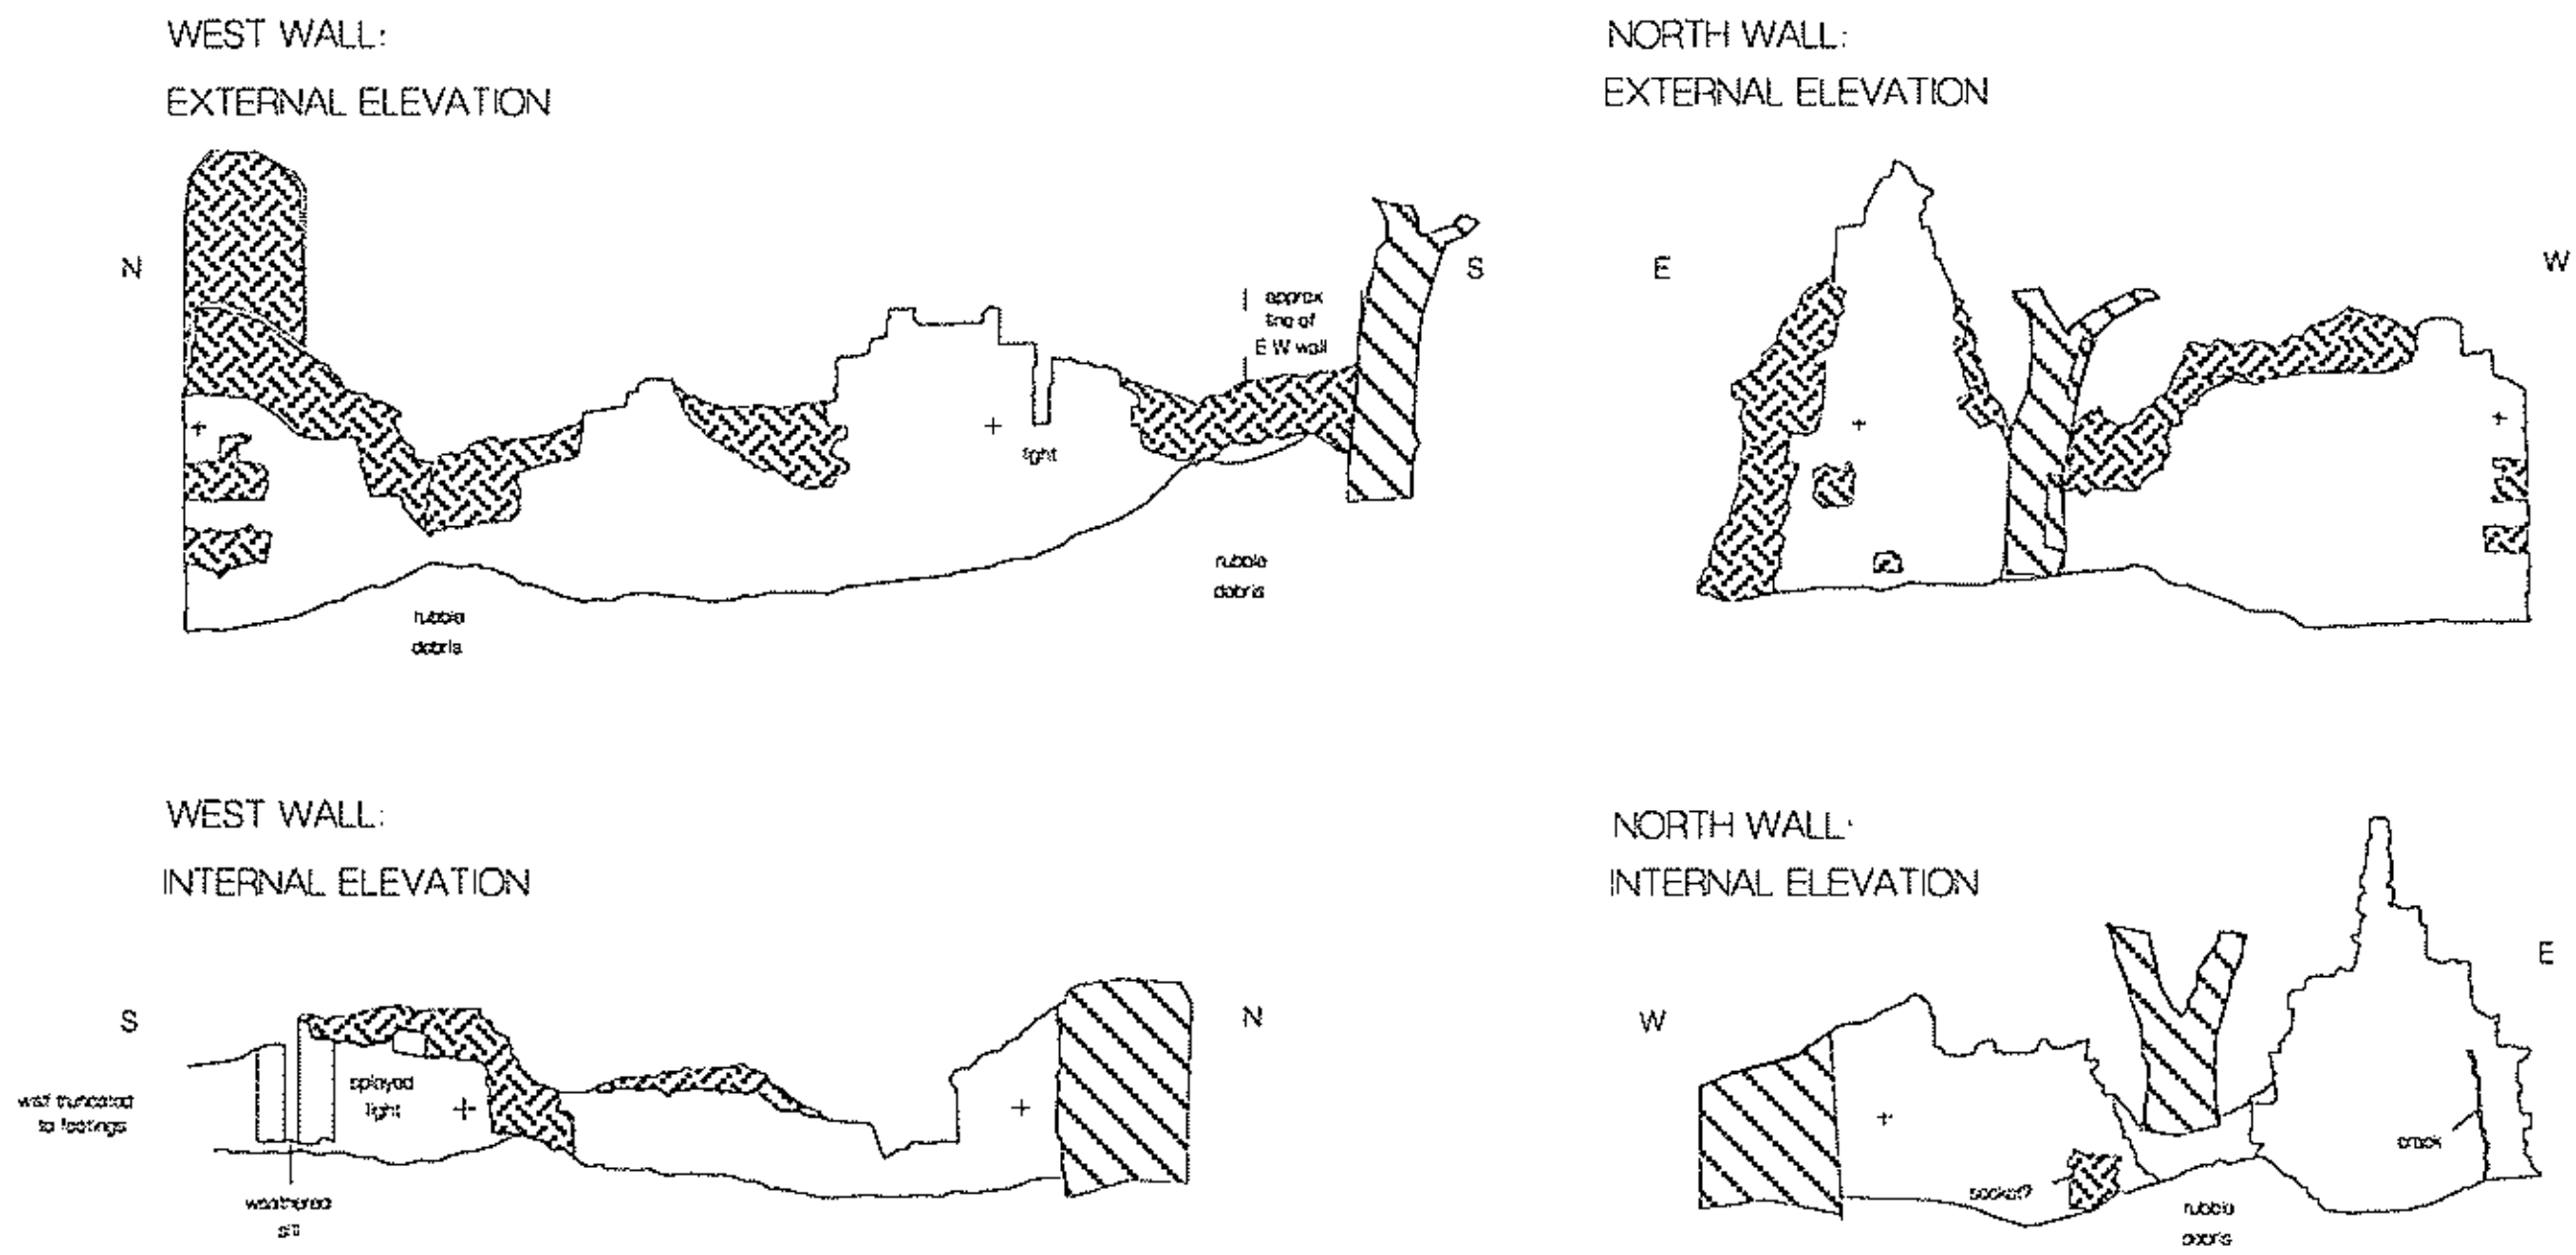
ILLUSTRATION 5: BUILDING D - ELEVATIONS

Building D is in a very ruinous condition. It was a rectangular building, undoubtedly single-storey and probably gabled to the north and south, extending into Enclosure II from its southern boundary, the wall of which appears to butt against Building D. The scarp upon which the boundary wall lies has been produced northwards as a platform beneath the building.

The internal dimensions of Building D are 7m N-S by 5m E-W, and it is of limestone rubble of rather crude construction and crudely quoined,. Only the west and north walls survive to any degree, standing to a maximum height of 3m to the north and 2m to the west (window head level), but badly weathered and with much missing masonry. There are no remains of any finishes, either externally or internally.

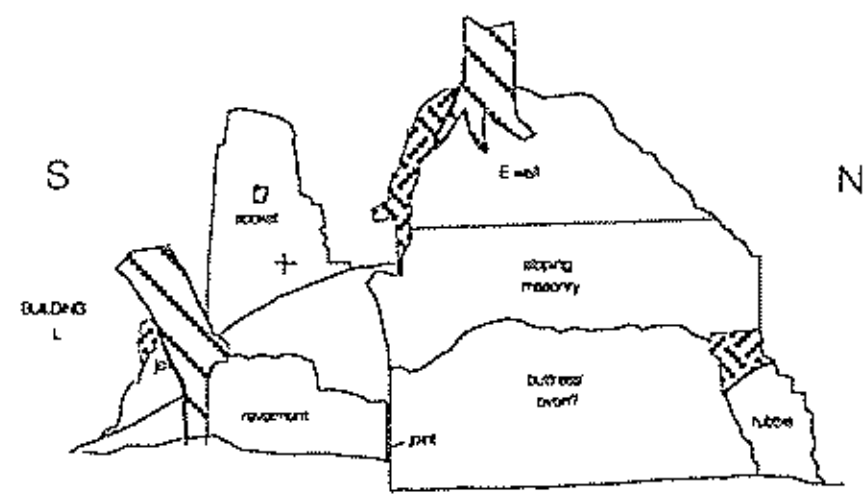
THE SISTERS' HOUSE, MINWEAR		
ILLUSTRATION 12: BUILDING K - ELEVATIONS		
Archaeoleg CAMBRIA Archaeology		
Survey by: N Ludlow & H Wilson		
Scale 1:50	April 1997	Record No. 3594

The south wall has survived to 3.5m at the east end descending to 2.6m in the west half. It butts against the remains of both the east and west walls but in this case need not imply a multi-phase origin for the building as we see it, being possibly a constructional idiosyncrasy. The wall is in fair-poor condition and leans inwards; this, however, may be a constructional feature. It exhibits several features. At the west end is is a small light, 0.4m square and very ruinous, its timber lintel gone. Between 5m and 8.5m from the west end is a broken-out area of corework rising the full height of the wall which apparently represents a secondary, inserted fireplace. A through void on the west side may represent a broken-out socket for a hood support, while the fireplace back has an area of secondary repair. Immediately to the east is a narrow blocked doorway 0.85m wide which has lost its head and the walling above; just east of this is a line of possible facing stones representing the eastern reveal of a fiuther light which has weathered out. A similar feature lies at a slightly higher level 5.2m from the east end of the building. The quoins and displaced sill stones for a second entry occur between 2.5m and 3.6m from the east end, which too has lost its head and all surrounding walling.
