THE SISTERS' HOUSE
MINWEAR, PEMBS
PRN 3594

AN HISTORICAL SUMMARY AND STRUCTURAL DESCRIPTION

AUGUST 1997

Report prepared for Pembrokeshire County Council
by
Neil Ludlow

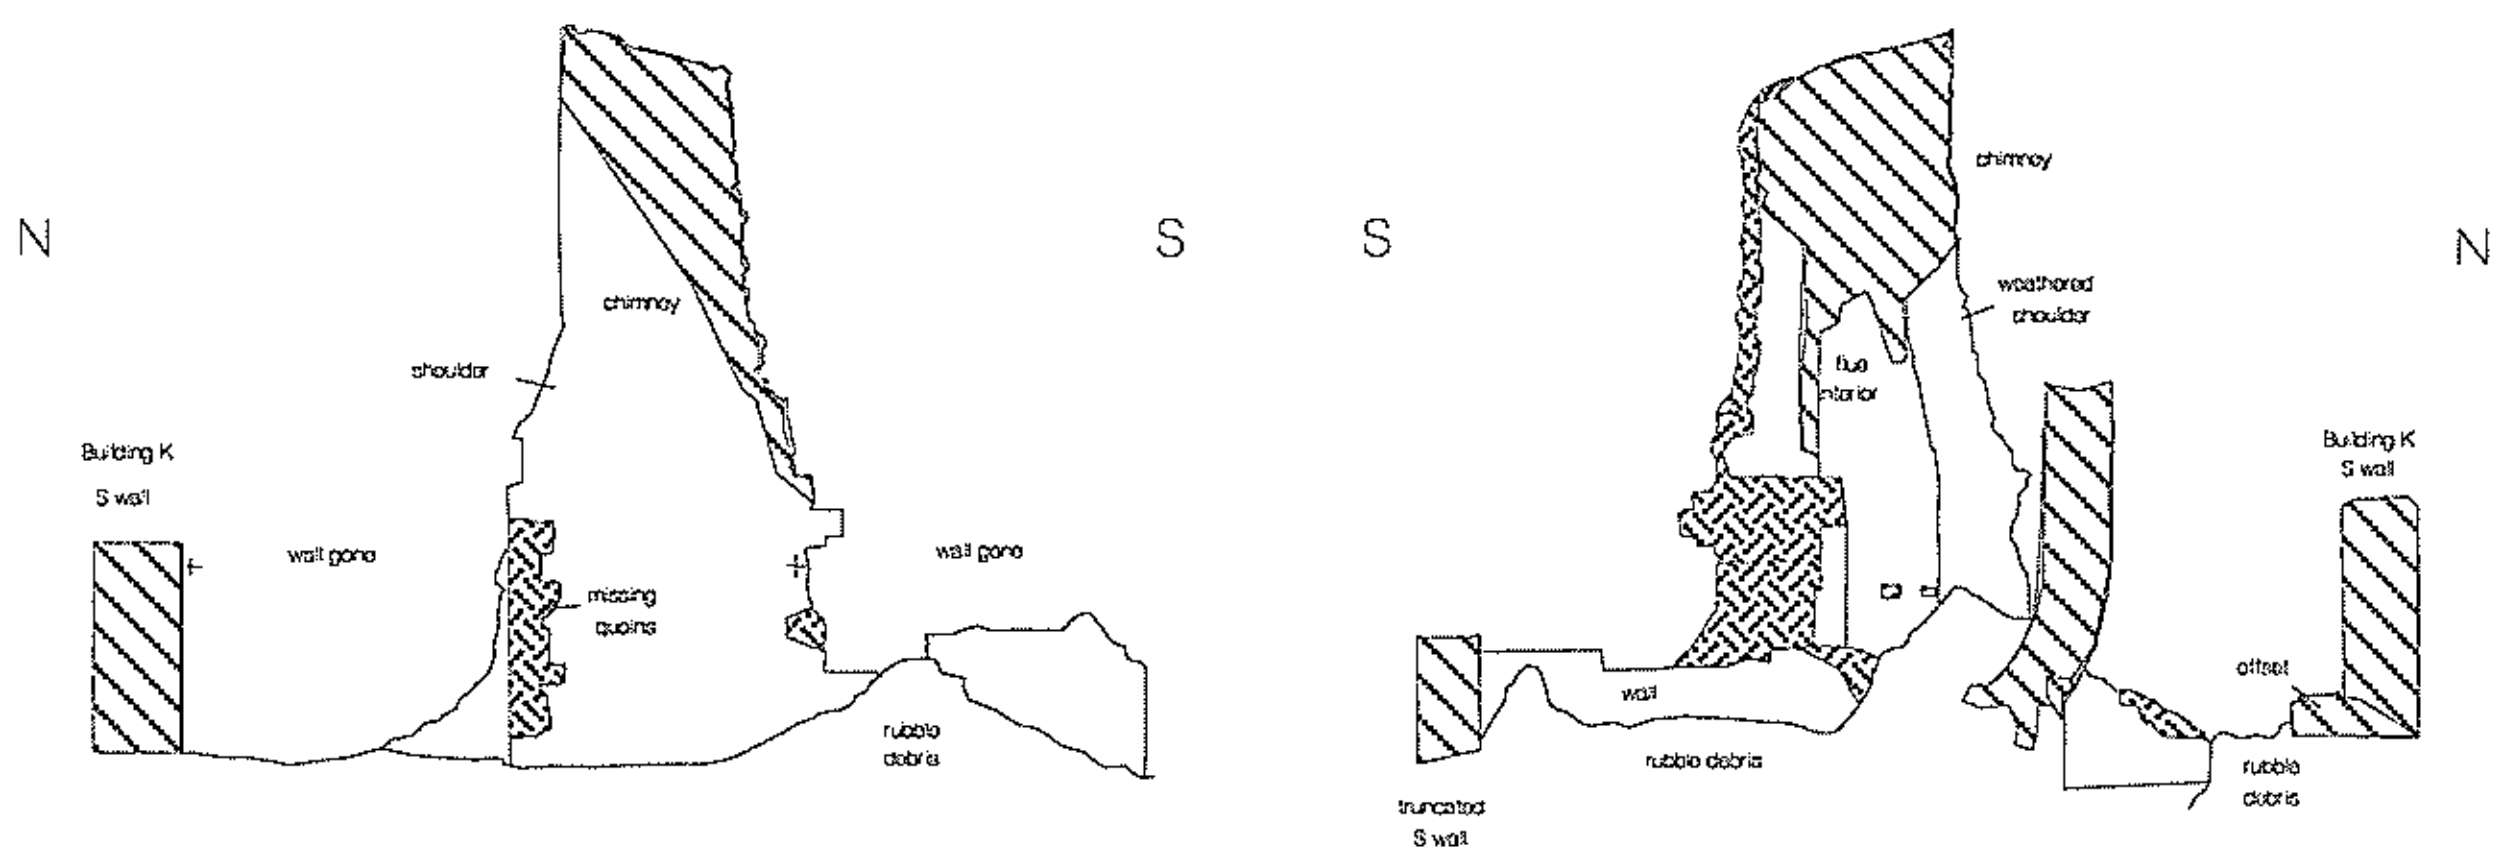
ILLUSTRATION 13: BUILDING L -
WEST WALL ELEVATIONS

Building L appears to have been a north-south rectangular structure lying - and butting - against the southern half of Building K. It is in very poor condition, very little of it surviving apart from the lateral chimney in the central section of the west wall. The internal dimensions of the building are 7m N-S and 4m E-W, and it is divided into two areas by a cross-wall which butts against the east wall at least. The southern chamber of the two appears to project somewhat further to the east than the northern, and is chiefly defined by its below-ground cellar/undercroft, whose (vaulted?) roof has gone and which is now occupied chiefly by rubble and its depth unknown. The northern chamber may too lie over a cellar - the present ground surface is highly unstable. Its north and east walls exhibit a wide offset or benching.

The surviving western, side wall spans the two chambers but has gone apart from the central chimney. The upper part of its stack has gone but it still survives to a height of 6m, though in poor condition. It is square, and well-constructed with good ashlar quoins and shoulders; the flue is now open to the building and the fireplace itself has gone. There may have been a light immediately to the south, suggested by the possible remains of the northern reveal.
