## CLWYDIAN ESA, HISTORIC MONITORING

BASELINE 1994

OS 1:10000 SHEET: SJ <i>16 NE</i>	GRID REF: SJ <i>(168 692)</i> <i>actual lime kiln surveyed</i>
PRN: <i>103126-8</i>	SITE NAME: <i>Big Wood lime Kiln (ref no. not known)</i> <i>at SJ 168 688</i>
AIR PHOTO No <i>146</i>	LANDSCAPE TYPE:
No GROUND PHOTOS: <i>6</i>	<i>Rolling farmland</i>
DATE SURVEYED: <i>16/2/95</i>	SURVEYED BY: <i>Dy Piers</i>
ACCESS: <i>Easy access from opposite Station Lodge just off A541 S. of Nannerch village. Woodland owned by Capt. Archdale, Penbedw. Mrs Archdale willingly agreed to a site visit.</i>

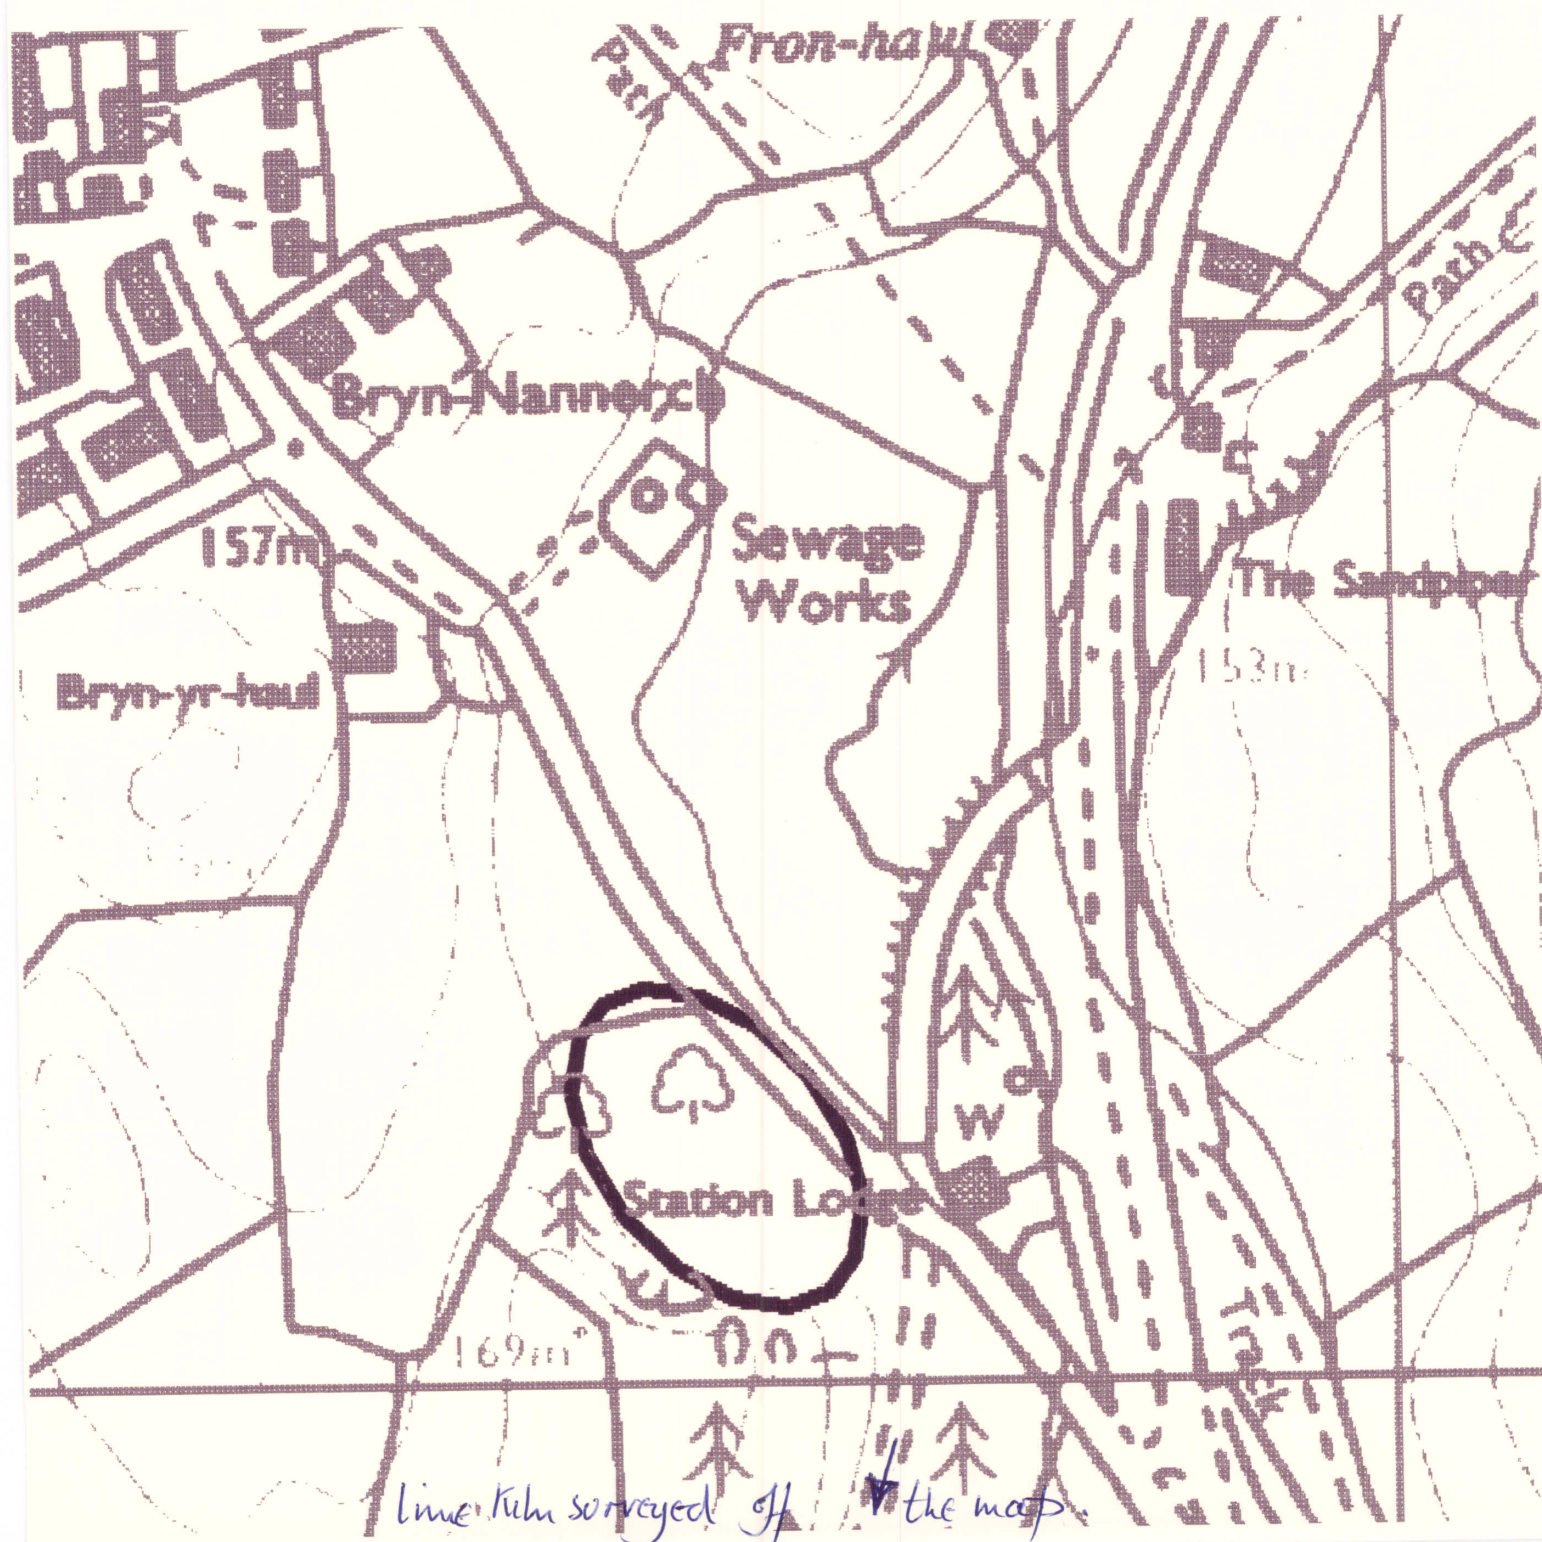
*lime kiln surveyed at SJ 168 688*

There was no evidence of some Kilns I-III in the area marked. Local workmen from Penbedw were not aware of any kilns apart from one about 1/4 mile SW of the area. This is the one surveyed. (Photo 1 shows the area enclosed as containing the kilns. It is the site of limestone quarrying but now overgrown) The kiln surveyed is in particularly fine condition and clearly shown in the photos

A woodland path goes past the site but as the woodland is private it is unlikely to be threatened by visitors. The major threat is damage by tree routes - see photo 3 although some felling has taken place photos 2 and 3
