LLEYN PENINSULA ESA, HISTORIC MONITORING

BASELINE 1994

OS 1:10000 SHEET: SH 44 SW	GRID REF: SH 4308 4444
PRN: 1311 SITE NAME: Coe Men, Lloyd starting stone, SW of Tyddyn Mawr	
AIR PHOTO No 88/04/01	LANDSCAPE TYPE: C. Moorland Basin
No GROUND PHOTOS: 4	
DATE SURVEYED: 30/8/94	SURVEYED BY: Wyn Davies
ACCESS: Path @ Tyddyn Mawr Farm-yard, & walk down to site via field track. Site owned by Messrs Jones, Tyddyn Mawr Farm.

LLEYN PENINSULA ESA HISTORIC MONITORING RESURVEY 1998

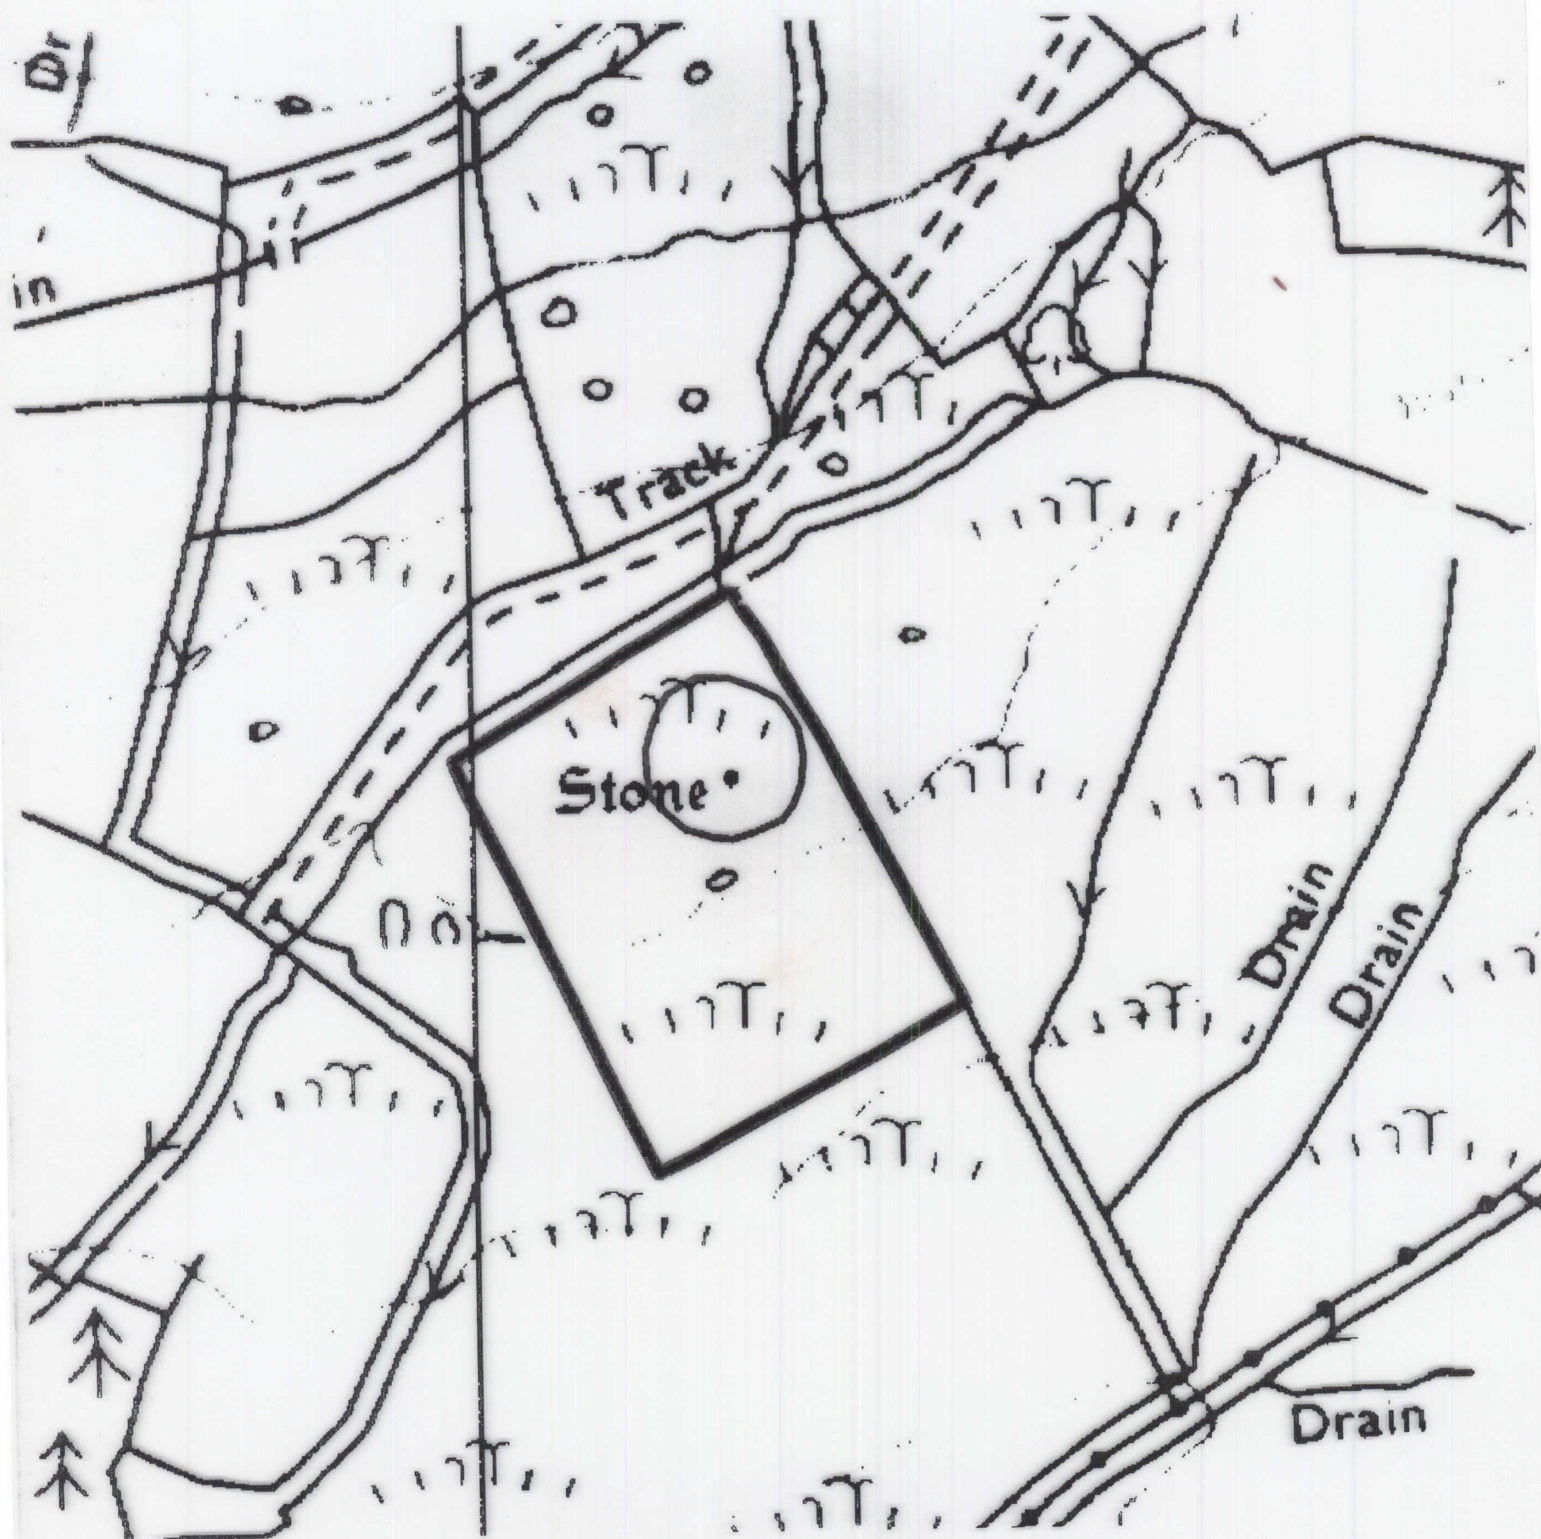
Stone stands about 5' above ground level, stands solid, & appears to be in good condition. A clearly visible texture, extremely easy to locate.

1. Could be used as a rubbing point by cattle & sheep.
