LLEYN PENINSULA ESA, HISTORIC MONITORING

BASELINE 1994

OS 1:10000 SHEET: SH 43 NW.	GRID REF: SH 4331 3537
PRN: 1332 SITE NAME: Long Hut, S. of Penryn, Morfa Abererch. No other sites present.	
AIR PHOTO No 88101146	LANDSCAPE TYPE: M. Coastal & Valley Flats
No GROUND PHOTOS: 7	
DATE SURVEYED: 28.9.94	SURVEYED BY: Wyn Davies
ACCESS: Park car at Penryn Farm yard. Land owned by Starcoast World, tenants Messrs E.O. Evans, Penryn Farm (two old ladies) also let the land. The land is not in the ESA scheme although Messrs Evans would like to be, but Starcoast World refused. Walk from farm yard to site.

LLEYN PENINSULA ESA HISTORIC MONITORING RESURVEY 1998

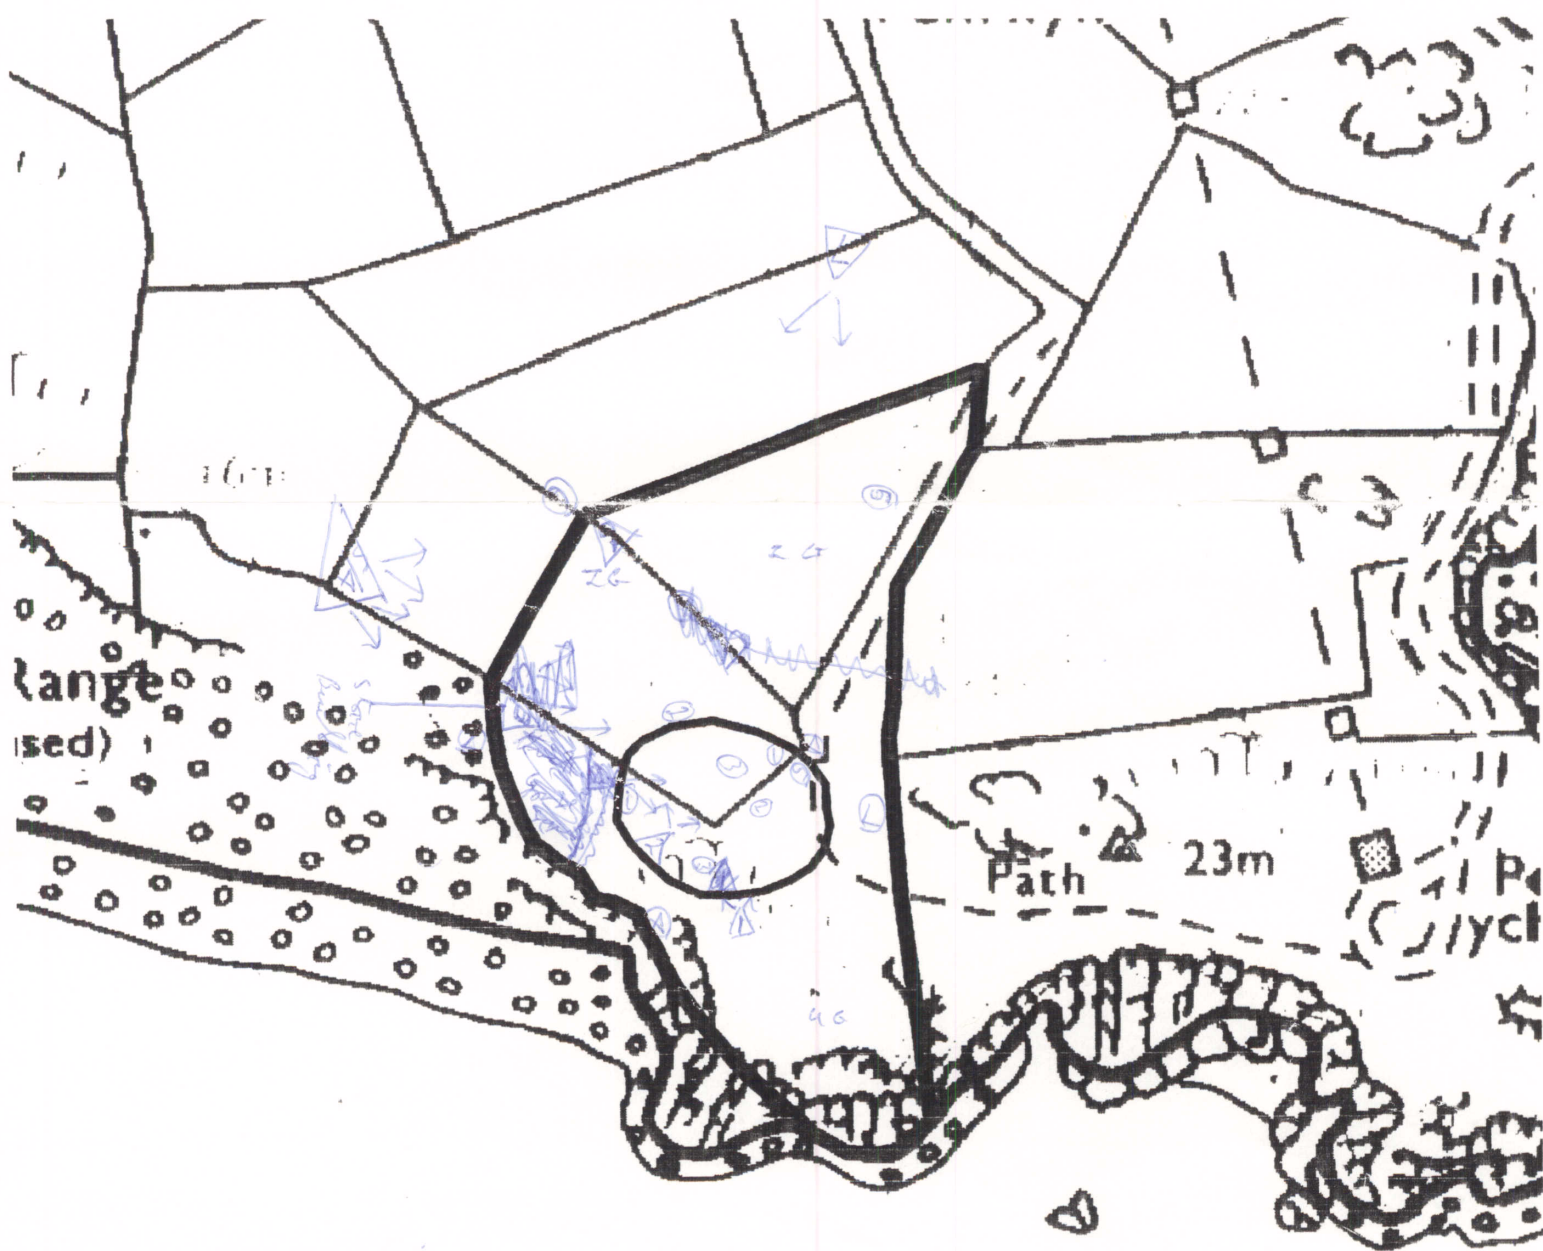
1332

Nothing to see at or above ground level
of a monument. Even in late September
quite a few people were walking around,
one family (see photographs) even stopped for
a picnic on the site.
