LLEYN PENINSULA ESA, HISTORIC MONITORING

BASELINE 1994

OS 1:10000 SHEET: SH 12 NE.	GRID REF: SH 1653 2671
PRN: 776 SITE NAME: Hyman Saint-Holy Well, Minsion.	
AIR PHOTO No 88/05/58	LANDSCAPE TYPE: E. Coastal plateau
No GROUND PHOTOS: 5	
DATE SURVEYED: 7.9.94	SURVEYED BY: Wyn Davies
ACCESS: Park car on grass verge opposite Minsion house. Photograph 4 shows access path through vegetation to well. Distance from road to well approximately 8-10 metres.

LLEYN PENINSULA ESA HISTORIC MONITORING RESURVEY 1998

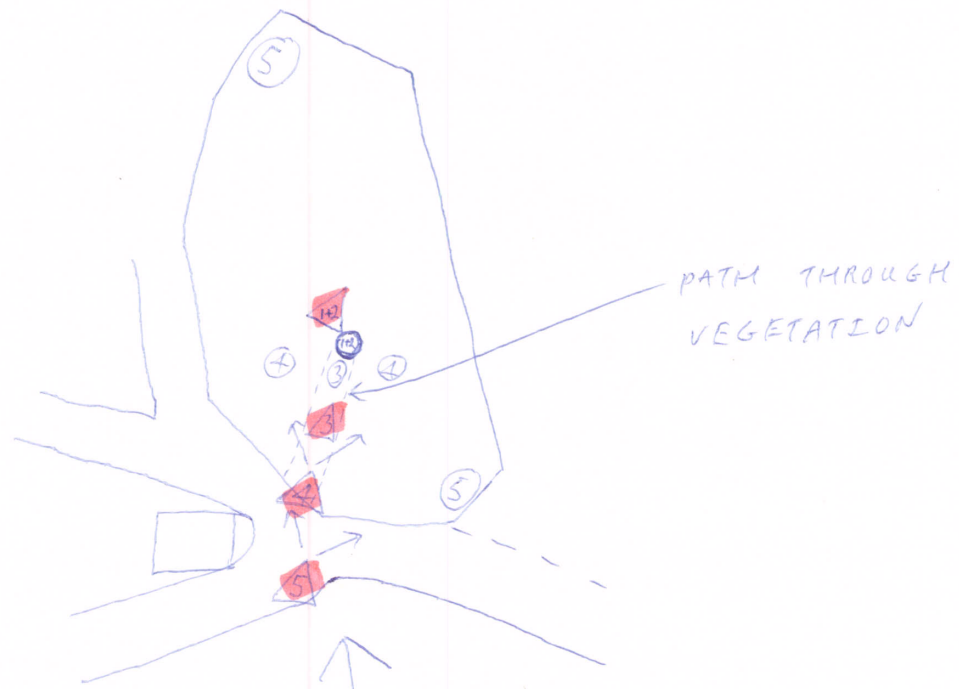
The well is made of cemented stone & has a hinged metal cover covering most (not all) of the well. Unmanaged site - neglected appearance.

In good condition. Stone wall of well is solid, but hinged metal cover is too small for well, & as a result there are a lot of leaves in the water / well. Otherwise, the monument is O.K. - scrub / vegetation biggest threat to monument as it now stands.

1. Root damage by trees.
2. Scrub encroachment - engulfing of well.

Cover over well does not fit properly and
one of the hinges is rusted through

The site is now very easily located with a good path from the roadside. It is more susceptible to vandalism - damage to the cover and stone work. Once the second hinge on the cover is rusted through there is a risk of leaves and other rubbish falling into the well.
