# PRESELI ESA, HISTORIC MONITORING

BASELINE 1994

| PRN: 17010 SITE NAME: SLEDECH | |

## PRESELI ESA HISTORIC MONITORING RESURVEY 1997/98

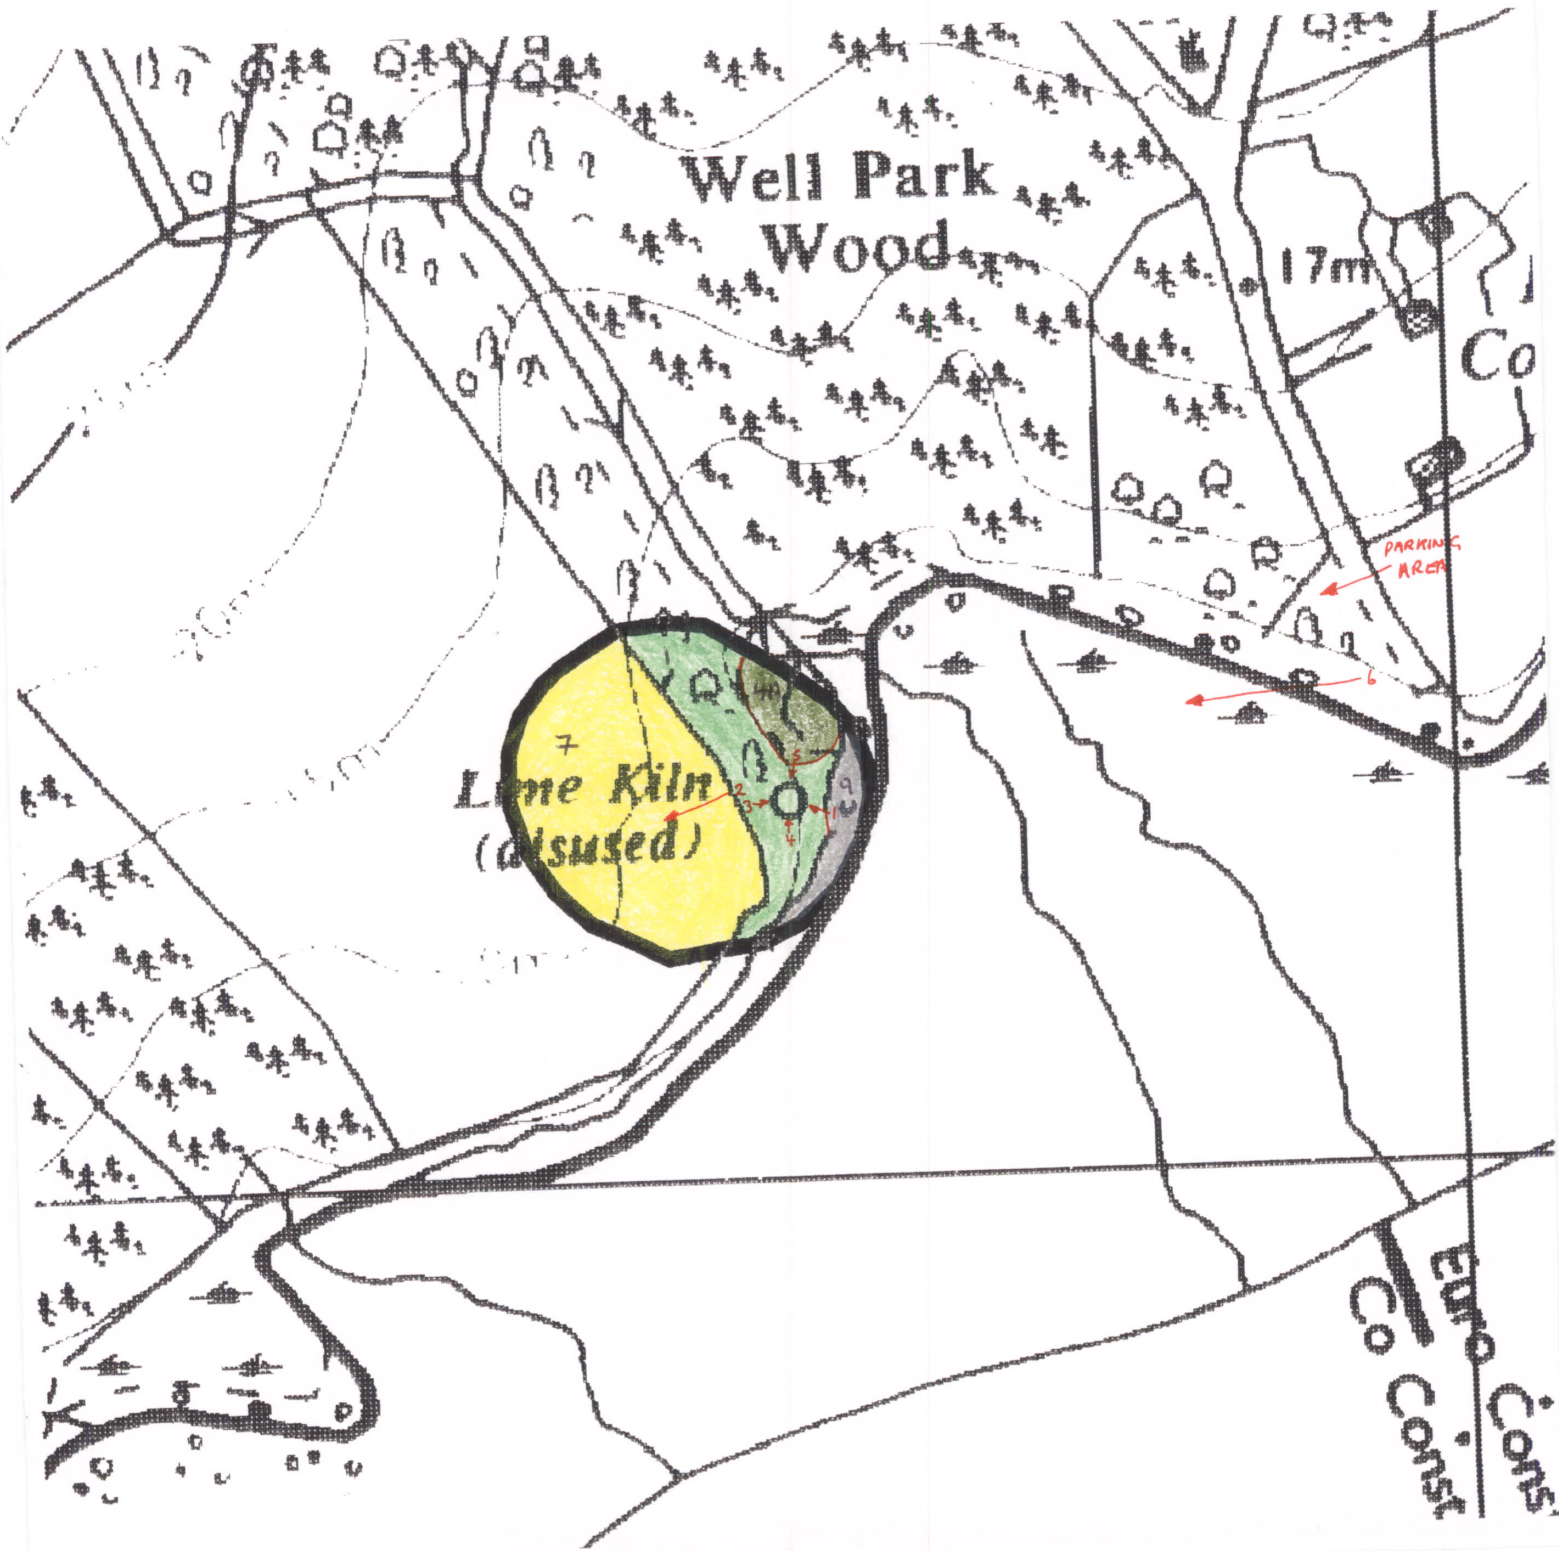
**DESCRIPTION/CONDITION OF MONUMENT:** Appears as a vertical bank / wall of stones ~ 2/3 m in height. was probably circular in shape originally and has been built against a bank. Much of the monument is missing so that there is now a gap between the remaining structure and the bank. Vegetation (grass / bramble / holly) is covering much of the stonework and a mature beech tree has grown up

Monument is being damaged, the main problems appear to be caused by tree roots breaking the structure apart and even human access and interference with the site. Stones have been removed from the monument and used to make a fireplace. A footpath was close to the monument and is causing damage by erosion. The mature beech tree

D in the gap between the wall and bank. large tree roots are visible on the structure and this seems to be the main cause of its destruction. The footpath from the beach ascends the bank next to the monument and has certainly contributed to the demolition of the stone wall.

E has caused considerable damage by growing through the monument and pushing it apart. Other vegetation including 2 small holly bushes is growing on the remaining structure and will further contribute to weakening the monument.

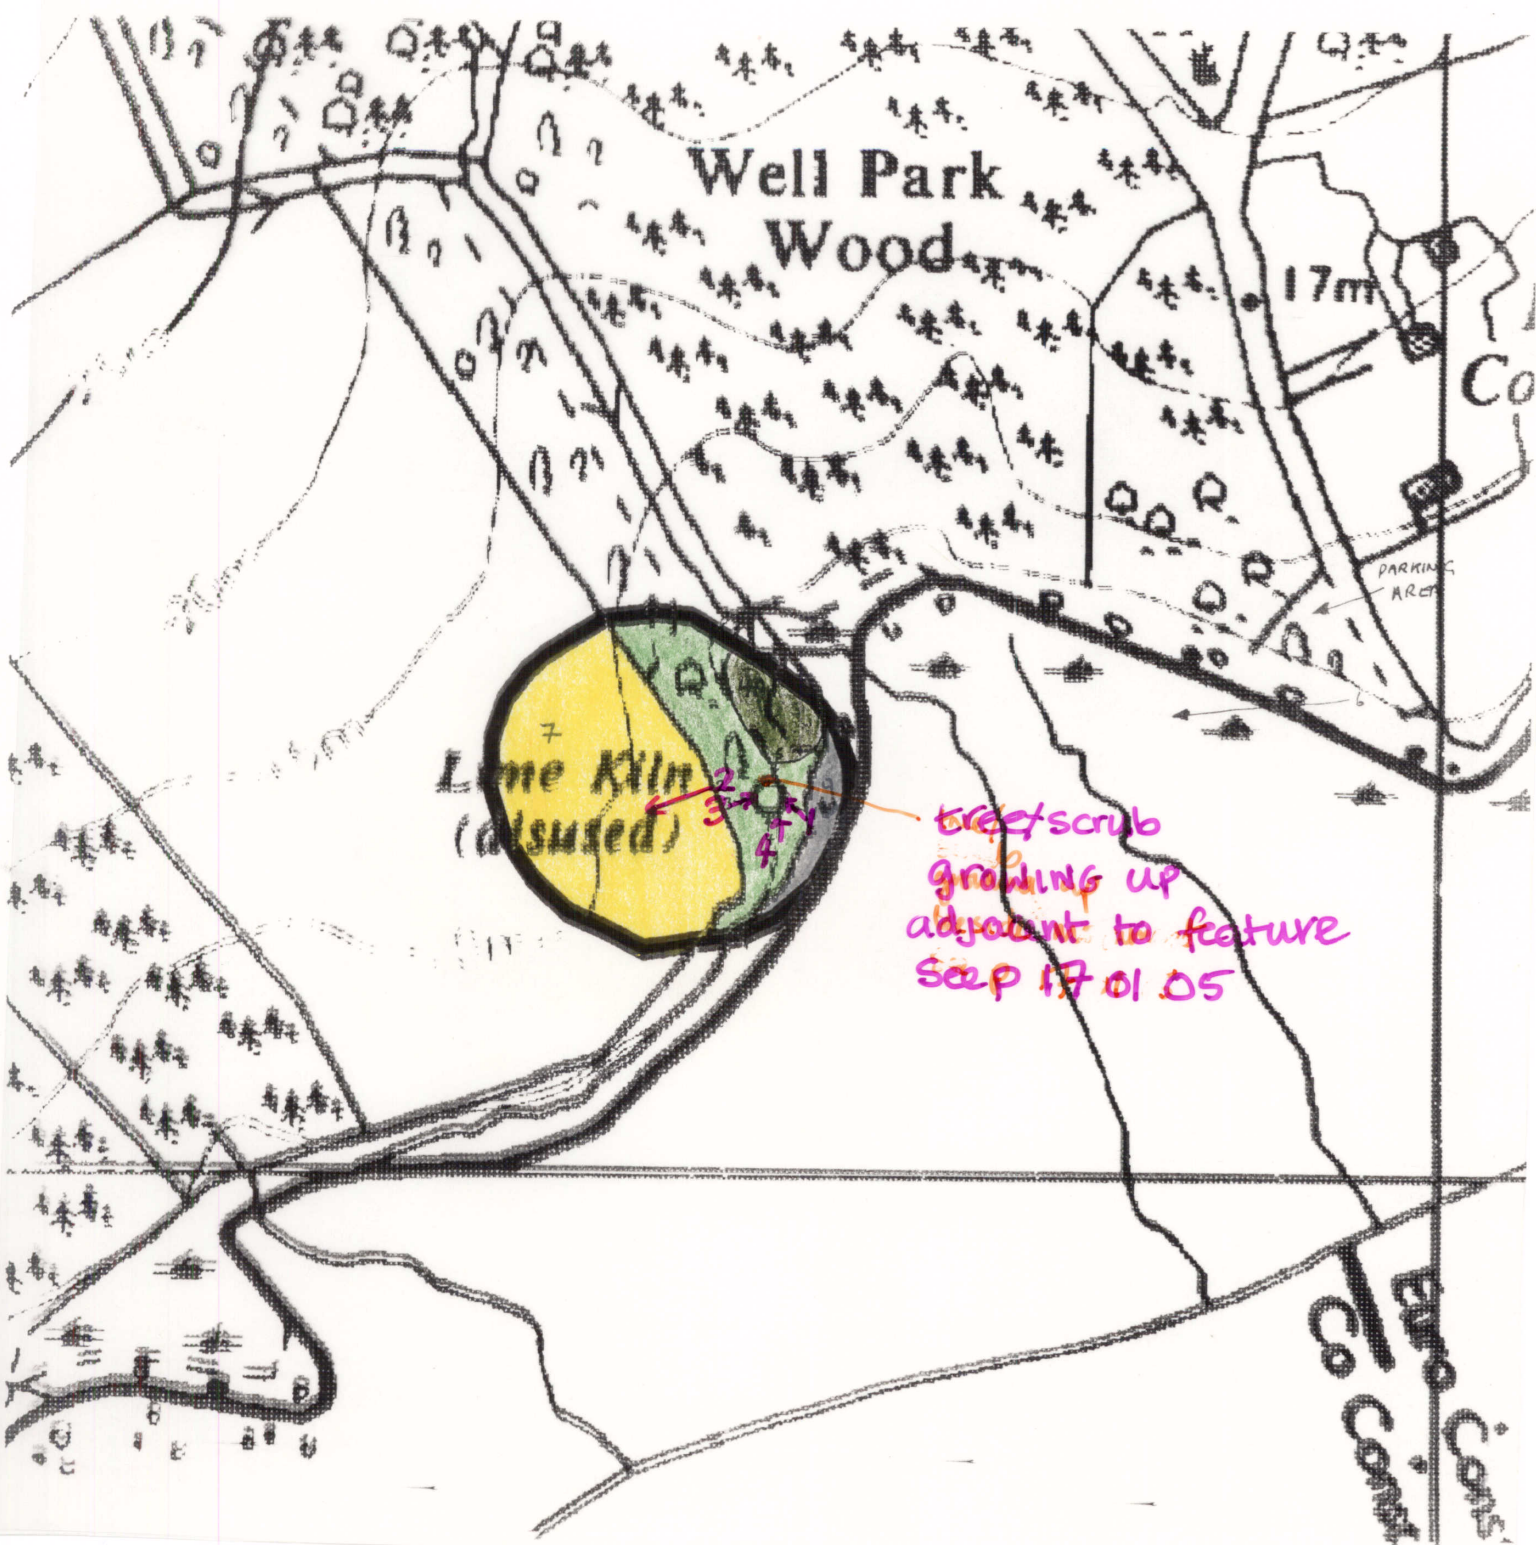
SN0078 1213

as marked on plan photo  
170105 shows growth of a young  
sapling immediately adjacent  
to kiln - This may cause problems  
in the future as the tree grows  
to maturity + the roots require  
more space.

WHICH IF ALLOWED TO CONTINUE  
WILL IN TIME CAUSE DAMAGE VIA ROOTS AT THE BASE OF THE  
KILN.
