# MEDIEVAL AND EARLY POST-MEDIEVAL CHURCHES AND CHAPELS

A THREAT-RELATED ASSESSMENT 2010-11

Prepared by Dyfed Archaeological Trust  
For Cadw

RHIF YR ADRODDIAD / REPORT NO. 100039  
RHIF Y PROSIECT / PROJECT RECORD NO. 2010/47

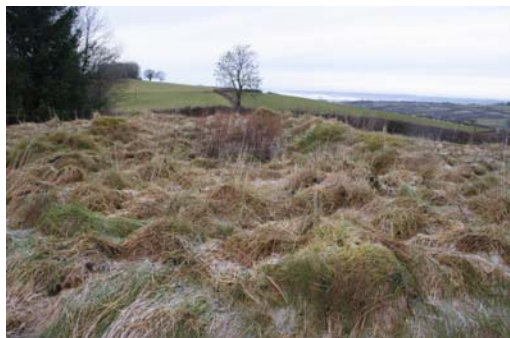
Remains of late medieval chapelry to Llandeilo Fawr parish, which was vestigial in the early 20th century (RCAHM 1917, 89 No.266). It was dedicated to the 'Celtic' St David. Site visit in 2011 showed that the chapel is now represented by a roughly rectangular earthwork, orientated east to west, and consisting of at least two chambers. The remains are located on a slight mound within a large enclosure, which is not necessarily contemporary.

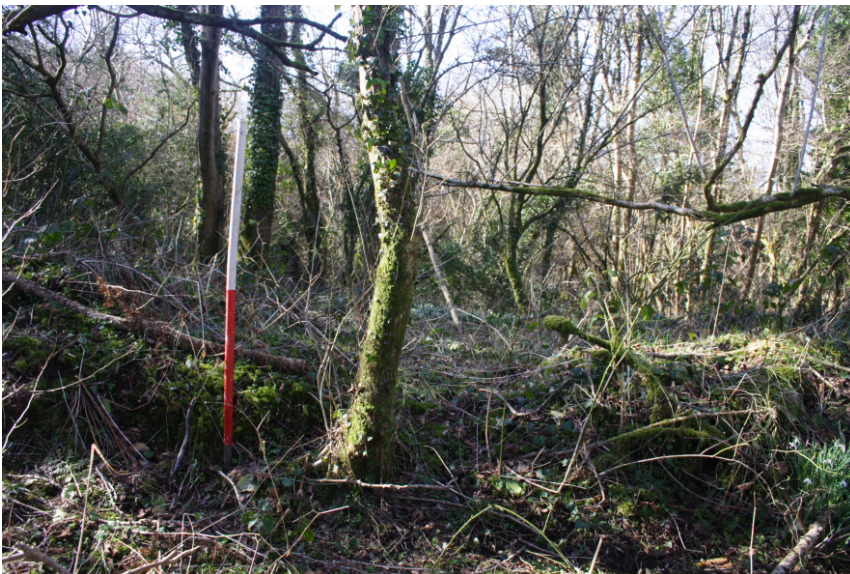
The site of the chapel was visited during the Churches and Chapels project, 2011. It lies within a fenced-off area of woodland that is very overgrown with brambles. Earthworks were recorded on an area of relatively levelled ground above a stream. The full extent and accurate form of the earthworks were difficult to determine, partially due to the indistinct and incomplete nature of the site itself and also because of the ground-covering vegetation. The best preserved earthwork runs north-south, alongside a possible trackway to the east. This stands some 0.40 metres high and stone courses are revealed within its length of some 12 metres. There appears to be a possible entranceway within this earthwork and it may be part of an enclosure around the chapel to the west, where. very slight earthworks were recorded as comprising a square some 6x6 metres, sat on a levelled platform. The farmer informed me that an excavation of the site, some 30 years or so ago, by Aberystwyth University revealed nothing.

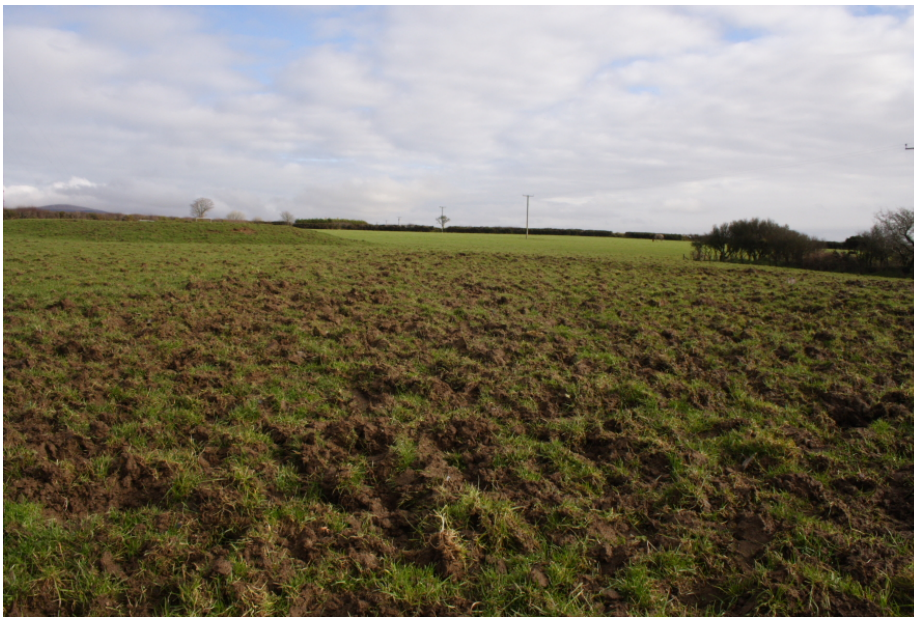
The site comprises a rectilinear enclosure delineated by low earthwork banks that are clearly discernible on the ground. The enclosed area has a high frequency of stones and slate fragments. The site lies within a pasture field and there are no surviving upstanding remains of the former chapel.

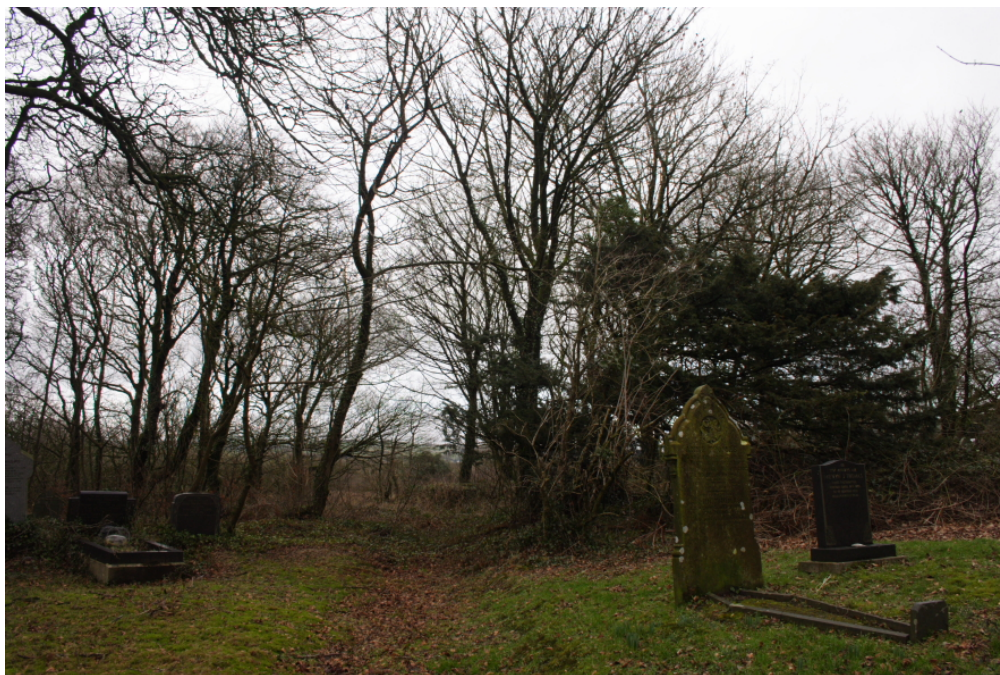
The church is a roofless shell with all the walls standing to a height of just over a metre. There is no evidence for stone tumble or any roofing material, indicating that the walls were reduced for the site to be managed as a ruin. The wall tops are capped with concrete. The chancel arch is now only marked by an internal buttress. Within the chancel there is a stone cross carved in relief on the east wall, a window recess on the southern wall and a small stone shelf in the northeast corner. At the western end of the church is the stone base of the former tower. The church sits within a graveyard, with early 20th century graves to the north of the building and 19<sup>th</sup> century graves to the west. The area just within the churchyard gate appears to still be tended and there are more recent headstones, the latest dated 1979.

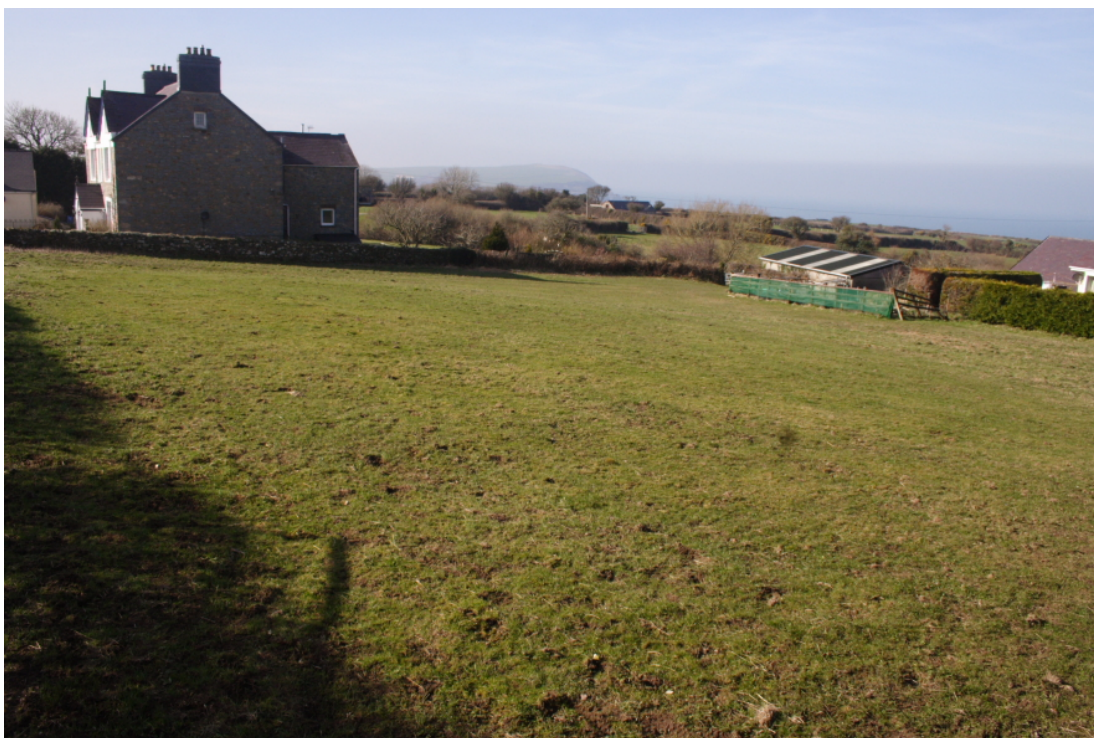
In 2011 no sign of earthworks were seen at the recorded location within a field currently under pasture. The field slopes gently up towards the southeast. Apart from a few small fragments of slate, no building material was apparent within the field.

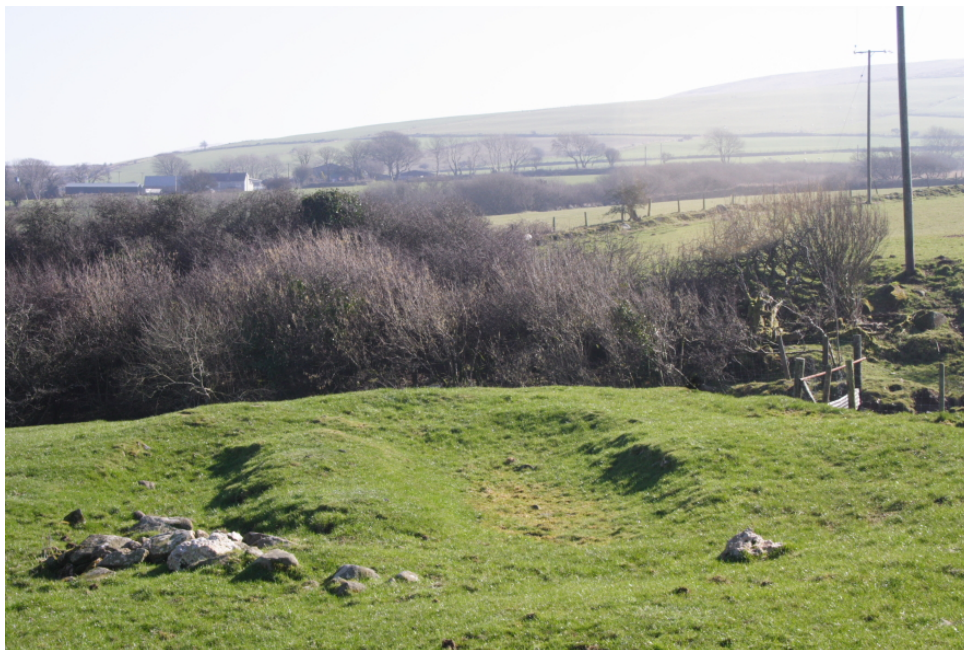
The site now comprises a rectilinear area of earthworks aligned east-west and measuring approximately 16 x 10 metres. Mainly covered with grass, there are also numerous exposed stones particularly at the northwest corner. A stream runs north-south close to the eastern edge of the site

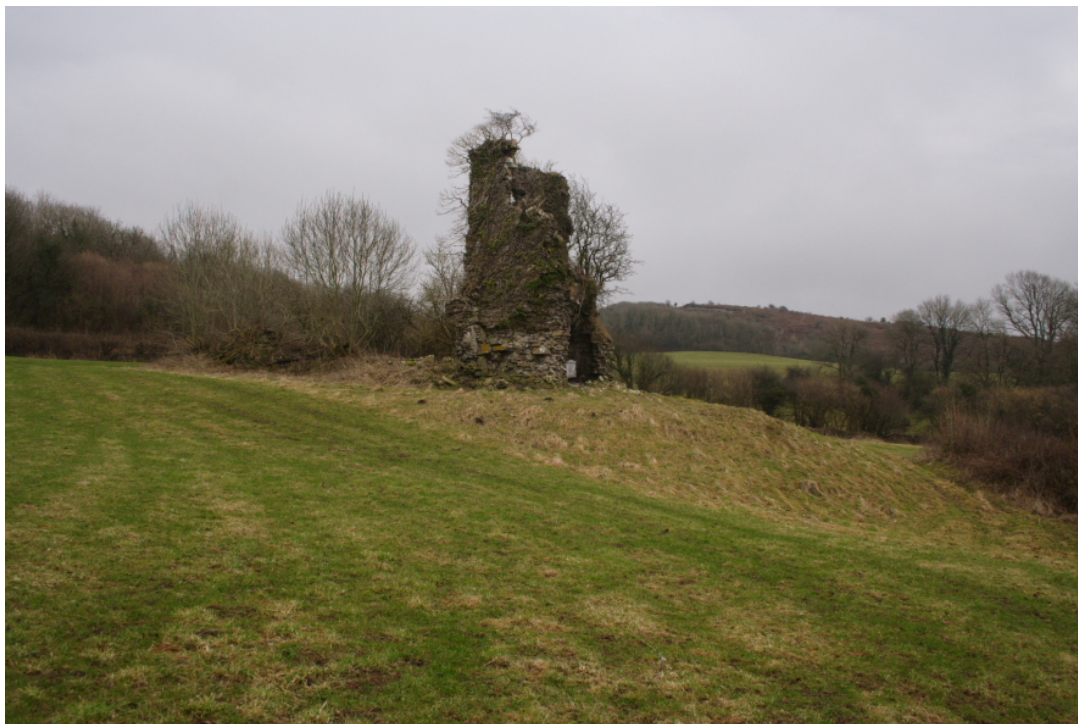
It now (2011) consists of substantial standing remains of a medieval chapelry to Llandyfaelog parish (now in Llangendeirne parish), comprising a chancel, nave and tower, situated on a raised platform and orientated E to W. The condition of the church as ruinous was recorded by R. E. Kay (DRF) in his notebooks at the end of the 19th century. The tower still stands to around 4m, but is covered in ivy and scrub and has clearly deteriorated since Kay's recordings. The walls of the nave and chancel are around 1m high, but are also covered in vegetation. The interior of the church has been used to dump old farm equipment.

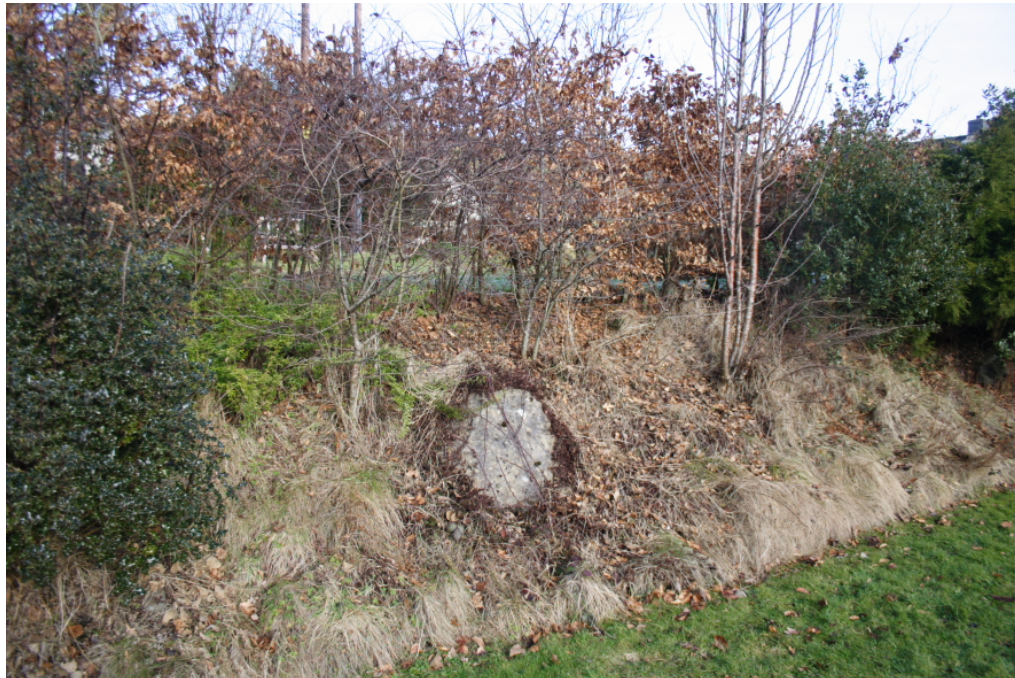
Site visit in 2011 revealed no upstanding remains visible - the area marked on the OS 1st ed is now a house and garden.

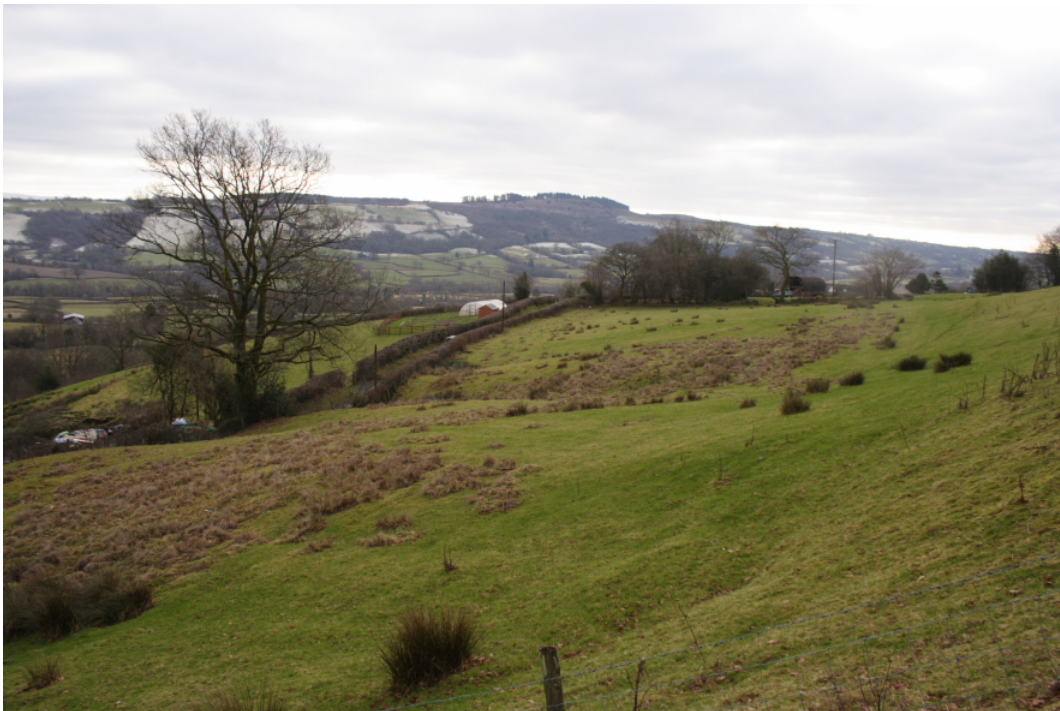
The field-name 'Mynwent Capel Llanfihangel' represents the site of the medieval Capel Mihangel, which was a grange-chapel to Talley Abbey, belonging to Cefn-blaidd Grange (Richards 1974, 113), and was mentioned in a mid 18th century list when it was 'ruinated' (Price 1879, 165). It stood near Ty Hewell Farm (RCAHM 1917, 264) on the slopes of Mynydd Cynros, from which it received its alternative name 'Llanfihangel Cynros' (Richards 1974, 113). Site visit in 2011 showed that no trace of this chapel survives above ground, although a few small 'shaped' stones may be the remains of the masonry. Presumably the cottage Ty-Hywel is constructed from the stonework of the chapel. The chapel is located in a steep sided valley, but there are 3 places where the slope levels out and one of these were probably the location of the building and graveyard.

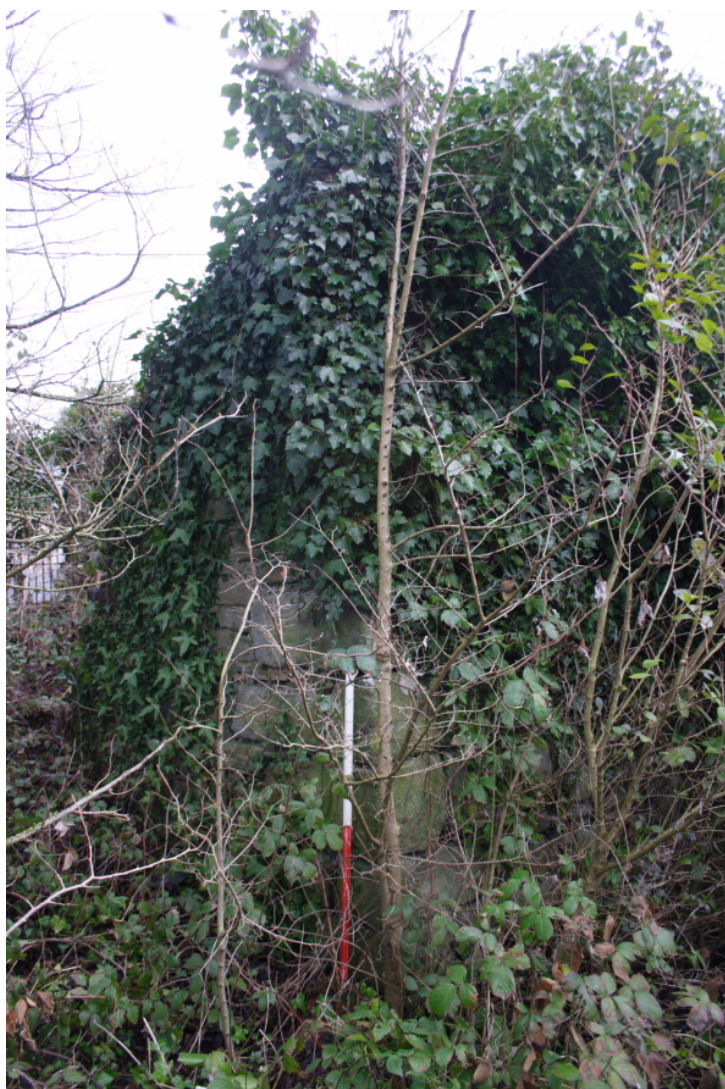
A medieval chapel-of-ease to Llanelli parish, ruinous by 1833 (Lewis 1833), whose remains still survive in Llwynhendy, on the opposite side of the B4297 to the de novo St Davids Church (PRN 7276) by which it was superseded in the mid 19th century (RCAHM 1917, 119 no.347). Part of the west and south walls of the nave survive and are believed to date from the 12th or 13th century, the rest of the structure is believed to survive under the road. The chapel had burial rights and was associated with a cemetery. A local resident stated that a churchyard was located next to the chapel and that school children dug up bones from the site. A gravestone was also dug up from a neighbouring garden. It was dedicated to the 'Celtic' St David, but was probably a late medieval foundation (Yates 1973, 57-8) there is no current evidence for an early medieval date. The remains of the chapel, and the area between it and Llwynhendy Road, are a scheduled ancient monument.

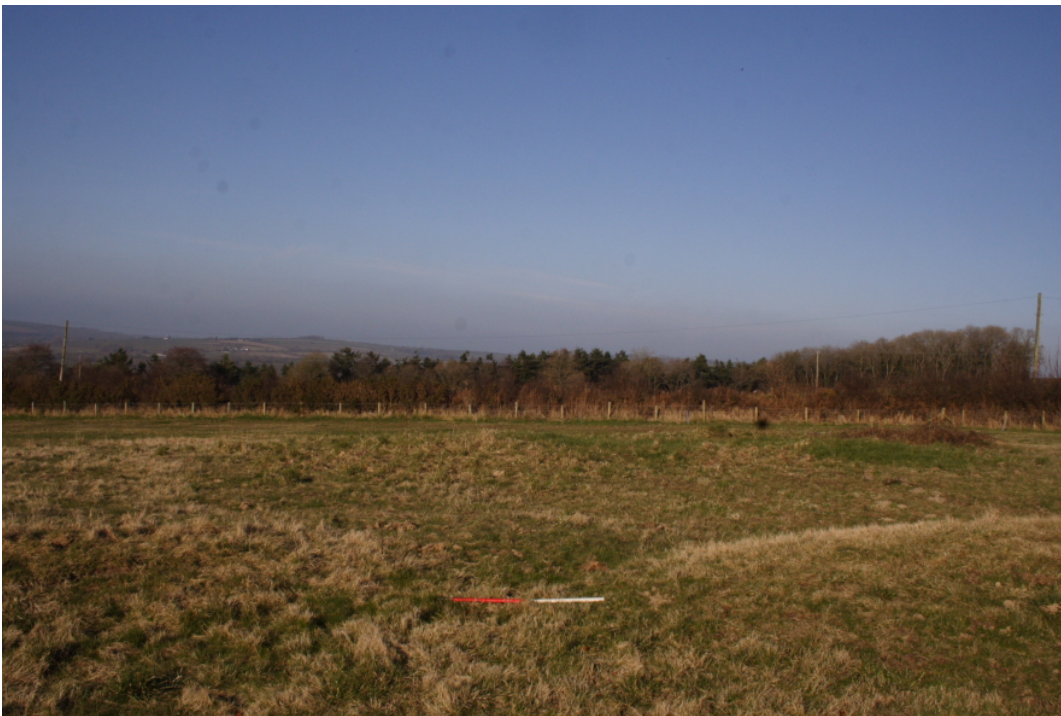
The owners informed me that there is a well in the field on the other side of the lane, associated with the subterranean watercourse that runs north-south just to the east of the site.

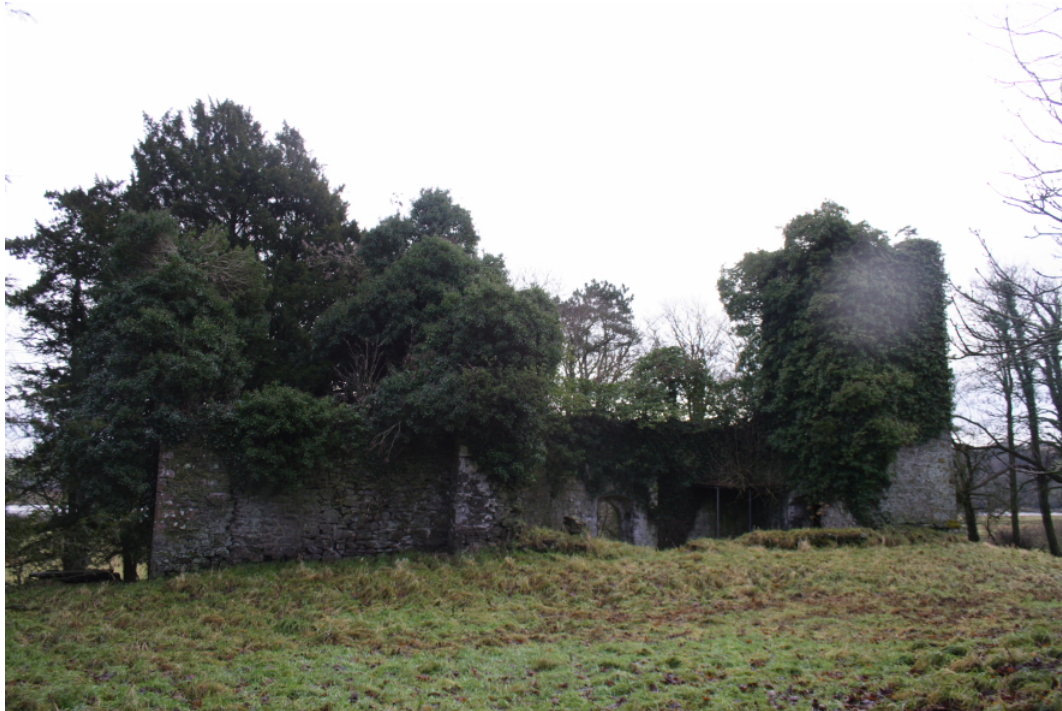
Small medieval parish church comprising chancel, nave and west tower, standing in a large rectangular earthwork enclosure. There is an entrance in the south wall and west wall (into the tower). The south and east walls still exist to roof height, but the north wall is only around 1m high. A modern concrete structure exists in the SW corner of the nave and may be where current services take place. The church appears terraced into the slope. A mound of material abutts the north wall, presumably the collapse from that wall.

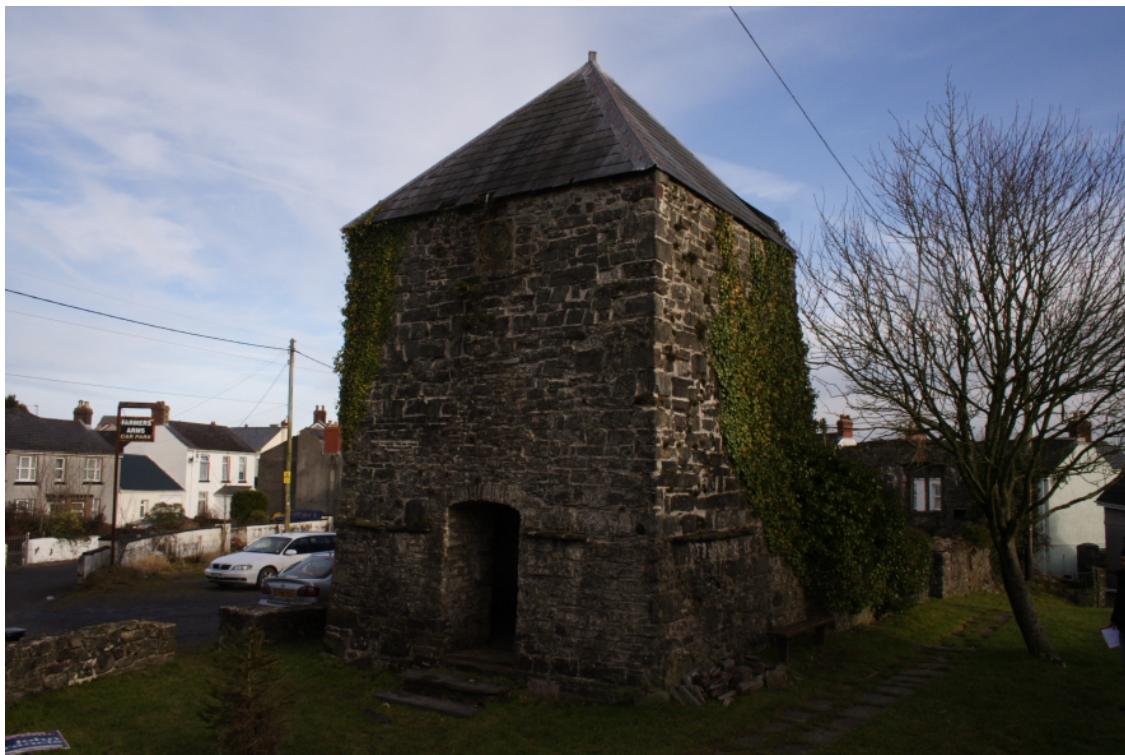
Former chapel-of-ease to Llanstephan parish which became disused in the mid 20th century and is now ruinous. The remains are scheduled. Site visit in 2011 showed that it comprises a chancel and nave with a roofed tower at the western end. The N and S walls stand to about 1m, but the E gable end is much more substantial, surviving to roof height.

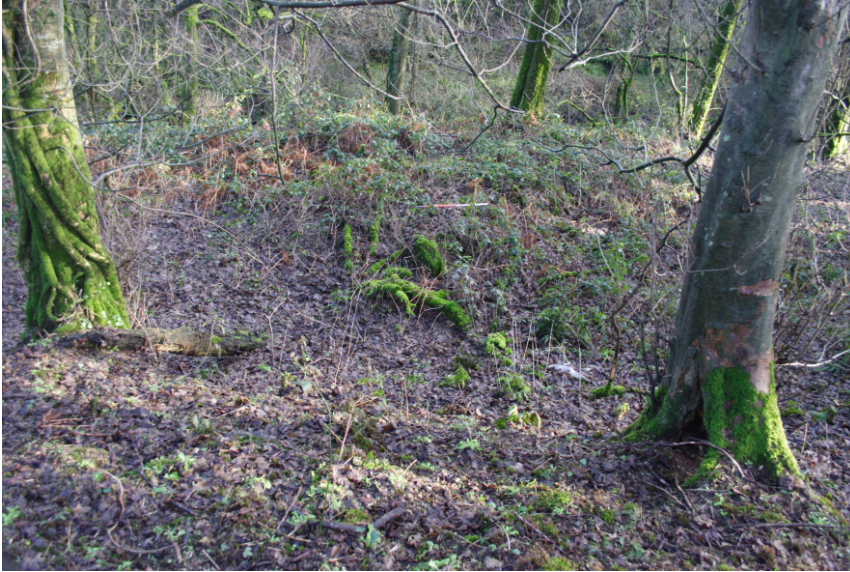
Site of undated (medieval?) chapel, represented by rectangular platform and place-name 'Old Chapel'. The site comprises a relatively level, rectangular platform cut into a steep, north-facing, wooded slope, accessed by a pathway to the northwest. No remnant of the chapel building was evident, although two substantial stones were noted in the centre of the platform

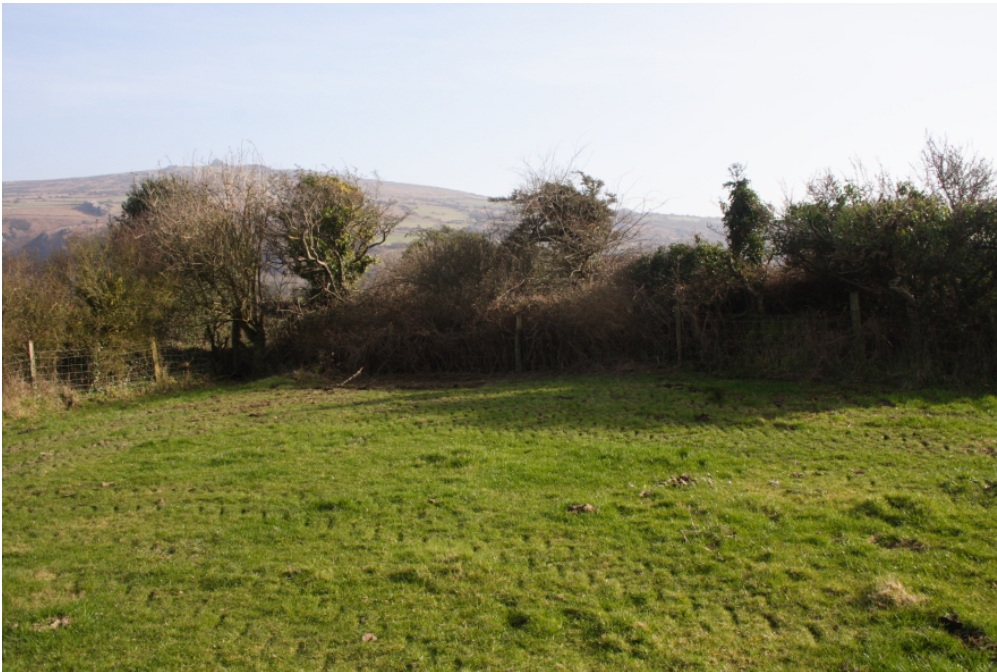
In 2011, no evidence was found for earthworks or building materials at the recorded location of the chapel. The field is under pasture and slopes down towards the east. The owner of Garn Farm believes that the actual location of the chapel was just to the north, on the other side of the adjacent lane, from where stone is thought to have been taken to build the farmstead (now ruined) opposite.

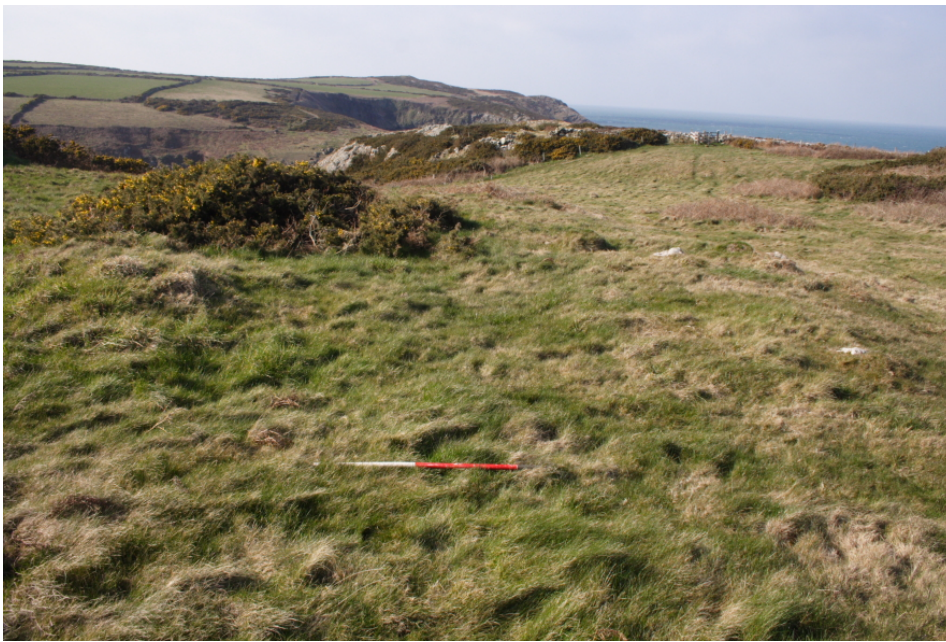
A site visit in 2011 revealed no structural remains, but possible earthworks were recorded, although they were indistinct and partially obscured by extensive gorse. A local resident believes that stone from the site was taken to build one of the nearby cottages.

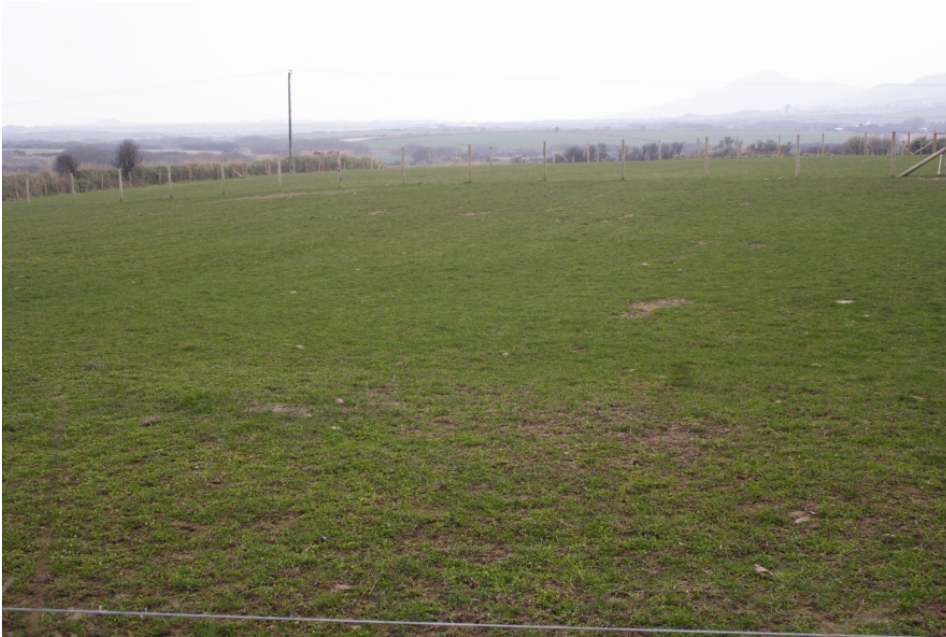
The site is now (20110) a generally flat field under short grass and there are no structural remains. Earthworks could be discerned, although they were very slight, forming a possible rectilinear enclosure. Local residents informed me that the stone font from the site had been removed to St Non's.

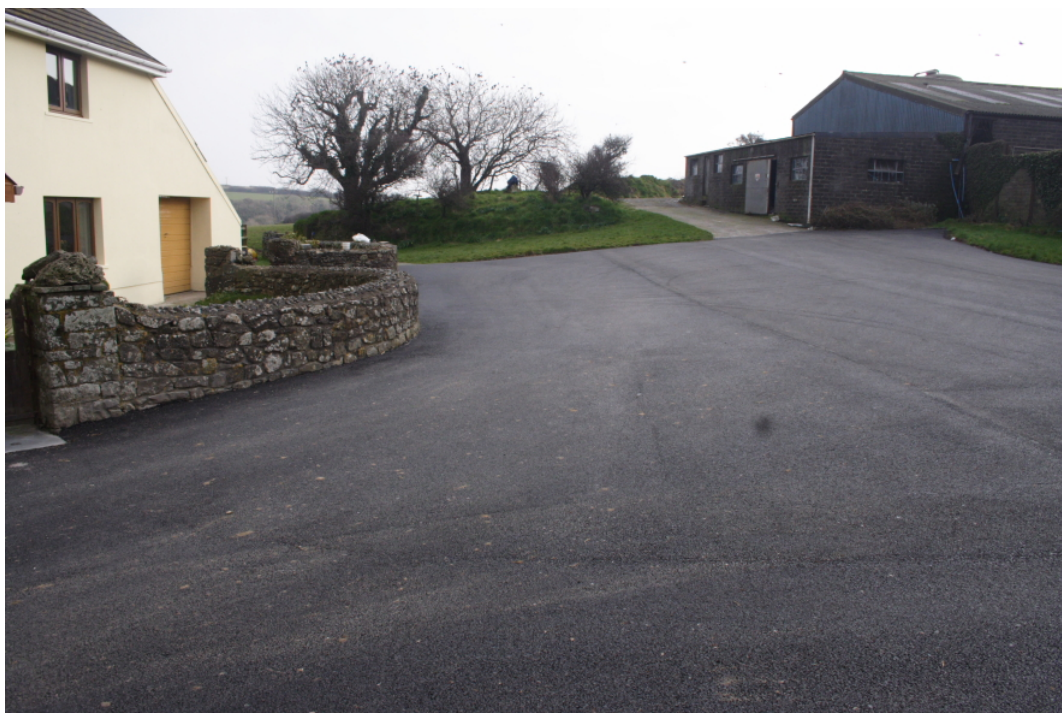
The recorded site of this chapel is based on its location on historic Ordnance Survey maps where it is shown located immediately south of the farmhouse and to the east of an L-shaped complex of farm buildings. These buildings all still stand (2011) but the area of the chapel is now a tarmacked driveway / courtyard.

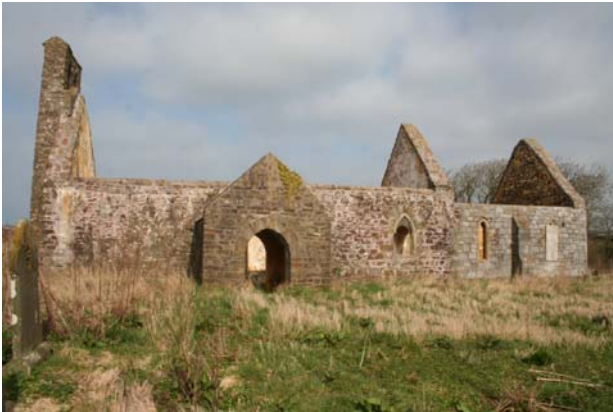
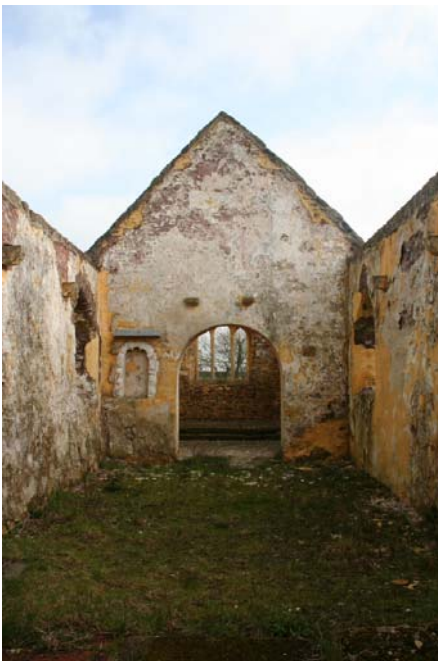
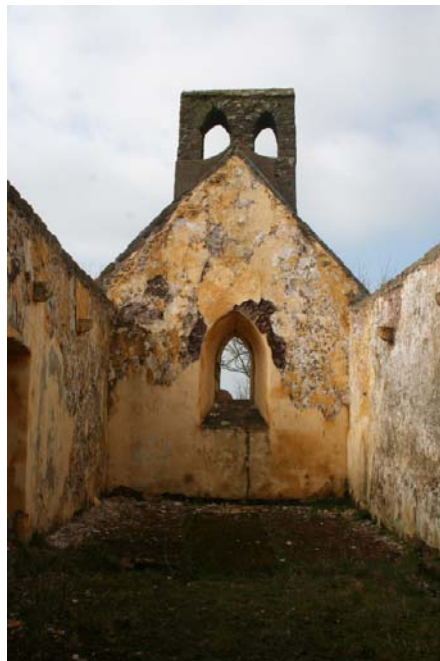
Medieval parish church listed in Taxatio of 1291. It is located in a small, square churchyard next to a farm. It consists of a nave, chancel and south porch with a west bellcote. It is roofless and conserved as a ruin. The nave and chancel arch are late medieval, but the chancel dates from the restoration of 1874.

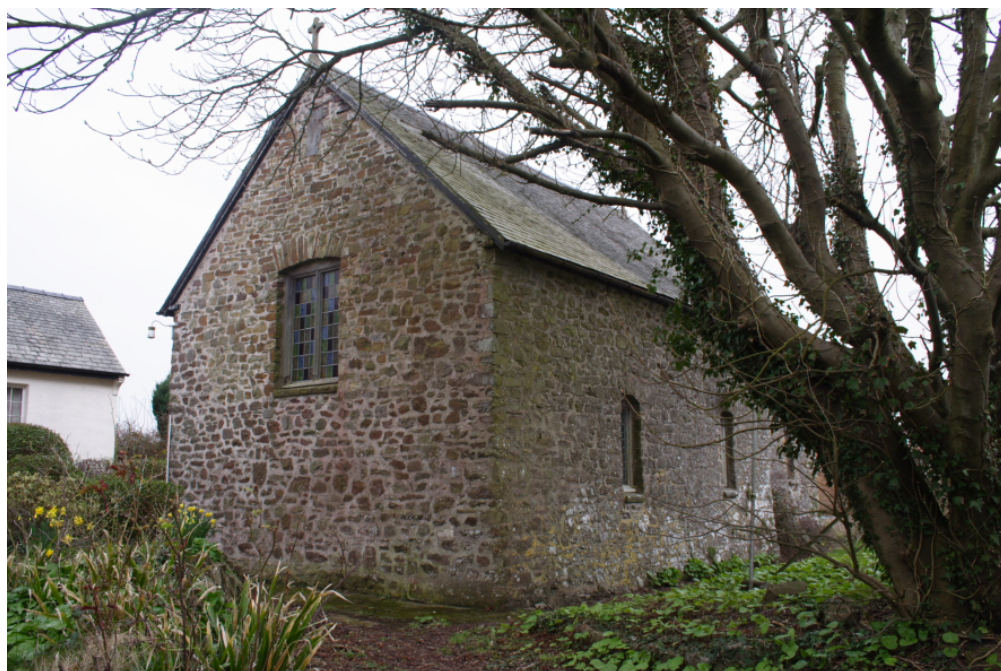
A medieval chapel in Steynton parish (now in Milford Haven parish). It was founded in the 13th century as a chapel to Pill Priory. It was disused by the early 19th century and ruinous. It had burial rites and the boundary of the ancient cemetery was visible in the early 19th century. It was restored in 1930-01, but much of the fabric is medieval. It consists of a small nave and chancel, both vaulted. In 2011, it was recorded as being well maintained and located in the garden of a house. The dedication of this chapel is a little confused, some authorities having it as St Catherine, others as St Thomas a Becket.

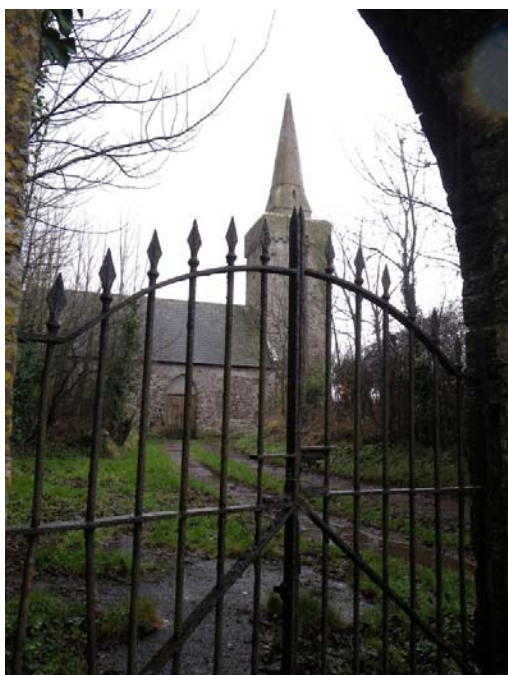
Its fabric is mostly medieval, and comprises a chancel, nave and west tower. It has vaulted roofs. The windows are now covered with zinc sheets, guttering is missing, ivy is growing up the walls and the over part of the lightning conductor has been removed.

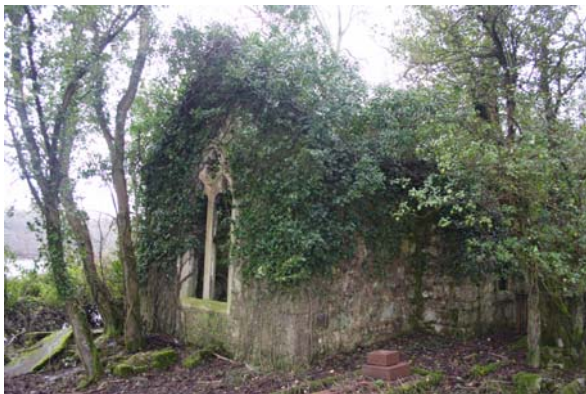
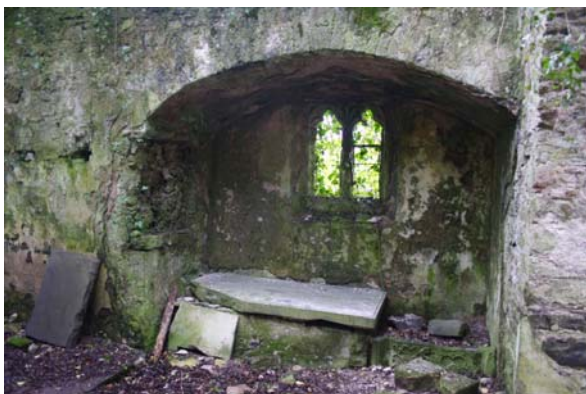
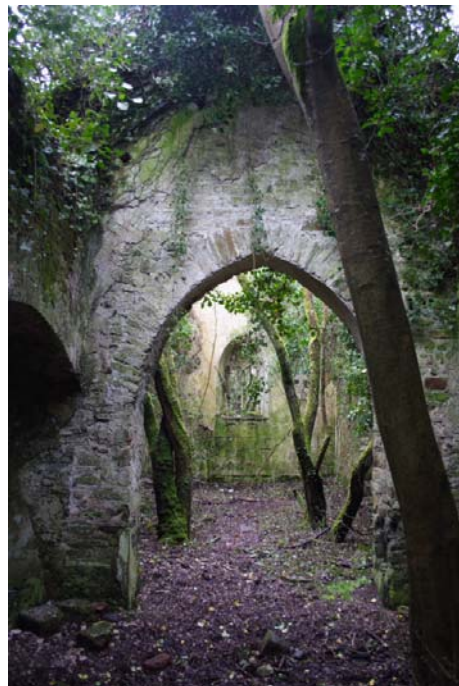
A field visit to the site during the Churches and Chapels project (2011) observed the building to be within a wooded churchyard fenced off from the pasture field to the north and located on a large, raised rectilinear platform above the Hook Reach. There are two, opposite arched doorways in the north and south walls of the nave and window apertures in the north, south and west walls. Stone steps in the southeast corner of the nave indicate the position of the pulpit. Through the chancel arch, there are further windows in the north and south walls of the chancel, set within wide, arched recesses. The recess within the south wall has a stone box tomb in it and remnant of similar is apparent within the opposite wall. A further, smaller arched recess is located in the southeast corner of the chancel, with a remnant of carved stone column. A large twin-arched window dominates the southern gable, above a slightly raised area where the altar would have stood. The floor of the church is obscured by vegetation growth. Some stone slabs and loose masonry were apparent within the nave.

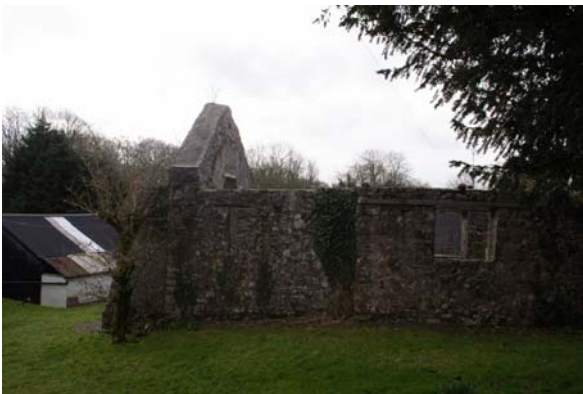
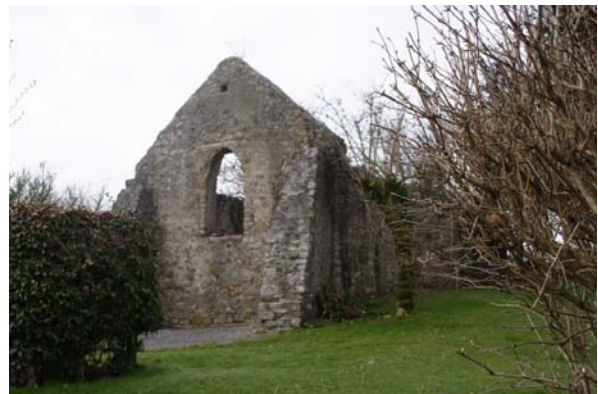
In 2011 a site visit showed it to be a simple rectangular building with a bell tower at the west end, and walls standing to their full height, but roofless. The masonry seems to be in good condition, and it stands within a private garden surrounded by lawns. Some gravestones are visible.

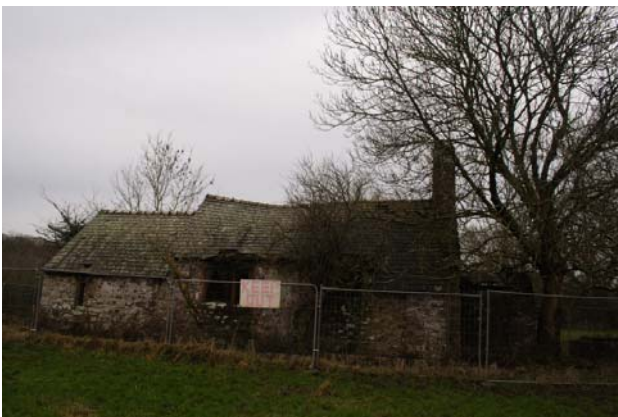
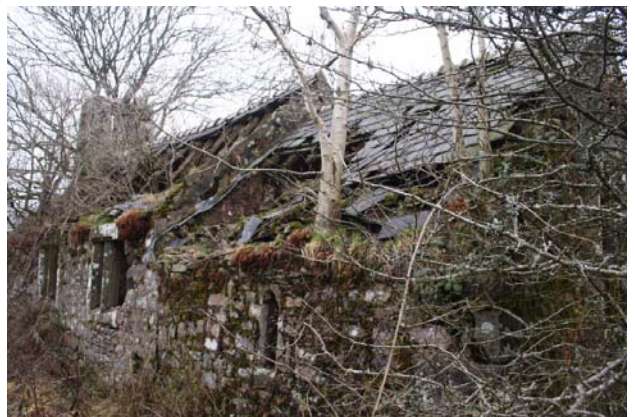
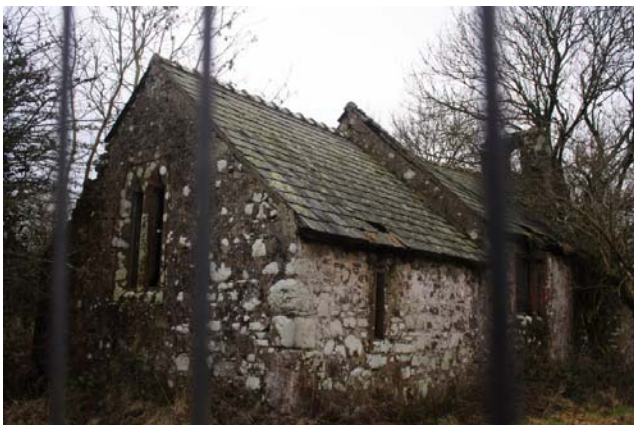
The church was visited during the Churches and Chapels project of 2011. It was encircled with high wire fencing, with notices to 'keep out' so the interior was inaccessible. The building stands within a circular pasture field on the edge of Canaston Wood. There is no attendant graveyard. It is a 2-cell building aligned east-west, comprising entrance porch, with bellcote, to the west and the chancel lower in height to the nave. A later extension has been added to the northwest corner of the nave but, without seeing it from inside, its purpose is unknown. A substantial stone plinth stands beyond the western entrance, presumably the base of a cross. The roof timbers on the southern side of the church have rotted through and collapsed, although the ridge and ridge tiles survive. The roof on the northern pitch is still intact, although bowing inward at the centre, with some slate displacement. The porch roof has collapsed and the masonry on the southwest corner has been damaged. Elsewhere, the masonry stands to full height and is generally free of vegetation. However, the exposed wall tops on the southern side have plants, including young trees, growing from them. More mature trees and a thorn bush grow close to the church, particularly to the northwest, where their branches are causing damage to the fabric of the building.

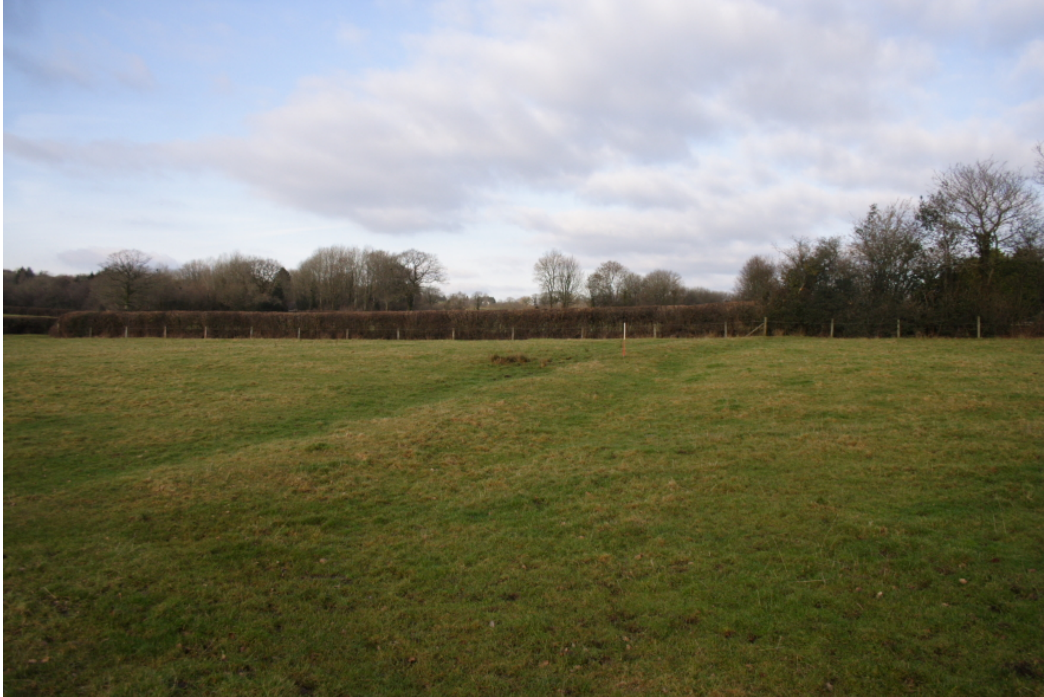
OS 1st ed. shows site of chapel in field to NW of Arfryn cottage. A site visit (2011) confirmed that no trace survives above ground. A linear earthwork, probably an old field boundary, runs SW to NE across the field. The exact location of the chapel was not clear, and there were no earthworks or masonry remains.

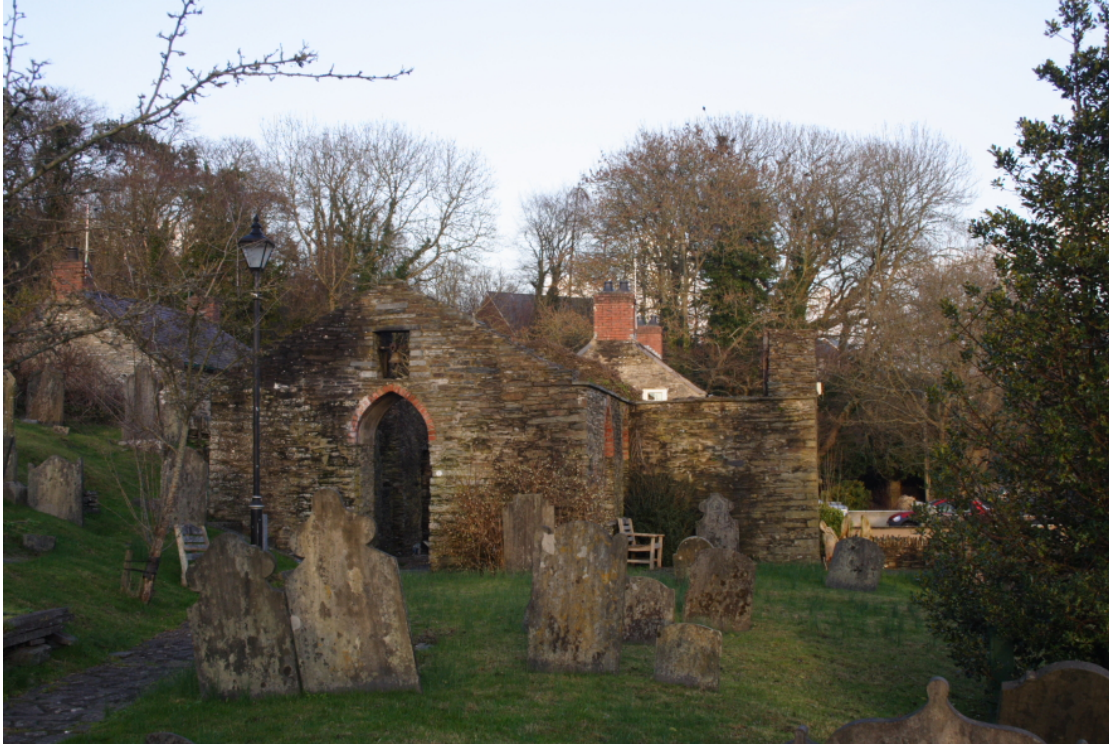
The now roofless church is aligned east-west and is built of slatestone rubble. There is a high, arched doorway, below a bell-tower, at the western end leading to a single space comprising the nave, chancel and a later south chapel. A doorway within the northern wall leads through to a vestry containing a fireplace. All internal furniture - pews and pulpit - have now gone and the floor is now of stone slabs and gravel. There is a stone slab altar on the raised platform of the chancel and a wooden cross stands on the window sill of the south chapel. Two floodlights have been placed on the floor, under the northern wall. The church sits within a rectilinear churchyard containing numerous graves.

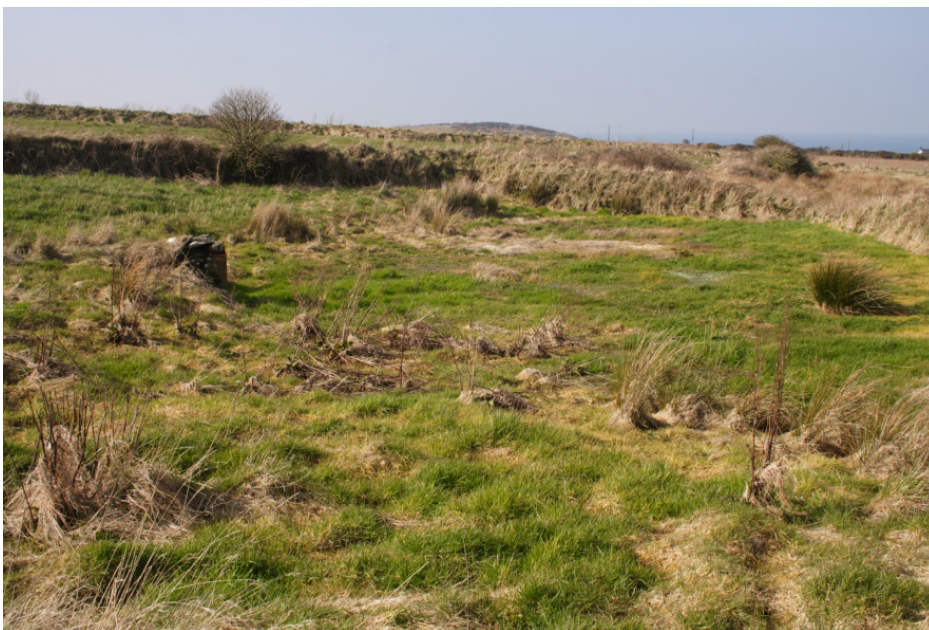
Recorded site of a well-chapel to St David's. It was ruinous by the 17th century but the associated well house (PRN 7571) survived. The site was represented by an earthwork by around 1900 and this had gone by 1925. The site is also recorded as PRN 2842. It is marked on the 1907 2nd edition Ordnance Survey map as the 'Supposed site of chapel'. The site was visited during the Churches and Chapels project of 2011 but no surface evidence for the chapel were noted. The area is under relatively long grass and slopes down towards the north, becoming increasingly waterlogged. The well survives at the edge of the marshiest area, with a stone and brick surround.

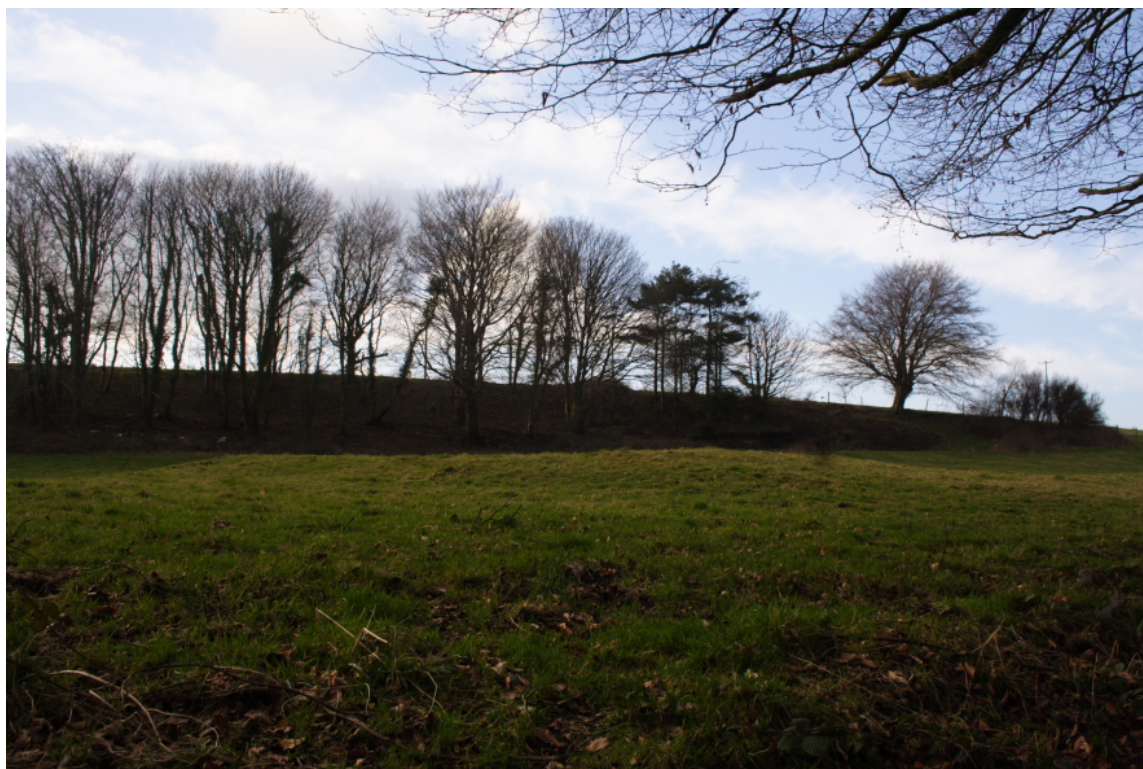
The site comprises a subrectangular earthwork platform some 16m x 14m, aligned east-west within a pasture field above a stream, which runs to the east of the site. The slopes of the platform are well defined and stand some 0.50m high and the relatively level top measures approximately 12 m x 8m. No vestige of the former chapel building was evident. A possible further platform was evident to the south of the main earthwork and it has been suggested (in 1975) that this may represent a burial enclosure. A local resident told me that the chapel was linked to the nearby Noyadd Trefawr mansion by carriageway that ran alongside the stream. Remnant of stone walling was recorded adjacent to the stream where it was believed the carriageway reached the entrance to the chapel site - marked on the modern OS10k map as a rectilinear interruption within the boundary.
