# MEDIEVAL AND EARLY POST-MEDIEVAL CHURCHES AND CHAPELS

A THREAT-RELATED ASSESSMENT 2010-11

Prepared by Dyfed Archaeological Trust  
For Cadw

RHIF YR ADRODDIAD / REPORT NO. 100039  
RHIF Y PROSIECT / PROJECT RECORD NO. 2010/47

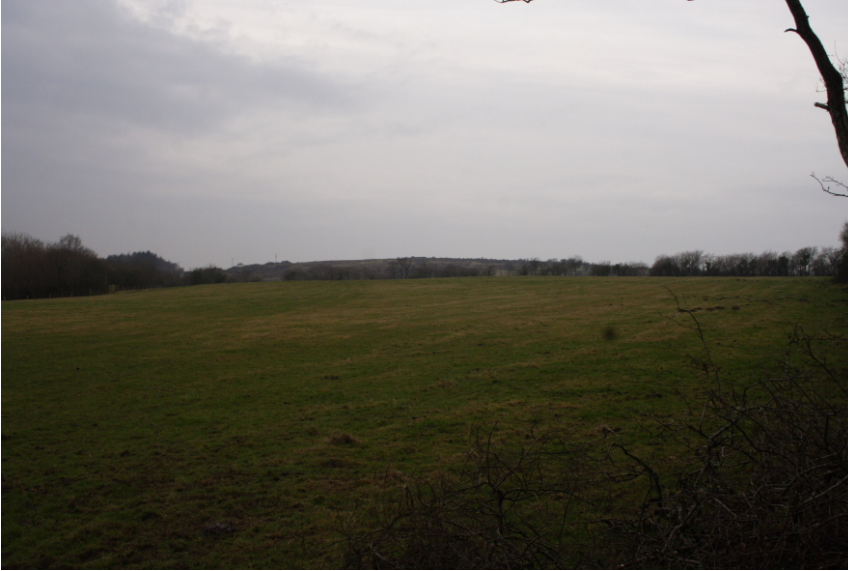
Situated near the farm with the name of 'Capel Sylen'. Only stones remain on this site. The farmer in 1983 from Pantyceln nr Capel Sylen farmhouse remembers a service held here in the ruins. The exact location of this former chapel was not clear on the ground. No stones could be located at the given coordinates.

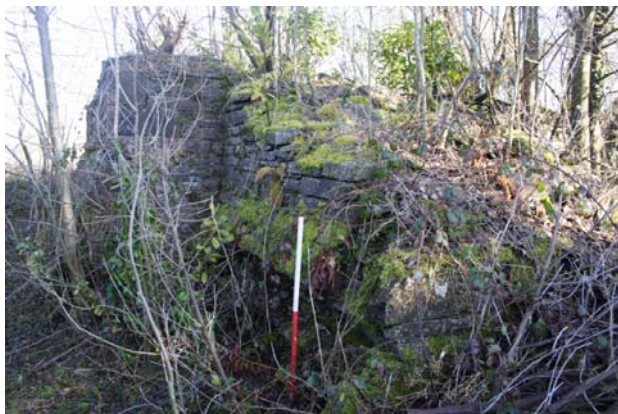
Site of a now ruined church built in 1853, and depicted on the 19th century Ordnance Survey map, to replace the medieval church (PRN 1107) on the same site. The church walls now stand to a minimum height of about a metre and the interior has been infilled with the stone demolition. This destruction has occurred since 1984, when the RCAHMW recorded the site to be complete, roofed and with interior fittings. The shaft of a medieval cross (PRN 1110) stands within the extensive, walled churchyard, which is now (2011) heavily overgrown.

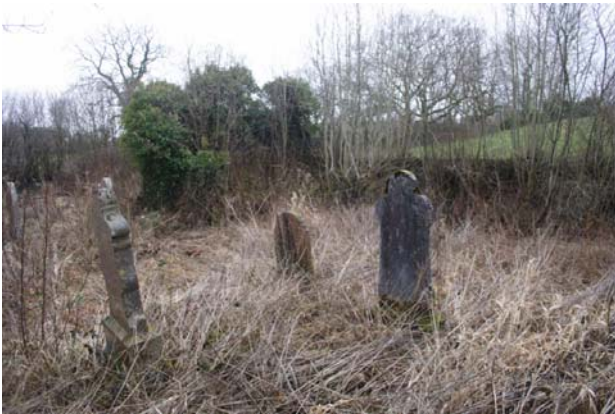
The remnant of a chapel building is located within a rectilinear churchyard that contains several in situ graves. The churchyard is bordered by a stone wall to the east and north, a stream to the south and hedgerows to the northwest and west.. Only the western end wall of the chapel survives, although this is obscured by heavy vegetation. Further masonry stands at the southwest corner and there is a wall remnant, aligned north-south, amongst piles of stone tumble that represents either part of the eastern end wall or an internal dividing wall. Piles of tumbled stones are heaped around the building remains and the churchyard is heavily overgrown.

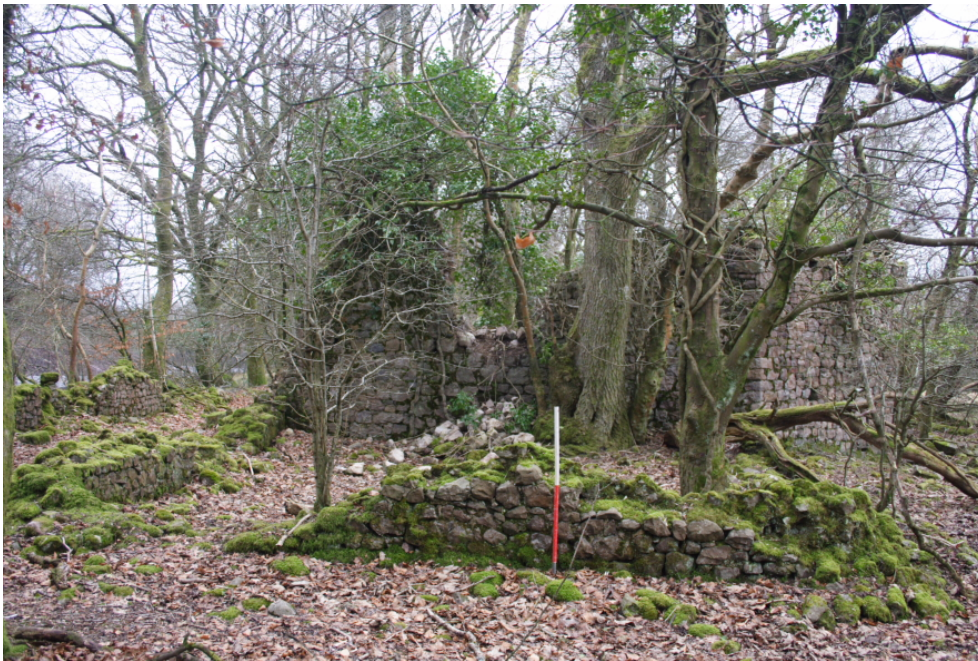
A structure, apparently known locally as a chapel, in a bad state of repair. Site visit in 2011 showed that the structure is an octagonal building around 10m in diameter. A small rectangular annexe is fixed to its north side, but there is no entrance passage between the two structures. The building is set within a rectangular stone built enclosure and sits along the line of an old droveway. The entrance to the structure is presumably on the SE side, but this is not clear due to masonry collapse. There is considerable fallen masonry within the structure and vegetation has colonised the area and is damaging the building. The owner is certain that the structure is not a chapel. It is not marked on the OS 1st or 2nd ed maps as a chapel and its shape is contrary to other chapels in the region. It is likely to be a folly or an elaborate cattle shelter - for a comparable octagonal structure see William, E. 'Hist farm buildings of Wales' (1986, fig 90). Its shape suggests it could be a large dovecote, although there are no apparent nesting holes within the interior.

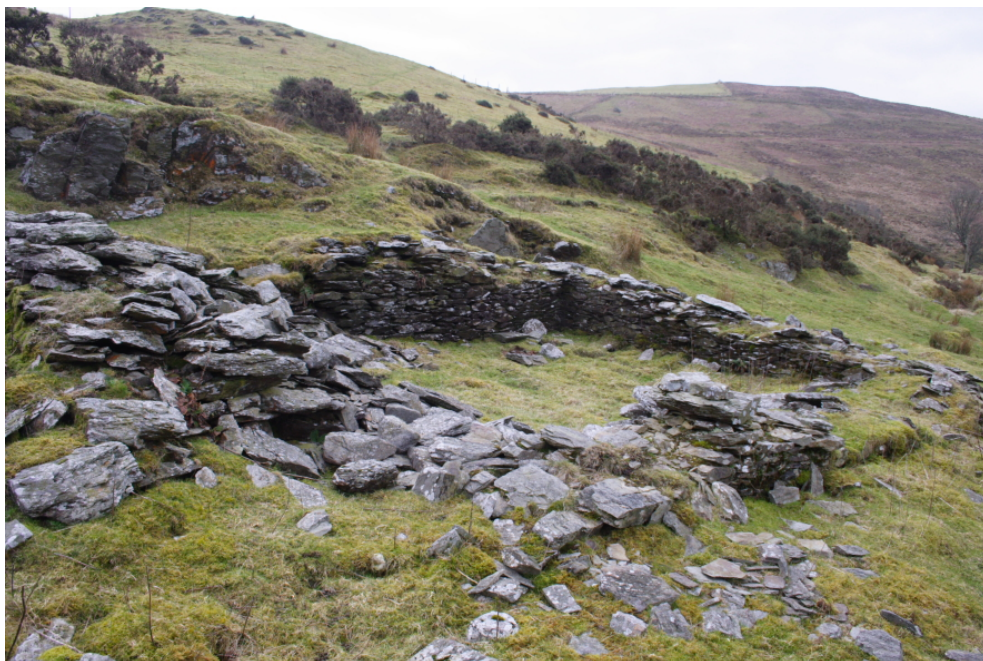
The remains of this building comprise a small rectangular (approximately 5x6 metres) structure of drystone walling set on a levelled platform into a west-facing slope. Largely destroyed, the eastern (rear) wall of the structure survives to some 15 courses, set into the bank. The footprint of the building is discernible but there is much tumble/stone piling against the northern wall. No sign of roofing material and the remaining wall heights are insufficient to ascertain window placements. There are also no obvious doorways - entrance was possibly through the, now obscured, northern end wall. Nothing in the physical remains mark them out as a chapel site and it is not labelled as such on the historic OS map. However, it is recorded by Protheroe-Jones (1993) as Sir Hugh Myddeton's Chapel - "built to serve miners in the 16<sup>th</sup> century".
