**ROCH CASTLE,
PEMBROKESHIRE
(SM 8803 2121)**

**HISTORIC BUILDING
RECORDING AND
ARCHAEOLOGICAL
INVESTIGATIONS**

RHIF YR ADRODDIAD / REPORT NO. 2011/26
RHIF Y PROSIECT / PROJECT RECORD NO. 100723

March 2012

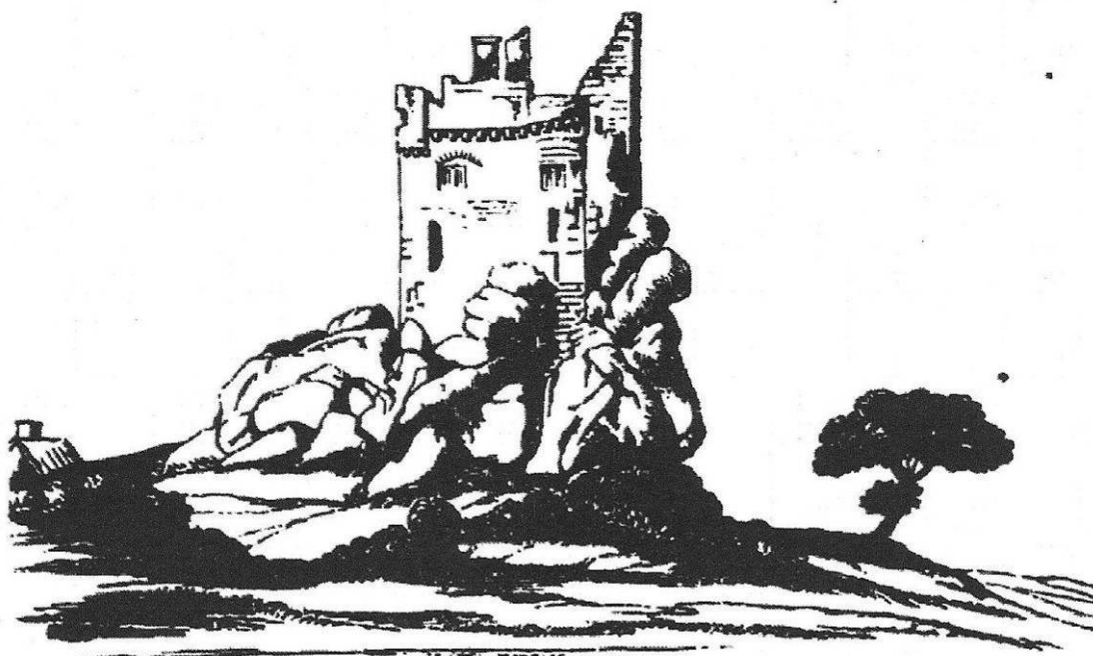
Illustration 2: The western elevation of Roch Castle (PSAL 1857, p102)

The illustration of the western elevation of the castle from 1857 (Illustration 2) is very similar in appearance to that of the 1748 sketch, in that it

The Square Tower is shown as collapsed on the inside of the castle (Illustration 2), but to full height on the exterior with crenellations surviving (Illustration 3). A small two light window is shown at second floor level on the southwestern facade of the tower, with an arched opening below which indicates partial collapse of the lower part. The Stair Extension indicates a large breach in the wall.

The sketches from 1857 indicate damage the western side of the Square Tower (Illustration 2) and also on its southern facade and on the eastern side of the Stair Extension as described above (Illustration 3). This is also very similar to the sketch of the southern side of the castle from 1865 (Illustration 6). The sketch of the eastern and northern facades indicates breaches in the wall from the second floor down in the area of the entrance on the eastern side and a similar breach is shown on the northern facade from the area of the doorway that now leads onto the top of the Northern Extension. The parapets above these facades are also shown to be badly damaged. These areas of damage are also clearly visible on the photographs of the late 19th century (Photos 1 & 2). The damage to the top of the Square Tower shown on Photo 2 is considered to be from alteration of the photograph and not a real area of collapse.

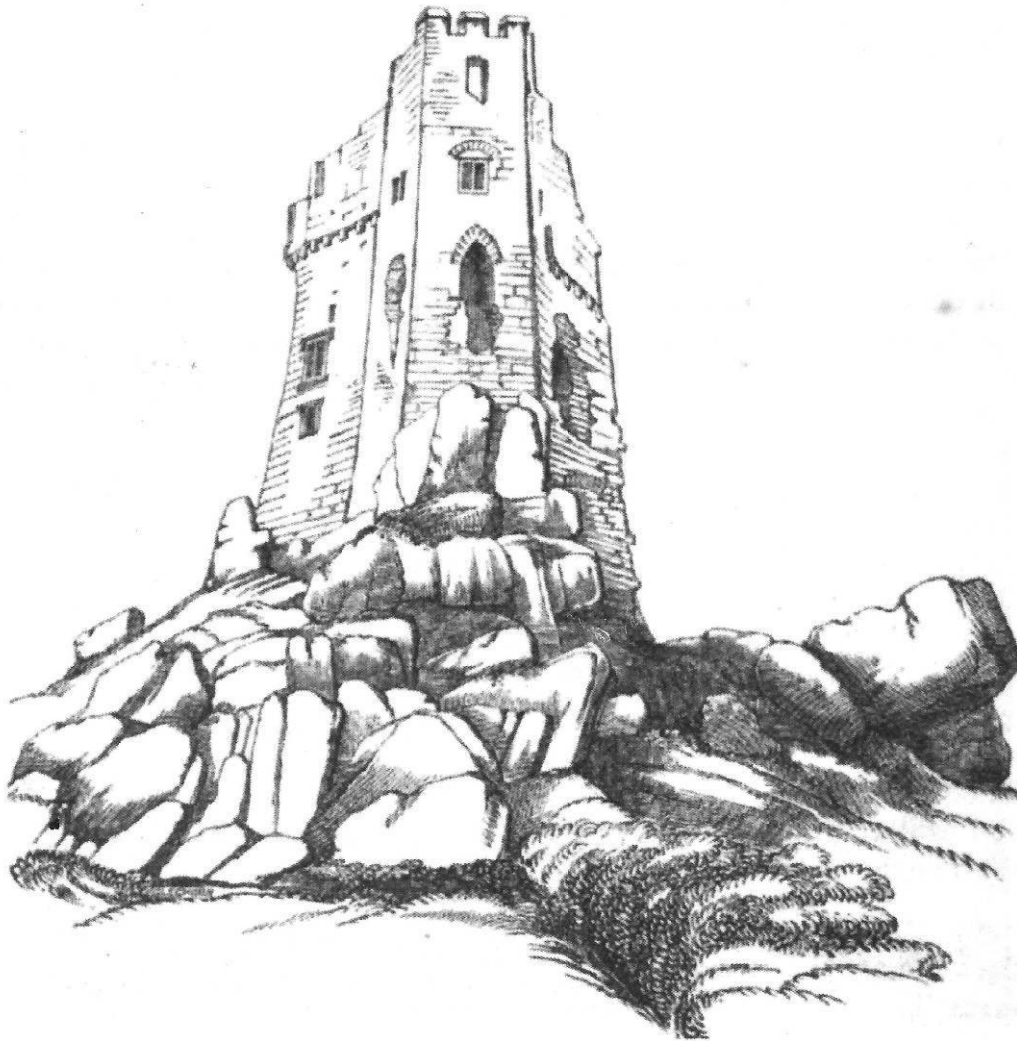
Illustration 3: The southern elevation of Roch Castle (PSAL 1857, p102)

Both of these illustrations indicate that the basic exterior fabric of the castle survived relatively intact. Corbelling is shown running around much of the western, southern and eastern sides of the castle at a higher level (as survives today). Four windows frames are shown as surviving all of two lights. They also clearly indicate the scale of the rocky outcrop on which the castle is constructed (if a little exaggerated in places).

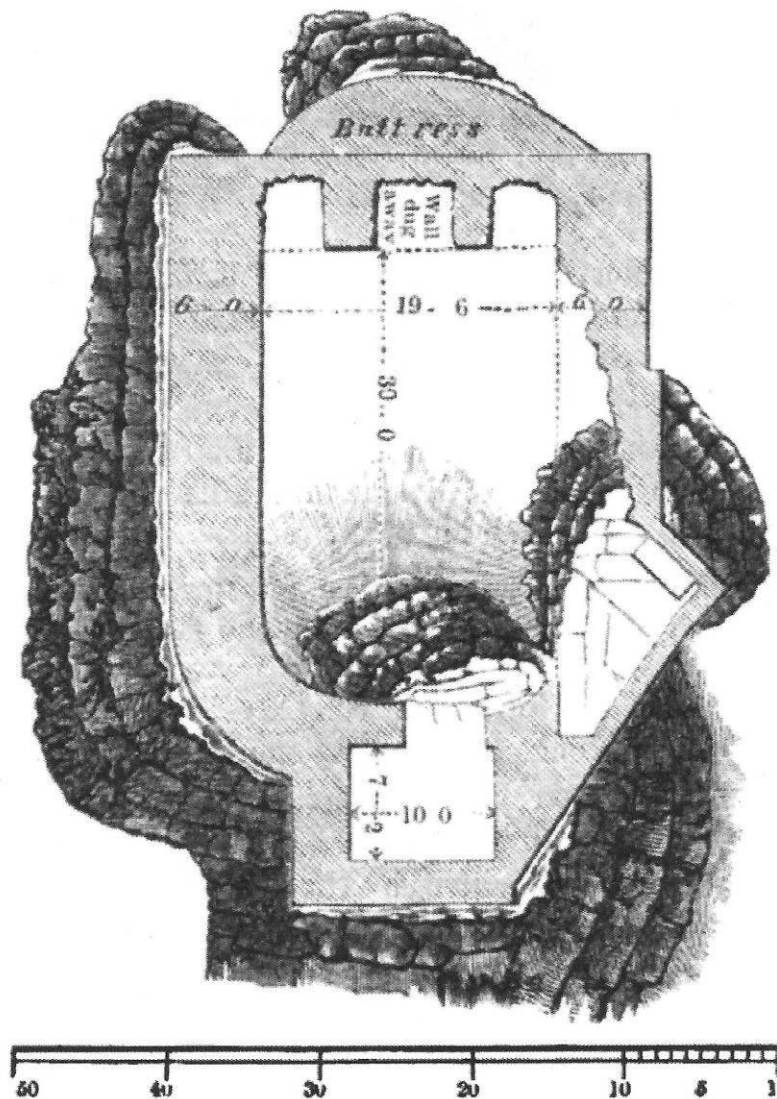
Illustration 4: Plan of the ruins of the Tower, scale in feet (PLAS 1857, p103)

The detailed plan of the ruins (Illustration 4) provides the earliest evidence for the pre-20th century layout of the castle. The plan is of the ground floor and is interesting as it shows no obvious access at this level. The plan shows the outcrop of rock visible within the castle walls in the southern part. To the north is a roughly semi-circular projecting feature labelled as a buttress. The northern wall has three square areas cut into the width of the wall, but they are shown as not going all the way through. The interior of the eastern wall of the castle is shown as being damaged, with the thickness of the wall diminishing towards the area of the Stair Extension, which is itself indicated as lying directly upon the exposed upper part of the rocky outcrop. The Square Tower to the south is also shown as lying directly upon the rock. The mass of wall between the Stair Tower and the room within the Stair Extension is also notable as discussed in more detail below. The width of the Stair Tower walls has been exaggerated.

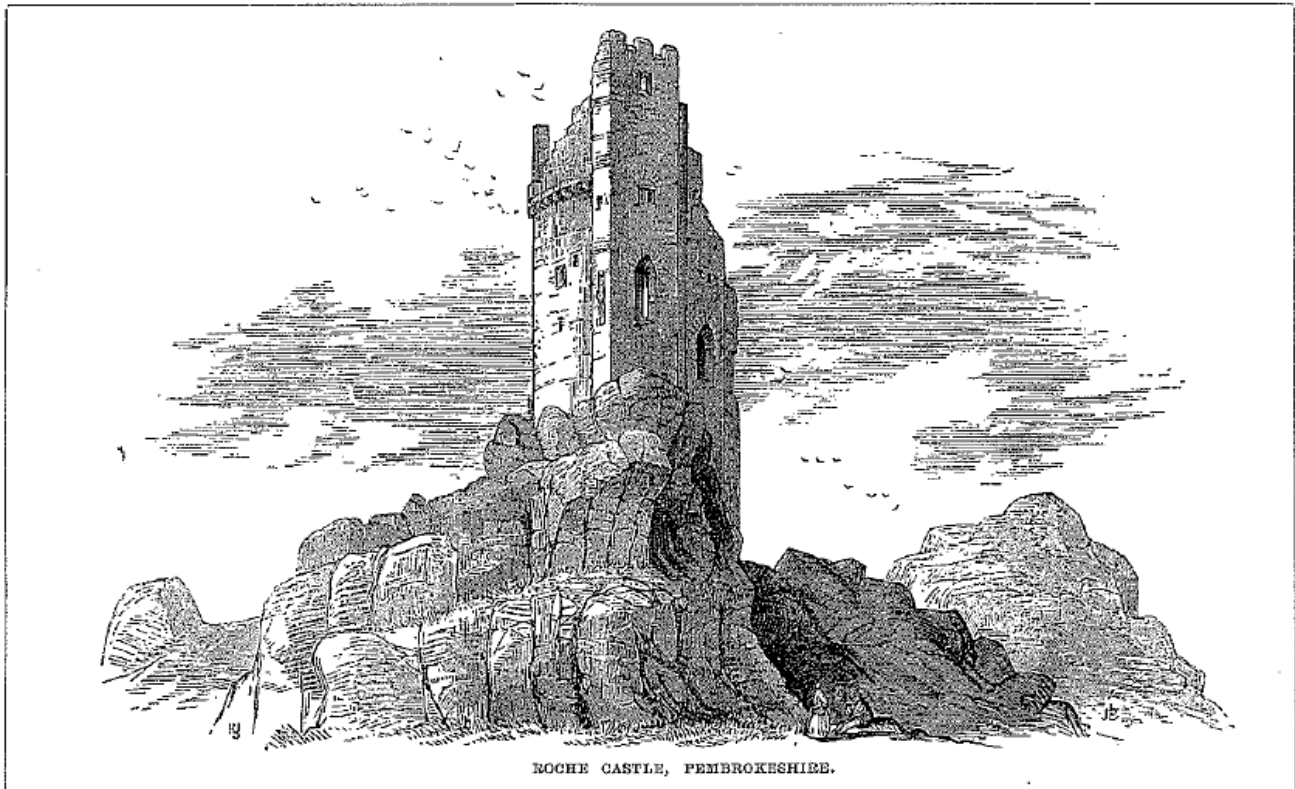
Illustration 6: Roch Castle Southern Façade (Archaeologia Cambrensis 1865)

In the background on the top of the castle, an arched opening is shown with a small window opening adjacent to it. As the illustrations from both 1857 and 1864 indicate that although the facade of the Square Tower was intact, the rear walls had collapsed. This would indicate that this arched opening would have been within the top room.

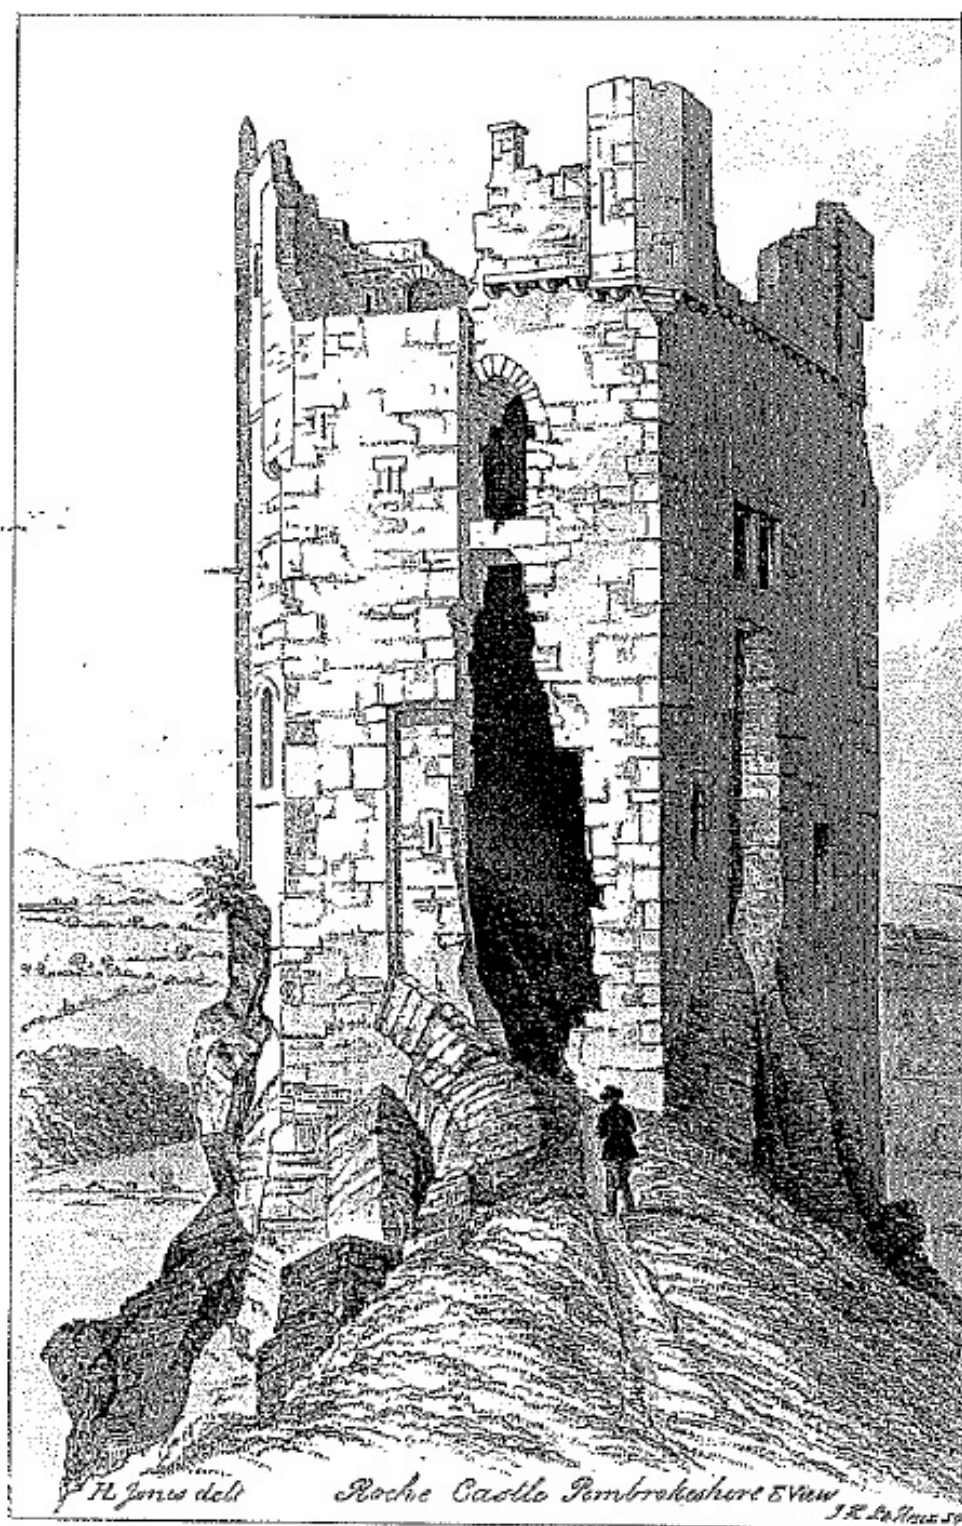
Illustration 7: Roch Castle Eastern and Northern Façades (Archaeologia Cambrensis 1865)

Window lights for stairs are shown on the eastern facade, the first located on the stair from the basement to the first floor, and a second pair of lights rising nearer the top of the facade. Two windows are shown either side of the large void on the northern facade of the castle, with a second two light window opening above.

The doorway is an early 1900s addition, being located in an area where the walls had been breached previously, possibly during the Civil War. Photographs and Illustrations from the 19th century clearly show this void through the wall (Photo 1; Illustration 7). The stairs were constructed on built-up material, allowing access to the level of the doorway (Photo 9). The eastern wall of the castle is situated on the very edge of the rocky outcrop. This part of the façade has been significantly rebuilt, with the repair of the collapsed area of walling and insertion of the doorway.

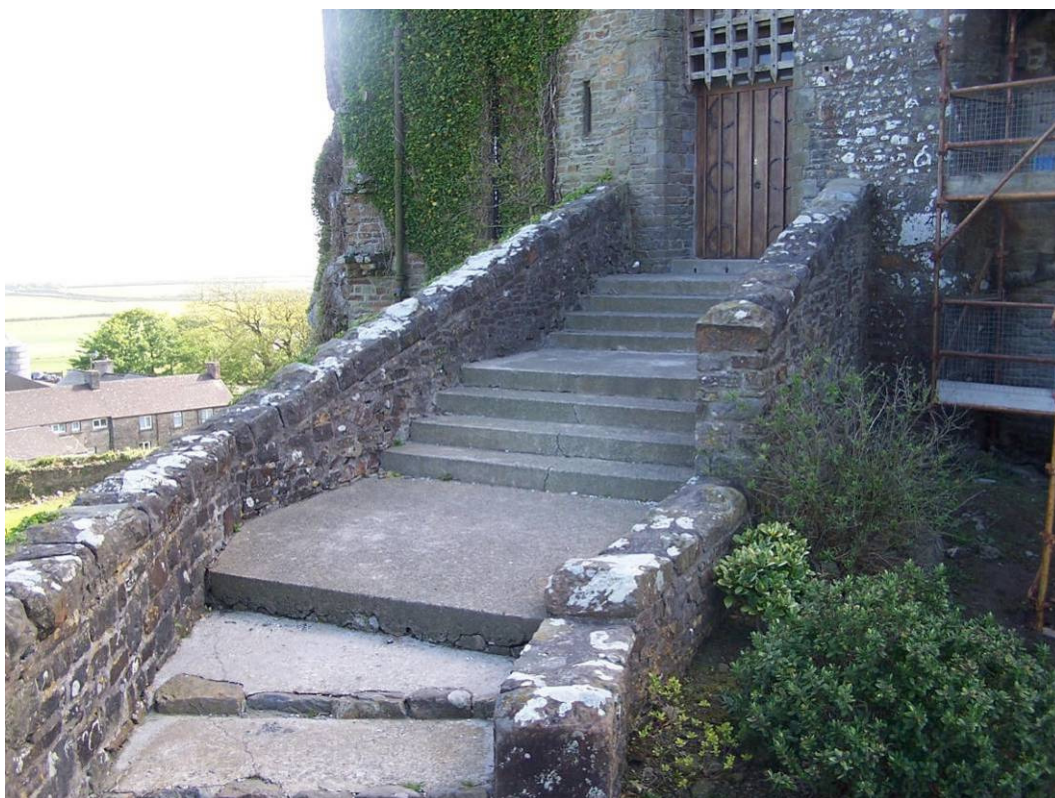
Photo 9: Raised stair and entrance doorway constructed between 1901 and 1904

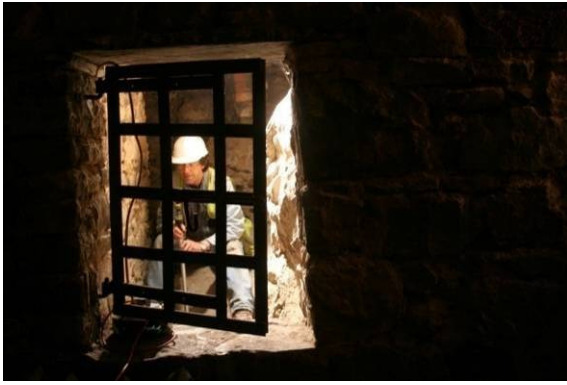
The Basement / Ground Floor was subdivided with a rough built stone and cement wall during the early 1900s renovations to hide the area of the rock outcrop. Photographs 4 and 5 above shows the layout of the room in the 1950s, with the entranceway, stair and dividing wall (partially covered by a wooden dresser). The area behind the dividing wall was also divided with a second stone and cement wall creating a mock 'prison cell' (Photo 10).

Photo 10: recording within the mock 'prison cell'

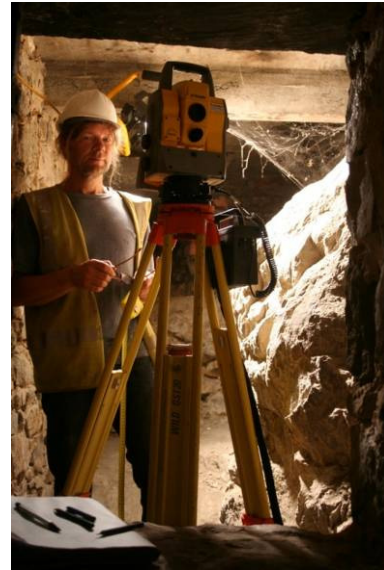
During the survey the dividing wall was still in place, with the original intention to retain it, as well as the dresser. Due to contamination issues with asbestos being present within the dividing wall and behind the dresser, these were eventually removed to create an open-plan basement level. Survey and photographic record was difficult behind the dividing wall (Photos 10 -13).

Photo 12: Surveying behind the dividing wall

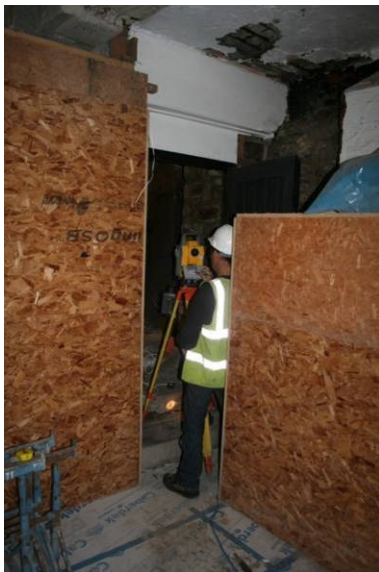
Photo 11: Surveying through the doorway of the dividing wall

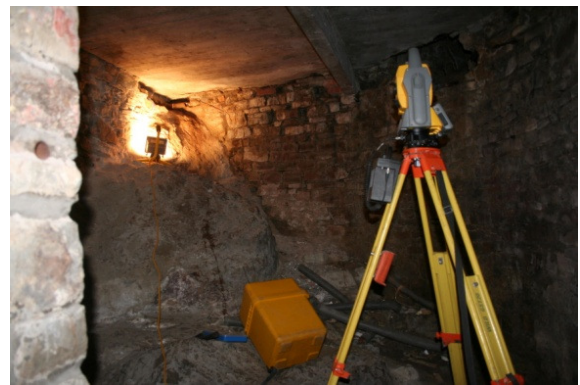
Photo 13: Surveying the rock outcrop behind the dividing wall

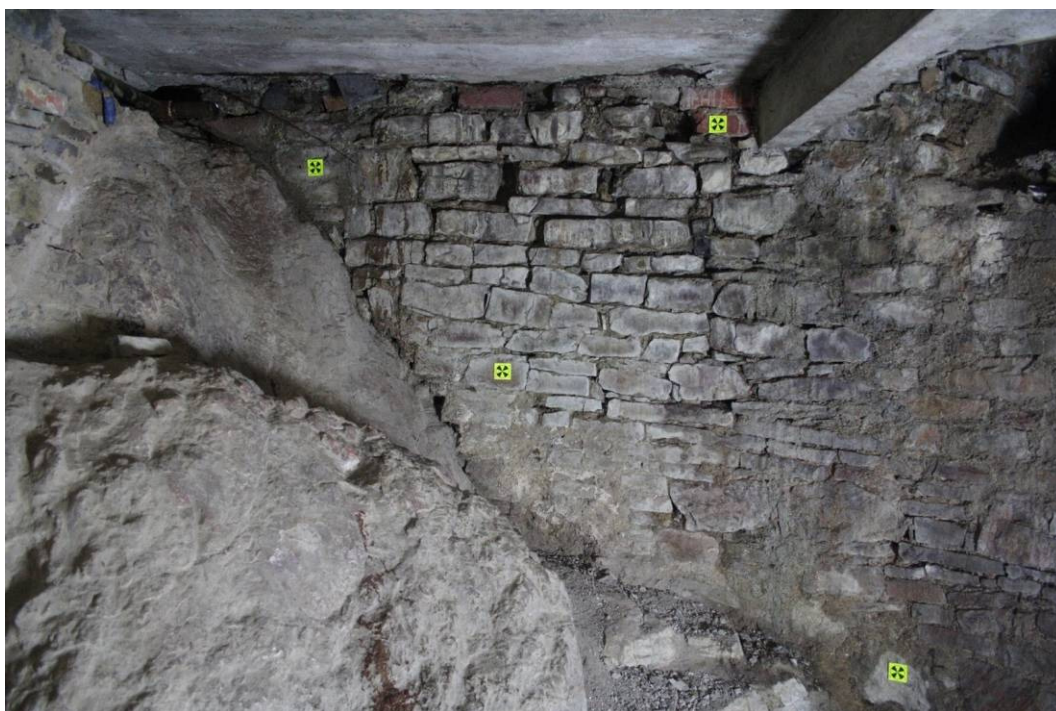
Within the southern end of the basement it is very clear how the walls of the castle have been built directly upon the rock outcrop (Photo 14). There is little evidence both on the inner and outer faces of the castle for the walls to have been tied in to the underlying rock. It is presumed that the thickness of the walls in this area (of over 1.6m width) was sufficient for the rubble core of the wall to knit together with the rough surface of the outcrop. It is also evident that the outer face of the castle wall descends lower than the interior wall in front of the rock outcrop (Photo 15).

Photo 14: Southwestern outer wall of the castle built directly upon rock outcrop in southwestern part of basement (window light visible in top right)

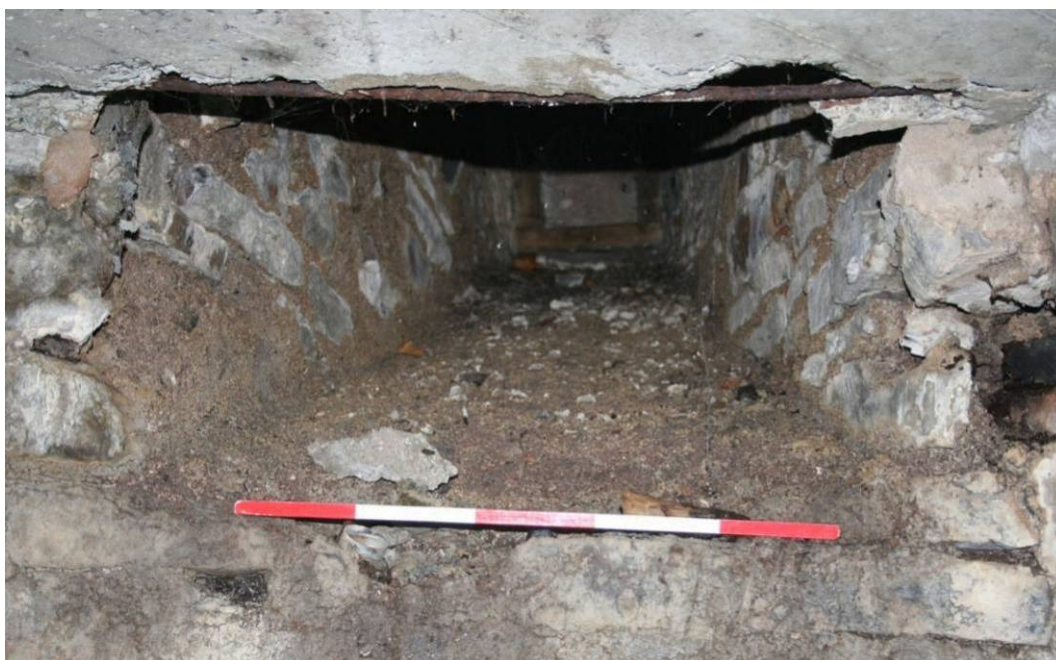
A single window light is present within the southern part of the basement, encompassed within the apsidal end of the original D-shaped tower (Photos 14 – 16). This is located on its southwestern side and comprises a sloping light well leading down from a window light at the same level as the existing ceiling. The internal window opening measured 0.75m in width and with 0.45m in height exposed below the existing ceiling. The window was splayed on either side leading to an external window opening of approximately 0.60m x 0.20m. This may be the only original window opening at this level

Photo 16: Window light exposed within the Basement / Ground floor

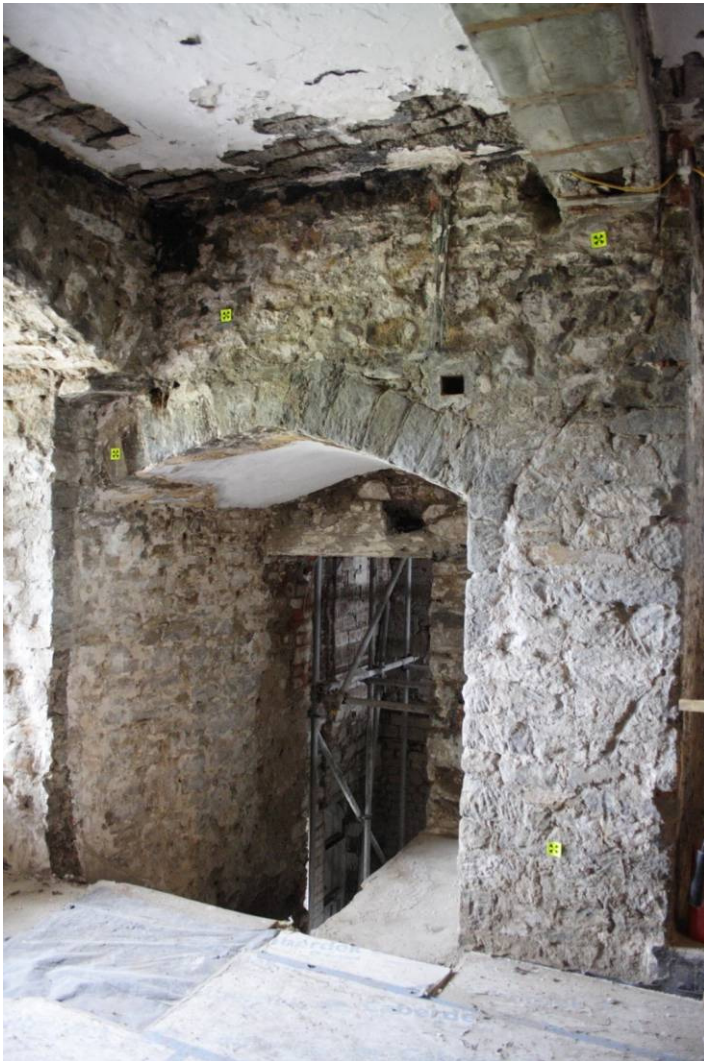
Photo 18: Western opening in northern wall of
Basement / Ground Floor

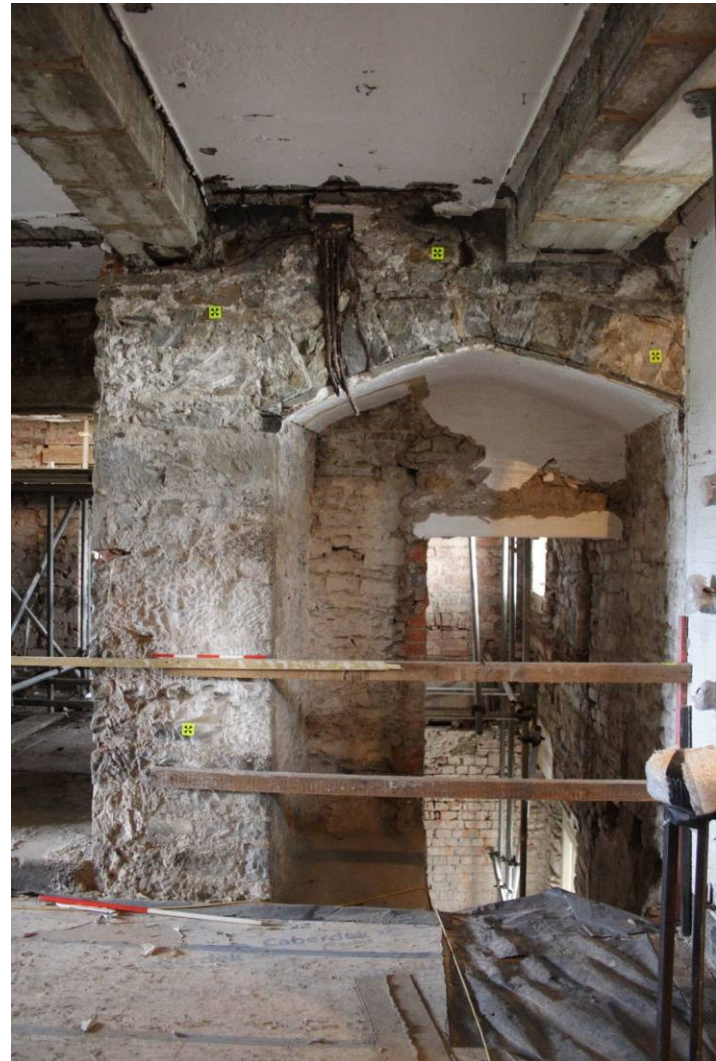
Photo 19: Eastern opening in northern wall of
Basement / Ground Floor

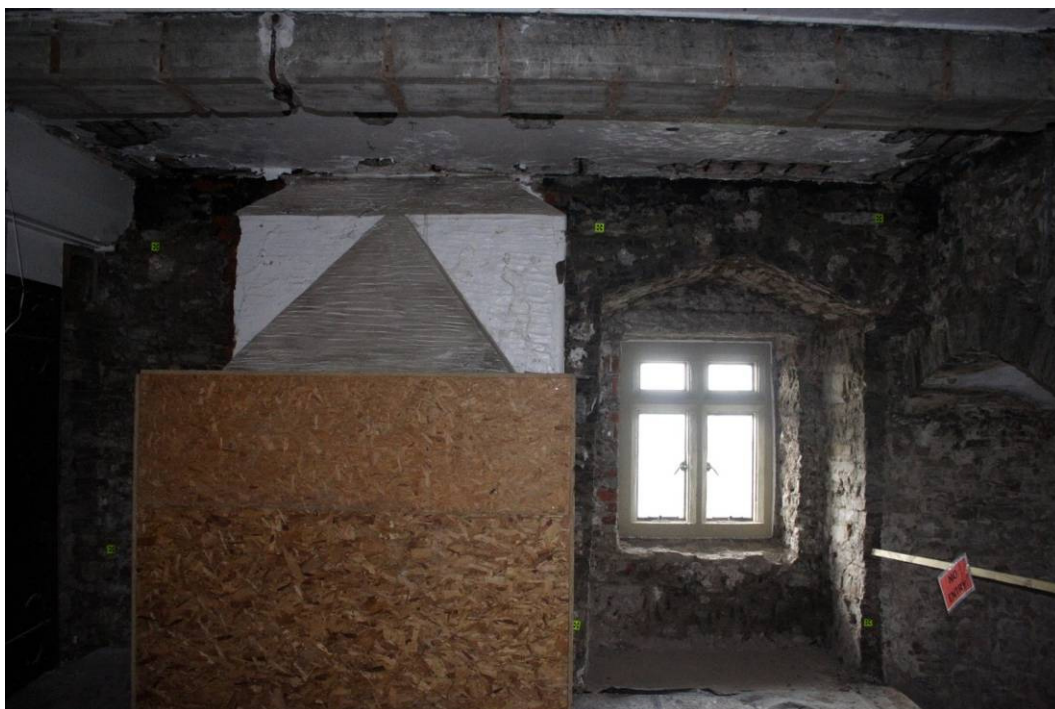
Photo 20: Window opening and covered fireplace in western wall
of Basement / Ground Floor

A fireplace was also present on the western wall which had been covered and protected during the building recording works (Photo 20). The fireplace is best seen in Photo 4 from the 1950s, which shows a mock medieval style surround. The location of the fireplace on the western wall of the castle does tie in with the flues that exit in two places on the roof of the castle, as seen surviving on the 19th century illustrations and which are still present today. It is therefore possible that a fireplace originally existed in this location, although all evidence except for the rear flue, had been removed. There is no indication of a fireplace here on the 1957 plan of the castle, although this may be due to the low level of detail included on the plan.

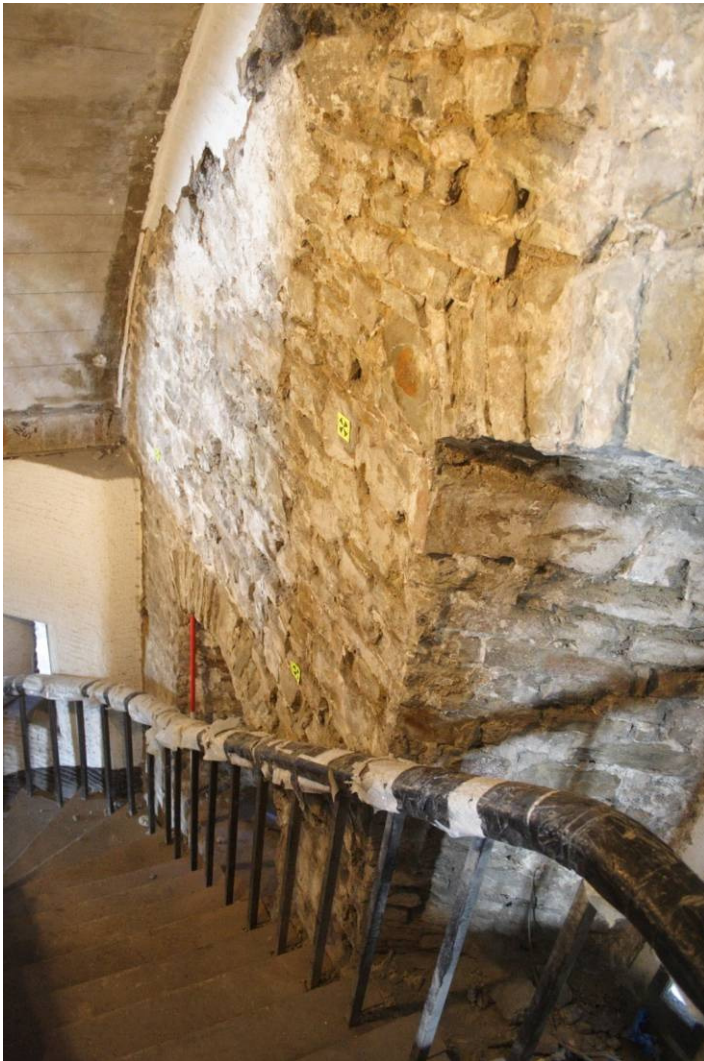
Photo 21: Pair of window lights looking down to Basement / Ground Floor, with modern concrete partition at bottom

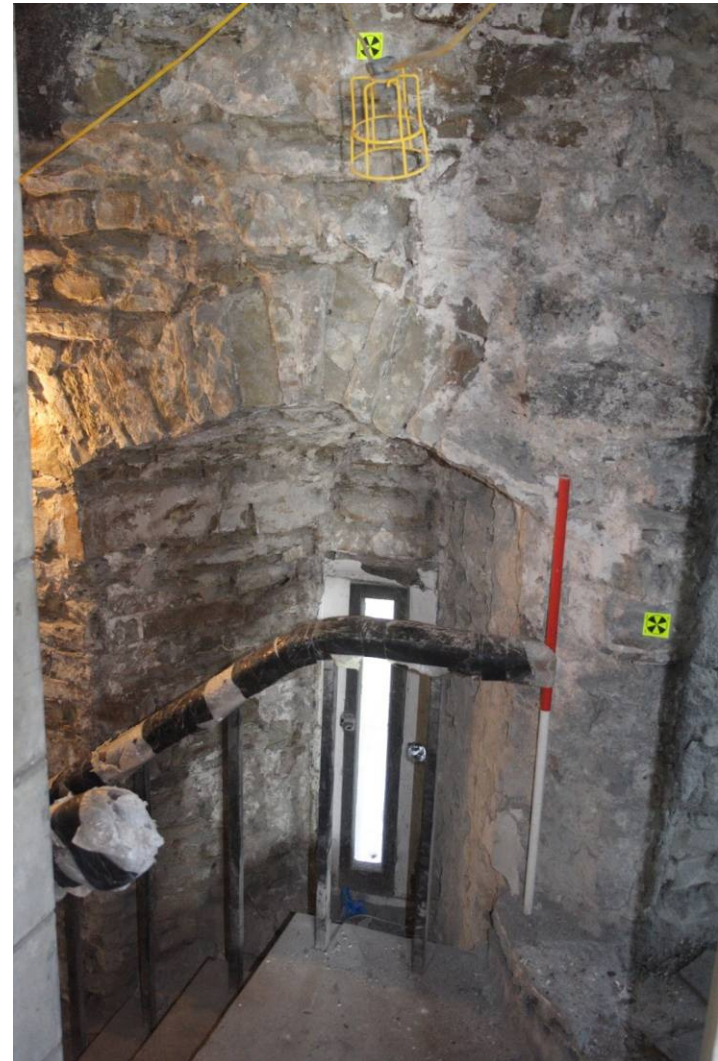
Photo 22: Upper window light on stairs to First Floor

Both windows were constructed in a similar way, having an arched headed opening, splayed in to a smaller opening on the external face of the castle. The interior opening of the upper window (Photo 22) was c.1.45m in height, rising to 1.72m at its centre, and a width at its base of 0.93m. The external window aperture measured 1.48m in height and 0.33m in width. The lower window (Photo 23) internal opening was c.1.00m in height rising to c.1.19m in its centre, and of 1.08m width at its base. The external window aperture was c.0.97m in height and 0.37m in width. The window heads of both windows on the internal face were constructed of fairly neat voussoirs. Externally both windows were of simple surround with stone lintel above. The wall in which the window lights are present was c.0.60m in width.

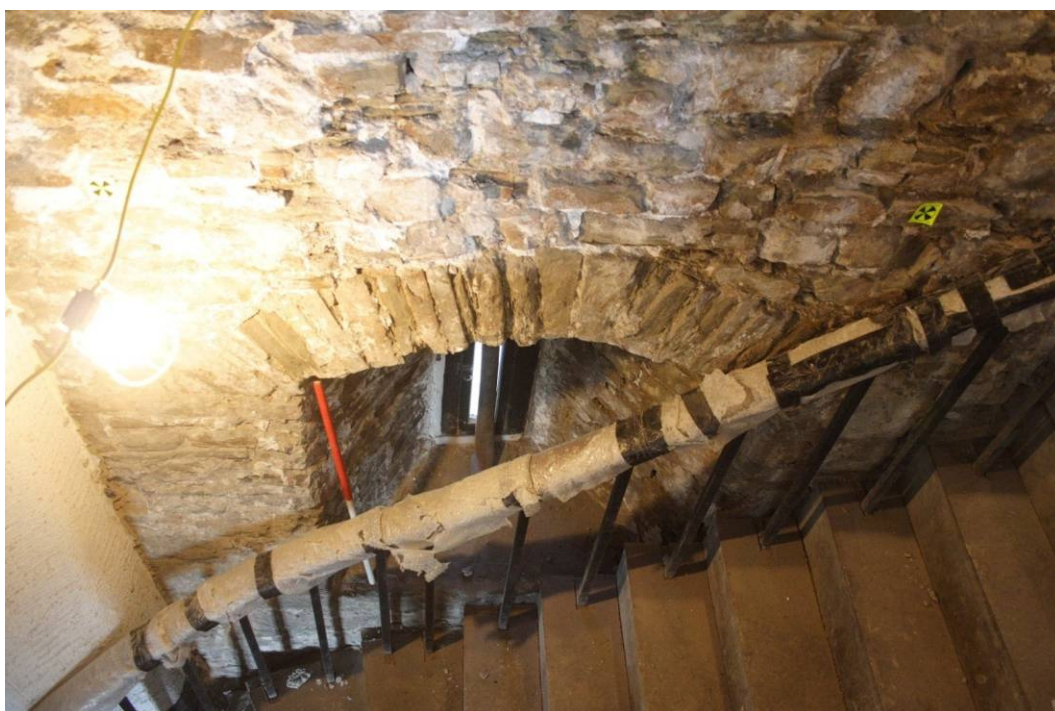
Photo 23: Lower window light on stairs to First Floor window

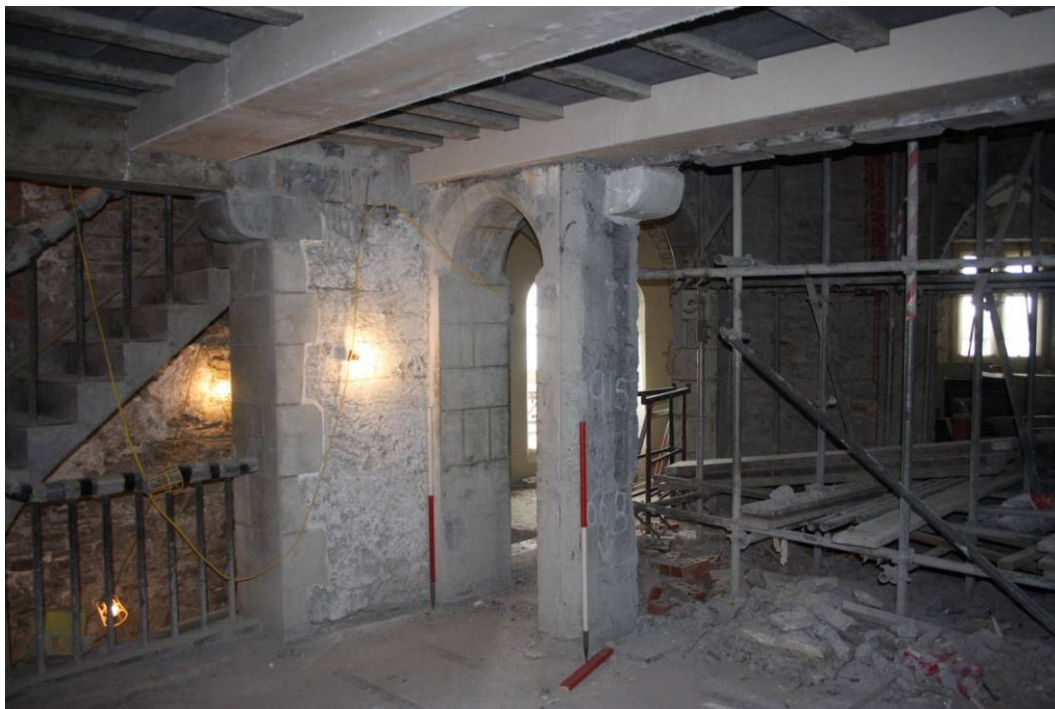
The top of the flight of stairs from the Basement / Ground Floor level provides access to the existing First Floor of the D-Shaped Tower. A partial wall is present on the inside of the stair which was built in the early 20th century restoration (Photo 24). It incorporates large faced quoins on the exterior of the wall segment and stone corbels at the top of wall which supports a concrete beam above. A 1900s stone archway projects into the room, which has been retained. The 2010 replacement concrete floor can be seen tied in to the earlier concrete beam and wall (Photo 24).

Photo 24: Wall segment on the inside of the stair way from the Basement / Ground Floor level showing stone corbels and archway

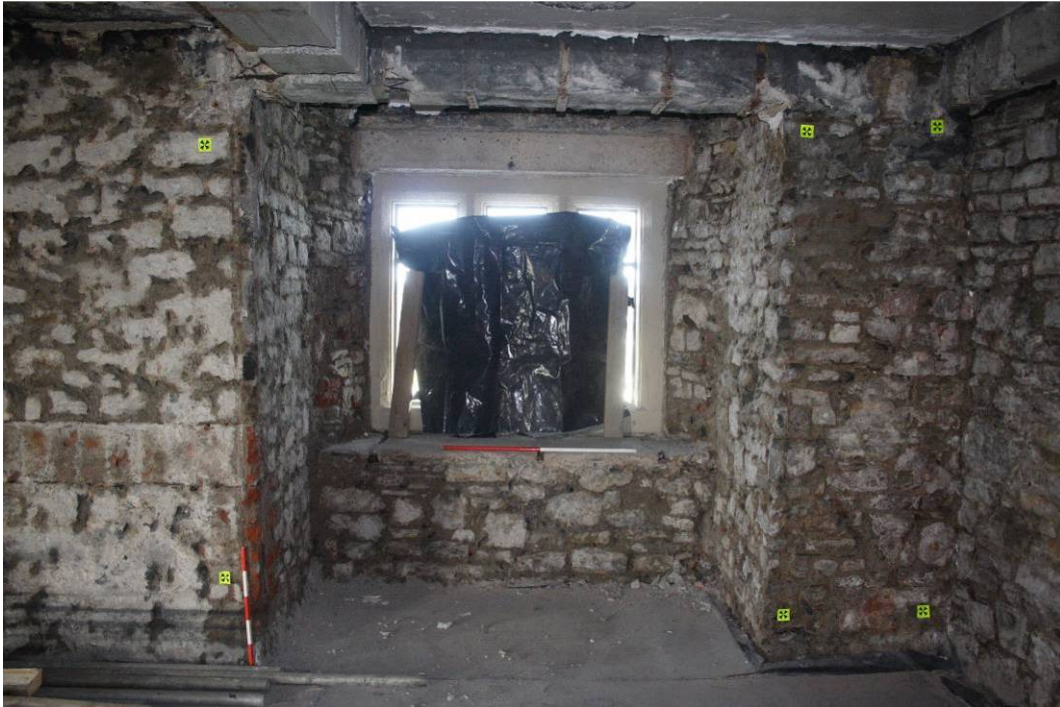
Photo 25: Window opening in western wall of First Floor of D-Shaped Tower

The dimensions of the western window include the main squared aperture on the internal face of 2.07m width and 2.53m height. The window recess, to the jutting window sill, measured 1.01m deep, with the window sill itself 0.53m in depth. The actual window aperture measures c.1.64m width by c.1.45m in height. A slight splay is present on the sides of the window aperture.

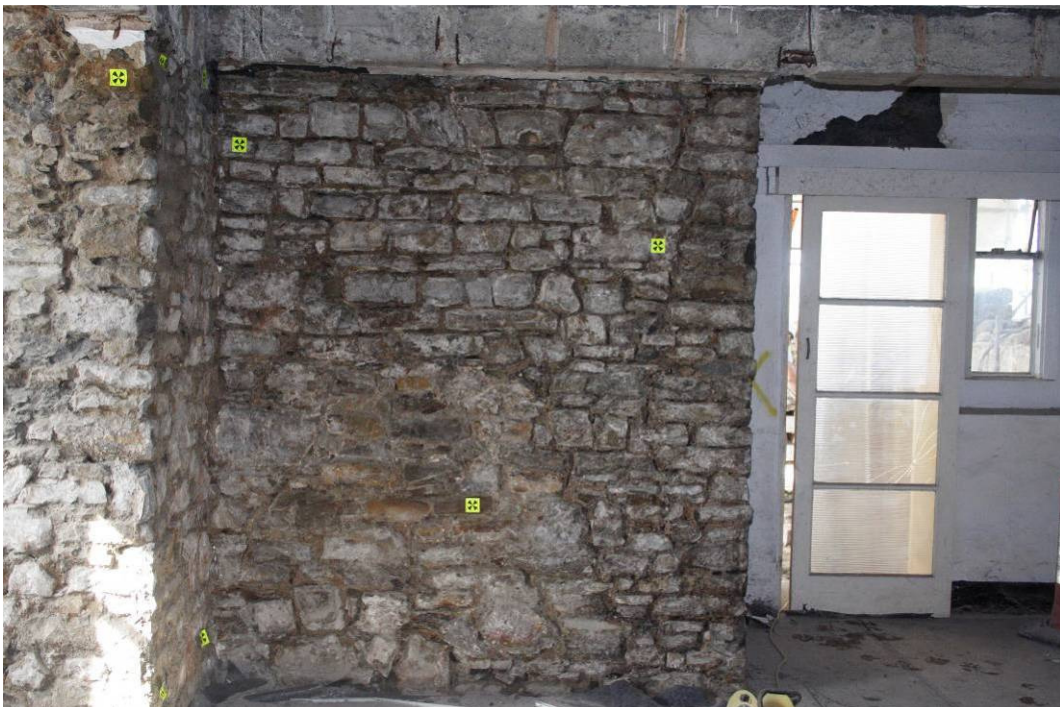
Photo 26: Western side of doorway opening in northern wall of
First Floor of D-Shaped Tower

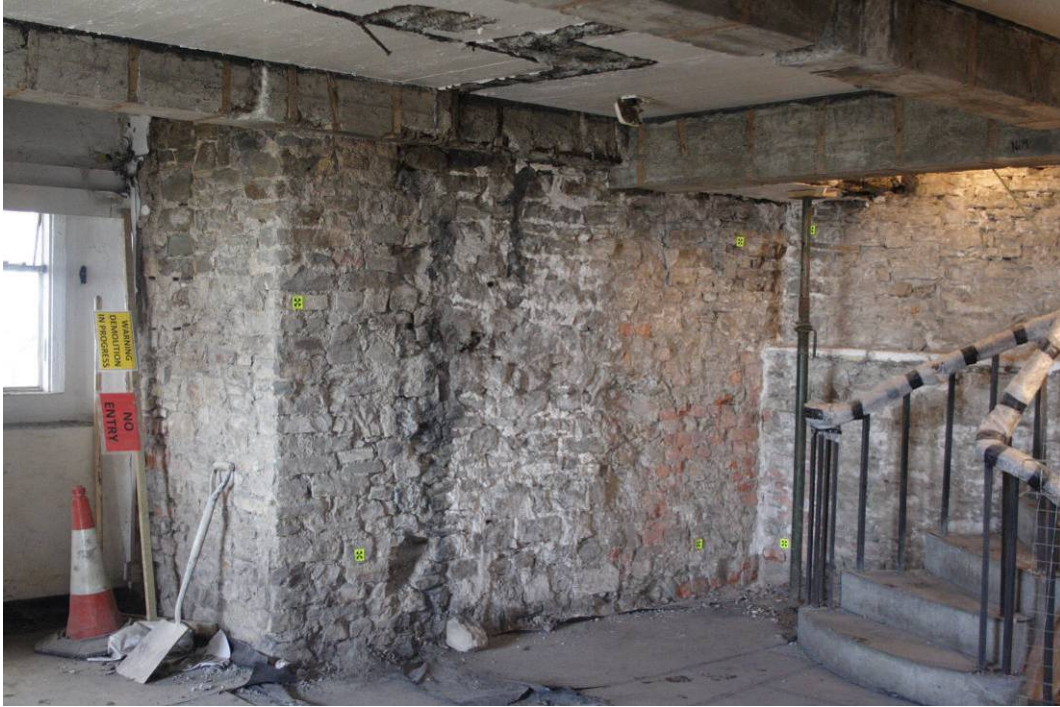
Photo 27: Eastern side of doorway opening in northern wall of First Floor of D-Shaped Tower

The dimensions of the northern opening (doorway through to roof of the additional floor added in the 1920s to the Northern Extension) were 1.96m in width, 2.54m in height and 1.32m in depth to the extant doorframe (Photo 27).

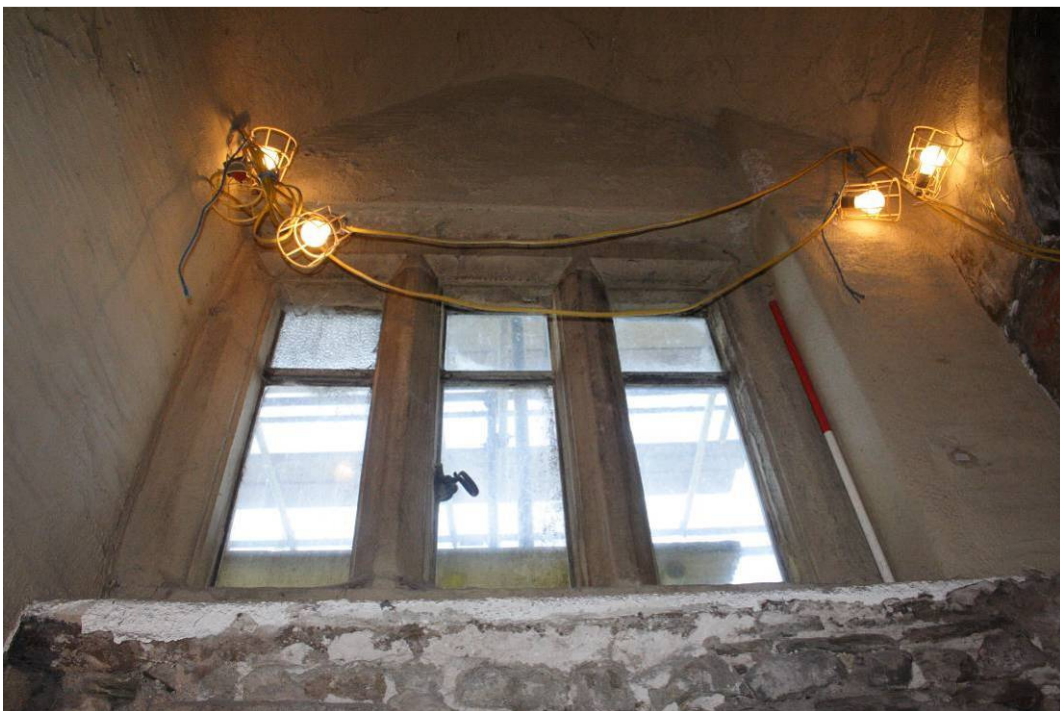
Photo 28: Window in eastern wall of tower at First Floor level of tower, rising to apex at Second Floor level (oblique near vertical view)

The window opening on the eastern wall was directly opposite that to the west, but was located within a main stairwell. The window recess was visible to the height of its apex at Second Floor level (Photo 28). The width of the exterior wall of the castle in this location had been considerably reduced. This seems to have been partially due to the insertion of a new concrete stair during the 1900s renovations, and possibly also as a result of the collapse of the inner face of the wall as noted by Clarke in 1865, indicative of a former stair within the thickness of the wall. The full window measured 4.03m in height and 1.97m in width. Towards the base of the window a jutting step was present in the thickness of the wall, the function of which was unclear, but seemed to relate to the 1900s renovations. The window rose 3.64m from this step to its apex. The width of the external wall at the apex of the window was substantially larger than that below.

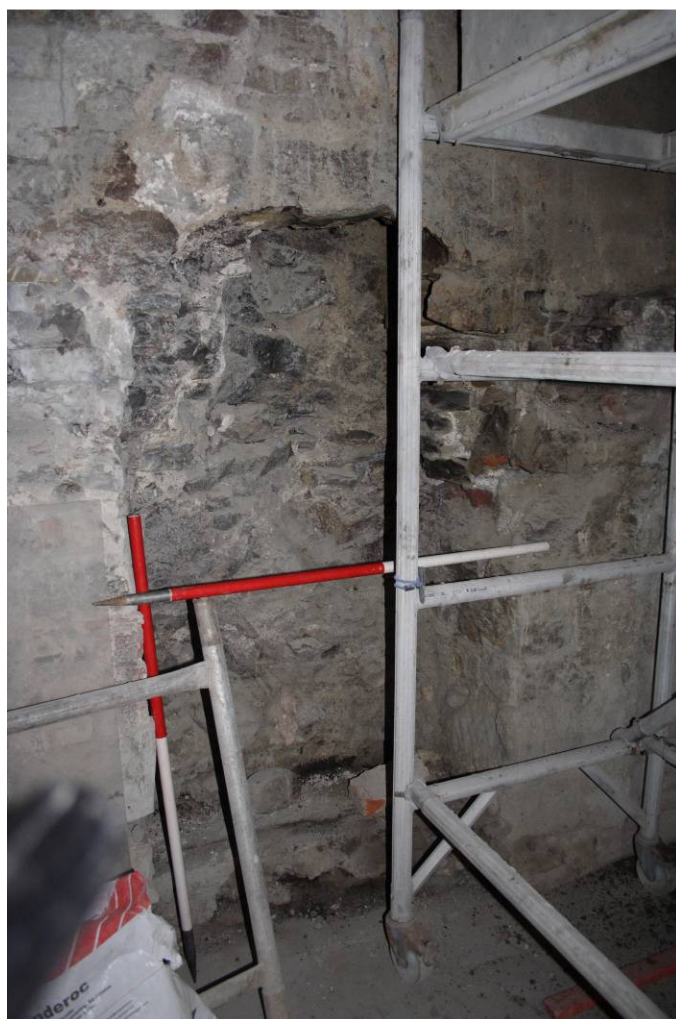
A small fireplace opening is present in the western wall, just before the curve of the D-Shaped Tower begins. This was a roughly made opening starting at floor level and rising c.1.7m in height. The northern side of the reveal for the fireplace aperture had a stone quoins at its lower level rising to a height of approximately 0.82m, possibly indicating an earlier opening, although there were no corresponding quoins on its southern side, so it may represent a step in the width of the wall, possibly associated with the point where the curving wall begins. The remainder of the aperture had been cut into the existing wall and the edges were left rough. A substantial 20th century fire surround and hood had existed in front of this fireplace, so there had been no need for this opening to have been made very neatly as it was not exposed. Two small cuts had been made on either side of this opening in which the hood had been tied to the wall, one being visible in Photo 29.

Photo 29: Fireplace in western wall of First Floor Level of D-Shaped Tower

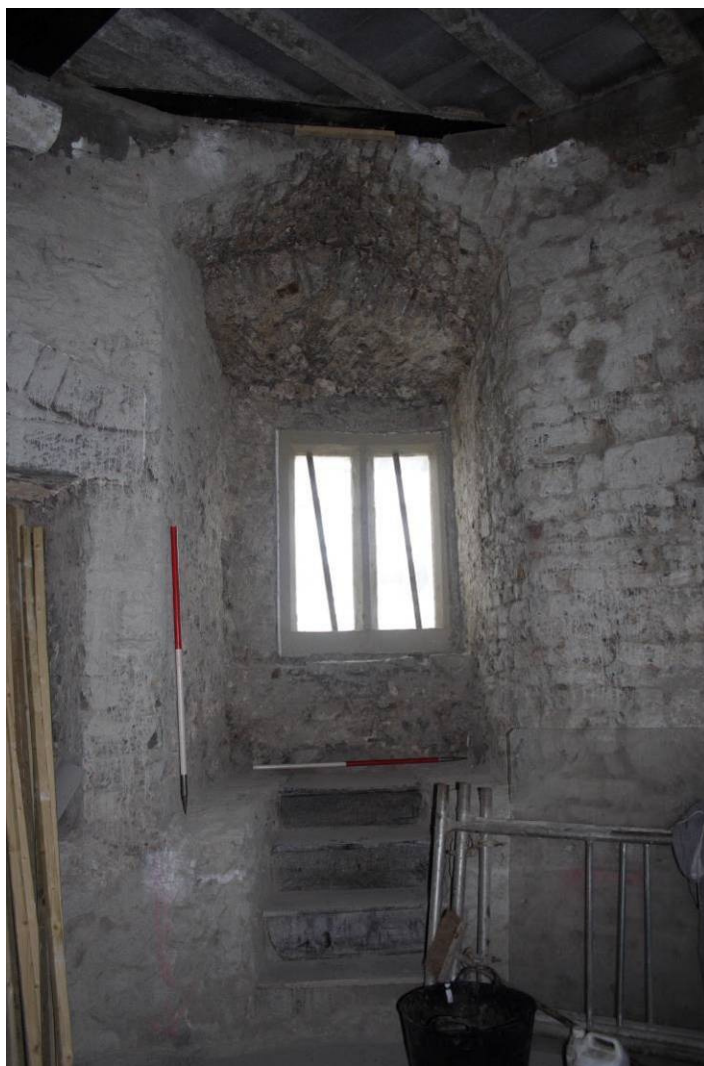
Photo 30: Window in southwestern wall of D-Shaped Tower at First Floor level

The top of the window was arched on the interior wall, formed of roughly coursed stone. The interior of the opening measured 2.20m in height and 1.37m in width. The height of the apex of the window to the floor level (base of steps) measured 2.80m. The upper arch of the window was created in two runs, with the outer one slightly lower and offset to the inner part. This may have been a necessary form of construction to create a stable arch through the curving wall, it may indicate modification or an adaptation of a former garderobe corridor. This drop was located 0.83m into the wall, and continued for the remaining 0.85m to the window aperture.

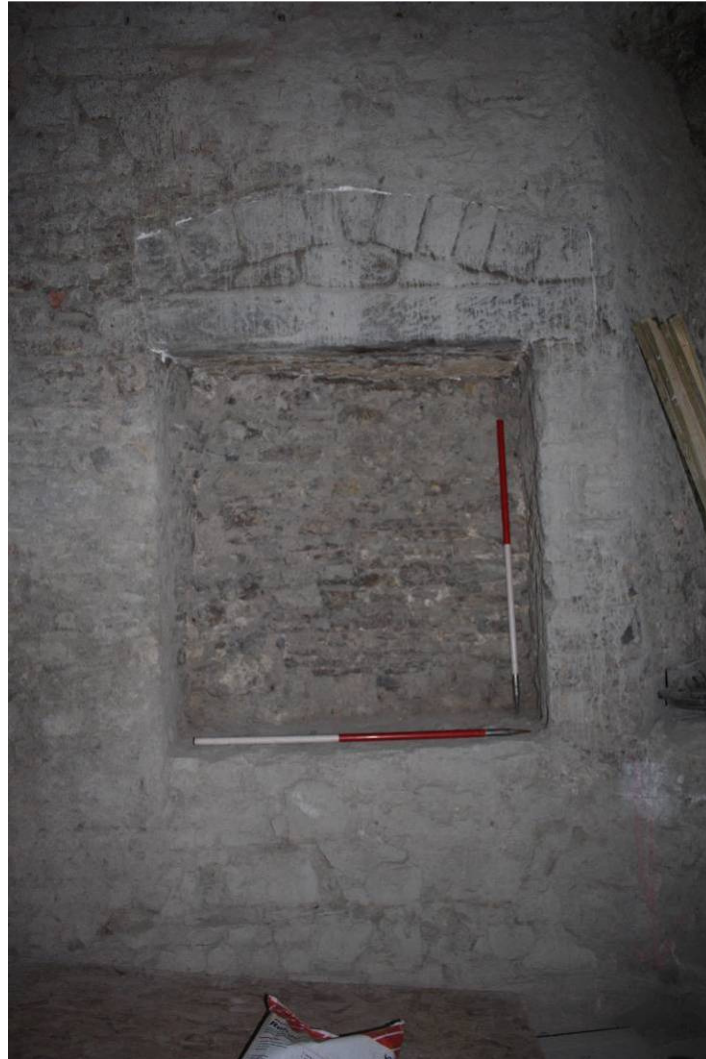
Within the central southern part of the curving wall was a rectangular recess. This measured 1.34m in height, 1.23m in width and was 0.49m in depth (Photos 31 & 33). A large stone lintel formed the upper part of the recess, with a segmental relieving arch above. No flues or other features were present within the recess to provide indications of what its original function was, although

Photo 31: Rectangular recess within south wall of first floor
