**ROCH CASTLE,
PEMBROKESHIRE
(SM 8803 2121)**

**HISTORIC BUILDING
RECORDING AND
ARCHAEOLOGICAL
INVESTIGATIONS**

RHIF YR ADRODDIAD / REPORT NO. 2011/26
RHIF Y PROSIECT / PROJECT RECORD NO. 100723

March 2012

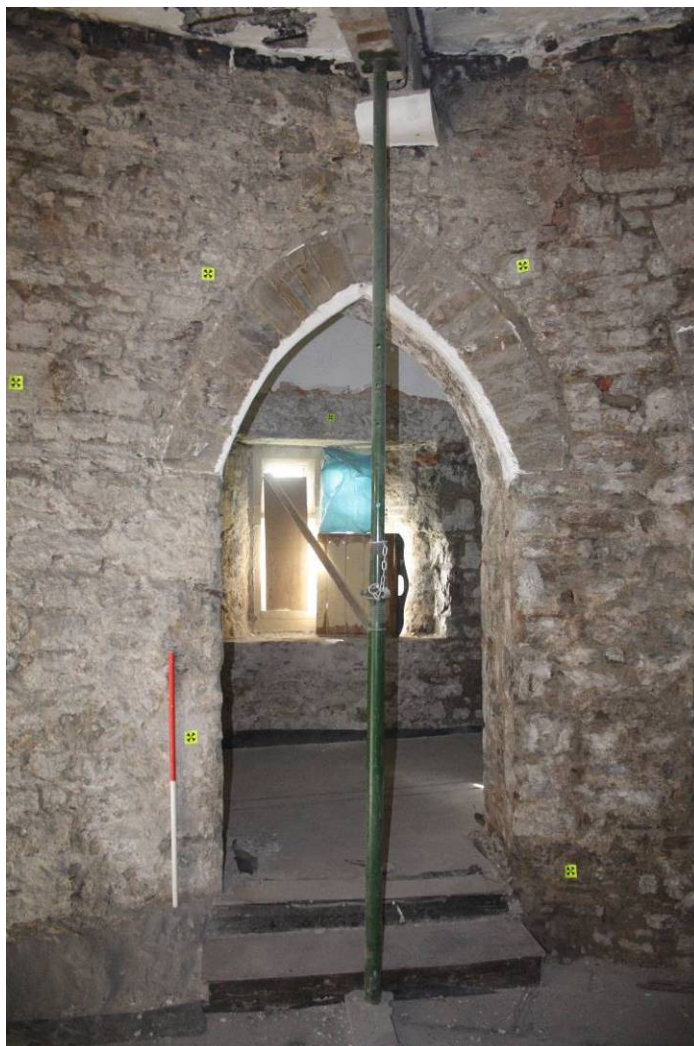
The internal curve of the D-shaped tower continues towards the southeastern part of the first floor level, although this has been heavily modified during the early 20th century renovations. A pointed arch doorway leads from the first floor into the lower floor of the Square Tower to the southeast (Photos 32 & 33). This would appear to be a modern doorway opening, the original entrance to the Square Tower is discussed below. It measured 1.18m in width and had a height to the apex of the arch of 2.45m from floor level within the Square Tower (c.2.75m depth to first floor level of the D-Shaped Tower). Two steps led up into the room from the first floor level.

Photo 32: Entrance from first floor of D-Shaped Tower to Lower floor of Square Tower

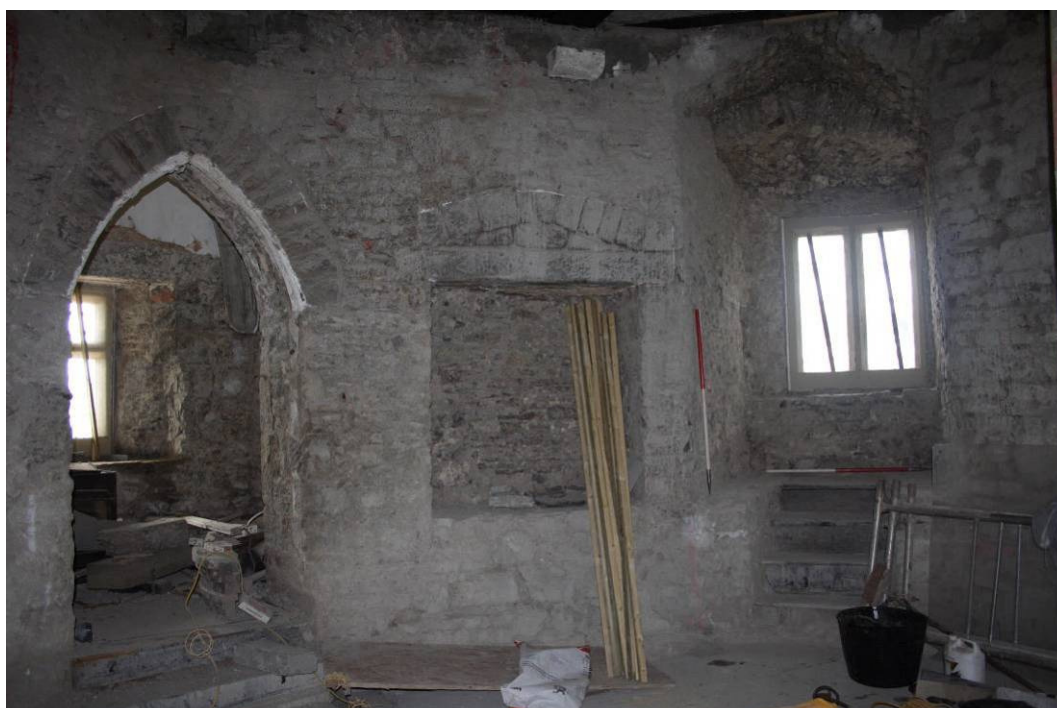
Photo 33: Overall shot of southern end of First Floor room of D-Shaped Tower

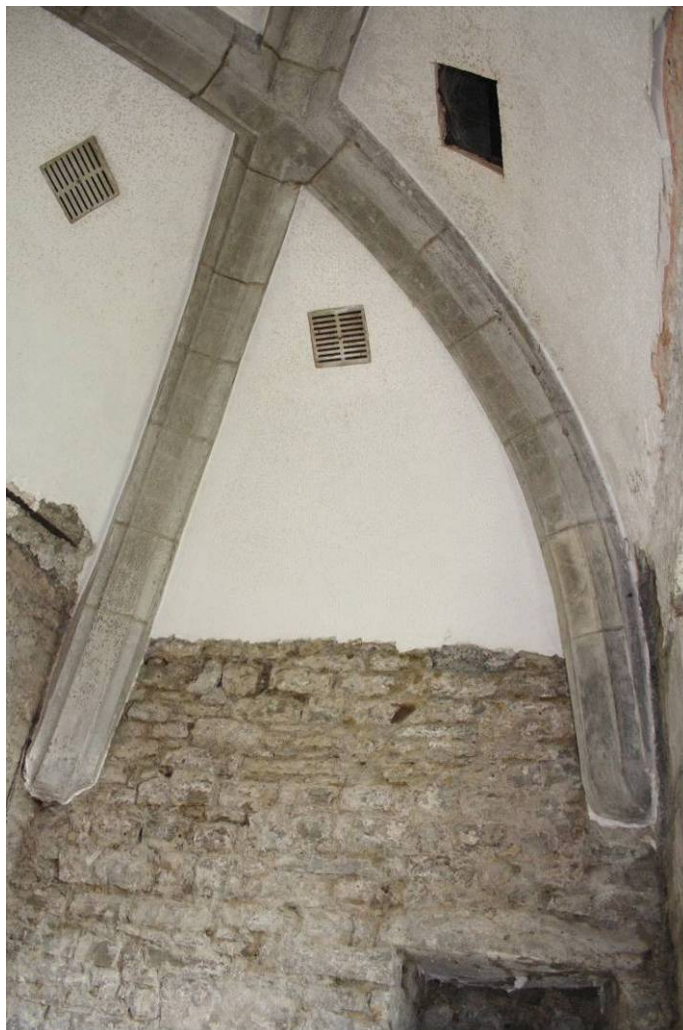
Photo 34: Part of the replica ribbed and vaulted ceiling of the Lower Floor of the Square Tower, facing northeast with small alcove below

A small alcove was present on the northeastern side of the room (Photo 34), which measured 0.68m in width, 0.42m height and 0.52m in depth. A stone lintel covered the alcove. The northeastern elevation appeared to be built in a single phase of construction which could easily have been original medieval fabric, although the other side of this wall (within the Study of the Stair Extension) suggested a 20th century rebuild (see below).

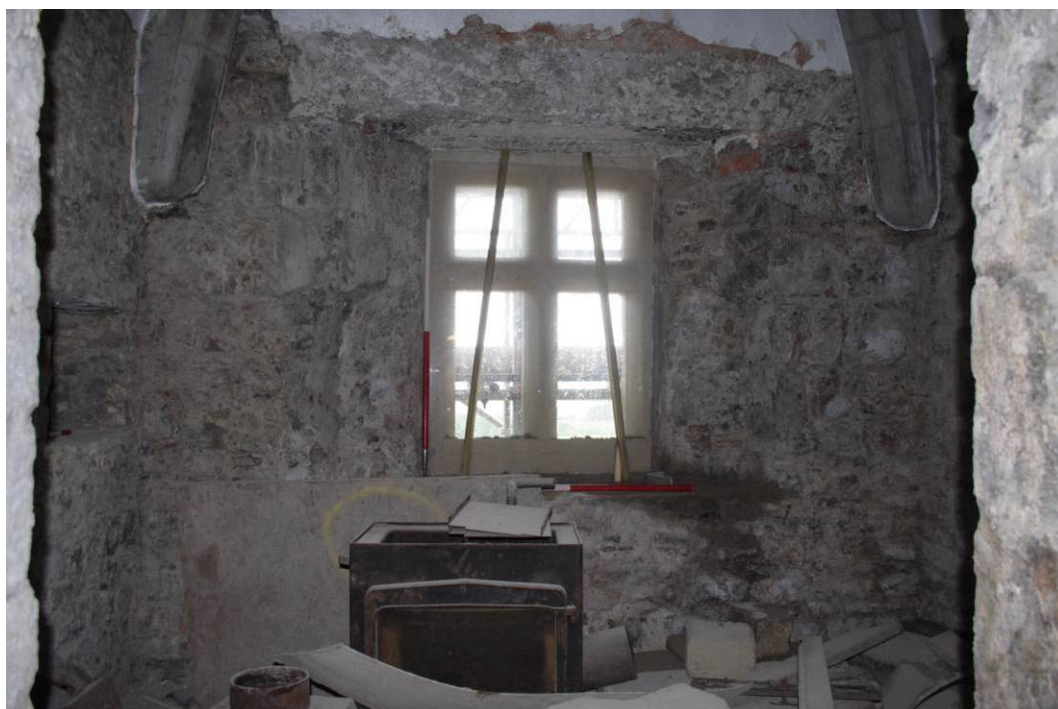
The southeastern side of the room contained the centrally located main window (Photo 35). The internal aperture measured 1.45m in height and 1.65m in width. The window opening was 0.48m in depth and splayed on either side to the main window aperture, with a large stone lintel above.

Photo 35: Window in southeastern wall of Lower Floor of Square Tower

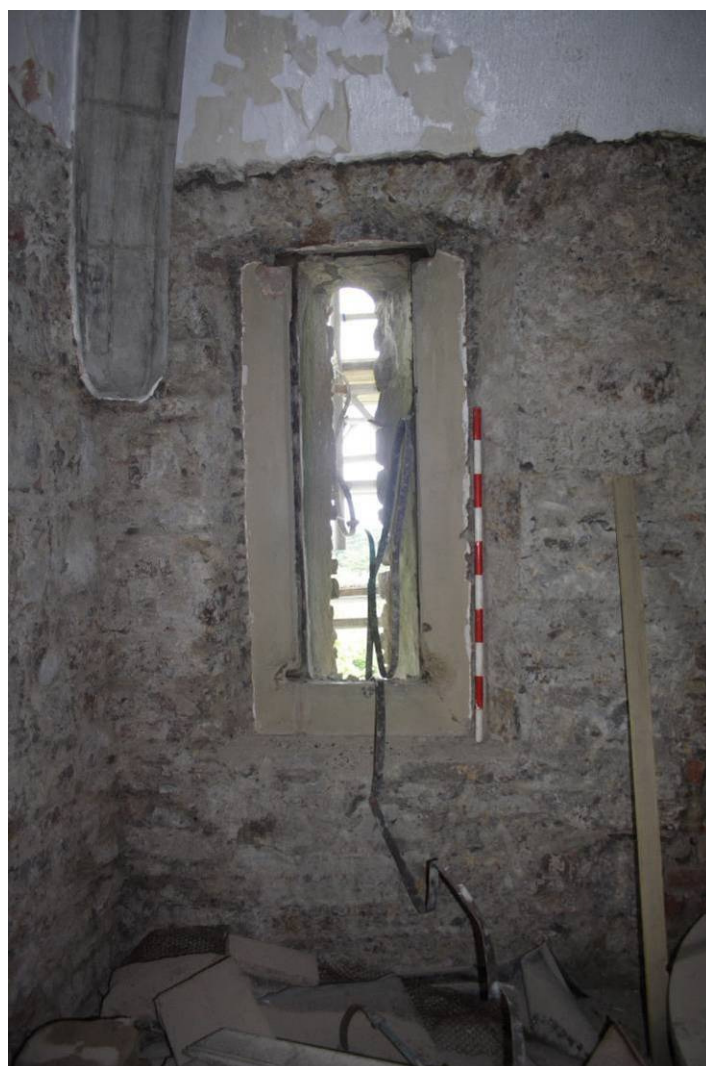
The southwestern side of the room had a single narrow splayed window opening measuring 1.48m in height and 0.9m in width, with a depth of 0.20m to the window frame (Photo 36).

Photo 36: Window in southwestern elevation of Lower Floor of Square Tower

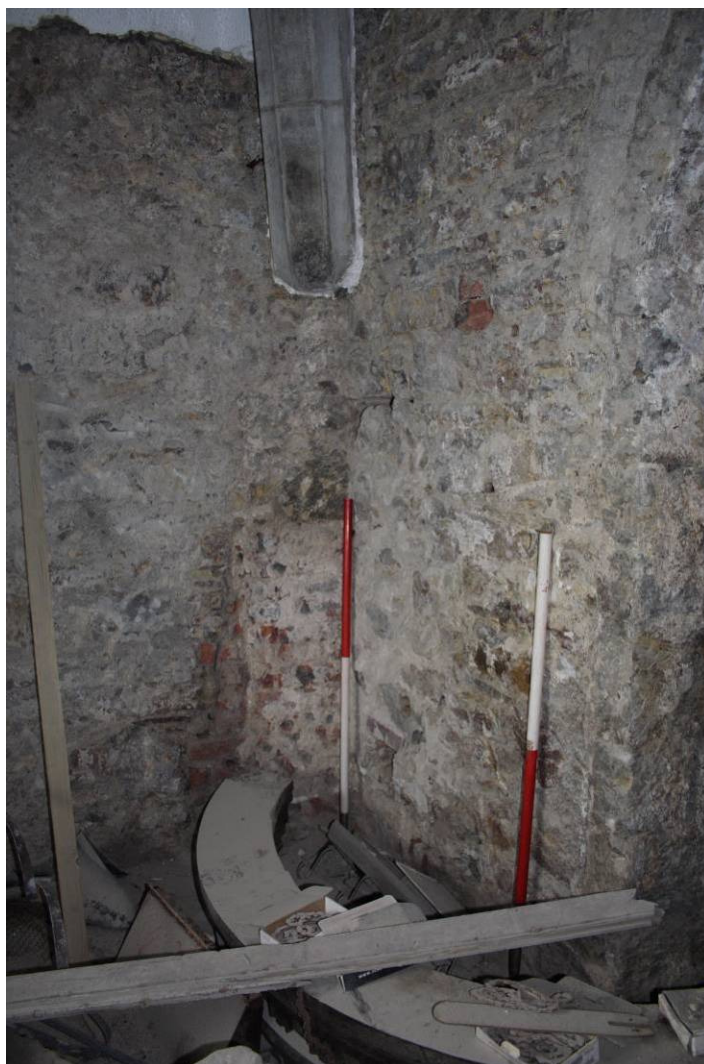
Photo 37: Northwest corner of Lower Floor of Square Tower showing projecting stonework

The northwest corner of the room contained a patch of stonework which projected slightly into the room, such that there was not a sharp corner (Photo 37). A few fragments of brick were located on the surface, which appeared to be facing to the projection as opposed to its structural fabric (perhaps to smooth off rough rubble stonework to allow it to be plastered over).

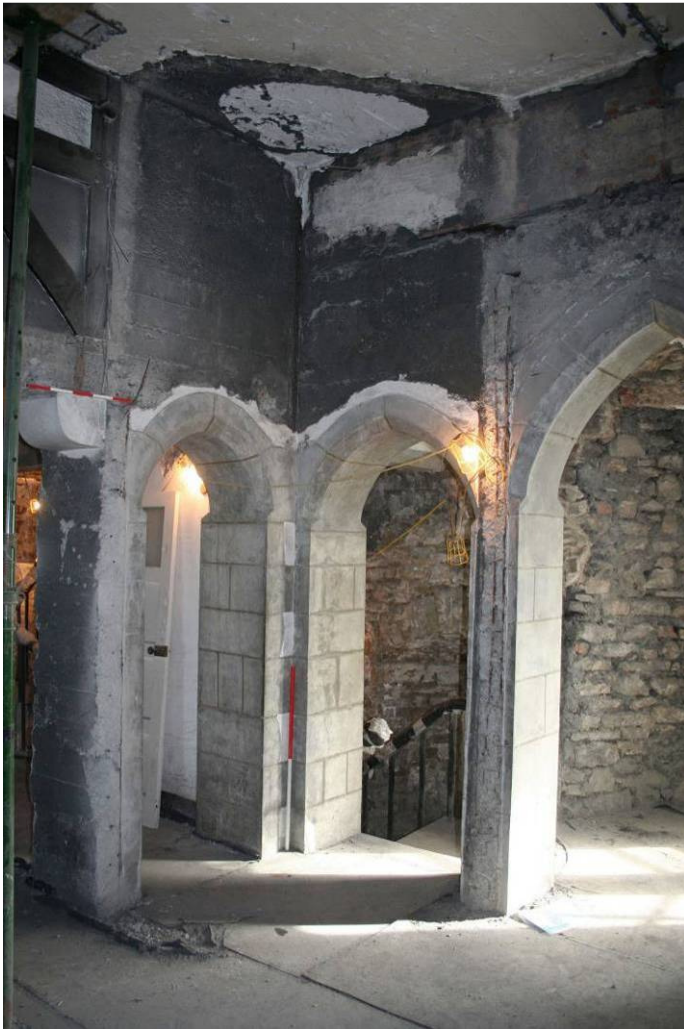
Photo 38: Eastern side of first floor showing doorway to stairs and Study on right hand side of photograph

To the east of the doorway from the First Floor of the D-Shaped Tower to the Lower Floor of the Square Tower was a second pointed arch doorway leading into the Study in the Stair Extension. This was also of modern date and lay adjacent to the archways at the top of the flight of stairs to the First Floor as discussed above (Photo 24). The arch leading into the Study was taller than the others (Photo 38). This is also a 20th century addition.

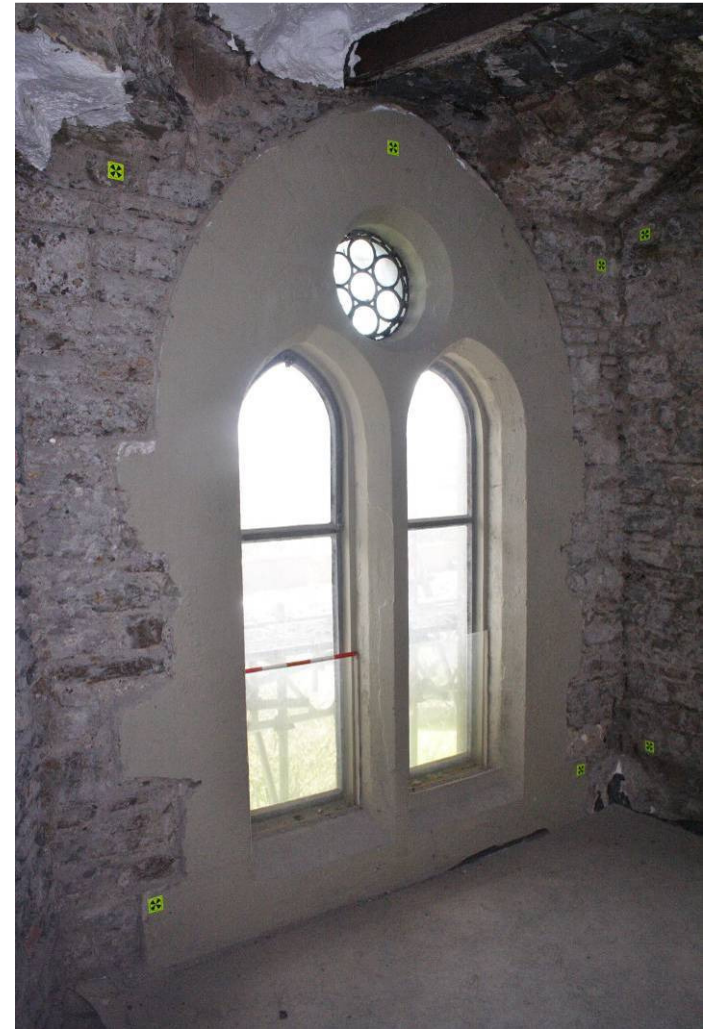
Photo 39: 1901-1904 Window within southeast wall of Study

The Study room was trapezoidal in shape 2.50m in maximum length and 1.75m maximum width. The main wall on its southeastern side contained a large ornate window containing two tall arched lights with a round window placed centrally above all encased within large pointed arch, moulded stone frame (Photo 39). The window dates from the 1901 – 1904 renovations and was evidently inserted to fill a large void which is shown on the 19th century illustrations and photographs of the castle. The window is a basic copy of those within the northern facade of St Marys Church at Roch which is visible from the window to the southeast.

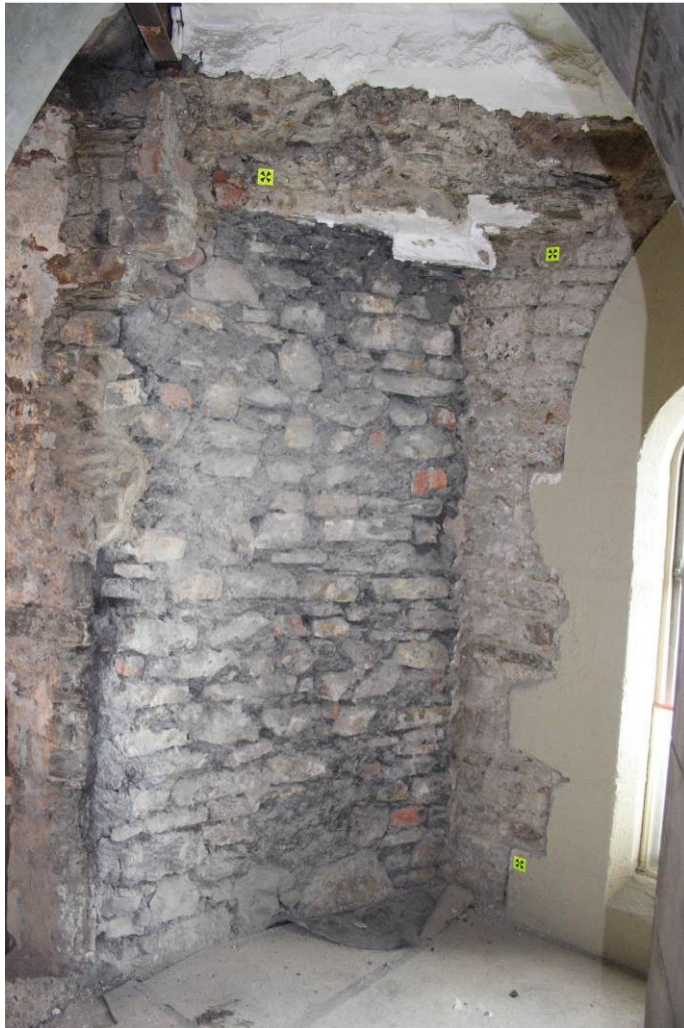
Photo 40: 1901-1904 northeastern wall blocking of possible former garderobe

The northeastern wall of the room also dates from the 1901 – 1904 renovations, and suggests blocking of a former void (Photo 40). It is possible that this may have been a medieval garderobe, inserted as part of the Stair Extension (as is present directly above on the second floor). A garderobe is noted in Clarke's 1865 description in this location. Above this wall within the ceiling are possible indications of the underside of winders for a former curved stairway above, which do not correspond with any existing stairs.

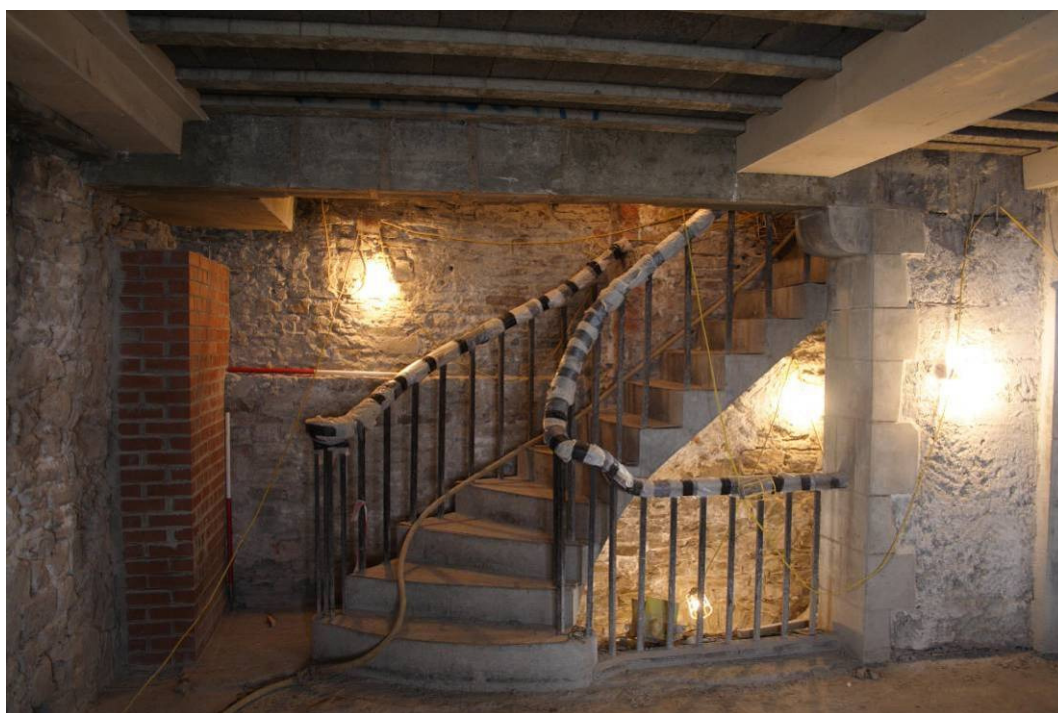
Photo 42: 1901-1904 concrete stairs leading from
First to Second Floor of D-Shaped Tower

The stairway leading from the First to the Second Floor of the D-Shaped Tower is made of concrete and is an insertion dating to 1901-1904. A contemporary iron balustrade with wooden handrail is present (Photo 42). The stairs pass a large tall window on the eastern side (as discussed above). The thickness of the exterior wall in this location is far thinner than that to the north and east and may suggest a former stair was present in the thickness of the wall, but had collapsed, as had the inner face of the wall prior to the 1901-1904 renovations.

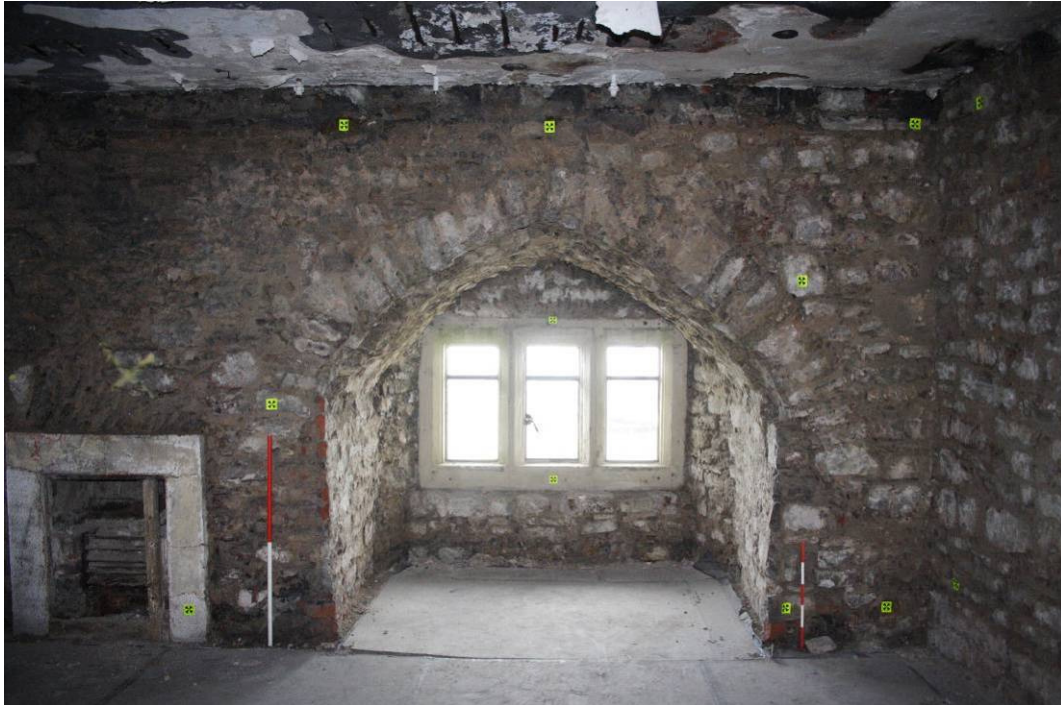
Photo 43: Window in western wall of northern room of the
Second Floor of D-Shaped Tower

c.4.9m east to west. Two windows were present in the western and northern walls, both rising from the concrete floor level to the apex of Tudor style arches forming alcoves within the majority of the width of the walls. The western window alcove (Photo 43) measured c.2.00m in width and 1.45m in depth, with slightly splayed reveals adjacent to the window itself. The window arch rose to a height of 2.00m at its apex, formed of stone voussoirs on the wall facade and stone corbelling. Inserted bricks on the outer edges of the reveal may suggest partial 1901-1904 infilling.

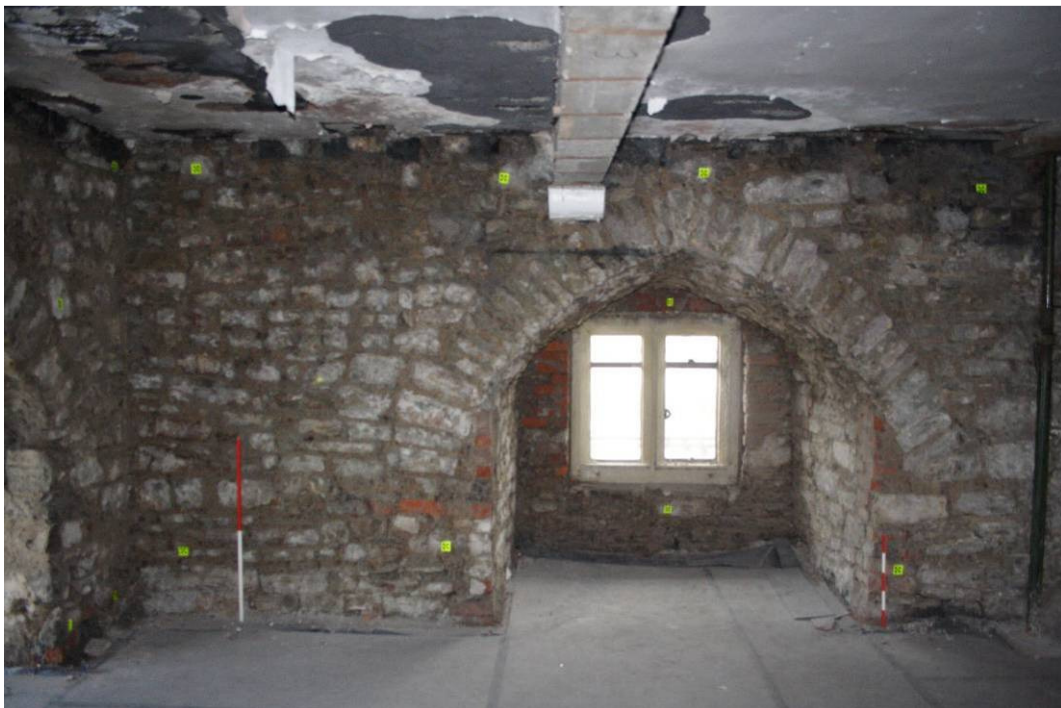
Photo 44: Window in northern wall of northern room of the
Second Floor of D-Shaped Tower

The window alcove in the northern wall (Photo 44) measured c.1.96m in width and 1.45m in depth. The height to the apex of the arch was 2.07m. There were no splayed reveals adjacent to the window, but brick insertions were noted on the internal facade suggesting rebuilding of the external face of the window, probably during the 1901-1904 renovations. Brickwork was also noted on the edges of the reveal, again suggesting partial infilling in the early part of the 20th century. The arch was again faced with stone voussoirs with corbelling forming the remainder of its roof.

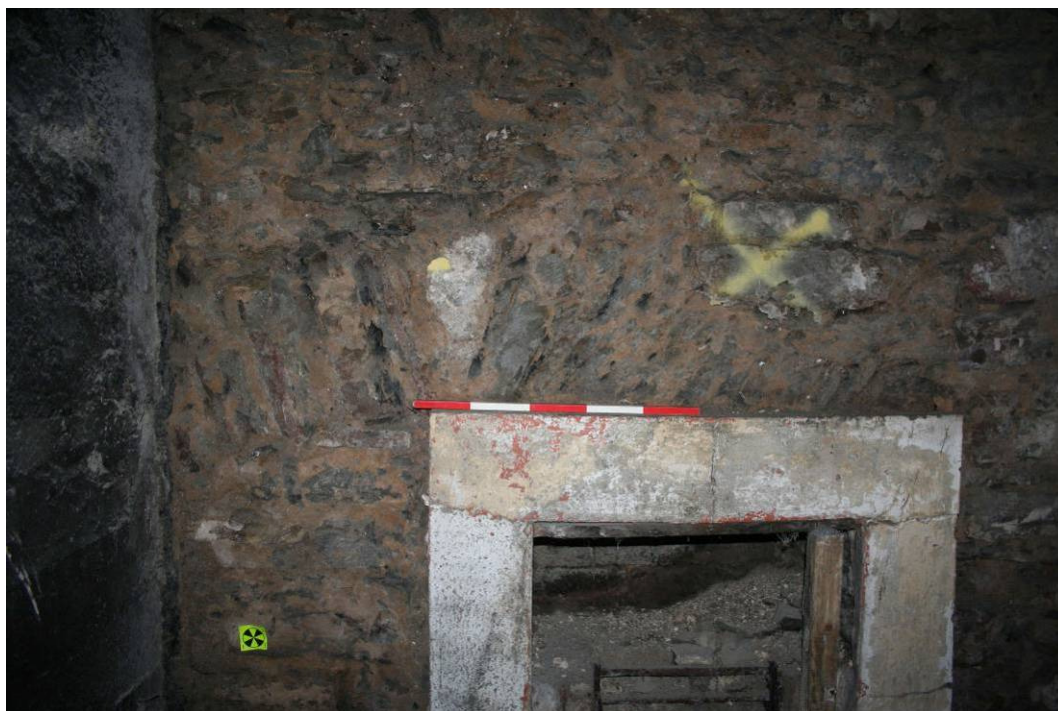
To the south of the western window lay a 20th century fireplace (Photos 43 and 45). It is likely to have reused an earlier fireplace as a stone arch was present above the opening. This arch continued through the adjacent modern partition wall and was then visible in the upper part of the First Floor below (visible beneath the floor level of the adjacent southern room). Its full span would have been around 2m, with the top of the arch some 2.8m from the possible medieval floor level below. The feature may represent a tall medieval fireplace or alternatively a doorway to a stairway in the thickness of the walls curving to the south (although no further evidence for this could be conclusively seen). The height of this feature may fit better with the doorway theory.

Photo 45: Earlier arch above 20th century fireplace

Stairs to the upper floors were located within the thickness of the walls possibly to the east. The eastern stair has been altered by the later Stair Extension and 1900s alterations, but follows roughly the original alignment. An archway on the western wall visible at the existing second floor level (Photo 45) indicated a former tall opening in the wall which may have led to a garderobe passage. A garderobe may also have been positioned within or adjacent to the stair on the southeastern wall, although evidence is lacking.

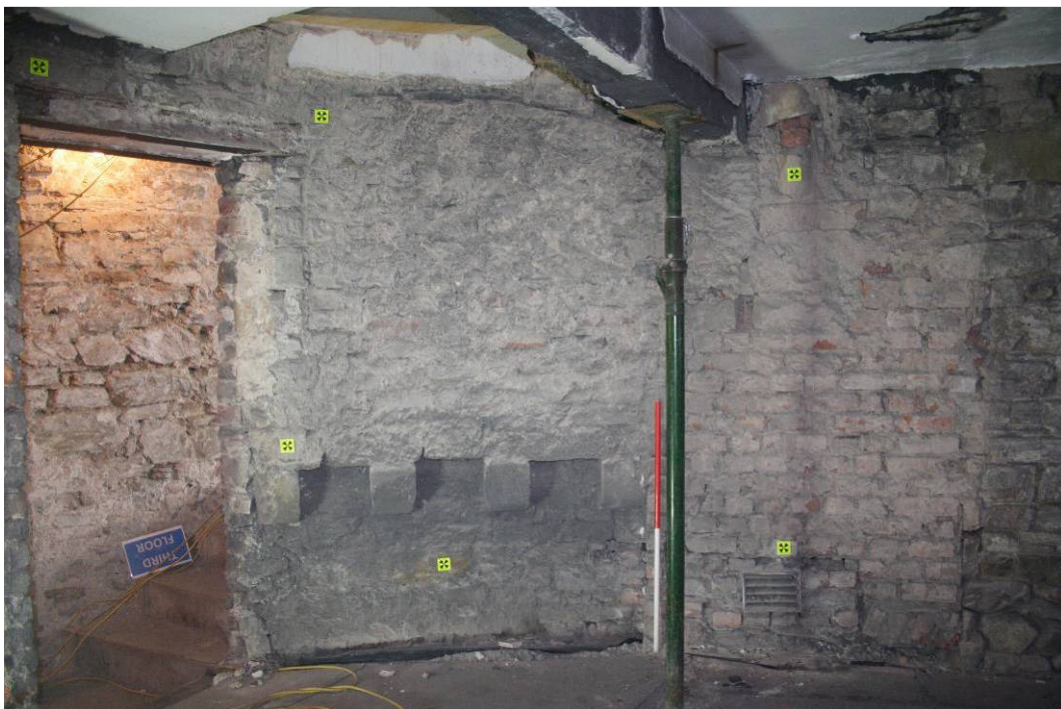
Photo 47: Southeastern part of southern room of Second Floor showing corbels and section of brick infill

Within the stone wall adjacent to the doorway were a series of four corbels with the wall widening above (Photo 47). This area of the room had evidently been subject to considerable remodelling and rebuilding, with the 1901-1904 brick wall to the north and an area of brick infill to the southwest of the corbels. The northern corbel appeared to have been cut through as the ragged cut marks were visible on its exposed end, and for the block of stone above. The doorway is evidently a modern insertion (dating from 1901-1904). The area of brick infill to the southwest covers the middle part of the southern facade of the room. A small vent was present in the brick wall. The brick infill was taken down during the renovation works and it was confirmed that it covered a chimney flue behind. Further to the west, the wall returns to stone construction with little evidence of repair or rebuild, other than a ceramic pipe built against and into the wall, a remnant of its former use as a bathroom (Photo 48).

The existing southern room of the second floor is at a slightly higher level than that to the north, although originally they would have been at the same level. The conjectured floor level projected from the room to the north would correspond roughly with the level above the corbels visible in the curving wall to the southwest (Photo 47). As noted above, it is thought that a stair was present in the western wall in front of the existing window opening, which curved around the southwestern side of the castle leading to an upper level.

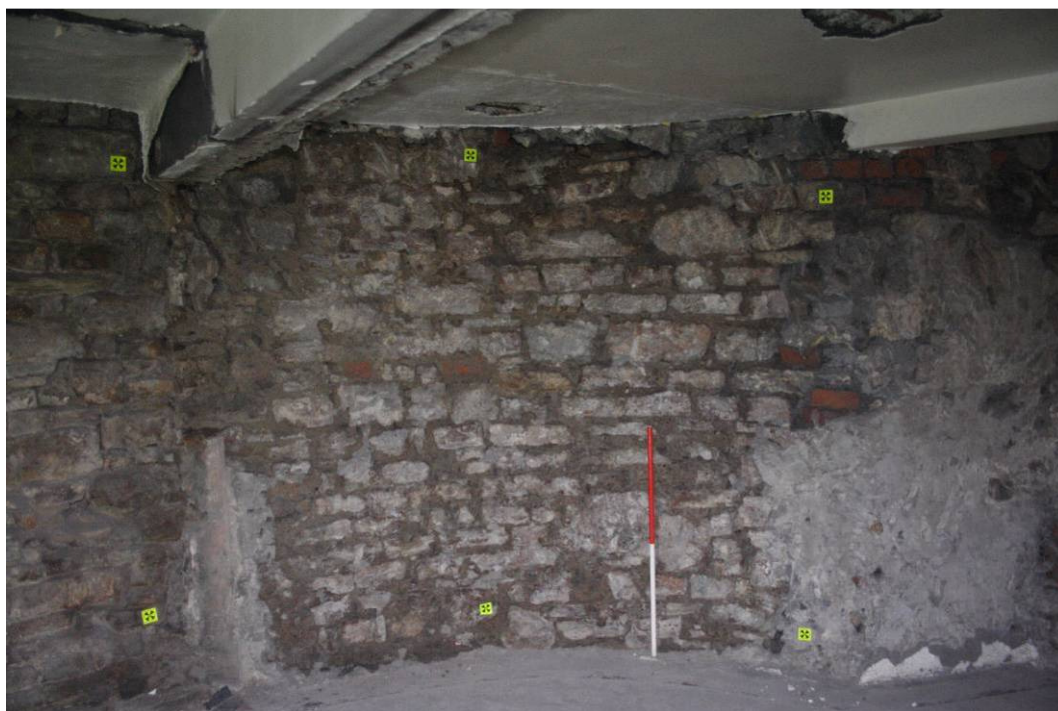
Photo 48: Southern wall of southern room of Second Floor
(bricks and plastered area to west mark the reveal of the western window)

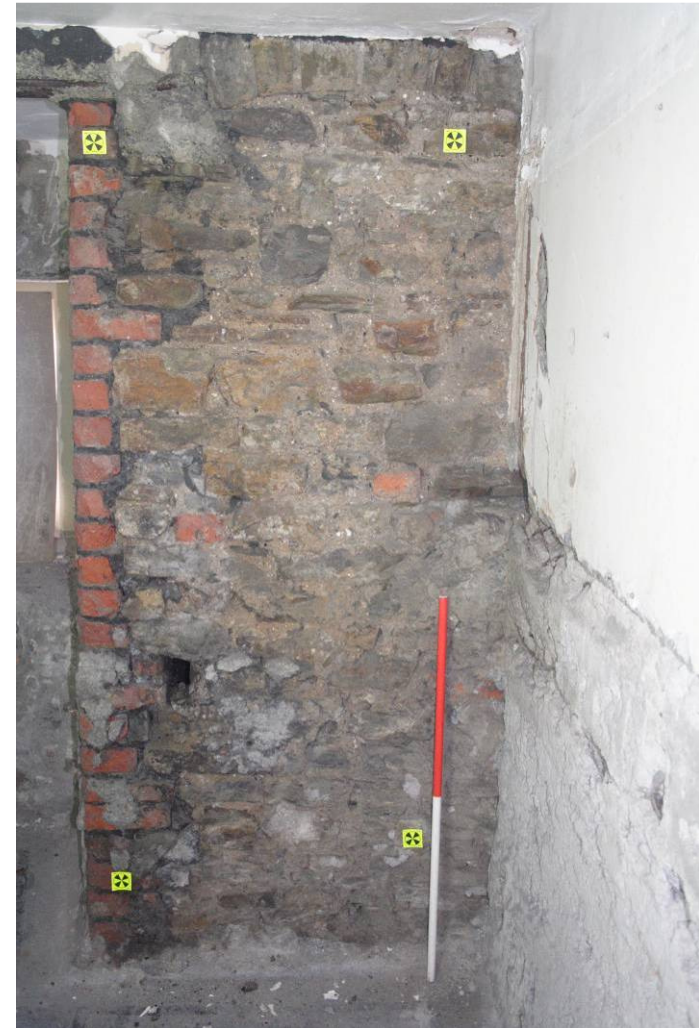
To the north of the window the facade of the western wall was mostly of stone construction although there again appeared to be infill or repairs of uncertain date (presumably earlier than the 1901-1904 renovations due to the lack of brick used). At a level of 2.26m above the floor level was a small stone arch, which had been infilled below (Photo 50).

Photo 50: Wall to north of western window in southern room of Second Floor showing stone arch at top

It seems likely that the western wall of the southern room of the Second Floor Level of the D-Shaped Tower was originally narrower in the vicinity of the window. This could suggest an earlier window opening was present or alternatively there may have been a stair enclosed within the thickness of the wall. If the inner face of the wall had partially collapsed prior to the 1901-1904 renovations (as the information recorded by Clarke in 1865 may suggest), then it may have been an opportunity to insert a new window opening through the full thickness of the wall, perhaps utilising an existing window light. The location of the entrance to the stairs is not known, but potentially could be indicated by the stone arch seen to the north of the window opening or alternatively this is an arch over a former small fireplace.

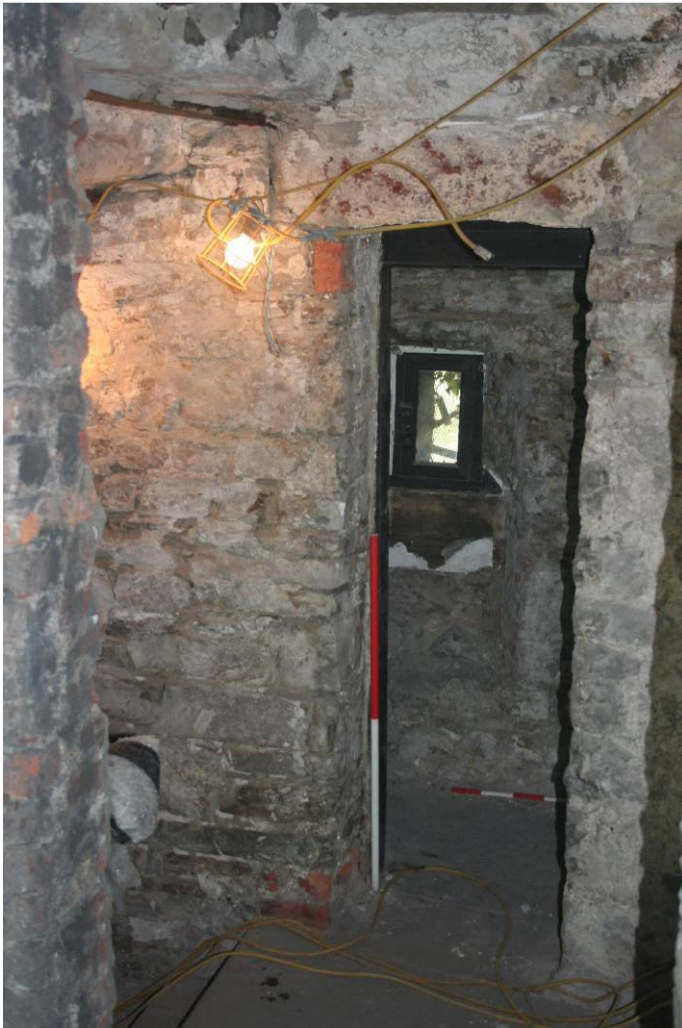
Photo 52: View into Garderobe within Stair Extension showing window

A small window opening was present on the eastern wall c.1.20m in height, 0.55m in width and 0.25m depth to the window frame (Photo 52). The window reveals were splayed on either side. The base of the window had been significantly modified and reduced in height for a sink unit which was formerly located within the room. A small vent was also located to the north of this window with a metal cover (Photo 53).

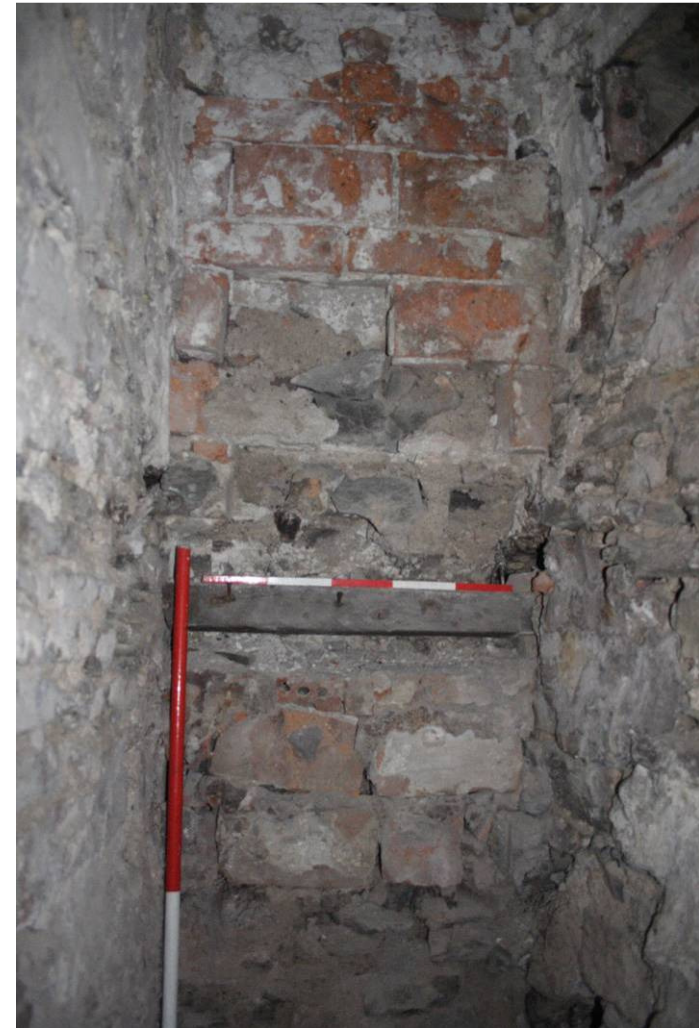
Well constructed stone walls were present on the eastern and western sides of the room, whereas the northern end was significantly rebuilt and patched (Photo 53). The patching included brickwork, with bricks laid normally and also rows with bricks laid on their sides. A modern toilet had been located at this end of the room previously.

Photo 53: Northern wall within Garderobe in Stair Extension showing brick patched walling, with small vent to east

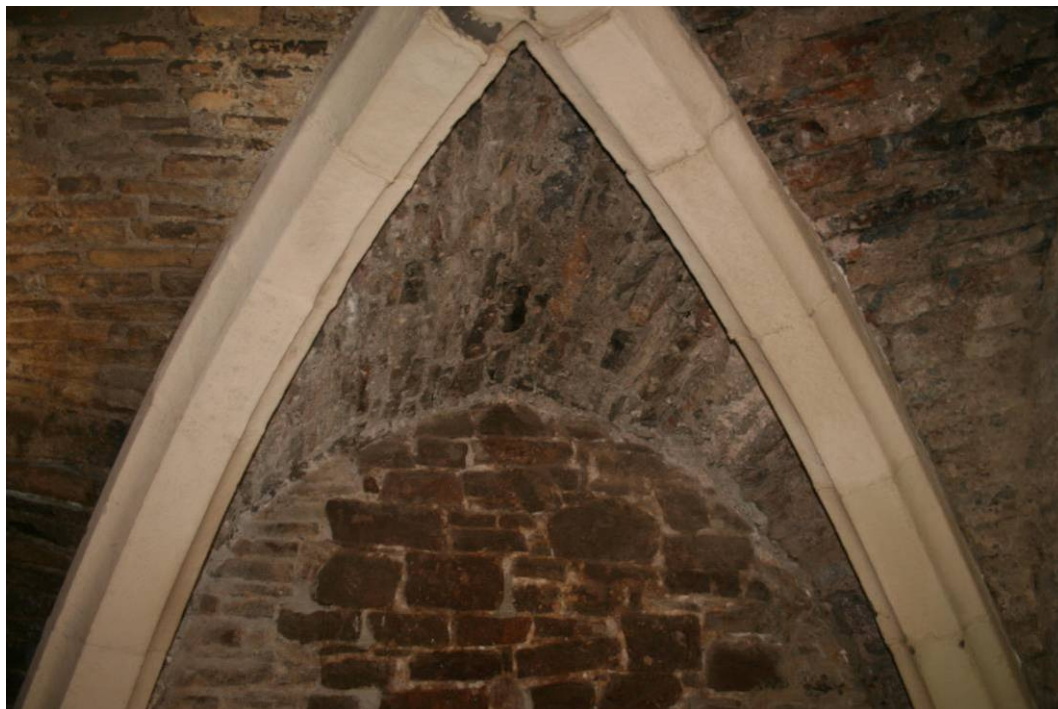
Photo 54: Part of ribbed and vaulted ceiling of Middle Floor of Square Tower

From the garderobe the stairs rise a little further and split in two directions. A curve in the stair to the southwest provides access to the middle floor of the Square Tower, the other curves sharply on a partial stone spiral stair with central newel leading to the Third Floor Level. The room forming the Middle Floor of the Square Tower measures c.2.60m north to south and c.3.3m east to west. The roof comprised a ribbed and vaulted stone ceiling comprising mostly original fabric, although a number of replacement re repaired stones were noted on the ribs.

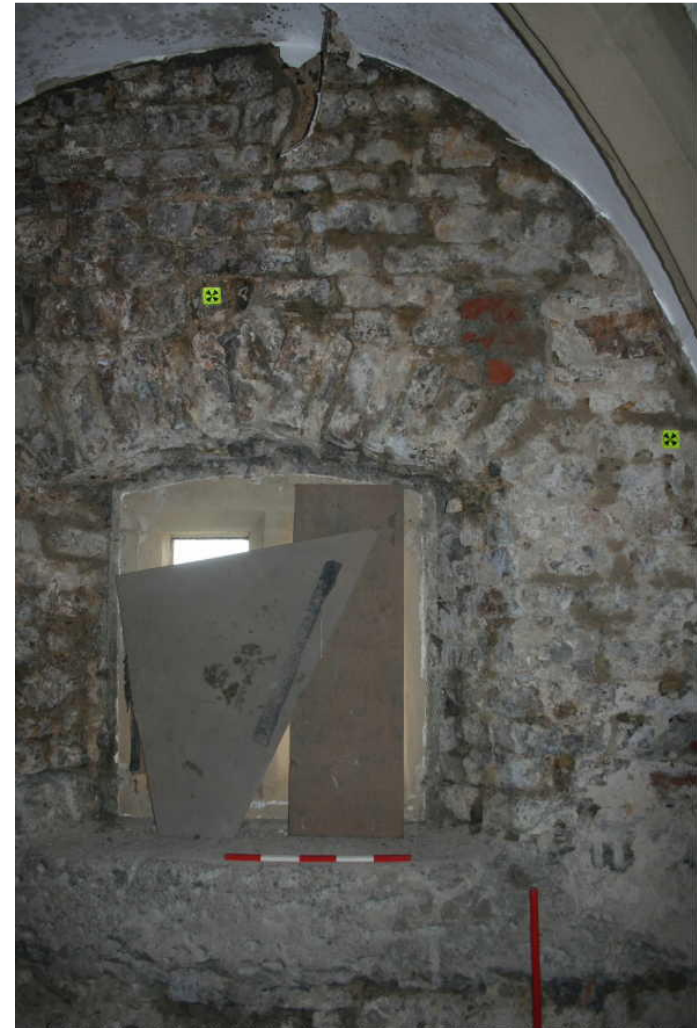
The main window of the room was again located in the centre of the southeastern wall, measuring 1.20m in width and 1.19m maximum height (Photo 56). The window cill was 0.31m in depth. A stone arch was visible above the window which is likely to be original. The reveals of the window were splayed on either side. The window cill was formed by a large mass of concrete forming a beam. This could be seen in the fabric of the wall on either side of the window and into the southwestern wall and is a repair dating to the 1901-1904 renovations underpinning formerly unstable fabric above. A further smaller window was present on the southwestern wall which used the concrete beam as its cill. The window opening measured 1.15m wide by 1.06m in height, with a depth of 0.31m to the window frame. The reveals on either side were sharply splayed and it had a concrete lintel above. This is presumed to be a 1901-1904 remodelling of an earlier window.

Photo 56: Window in southeastern wall of Middle Floor of Square Tower, showing stone arch and concrete cill

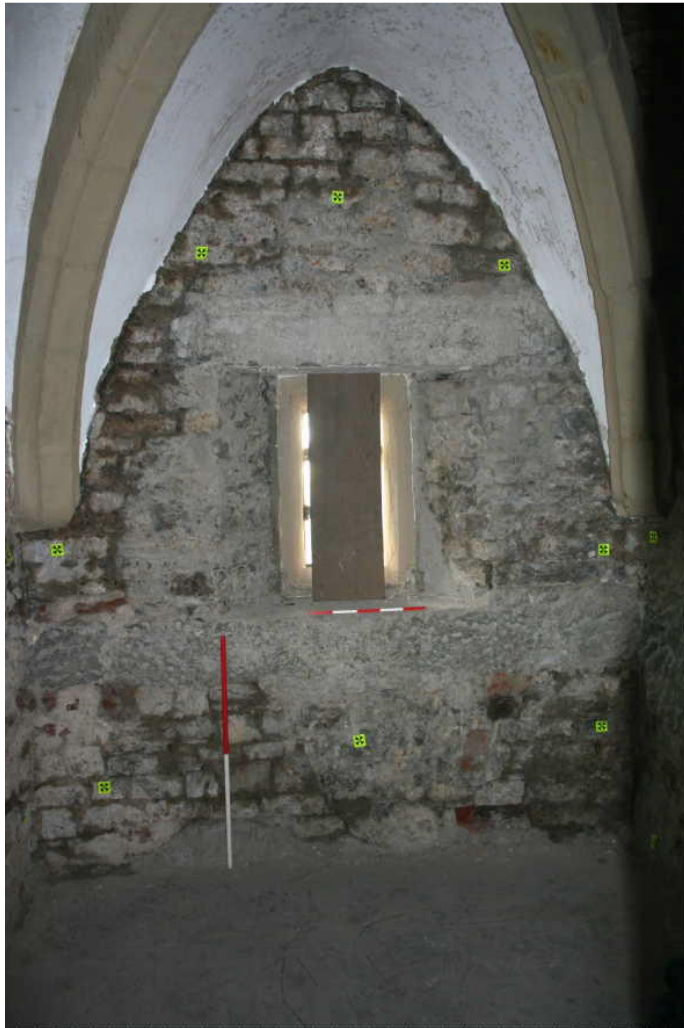
Photo 57: Window in southwestern wall of Middle Floor of Square Tower, showing concrete lintel and cill

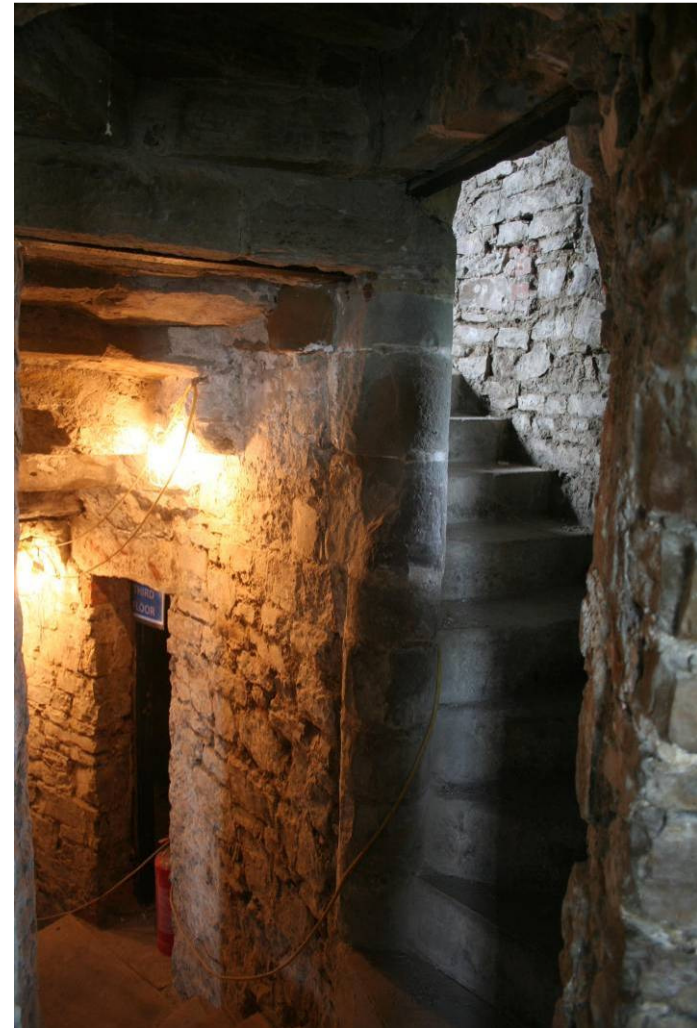
Photo 58: Curving stone stairs and newel from Second to Third Floor of the D-Shaped Tower

As noted above, the stairs leading from the Second to Third Floor Level of the D-Shaped Tower were formed by a curving stone stair with central stone newel, which turned 90 degrees before heading upwards to the north (Photo 58). The stairs had been partially repaired with concrete levelling spread on the treads of some of the steps. The stairs are considered to be largely original associated with the addition of the Stair Extension.

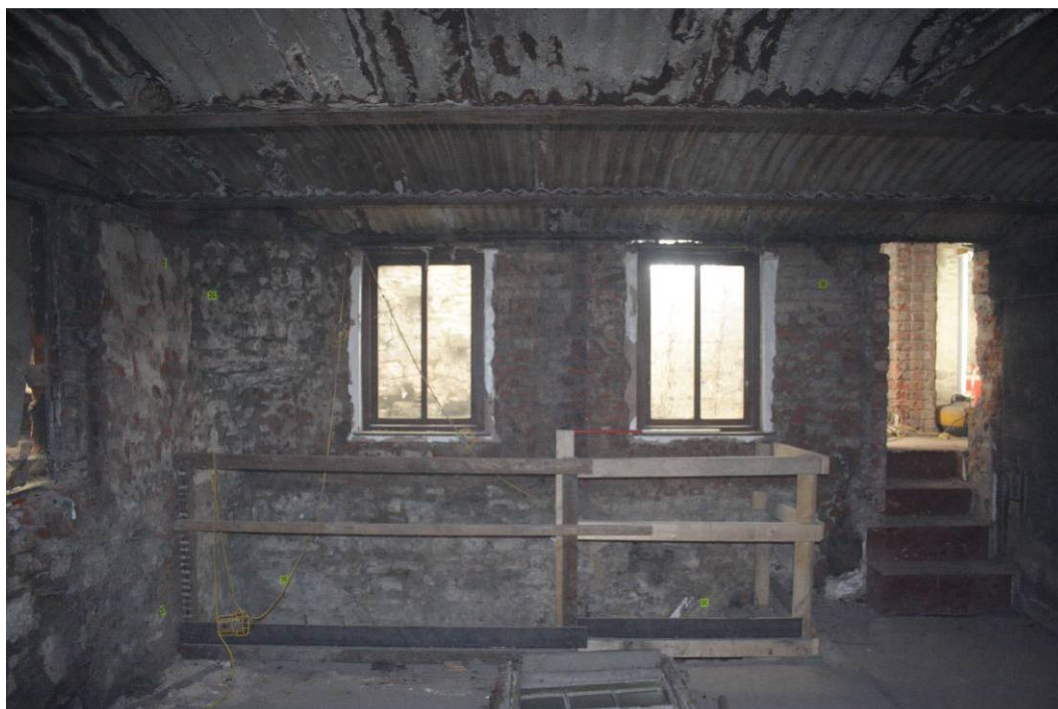
Photo 59: Eastern wall of northern room of Third Floor Level of D-Shaped Tower

The room was a mix of 1901-1904 brick construction and concrete roof built onto areas of probable medieval stonework along the lower parts of the wall and in the northeast corner. On the eastern wall two modern windows had been inserted through a mix of stone and brick built walling (Photo 59). The windows viewed the roof walkway with stone parapet behind. The northeastern part of the wall had a void in the floor where the former stairway had been removed. A projecting area of stonework in the northeast corner represents the corbelled base of the northeastern turret (Photo 60).

The top of the stone built lower parts of the walls correspond with the roof walkway level, as can be seen in the doorway (Photo 59). It is possible that this wall is of medieval date although it had been heavily modified and raised with later brick construction.

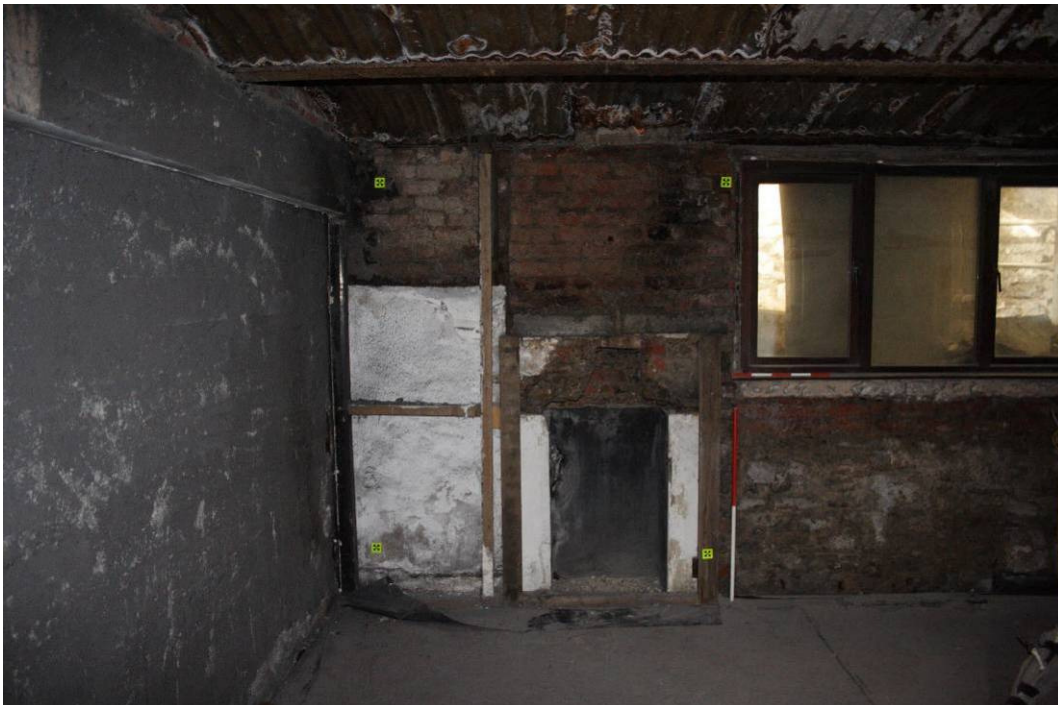
The southern wall of the Third Floor was of modern concrete construction, with the adjacent western wall a mix of brick with stone built lower parts (Photo 61). A modern window had been inserted to provide light, which again overlooked the roof walkway and stone parapet behind. A modern fireplace had been inserted into the southern end of the western wall.

Photo 61: Southern concrete wall and western wall of brick with lower parts of stone construction, and fireplace

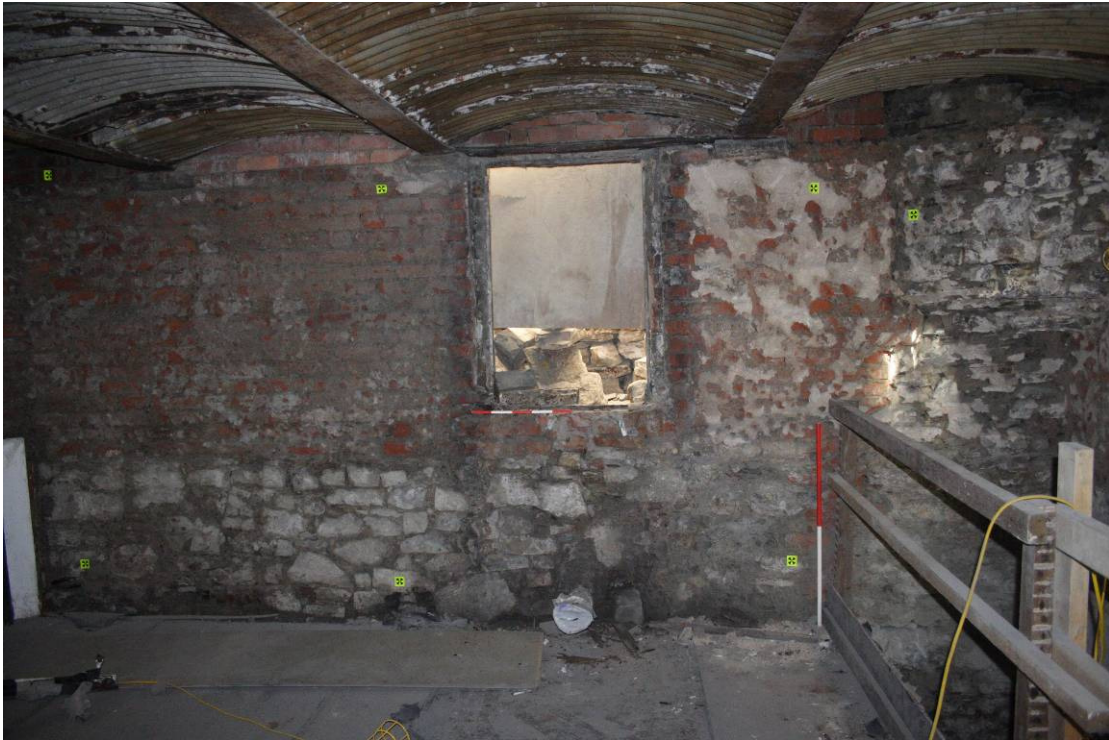
The northern wall of the northern room of the Third Floor Level of the D-Shaped Tower was again constructed of brick for the upper parts of the wall and with stonework for the lower parts (Photo 62). Another modern window had been inserted in this wall overlooking the roof walkway and stone parapet behind.

Photo 62: Northern wall of northern room showing stone and brick built walls, with stone turret base in northeast corner
