**ROCH CASTLE,
PEMBROKESHIRE
(SM 8803 2121)**

**HISTORIC BUILDING
RECORDING AND
ARCHAEOLOGICAL
INVESTIGATIONS**

RHIF YR ADRODDIAD / REPORT NO. 2011/26
RHIF Y PROSIECT / PROJECT RECORD NO. 100723

March 2012

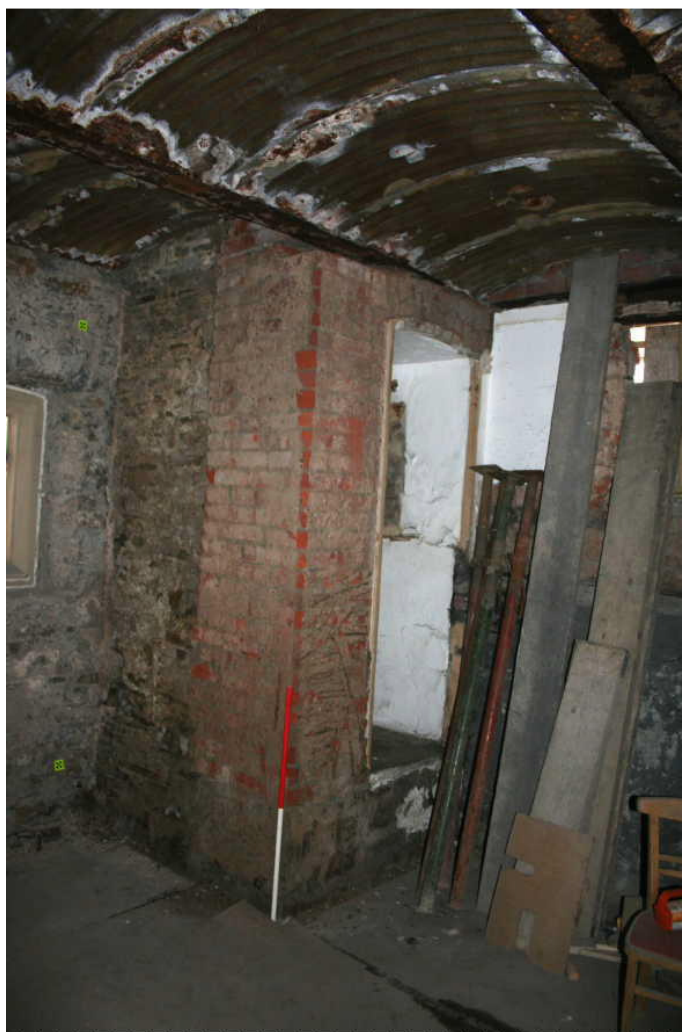
The western side of the room had a brick built alcove in the northwest corner, constructed against a stone built projection (Photo 64). The western wall comprised the curve of the D-Shaped Tower, but was noticeably narrower in this area. The wall is over 1.6m thick on the Basement to Second Floor, whereas here it is c.0.45m thick. The stone projection lies above the location of a fireplace on the First Floor Level and a possible smaller one on the Second Floor. With the narrowness of the wall in this location, it is presumed the projection houses a chimney flue. This projection was adapted at some point during the 20th century with the construction of a brick walled cupboard. The base of the cupboard was of stone construction, and matched the width of the stone wall below, although it is uncertain if this was a later addition or an original feature. The continuation of the western wall has two windows within its curve (Photo 64). Evidence of cut stone and areas of cement infill suggest that both of these windows are later insertions, associated with the 1901-1904 renovations.

Photo 64: Northwest corner of southern room of Third Floor Level showing brick and stone projection

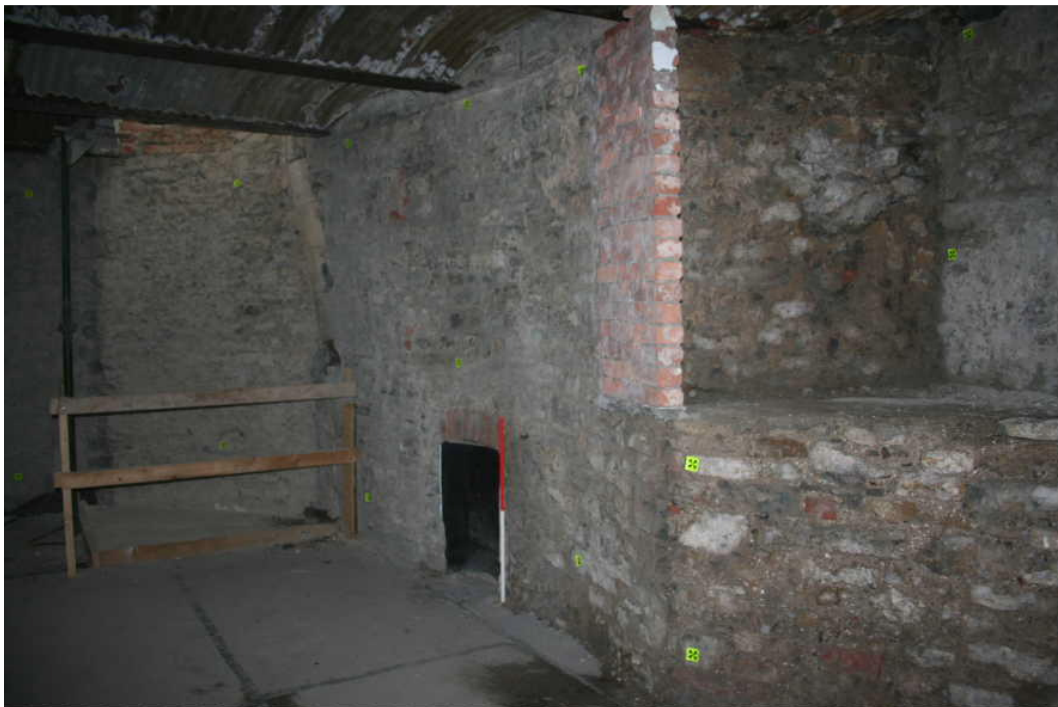
To the south of the windows, the western wall substantially increased in width (Photo 65). The remainder of the southern wall continued the line of this increased width, with a fireplace centrally placed. A step in the wall was present, rising to a level area 1.16m above floor level. The step projected out diagonally from the wall, a length of 1.64m, with the inside edge measuring c.0.65m in length and the length against the internal wall face c.1.50m in length. A brick partition wall had been built on the inside edge of the step to ceiling height to create a storage area, the brick construction seemingly more recent than the 1901-1904 renovations style. The facade of the stone work below the step and the facade above appeared to be later blocking of uncertain date.

Photo 65: Southern wall of southern room of Third Floor Level
showing increased wall width and step

The layout of the roof level of the D-Shaped Tower is unclear. There is good evidence for stairs leading up to it on the southwestern side, as discussed above and also from the two staggered window lights at the existing third floor level (Photos 65 & 66). The layout of the step in the wall of this room (Photo 65) provides further evidence for a former stairway curving through the wall in this part leading to the curved arched alcove seen in the Upper Floor of the Square Tower (Photo 72).

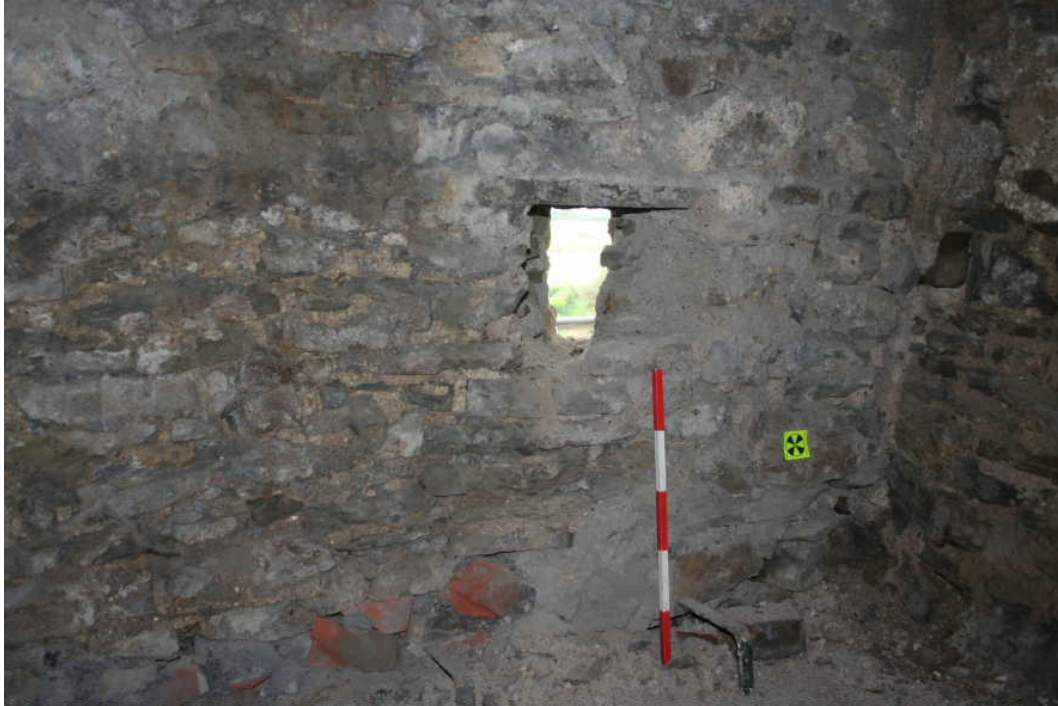
During the renovation work three blocked window lights were exposed within the western wall of this room. The light below the northern window on the western wall was partially unblocked indicating that the internal aperture measured 0.30m in width and at least 0.38m in depth (some blocking may have remained) (Photo 66). The possible base of this light was 0.40m above the room floor level. A stone lintel sat above the opening. The reveals on either side were splayed to a narrow opening.

Photo 66: Northern window light on western wall

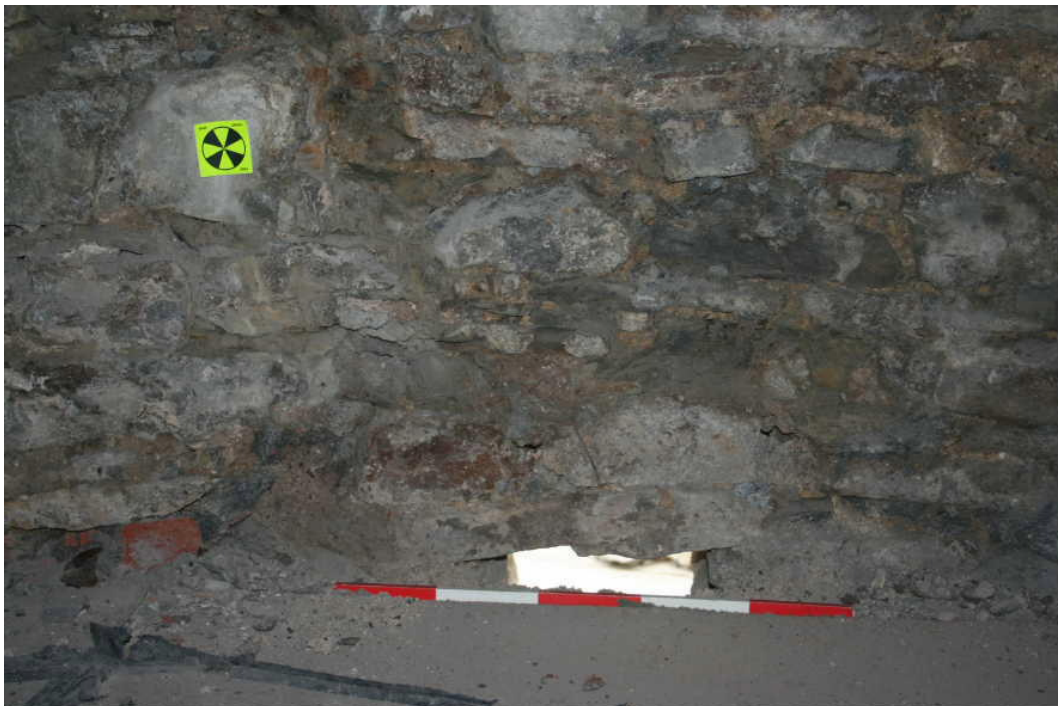
Photo 67: Southern window light on western wall obscured by floor level

A further window light was revealed to the south, below and to the southwest of the other window in the western wall (Photo 67). This was only just

visible as it was mostly covered by the concrete floor level. A stone lintel sat above the aperture. Although mostly obscured by the 1901-1904 concrete floor, no sign of splayed reveals were shown and the window aperture was a similar width to the internal opening (c.0.20m).

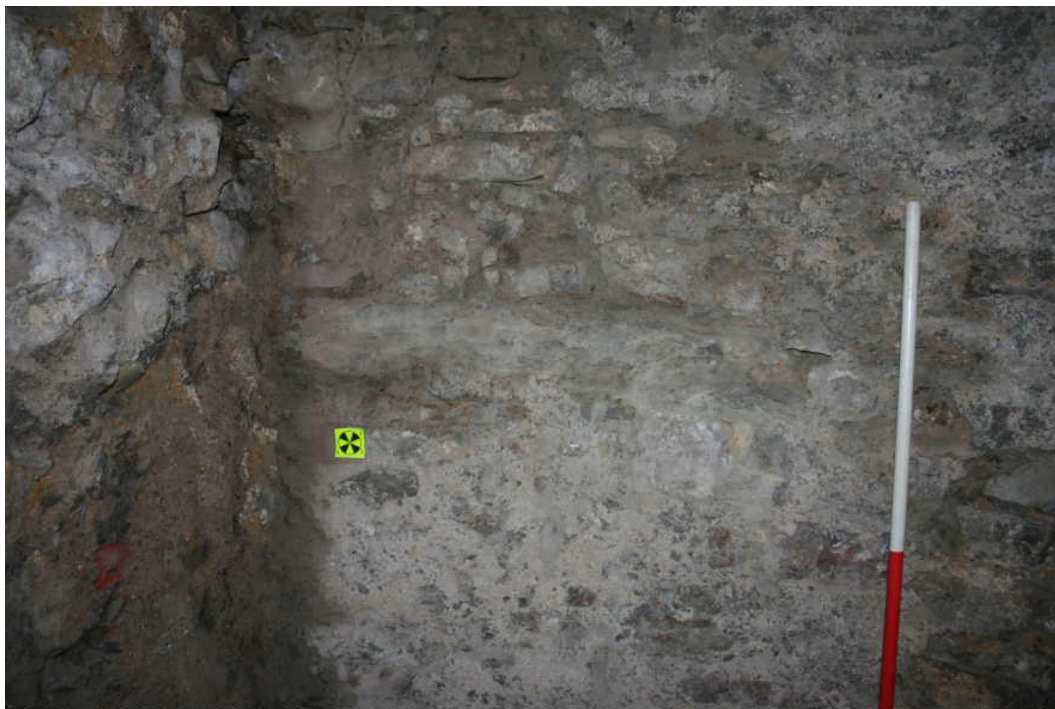
The third window light was located above the step in the wall. This was not unblocked and was evident only as a large stone lintel with an area of patching below (Photo 68). The lintel projected behind stonework to the southwest of the step in the wall, indicating that this was later blocking. The lintel measured at least 0.84m in length.

Photo 68: Stone lintel and blocked aperture below above step on southern wall

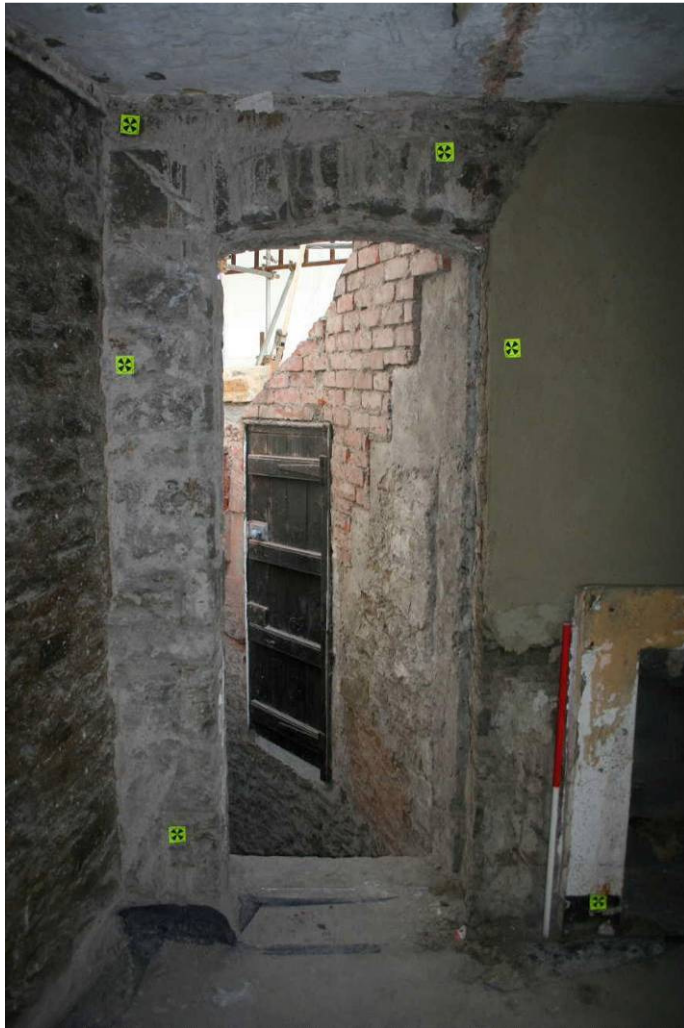
Photo 69: Doorway into Upper Floor of Square Tower from east, with area of brick build and door to stairs accessing roof

The entrance is in the eastern wall, c.2.14m in height and 0.76m in width. A stone arch is present above the doorway, which appears to be an original feature although the door frame and stairs leading to the room are constructed with concrete and cement. This may indicate adaptation of an earlier opening. A modern fireplace lies to the southeast of the doorway.

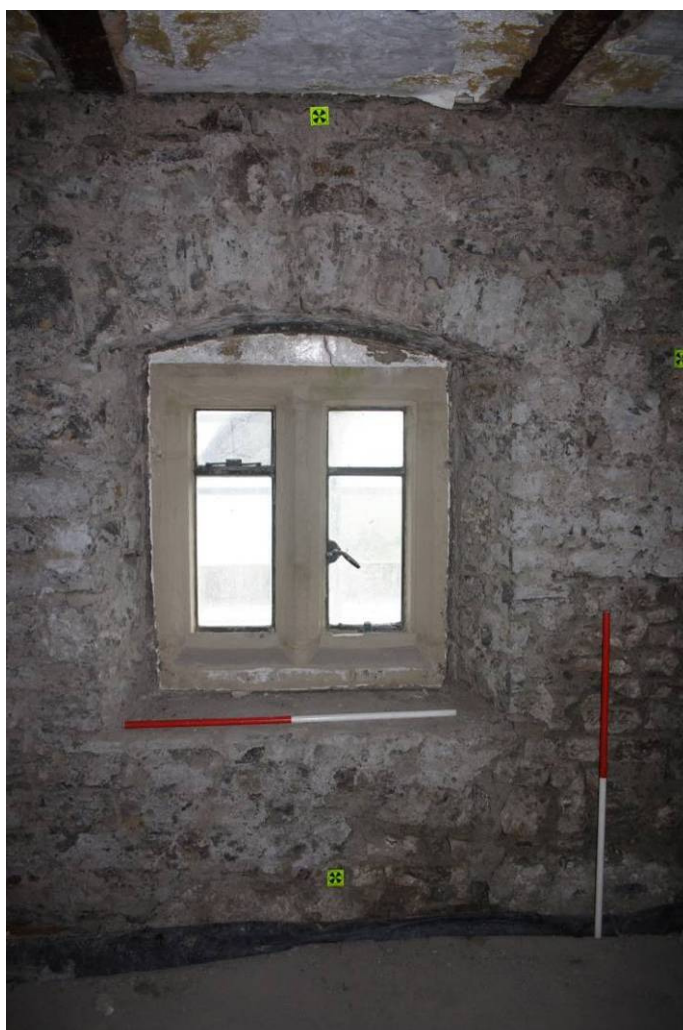
Photo 71: Window in southeastern wall of Upper Floor of Square Tower

The southeastern wall has the main window for the room, which measures 1.20m in width and 1.23m in height to the apex of the arched opening (Photo 71). It was c.0.29m in depth. The wall fabric suggested the area had been repaired to some degree, but no indications of substantial rebuild were noted. The window aperture was slightly splayed.

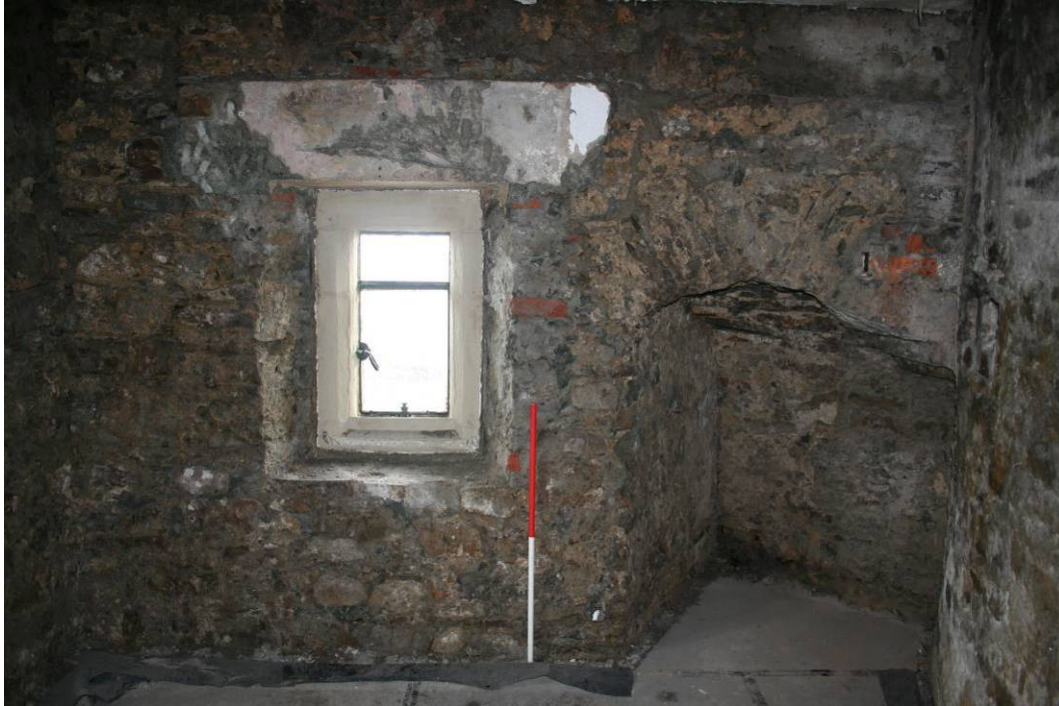
The southwestern wall of the Upper Floor has a smaller window within it, which may be a modern insert or modification as it is had a large concrete lintel and substantial cement and brick edging on the northeastern reveal (Photo 72). To the northeast of the window was an irregular shaped alcove with stone arch above and corbelled stone roof (Photo 72) sloping back. The base of the alcove was 1.25m in width, with a maximum height to the apex of the arch of 1.52m. The alcove curved to the northwest measuring c.1.19m deep on its southern side and c.0.55m deep to the north.

It is probable that the alcove represents part of the original entrance into the Upper Floor of the Tower. The floor level of the room was presumably altered during the 1901-1904 renovations and raised. If the earlier floor level was lower

by as little as 0.5m, then the alcove would form an entrance of around 2m height. The rear of the alcove had been blocked with stonework, similar to that seen on top of the step in the southern room of the Third Floor of the D-Shaped Tower below. The projected line of the staircase within the width of the wall, which may have started at a level within the Second Floor of the D-Shaped Tower, would lead directly to this alcove. It is possible that the stair pre-dates the tower and would have led onto battlements on the roof (discussed further below).

Photo 72: Southwestern wall of Upper Floor of Square Tower showing window and arched alcove

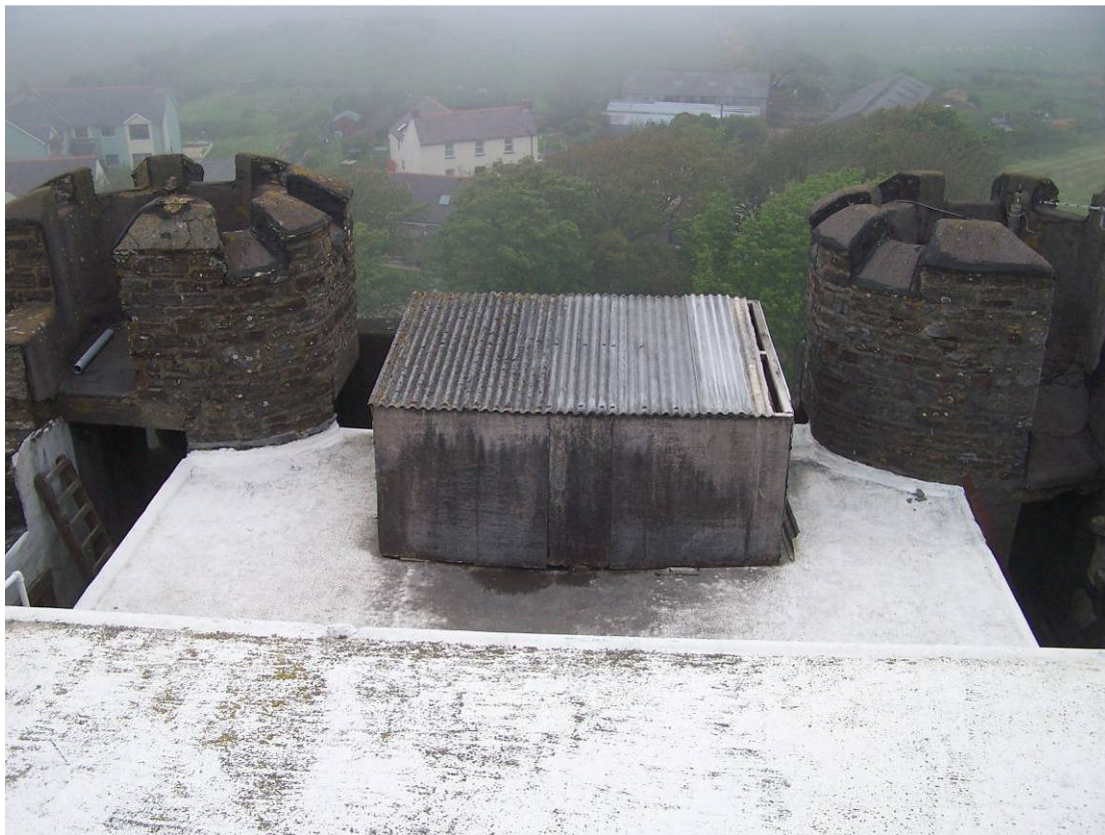
The roof walkway around the northern room was accessed directly from the medieval stone stairs leading from the Second Floor (Photo 58). Two turrets were located on the northwest and northeast corners of the D-Shaped Tower (Photo 73), with the walkway leading below both. The northeastern turret would appear to be of substantially medieval fabric. The base of the turret was seen in the northeastern corner of the room below. A corbelled dome supports the floor of the turret which can be seen from the walkway beneath. A series of blocks projecting from the inside of the parapet wall in front of the turret would have originally held a wooden staircase leading up to the turret floor (Photo 75). The

northwestern turret had been rebuilt during the 20th century, with steel beams forming the support for the floor and other obvious signs of rebuilding. No indications of step supports were present associated with this turret.

Photo 73: Southern roof layout of D-Shaped Tower and turrets prior to renovation work (asbestos roofed structure housed a water tank)

The 1901-1904 renovations included repairs to the northeastern turret and also the complete rebuild of that to the northwest (Photo 73). Much of the parapet was also rebuilt or repaired at this time.

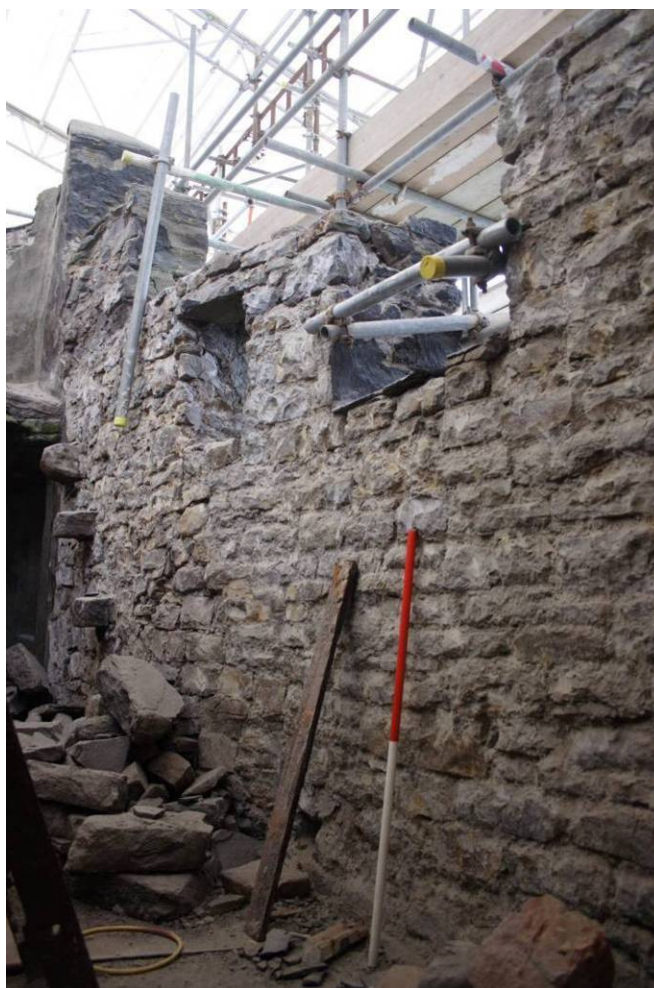
Photo 75: Walkway around northern room and stone projections in parapet wall for former wooden stairs leading to northeastern turret

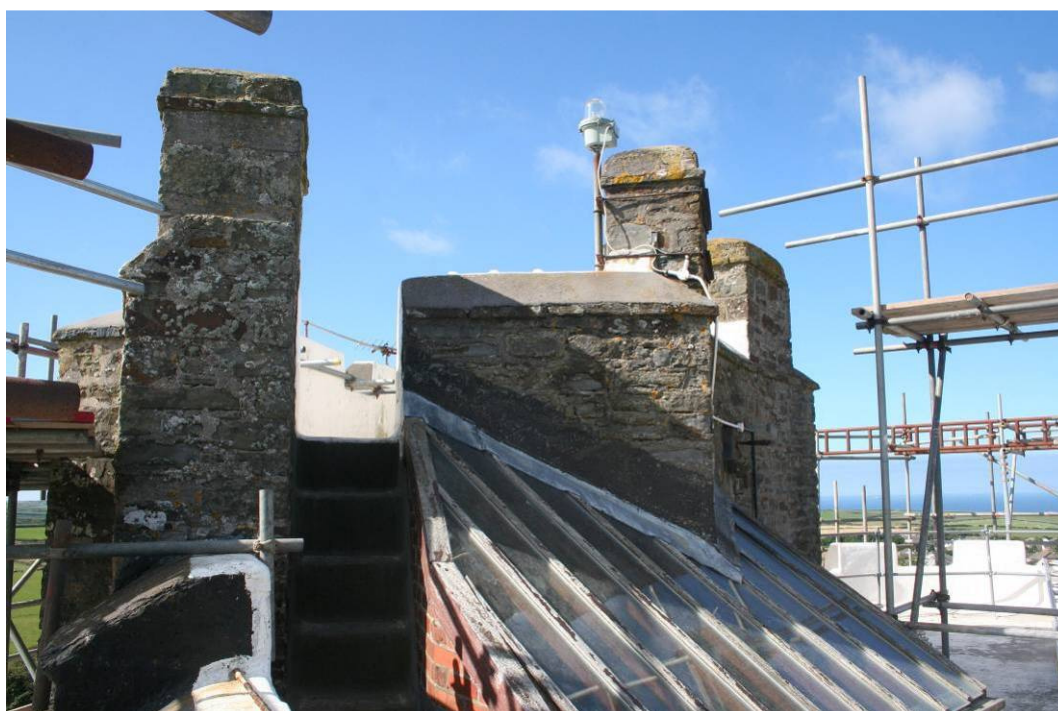
Photo 76: Stairs leading to roof of Square Tower

The highest roof structure was that above the Square Tower. It was formed by the modern concrete ceiling of the Upper Floor room. A staircase gained direct access to this roofed area, which ran on the outside of that leading to the Upper Floor room (Photo 76). These stairs were of modern concrete construction, but it is possible they followed an earlier alignment. The stair to the roof was accessed via a small door in the wall of the adjacent stair to the Upper Floor room (as can be seen in Photo 69).

The parapet contained crenellations of various sizes, many of which would have been rebuilt during the 1901-1904 or later works. Early pictures of the castle indicate that the parapet was in a poor state of repair by the 18th century, but that a number of larger vertical projections were present. These features correspond with chimneys above the flues noted in the western and southern walls of the castle. The two largest chimneys (Photo 77) were located on the western wall and served the fireplaces on each of the three floors of the D-Shaped Tower. These chimneys had been subject to repairs, but are probably substantially of medieval build. The chimneys on the Square Tower are visible on Photo 76.

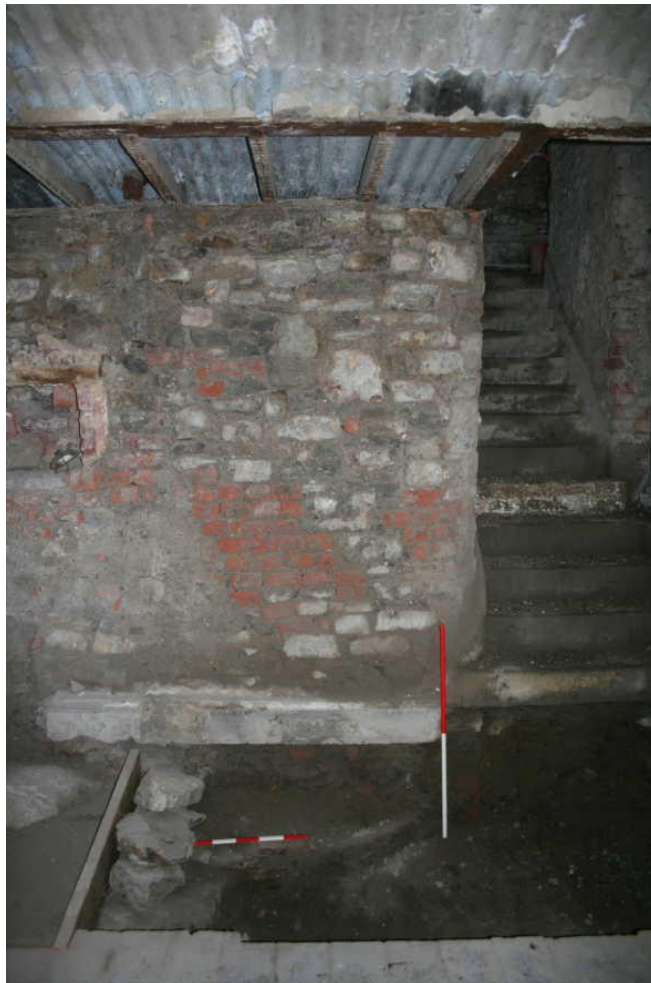
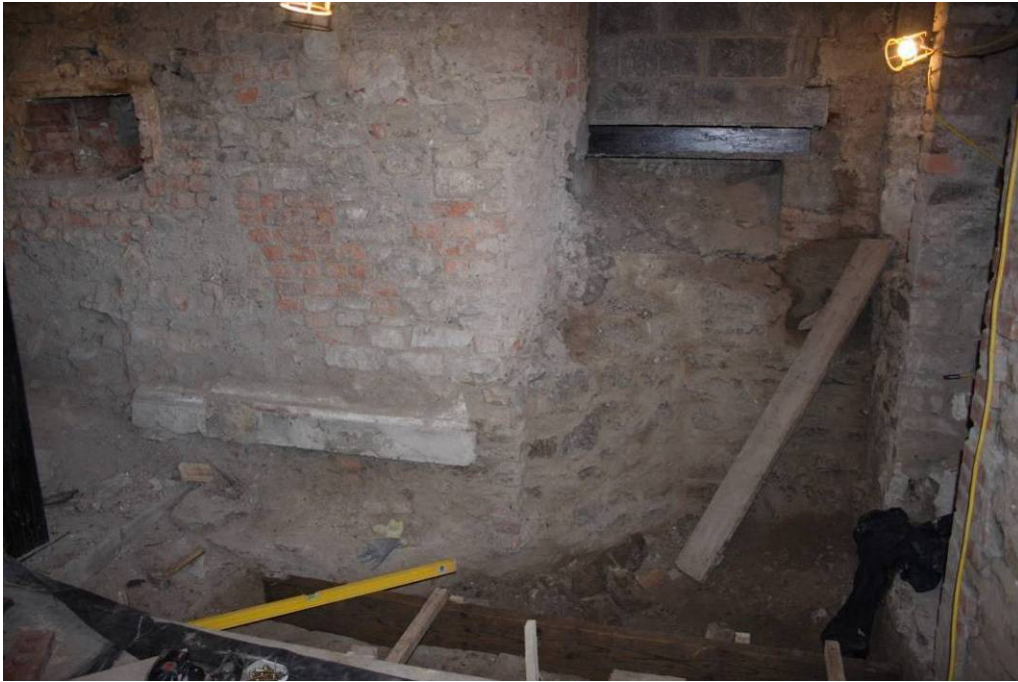
Photo 78: Curved structure (adjacent to scales) recorded at first floor level of Northern Extension on northern facade of the castle

Photo 79: Detail of curving structure following removal of stairs recorded at first floor level of Northern Extension on northern facade of the castle

The 1857 plan also shows a buttress was present on the northern facade. The remains of a semi-circular stone built feature were recorded in this location at first floor level of the Northern Extension (Photos 78 & 79). It had been significantly altered when the Northern Extension had been built, with the curving facade removed above the first floor level of the Northern Extension. A large mass of walling was present above and set back from the curving structure (Photo 78). This mass of wall was substantially stone built with rough brick patching on its face. A large concrete support had been inserted above the exposed area of the curved structure and the wall above.

It is suggested that the original entrance to the stone tower would have been on its northern side at first floor level. Even if the entrance had been at the basement level, there would still be a significant drop from to ground level around the rocky outcrop, and thus created a secure keep. It is likely that timber structures were constructed to provide access to the tower, perhaps utilising pre-existing ones associated with the earlier earth and timber phase. The small apsidal projection on the northern facade of the tower may be associated with such an entrance structure (Photos 78 & 79).

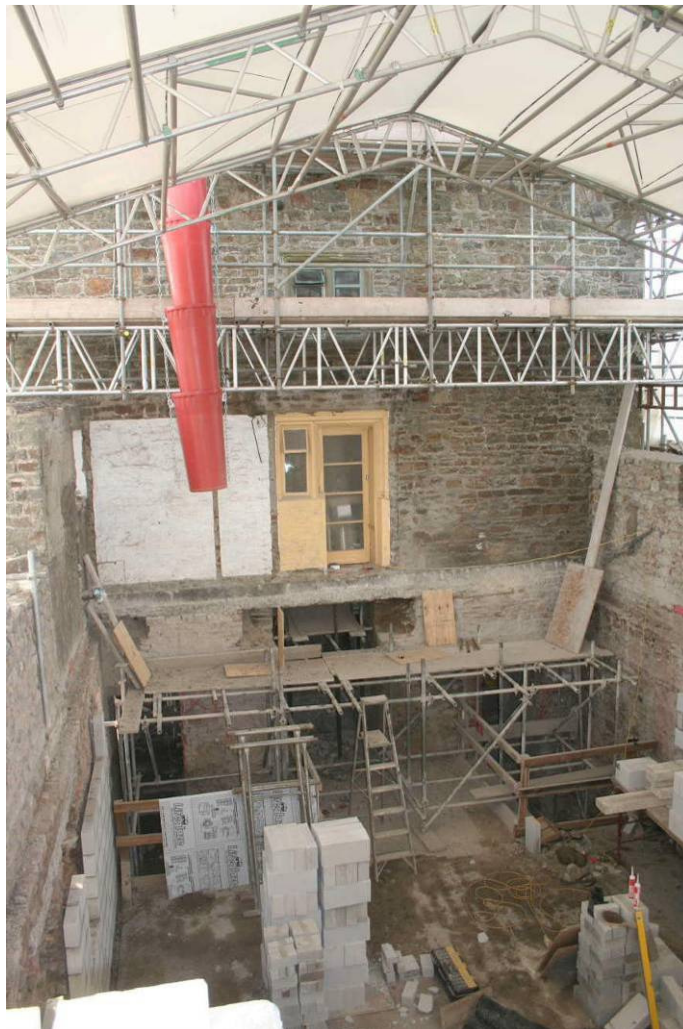
Photo 81: External view of northern facade of castle showing doorway from First Floor Level of D-Shaped Tower and opening below (taken following removal of roof structure for Northern Extension)

Following the construction of the upper storey of the Northern Extension in 1922, a doorway was constructed giving access between the First Floor of the D-Shaped Tower and the new roof level of the Northern Extension. It is not known what form this opening took between 1904 and 1922, and is presumed to have been a window. The opening corresponds with a large fissure in the northern facade which is shown on the 1865 illustration of the castle (Illustration 7), which

ran from below the arch of the window in the Second Floor to the rock outcrop at basement floor level. It is assumed that during the 1901-1904 renovations, this void in the wall was utilised to create access between the castle and extension, and this was subsequently modified in 1922 to create a new doorway onto the extension roof (Photo 81). A small kitchen was built on the roof of the Northern Extension at a later date, accessed via this doorway, when the castle was used as holiday accommodation. When the roof of the Northern Extension was removed (prior to a new one being constructed) it was possible to view the majority of the northern facade from the Basement Level of the D-Shaped Tower upwards (Photo 81). This showed the continuation of vertical sides of the central doorways in the northern facade between the floor levels, which indicates the fissure seen on the 1865 illustration was probably modified as one large single opening during initial renovations works.

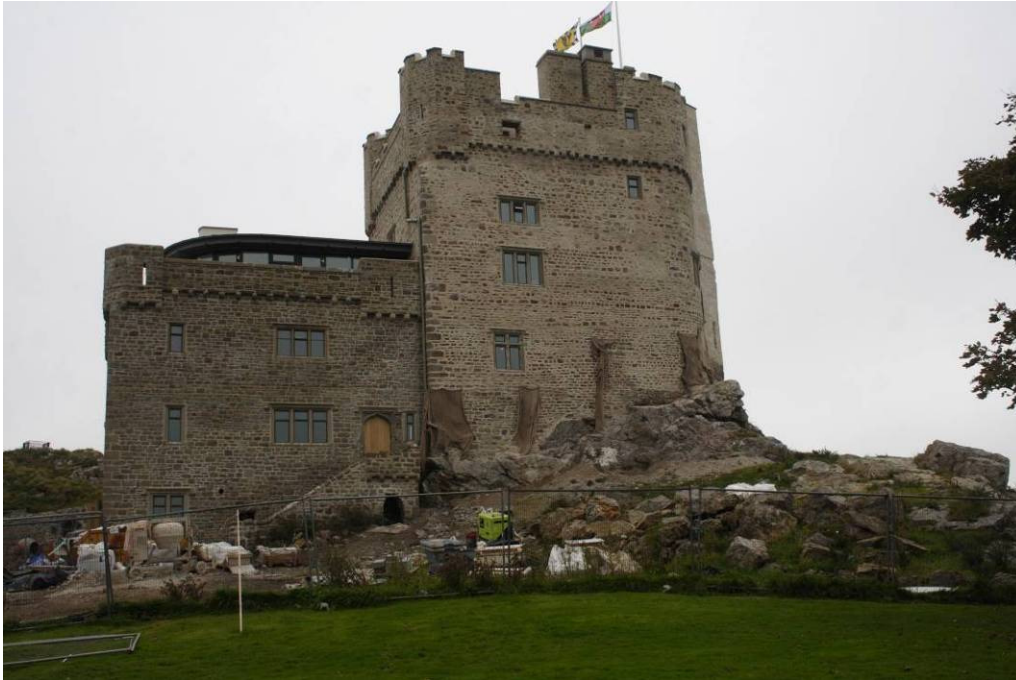
Photo 83: Western elevation in September 2011

The western elevation of the castle includes that of the Northern Extension (Photo 83). Based on internal layout it is known that the windows on the northern part of the façade are replacement windows but in original window locations. As noted above, the northwestern turret was a modern rebuild (and completely rebuilt as part of these renovations), although may have some original fabric on the outer wall above the corbel course.

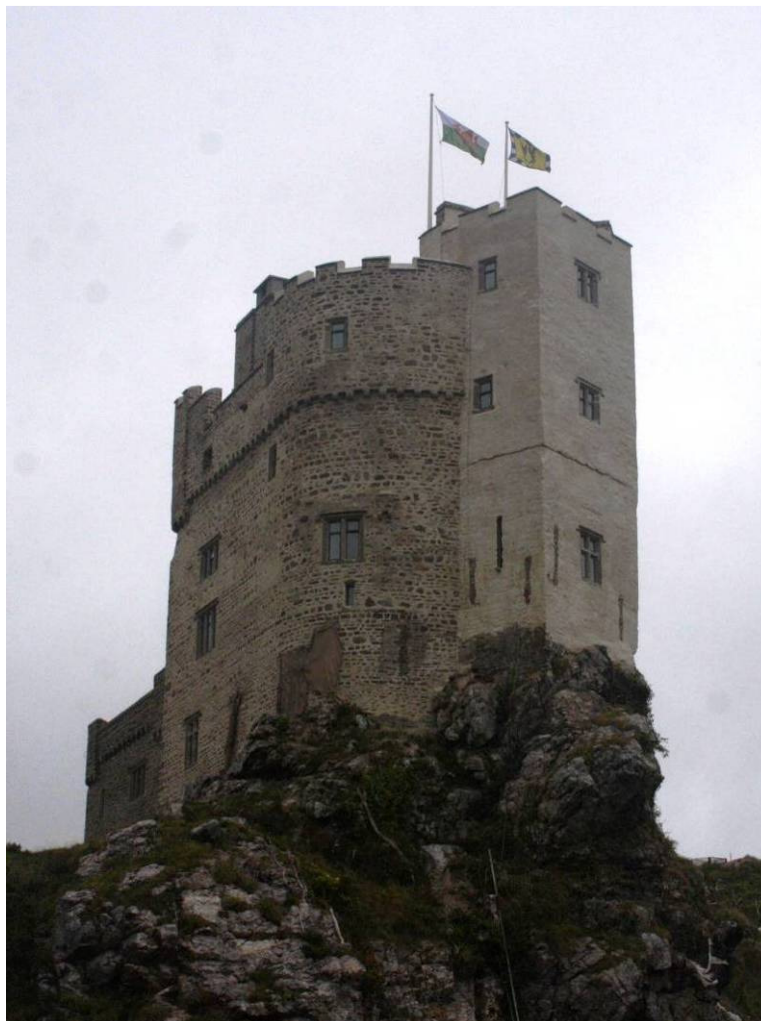
The southwestern elevation comprises the curving wall of the original D-Shaped Tower and the later Square Tower (Photo 84). Illustrations and photographs indicate that this was the most intact part of the original structure and all but the upper parts would be of medieval date (although with re-facing and re-pointing associated with the 1900s and recent renovations).

The small window light serving the southwestern end of the Basement Level can be seen below the main window, in the southwestern wall of the First Floor. This is an original window opening. A second feature lies to the east of the larger window, which has the appearance of a waste chute from a garderobe. The probable location of stone stairs within the curve of the wall above this point (noted at Second and Third Floor Level) may indicate that garderobes were also incorporated within the walls next to the stairs (a common location), although no clear structural evidence was revealed within the building. The Square Tower is built directly upon the highest part of the rock outcrop.

Photo 84: Southwestern elevation of Roch Castle September 2011

On the exterior of the southwestern curve of the castle a waste chute is visible, adjacent to and just above the southwestern window opening at first floor level (Photo 84). This was presumably from a garderobe which would have been present at the original second floor level of the D-Shaped Tower. No clear evidence for how it was accessed was visible on the interior face of the wall due to later re-facing. A small window light just visible above the concrete floor in the room above could be the remains of the window to the garderobe lying directly below the projected stair curving to the upper level (Photo 67).

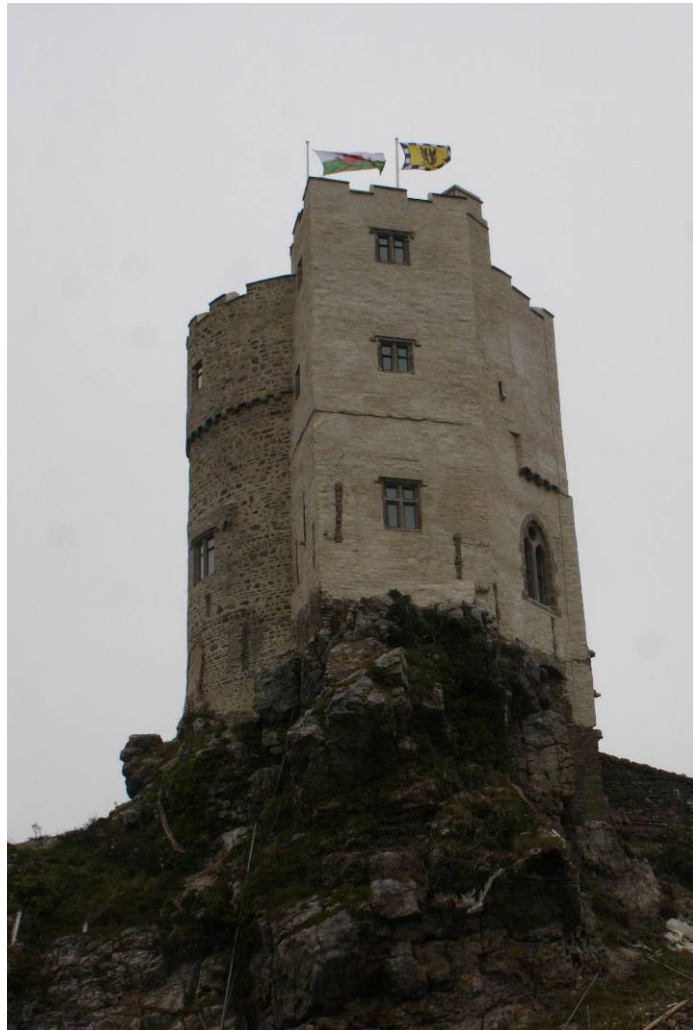
Photo 85: Southern elevation September 2011

The southern elevation (Photo 85) comprises the main facade of the Square Tower. Early photographs and illustrations indicate that this survived relatively intact. The windows within this southern elevation correspond with original window locations, although they have been remodelled and rebuilt.

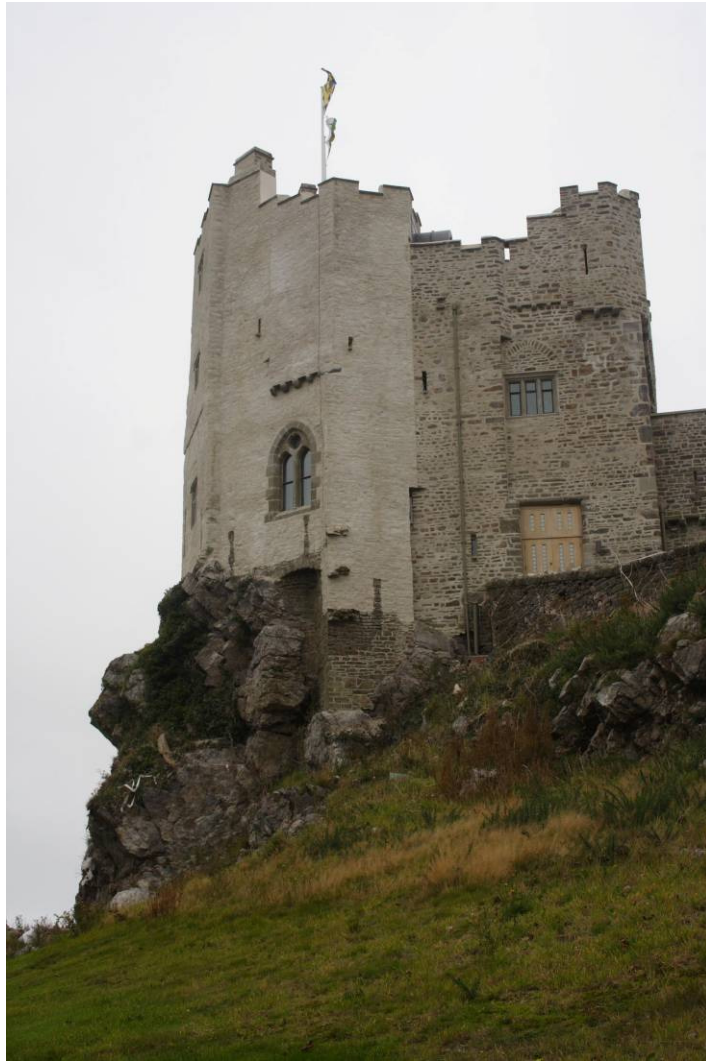
Early photographs and illustrations indicate that the eastern elevation had survived in a poor state of preservation before the 1901-1904 renovation, with a large void in the wall at the first floor and in the area of the existing castle entrance, as well as significant disturbance to the upper levels of the castle. The facade was substantially repaired and remodelled.

Photo 86: Eastern elevation (September 2011) showing Stair Extension and part of D-Shaped Tower

Also present on this elevation are three sets of projecting stones to the right of the relieving arch which are those as described by Clarke in 1865 which are thought to indicate the intention of a further wall projecting off from the main castle. No evidence for a projecting wall ever having been built has been revealed. It is possible that these stones were associated with the construction of the Stair Extension, as supports for scaffolding or ladders. They may have been left for to facilitate later repairs.

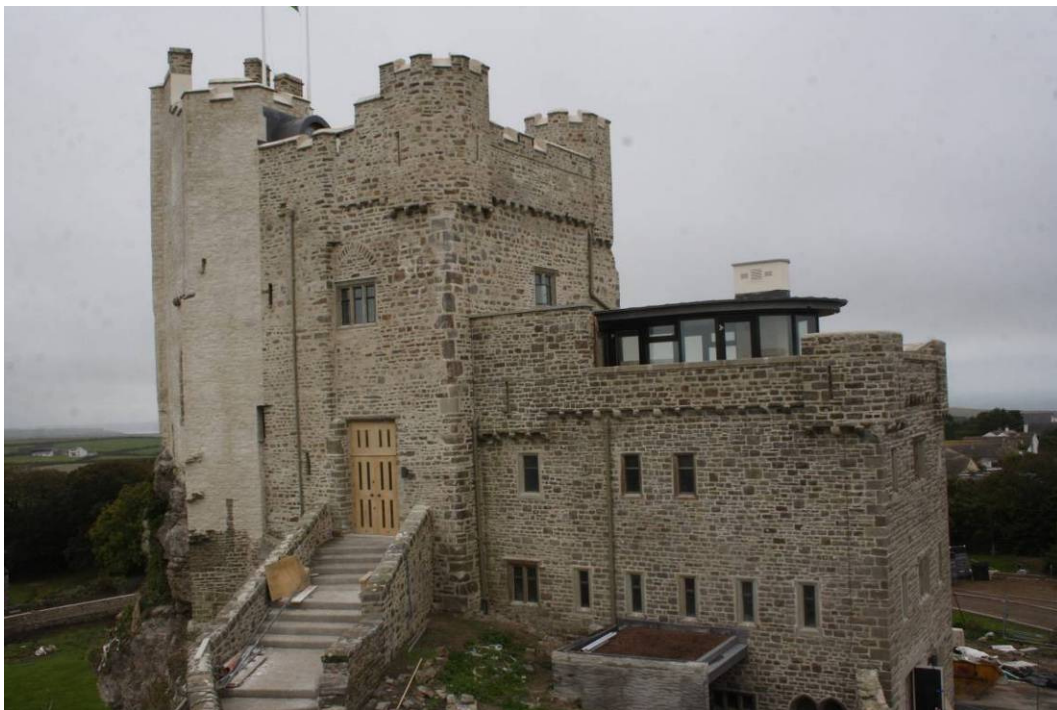
Photo 87: Eastern elevation (September 2011) showing main entrance and stairs and Northern Extension with new D-shaped construction on top

Above the Northern Extension roof, the D-Shaped Tower facade has the two turrets visible and the corbel course around the base of the parapet wall (this can be seen obliquely on Photo 87). A central window is that seen on the northern wall of the northern room of the Second Floor of the D-Shaped Tower.

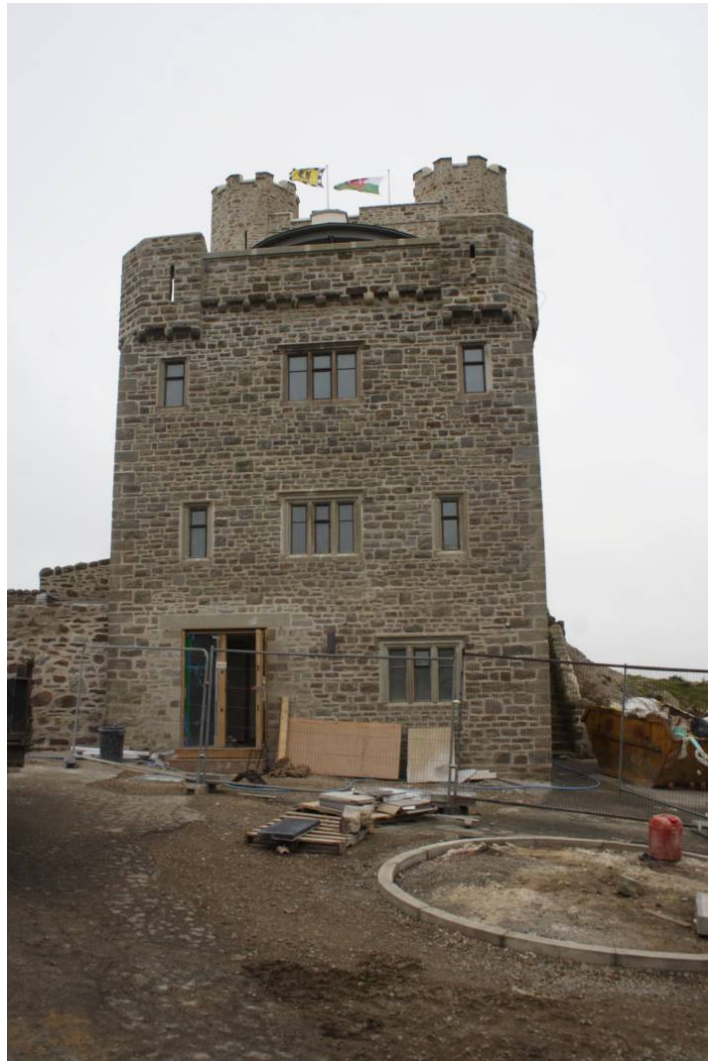
The northern facade of the Northern Extension has been constructed to mirror that of the earlier castle behind (Photo 88) with upper corbel course and imitation turrets at the corners.

Photo 88: The northern elevation showing Northern Extension with turrets of D-Shaped Tower just visible above (September 2011)

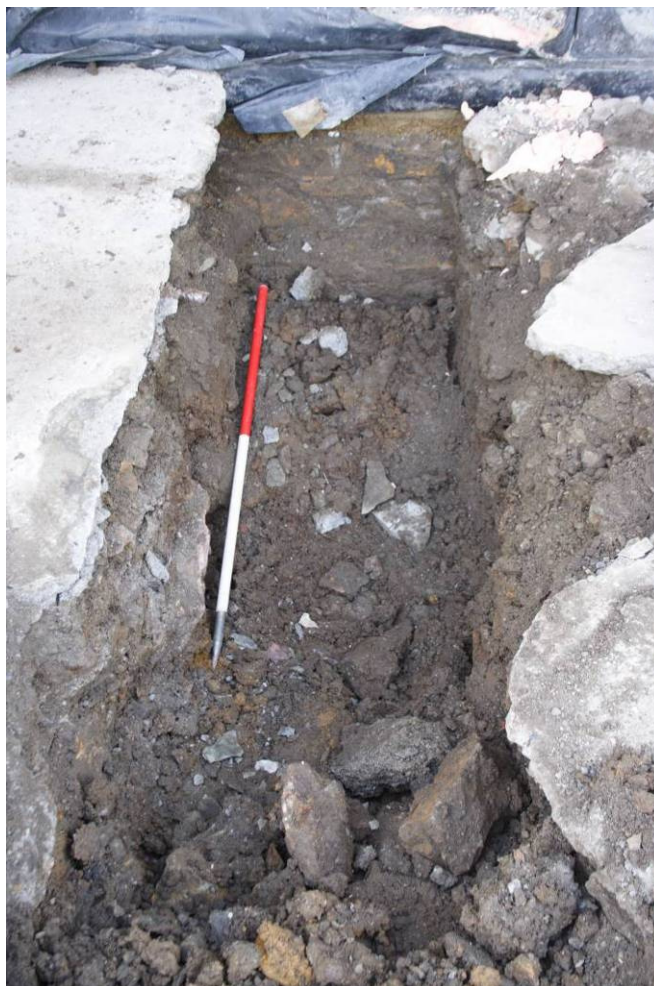
In the area closest to the Northern Extension a depth of made ground was observed which contained late 19th century and early 20th century debris within it (Photo 89). The ground may have been raised to create a level area outside of the Northern Extension both for the later driveway and also to assist with its construction. The nature of the debris within the soil would indicate that material had been imported onto the site (there would be no reason for debris of this date to be at the castle prior to its restoration). Such material may well have also been used in the construction of the ascending external stairs to the entrance doorway on the eastern side of the castle (as exists today).

Photo 89: Service trench excavated directly outside of the entrance on the northern end of the Northern Extension (footing of wall at top of photo)

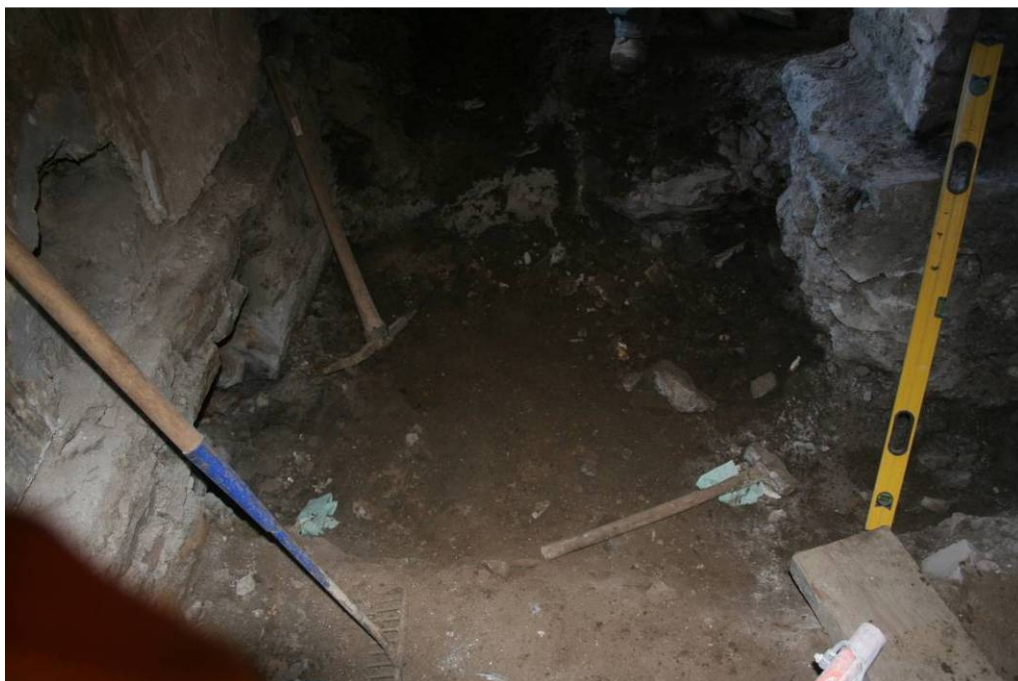
The floors within the base of the Northern Extension were removed in order that they could be replaced. The floors and associated make-up were in places 0.8m in depth, comprising rubble stone lower levels with subsequent concrete screed and floors layers above (Photo 90). It is probable that the floors had been resurfaced on a number of occasions. In places the bedrock was much higher and the floors were laid directly upon it. This was more evident in the southern part of the extension. A dark loose silty soil was present under many parts of the flooring. It is possible that this may be the original soil surface that was present before the Northern Extension was constructed, although no finds were recovered from the soil to provide a date.

Photo 90: Excavation through floor levels below Northern Extension showing depth of make-up (not bedrock at top of photo)

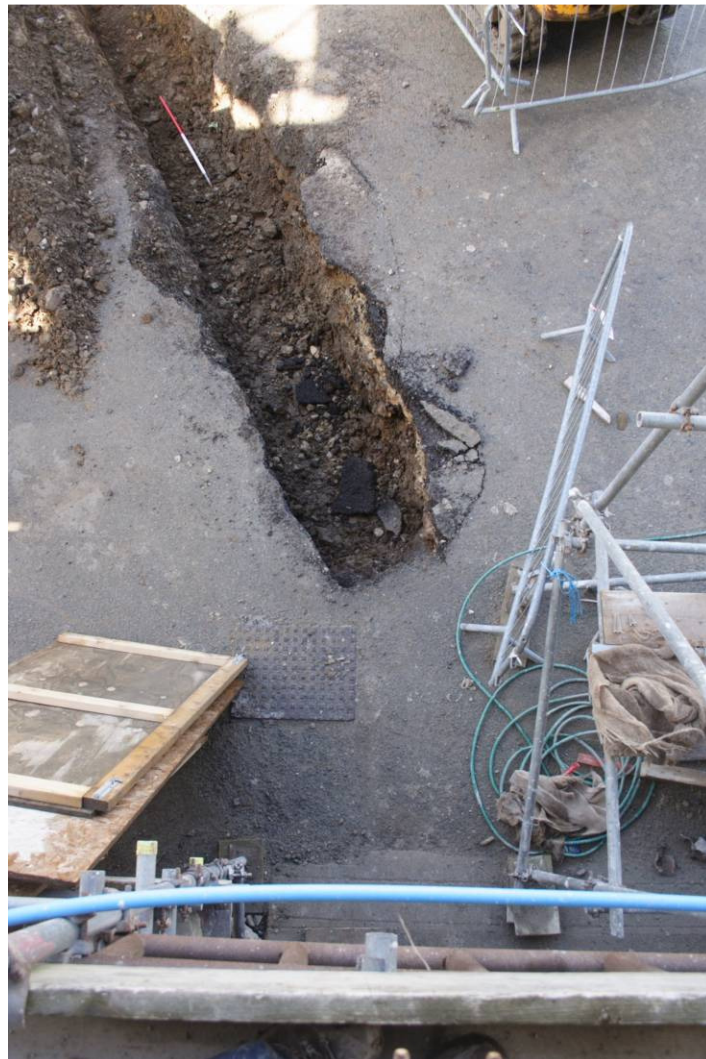
A number of service trenches were excavated across the driveway and around its perimeter. The majority of these trenches were shallow at less than 0.50m depth. The trench excavated across the northern part of the driveway (Photo 91) revealed no archaeological deposits, the trench not deep enough to penetrate through the make-up layers of the drive. The driveway had evidently been resurfaced and repaired a number of times.

Photo 91: Service Trench across northern part of driveway
