**ROCH CASTLE,
PEMBROKESHIRE
(SM 8803 2121)**

**HISTORIC BUILDING
RECORDING AND
ARCHAEOLOGICAL
INVESTIGATIONS**

RHIF YR ADRODDIAD / REPORT NO. 2011/26
RHIF Y PROSIECT / PROJECT RECORD NO. 100723

March 2012

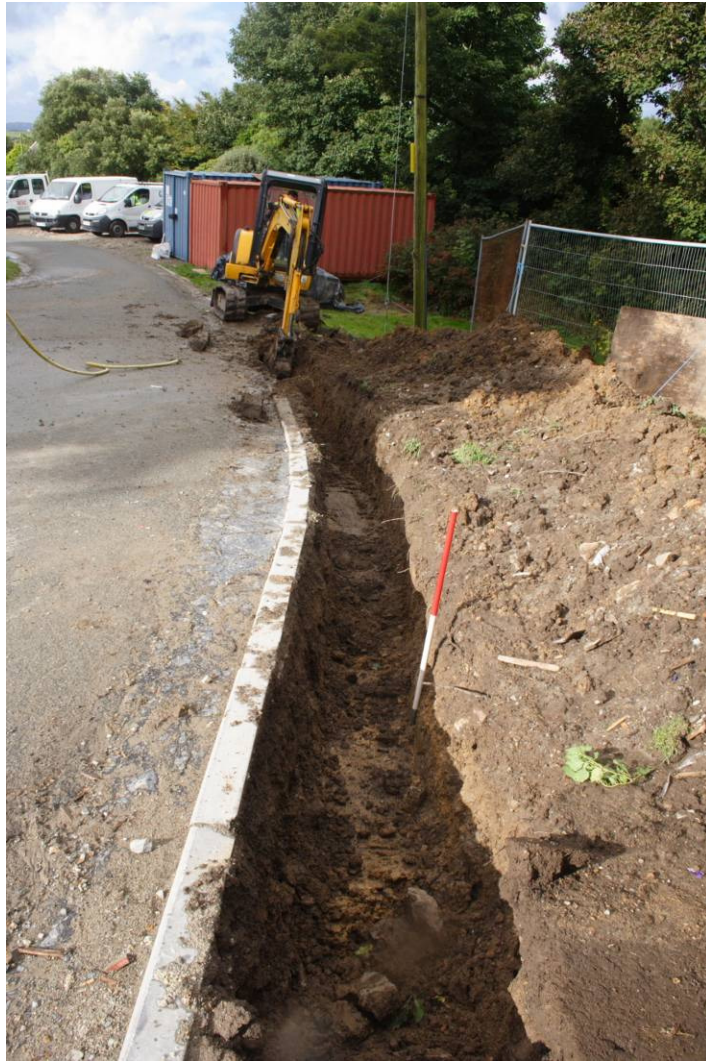
The service trench excavated around the northern edge of the driveway was outside of the former tarmaced area and cut through topsoils and subsoils (Photo 92). The topsoil was a very loose, dark reddish brown, humic soil of around 0.30m depth which lay above a yellowish brown subsoil containing fragments of weathered bedrock. This subsoil appeared to be undisturbed natural ground. The only finds recovered from these trenches were of 20th century date lying in the topsoil. It is considered possible that the area was landscaped, possibly when gardens were laid out for the castle in the early 1900s. This is suggested by the complete lack of finds of any earlier date, although it should also be noted that the trenches were only of around 0.50m width and represent a very small sample of the overall area.

Photo 92: Service trench around perimeter of driveway

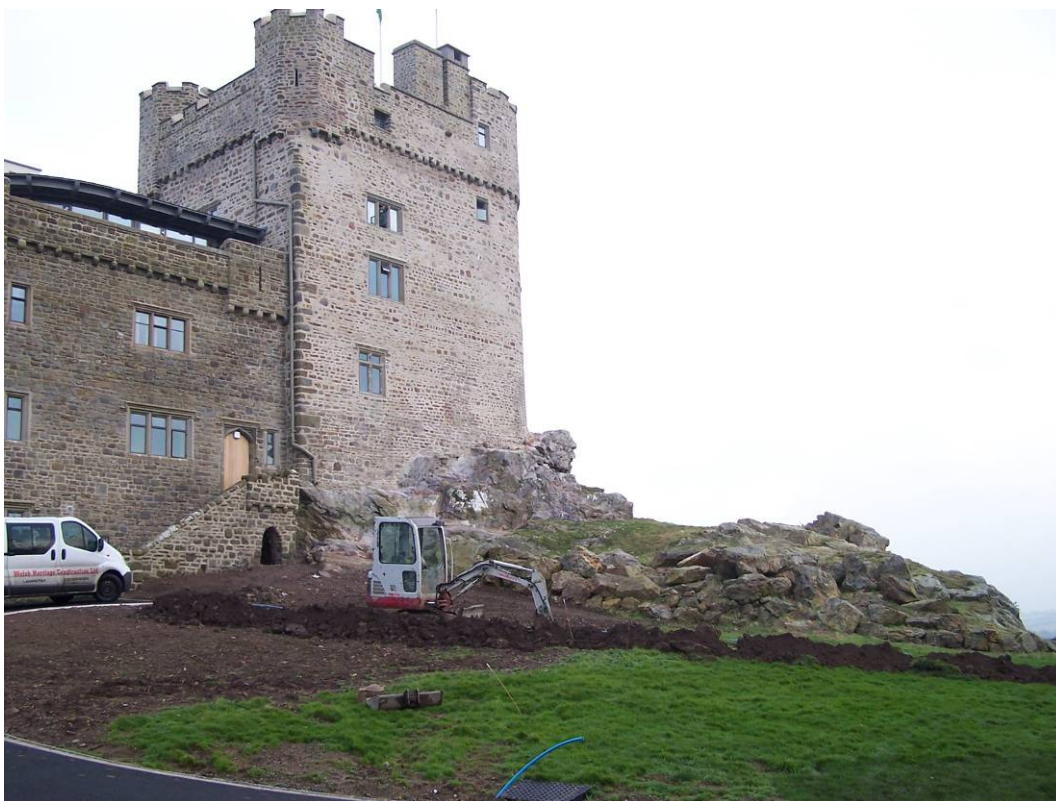
A service trench excavated on the western side of the castle between the northern part of the driveway across a lawned area back to the drive further down slope indicated a different make up of soils (Photo 93). The trench was excavated along an earlier 20th century water pipe, which had previously disturbed the ground surface for the majority of the length of the trench. At its northern end it was close to the exposed outcrop of rock on which the castle sits. A number of loose and angular fragments of broken bedrock were present in the topsoil, which was around 0.5m deep in the end of the trench nearest the castle. The rock fragments were very angular and had the appearance of being more recently broken (ie. not associated with the medieval construction of the castle) and presumably originate from levelling associated with the 1900s construction phase. Nearer to the castle, the topsoil contained fragments of brick, ceramic material and modern detritus indicating it derived from a mix of the 1900s phase of construction and also more recent building work (the area was used as a temporary car park during this phase of renovation). As the service trench ran down slope the topsoil became shallower and contained far less modern material.

Photo 93: Service trench excavated across lawned area to west of castle with rock outcrop behind

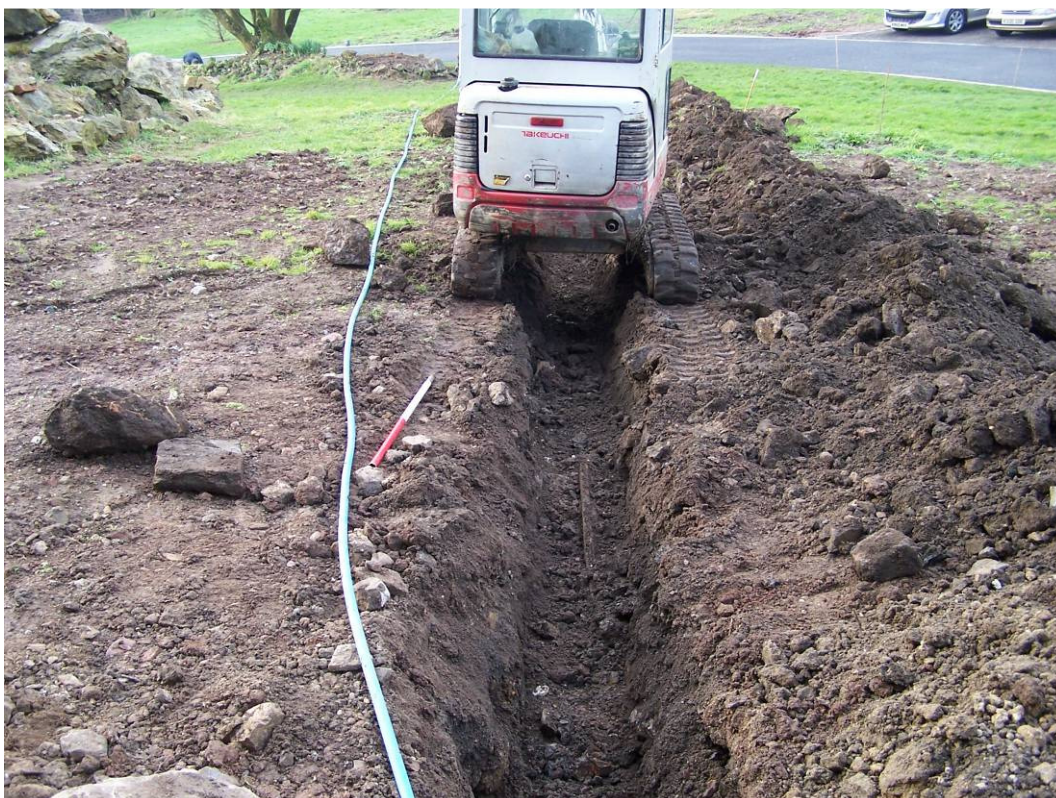
Photo 94: Service trench excavated across lawned area to west of castle (viewing southwest down-slope)

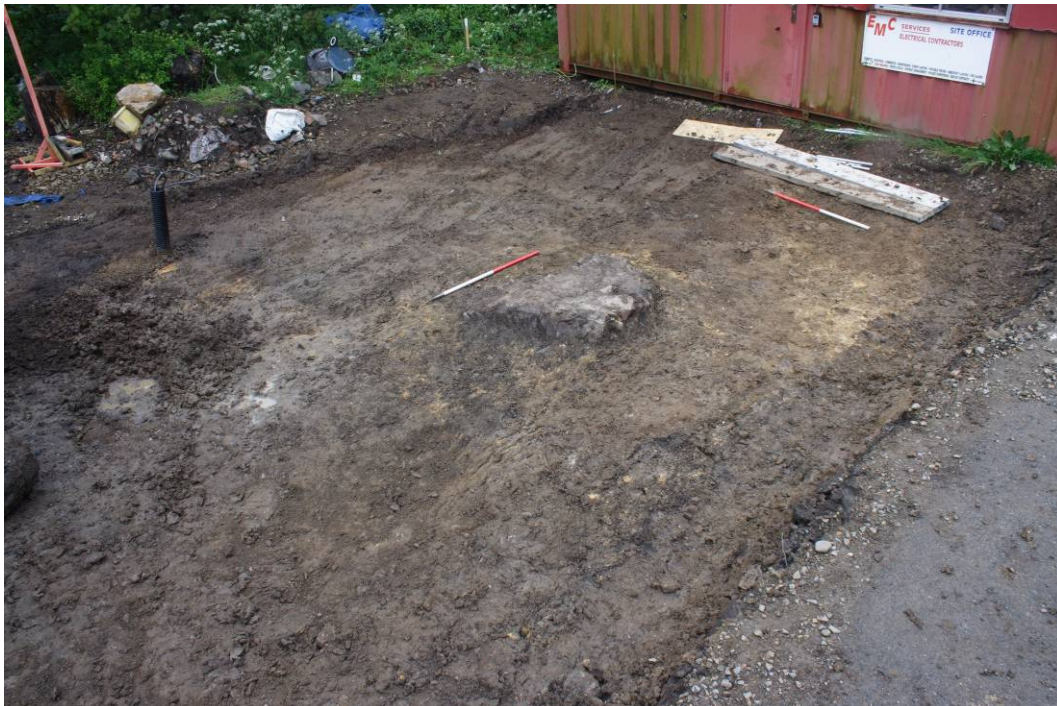
A car parking area was also constructed to the west of the driveway which involved a topsoil strip across its footprint (Photo 95). The topsoil strip was undertaken under full archaeological supervision. Following the discovery of a large piece of possible stonework within the trench and possible associated features a second archaeologist assisted with the work and the area was hand cleaned and surveyed. The stonework was revealed to be a large outcrop of bedrock, and the nearby features a mix of remains of vegetation (root holes for trees and shrubs) and hollows in the underlying bedrock. No finds or features of archaeological significance were revealed within this area.

Photo 95: Car Parking area following topsoil strip showing outcrop of bedrock

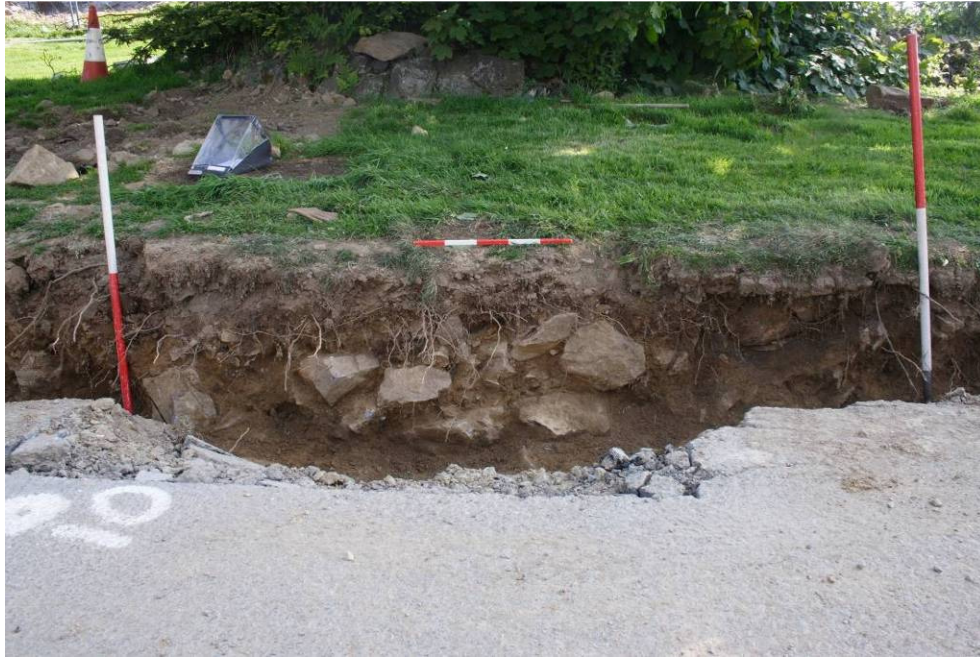
Photo 96: Area of accumulated rock within kerb trench

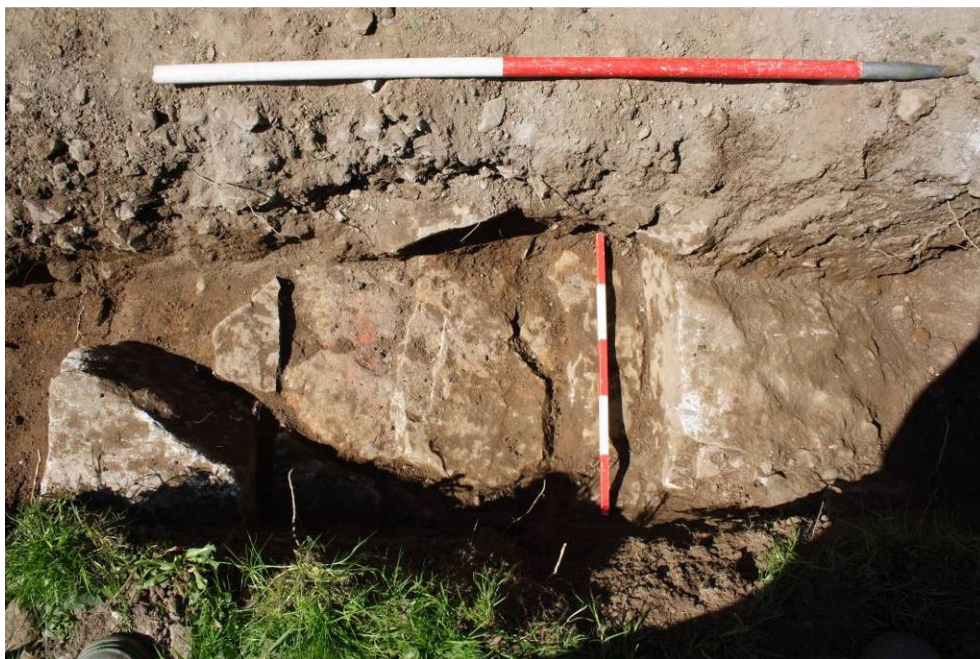
Photo 97: Probable wall within eastern kerb trench at southern end of driveway, plan view taken from western side

The feature comprised a large stone block to the south which rose 0.20m from the base of the trench, and a large broken stone forming the central part of the feature (Photo 97). A further stone block was found to the north after further excavation, again rising slightly from the trench base. The feature measured 1.4m in width and was visible crossing the trench, but was not present in the kerb trench on the eastern side of the driveway. The feature is thought to represent the remains of a large wall of uncertain date. No finds were recovered from the area and no bonding material was recorded between the stones.

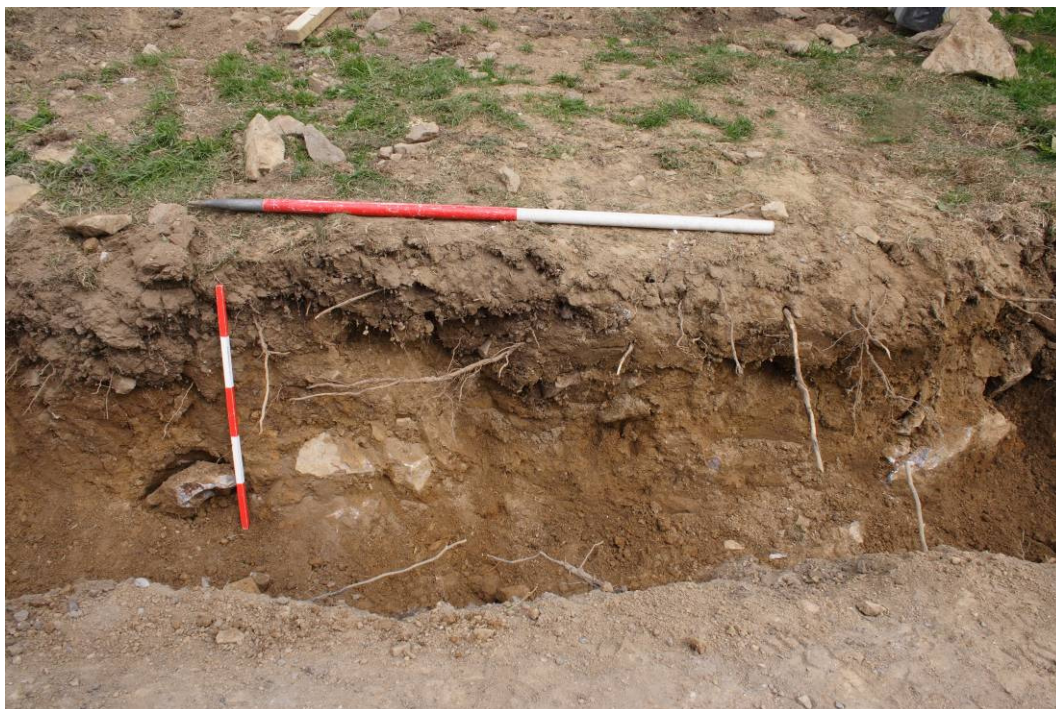
The remainder of the kerb trenches were devoid of archaeology, and comprised a shallow topsoil on top of a yellowish brown natural subsoil with decayed and broken bedrock (Photo 99). Overall the extent of disturbance caused by the insertion of the kerbing was minimal (Photo 100), and was a far better methodology in terms of minimising archaeological disturbance, than a complete removal of the existing driveway surface and rebuild as was originally proposed.

Photo 99: Typical section of kerb trench with topsoil upon lower subsoil with broken bedrock

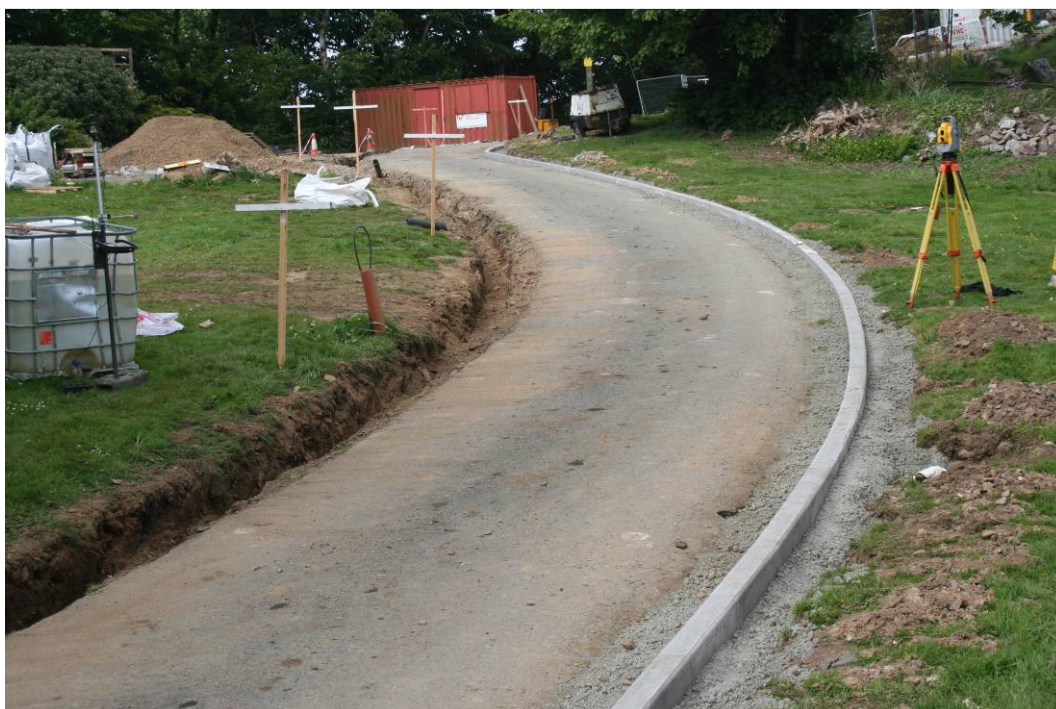
Photo 100: View north along driveway following insertion of kerbing along eastern trench, with western trench still open

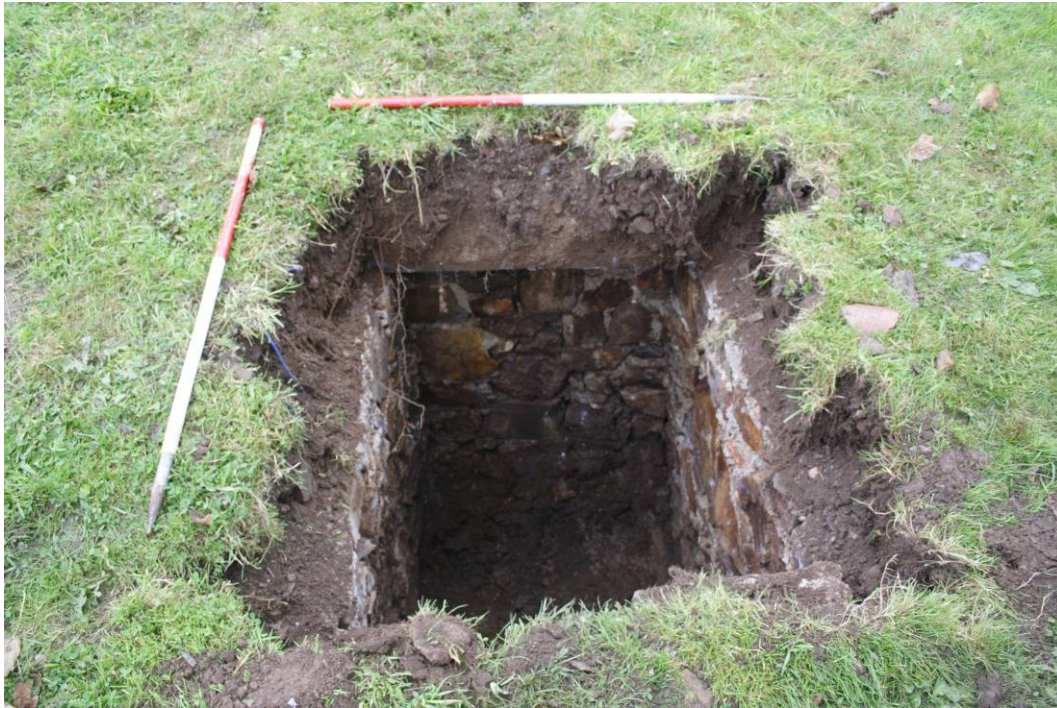
Photo 101: Stone chamber to east of castle from east

Following removal of collapsed material from within the chamber, it was possible to see that a modern ceramic drain pipe fed into its western side (Photos 101 & 102). The stone chamber was bonded with concrete and had a few brick inserts in as well. It measured 0.9m north to south by 1.1m east to west and was 1.3m in depth. The base of the chamber was directly onto underlying subsoils and bedrock. It could be seen that a drain pipe on the rock outcrop that formerly connected to pipes from the castle, projected towards this chamber (Photo 103). It is presumed that the feature is a soakaway of early 1900s date associated with water management at the castle. It is very likely that other such chambers lie within the grounds close to the castle.

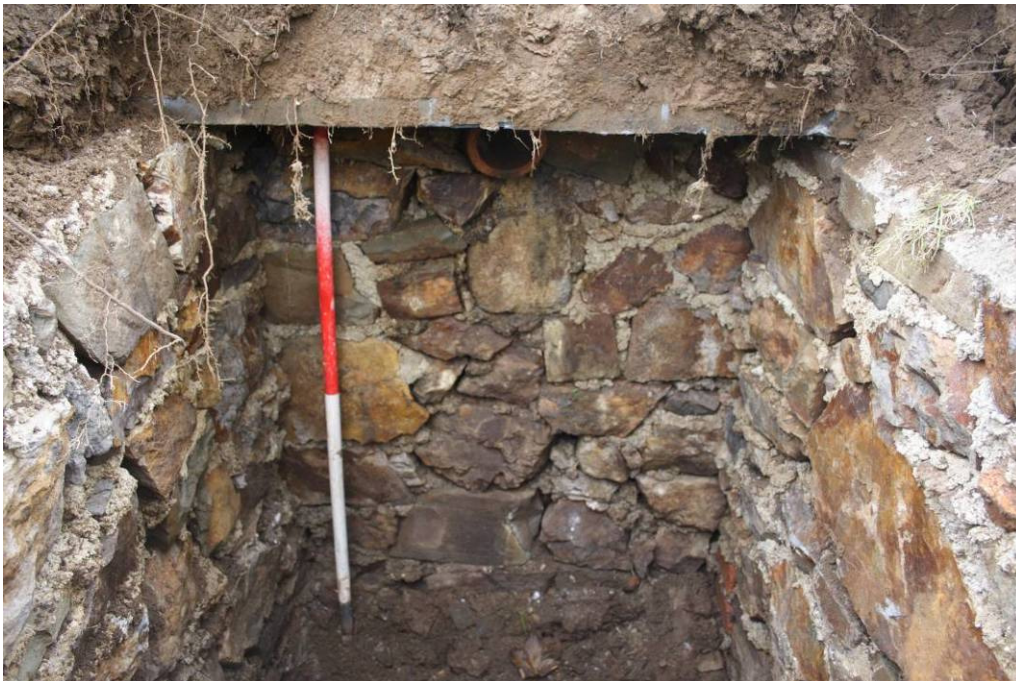
Photo 102: Stone chamber to east of castle showing drain pipe on western side

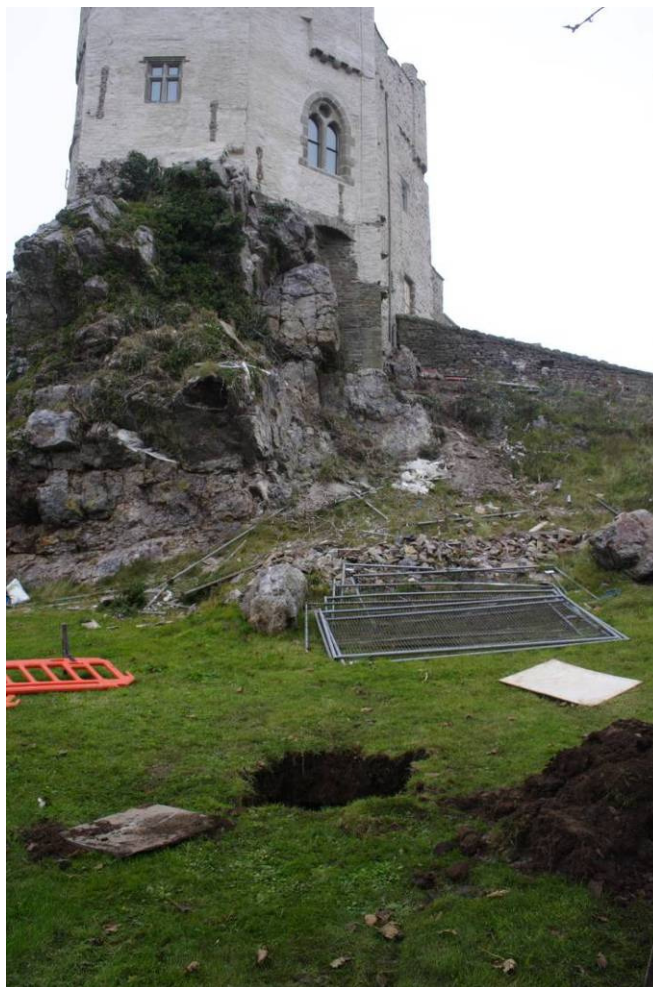
Photo 103: Location of stone chamber with castle behind
(note drain pipe on side of castle in line with the chamber)

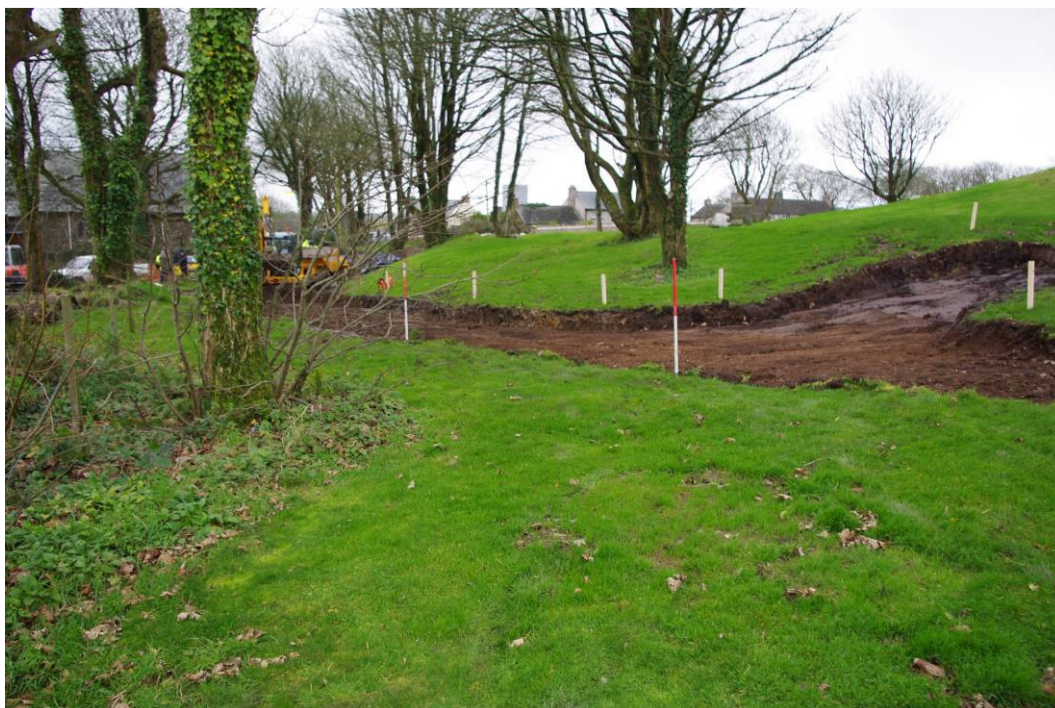
The driveway mostly followed the line of the moat around the castle (Photo 104), and it is presumed that the post-medieval pottery recovered from the stripped surface represented material that had been backfilled into the ditch. The area stripped closer to the roadway, and clearly over the top of the backfilled moat, comprised a mix of very damp dark clay soil (Photos 105 & 106).

Photo 104: View southeast across driveway showing raised ground on the inside of the moat

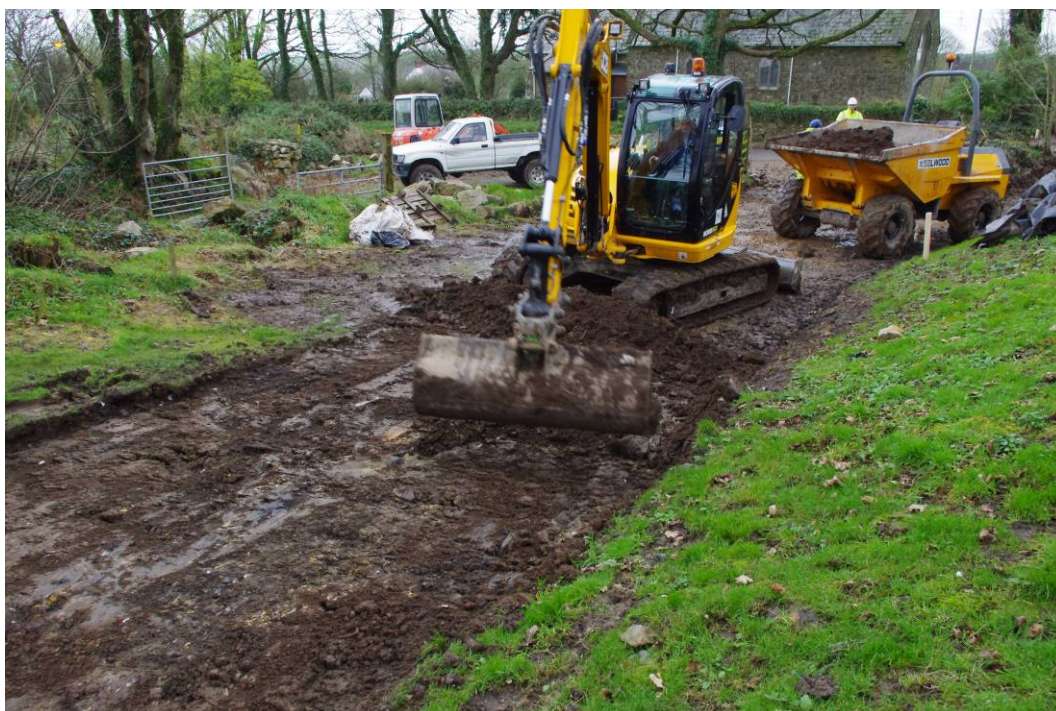
Photo 105: Topsoil stripping of driveway at southern end, viewing southeast with St Marys Church behind (note dark soils revealed)

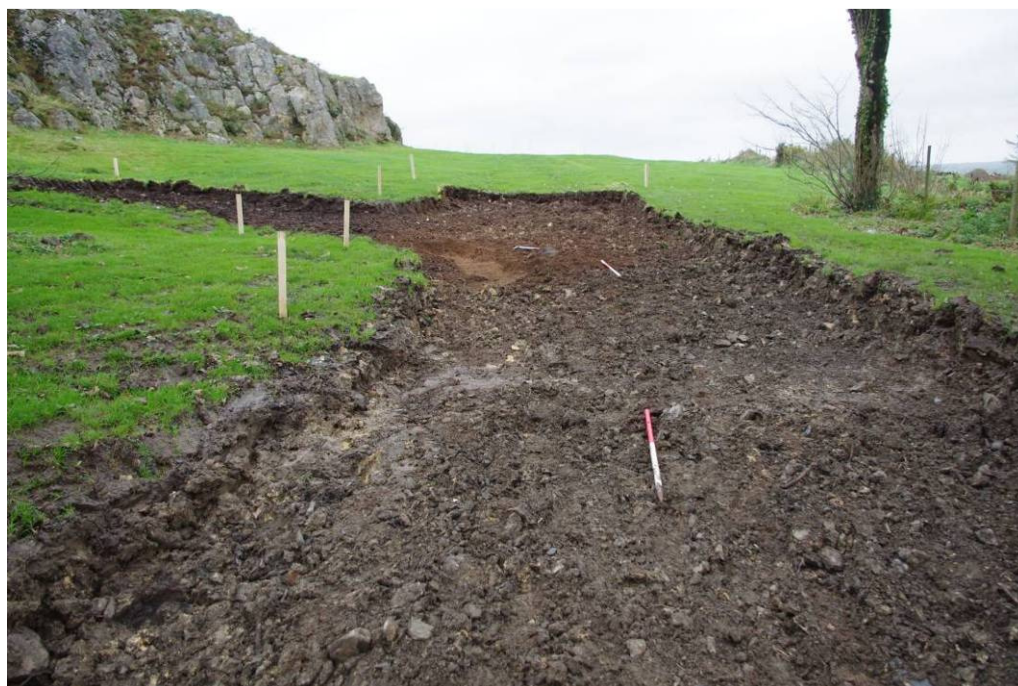
Photo 106: View north of northern end of driveway with turning area to west, showing darker soils to south and lighter brown material to north

At the very northern end of the driveway bedrock was encountered as would be expected on the rising ground heading up to the outcrop to the northeast of the castle (Photo 106). At the western end of the turning area (small spur of driveway heading towards the castle) an irregular shaped feature was revealed which contained rotting vegetation, branches and organic matter. The feature was not investigated further as it was seemingly of quite recent date and may have contained human waste. Although probably originating from a modern cess pit, the feature was not itself a cess pit, perhaps a dump of material removed from an overflowing or blocked cess pit, on top of which vegetation and garden waste was dumped in an attempt to mask the smell or provide a temporary cover.

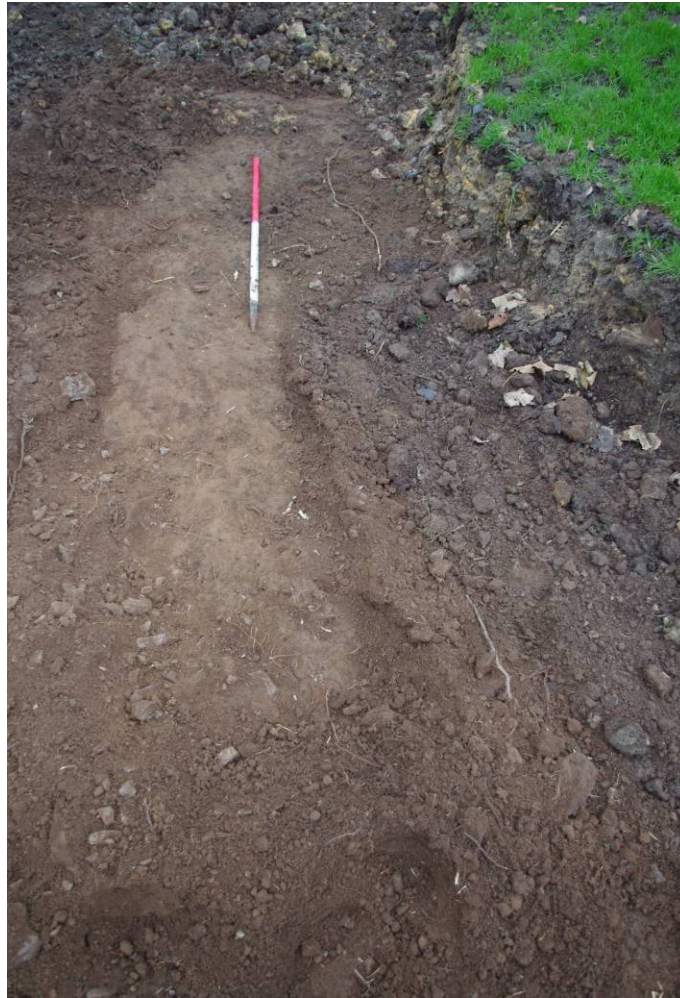
At the northern end of the driveway its alignment left the moat and crossed the probable embanked area on its western side (inside of the bailey). The soils here did not appear to be directly onto natural ground, but the suggestion of embanked soil comprising a fine and compacted reddish brown soils. This would indicate a raised earthwork bank was formerly present inside the moat (Photo 107).

Photo 107: Area of fine and compact soil indicating a possible bank on the inside of the moat, with darker soil of moat to top of photo (viewing south)

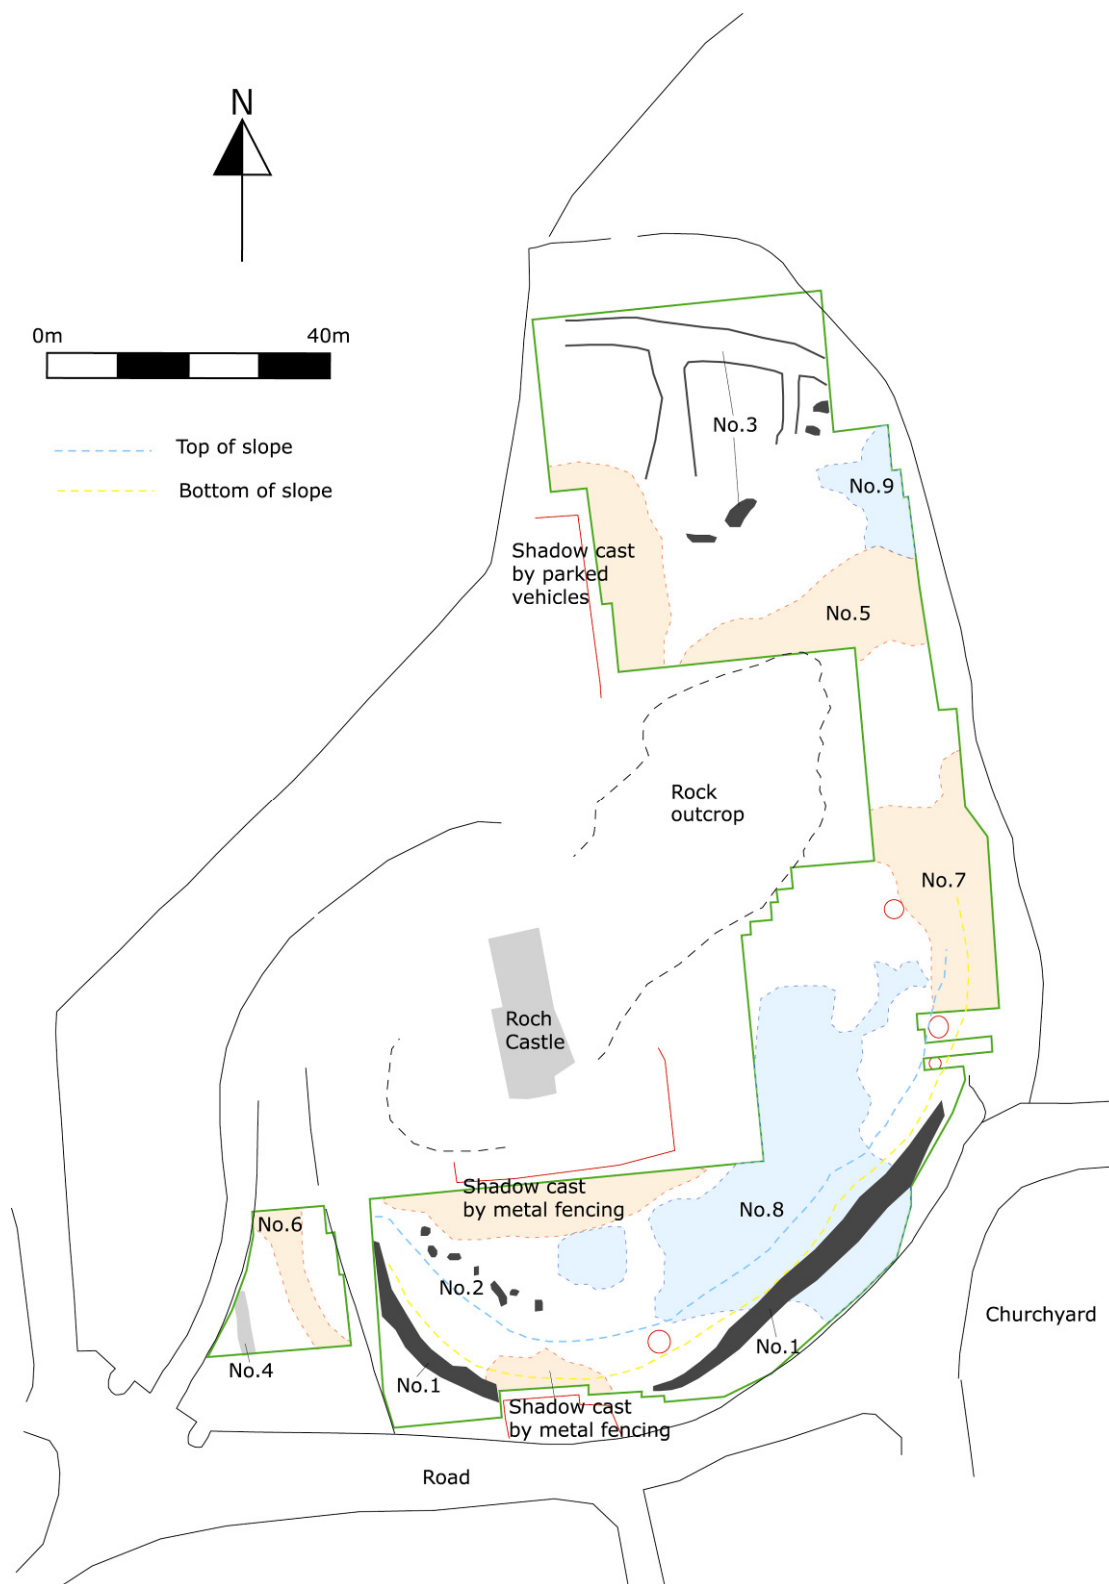
A further series of these more discrete individual areas of magnetically positive responses runs along the inside of the edge of the moat on raised ground for a distance of c.20m. Such readings may be indicative of a series of pits or large postholes. Their location at the top of the slope may indicate a connection between the two, possibly associated with an inner line of defences such as a timber palisade. Such a palisade could be either of medieval date, or even potentially associated with Civil War refortification of the castle. The size of these anomalies, if the posthole theory is correct, is far larger than would be needed for a simple stock proof fence.

Figure 10: Interpretation of geophysical survey results, overlaid with local topographical detail. The survey area is outlined in green, the numbers refer to the geophysical interpretation' below

At the northern end of the site are a series of rectilinear anomalies, represented by areas of magnetically negative readings flanked by magnetically positive readings. Such readings are often found to represent buried banks, or possibly walls, flanked by ditches. Their rectilinear appearance is a strong indication that these are man-made features, representing enclosures with a suggestion of more disturbed ground within the enclosures. The current topography of this area is one of relatively flat ground enclosed by a field bank to the north and east, and a wall to the west. On the outer side of all these boundaries the ground drops away sharply on to lower ground (the possible outer bailey lies to the north of this). This line is considered to be a continuation of the castle moat visible to the south indicating a possible enclosed second area to the north of the castle. Their location hints at the possibility that these enclosures could be associated with settlement activity and division of land within the inner castle bailey enclosed by the moat. However, they may also be unconnected features, such as later field boundaries or enclosures. These features do not appear on any earlier mapping and so are most unlikely to be later than 1700.

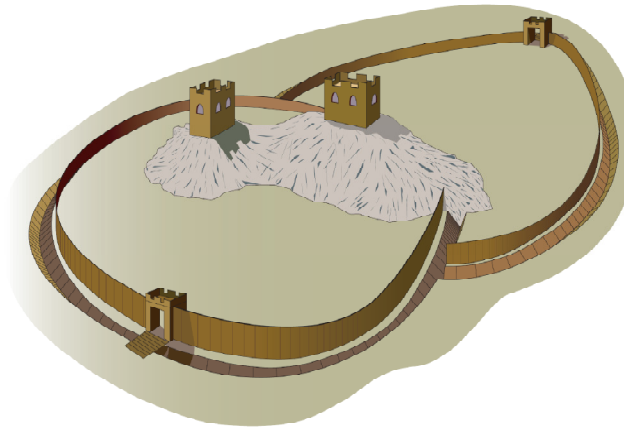
There is no obvious earth mound at Roch, suggestive of a man-made motte. The area of the roundabout in the driveway to the west of the castle suggests a slight rise in the ground level although this may be a natural topographic feature caused by the underlying geology as opposed to a man made earthen mound. The rocky outcrop to the northeast of Roch castle is a more regular dome shaped features than that on which the present castle is built. It is conceivable that a timber tower was present on this outcrop, which may have, with rock cut postholes, although to-date no such features have been identified. This outcrop is the more level of the two and perhaps would have been the first

Figure 11: Possible layout of
Phase 1: Early 12th Century - Earth and Timber phase

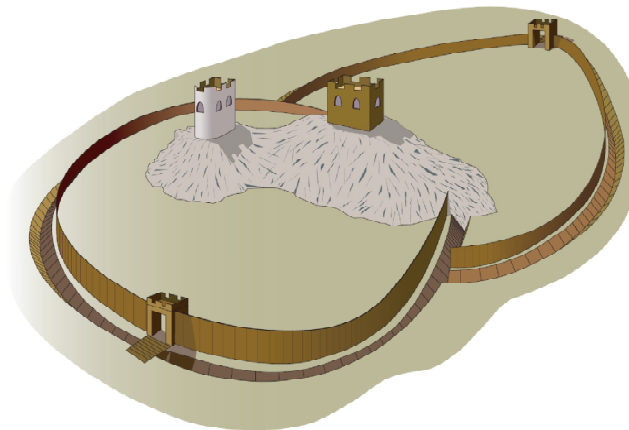
Figure 12: Possible layout of
Phase 2: c.1200 - D-Shaped Stone Tower and Wider Defences

This first stone tower would have had a primarily defensive role, but at the same time also indicating the status and strength of the owner. It would have been an imposing edifice, enhanced by the additional height of the rock on which it was built presumably as a deterrent to any Welsh offensives that may have been launched against it. In its defensive role, it would have been a stronghold or keep located within the centre of the wider castle defences (moated enclosure). It is possible that a second timber built stronghold was retained on

the other rock outcrop during the construction of the stone tower, to maintain the defensive function of the site. It is possible this other tower was retained.

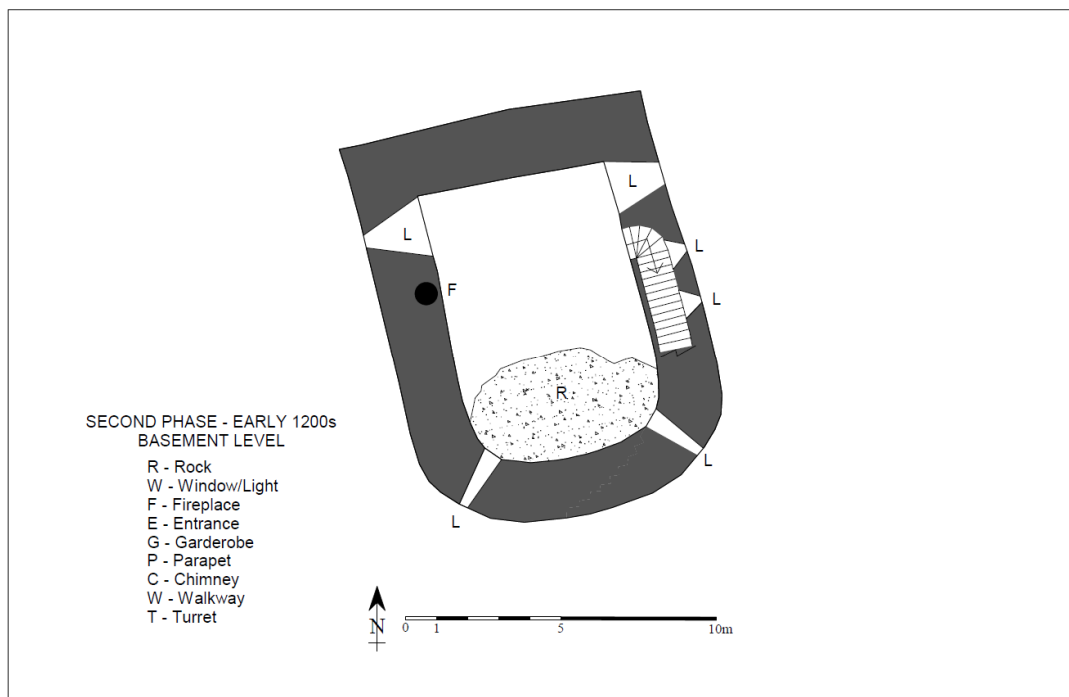
Figure 14: Basement Level of D-Shaped Tower c.1200

It is likely that the basement floor of the tower, within which lies the projecting rock outcrop (Photo 17) would have been used as a store room, and as is often the case with similar keep structures, and there may have been no entrance at the basement level (a short-term defensive measure). The presence of the exposed rock outcrop would certainly suggest that it would have had a utilitarian function as opposed to a state room or as chambers. The basement contains a single surviving window light at its southwestern end within the curve of the wall (Photo 16). The opening of the light is much higher and narrower than the bottom part of the window splay. This is a typical defensive form of window opening, the splay providing as much light into the room as possible from a small window opening. A fireplace located on the western wall may have utilised an original chimney flue, as a number are present within this wall in the floors above.

The window openings at the northern end of the basement to the west (Photo 20) and the two on the northern wall flanking the later entrance through to the northern extension (Photos 18 & 19) are all large openings. The sides of the windows are straight and not splayed, maximising light entering the room, but minimising security. It is considered that these are later openings when the defensive role of the castle has become of lesser importance. It is possible they are adaptations of earlier openings, but there is no evidence to confirm this. The doorway opening on the eastern side of the basement is a far later insertion.

The basement appears to have been accessed via stairs that ran through the wall on the eastern side of the D-Shaped Tower, although the layout was changed with the construction of the later Stair Extension. The two windows rising up the stairs are splayed suggesting an early date, although the lower would seem to be contemporary with the later Stair Extension (Photos 23). The upper window has a much deeper splay, indicating a wider wall at this point and perhaps suggesting it is an earlier window modified with the construction of the Stair Extension. There is no indication of a stair on the western side of the basement, so it is assumed that the stair was on the eastern side, but modified at a later date.

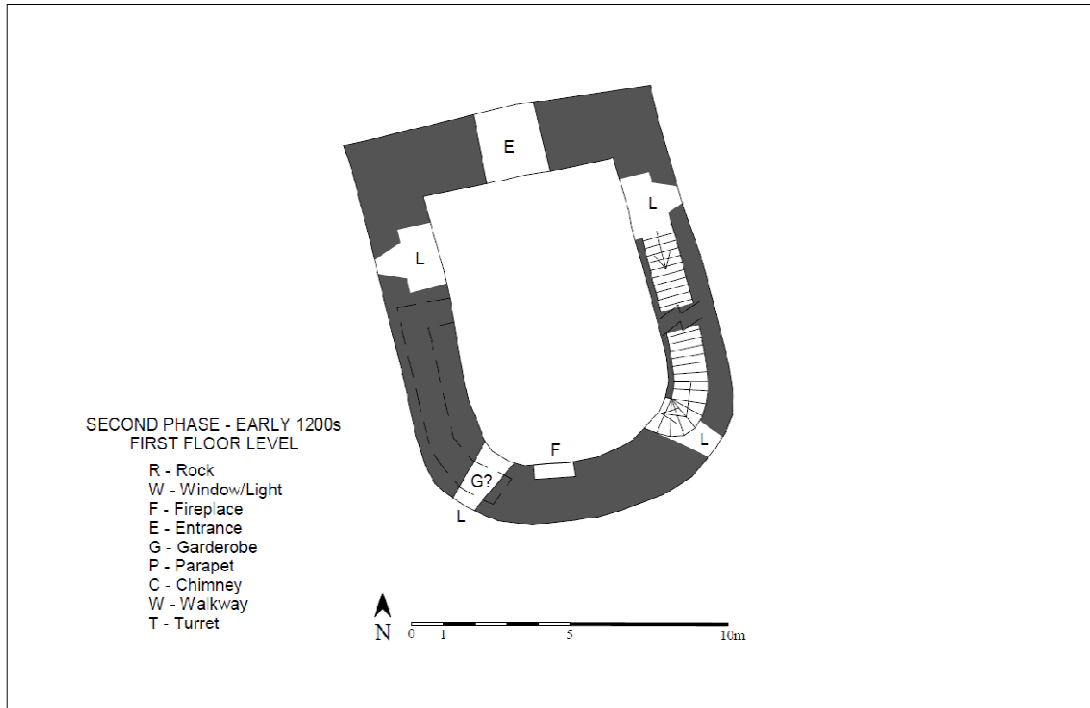
Figure 15: First Floor Level of D-Shaped Tower c.1200

As noted in the discussion, the first floor level was lowered during the 1900s restoration. The original floor level would have been located at the base of the window in the southwestern curve of the tower (Photos 30 & 33), the base of the adjacent recess (Photos 31 & 33) and the cill of the window to the west (Photo 25). The 1857 description of the castle suggests a vaulted stone floor was present at the first floor level, although this is not noted by Clarke (1865). All evidence for the floor construction has been removed by the 1900s renovations, with the inner face of the wall having been largely rebuilt where the evidence would have been. Perhaps this rebuilt face may have been necessitated by the removal of vaulting stonework projecting from the walls at this level?

The first floor would have contained the Great Hall. The window openings at this level have again all been altered, although that in the southwestern curving wall may be largely original (Photo 30). It is slightly splayed and the stepped arch above either indicates a construction method necessitated by the curved wall, or could alternatively be evidence for alteration at a later date, or a garderobe passage. The three windows to the west south and north in the northern end of the first floor level have all been significantly altered both in the medieval period and during the 1900s renovations (Photos 25 to 28). It is probable that the window openings in the 1200s phase of the castle were splayed recesses to narrower openings for security and strength, which were later widened. A fireplace is present on the western wall utilising the flues on this side of the castle which may be original (Photo 29). The recess in the centre of the southern curving wall may also have been an original fireplace (Photo 31).

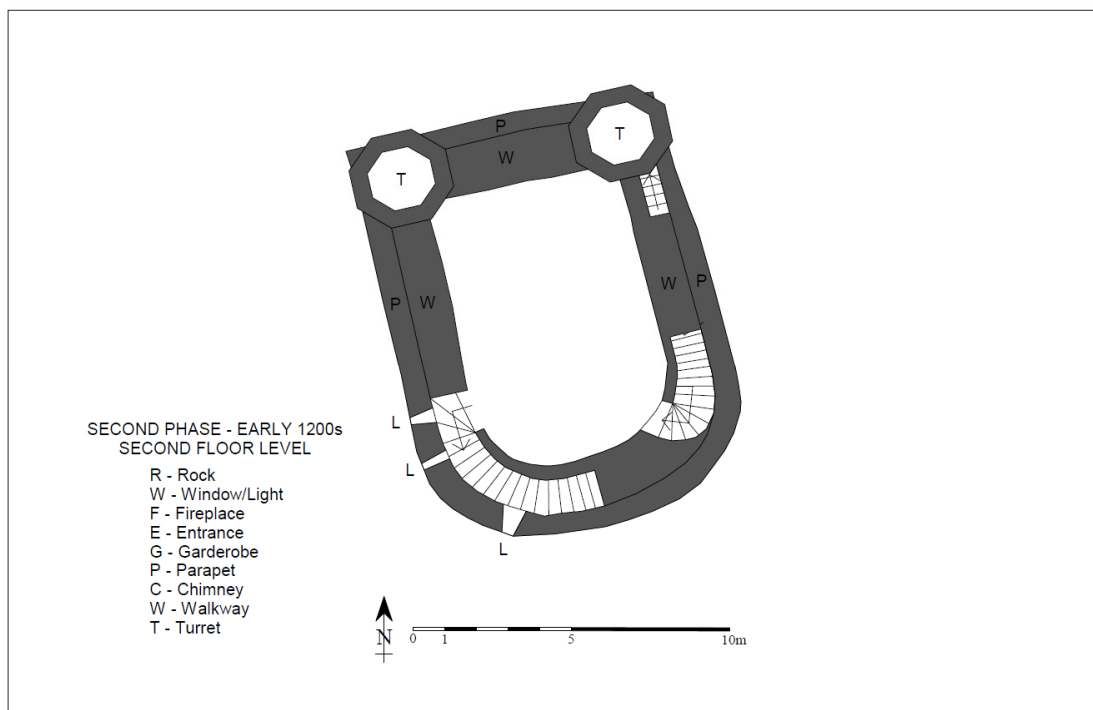
Figure 16: Second Floor Level of D-Shaped Tower c.1200

A second floor was present above the Great Hall accessed from the eastern stair. This was presumably divided into chambers and service apartments. The floor was probably constructed of timber as there is no evidence for any vaulting or large-scale rebuilding of the internal face at this level. It is considered that the floor level would have been located directly above the window arches as seen in the existing northern room of the second floor level (Photos 43 & 44; Figure 9). This would be very similar level to the ceiling within that room as exists today. Inconclusive suggestions of lug holes for timber rafters were present directly below the concrete ceiling during the building recording, but it was uncertain if these were associated with more recent ceiling materials.

The existing southern room of the second floor is at a slightly higher level than that to the north, although originally they would have been at the same level. The conjectured floor level projected from the room to the north would correspond roughly with the level above the corbels visible in the curving wall to the southwest (Photo 47). As noted above, it is thought that a stair was present in the western wall in front of the existing window opening, which curved around the southwestern side of the castle leading to an upper level.

The northern half of the second floor level would have been substantially stone built, but presumably with a timber superstructure, in a similar layout as is now present, with a walkway between the room and the parapet. To the south the stone walling is present to a higher level and may suggest a stone walled room with a timber roof.

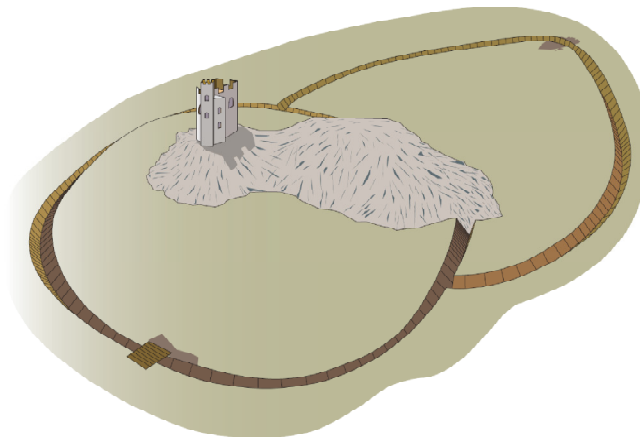
Figure 17: Possible layout of Post-1314 –
Addition of Square Tower and Stairs and Gentrification of Castle

At some point following the lightning strike in the 14th century significant repairs are made to the castle, remodelling the stairs on its eastern side and addition of the Square Tower to the southeast. The additions both clearly project from the original D-Shaped Tower, and the absence of the circuit of corbelling is also apparent.

As noted above, the Lower Level of the Square Tower was originally accessed via a curving stair leading into the northeastern side of the room, but which was blocked at a later date (Figure 17). The existing entrance from the existing First Floor level is a modern insertion. The floor of this room lies directly upon the top of the rocky outcrop (and subsequently re-floored with concrete). The roof was presumably ribbed and vaulted as survives relatively intact in the Middle Floor level, but which was rebuilt in this room in the 1900s. The windows in the room are all in the original locations although heavily modified.

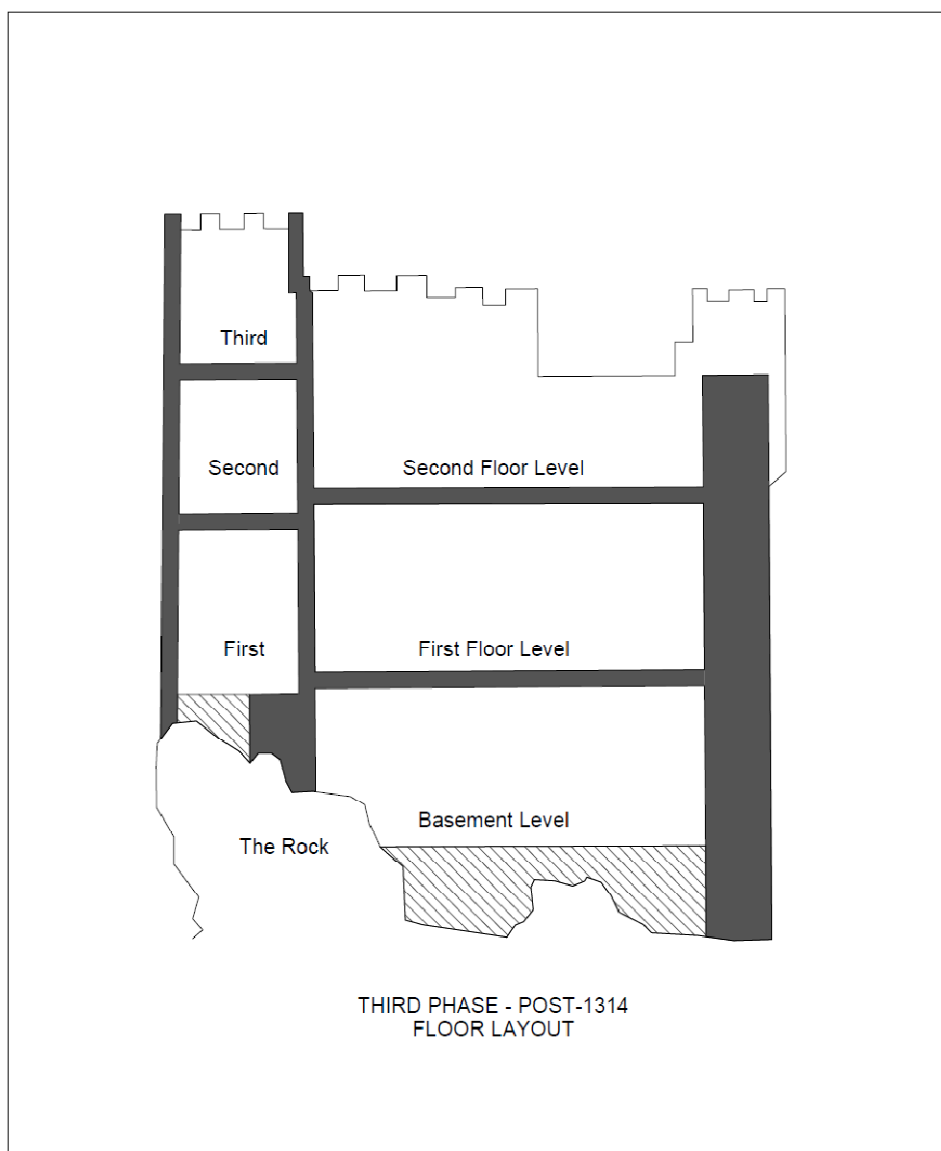
Figure 18: Floor Layout of Phase 3 of Castle Post-1314, north to south section

The Middle Floor level was also accessed via stairs from the Stair Extension on its northeastern side (Figure 18). The windows in this floor level are
