**ROCH CASTLE,
PEMBROKESHIRE
(SM 8803 2121)**

**HISTORIC BUILDING
RECORDING AND
ARCHAEOLOGICAL
INVESTIGATIONS**

RHIF YR ADRODDIAD / REPORT NO. 2011/26
RHIF Y PROSIECT / PROJECT RECORD NO. 100723

March 2012

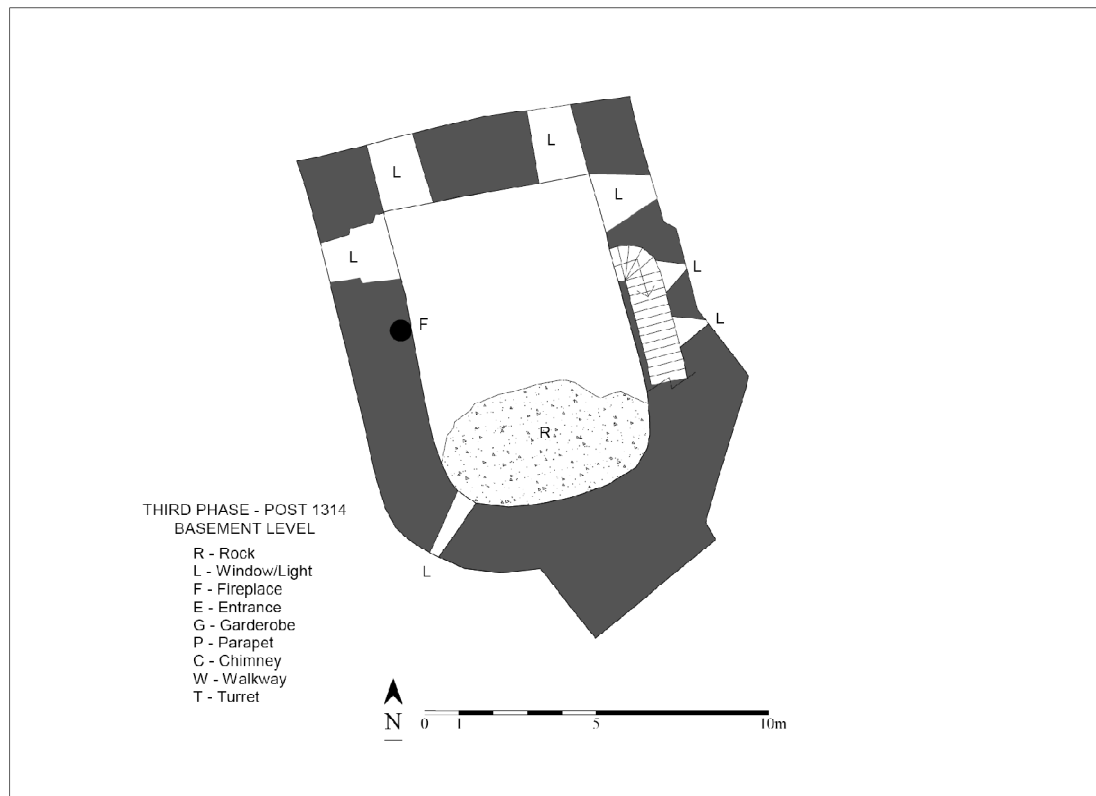
Figure 19: Basement Level of Phase 3: Post-1314 Castle

The Stair Extension added modified staircases leading from the basement to first floor level, with the reuse of the lower window and possible adaptation of the upper window (Photos 21 to 23; Figure 19). The existing stairs are new concrete additions inserted in the 1900s following the line of the earlier, but offset to the north. It is uncertain if the lower doorway was added at this time or if it is a 1900s addition.

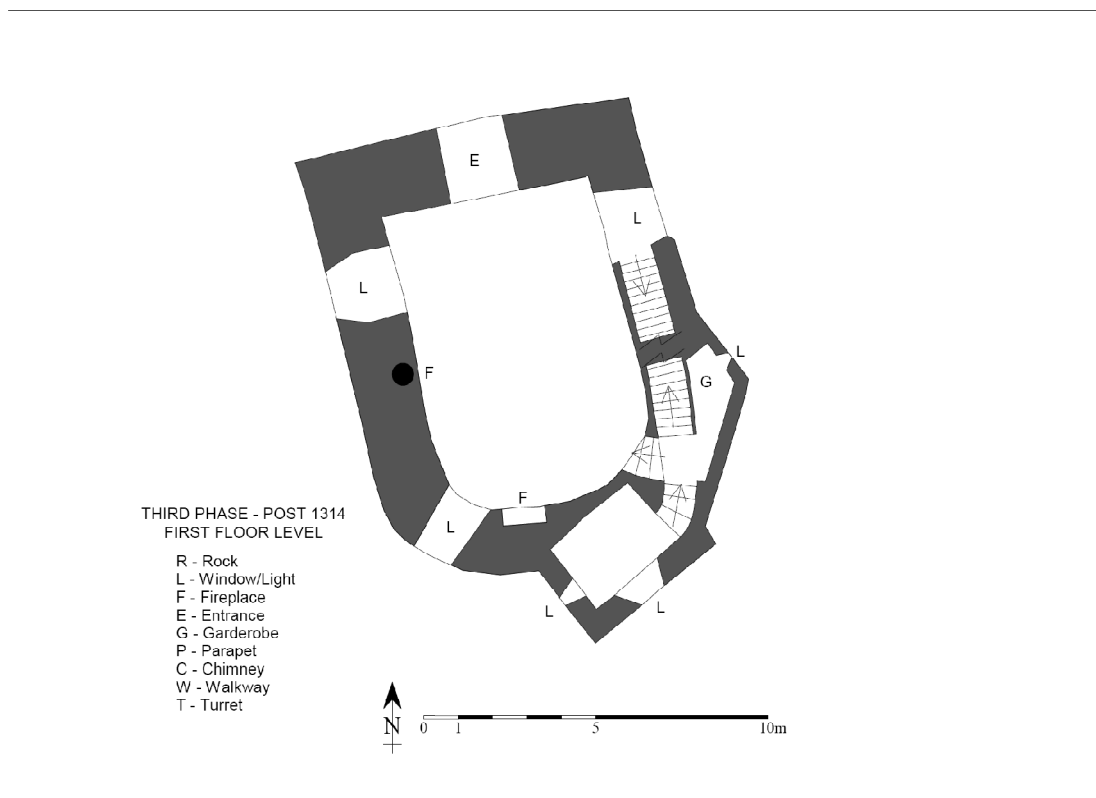
Figure 20: First Floor Level of Phase 3: Post-1314 Castle

The stairs would have led to the Great Hall at first floor level (Figure 20), but also appear to have continued in an arc accessing the Lower Floor of the Square Tower. The former line of these stairs can be seen in the blocked passageway leading from the Study towards the Tower. To the north of this passageway a second area of blocking probably represents a former garderobe mirroring the one at the next level above, but heavily altered during the 1900s renovations.

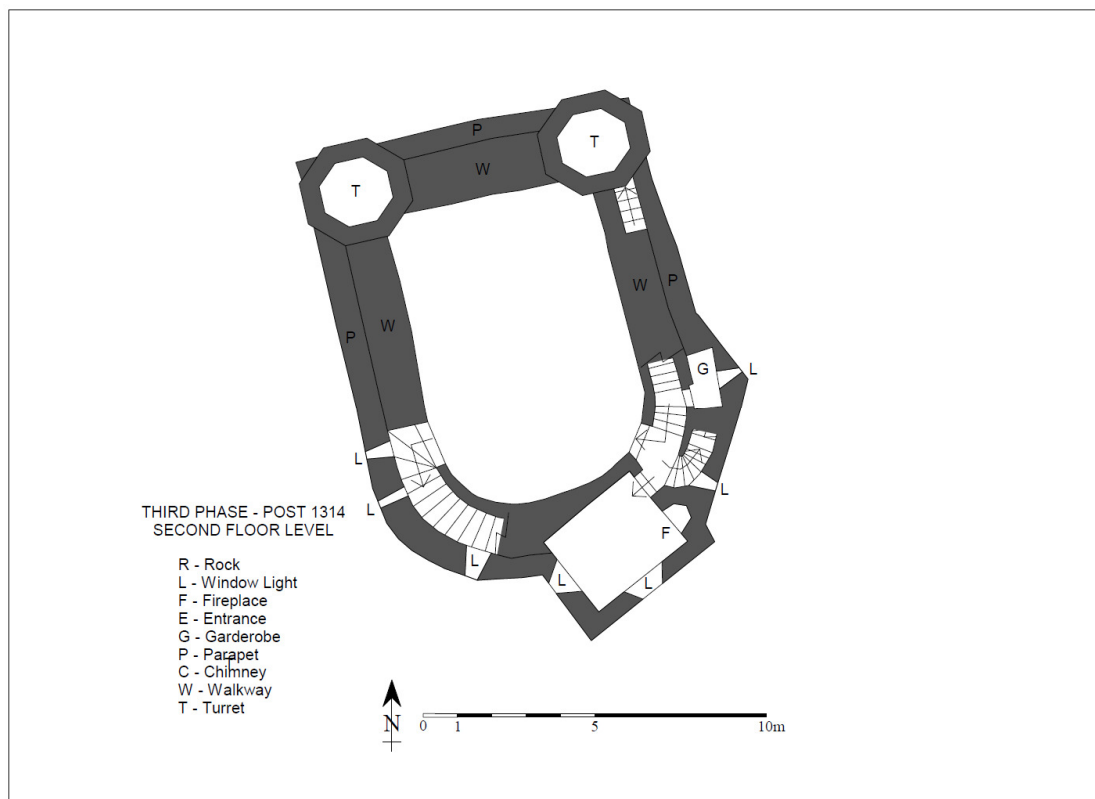
Figure 21: Second Floor Level of Phase 3: Post-1314 Castle

The stairs to the second floor level followed directly above those from basement to first floor reusing the majority of the original alignment (Figure 21). A garderobe is present leading from the stairway to the east (Photos 51 to 53) directly above the blocked one below. The stairs would have then led upwards to provide access to the second floor level of the D-Shaped Tower (Figure 21) and also the Middle Floor of the Square Tower. An offshoot of this stairway also curved back on itself within the Stair Extension to lead to the third floor level (Photo 58; Figure 22) of the tower (possible roof space and parapet).

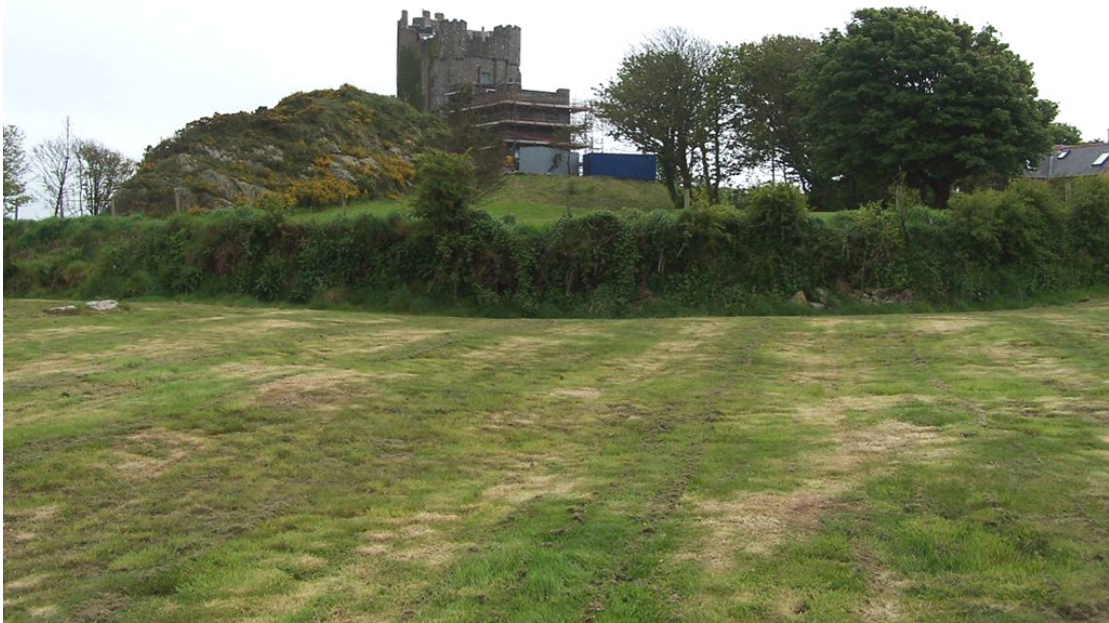
A change in ground level is present to the northwest of the castle (dropping own from the castle), following roughly the line of the ditch marked on the earlier OS maps which suggests the line of this feature is still visible, although possibly slightly further to the north than shown on the maps) (Photos 110 & 111). Stone work is present within this change in level, which may indicate a stone wall was formerly present, although the remains do not suggest a very substantial wall (ie. not a massive curtain wall that formerly surrounded the castle, but perhaps a revetment wall) (Photo 112). A breach is present through this area associated with a modern vehicle access track (Photo 110). It is understood that the land to the north and east of this ground level change is outside of the property boundary of the castle (as sold in 2009).

Photo 110: View south towards castle, showing change in ground level

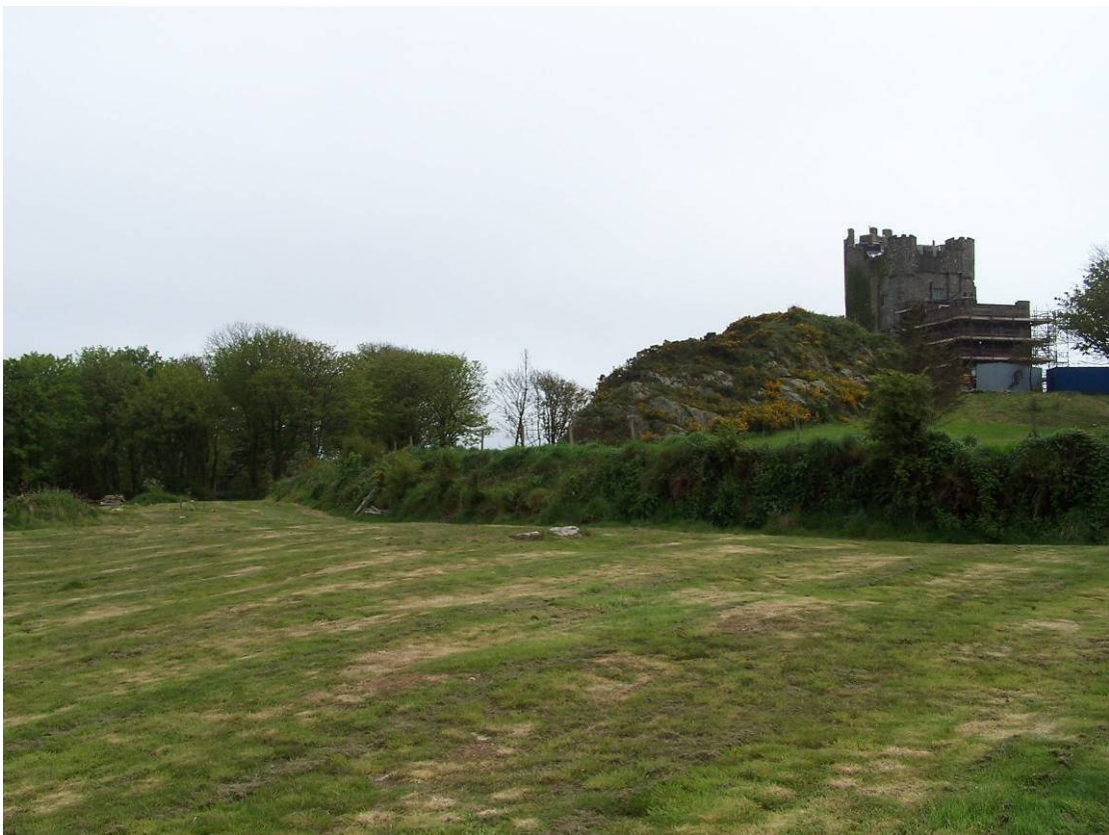
Photo 111: View southeast, showing change in ground level

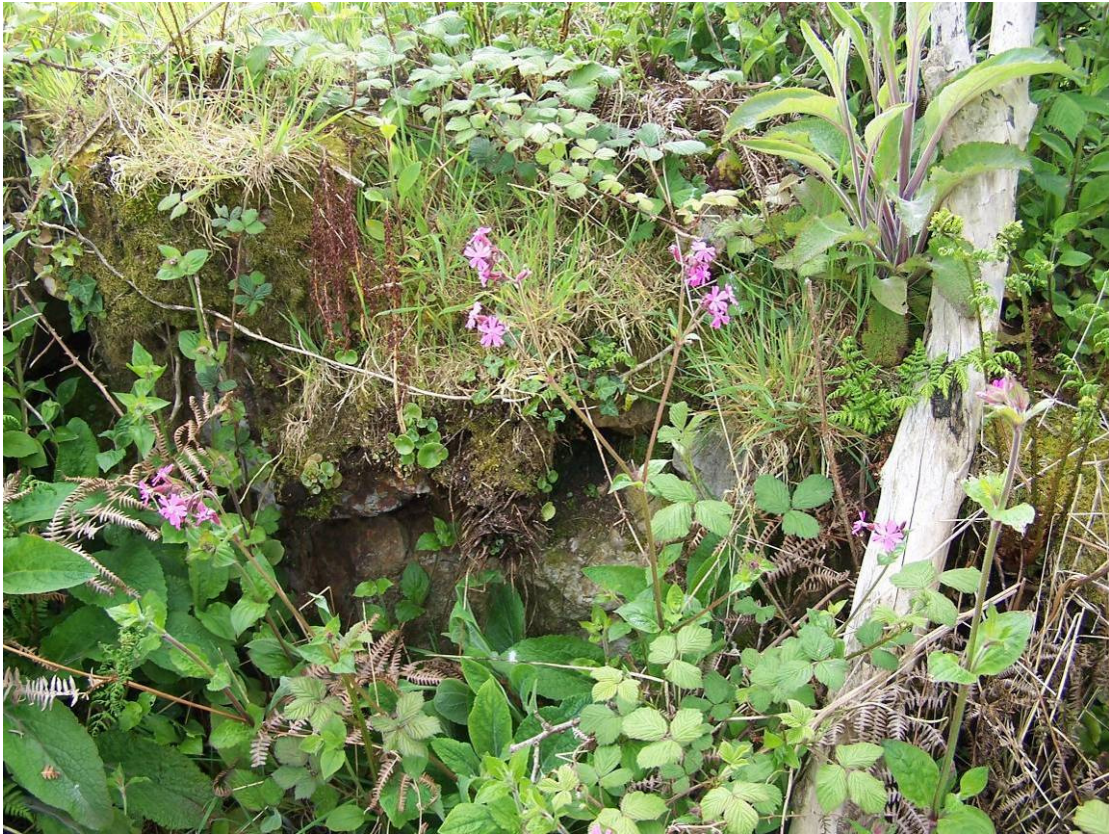
Photo 112: Stone wall along edge of change in ground level to the north of castle

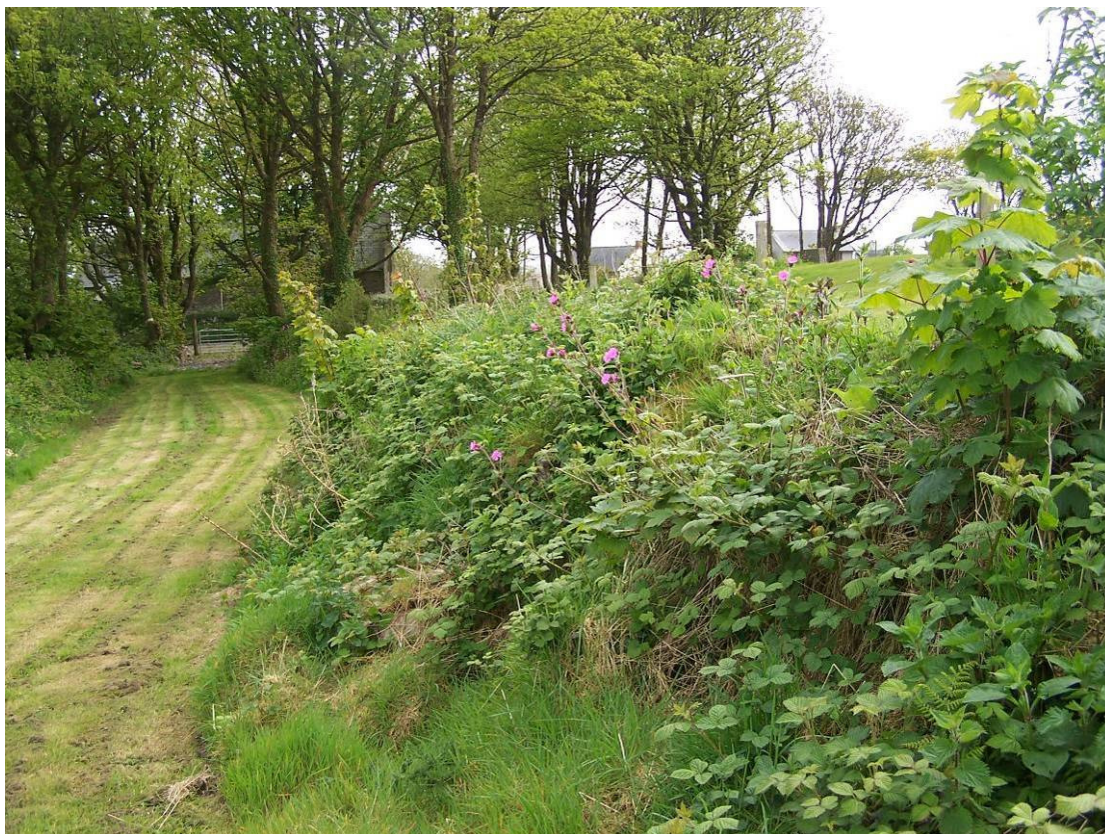
Photo 114: View southwards along trackway towards church, also showing raised ground associated with wall

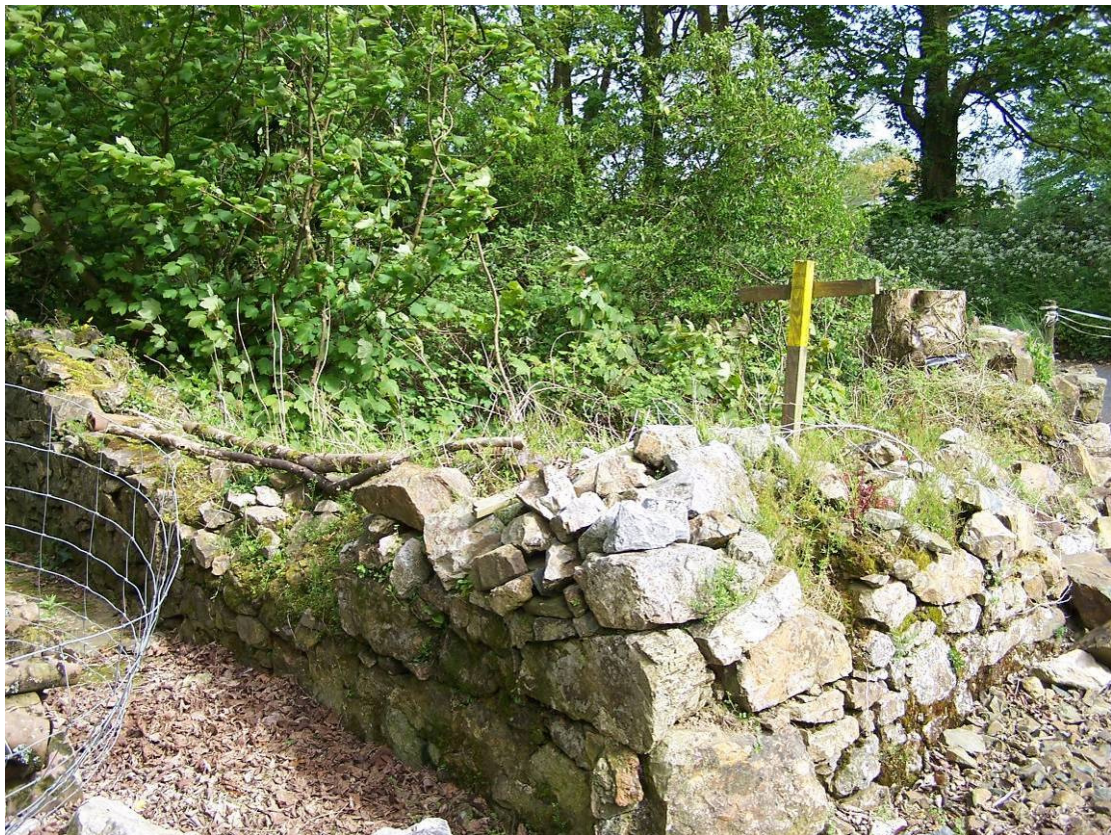
Photo 117: Stone walls associated with former cottage directly opposite the church

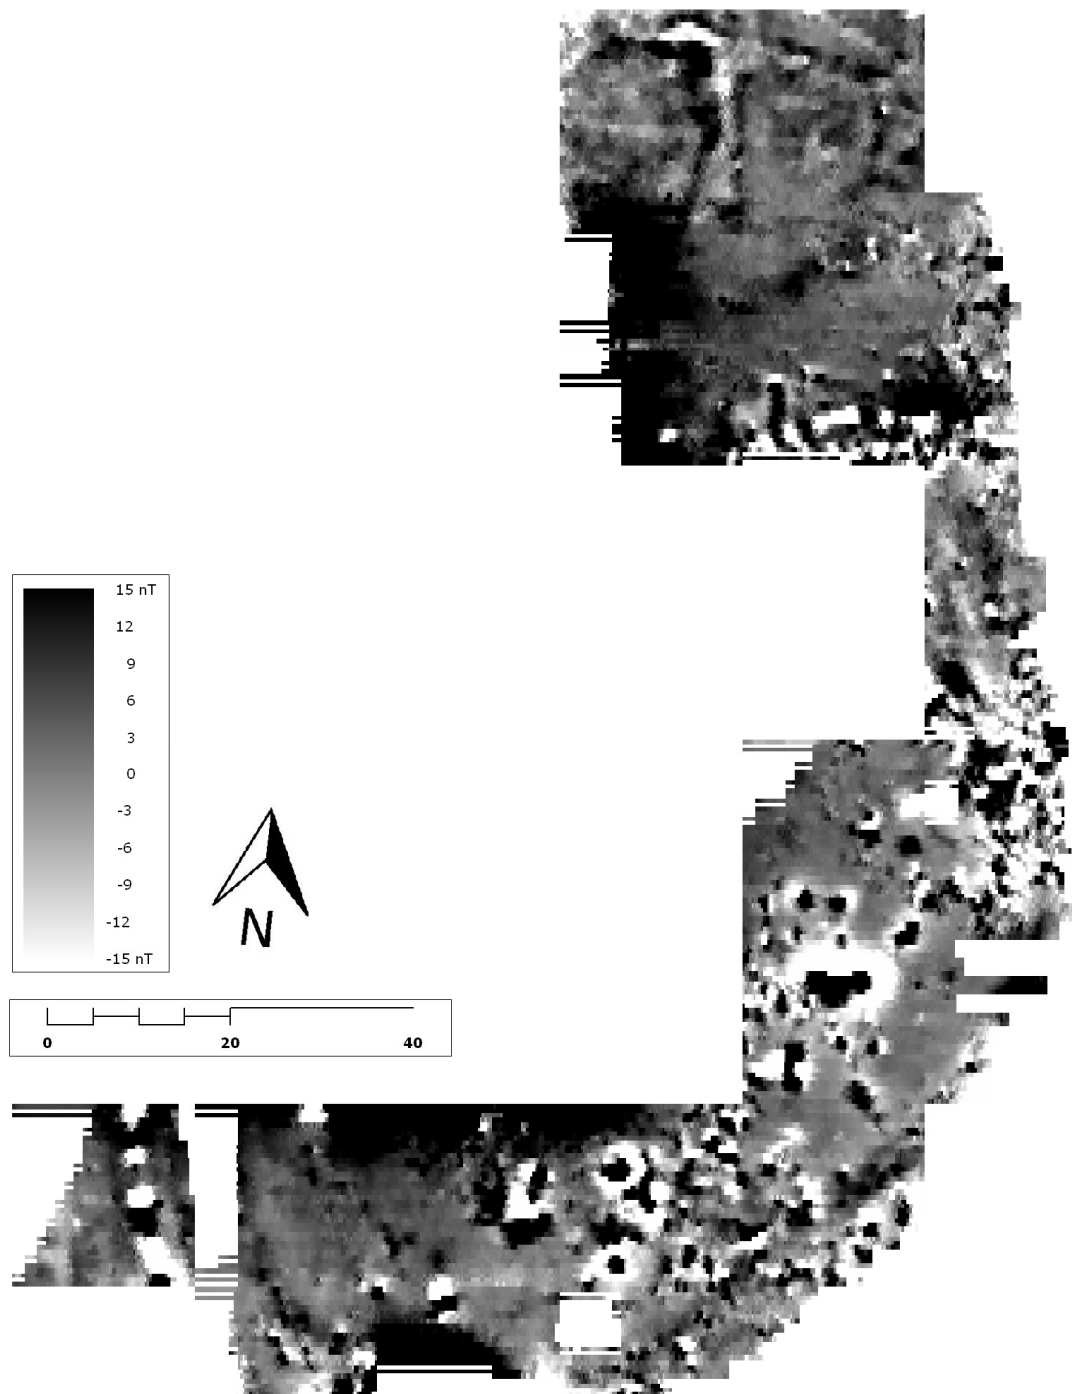
Figure 23: Geophysical survey results presented as a greyscale plot, clipped to a range from 15nT to -15nT. Measurement scale is in metres.

Processing of the geophysical survey data was performed using ArchaeoSurveyor 2.5, detailed explanation of the processes involved are described at the end of this report. The data is presented with a minimum of processing but the presence of high values caused by ferrous objects, metal fencing and vehicles tends to hide fine details and obscures archaeological features, thus the values were 'clipped' to remove the extreme values allowing the finer details to show through. The survey was clipped to a range from 15nT to -15nT (Figures 23 & 24).

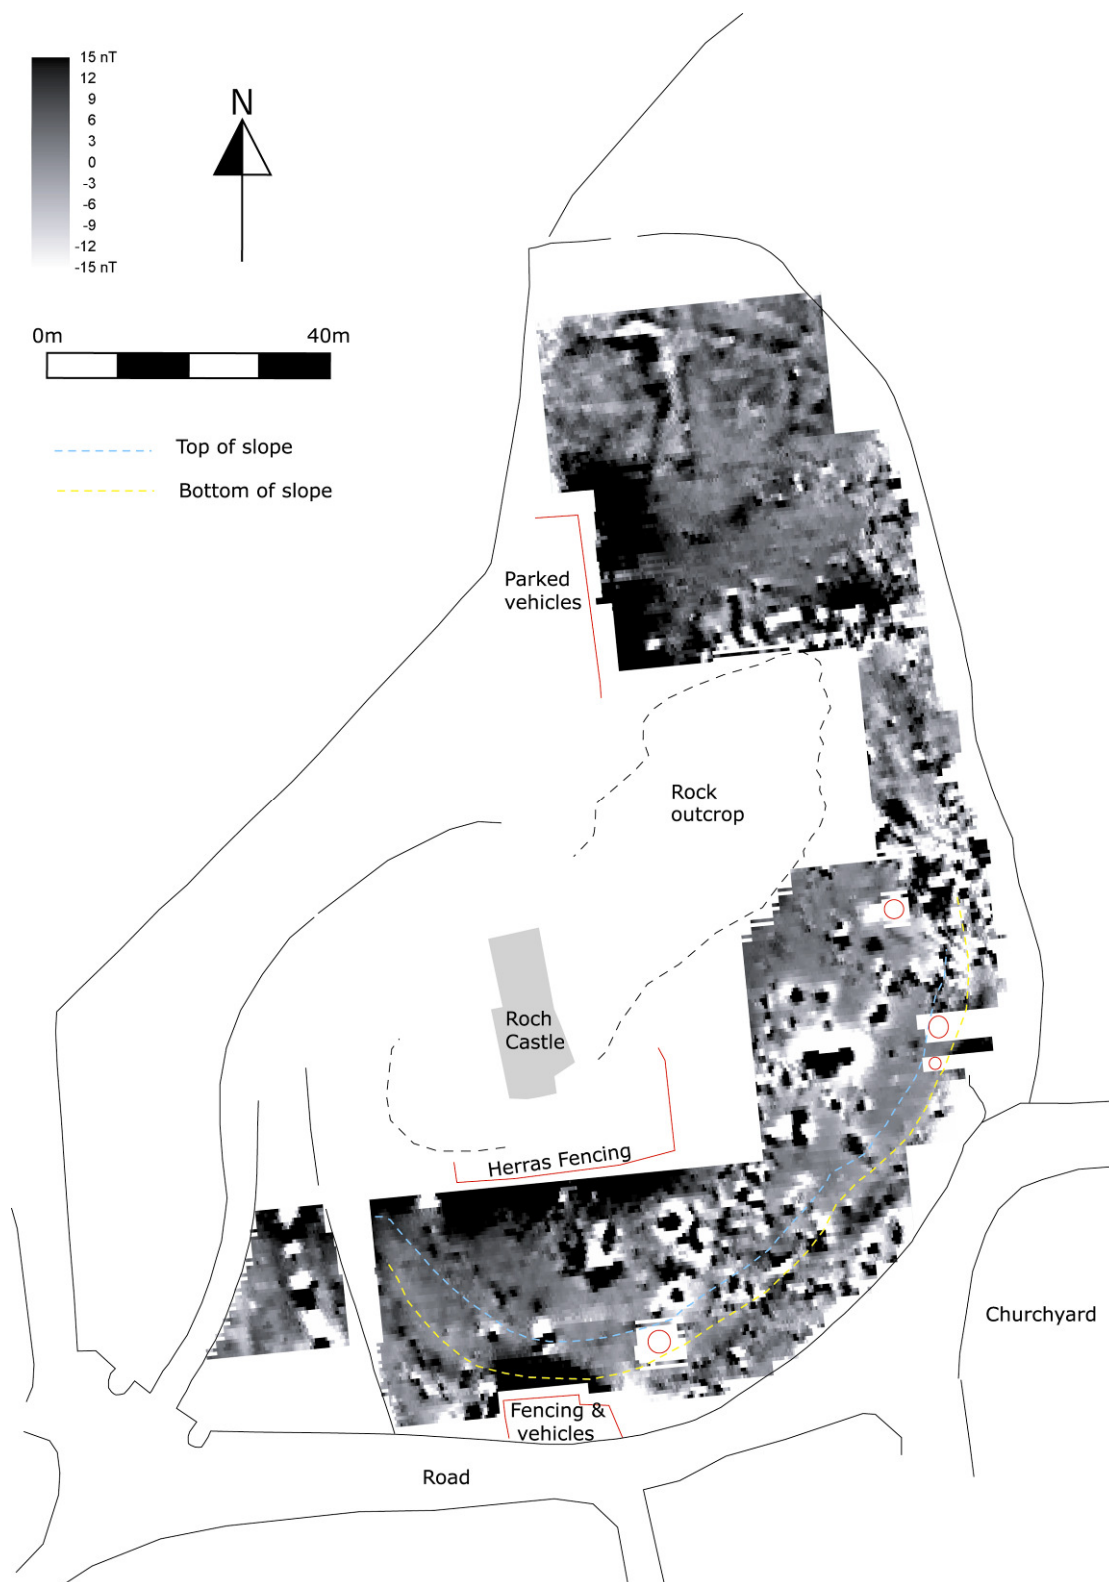
Figure 24: Geophysical survey results overlaid with local topographical detail.

The processed data is presented as grey-scale plots overlaid on local topographical features (Figures 23 & 24). The main magnetic anomalies have been identified and plotted onto the background topographic detail as a level of interpretation (Figure 25).

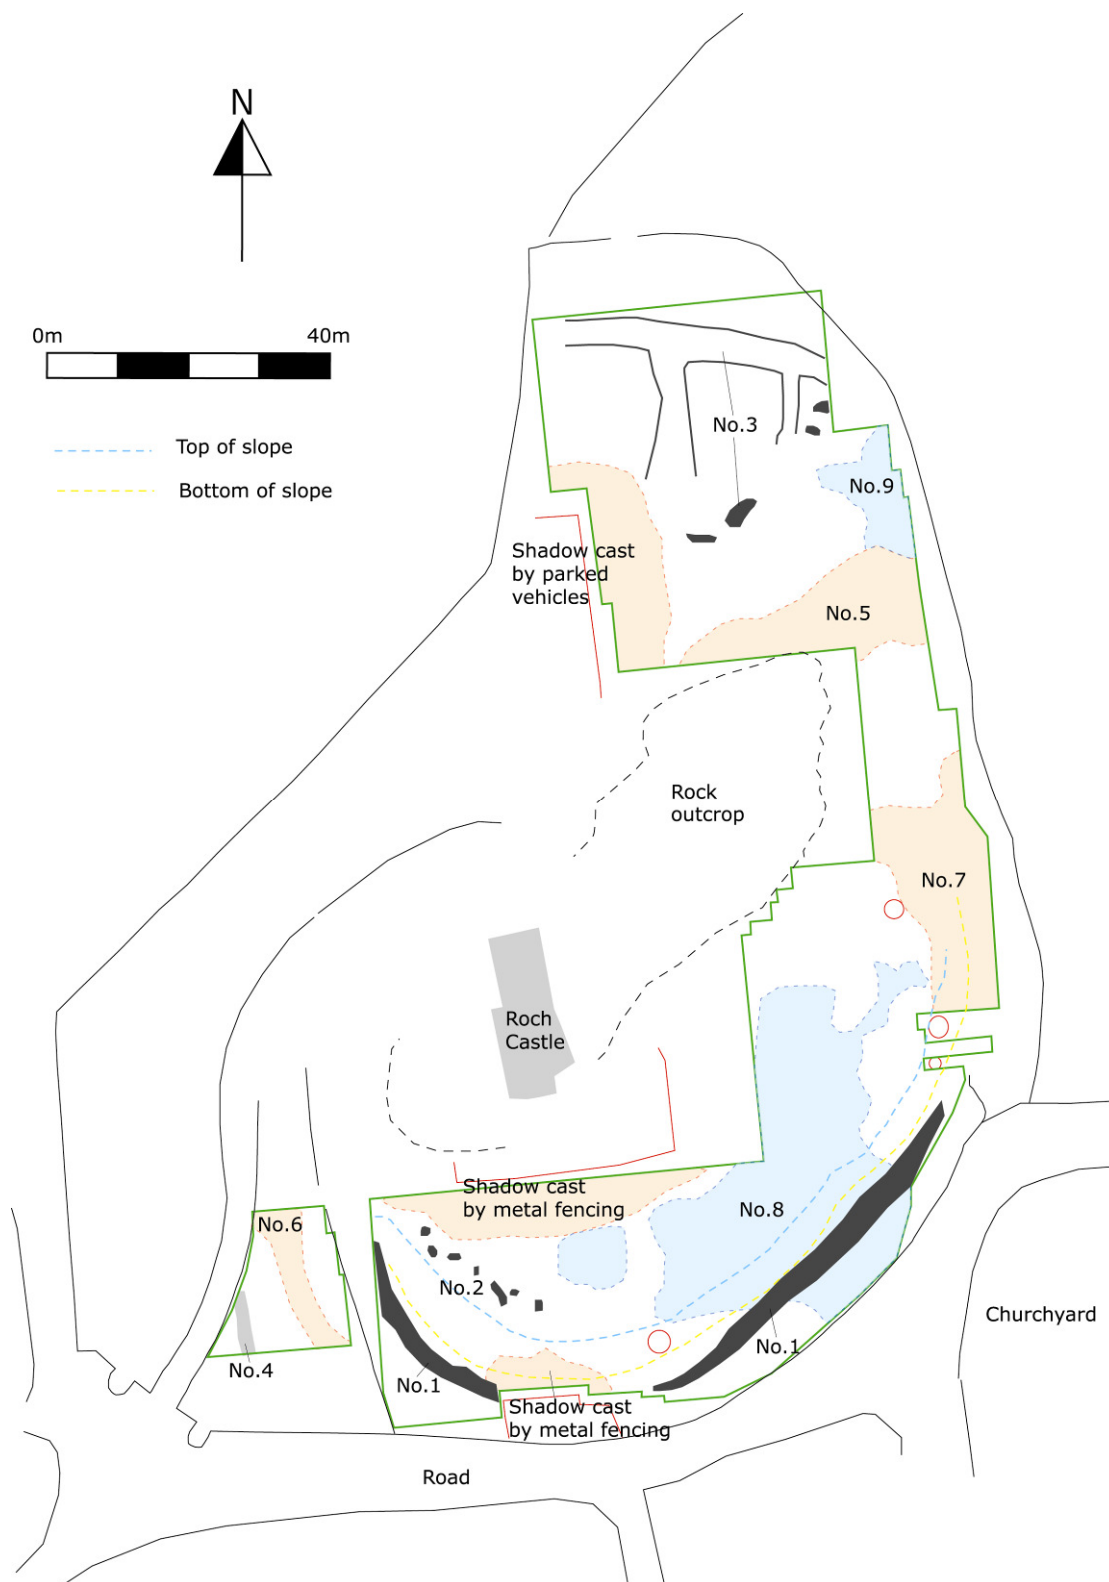
Figure 25: Interpretation of geophysical survey results, overlaid with local topographical detail. The survey area is outlined in green, the numbers refer the 'Geophysical interpretation' section of the main text document and above
