# CARDIGAN CASTLE, CEREDIGION ARCHAEOLOGICAL WATCHING BRIEF, PHOTOGRAPHIC SURVEY, & EVALUATION

Prepared by Dyfed Archaeological Trust  
For: Ceredigion County Council,  
Cadwgan Trust / Purcell, Miller, Tritton

RHIF YR ADRODDIAD / REPORT NO. 2011-50  
PHOTOGRAPHIC SURVEY - RHIF Y PROSIECT / PROJECT RECORD NO. 102421  
WATCHING BRIEF - RHIF Y PROSIECT / PROJECT RECORD NO. 102422  
NORTHEAST TOWER INVESTIGATION -  
RHIF Y PROSIECT / PROJECT RECORD NO. 102423  
FERNERY INVESTIGATION - RHIF Y PROSIECT / PROJECT RECORD NO. 102424

**Rhagfyr 2011  
December 2011**

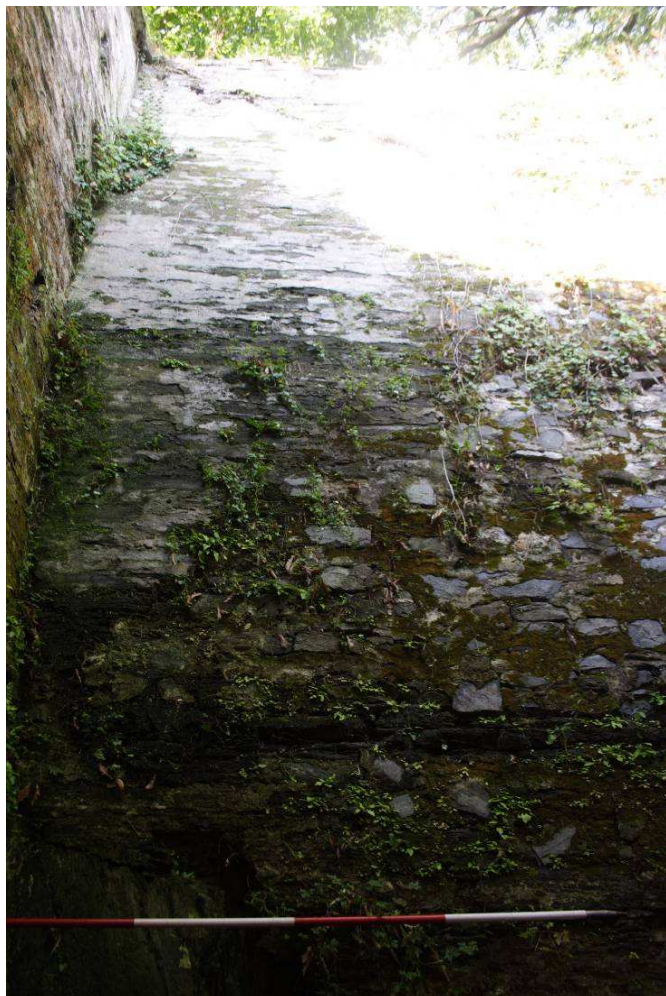
**Photo 4:** Southwestern half of southeastern elevation of Upper part of curtain wall in Room 3 of Stables, 2m scale

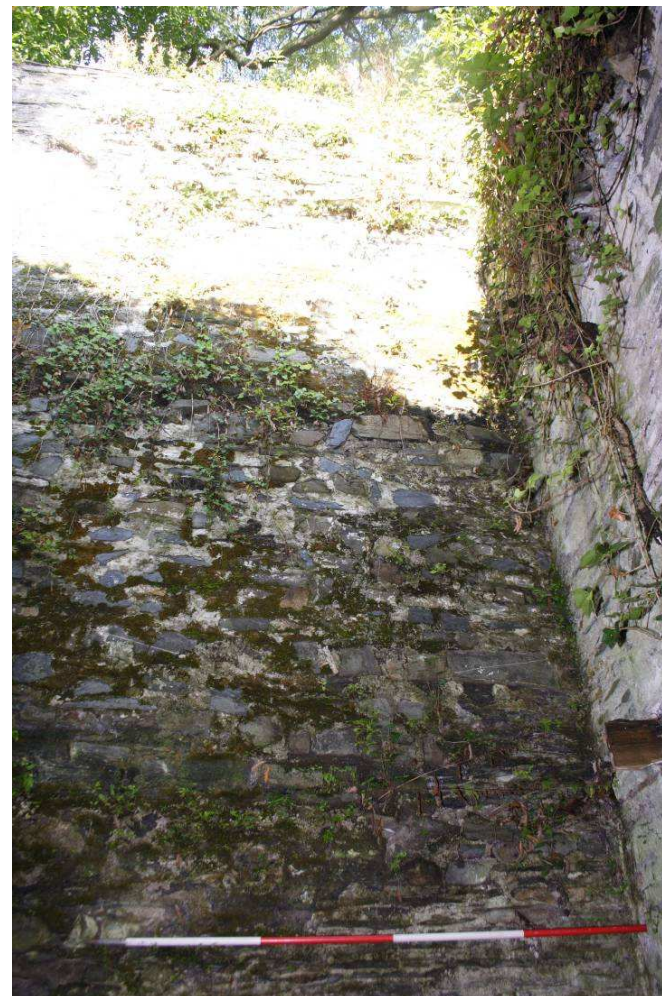
**Photo 5:** Northeastern half of southeastern elevation of Upper part of curtain wall in Room 3 of Stables, 2m scale

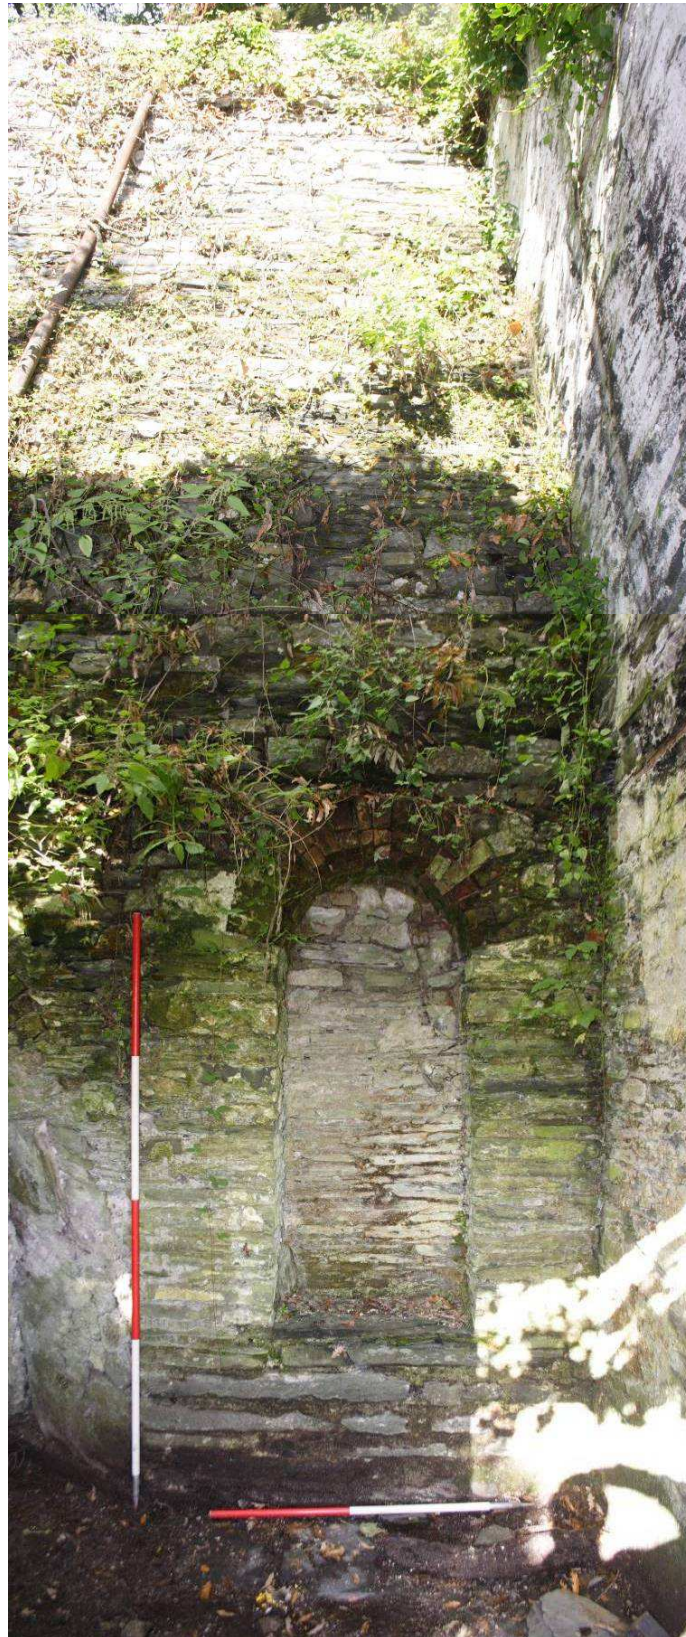
5.4.7 The northeastern alcove was far narrower, measuring c.1.94m in height and c.0.7m in width (Photo 7). The base of the alcove was at a similar level to the adjacent one, but was stone built. The arch was again built of brick. The back of the alcove was of neatly laid mortared stonework constructed of thin slabs. There was clearly no possibility of a flue behind this feature, as the brick arch was neatly mortared to the stonework behind.

**Photo 7:** Composite photograph showing southeastern elevation of Eastern Curtain Wall within southern half of Room 2 of Stables, 2m and 1m scale

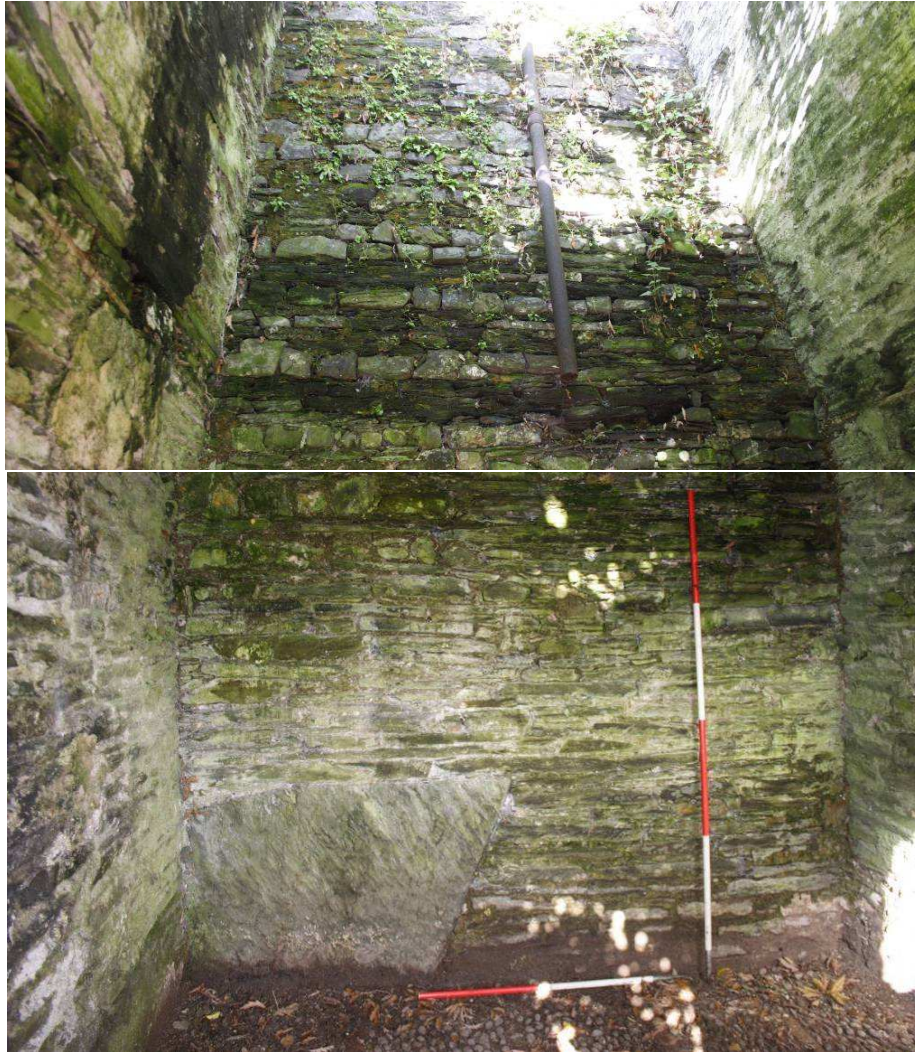
**Photo 8:** Composite photograph showing southeastern elevation of Eastern Curtain Wall within southern half of Room 1 of Stables, 2m and 1m scale

5.4.9 The eastern Curtain Wall facade within Room 1 displays far more regular coursing in its upper levels using courses of thin slabs, interleaved with courses of larger boulders (Photo 8). Although this may be partially as a result of less vegetation obscuring the stonework, there does appear to be a marked change in the construction of the wall in this area. The lower part of the wall is also better constructed using neatly laid and mortared thin stone slabs for a height of around 2m (it may have also been whitewashed during the use of Room 1). This stonework is similar in character to that at the back of the northeastern alcove in Room 2. At the base of the wall in the southwestern corner of the room, a single large outcrop of bedrock is present which has been neatly cut to continue the neat facade of the Eastern Curtain Wall.

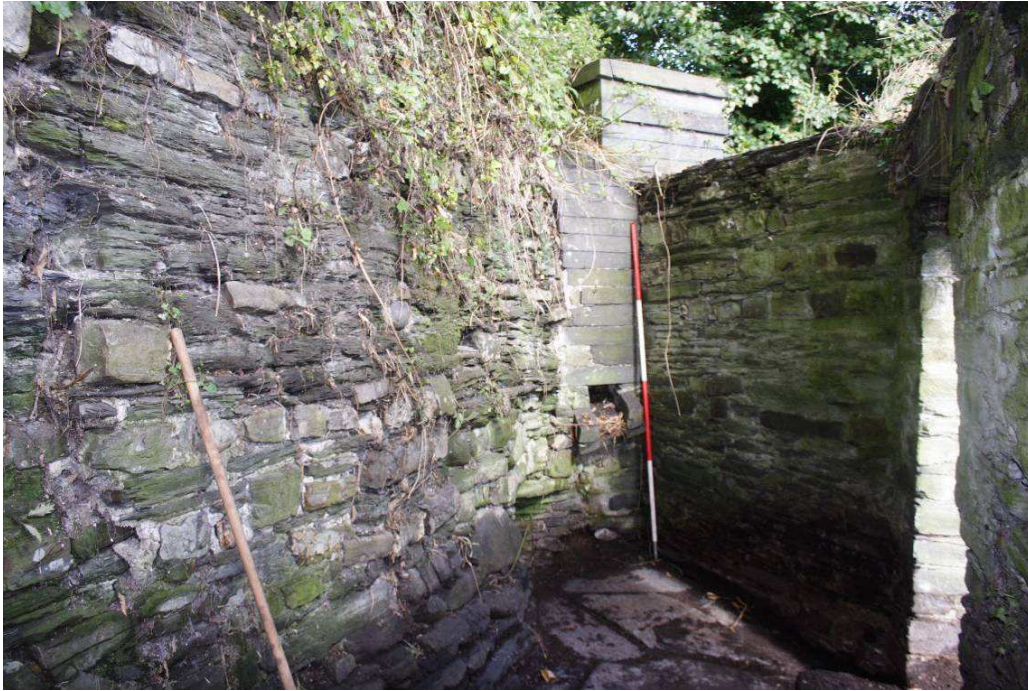
**Photo 12:** Lower part of southeastern elevation of North East Bastion within northern half of Room 4 of Stables, 2m scale

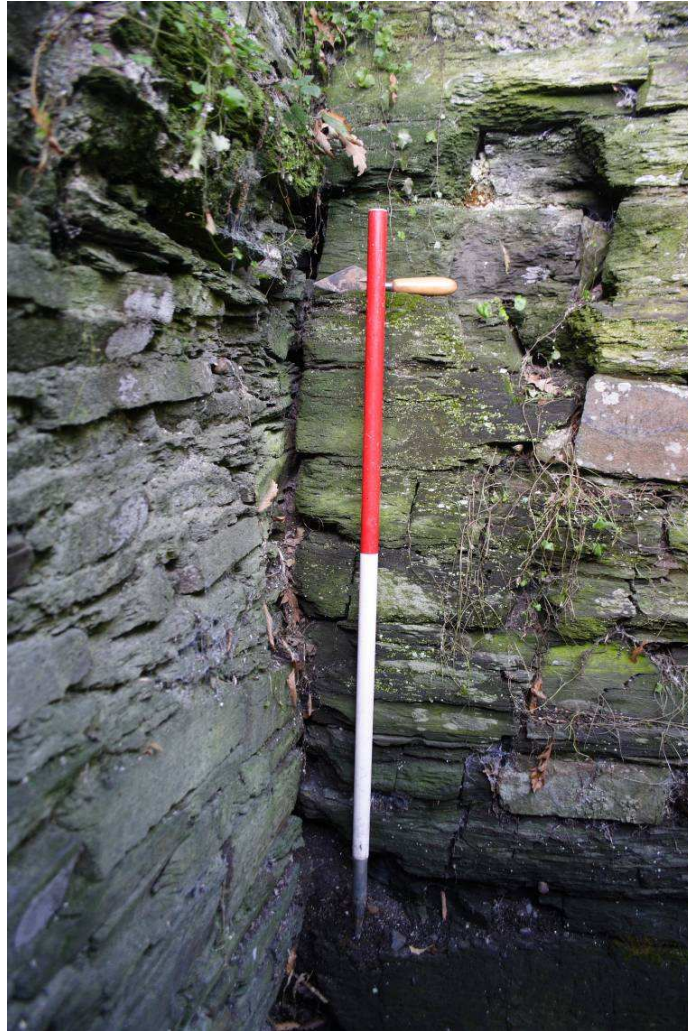
5.5.2 The wall of the Bastion is of different build than the Eastern Curtain Wall as seen in the adjacent Room 1, being of rougher coursing using a mix of thin slabs and larger stones. The northeastern end wall of Room 1 has been built against that of the Bastion, as can be clearly seen within the southern end of Room 4 (Photo 13) where the larger and more weathered stones of the Bastion and the thinner stones of the end wall of Room 1 can be seen to be independent constructions.

**Photo 13:** Detail of North east bastion Wall (facing) and the northeastern end wall of Room 1 butting against it, 1m scale

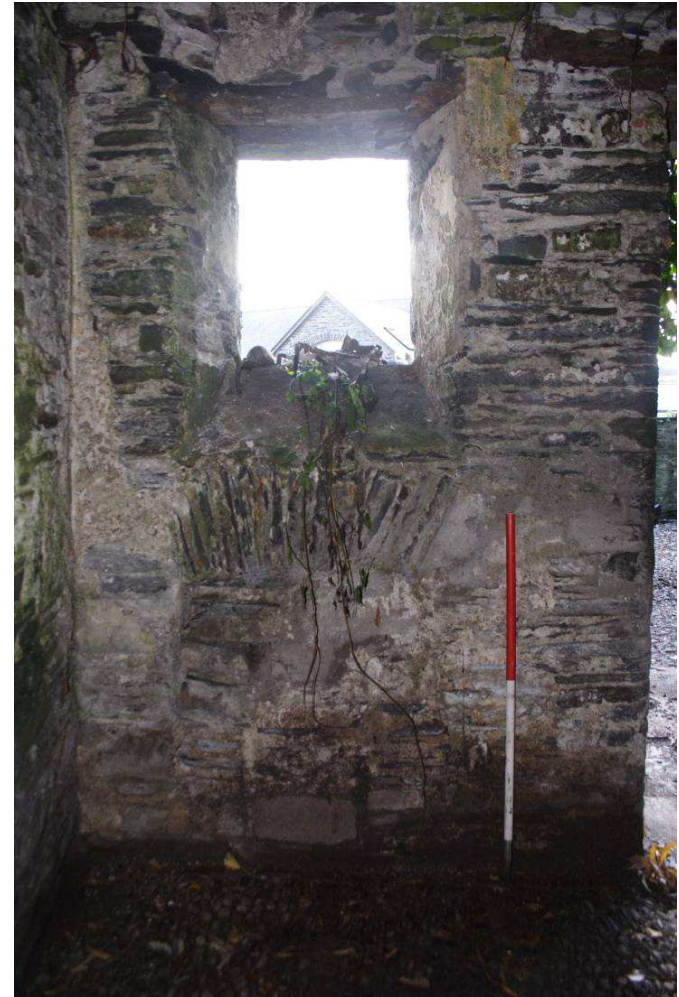
**Photo 17:** Internal view of window and earlier fireplace,  
1m scale

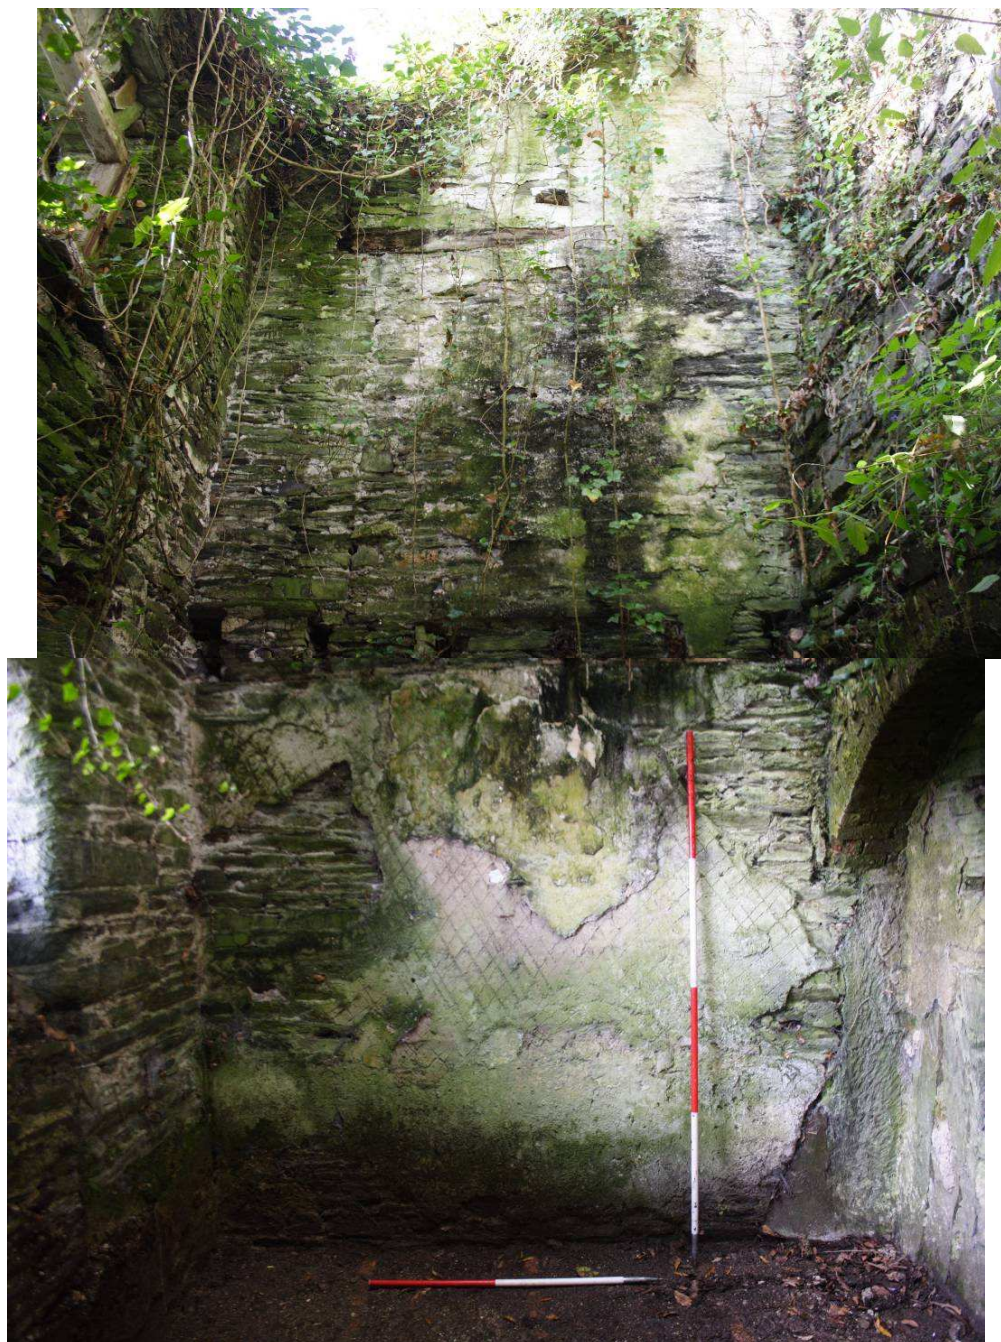
5.6.6 The northeast facing internal elevation of Room 2 has the remains of a scored base coat render at ground floor level, indicating the room had been plaster finished. At first floor level a blocked doorway was present leading to the southwest (Photo 23).

**Photo 23:** Composite photograph of northeast facing internal wall of Room 2 with blocked doorway or window to first floor level, 2m and 1m scale

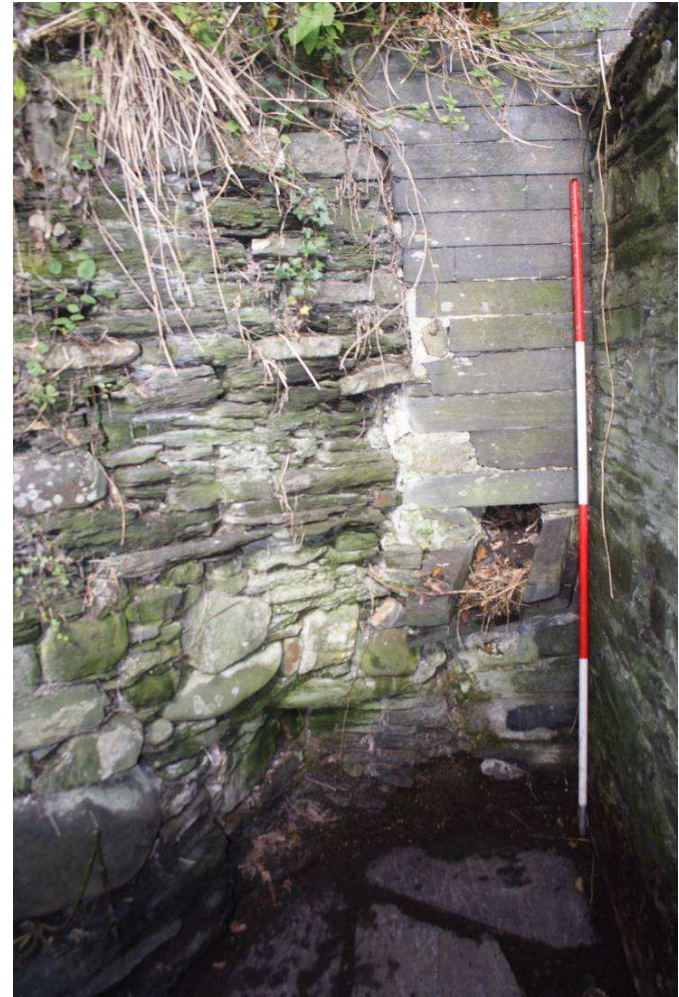
5.6.18 At the northern end of the room, a channel had been constructed through the stone wall (photo 29). Here the wall was made of very regular and angular stone blocks (more akin to the facade of the wall than the rest of the internal face). The channel itself was formed by narrow, long slabs projecting through both sides of the wall.

**Photo 29:** Stone channel through end wall  
in northern corner of Room 4, 2m scale

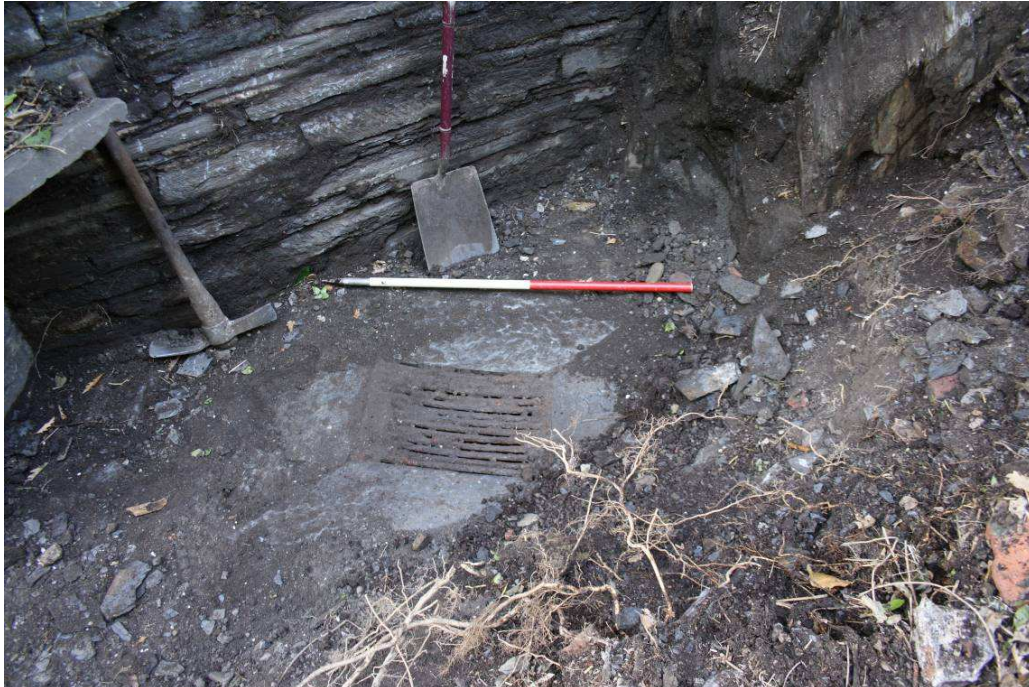
**Photo 35:** drain cover revealed at base of North East Bastion Wall, 1m scale

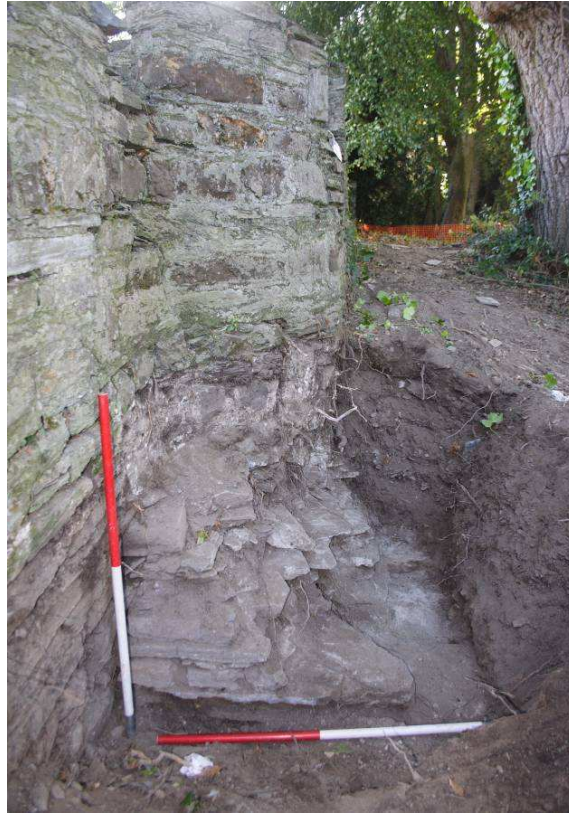
**Photo 38:** Profile of Exposed wall at southwest end of excavated area (Turkey Oak visible to the rear on the right) viewing southwest, 1m scales

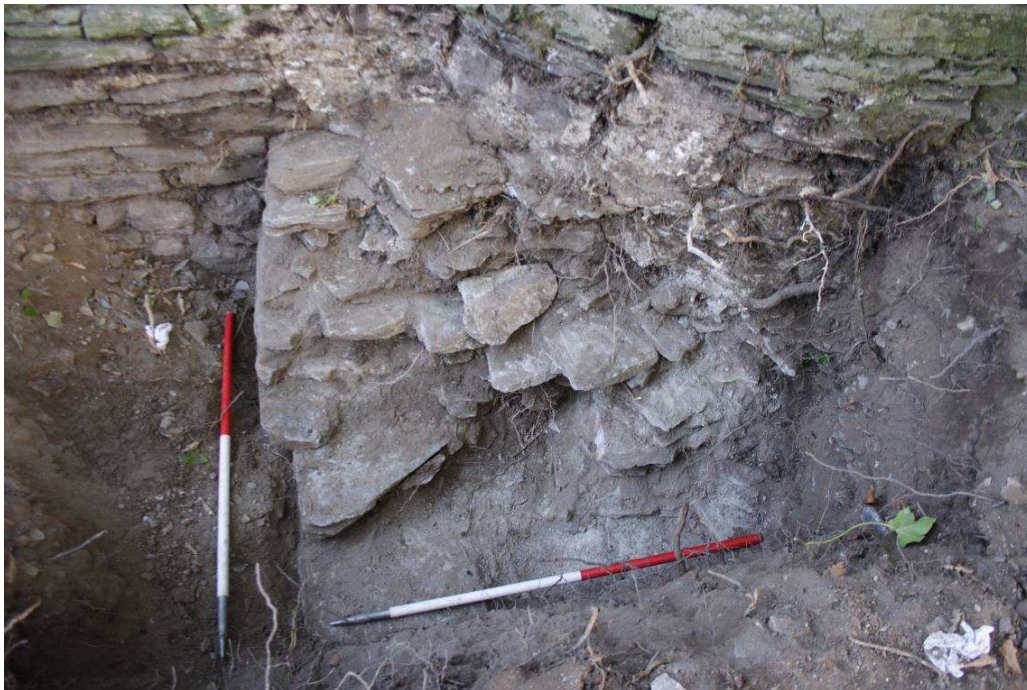
6.6.5 The exposed stone wall projected into the North East Bastion wall, as could be seen by an area of rough rubble stone and very white mortar in the face of the North East Bastion wall, which lay directly above the rubble core of the

exposed stone wall. A single sherd of medieval pottery was recovered from the surface of the wall of probable 13<sup>th</sup> or 14<sup>th</sup> century date.

**Photo 39:** Top view of exposed wall at southwest end of excavated area (with North East Bastion wall at top of photo), 1m scales

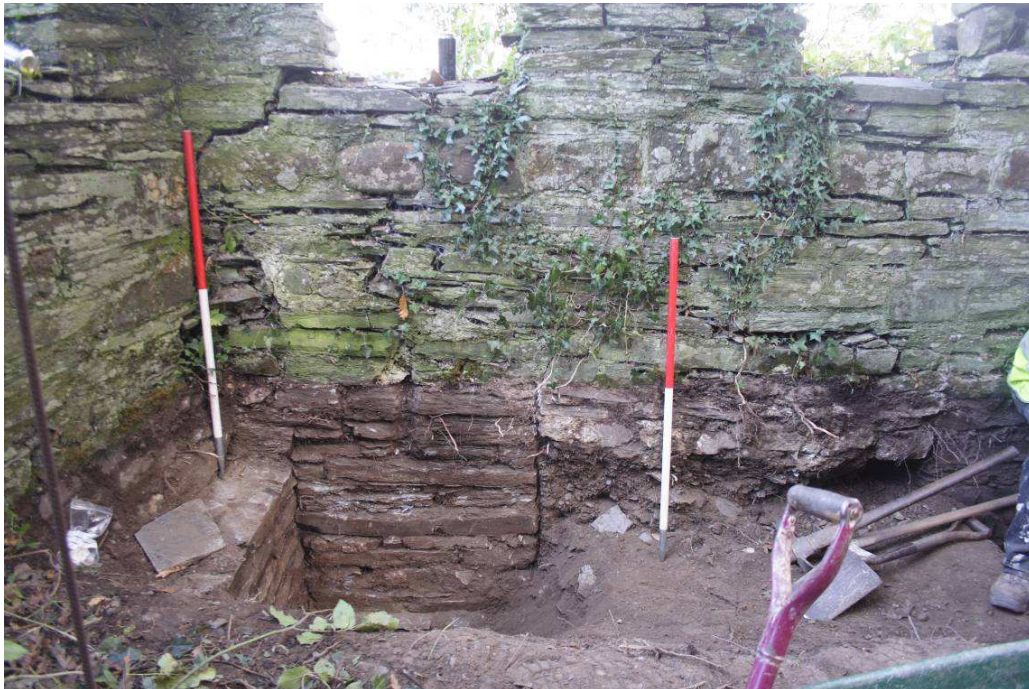
6.6.6 As the inner face of the bastion was exposed a recessed feature became apparent, hidden behind the depth of garden soils, built neatly into the inside of the North East Bastion wall (Photo 40 & 41; Figure 4). The recess was of 1.55m width. Evidently it had been infilled with rubble and garden soil, and a patch of later walling inserted to level the facade of the wall, presumably when either the 18<sup>th</sup> century or 19<sup>th</sup> century gardens were built. This was suffering from subsidence. The original alcove was edged with chamfered stones to a height of 1.15m from the base of the excavated area, above this point the wall had been rebuilt and the chamfered edge stopped. This was the same on both sides.

**Photo 40:** Alcove on inside of North East Bastion wall  
when first exposed, 1m scales

6.7.10 As part of the repair works the ground within the North East Bastion has been left low to leave the alcoves exposed. These have been re-pointed and a lintel placed over the one in the southeast wall. The exposed stonework of the southwestern side of the bastion has also been stabilised and left exposed.

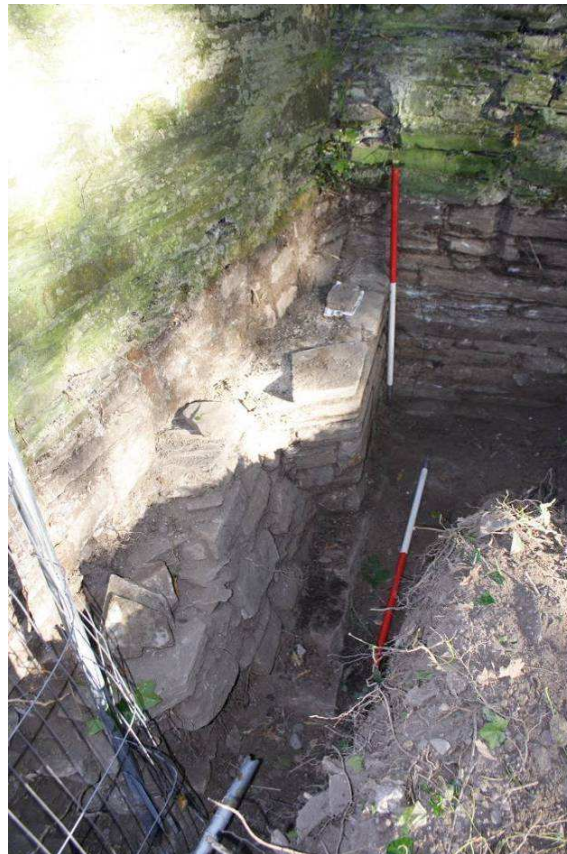
6.6.8 As the garden soil was excavated adjacent to the short surviving stretch of the northeast wall of the Bastion, a similar feature was observed in the exposed wall (Photo 42). Only the southeastern edge of this feature survived, but it again had chamfered edges and a sloping back rising from the same level as the other alcove. The surviving width of the alcove measured c.1.25m. The wall had been truncated in height in this area to a ledge 0.65m above the level of the excavated area. The two alcoves were of the same construction style and are presumably contemporary.

**Photo 42:** Alcove on inside of northeast wall of North East Bastion, 1m scales

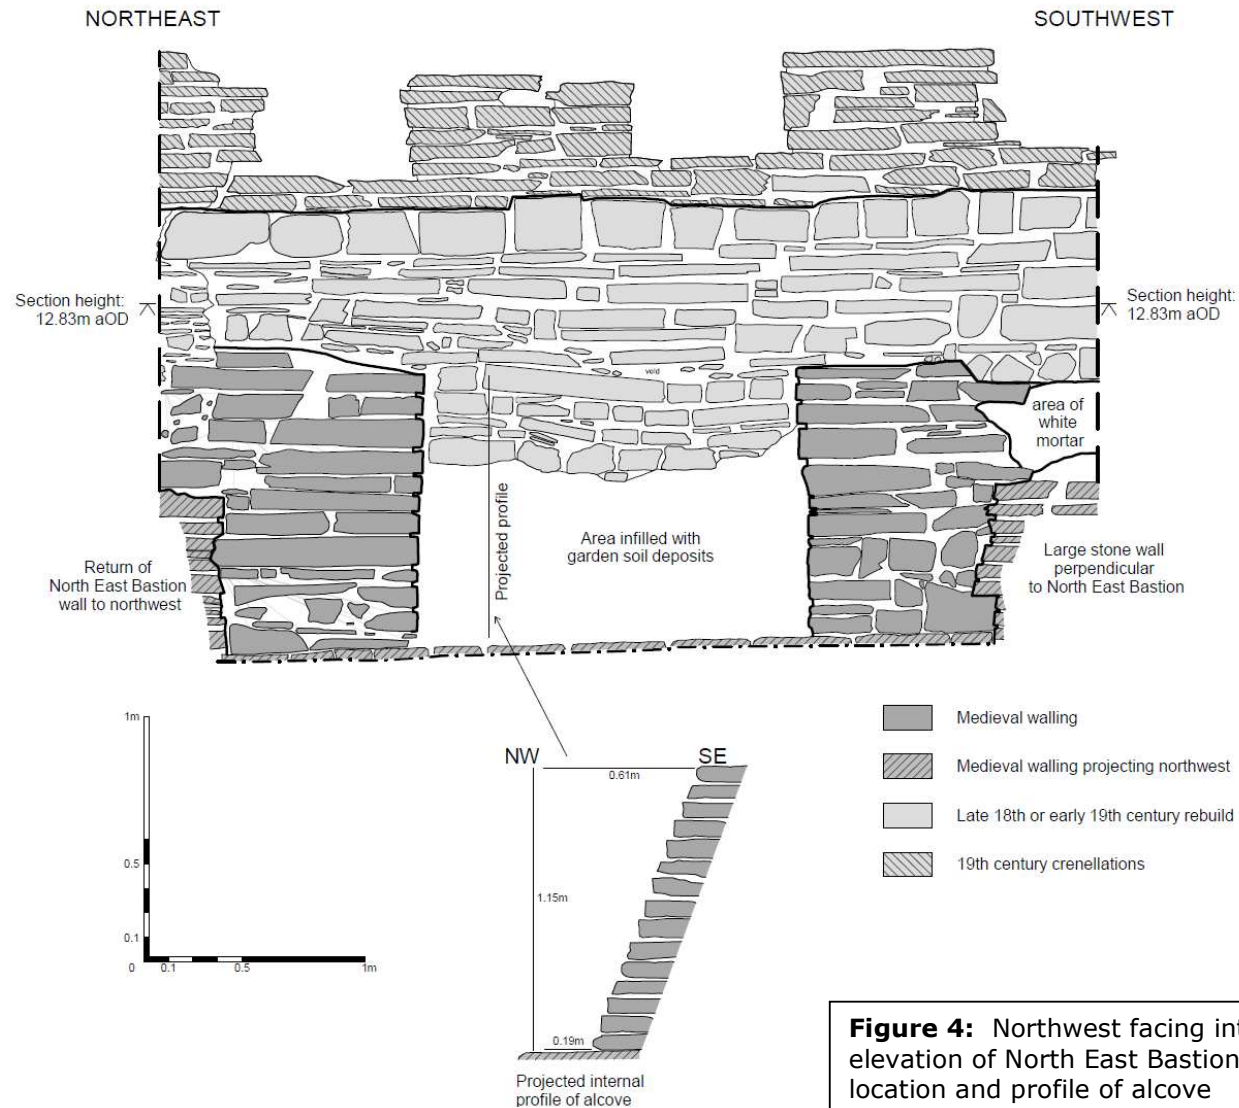
6.6.7 The base of the excavated area corresponded with a slight step out of c.0.10m in the bastion wall. The base of the alcove was also at this level, stepping back 0.19m from the front of the wall. The back of the alcove was sloped and lay c.0.47m from the front of the wall, where it could be measured (the higher part was obscured by the infilled stone work). A basic projection of the angle would indicate that it would measure around 0.61m at the top of the surviving wall.

**Figure 4:** Northwest facing internal elevation of North East Bastion showing location and profile of alcove

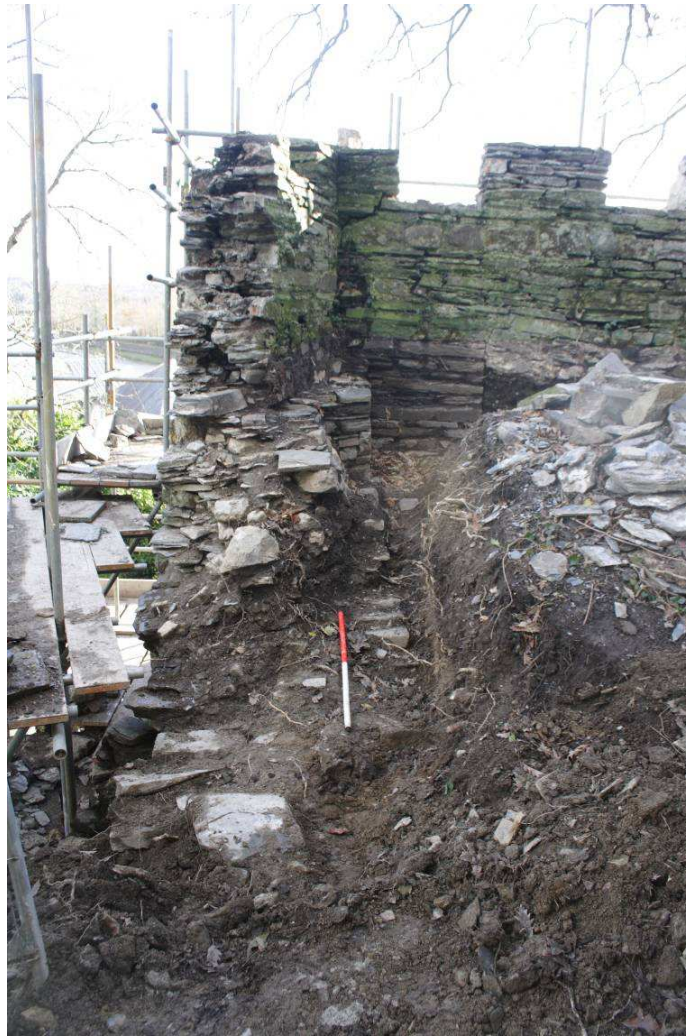
**Photo 43:** View south showing exposed northeast wall and both alcoves on inside walls of North East Bastion, 1m scale

6.6.11 The northwest to southeast return of the North East Bastion wall had been partially demolished in the past, but it was possible to follow the inner edge of the wall where it had been exposed for a maximum length of 3.2m (Photo 43). Above this level the wall significantly altered, presumably when the garden features were built, such that only part of the alcove survived (as noted above) and the end of the wall was left ragged. Above the alcove the late 18<sup>th</sup> or early 19<sup>th</sup> century garden wall had been built, again much narrower than the wall beneath and it was also aligned slightly differently. Due to previous collapse it was not possible to determine the lengths of the later wall.

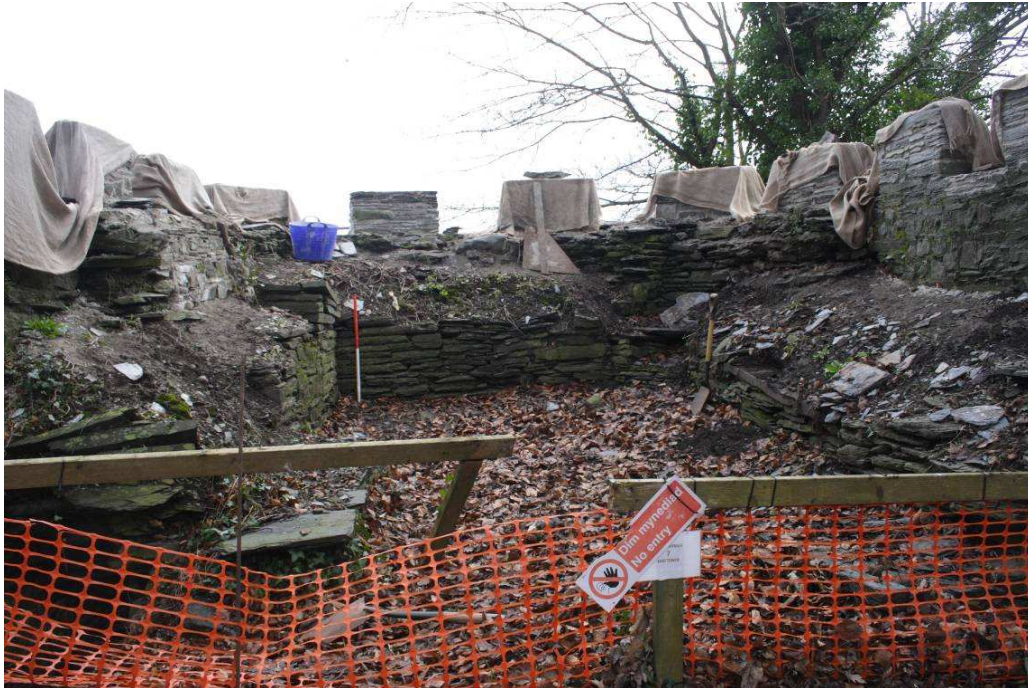
7.1.1 At the start of the investigation of the North East Tower the area was covered in soil, rotting vegetation and other detritus that had accumulated over the years (Photo 44). Following discussion with Purcell Miller Tritton, Tree & Sons and Cadw it was agreed limited excavation should be undertaken within the area to establish the state of preservation of the tower and attempt to determine the presence of any medieval archaeology or features associated with the late 18<sup>th</sup> / early 19<sup>th</sup> century garden phase.

**Photo 44:** View southeast into North East Tower prior to investigation, 1m scale

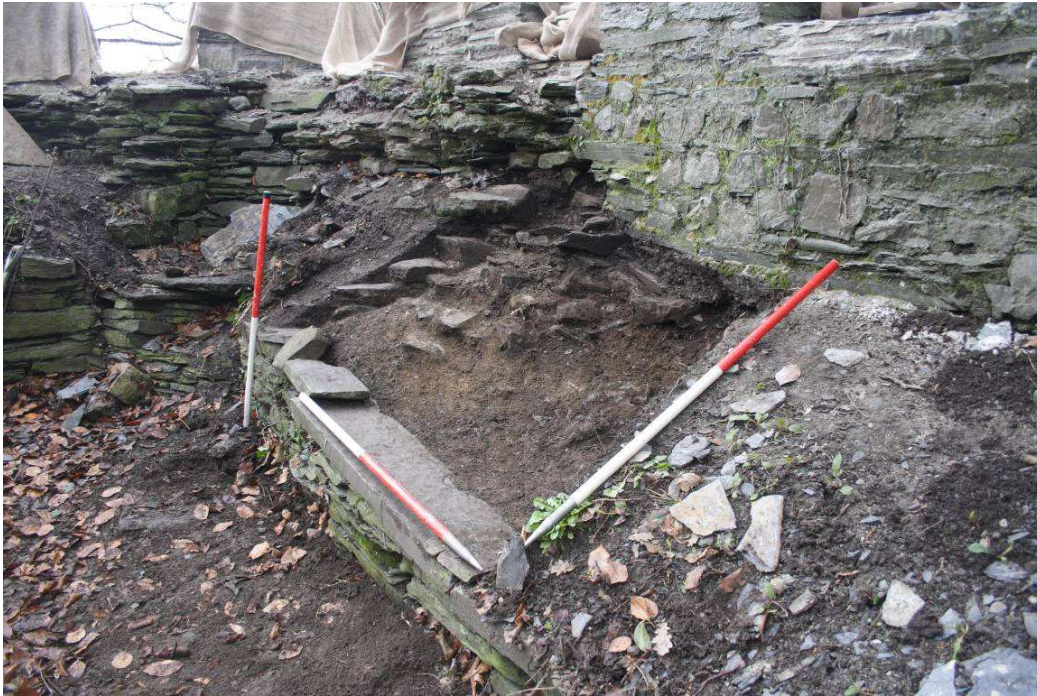
7.1.3 The southwestern side of the tower had an embankment of garden soil resting against the tower wall behind, and with a small retaining wall inside the tower. This wall was in a poor state of preservation. The face of the retaining wall lay 1.2m from the inside face of the 19<sup>th</sup> century crenellated wall of the tower. Excavation demonstrated that the wall was only c.0.25m in width, made of a series of long thin slabs (Photo 45).

**Photo 45:** Southeastern side of tower, showing small retaining wall, embanked garden soil and area of rubble core, 1m scales

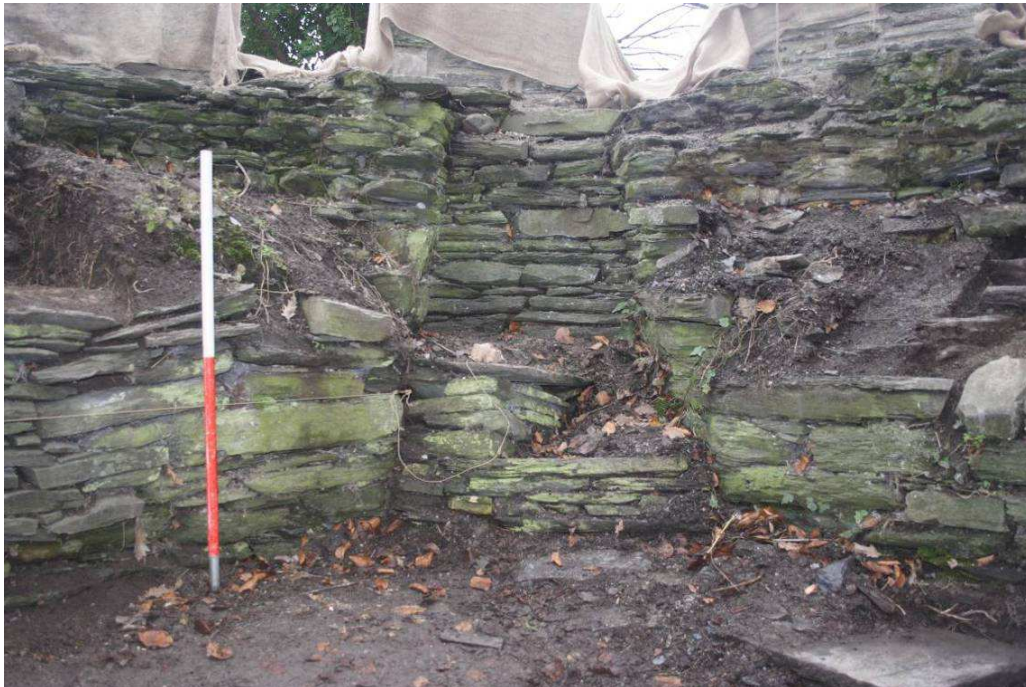
7.1.5 The southern corner of the tower the wall had a slight angle creating a north facing area of the facade of c.1m width. This contained a tapering recessed feature surviving within the substantial wall of the tower to a height of 1.15m and

with a depth of c.0.95m. In the base of the feature loose stonework had been placed which were stepped up to the east. These were evidently later than the recess; they were not bonded into the fabric of the wall.

**Photo 46:** Southern corner of tower, showing thickness of walling, and tapering recess with stepped stone infill

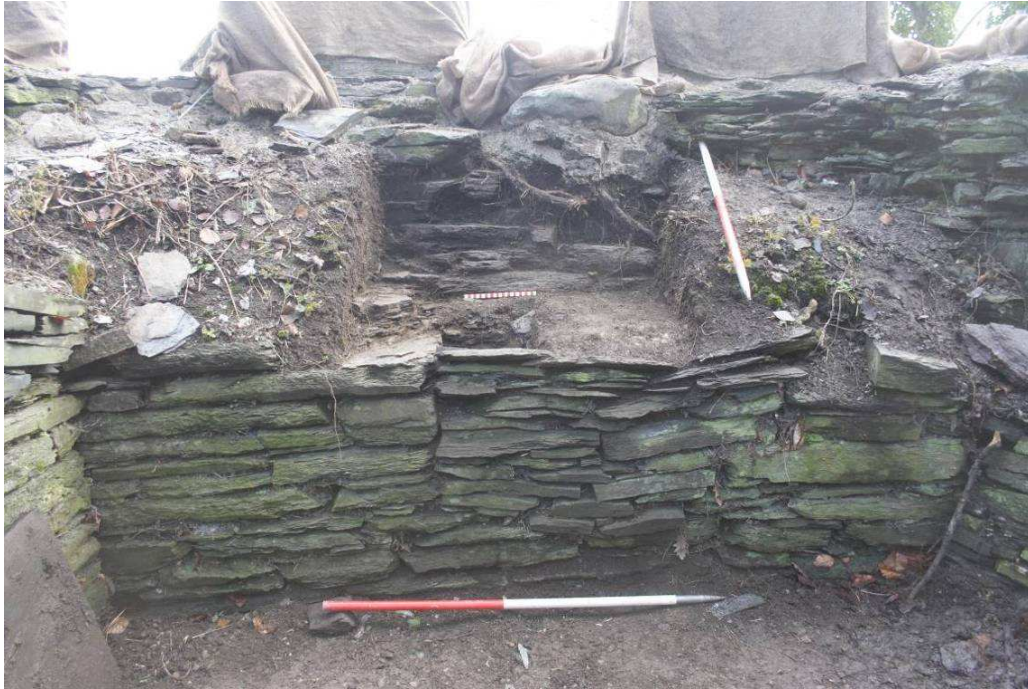
7.1.6 The substantial width of the southeastern end of the tower comprised a straight section of the tower wall being c.1.2m from its facade to the internal facade of the 19<sup>th</sup> century crenellated wall (Photo 47). The face of the wall was neatly constructed with rough coursing of long stone slabs. A joint was visible on the northeastern side of the wall, with only a slight hint of one to the southwest. The area between had been infilled with smaller and less well cut stonework.

**Photo 47:** Southeastern end of tower, showing substantial walling, possible area of infill and depth of garden soil above, 1m and 0.2m scales

7.1.8 The facade of the exposed area of wall behind the garden soil comprised rough, but well bonded stonework. Roots had caused some damage to the wall (Photo 47).

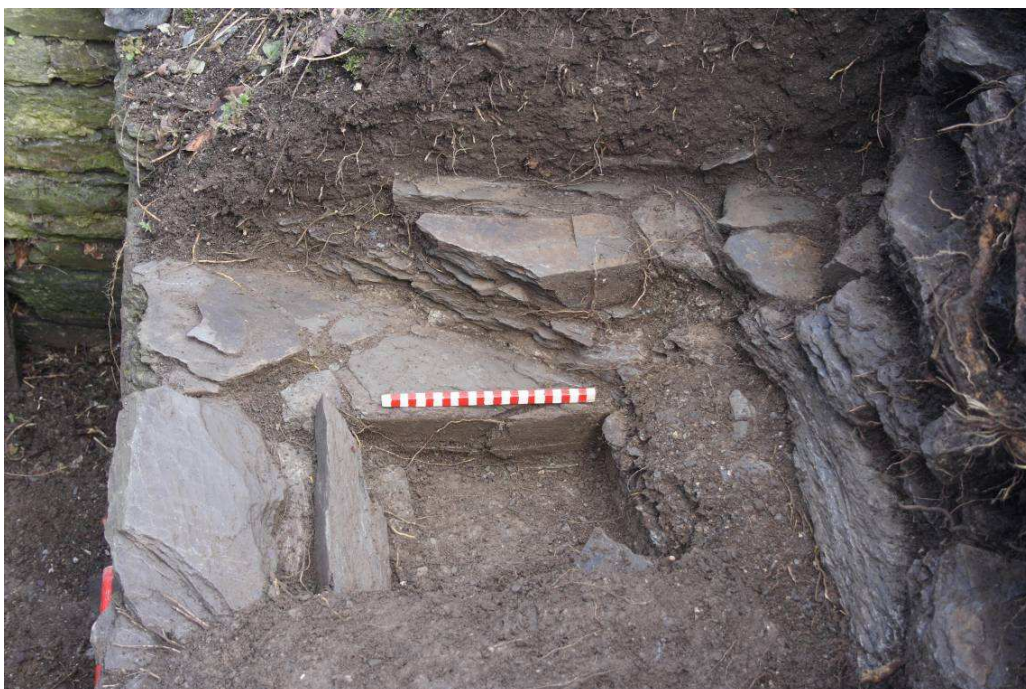
7.1.7 Excavation through the garden soil embanked on the top of the wall indicated a depth of around 0.65m of soil lying over a level area of stonework. At the base of the garden soil a small rectangular stone lined hole was recorded (Photo 48). It measured at least 0.30m by 0.40m in width. It was excavated to a depth of 0.15m maximum, removing further garden soil with lots of roots. This indicated that the southeastern edge was formed by well laid and cut stone work, corresponding with the joint seen in the facade of the wall. This also seemed to be the case for the small stretch of the southwestern part of the hole exposed. The northwestern edge was formed by smaller and looser stonework.

**Photo 48:** Rectangular stone lined hole in the top of the southeastern end of the North East Tower, 0.2m scale

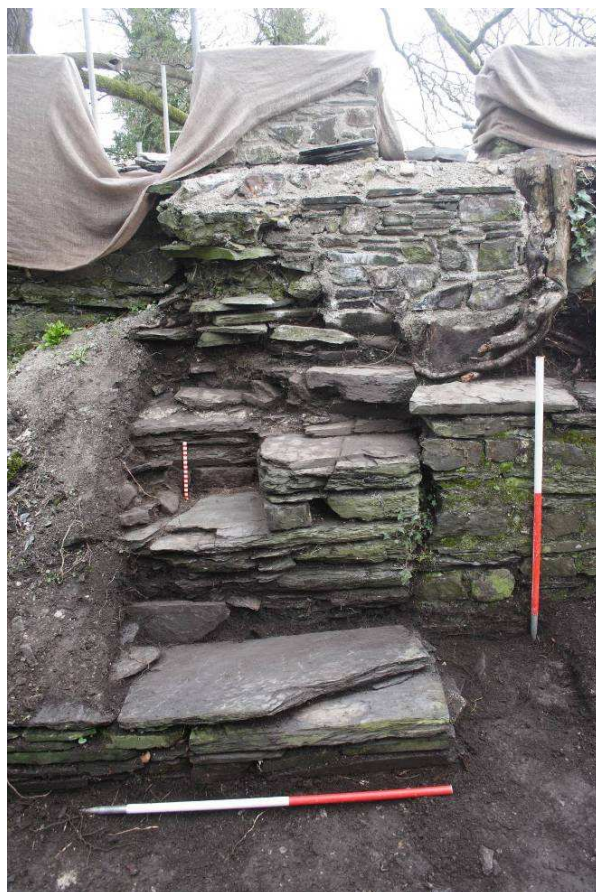
7.1.9 The facade of the northeastern wall of the tower, once exposed indicated that it had been deliberately stepped up from northwest to southeast (Photos 49 & 50). Two vertical joints were visible in the facade and also in plan on top of the exposed wall. Between the joints an area of different build was evident, comprising larger stones and liberal use of mortar, which is later infill. The area of wall to the northwest had been reduced in height and the area to the southeast left at quite a high level.

**Photo 49:** Full height of northeastern wall of the North East Tower, 1m and 0.2m scales

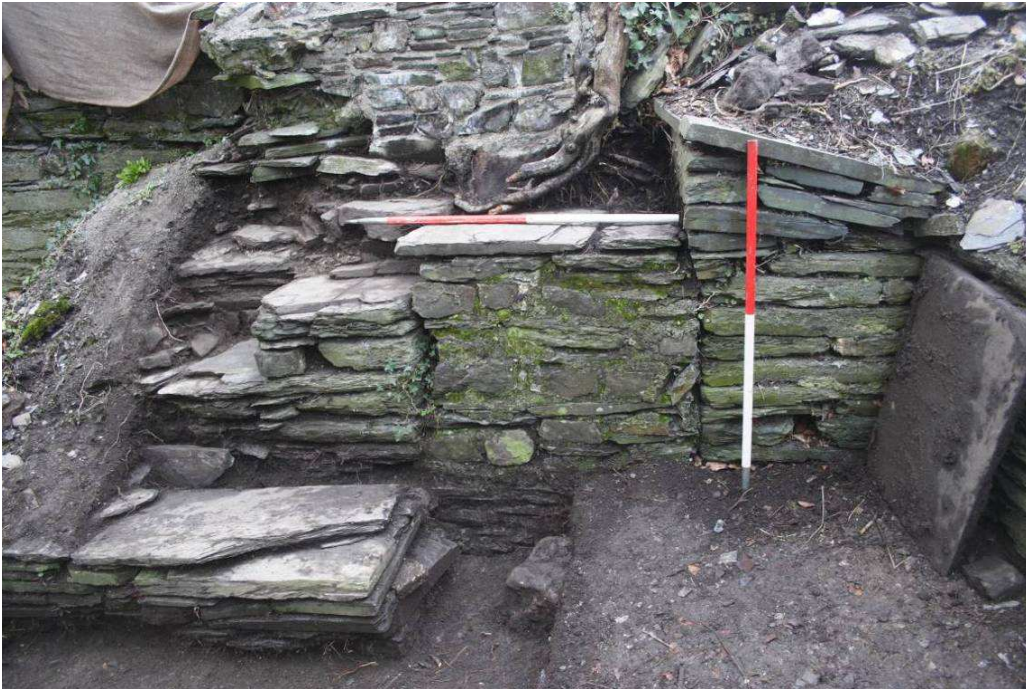
**Photo 50:** Facade of northeastern wall of the North East Tower, 1m scales

7.1.11 In front of the northwest end of the wall was a low plinth, constructed of thin slabs of stone (Photo 50 and 51). The top level of this plinth was lower than the first step of the wall behind. The stones used on the top of this plinth were very well cut and neatly finished.

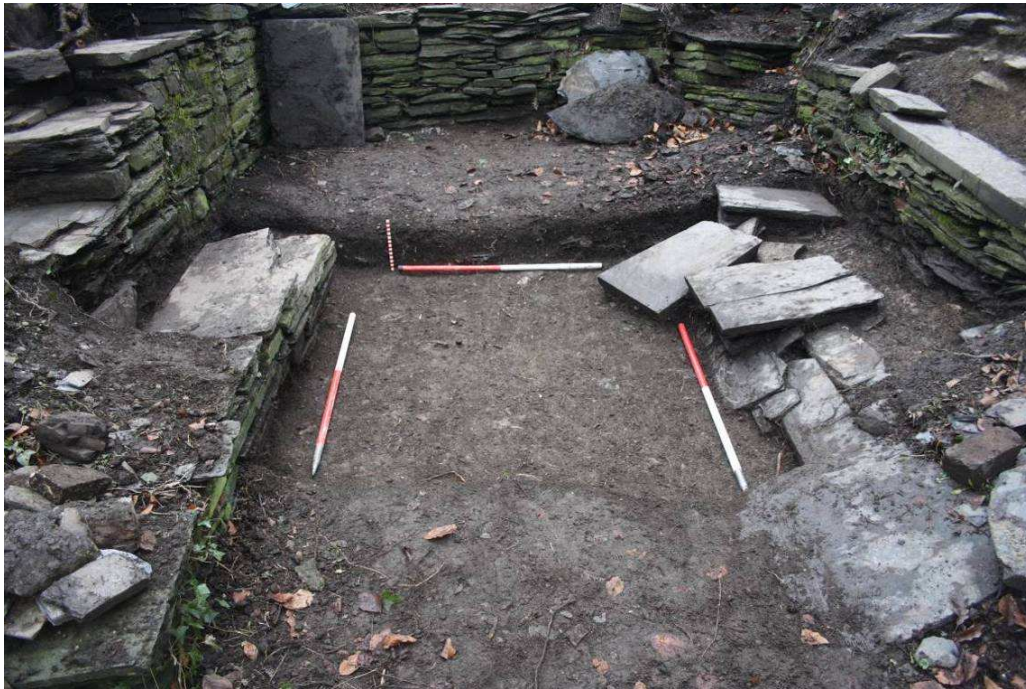
7.1.12 Excavation of a shallow depth of soil across the centre of the tower revealed the remains of a matching plinth on the southwestern side (Photo 51). This had slumped forward, with the majority of the upper slabs dislodged. This allowed the construction of the plinths to be recorded (Photo 52). Both plinths were c.0.5m in width, with the northeastern being 2.4m in length and the southwestern 3.7m. The upper slabs covered the entire width of the plinth, with narrower stones forming the front edge of the construction with soil infill behind.

**Photo 51:** Interior of tower following excavation, with plinths to the southeast and northwest, viewing southeast, 1m and 0.2m scales

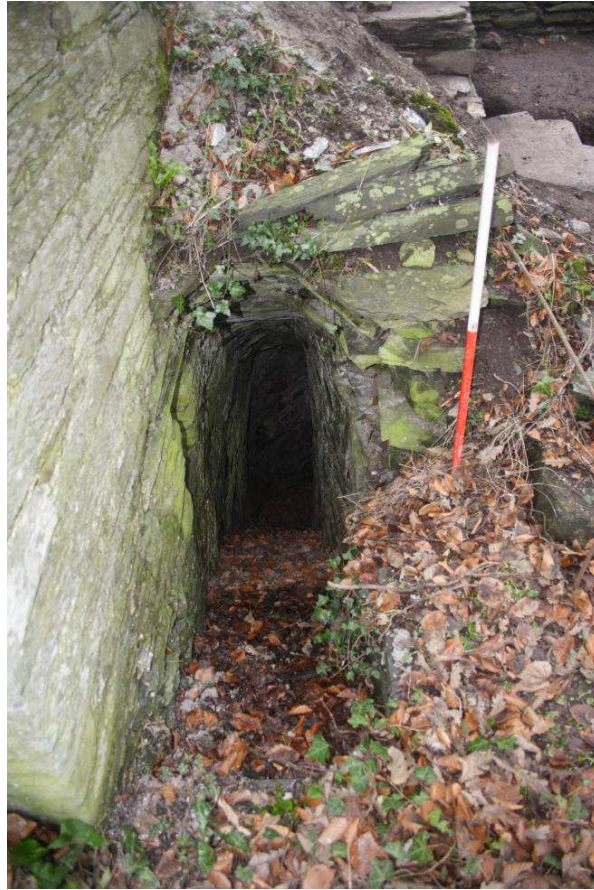
7.1.14 Running through the width of the tower walls to the northeast and southwest were two narrow stair cases (Photos 53 & 54). These had corbelled roofs, which were bonded into the walls (as could be seen at the surviving ends of the stairs). The steps led down through the tower to a garderobe at the southeastern end. On the southwestern outer facade of the tower an arrow loop is present of around 0.9m height (Photo 55). It was noted that this lay above the roof of the stairs, a light for these stairs being partially visible to the northwest (photo 55). A void behind the slit went back around 1.5m to a wall at the rear.

**Photo 53:** Northeastern steps through tower wall, 1m scale
