# CARDIGAN CASTLE, CEREDIGION ARCHAEOLOGICAL WATCHING BRIEF, PHOTOGRAPHIC SURVEY, & EVALUATION

Prepared by Dyfed Archaeological Trust  
For: Ceredigion County Council,  
Cadwgan Trust / Purcell, Miller, Tritton

RHIF YR ADRODDIAD / REPORT NO. 2011-50  
PHOTOGRAPHIC SURVEY - RHIF Y PROSIECT / PROJECT RECORD NO. 102421  
WATCHING BRIEF - RHIF Y PROSIECT / PROJECT RECORD NO. 102422  
NORTHEAST TOWER INVESTIGATION -  
RHIF Y PROSIECT / PROJECT RECORD NO. 102423  
FERNERY INVESTIGATION - RHIF Y PROSIECT / PROJECT RECORD NO. 102424

**Rhagfyr 2011  
December 2011**

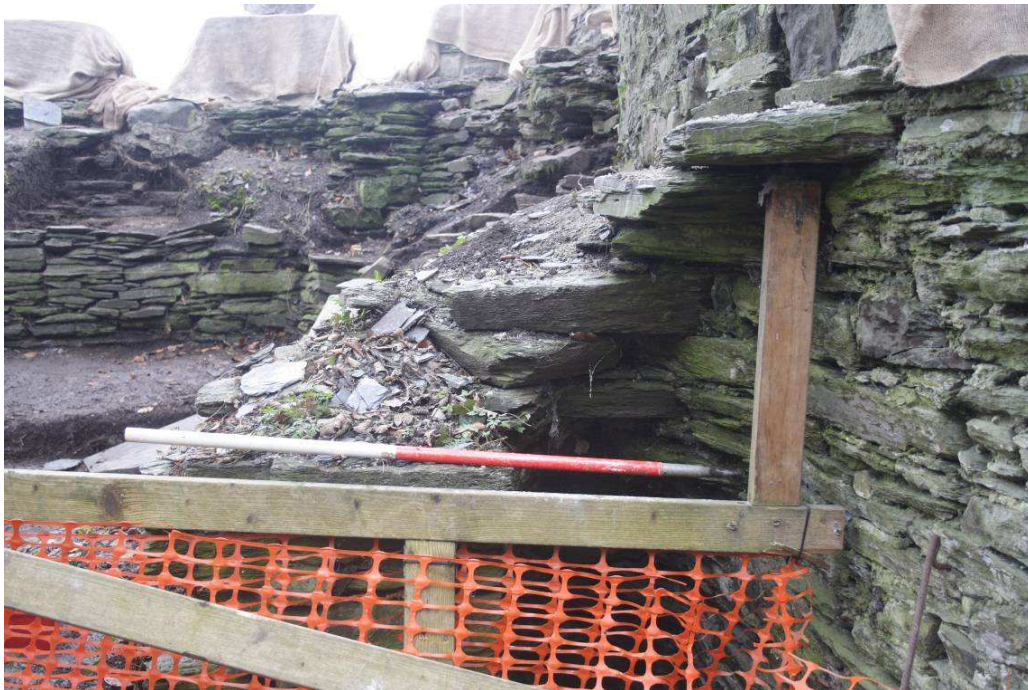
7.1.14 Running through the width of the tower walls to the northeast and southwest were two narrow stair cases (Photos 53 & 54). These had corbelled roofs, which were bonded into the walls (as could be seen at the surviving ends of the stairs). The steps led down through the tower to a garderobe at the southeastern end. On the southwestern outer facade of the tower an arrow loop is present of around 0.9m height (Photo 55). It was noted that this lay above the roof of the stairs, a light for these stairs being partially visible to the northwest (photo 55). A void behind the slit went back around 1.5m to a wall at the rear.

**Photo 54:** Entrance to southwestern steps through tower wall, 1m scale

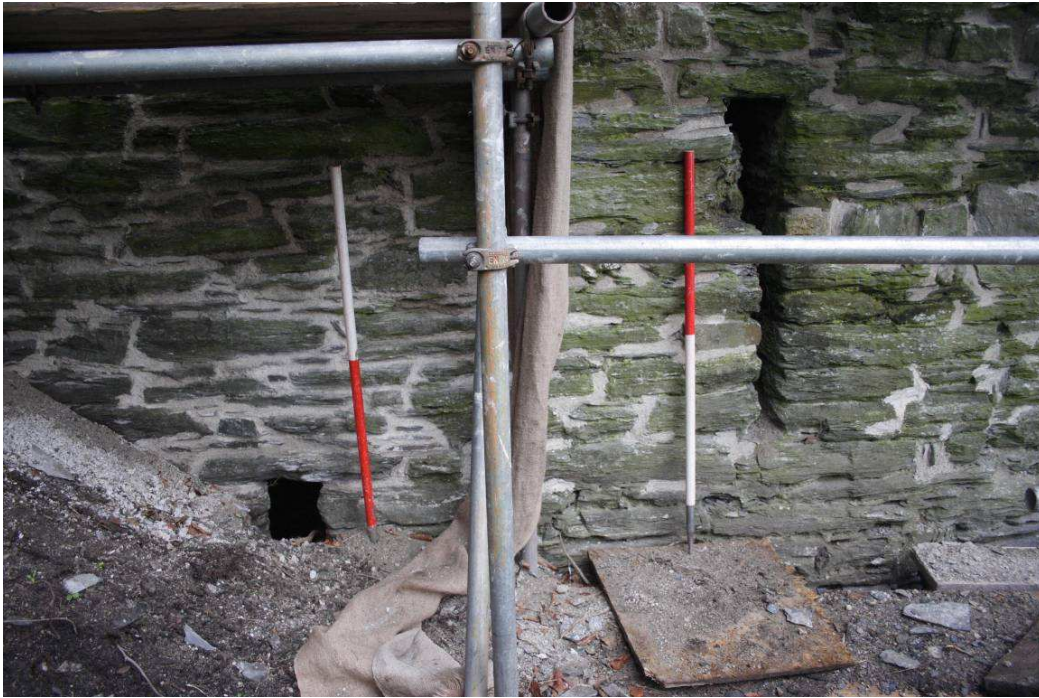
**Photo 55:** Arrow slit in southwest wall of tower,  
and lower light to northwest for stairs through wall, 1m scales

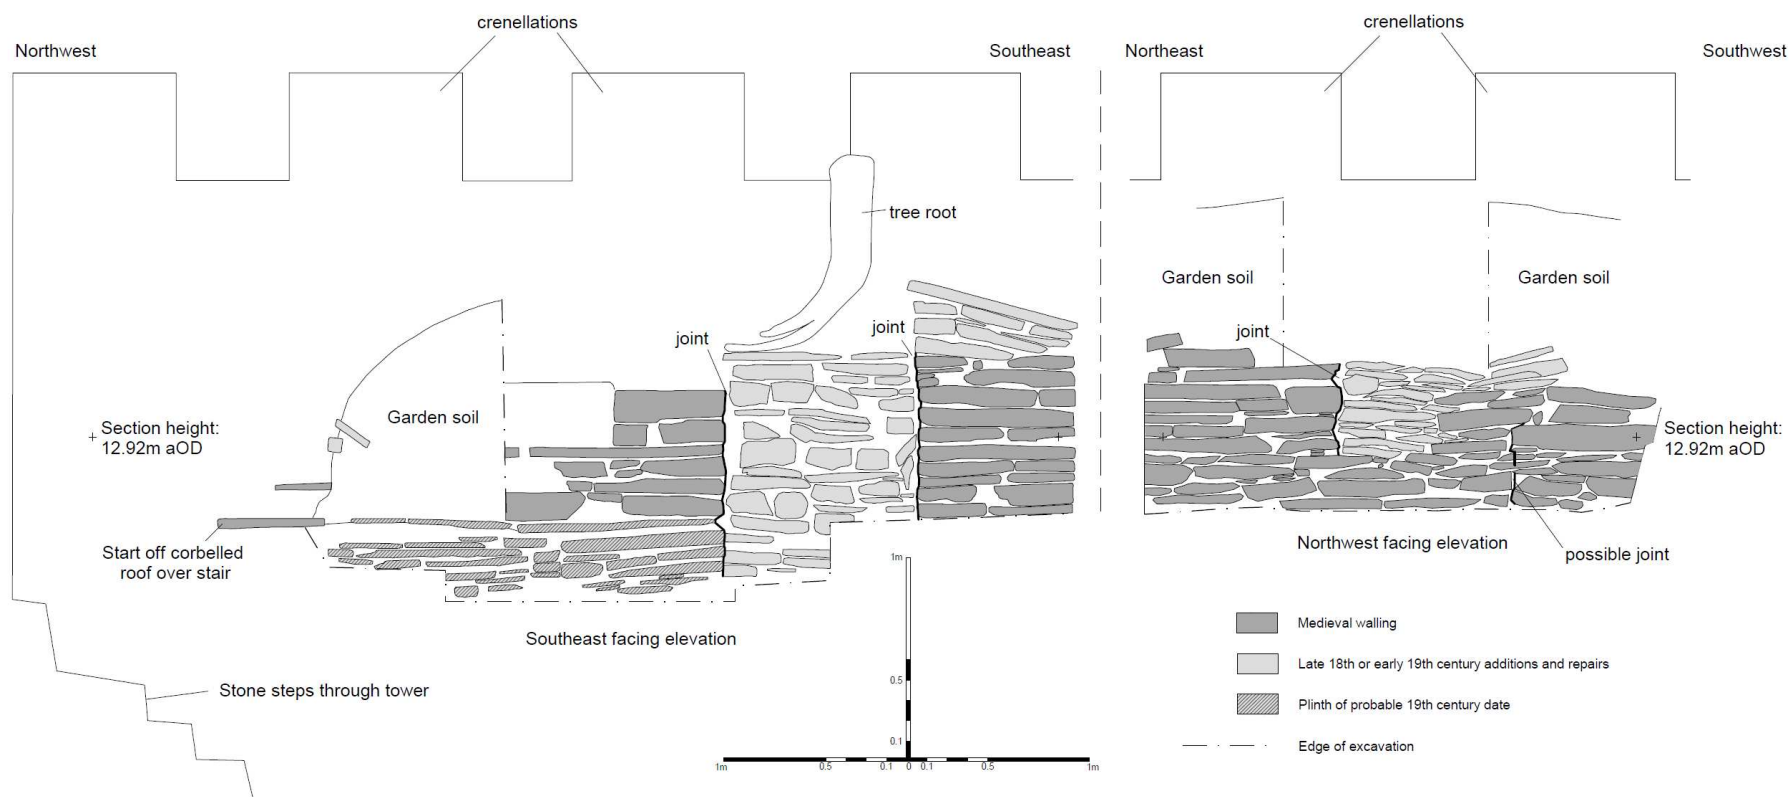
**Figure 6:** Northwest and Southeast facing sections of North East Tower showing steps and possible joints in the stonework

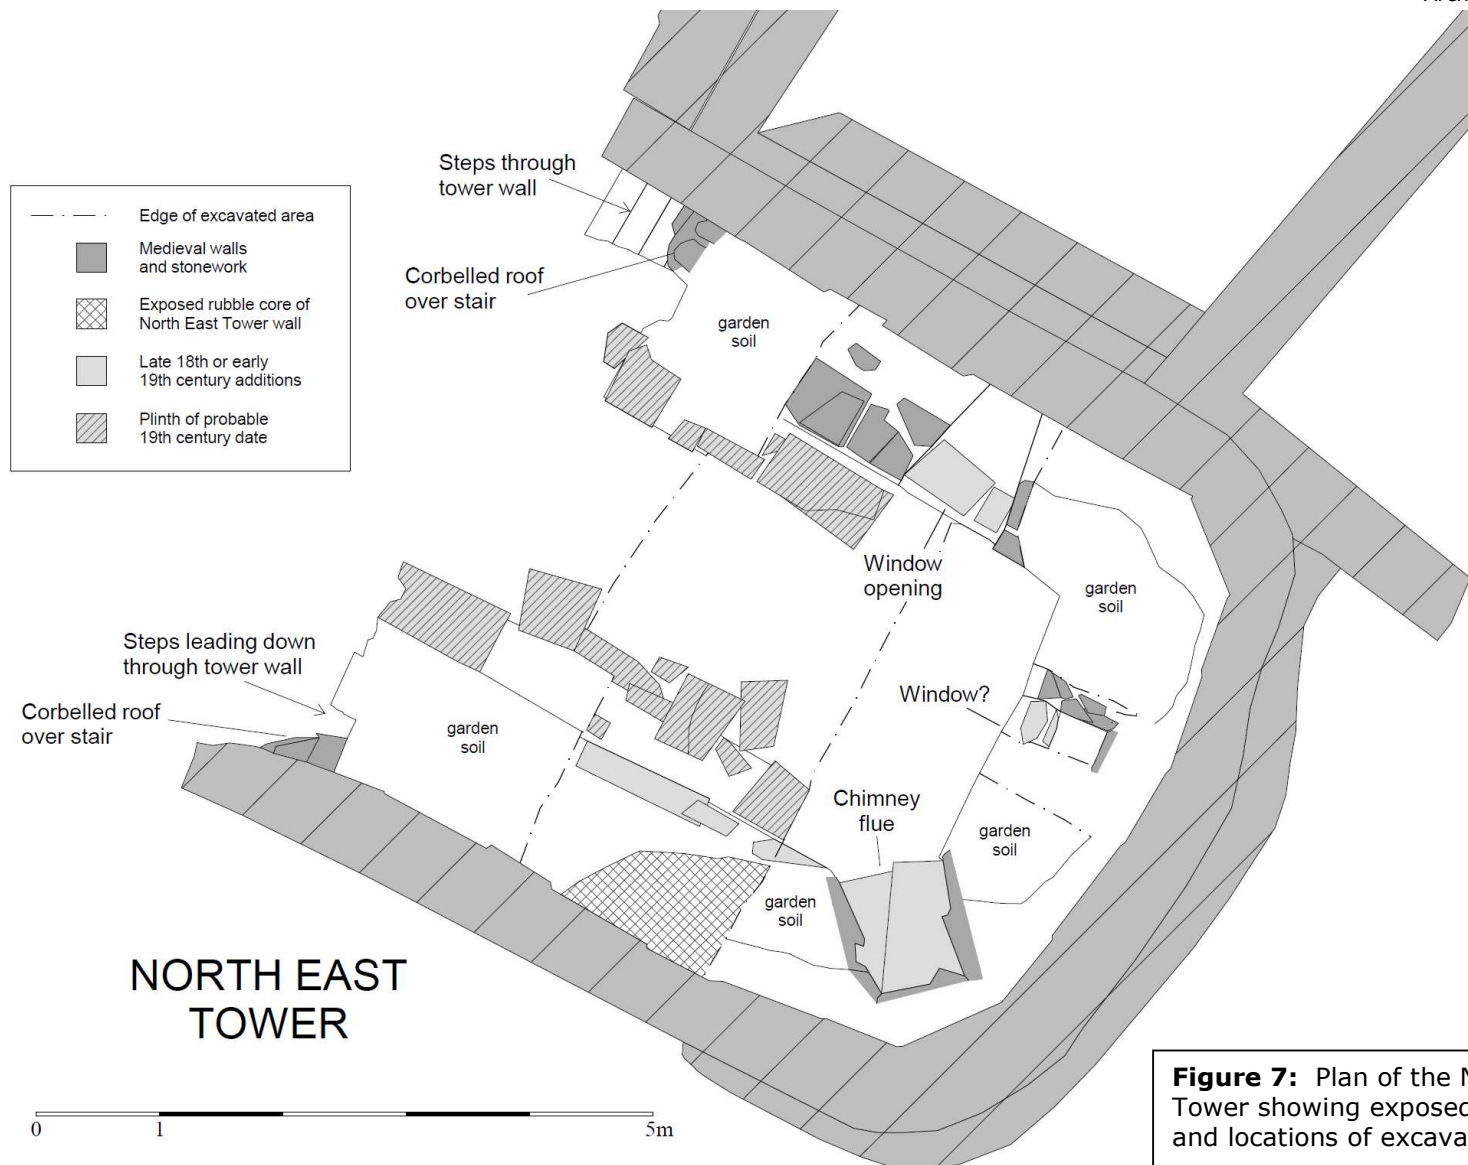
**Figure 7:** Plan of the North East Tower showing exposed stonework and locations of excavated areas

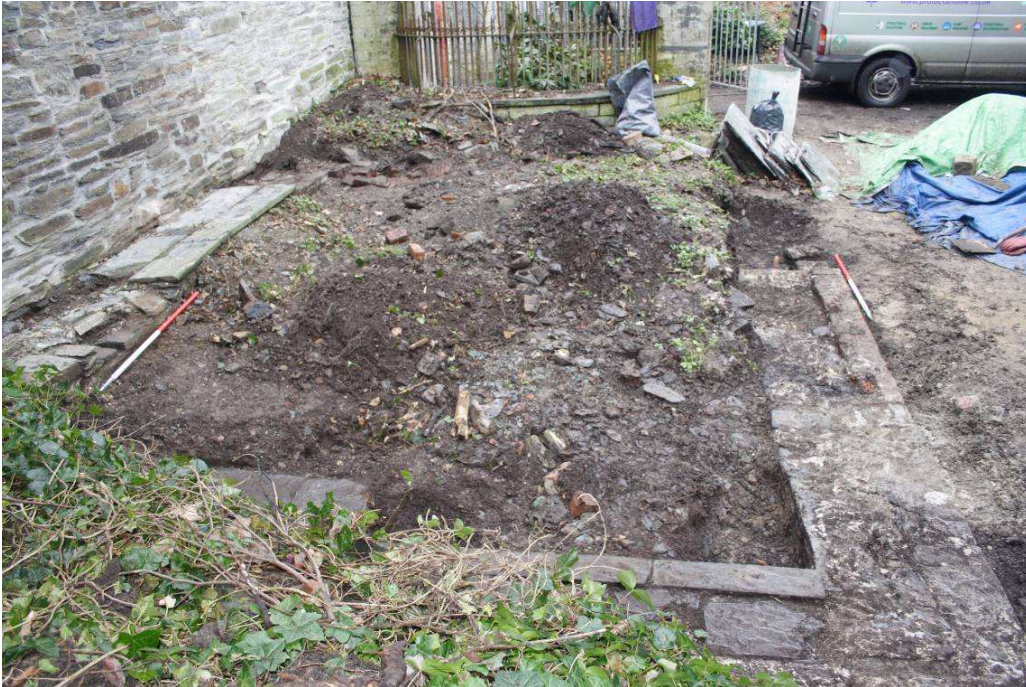
8.6 The investigation uncovered the southeast, northwest and southwest walls of the Fernery (Figure 8; Photos 56 & 57). The probable return of the northeastern wall was also identified in the northern corner of the structure (Photo 58). The building measured c.4.5m northeast to southwest and c.3.7m northwest to southeast.

**Photo 56:** View northeast across exposed area of the Fernery

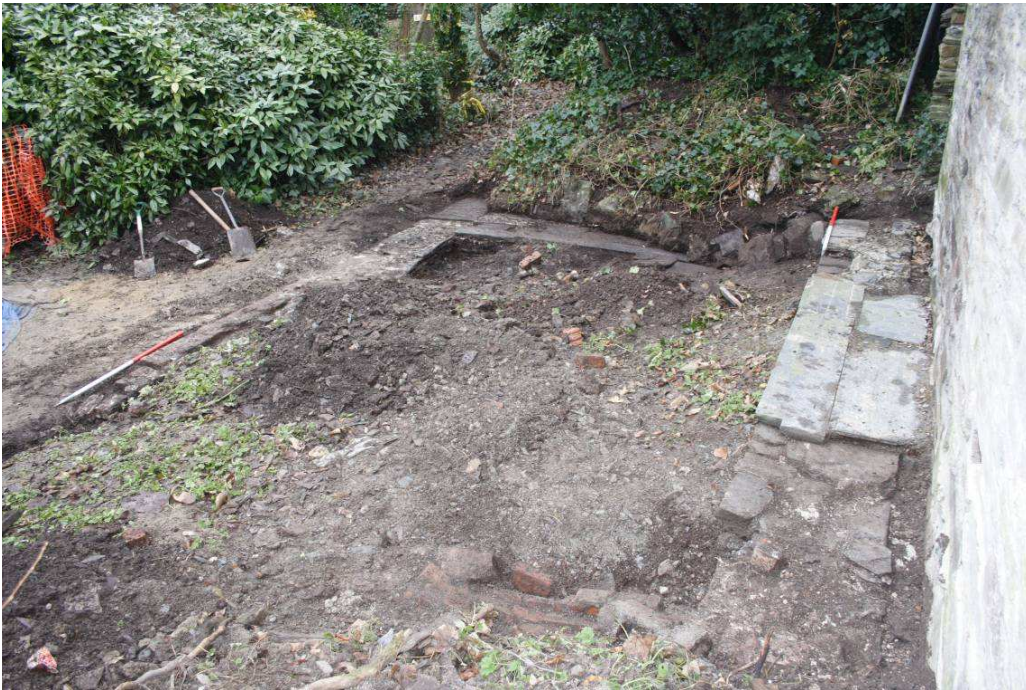
**Photo 57:** View south across exposed area of the Fernery

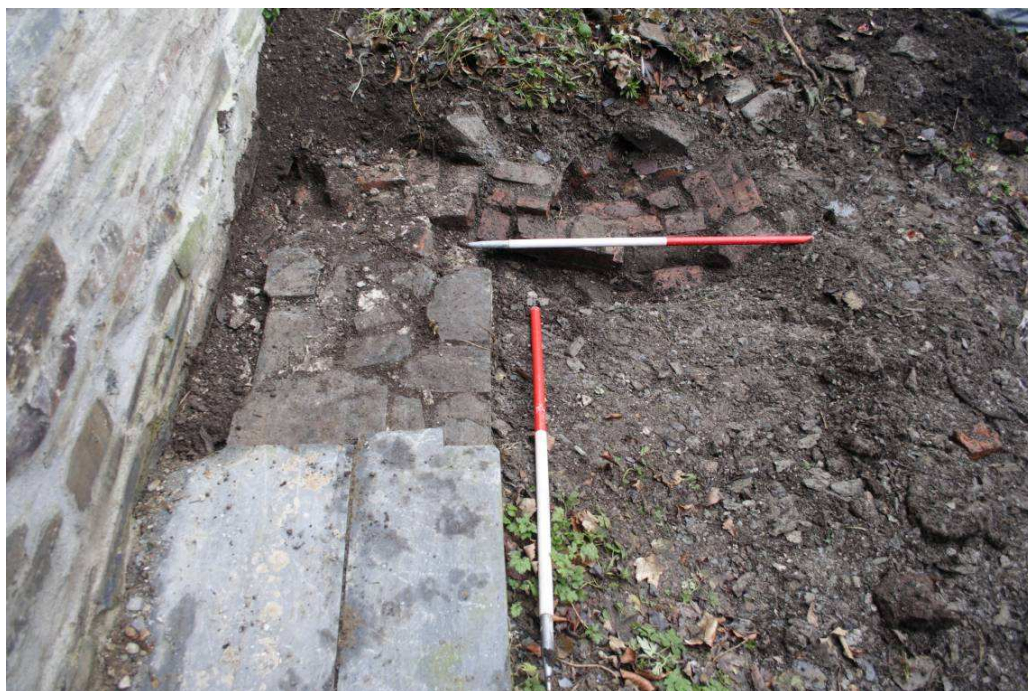
8.8 The northeastern part of the structure appears to have been truncated or robbed out in the past, perhaps reclaiming the brick for use elsewhere (Photo 58 & 59).

**Photo 58:** Northwestern corner of Fernery showing probable return built of brick

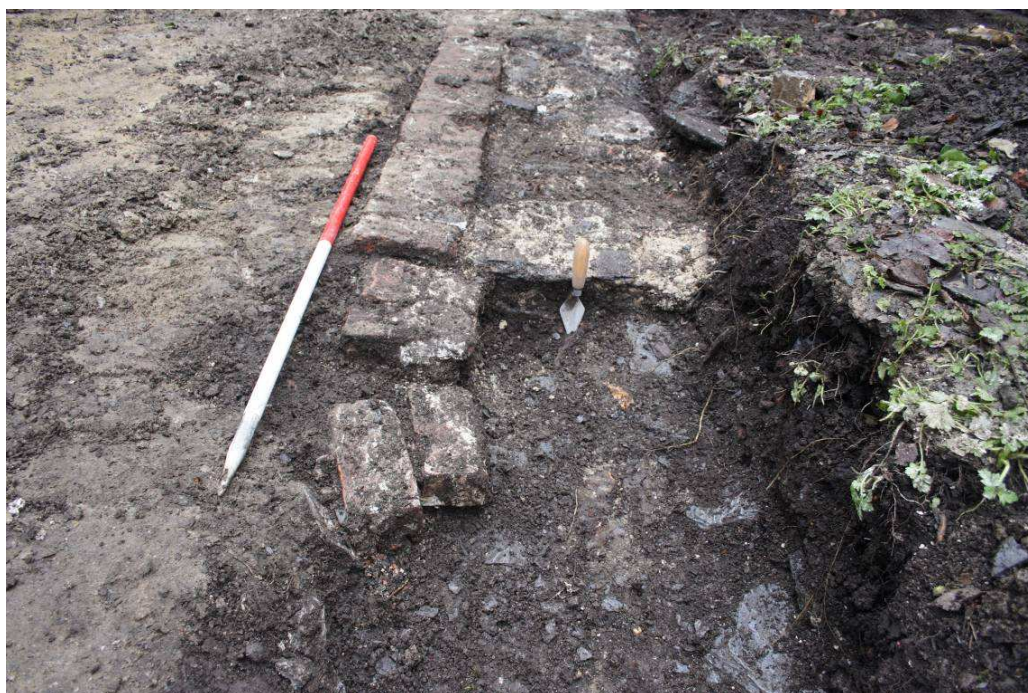
**Photo 59:** Northeastern corner of Fernery showing partly brick built wall and its truncated end

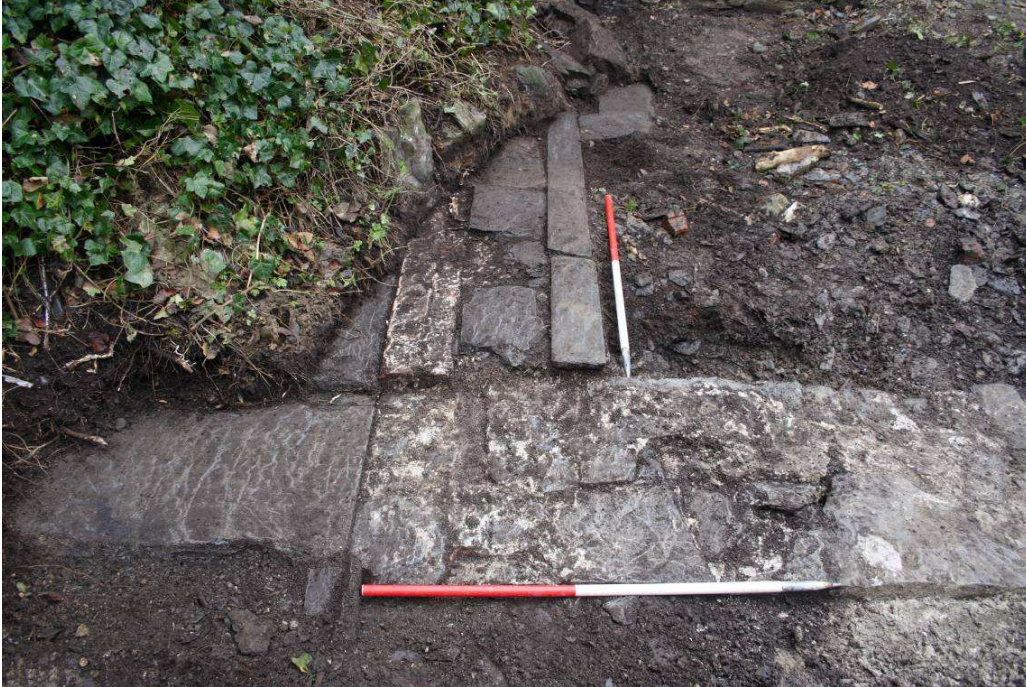
8.9 To the southwest of the Fernery two of slate slabs were revealed, with a suggestion that a flagged floor continued beyond the edge of the investigation area (Photo 60).

**Photo 60:** Southwestern corner of Fernery flag stones to the south

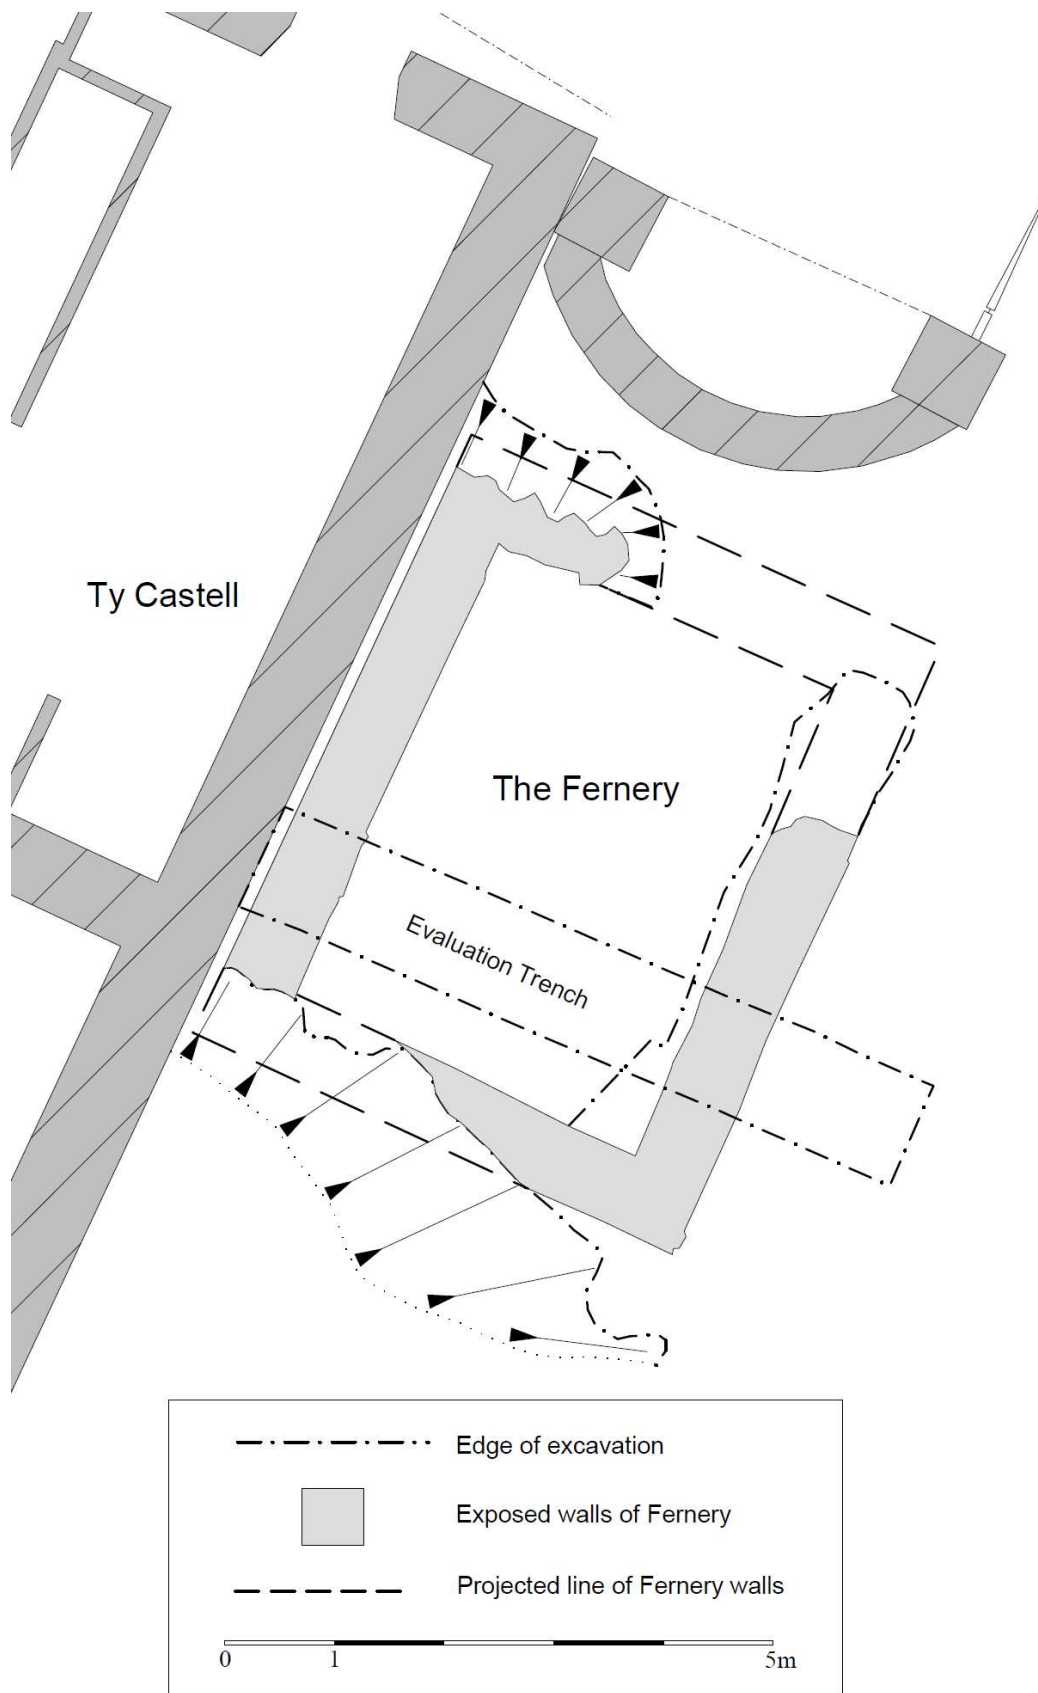
**Figure 8:** The Fernery
