PLAS ABERMEURIG, ABERMEURIG, CEREDIGION

PHOTOGRAPHIC BUILDING RECORD AND WATCHING BRIEF

RHIF YR ADRODDIAD / REPORT NO. 2011/59
RHIF Y PROSIECT / PROJECT RECORD NO. 102584

Rhagfyr 2011
December 2011

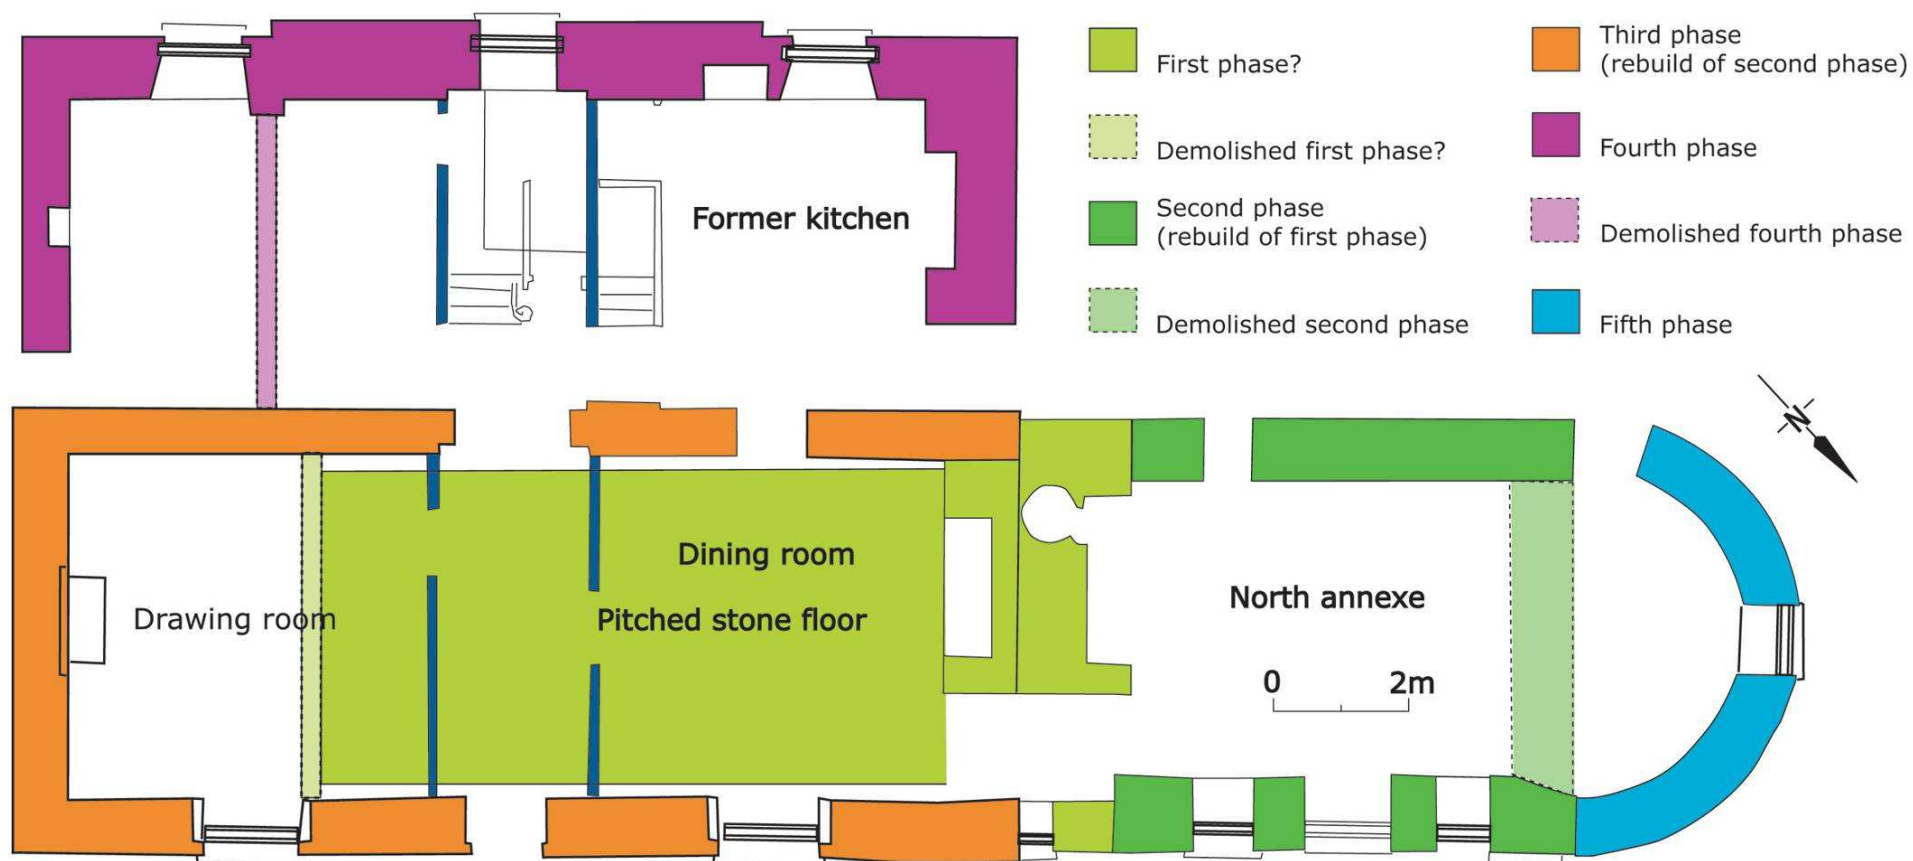
Figure 2: Ground floor phase plan

The blocked openings revealed in the dining room walls suggest that there was a second storey in the southern end of the building. The surviving evidence appears to suggest either that this was the form of the original building, or that it entirely replaced an earlier building. The only possible evidence to suggest there was an earlier building on the site is that the cobbled floor surface appears not to run up to the base of the walls (suggesting they were originally associated with different walls to those existing now).
