THE OLD SCHOOL, QUICKWELL HILL, ST DAVID'S, PEMBROKESHIRE:

PHOTOGRAPHIC SURVEY AND WATCHING BRIEF 2011

RHIF YR ADRODDIAD / REPORT NO. 2012/32 RHIF Y DIGWYDDIAD / EVENT RECORD NO. 102869

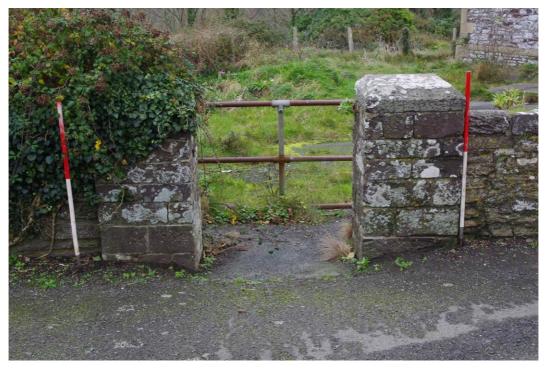
Photo 1: Southern pedestrian access into schoolyard, viewing west (image number 142)

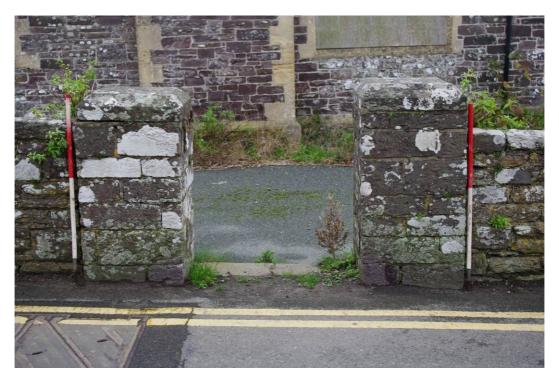
Photo 2: Central pedestrian access into schoolyard viewing west (image number 132)

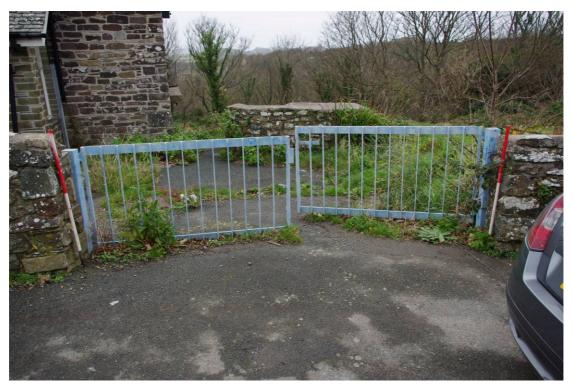
Photo 3: Northern main gated entrance into schoolyard, viewing west (image number 127)

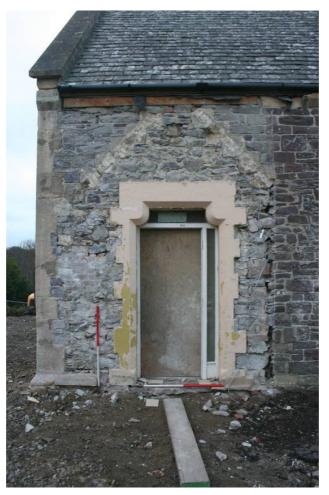
Photo 6: Shoulder-headed doorway in south end of east wall

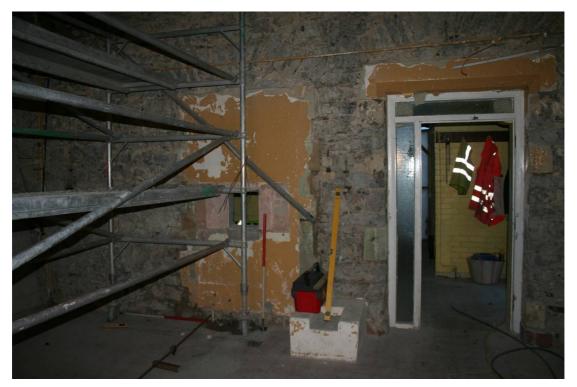
The removal of the render revealed a number of features. In the north wall a shoulder-headed doorway was uncovered lying approximately 1m to the west of the existing shoulder-headed doorway (Photo 9).

Photo 9: Pair of shoulder-headed doorways in north wall.

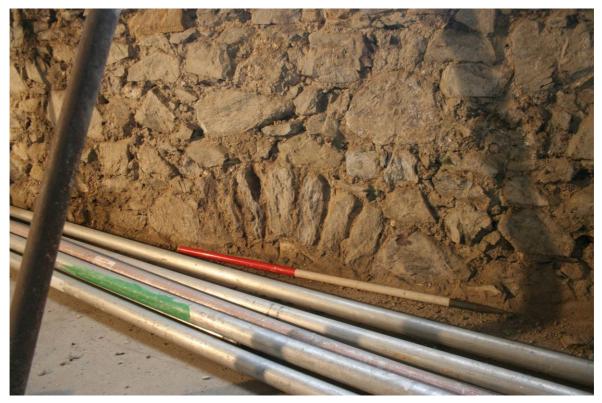
The floor has been raised approximatly 0.18m in the recent past when a damp-proof membrane was inserted, as evidenced by a small test hole in the floor. Consequently the arches spanning the ventilation grills are only partially visible (Photo 10).

Photo 10: Ventilation arch in west wall

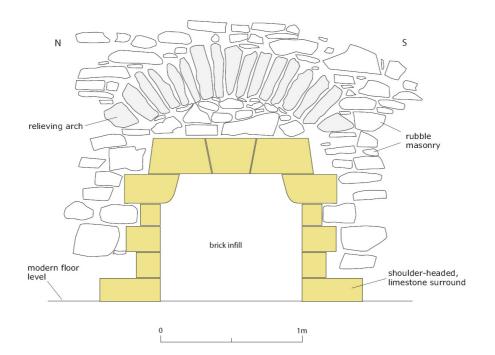
On the east wall the removal of the render exposed two blocked-up fireplaces and their shoulded-headed surrounds (Photo 11).

Figure 7: Diagram of fireplace in east wall

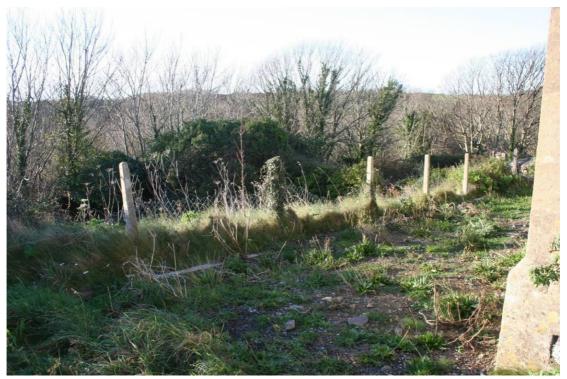
Photo 13: Looking northwest at level platform leading to the garden steps on the west side of school. Southwestern corner of school visible.

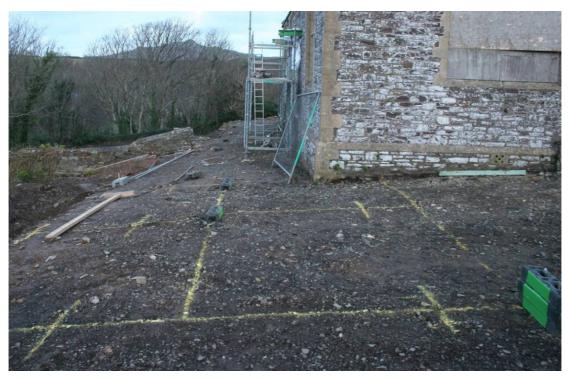
Photo 14: Looking north; after removal of overburden the trench lines are marked out.

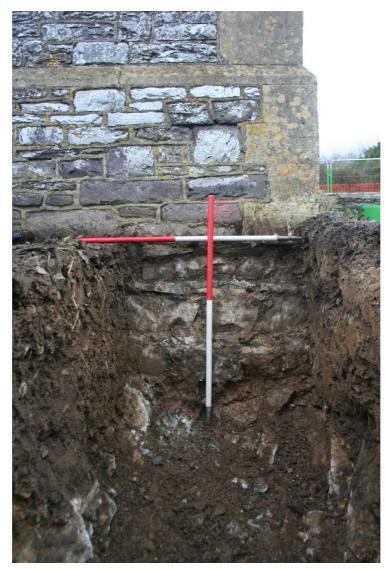
The three eastern trenches were approximately 8 metres long, 0.9 metres wide with an average depth of 1m The eastern and northern ends of trenches A (Photo 15) and B respectively exposed the footings of the southwestern corner of the school building (Photo 16, Figure 10). Two other trenches were cut inside the footprint to accommodate partition walls (Photo 14, Figure 9). The western exterior trench (trench D) averaged 1.5m in depth on its eastern side due to it being terraced into the incline (Photo 17).

Photo 16: Looking east; footings exposed in trench A.

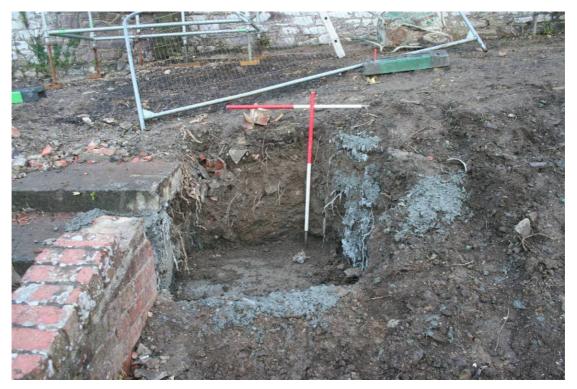
To the north of this footprint three box trenches were terraced into the incline. These measured 1.5m by 2.5m, ranging in depth from approximately 1m to 1.8m (Photo 18, Figure 9). These were dug to accommodate the framework for a pentice. This work was undertaken by a tracked excavator using a toothed bucket.

Photo 18: Looking east at box trench next to steps.

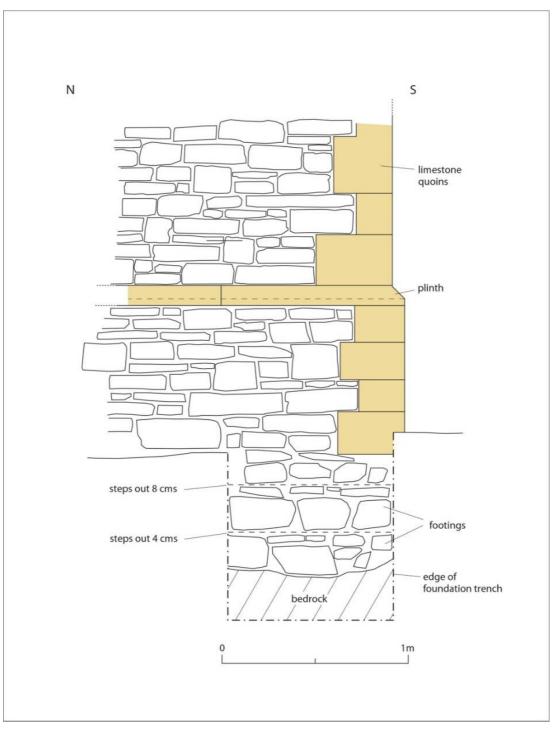
Figure 10: West facing elevation above trench A where it exposed the foundations of the southwestern corner of the Old School, St David's
