ARCHAEOLOGICAL QUINQUENNIAL REVIEW: CASTLEMARTIN RANGE, MANORBIER RANGE AND PENALLY TRAINING AREA

CONDITION ASSESSMENT

Prepared by DAT Archaeological Services
For: Landmarc Support Services.

RHIF YR ADRODDIAD / REPORT NO. 2015/50
RHIF Y DIGWYLLIAD / EVENT RECORD NO. 108638

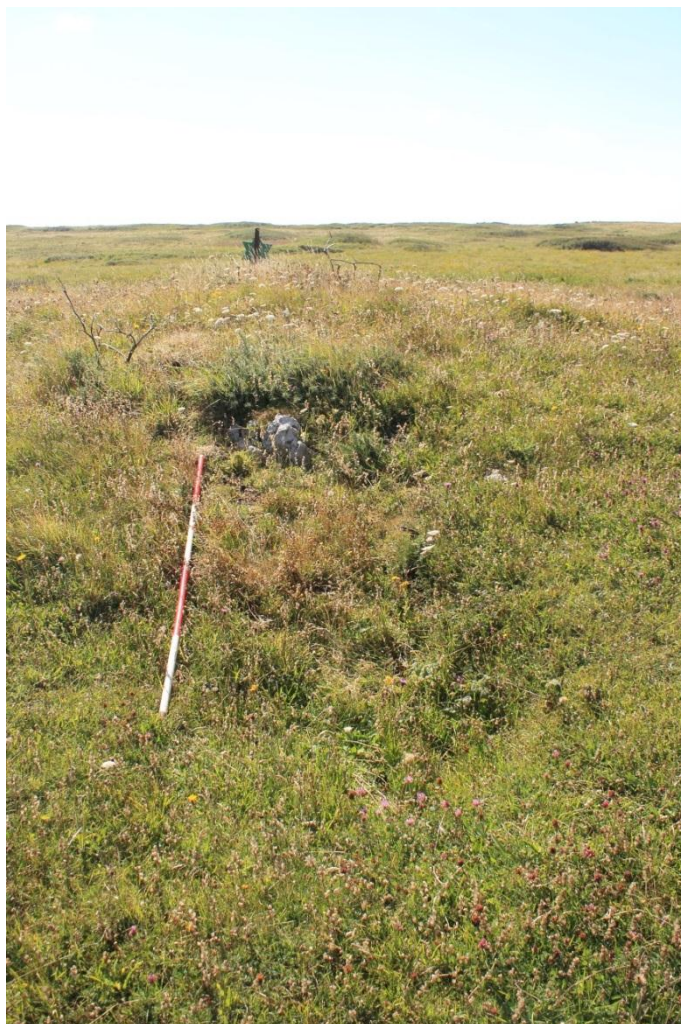
The tumulus earthwork appears as a low circular mound approximately 7.5m in diameter and 0.9m in height located on the coastal edge. A 'No digging' star is positioned on the monument (Photos 1 & 2) to indicate its significance and prevent damage to it. However, on the north side of the monument signs of recent digging or ground disturbance activity was observed (Photo 3), this appears to be scoop-like and maybe the result of impact from a projectile. Vegetation has grown back across the scoop so this probably occurred at least one year ago

Photo 3: Scoop located on the north side of the monument.

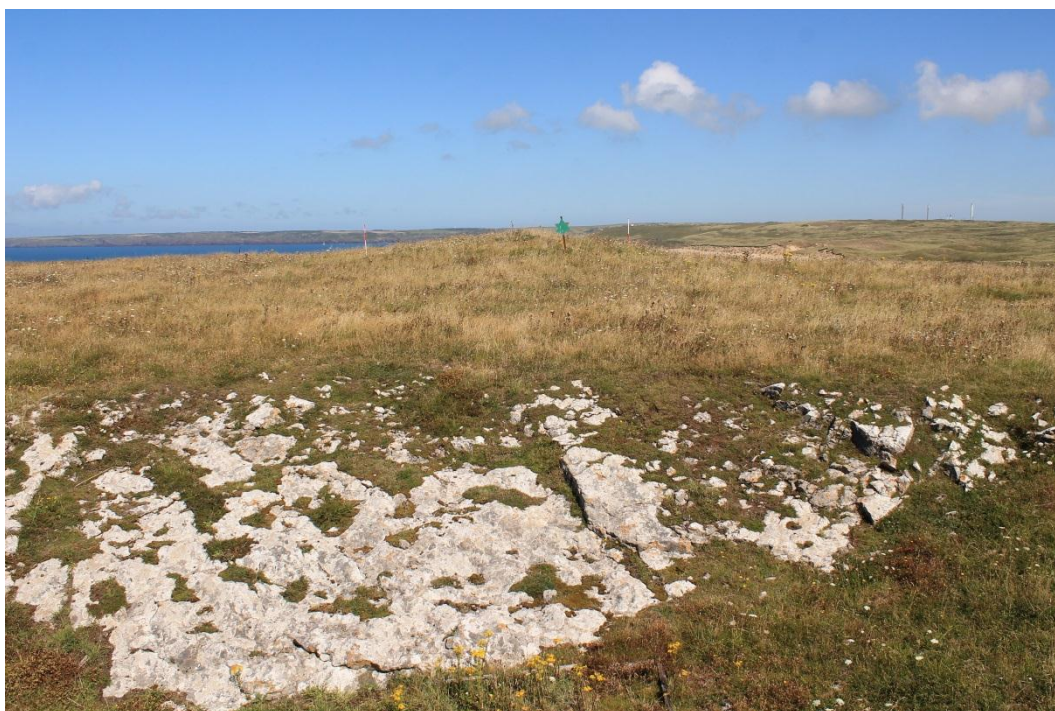
A quarry area lies further to the south of the monument recorded on plans of the site (Photo 4).

Photo 4: Viewing north from the quarry site towards the barrow

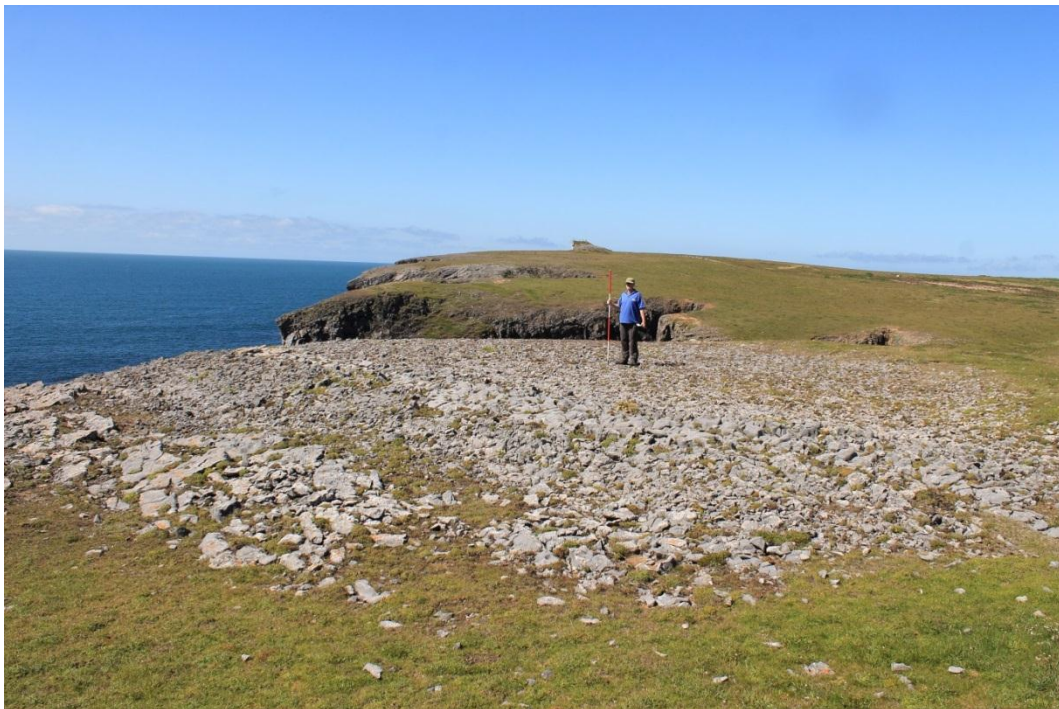
The upper surface of the southern part of the fort is also undergoing constant erosion from sea spray which has resulted in large areas of soil being washed away from the surface exposing the underlying bedrock (Photos 8 & 9).

Photo 8: Topsoil eroded on southwestern coastal edge.

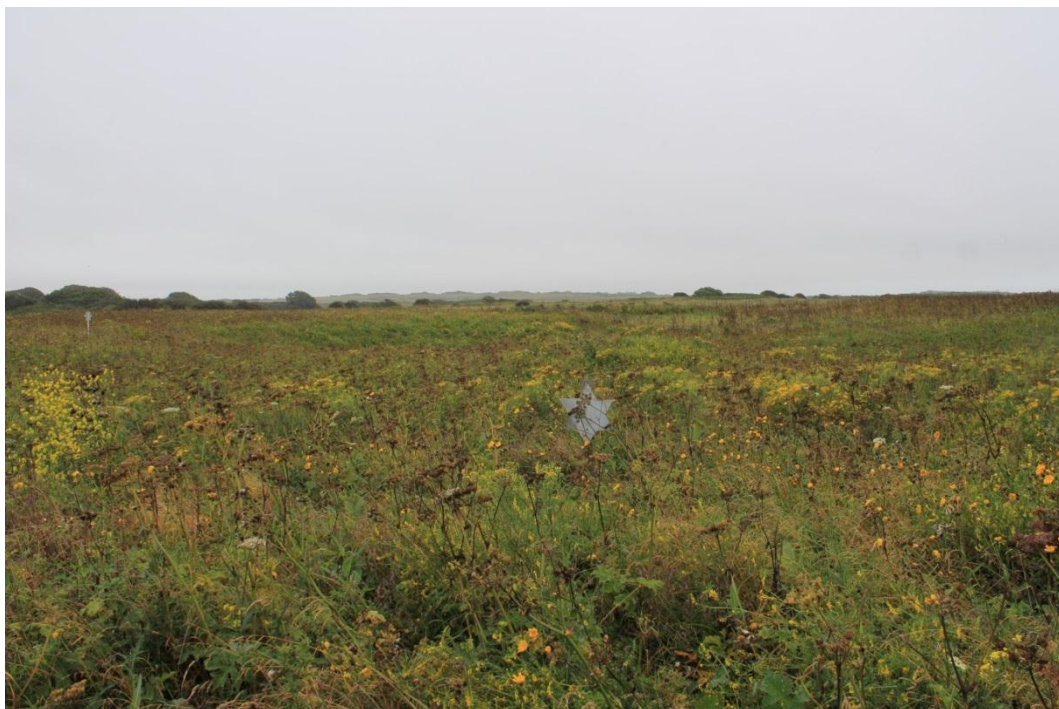
Photo 12: View looking south across monument with 'no digging' star in the foreground.

The only real threat to the monument appears to be from scrub encroachment and this should be monitored and preventative steps taken if it begins to pose a problem. Ideally the area should be strimmed a couple of times a year to prevent the more damaging species (brambles and brackens) taking hold.

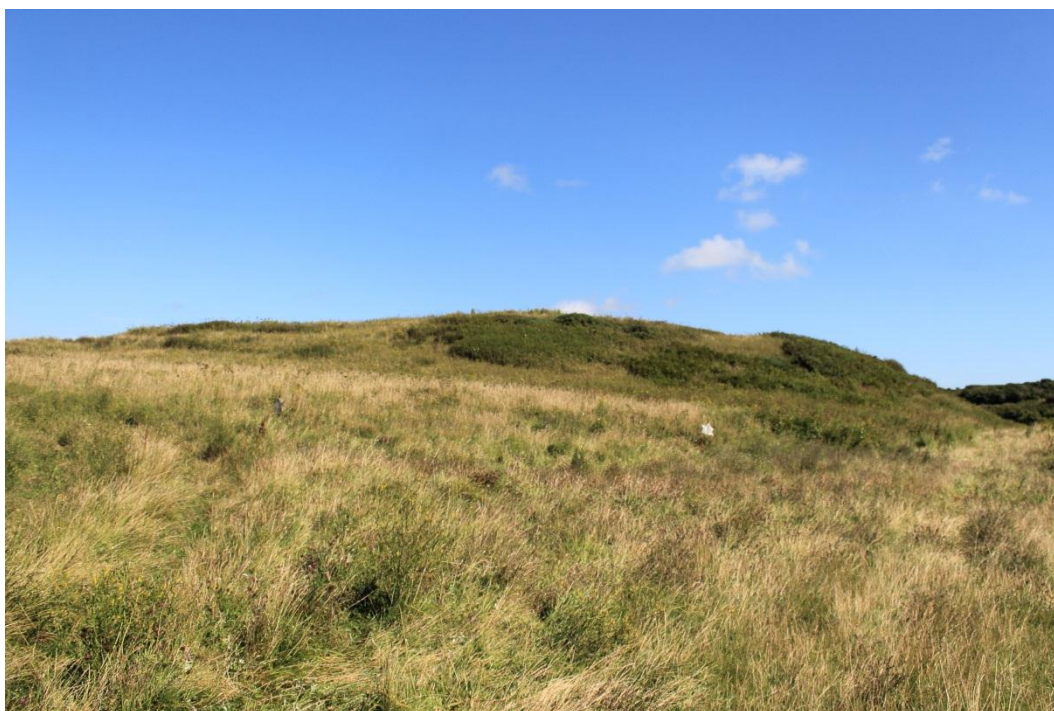
Photo 14: View east from the existing track way towards Bullibar camp on the hilltop, with 'no digging' star visible

The monument may also benefit from having more 'no digging' stars erected as these were only observed on its western edge near to an access track.

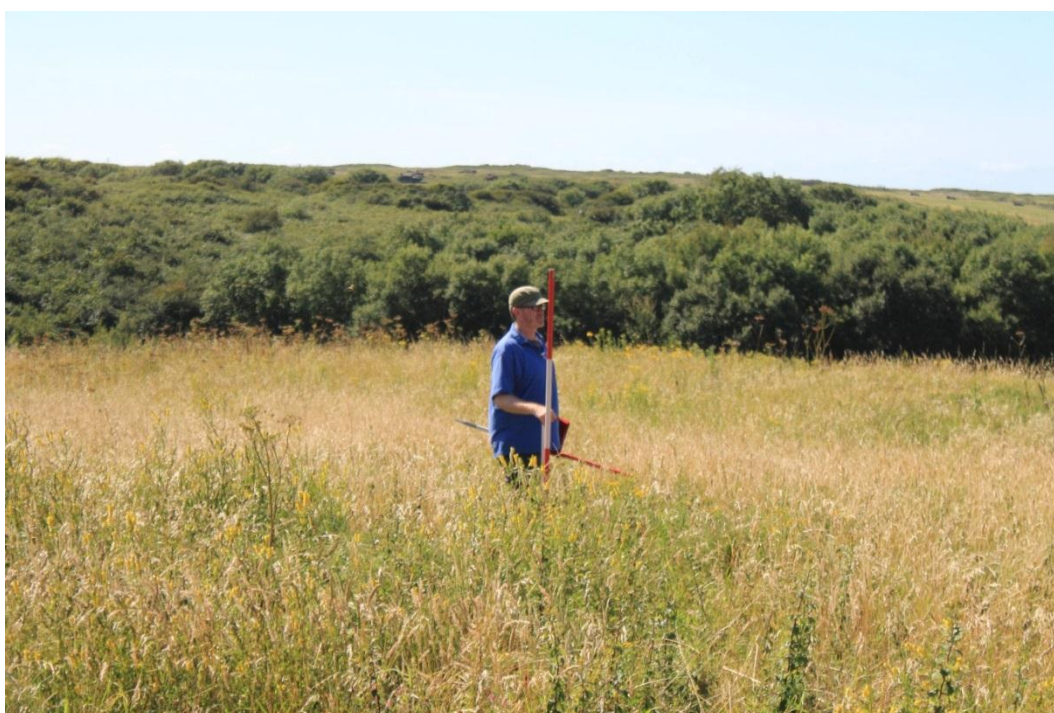
Photo 15: Viewing west across interior of fort demonstrating height of vegetation.

A programme of vegetation clearance should be implemented to remove the dense vegetation and inhibit the growth of the more destruction species (bracken, brambles and blackthorn). Vegetation clearance has been undertaken on the monument previously (Cadw description from 2002). The internal part of the monument could be mowed, assuming safe access could be made with a tractor. Blackthorn stands should definitely be cut back.

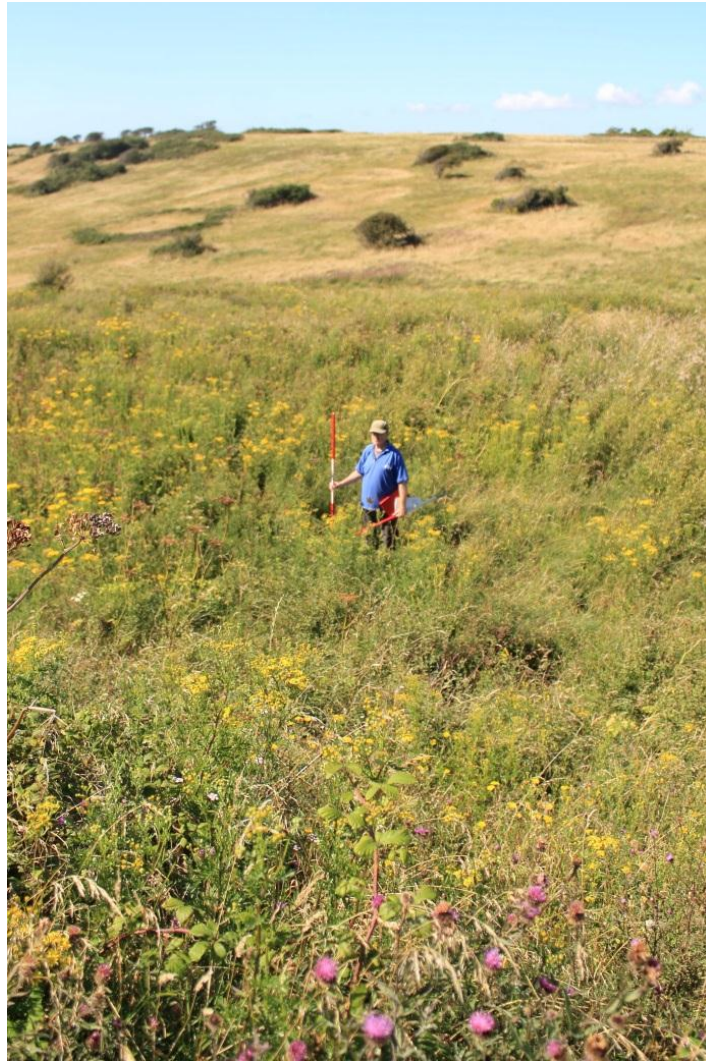
Photo 16: Viewing west across ditches showing height of vegetation.

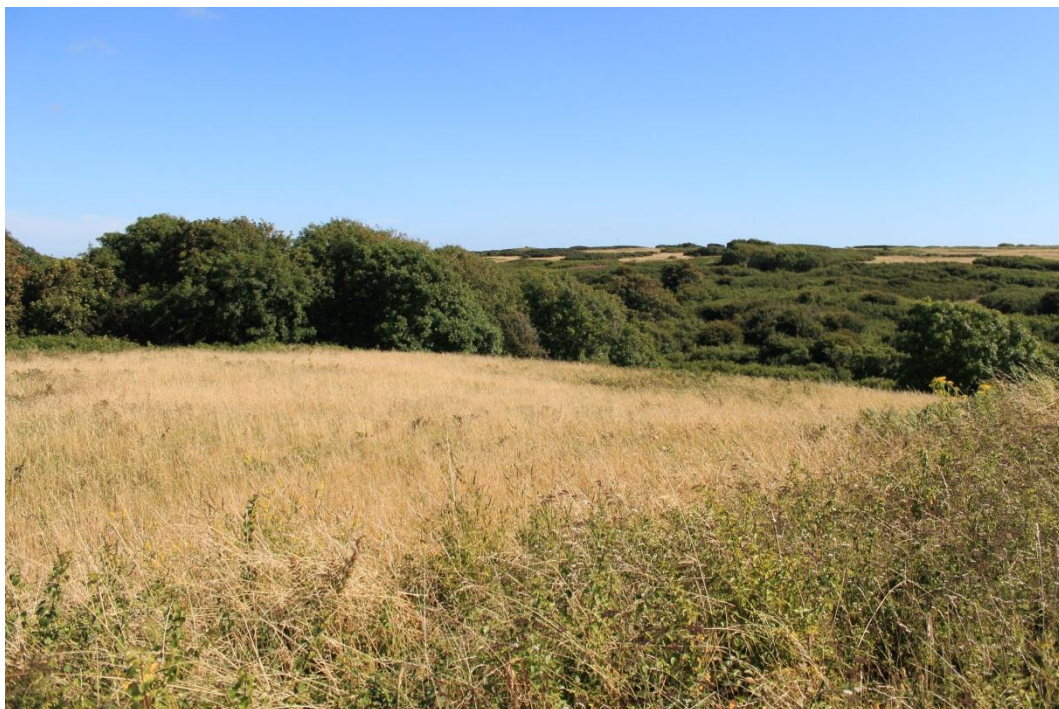
The condition of the monument appears to be generally fair and stable but would benefit from removal of scrub encroachment, particularly in its interior.

Photo 17: Interior of Bullibar East Camp, viewing southeast.

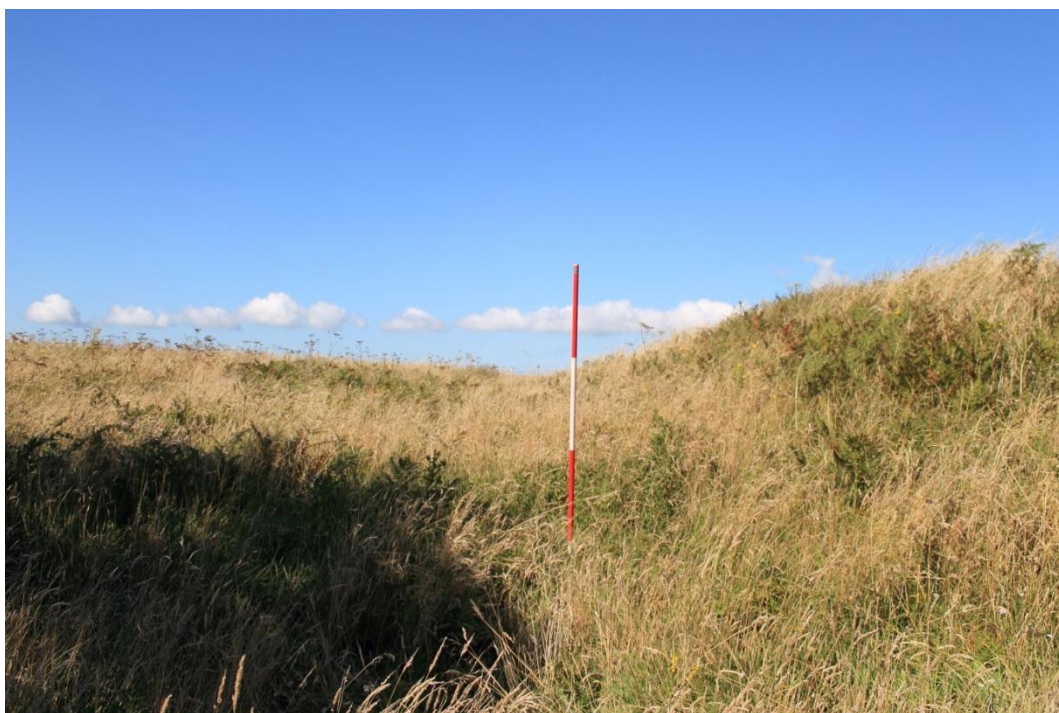
Photo 18: Viewing north along western ditches of Bullibar East Camp.

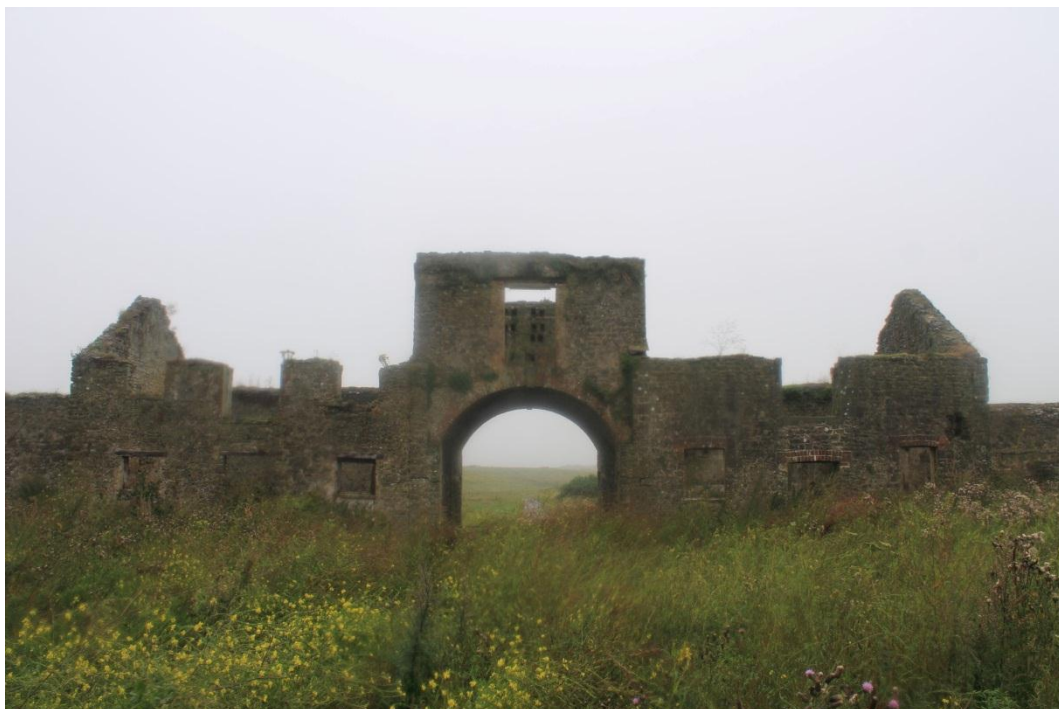
Photo 22: View from inside courtyard towards entrance range August 2015, showing height of vegetation (photo taken in poor weather)

Where possible invasive plants should be carefully removed from the walls of the building and wooden lintels should be inspected and replaced where necessary. A regime of regular cutting of vegetation within the courtyard should also be carried out. The grounds staff could also undertake basic monitoring of the structures at the same time, noting any collapsed lintels or note where structures may be about to fail in order that remediation works may be carried out.

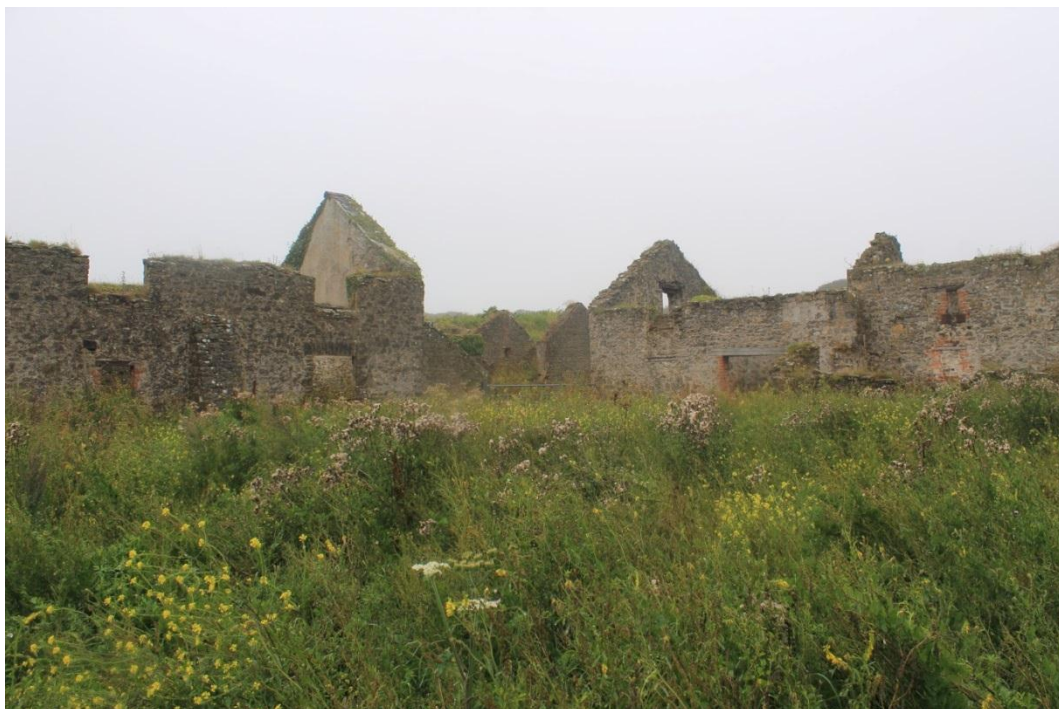
Photo 24: View South across interior of courtyard showing extent of vegetation growth.

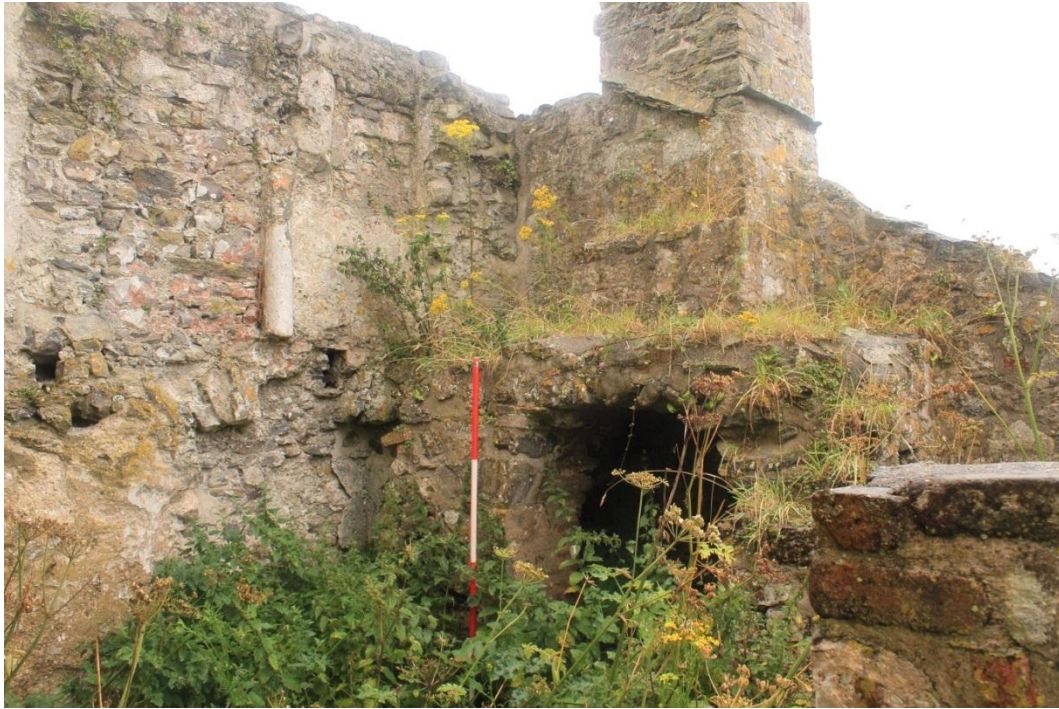
Photo 30: View of bread oven and showing extent of vegetation growth.

Where possible, invasive vegetation should be removed from the walls of the building and its interior and this should be continuously monitored.

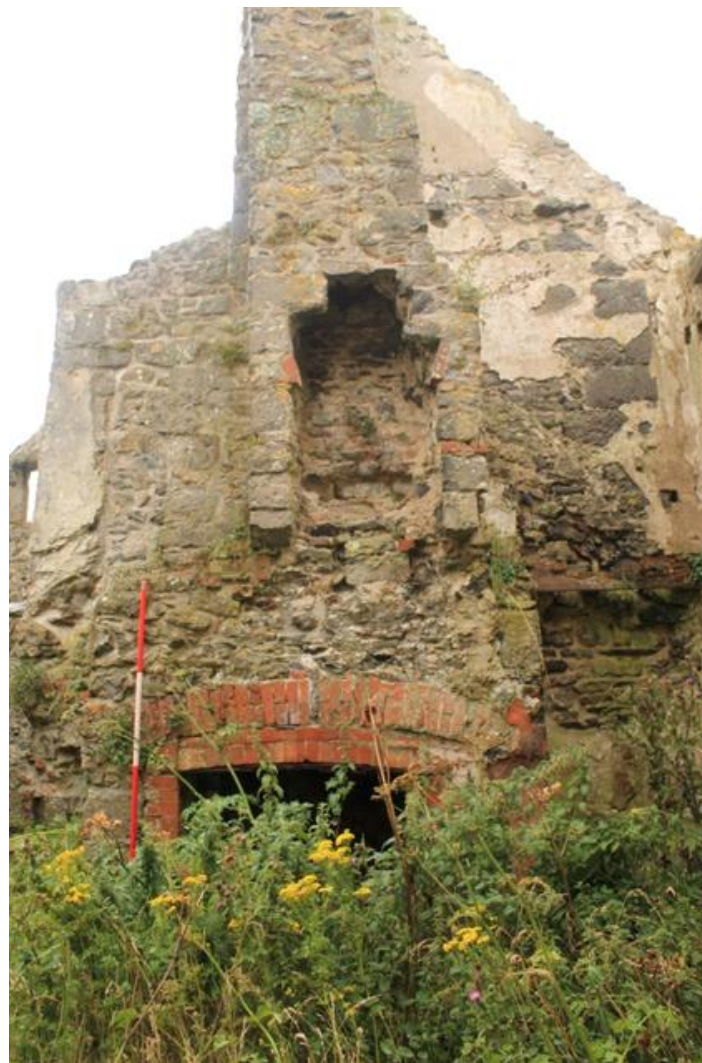
Photo 32: Northwest wall of kitchen showing fireplace and chimney and height of vegetation within interior of building.

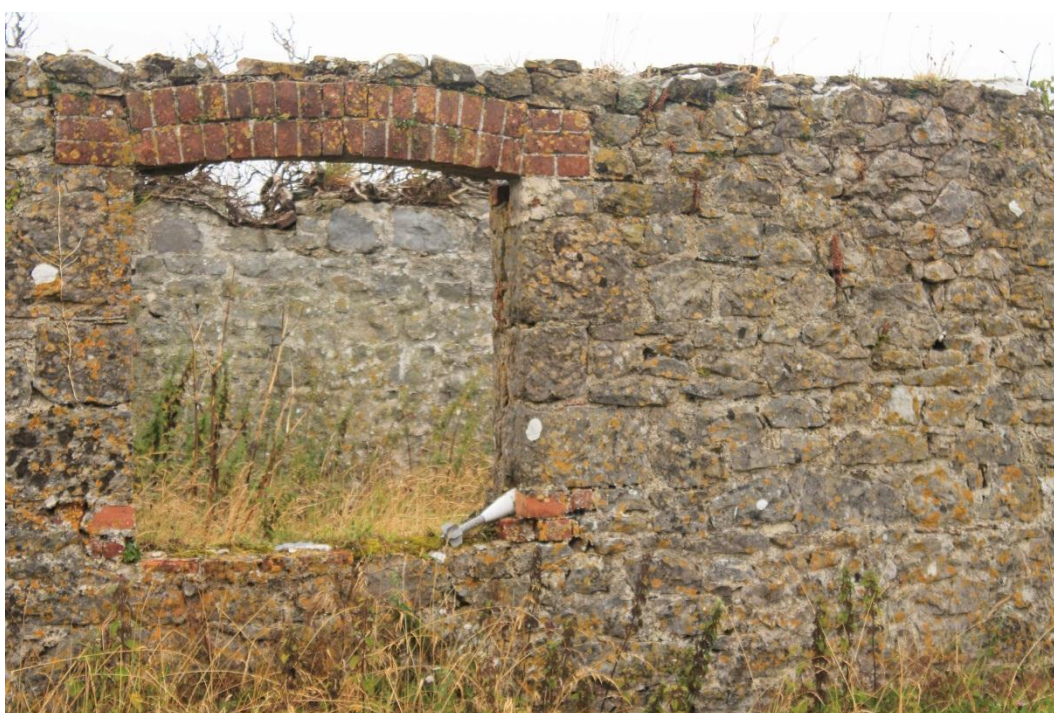
Photo 38: View east of window opening in cowshed showing mortar shell within window opening

If necessary firing targets should be relocated so that Pricaston Farm is no longer at threat from impact from shells.

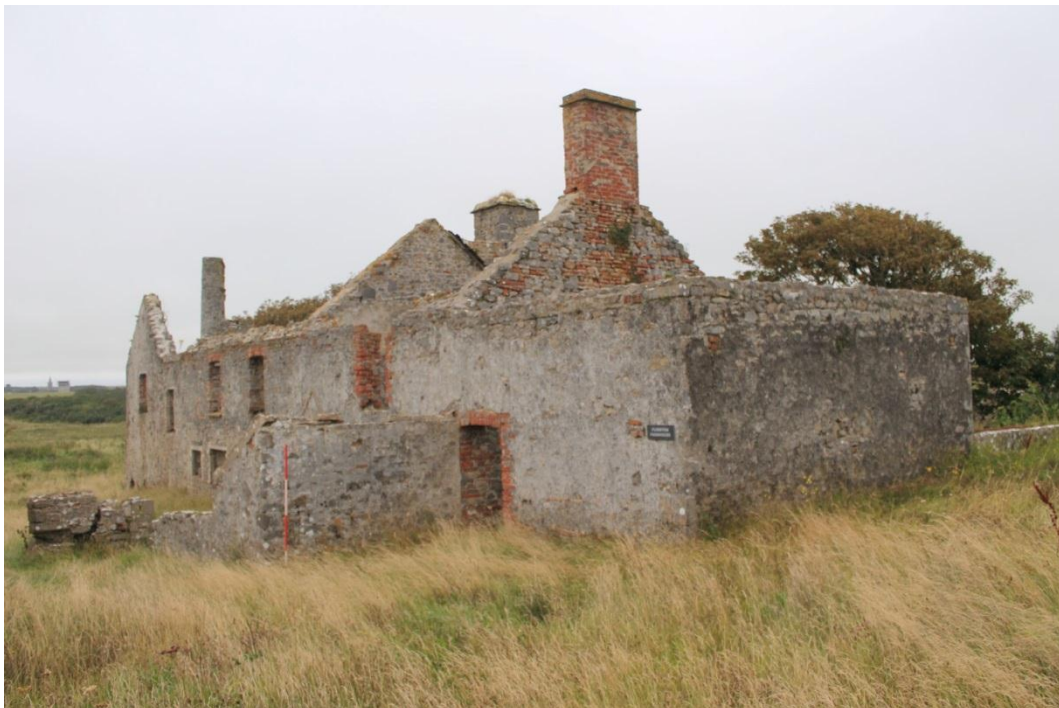
The current condition of Flimston Farmhouse is fair and most probably stable, although it would be beneficial to monitor vegetation growth which may adversely affect the infrastructure of the building.

Photo 39: External view of Flimston Farmhouse, viewing northeast.

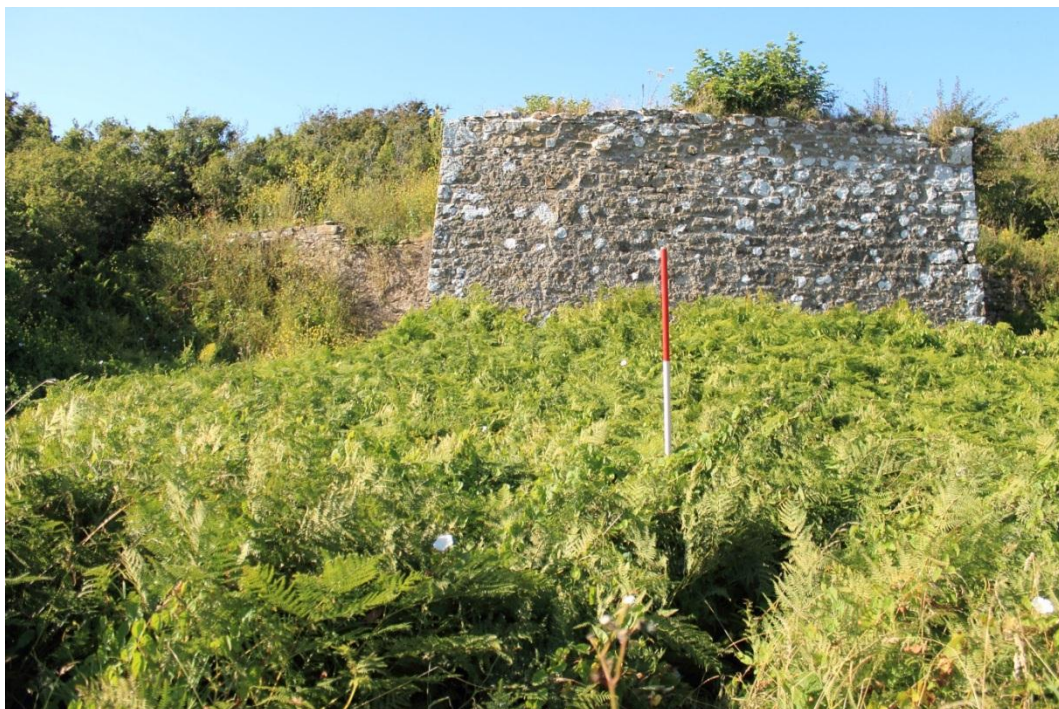
The area directly surrounding the limekiln is covered with dense vegetation making access to the kiln difficult (including dense brambles and bracken). As yet though the walls of the structure currently remain mostly free of vegetation, with some invasive growth just beginning on the rear walls (Photos 47 & 48). If this is left unattended then it will get worse so it is important to take action as soon as possible as a preventative measure.

Photo 47: Viewing north at Limekiln showing height of bracken around monument.

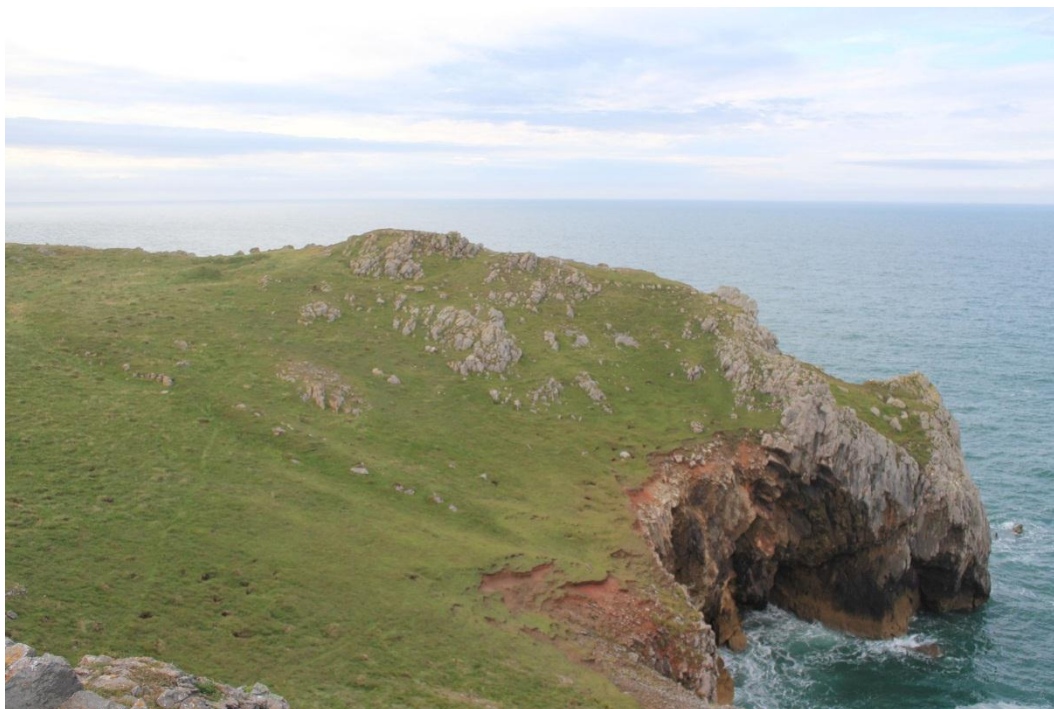
Crocksydam Camp is another promontory fort comprising defences across the landward end of the promontory. This camp appears to comprise only a single bank and ditch for its defences (Photo 55).

Coastal erosion is present on all but its northern side, although the majority of this appears relatively stable and the only sign of recent erosion on the cliffs is on the southern part of the monument which projects into the sea (Photo 56) and on part of its western edge (Photo 55).

Photo 55: General view across Crocksydam fort looking southwest

There were no obvious in situ protective measures in place around the monument and it should be marked with 'No digging' stars on its northern edge. There is no evidence of significant footpath damage nor any signs of scrub encroachment. The area is used for sheep / livestock grazing which is keeping

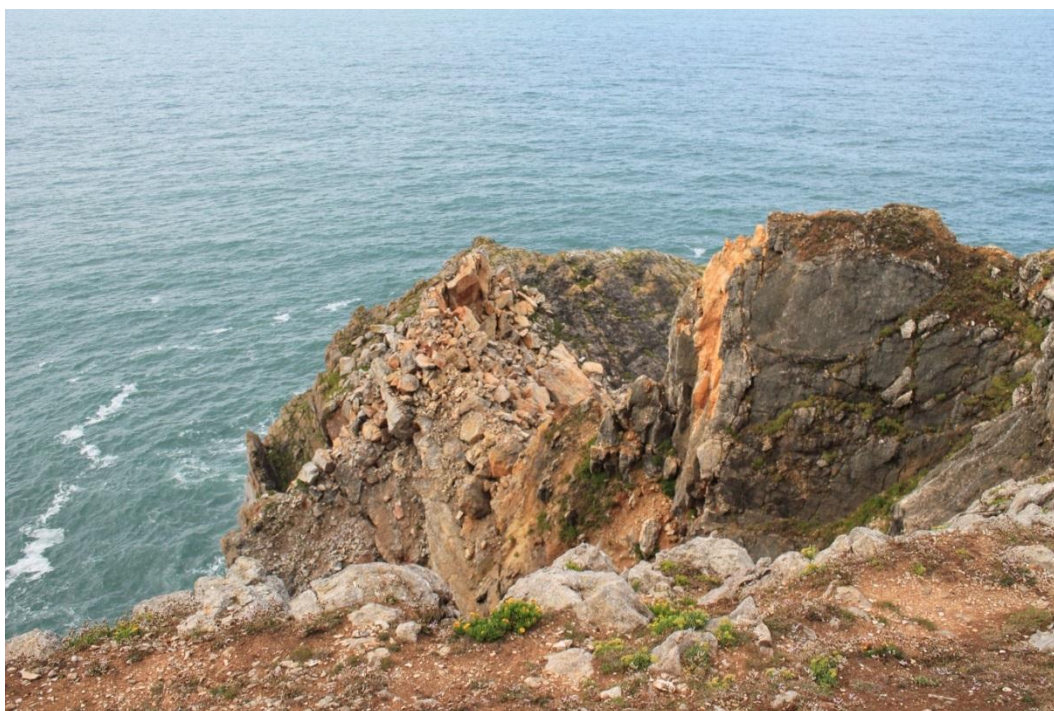
Photo 56: Viewing west across southern end of fort showing recent cliff collapse.

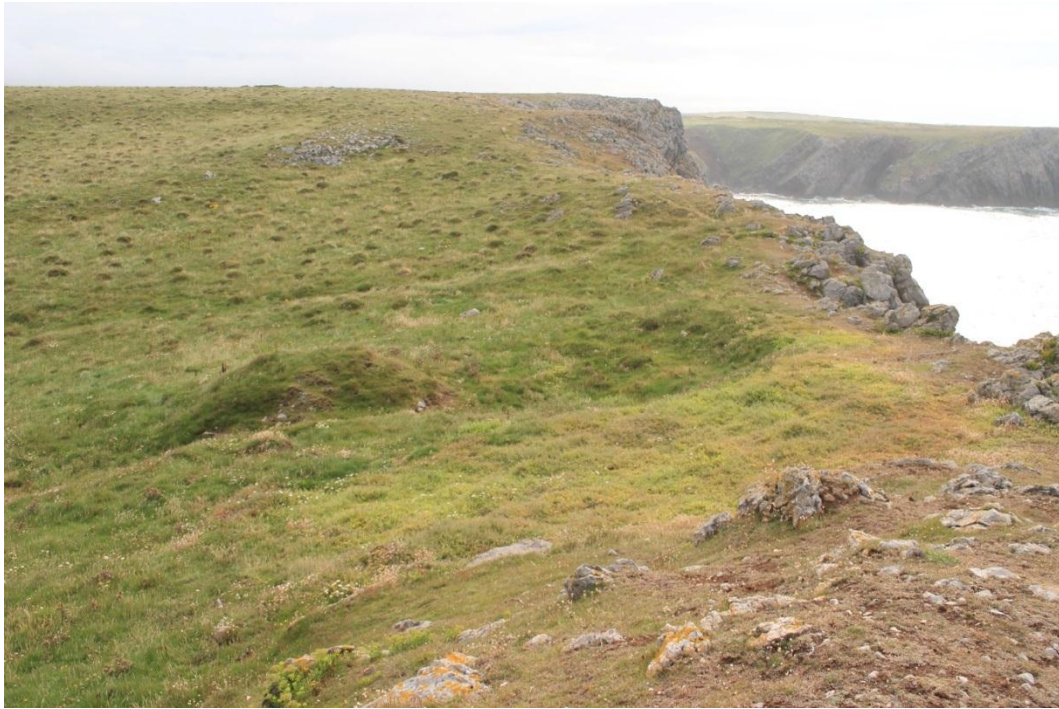
Two large depressions in the interior of the camp on its eastern side indicate previous episodes of digging, although these are of some age and do not represent modern disturbance (Photo 57). It was noted that much of the ground surface inside and outside of the monument is covered in ant hills (Photo 57 & 58). Although the ground surface has obviously been altered by the ants, the extent of disturbance below ground is uncertain but presumably will be having a negative impact on the archaeology. In terms of the archaeology it would be good if the ant population was controlled, but any such works would need to be discussed with ecological specialists. Potentially the presence of the ants (as well as livestock grazing) is preventing scrub encroachment and retaining the area as coastal grassland.

Photo 57: Viewing south west across edge of fort at pits/holes.

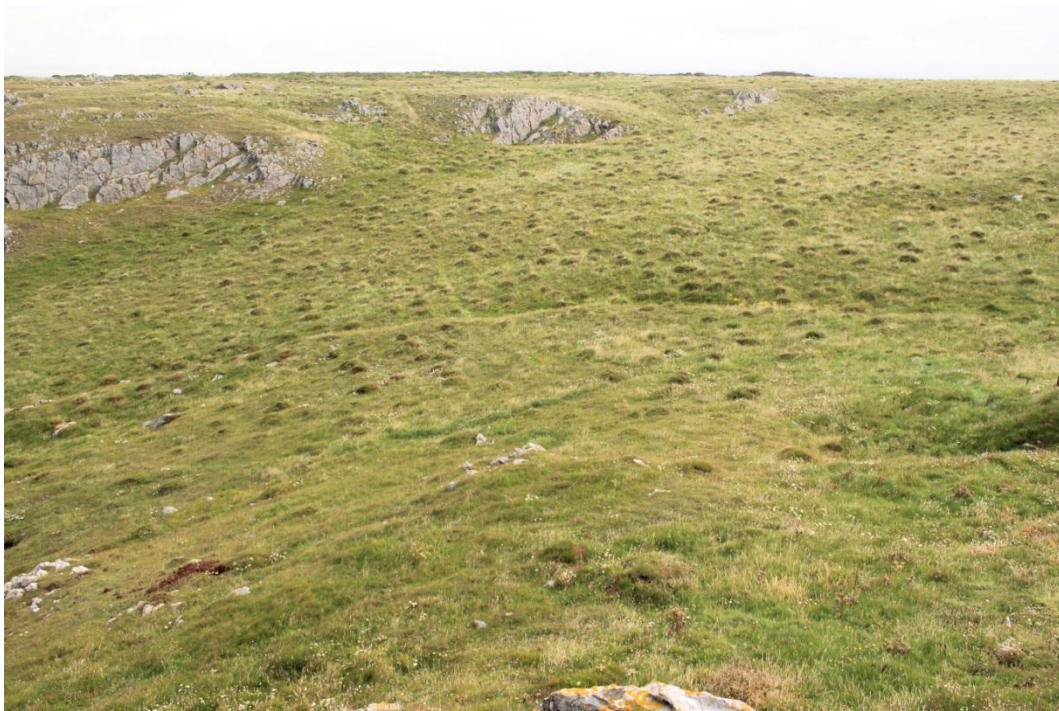
Photo 58: Viewing east across site showing significant number of ant hills littered throughout the interior of the monument.

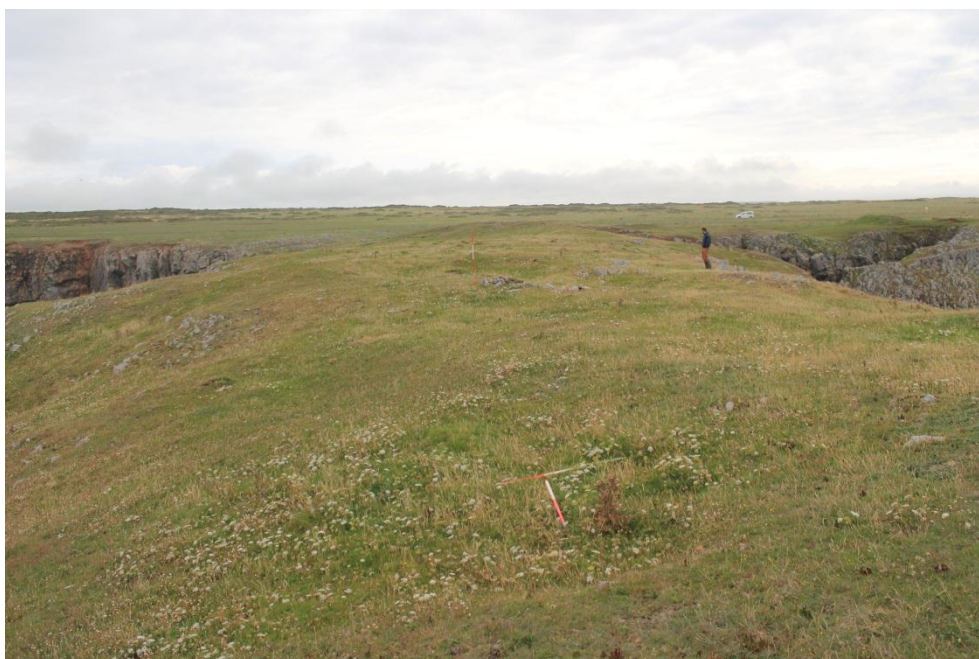
The majority of the interior of the fort away from the coastal edges survives in a good condition, with vegetation kept in control by livestock grazing (Photo 63). Possible indications of circular house platforms were also noted.

Photo 63: View northeast through main part of the interior of the fort showing its generally good condition, and possible remains of circular house platforms

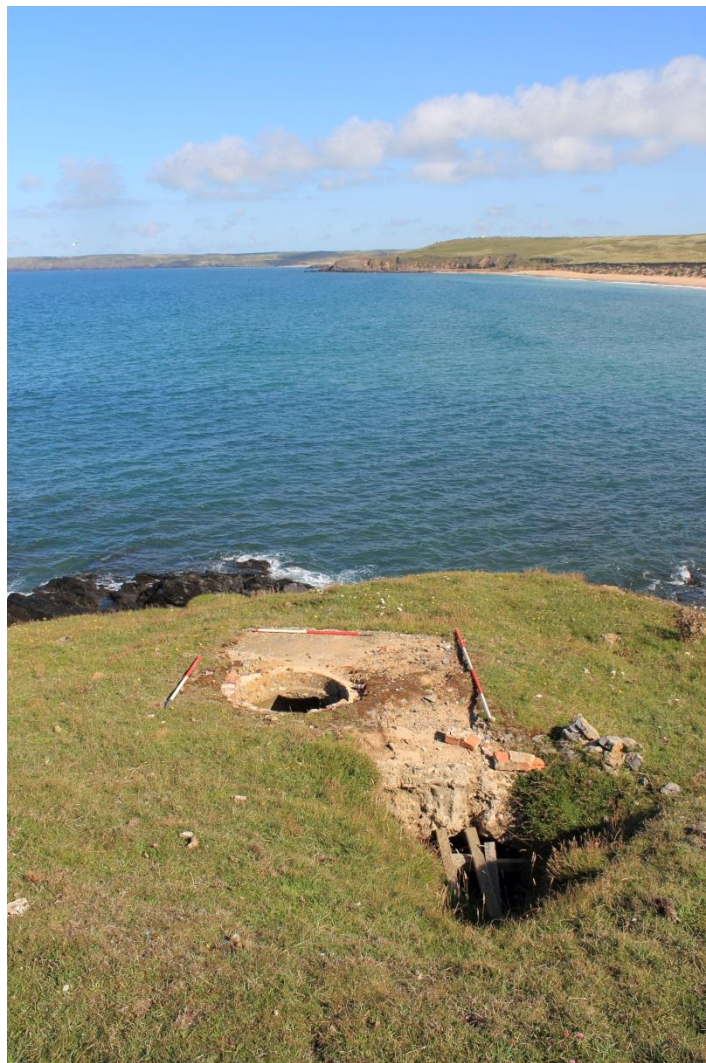
The surviving elements are in a poor condition and likely to continually decline through sea spray / sea salt eroding the concrete and reinforcing bars within (Photos 64 to 68). Nearly all of iron sheeting which would have been present within the shelters has now corroded away. There is slumping at the entrances to the magazines of all of the shelters observed.

Photo 64: View north across Tobruk shelter PE543C

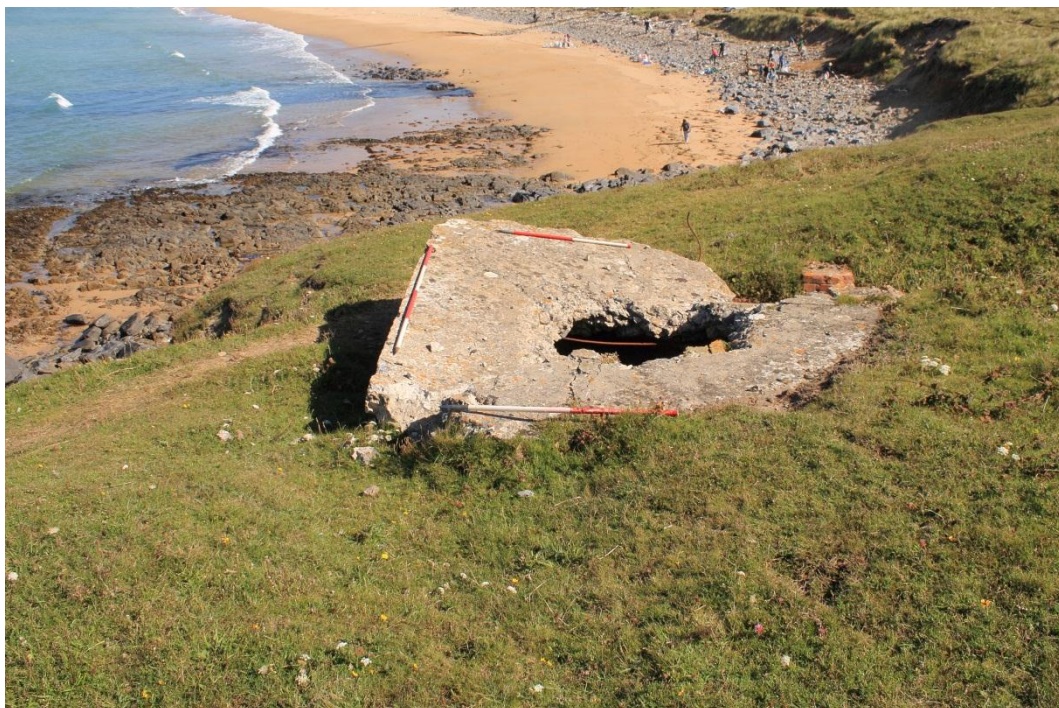
Tobruk shelter PE543B was in the worst state of preservation of those that were inspected during the survey

Photo 65: View north across Tobruk shelter PE543B
(in a very poor state of preservation)

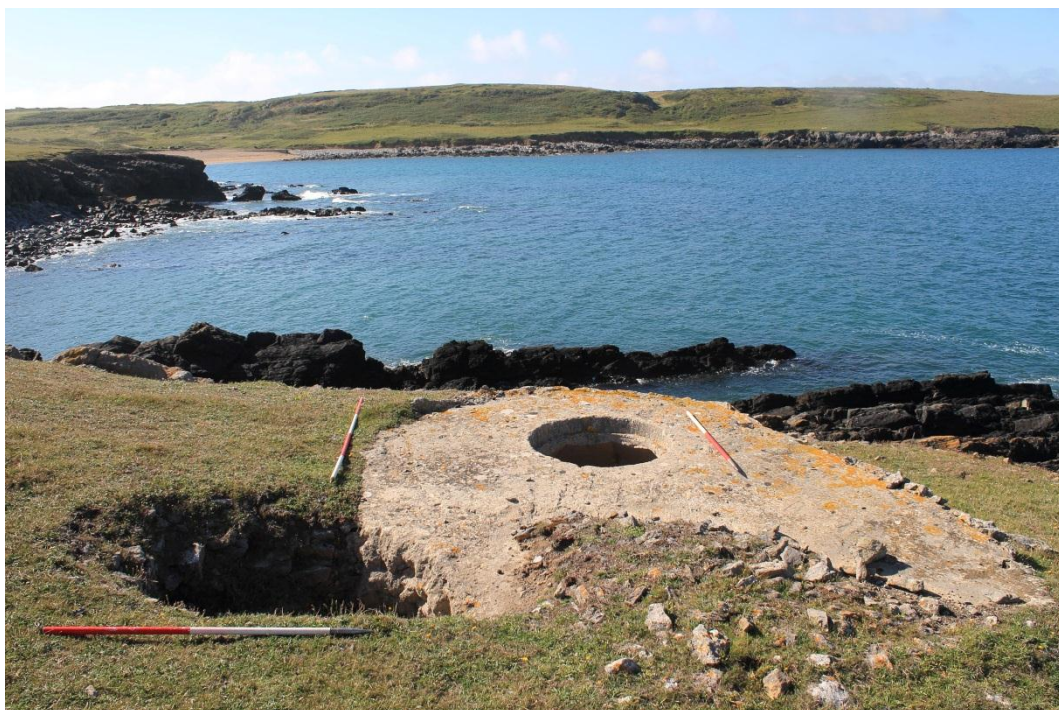
Photo 66: View south across Tobruk Shelter PE543D

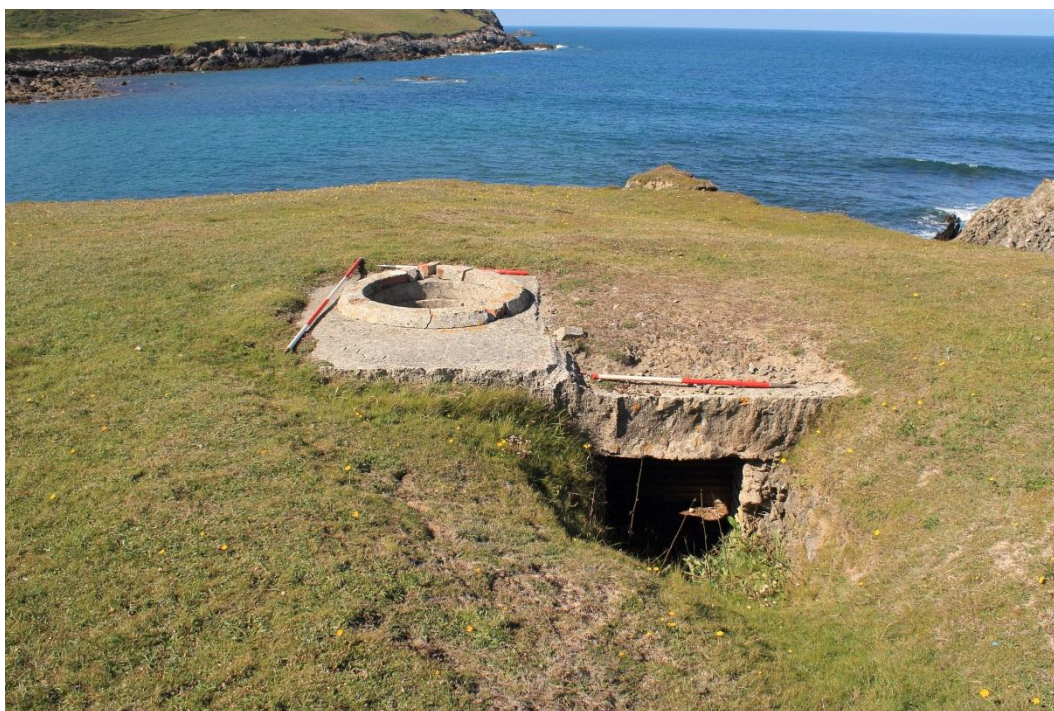
Photo 67: View southwest across Tobruk shelter PE543E

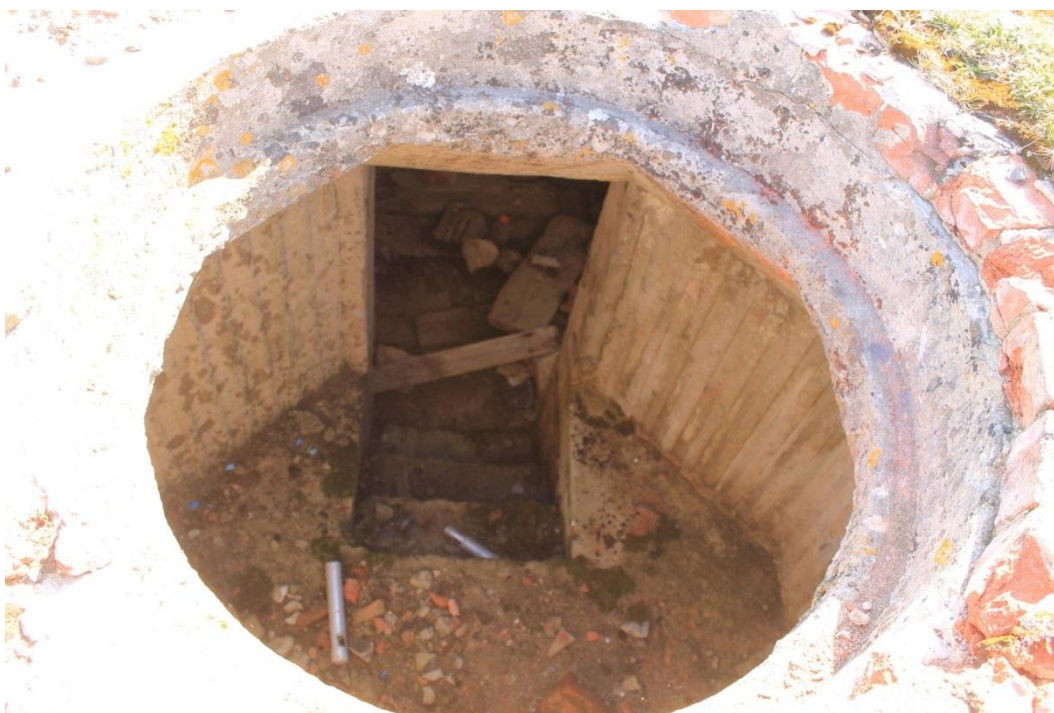
Grasses are starting to cover the concrete surface of the structures making it difficult to delineate the edges. Inside the shelters modern debris is accumulating through windblown material, purposeful waste disposal and fragments of military equipment, possibly ordnance (Photo 68). These should be cleared to prevent additional material being purposefully disposed of into them.

Photo 68: View inside Tobruk shelter PE543C showing collection of debris material.

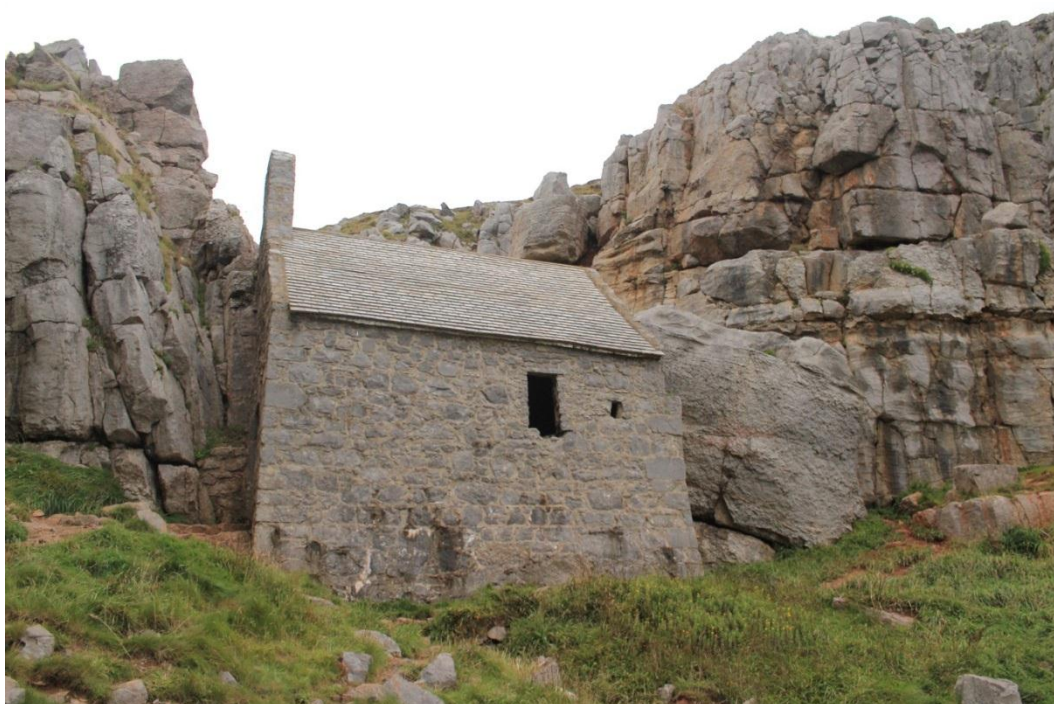
Structurally the chapel is in good condition and shows no obvious signs of decay (Photo 69), evidently being maintained and repaired. Internally the walls are suffering from damp which is affecting the remains of the plaster work (Photo 70). The Chapel should continue to be monitored for signs of structural decay and preventative measures taken

Photo 69: Exterior south facing wall of St Govans Chapel.
