ARCHAEOLOGICAL QUINQUENNIAL REVIEW: CASTLEMARTIN RANGE, MANORBIER RANGE AND PENALLY TRAINING AREA

CONDITION ASSESSMENT

Prepared by DAT Archaeological Services
For: Landmarc Support Services.

RHIF YR ADRODDIAD / REPORT NO. 2015/50
RHIF Y DIGWYLLIAD / EVENT RECORD NO. 108638

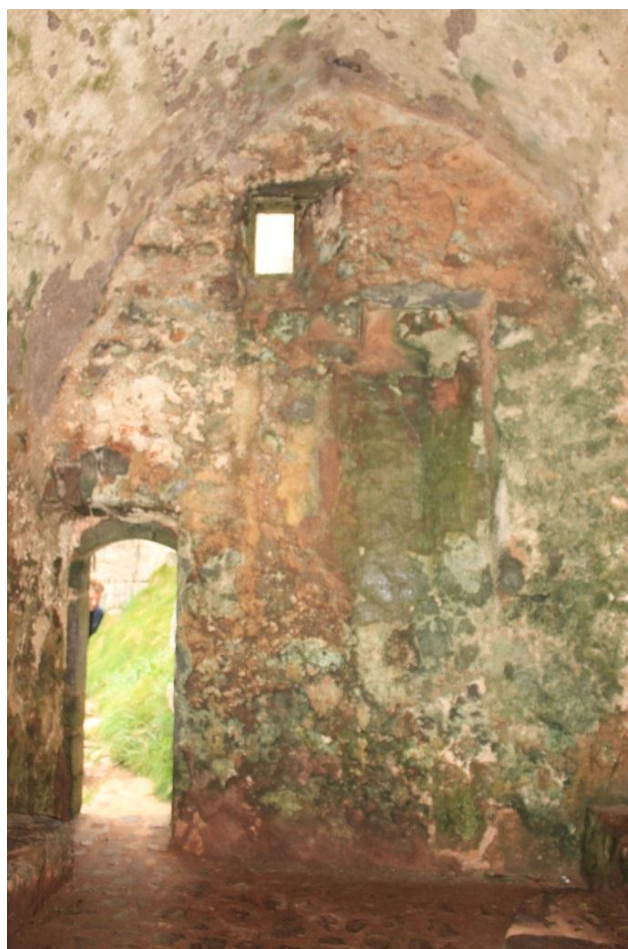
Structurally the chapel is in good condition and shows no obvious signs of decay (Photo 69), evidently being maintained and repaired. Internally the walls are suffering from damp which is affecting the remains of the plaster work (Photo 70). The Chapel should continue to be monitored for signs of structural decay and preventative measures taken

Photo 70: Interior east facing wall of St Govans Chapel.

when necessary. The chapel was not included in the original specification for the inspection, but was considered worthwhile as a Scheduled Ancient Monument.

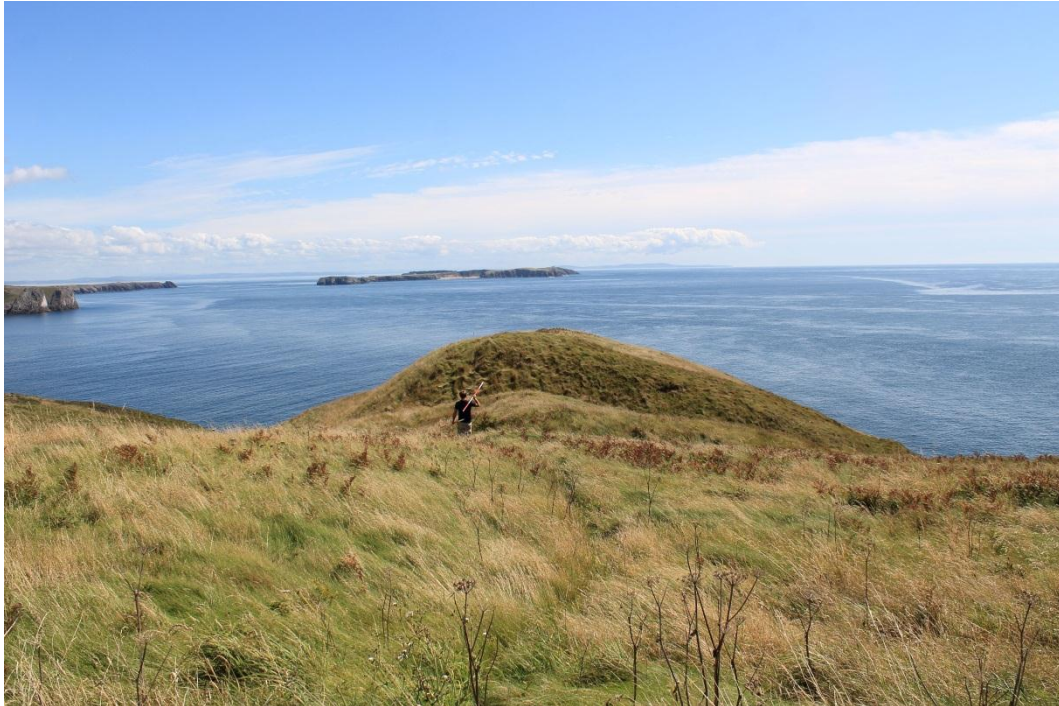
At the time of the survey, the main body of the fort was covered with thick lush grasses (Photo 71), with some smaller patches of scrub encroachment on its southern slopes. The eastern side of the northern defences were covered with denser vegetation and scrub (Photo 72). These were encroaching partially up the steeper bank on the northern side of the monument.

Photo 71: View east along Old Castle Head promontory fort showing main defences

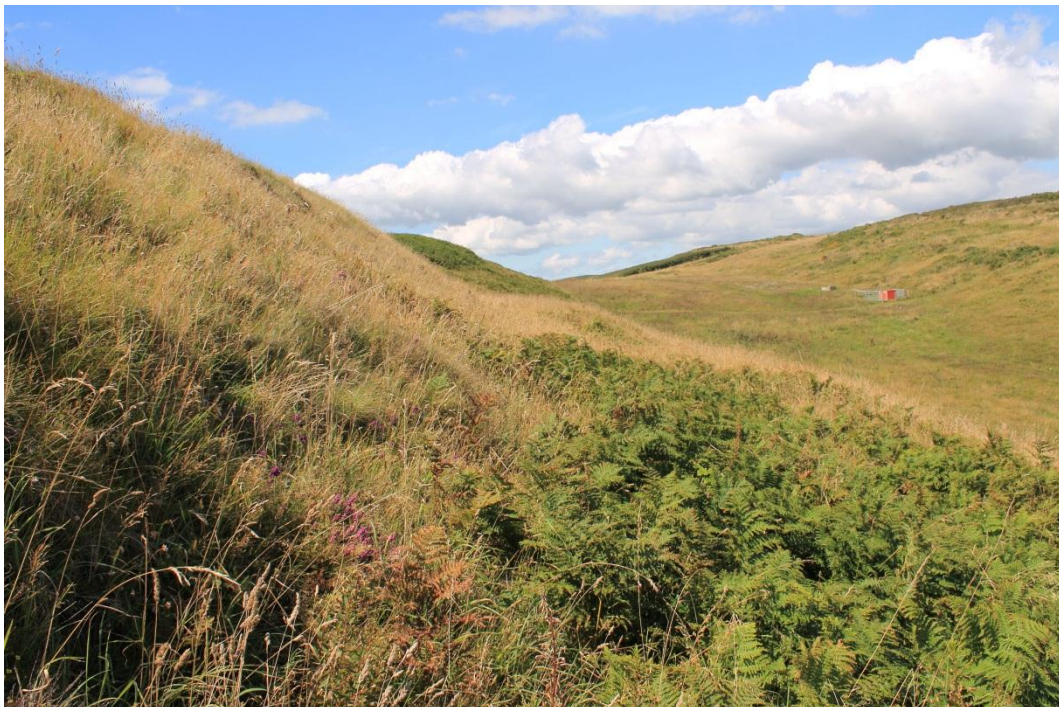
Photo 72: View west along lower parts of northern defences showing dense scrub on lower parts of slope

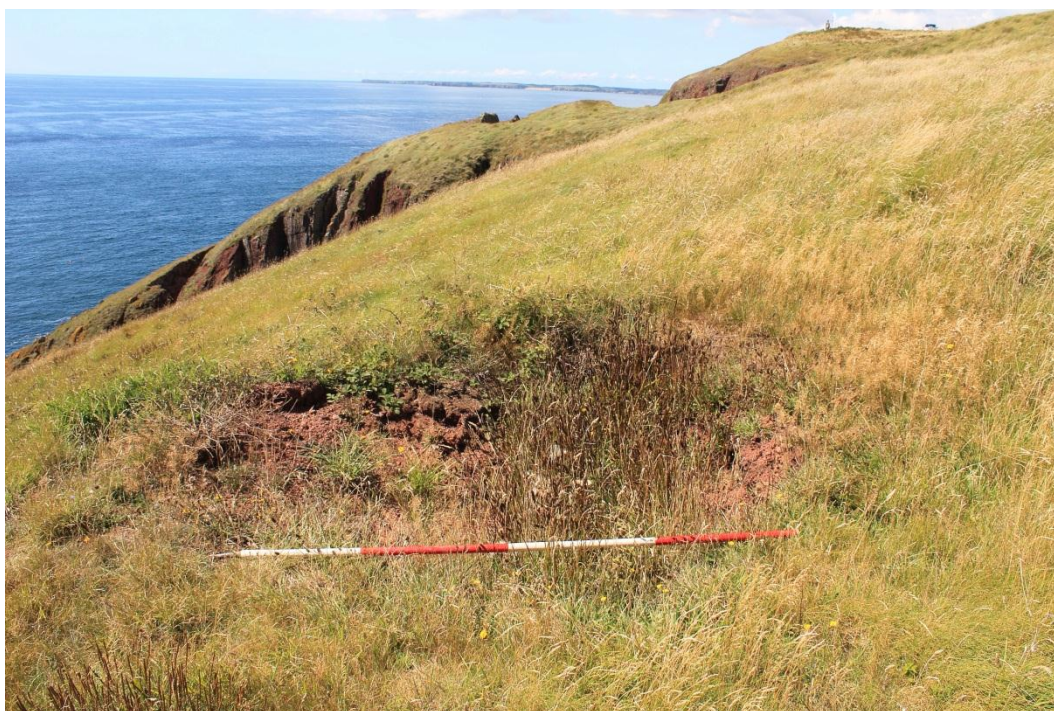
bottom, all the others had vegetation covering them suggesting they were over 5 years old. The more recent crater was said to have been over a year old. One older crater was visible on the southern slopes of the monument (SS 07576 96665) (Photo 75).

Photo 75: Evidence of old impact crater on southern slopes of monument

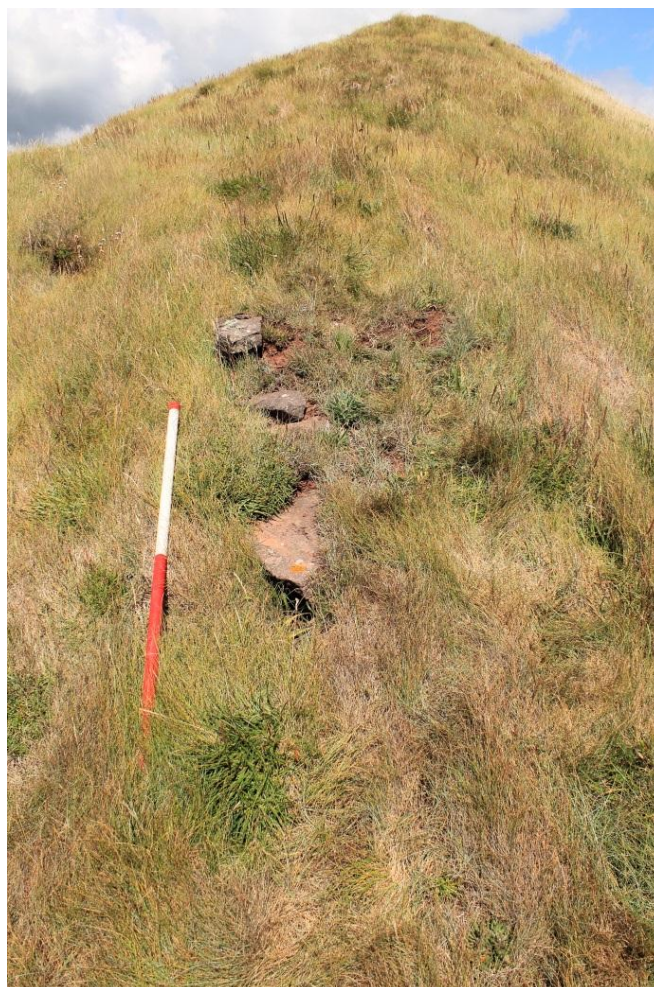
No signs of animal activity were noted, although these could have been hidden by the dense grasses. A stone wall (presumably a former field boundary wall) was becoming exposed on the western side of the monument (Photo 76).

Photo 76: Stone field boundary wall becoming exposed in bank
on the eastern side of the monument

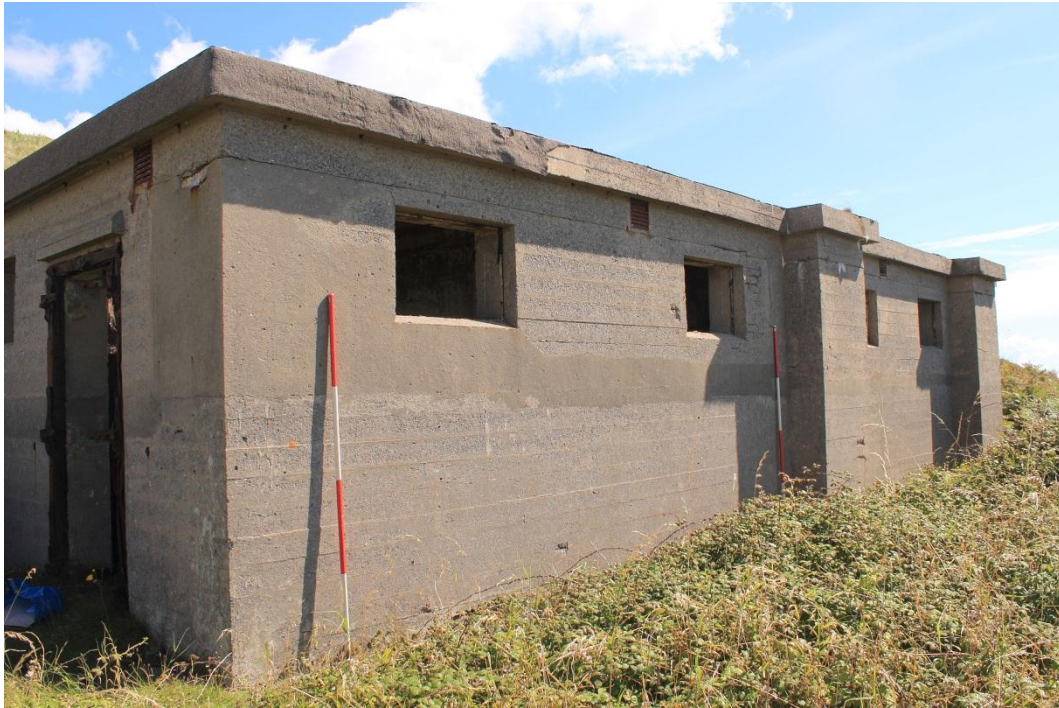
Three structures of the radar station still survive, with no other elements noted during the site visit (Photos 77, 78 & 79). The structures are relatively sound, being built of brick with reinforced concrete roofs and also floor slabs. Potentially some of the access roads and concrete hard standings still used by the Manorbier range may originate from the radar station.

Photo 77: Transmitter/receiver building PE493A, looking northeast

The buildings should continue to be monitored to observe for any structural failure or need for remedial works. The animal burrow, if unoccupied, should be backfilled to stabilize the floor of the building. The no entry signs within the Transmitter / Receiver building should be repaired and reattached to prevent unauthorized access.

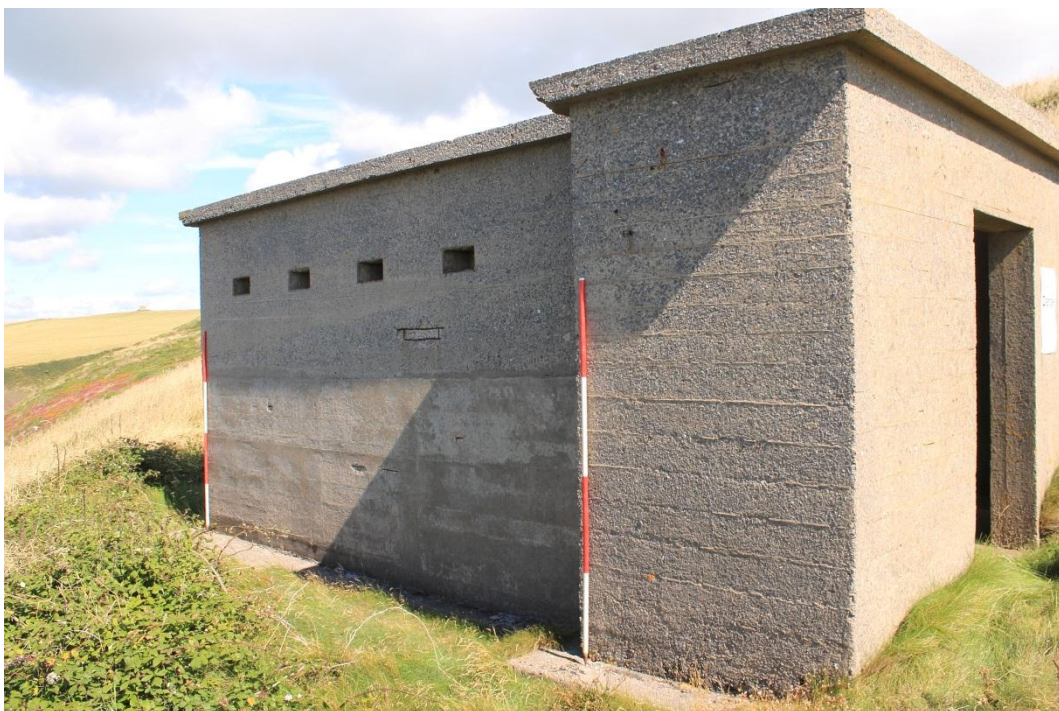
Photo 78: Stand-By Set House PE493B, viewing northeast

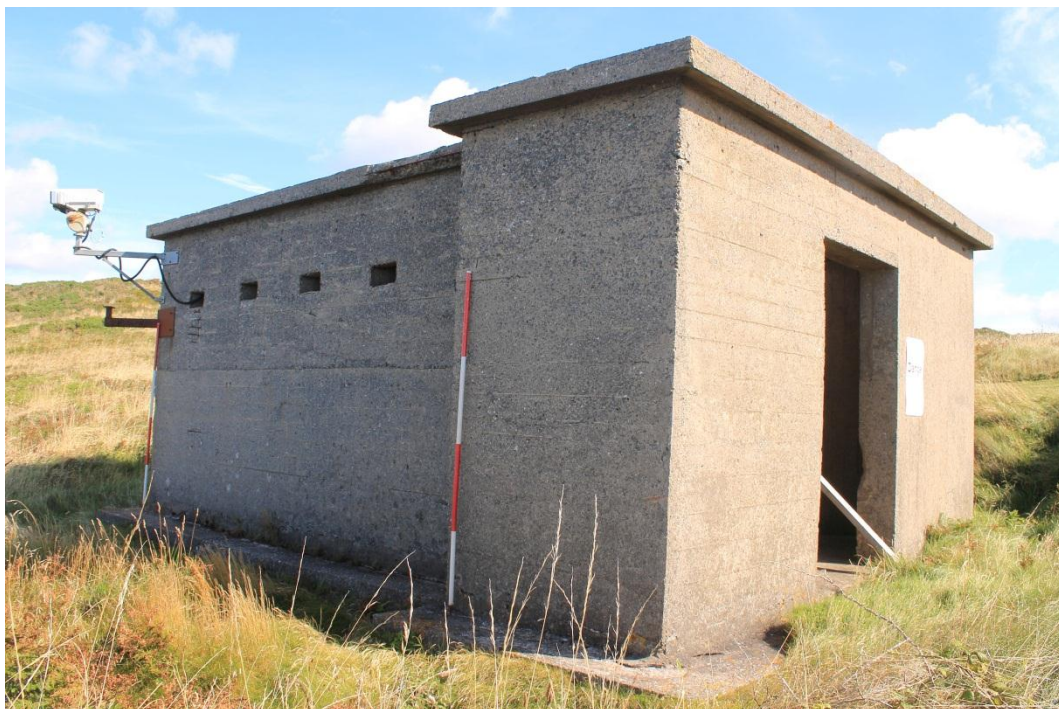
Photo 79: Auxiliary Stand-By Set House, viewing north

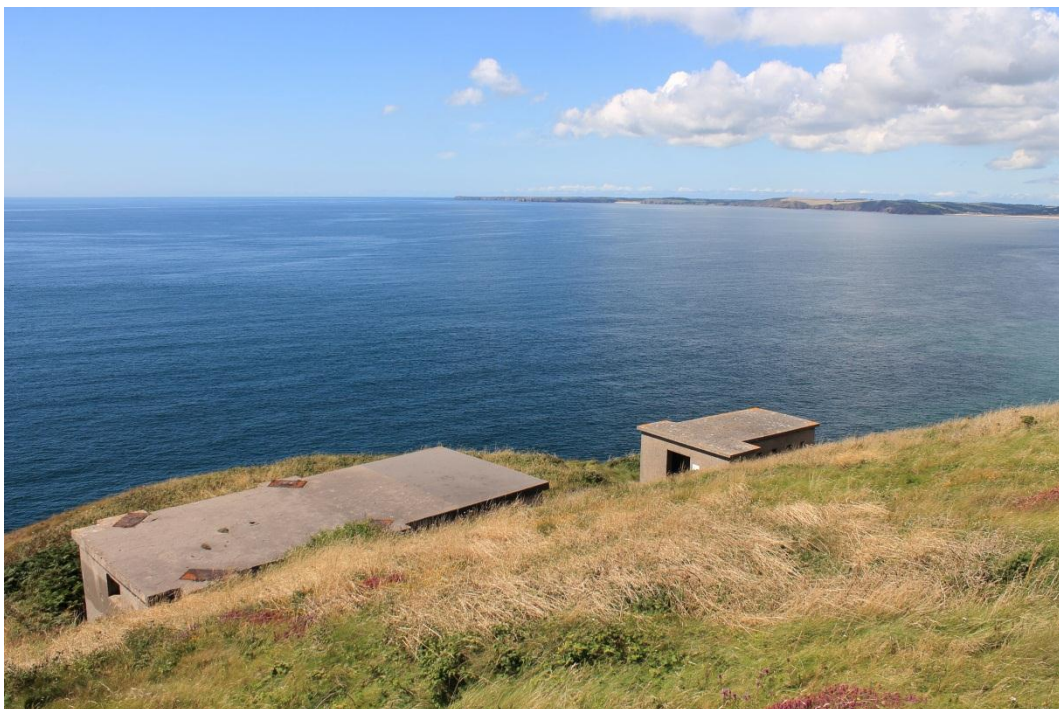
The roofs of the structures seem to be in a good state of repair and the fixings for the former gantry aerial still survive on the Transmitter / Receiver building (Photo 84).

Photo 84: View southwest across the roofs of PE493A and PE493B, with the fittings for the gantry aerial still visible on the roof of the Transmitter / Receiver building

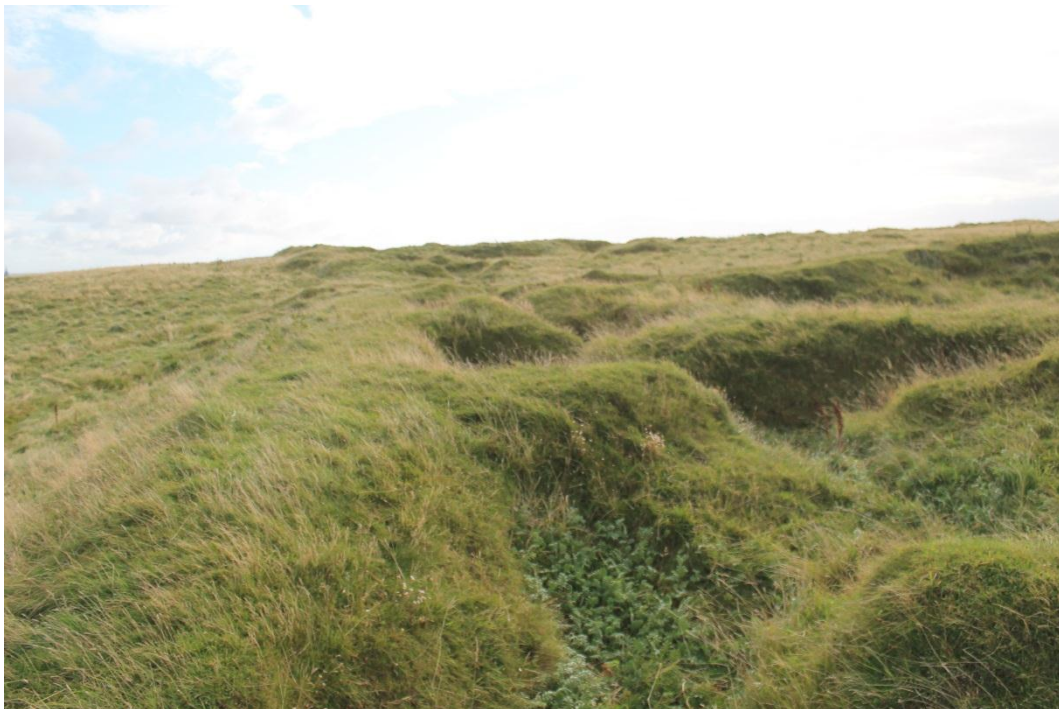
The Penally World War I practice trenches cover a large area. The main body of earthworks are associated with a typical trench warfare layout. This includes front line trenches (crenellated arrangement facing north) (Photo 85); second line trench system (also crenellated lying to the south) (Photo 86); connecting communication trenches between the two; associated island traverses; weapons pits and other associated infrastructure / command areas. Parapets are located on the northern side of the trenches. The earthworks for this area of the trenches survive relatively well except on its eastern side where the earthworks become far less distinct and are also now covered with dense vegetation.

Photo 85: View east along front line trenches, with parapet visible

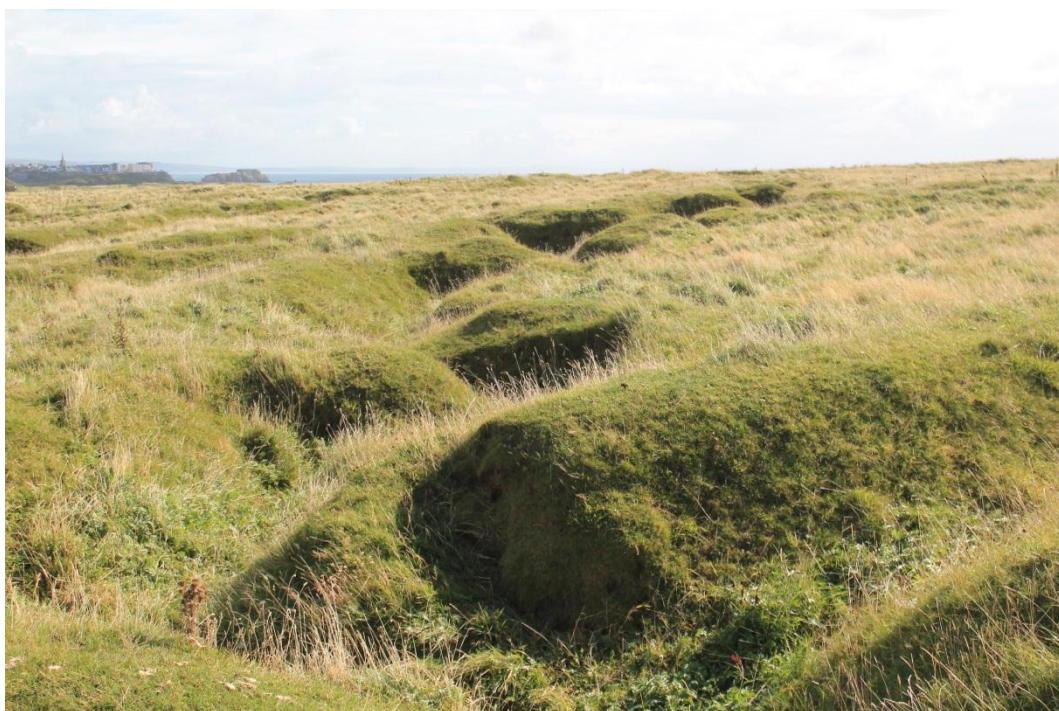
Photo 86: View east across second line trench system showing traverses

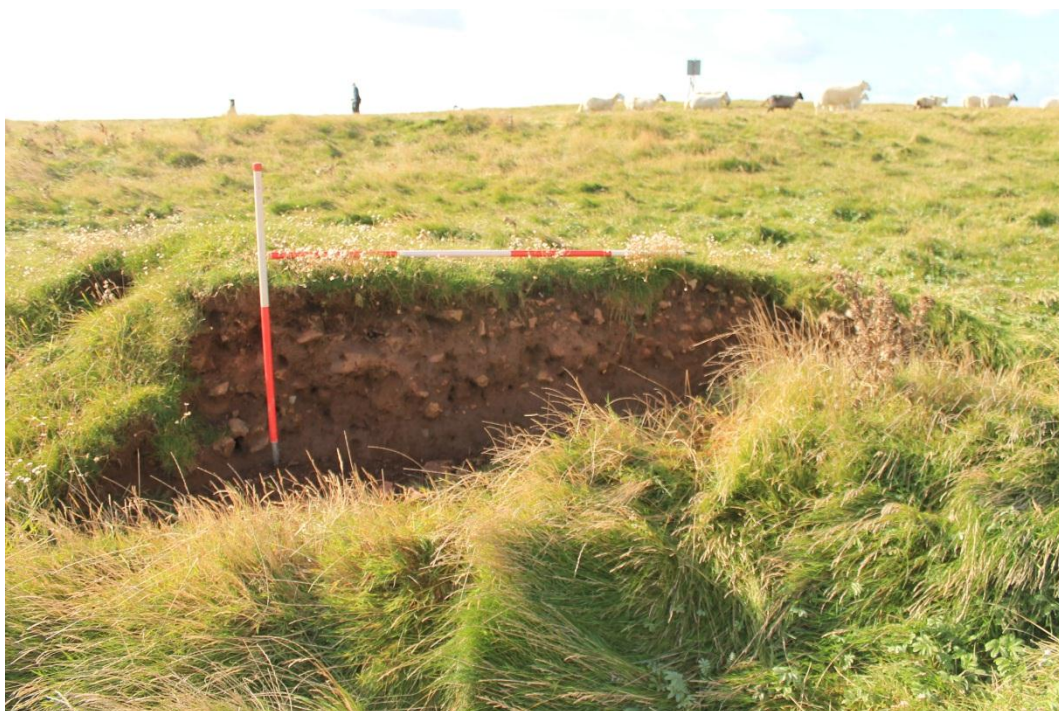
The trench edges were originally supported with wattle panels and possibly sandbags. These have long since failed and over the last 100 years the trench edges and parapets have slowly denuded, infilling them. The full depth of the trenches is no longer visible. Some weathering erosion is visible in some of the steeper sides of the trenches as would be expected (Photo 87). It is presumed that the differential survival of the trench earthworks is due to underlying geology, possibly with harder bedrock being present where the trenches survive best on the western side of the site.

Photo 87: Large area of erosion at southwestern end of main trench system, viewing south

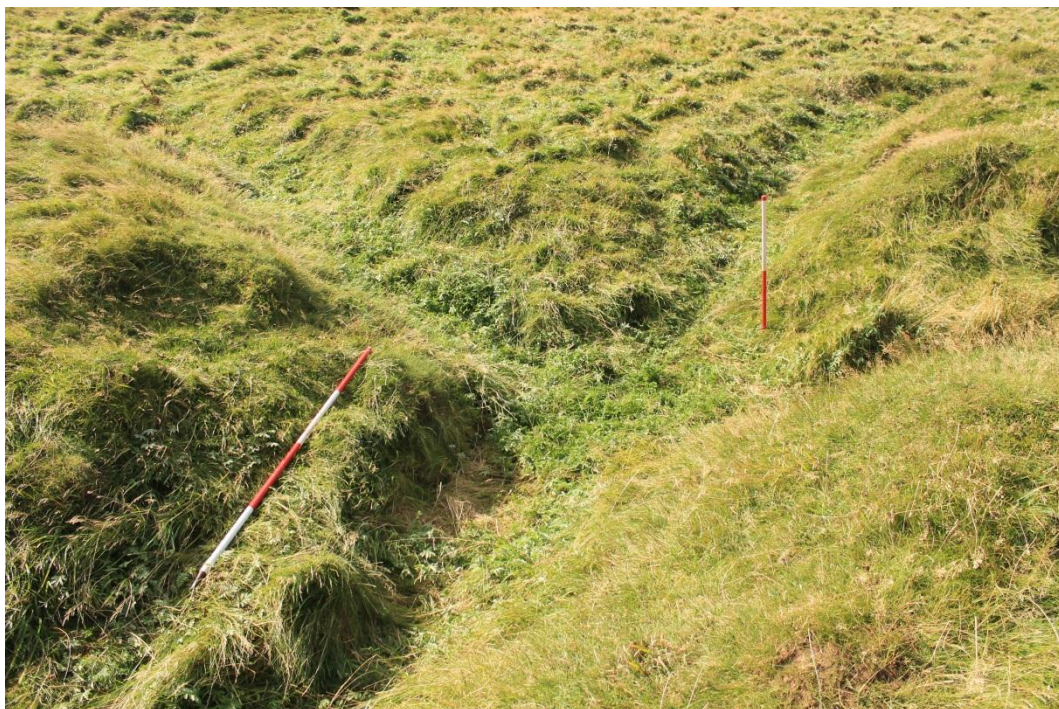
The land is grazed by sheep, which keeps the vegetation down across the majority of the site area, although it has led to some sheep track (Photo 88) and hollow erosion (Photo 89). Overall the damage to the monument from unchecked vegetation would be far worse than the slight damage they are presently causing.

Photo 88: View south across junction of communication trenches with sheep tracks and other erosion

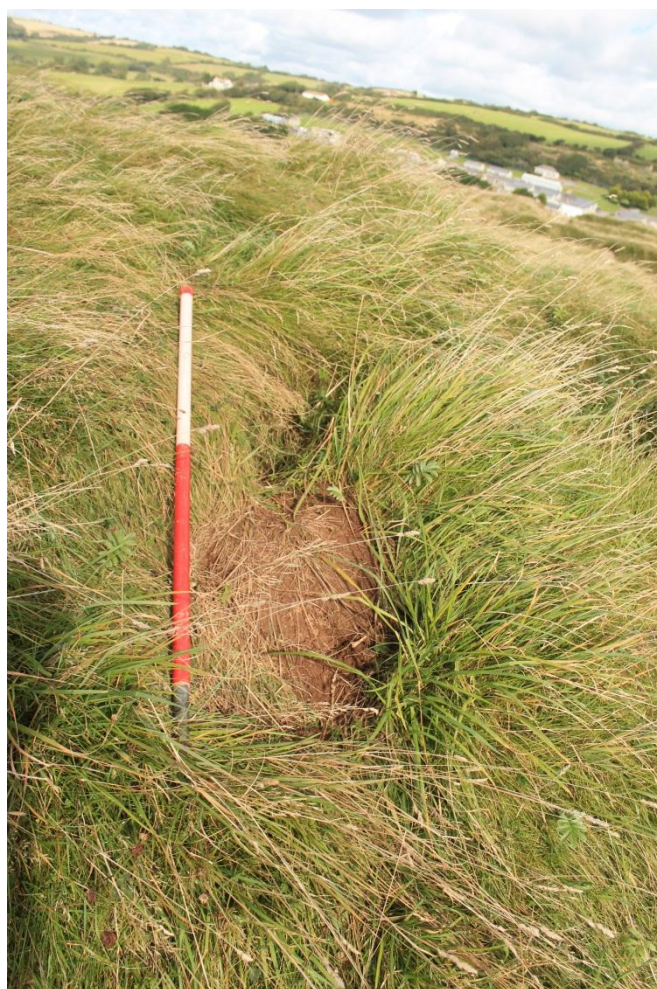
Photo 89: Sheep hollow or animal scrape on northern side of second line trenches

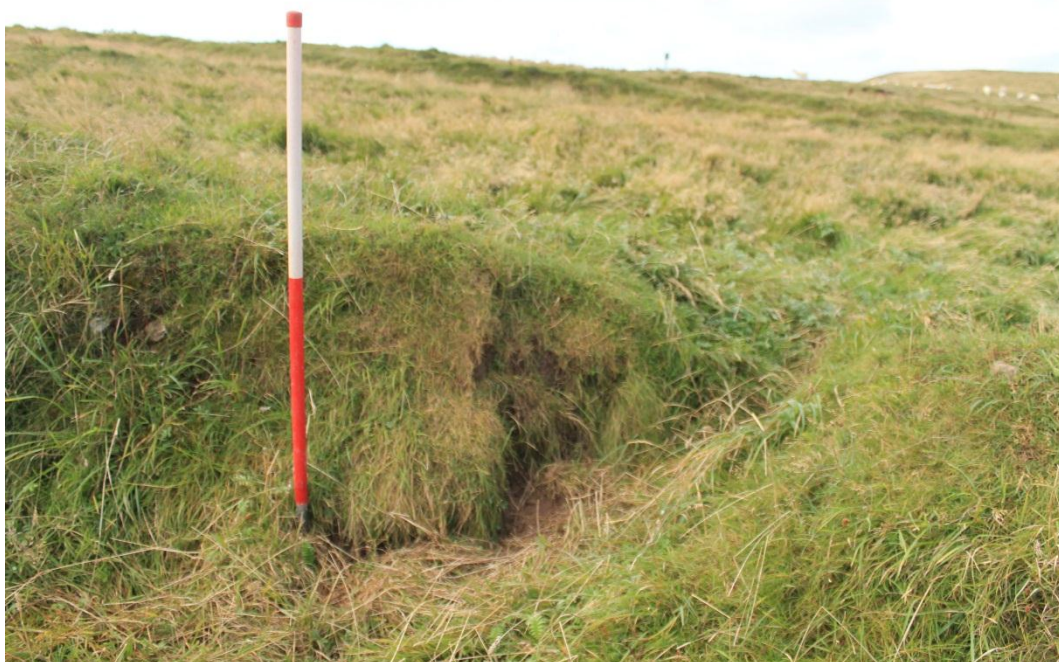
Rabbit burrows were noted through parts of the second line trench system (Photo 90). The damage could become quite extensive if the rabbit population remains unchecked, so some control is recommended.

Photo 90: Animal burrow within trench edges

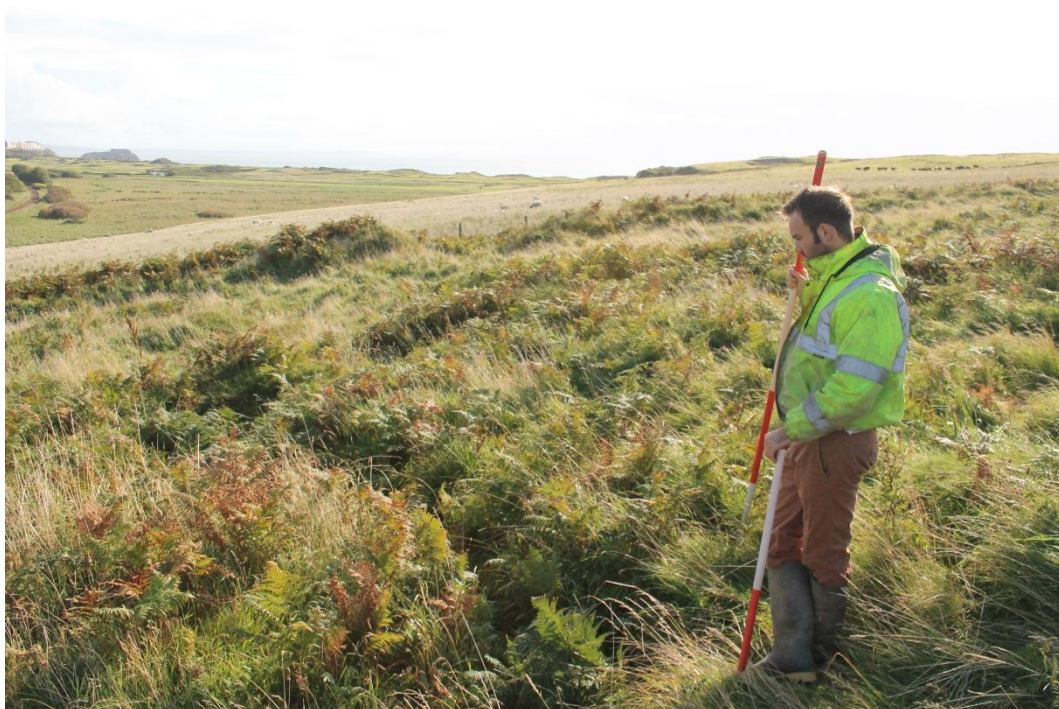
Dense vegetation and scrub (including bracken, thistles and other scrubland plants) is encroaching onto the monument from the eastern side. This is more extensive than was present during the 2004 survey by Wessex Archaeology and aerial photography by RCAHMS in 2007. The scrub would be best cut to enable the grasses to grow through and livestock to begin grazing the area again. This may need to be repeated every 5 years or so.

Photo 91: Vegetation encroachment on the eastern side of the Penally World War I practice trench system
