NATIONAL BOTANIC GARDEN OF WALES REGENCY RESTORATION PROJECT

PHASE 1 ARCHAEOLOGICAL INVESTIGATIONS AND STRUCTURE RECORDING 2015

INTERIM REPORT

RHIF YR ADRODDIAD / REPORT NO. 2015/61 RHIF Y DYGWILLIAD / EVENT RECORD NO. 108883

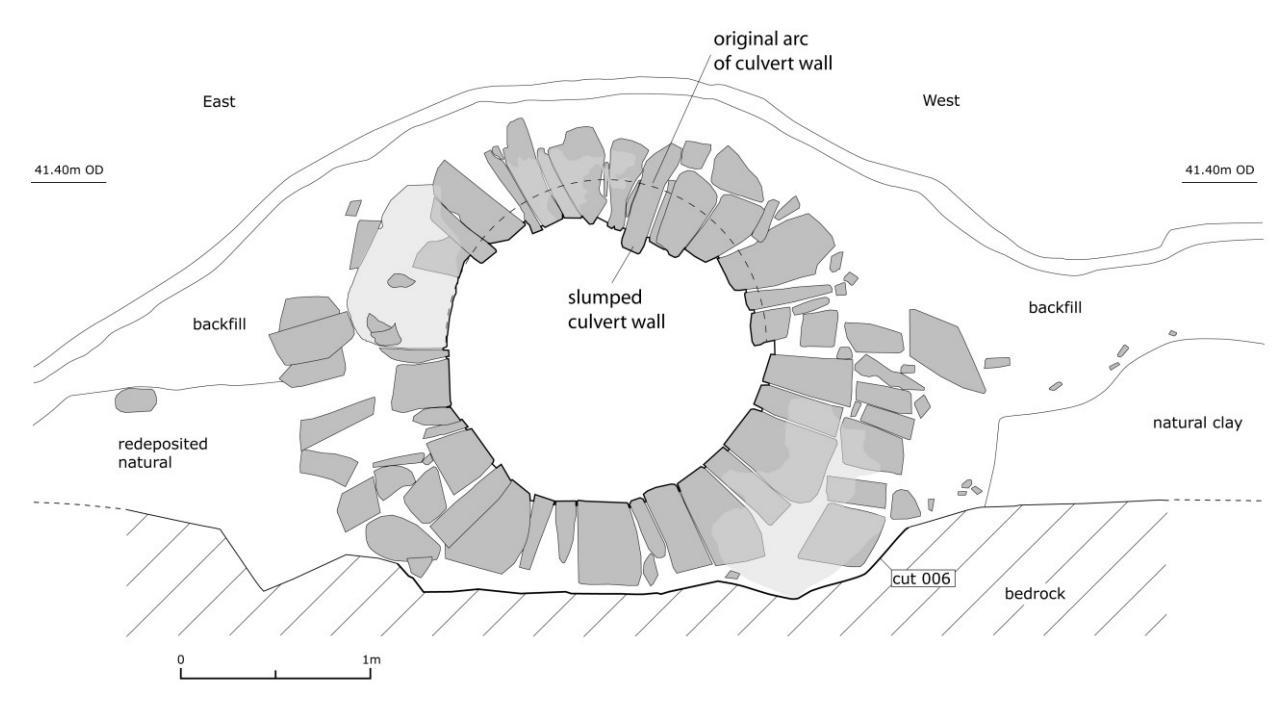
Figure 5: The end of culvert 1AS1

Structure 1 (Photo 1) is the north end outflow of a culvert leading from the north bank of the watercourse (opposite the Cascade [1BS8] in the Llyn Felin dam [1FS28 and 1GS29]). The end had a vertical face and there appear to be slight traces of limewash on the stonework. The internal diameter is 0.8m. The external diameter is approximately 1.65m. The culvert is constructed from dressed stone and lime mortar. The top of the culvert has slumped by approximately 0.2m (assuming it was originally completely circular) but is currently completely open except at its southern end, where it has collapsed as a result of riverbank erosion and tree root damage and is now almost totally obscured by a fallen tree and collapsed masonry. Approximately 10.5m of the culvert length survives intact.

- For reasons of safety, the outflow at the north end of this culvert should be blocked up to prevent access.
- If culvert 1AS1 were incorporated into the scheme, it is recommended that the south end of the culvert is cleared of the fallen tree, tree roots and fallen masonry to obtain more evidence of its relationship with culvert 1BS8 (if any survives).
- The north end of the culvert should be consolidated.
- If it is cleared of fallen masonry etc., the south end of the culvert it is likely to need consolidation and blocking up.

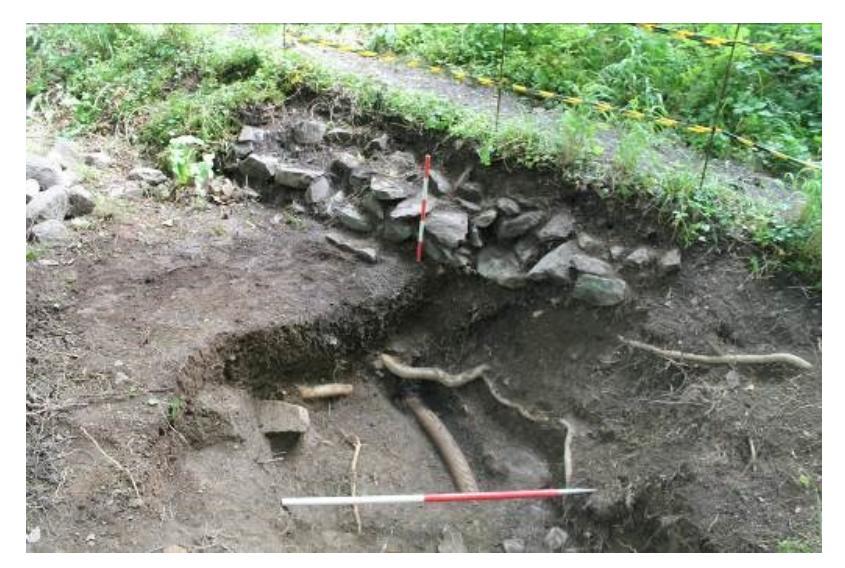
Photo 2: Drainage ditch A1S2

1AS2 (Photo 2) was investigated to ascertain whether the visible stonework was the remains of a revetment wall supporting and original trackway, and to characterise the ditch that ran alongside the existing path.

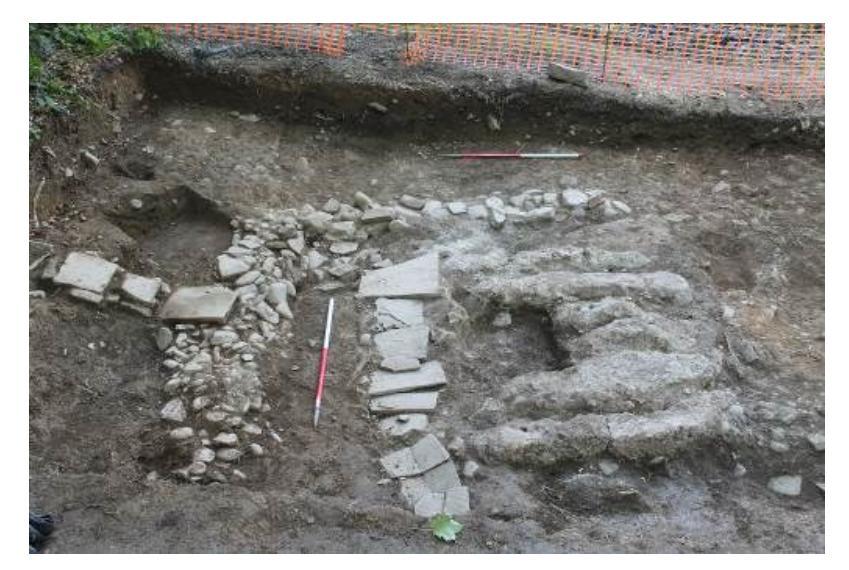
Photo 3: Drains and mortar spread after removal of overburden

Topsoil (001) and a thick deposit of yellow clay (002) were removed using a tracked mini-digger. The excavation area was located so as to reveal the majority (if not all) of the structure depicted in Hornor's painting of viewpoint 7. The remains of a rectangle of mortar were revealed, along with a variety of drains, conduits and other linear arrangements of stones (Photo 3). It was immediately apparent that the surviving evidence did not represent the well preserved remains of a substantial or well-built structure. Instead, any evidence of the above ground structure appears to have been systematically removed, leaving only parts of the sub-floor drainage system.

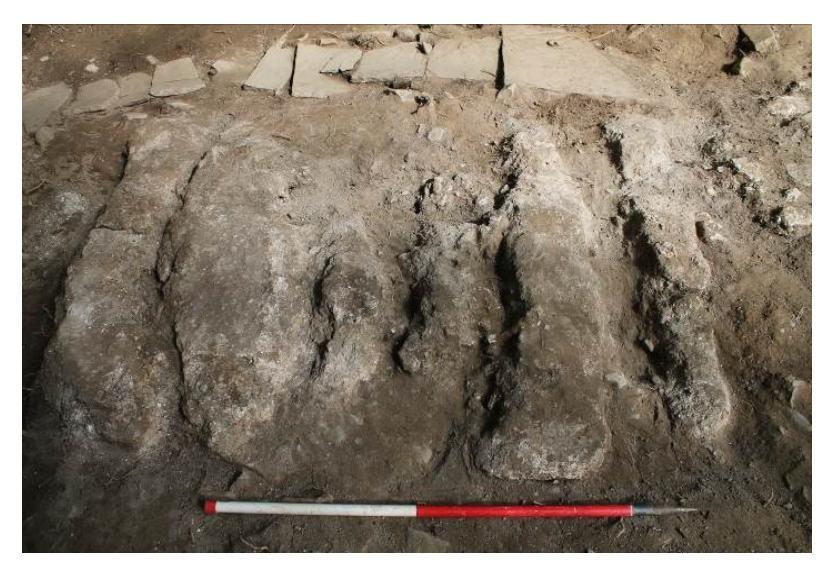
Photo 4: Detail of the mortar 'bed' looking east

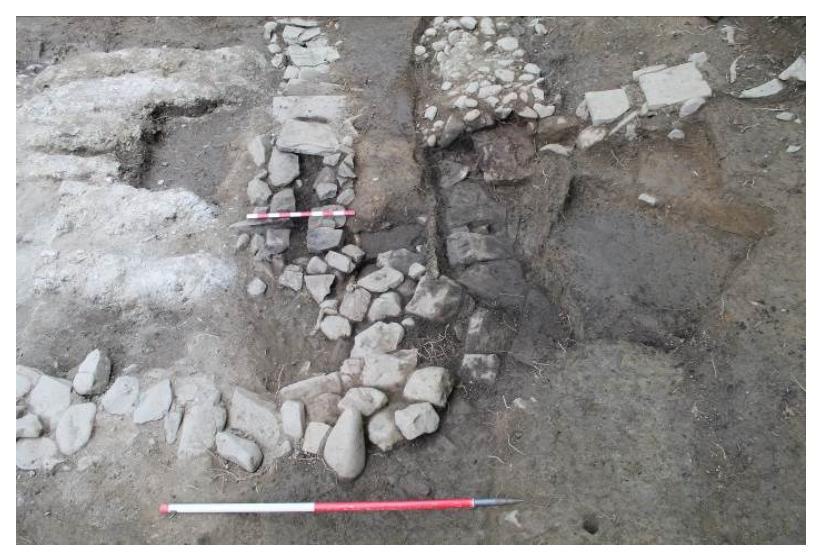
Running along the eastern edge of the mortar spread was a drain (044) on a north-south orientation, capped with flat tilestones (Photo 5). At least one of tilestones had a hole drilled in it, suggesting these were re-used roofing tiles. Further east was a second north-south oriented drain (047), capped with large river-cobble stones (035) and smaller cobbles (034).

Photo 5: Partially excavated later drains 044 (left) and 047 (right)

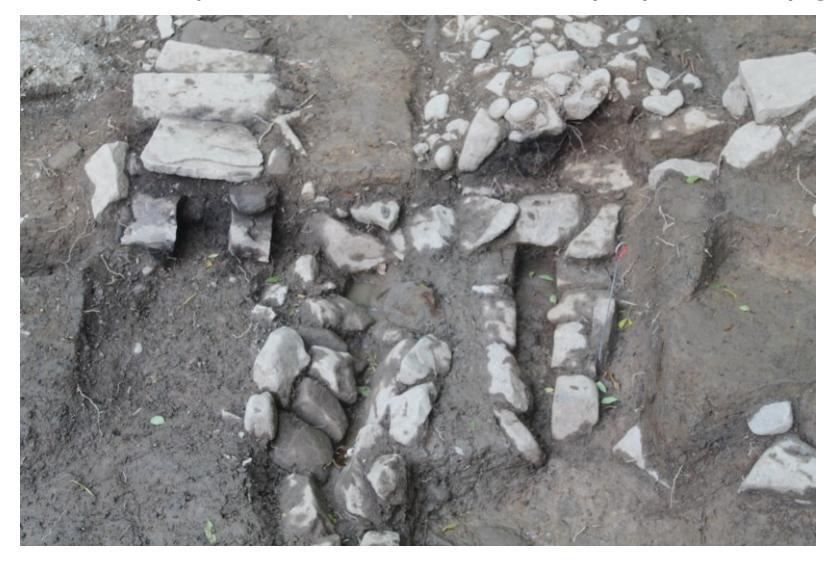
To the south of these drains ran another linear spread of stones (048) which made a right angle turn to an east west orientation (Photo 6). Careful removal of some of the stones of 048 revealed it to be a third drain. Also on an east-west orientation was conduit 043 (Photo 5). This was constructed from large cobbles similar to those of drains 048 and 047, and was capped with flat stone slabs, some of which appeared to be re-used from an earlier structure.

Photo 6: Partially excavated later drains with early drain 048 revealed (center)

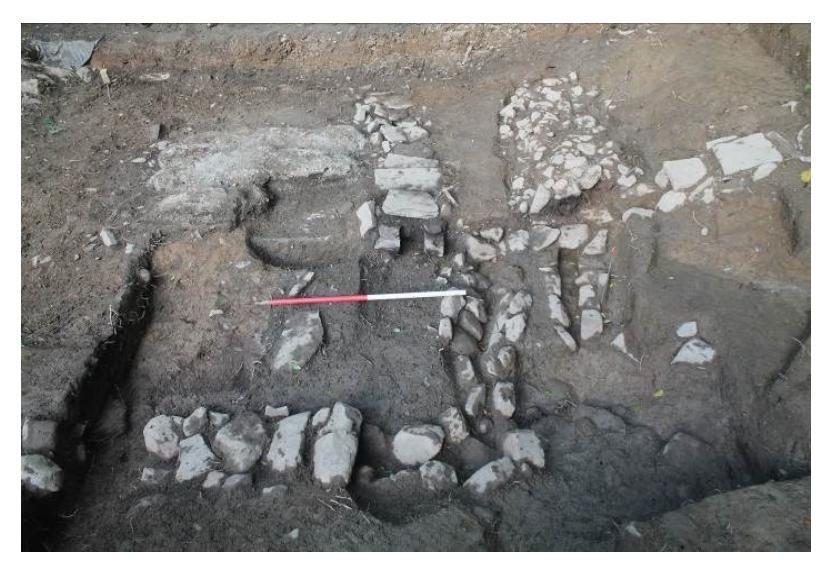
In section it was possible to ascertain that 048 was the earliest drain. It was originally probably associated with mortar spread 020 and conduit 043 which is presumed to be the means by which spring water was supplied to the building. The insertion of drains 044 (possibly first) and 047 (possibly second), however, has destroyed direct evidence of these associations (Photo 7).

Photo 7: Three phases of drains following removal of all capstones etc.

- The surviving drainage system is no longer functional.
- If the bath house is indeed a different building to the one excavated, where the bath house was located remains uncertain. Trees and undergrowth make prospection for the remains of the building problematic, but a programme of hand-dug test-pitting across the area may locate its remains.

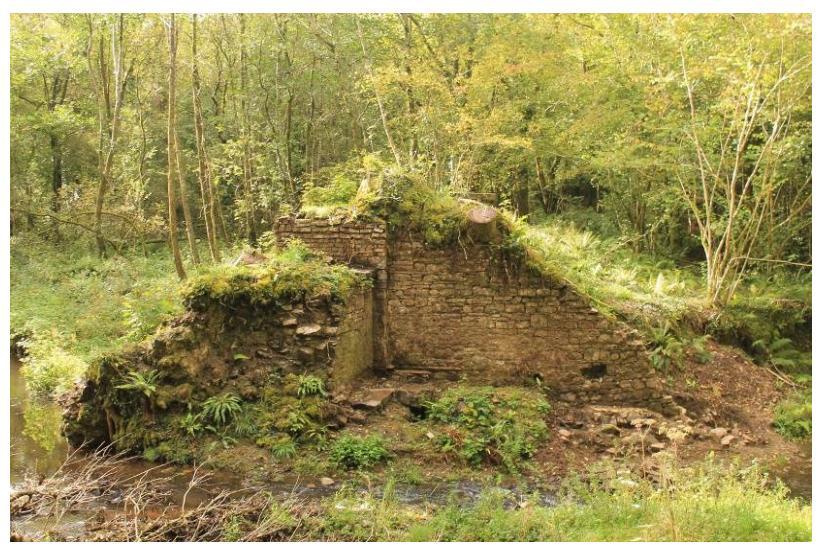
Photo 11: The remains of the Llyn Felin dam cascade (1BS8) looking southwest

The east side of the cascade has been lost, so it is uncertain what its original width would have been. It might be reasonable to extrapolate its original width on the assumption that the missing masonry is mostly likely to have comprised the east side wall of the cascade.

The cascade itself has masonry faces with a rubble and clay core. The top (the cascade spillway) is capped by stone slabs, linked with iron staples along the edges of the cascade drop. The flanking wall of the cascade has a brick facing. Although this appears similar to the brick-faced bridge abutments of 6AS25, there is no evidence for the curve of a bridge arch. Horner's depiction of the bridge over the Llyn Felin Cascade appears to show a 'rustic style' bridge. This may suggest that the red brick bridges are a later replacement for the earlier 'rustic' bridges, but no direct physical evidence of this has been identified.

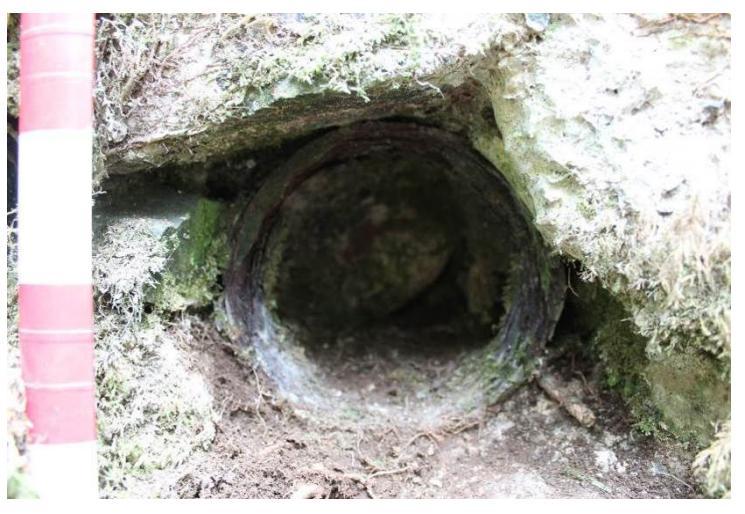
At a point where the base of the cascade is likely to have dropped down, there is a recess in the side wall containing a circular iron band (Photo 12). The purpose of this socket is uncertain, but it may have housed one end of an iron bar, perhaps used to strengthen the edge stones of the step in the cascade floor, or had some other purpose perhaps associated with creating turbulence in the cascade waters.

Photo 12: Detail of the recess containing a circular iron band

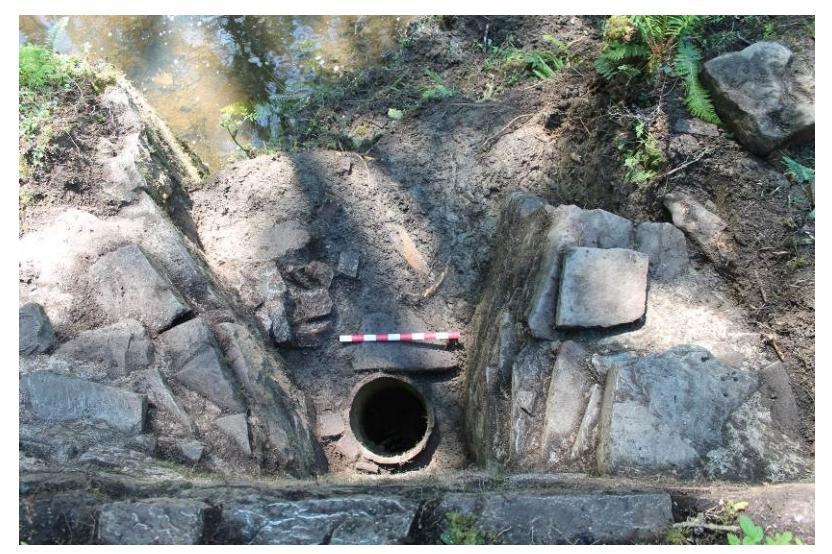
Photo 13: down pipe to culvert on south side of the cascade. Flanked by culvert wing-walls

On the south side of the cascade are two stone masonry piers flanking a 13" diameter vertical ceramic pipe (Photo 13). The top of the pipe seems high if the culvert was intended to drain the lake. If, however, the pipe provided access to a mechanism to open or close a sluice leading to the culvert (as has been suggested for 1CS7), it seems a bit low. Further excavation immediately south of the pipe would be needed to ascertain how it relates to the culvert (1BS9) running beneath the cascade.

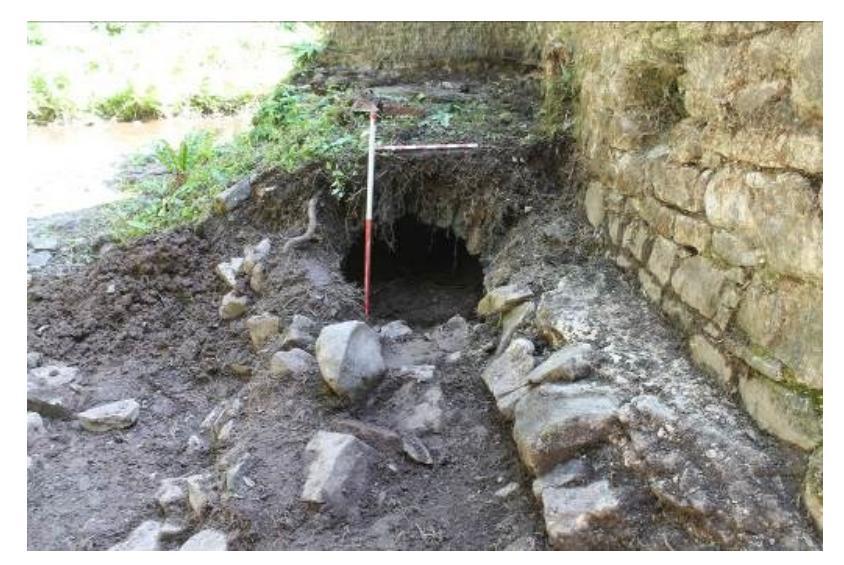
The culvert (Photo 14) runs through the masonry cascade and alongside the curving cascade side-wall. The space between the sidewall and the culvert has been partly filled with mortar.

Photo 14: Collapsed section of the culvert that ran beneath the Llyn Felin cascade (looking south)

- If the culvert and cascade are to be renovated to function as was originally intended, further investigation and recording may be necessary, to obtain a better understanding of how the culvert intake and sluice control system worked.
- Further investigation and recording may be desirable, depending on the potential impact of any proposed re-instatement of the cascade, dam and culvert on the existing remains of these structures.
- A more detailed survey (of the relative heights of the culverts, the base of the cascade and the riverbed than it was possible to achieve as part of the archaeological excavations), would be necessary to ascertain what would and would not have been possible in the original design of these features.

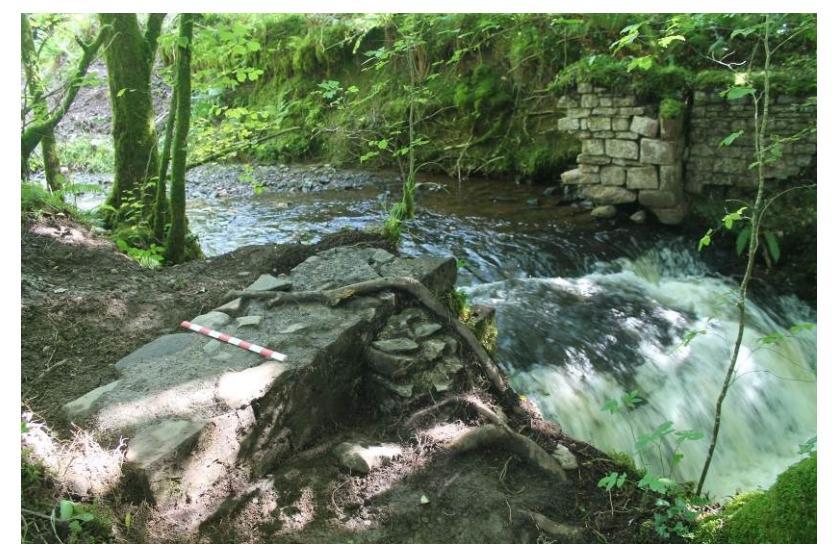
Photo 17: Diversionary dam cascade 1DS10

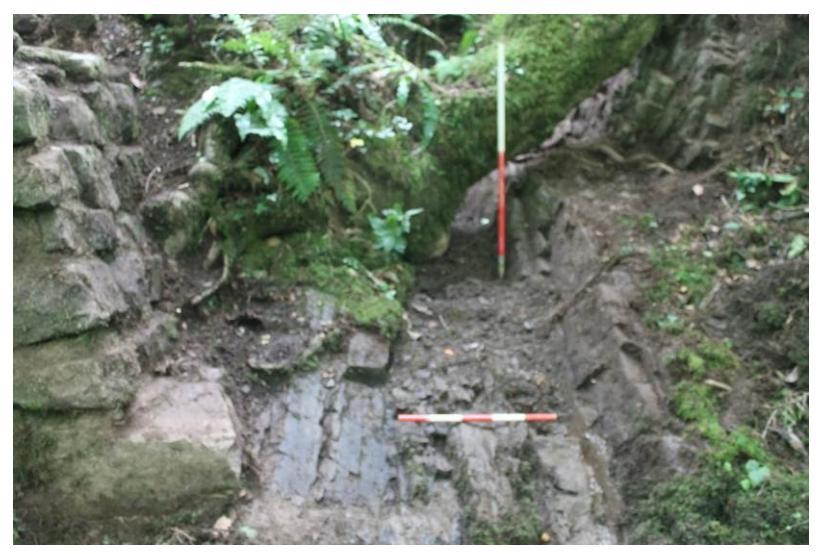
Photo 18: Outflow of rock cut storm channel 1ES40 looking west

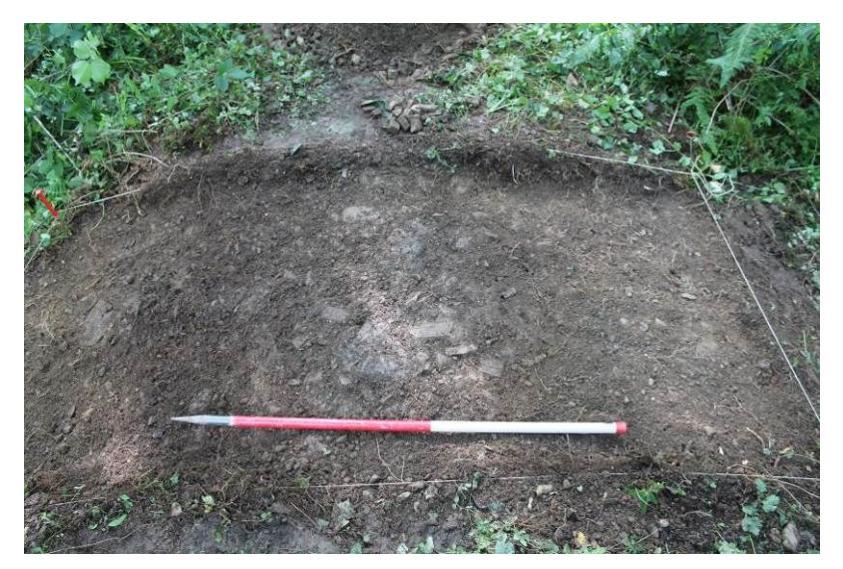
Photo 19: Remnant of track surface on top of the Llyn Felin dam

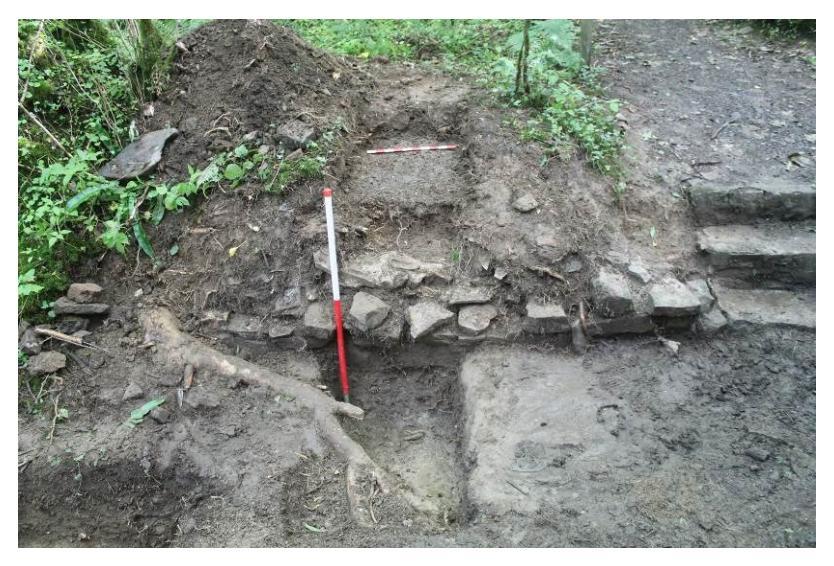
Photo 20: Bridge Abutment 1HS27 looking south

The roughly dressed stone rubble footings of a probable 2.2m wide bridge abutment were revealed immediately adjacent to the modern steps on the south side of the overflow channel (Photo 20). A single red brick located on the east side of the abutment suggests that it was brick-faced. Immediately to the south of the abutment was an associated crushed stone metalled surface. A vestige of mortared masonry on the north side may be the scant remains of the north abutment, suggesting the span of the bridge (and the width of the overflow channel) may have been about 2.4m wide.

- If a replacement for the bridge is likely to require more substantial footings, a watching brief during associated groundworks might reveal evidence for the form and construction of the bridge, and any evidence that it was an original feature or a later modification.
- Additional investigations to the west of the bridge may ascertain whether there was a sluice associated with the overflow channel.

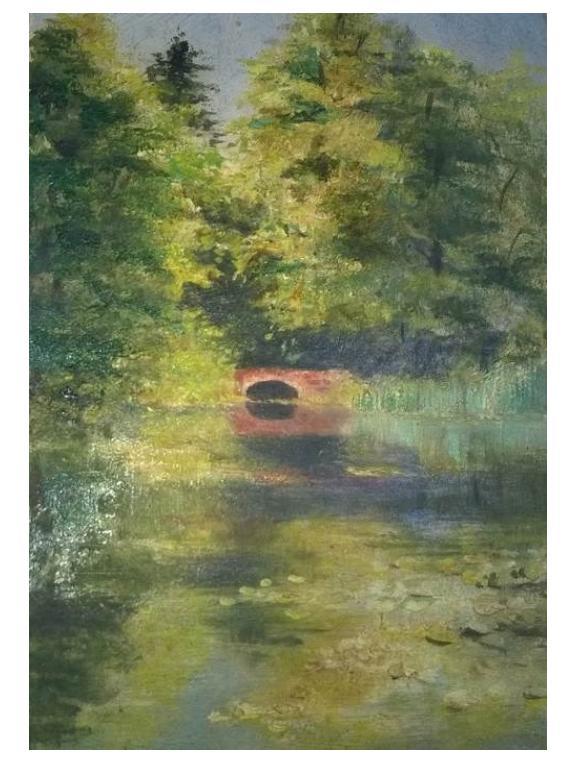
Plate 5: Painting by Alice Abadam circa late 19th century possibly depicting bridge 1HS27

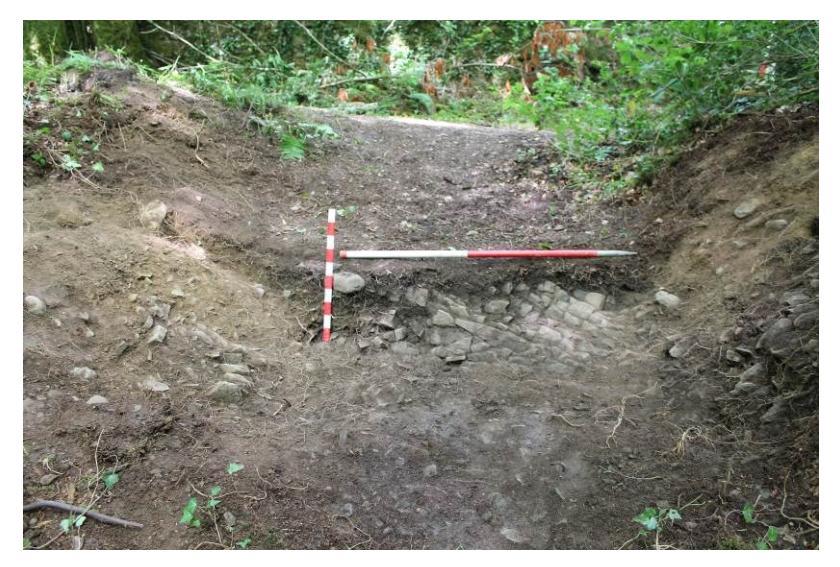
Photo 21: Site 1J looking north

Although it appears to be a cut feature, the banks of Site 1J, which are cut through soils as well as loose bedrock (Photo 21), seem unlikely to have constituted a water course. It seems most likely that the feature was intended to provide access to the river for some (probably practical) purpose or other. There was no evidence that there were ever rock cut or constructed steps in this location. There was no evidence to suggest a likely date of construction for this feature.

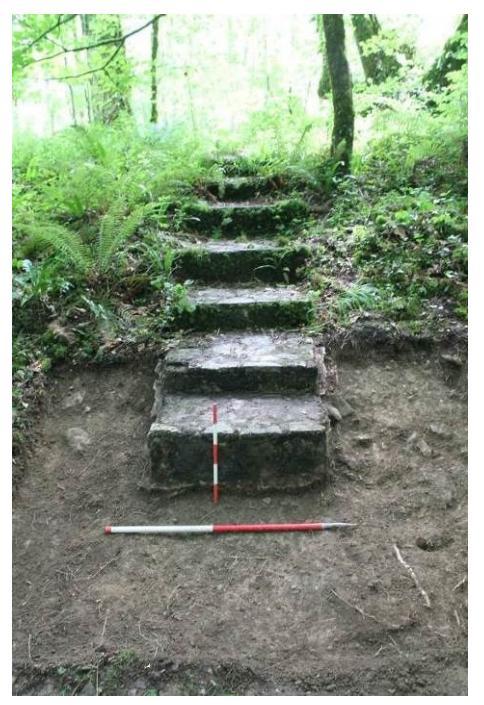
The steps on the north side of the west end of the dam (Photo 22) are modern. No evidence was revealed to suggest there were ever earlier steps or a metalled track surface in this location.

Photo 22: Modern steps (site 1L) leading up onto the Llyn Felin Dam, looking south

• If these steps were to be removed, there would be no need for further archaeological mitigation.

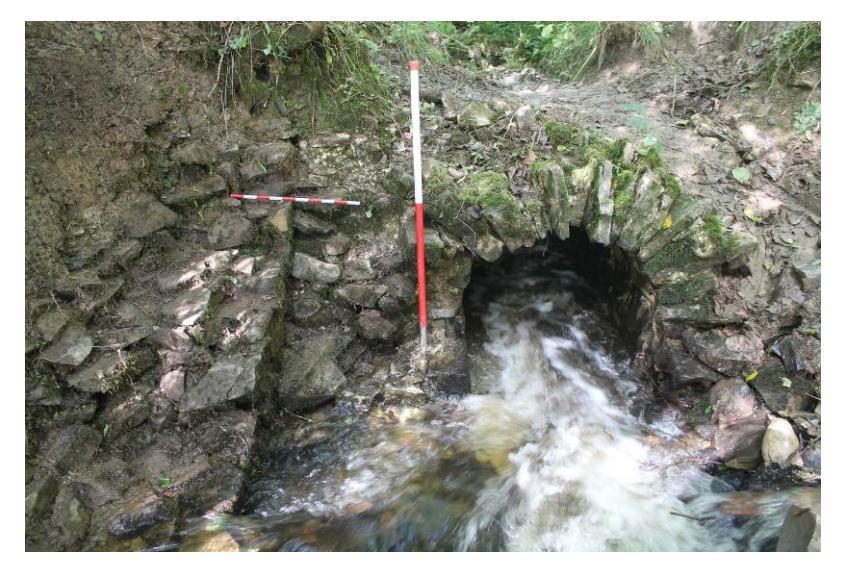
Photo 24: Culvert 2BS15 with revetment wall 2BS43 on left, looking north

There are vestiges of a masonry wall (Photo 24) on the western side of the culvert on the south side of the surviving culvert masonry in the 'breach'. It is uncertain whether this wall is the remnant of an earlier phase of culvert, or is a revetment wall constructed just prior to construction of the culvert to support the edges of the cut through the dam. The former perhaps seems more likely as there is no evidence of an equivalent revetment wall on the east side of the culvert.

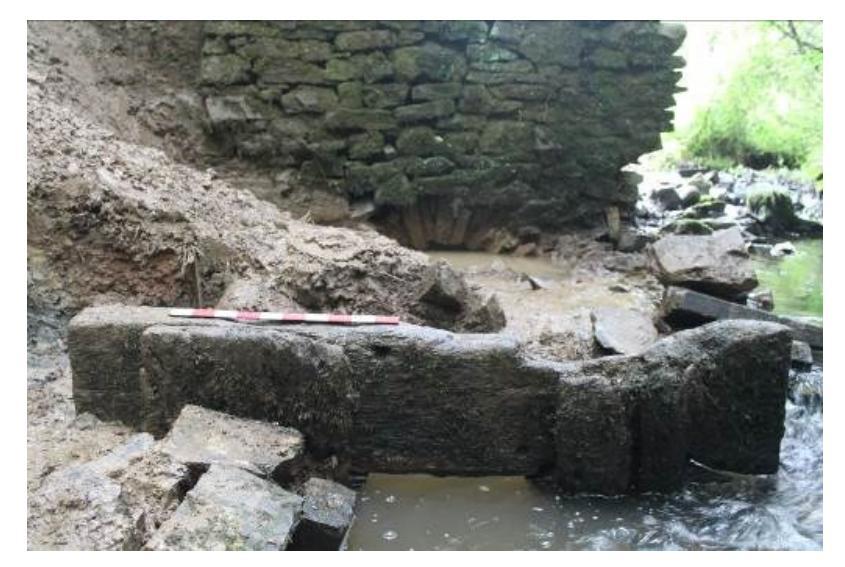
Photo 25: Sluice 2BS16 looking south

The remains of some kind of wooden sluice structure (Photo 25) survive, built across the masonry culvert 2m north of the masonry block containing the down-pipe (and presumed associated sluice), and the sluice intake. The culvert masonry and the sluice timbers appear to be integrally associated.

It is unclear what the purpose of a sluice in this location would be as it appears to significantly restrict the free flow of water through the culvert at this point. It is also unclear how the sluice could have been conveniently accessed from the level of the top of the dam for maintenance or repair.

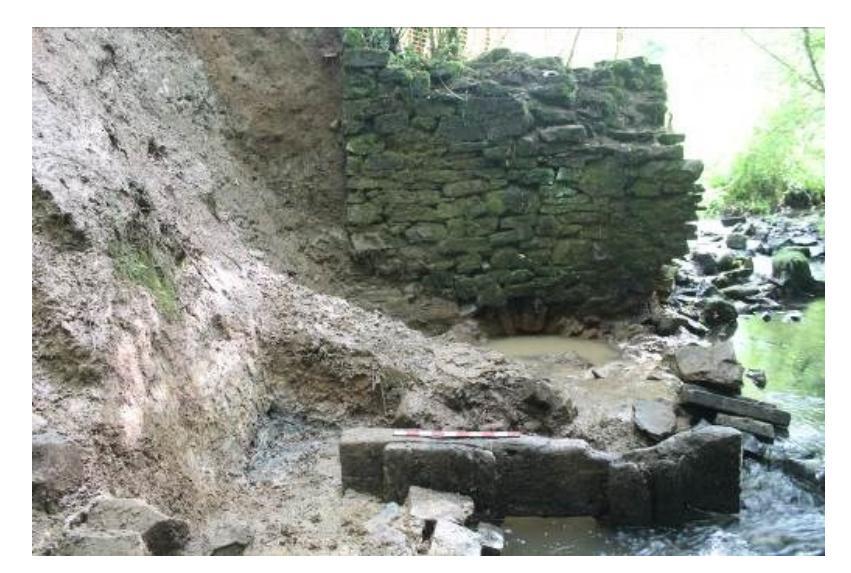
Photo 26: Downpipe masonry structure (2BS17) looking south

The substantial masonry block 2BS17 (Photo 26) (aka the culvert 'wing walls') appears to have been constructed to house the intake pipe (Photo 27) for the culvert that was inserted into the dam after its original construction. It may also have housed a sluice mechanism.

The western end has been partially destroyed. Assuming the culvert was located centrally, about 0.3m of the masonry has been lost, however, there is a roughly faced and slightly curving appearance to some of the masonry suggesting it may not have been a simple rectangular shape. There may have been masonry 'piers' on the south side of the structure channeling water into the culvert (similar to those on the Llyn Felin dam.

On the top of the masonry structure is the mouth of a 13" diameter vertical ceramic pipe. A similar pipe was present on the Llyn Felin cascade structure. It seems most likely that these pipes provided access to a mechanism for opening or closing a sluice to control the flow of water into the culvert. Alternatively the pipe itself may have fed water into the culvert.

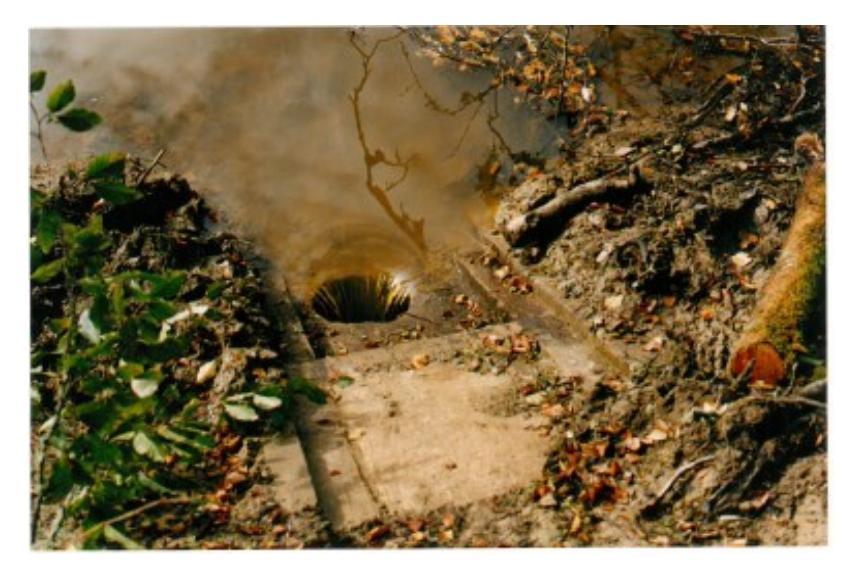
Photo 27: Photo from 1980s showing down pipe leading into the culvert looking south

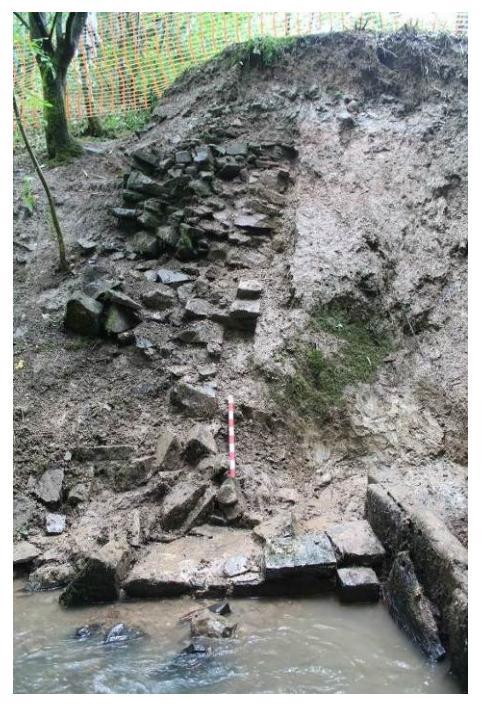
Photo 28: Masonry facing of Phase 1 dam. Looking east

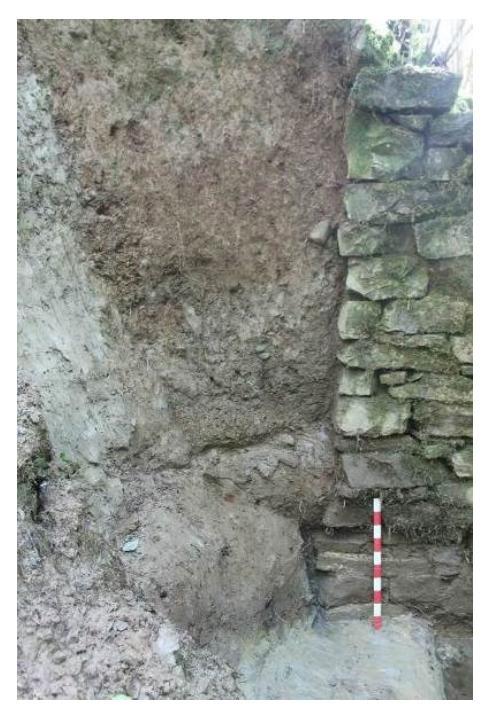
The cross section through the masonry may originally have been formed when the cut for the insertion of the culvert (Photo 29) was made.

Photo 29: Cut through the Phase 1 dam for the insertion of the culvert

- If engineering works are undertaken, a watching brief and/or additional archaeological excavation should be undertaken in this location to clarify how the dam was constructed, its relationship to the culvert features and the Phase 2 dam modifications.
- It would be worth undertaking more investigations of the culvert 4CS34 and dam 4AS44 to compare the construction characteristics of these structures with the early phase of the Llyn Mawr dam.

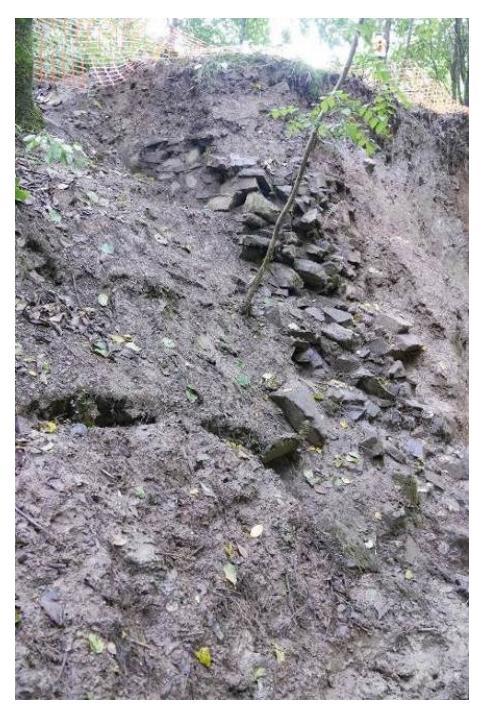
Photo 30: Phase 2 material deposited against the Phase 1 Dam masonry facing. Looking south

It was not possible to cut a cross section through the Phase 2 material deposited against the Phase 1 masonry facing (Photo 30).

- If engineering works are undertaken in this location, a watching brief and/or additional archaeological excavation should be undertaken to clarify how the dam was constructed, its relationship to the culvert features and the Phase 2 dam modifications.
- If the opportunity arises, it would be useful to obtain cross sections through the Llyn Mawr dam at other points along its length. Alternatively an auger survey might provide sufficient data to ascertain the extent of the phase 1 and 1 dams.

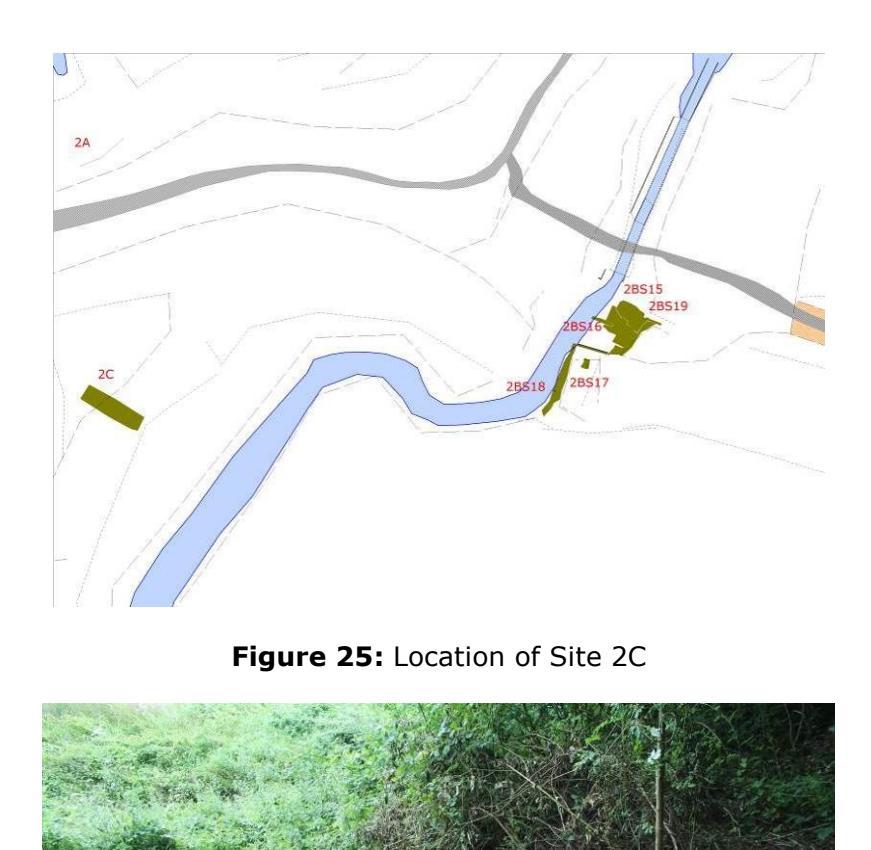
Photo 31: Trench 2C shore of Llyn Mawr

The investigations did not reveal any evidence of a constructed shoreline revetment. All the deposits appeared to be natural clays and silts. Lake sediment deposits were identified at the southern end of the trench.

The main bank slope (Photo 31) appears to represent the edge of the lake at the time of the repair works undertaken (see photo xxx). The level area at the top of the bank is likely to have been created during the repairs to the breach In the Llyn Mawr dam. The water level at this time is indicated in Photo 32.

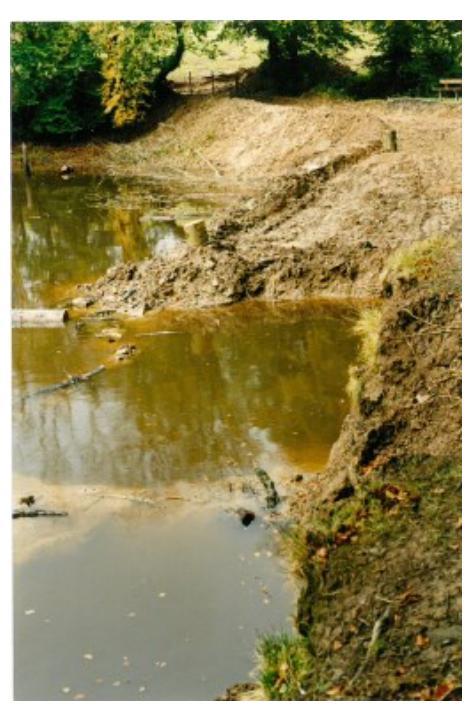
Photo 32: The location of investigation is close to the top left The water level is defined by the downpipe in Structure 2BS17 (see Photo 27).

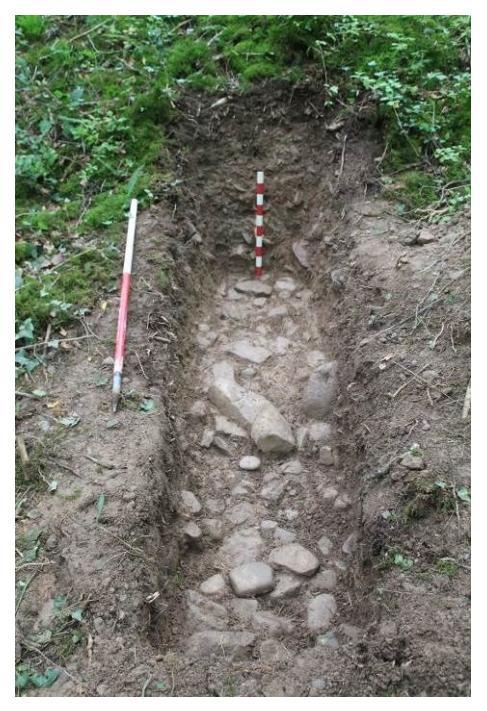
Photo 35: Structure 2GS11 facing south

The trench was intended to ascertain the northern extent of the dam. Beneath the topsoil, redeposited dam clay containing occasional small to medium-sized stones. Below the ground surface, a stoney horizon was revealed (Photo 35). Approximately half way along the trench a group of larger stones lying immediately above the stoney layer, marked a change in the stoney horizon from being relatively loose and irregularly lain, to being very compact and flattened.

The group of larger stones are considered to represent the northern edge of the dam structure. The compacted area lies below the dam structure. The looser stone horizon extends beyond the northern edge of the dam.

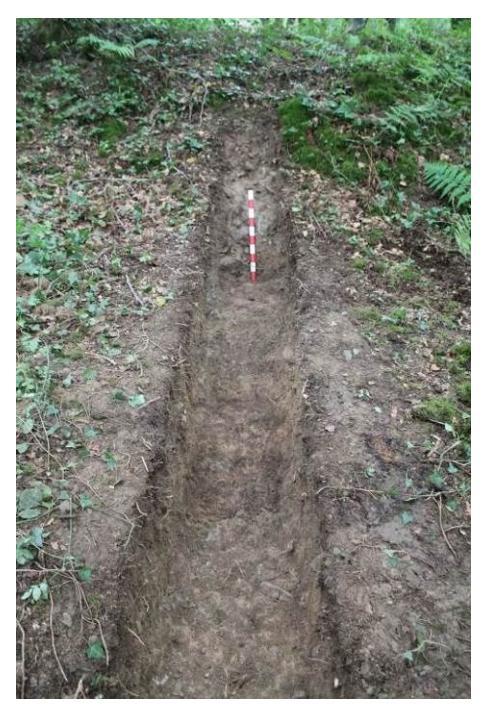
Photo 36: Carriageway? (2GS12) facing south

A location for a narrow trench (Photo 36) was selected that from the surviving landscape evidence was thought likely to provide a good chance of characterizing the Paxton-period path.

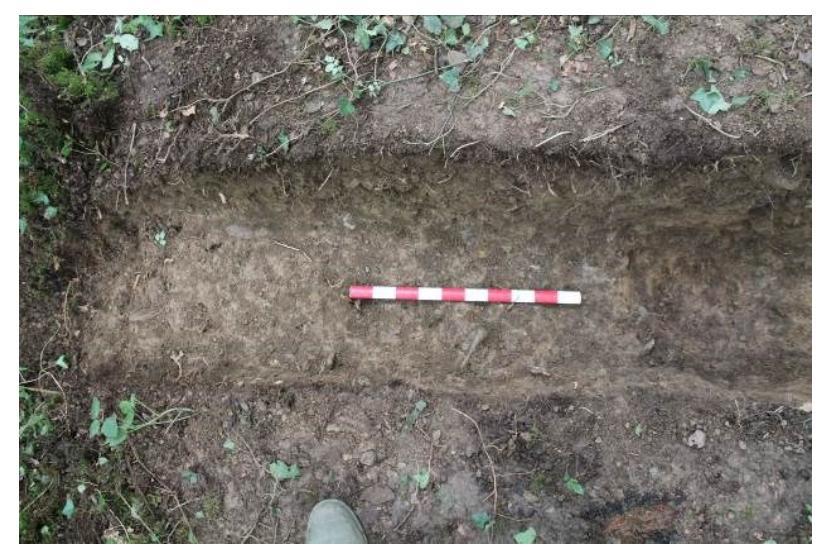
Photo 37: Carriageway? (2GS12) facing north

Other than a slightly stonier deposit at the north end of the trench, which may constitute a crude track surface (Photo 37), no convincing evidence of a formally constructed path surface was apparent other than could be traced from the associated landforms. Below the topsoil, yellow clays and silts appeared likely to be natural deposits, but it is possible that they are redeposited clays associated with the structure of the adjacent dam.

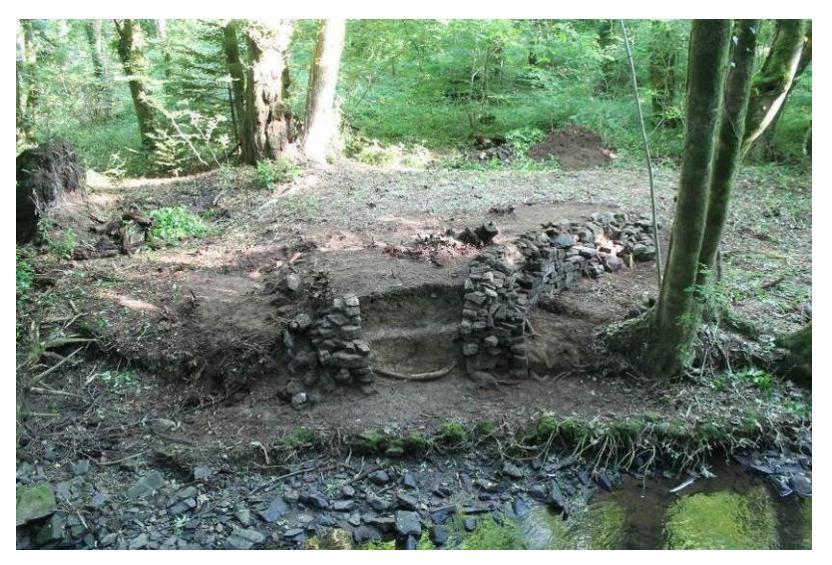
The west bank abutment footings (Photos 38 and 39) are bedded on solid natural bedrock that appears to be one side of the natural watercourse. Although not revealed during the investigations, it seems likely that the footings of the eastern bank are similarly bedded on bedrock, and that the limit of the surviving masonry on the eastern side marks the line of the east bank bedrock.

Photo 38: Structure 2KS33 looking east

• Although the feature has been surveyed, should the opportunity arise, structure 2KS33 would be a candidate for 3D photographic recording in order to produce an accurate plan of the feature.

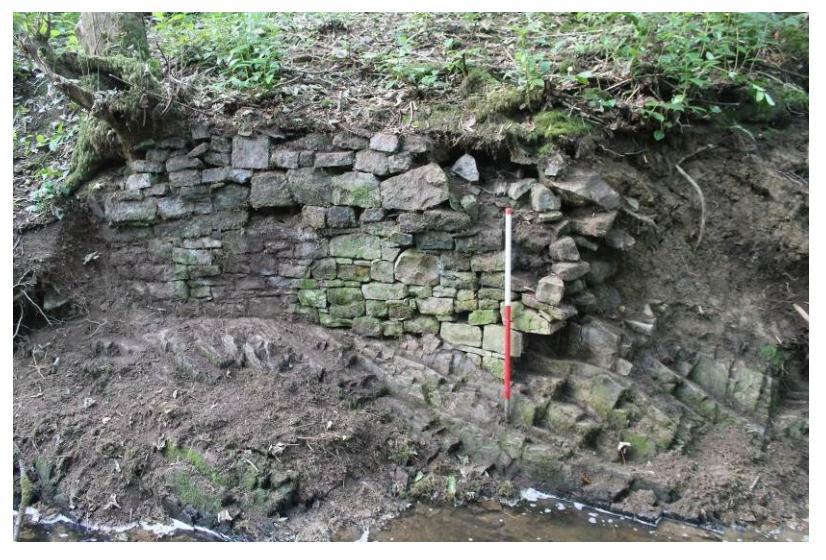
Photo 39: Structure 2KS33 looking west

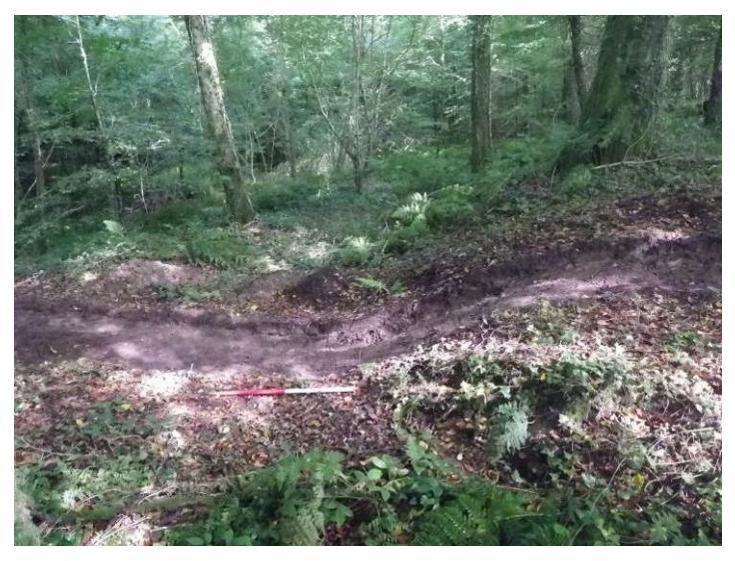
Although the platform (Structure 45) and the path (Structure 46) are clearly part of the designed landscape, no evidence of constructed revetment walls, metalled surfaces or structures was identified within the small excavation area (Photo 40). The features appear to be constructed as part of the dam structure in this location.

Photo 40: Platform (Structure 45) and the path (Structure 46) looking east

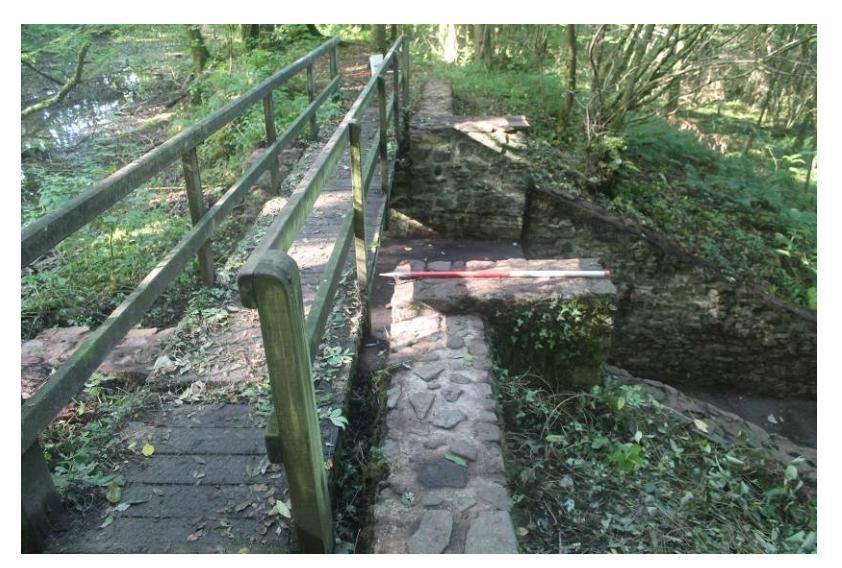
Photo 43: Bridge and masonry at the top of the cascade (looking west)

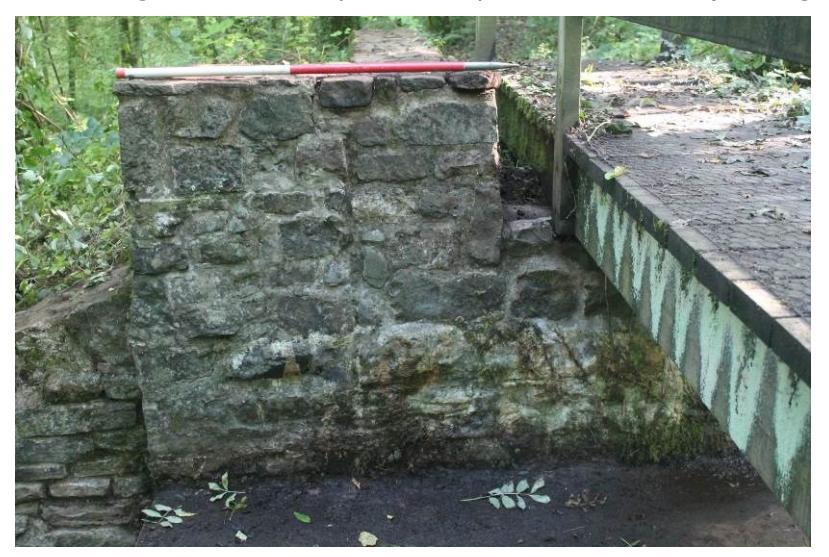
Photo 44: East side, looking east. Top of cascade

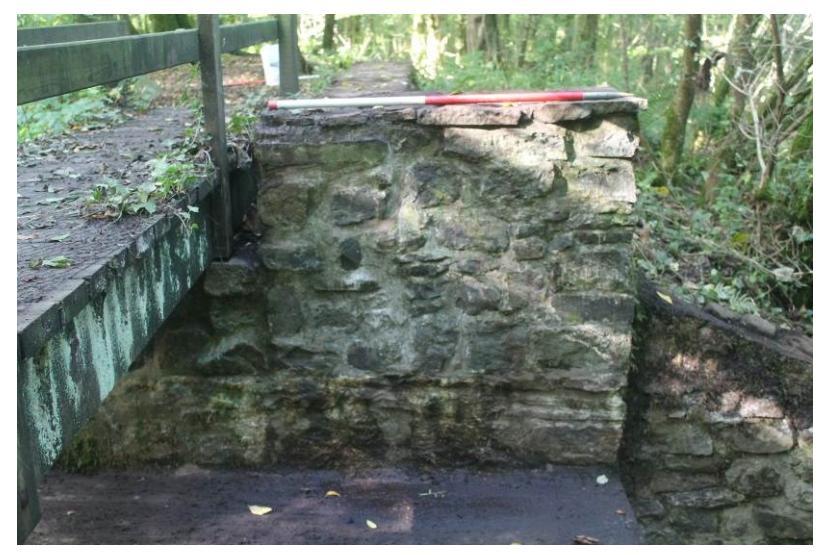
Photo 45: West side, looking west. Top of cascade

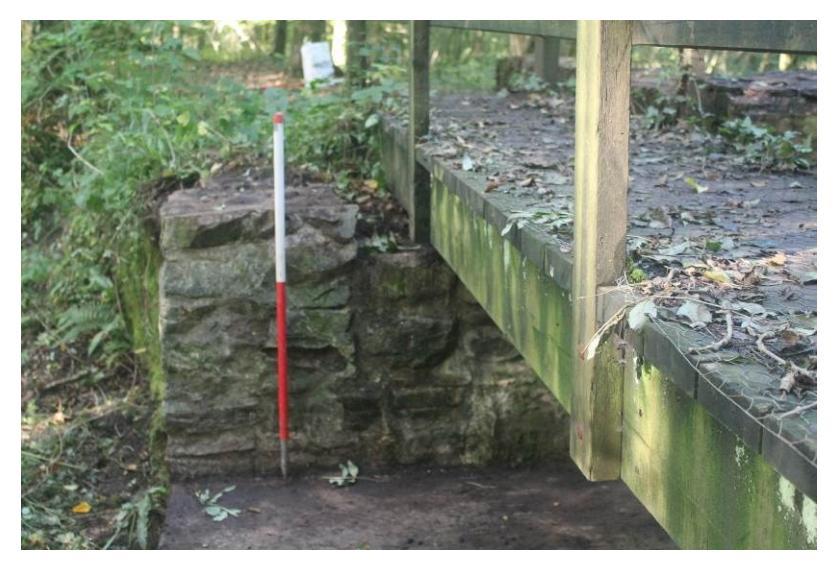
Photo 46: Top of cascade, west side, looking west

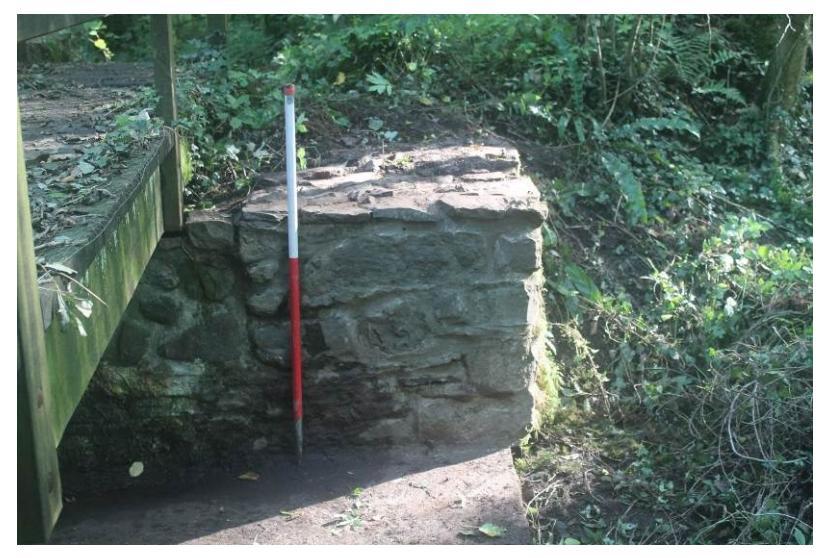
Photo 47: Top of cascade, east side, looking east

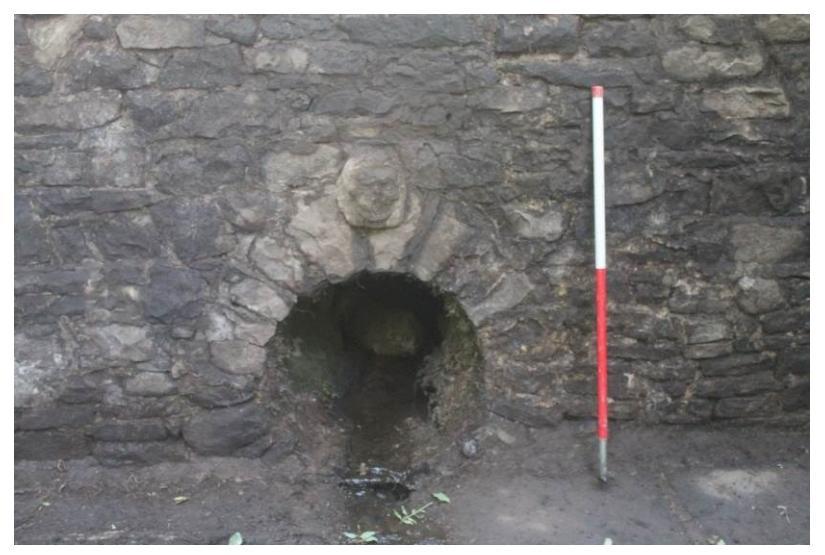
Photo 48: Culvert at base of first drop of cascade
