NATIONAL BOTANIC GARDEN OF WALES REGENCY RESTORATION PROJECT

PHASE 1 ARCHAEOLOGICAL INVESTIGATIONS AND STRUCTURE RECORDING 2015

INTERIM REPORT

RHIF YR ADRODDIAD / REPORT NO. 2015/61 RHIF Y DYGWILLIAD / EVENT RECORD NO. 108883

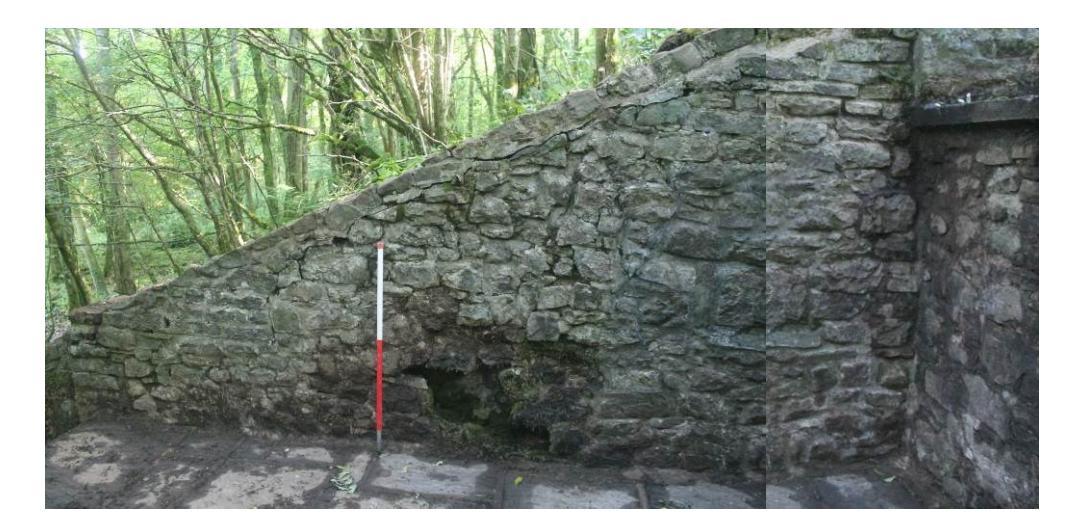
Photo 49: East wall at the first drop of cascade

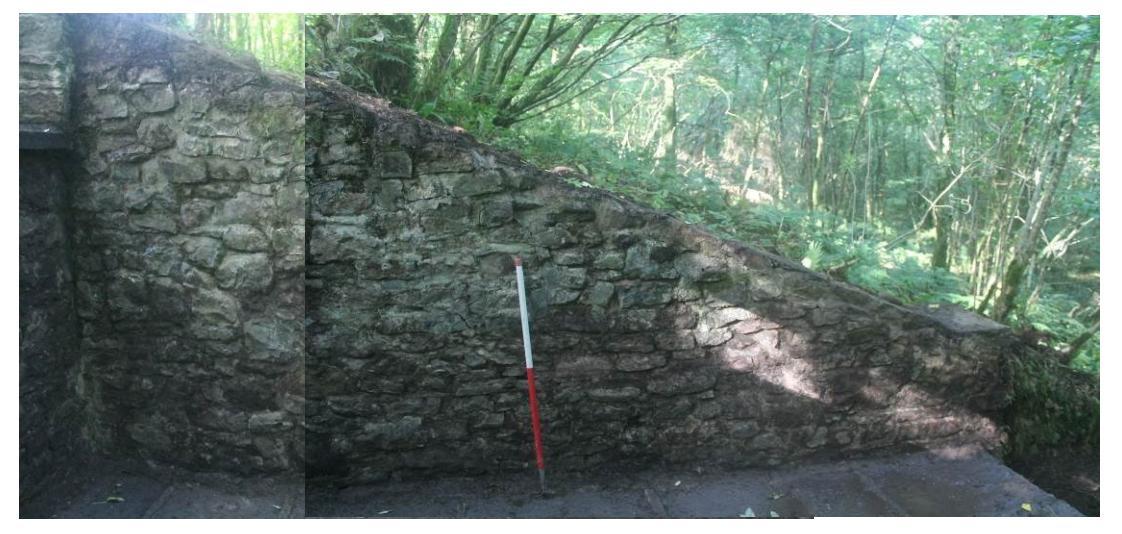
Photo 50: West wall at the first drop of cascade

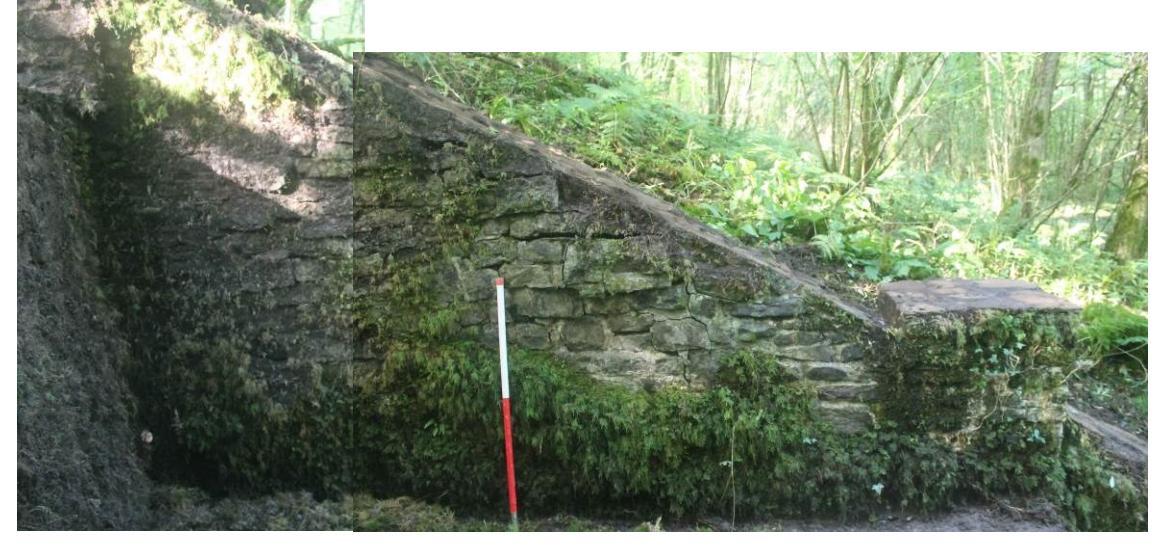
Photo 51: West wall at the second drop of cascade

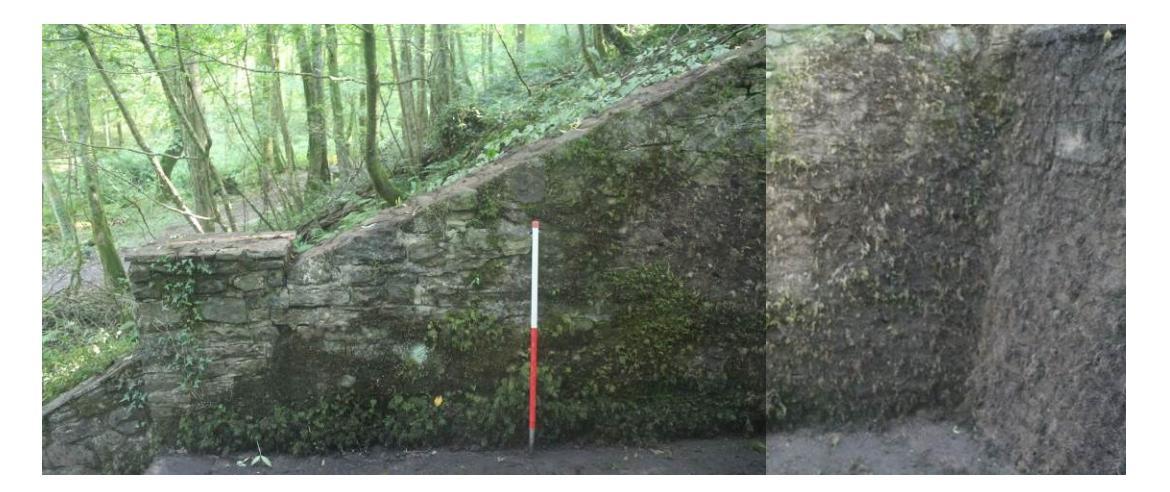
Photo 52: East wall at the second drop of cascade

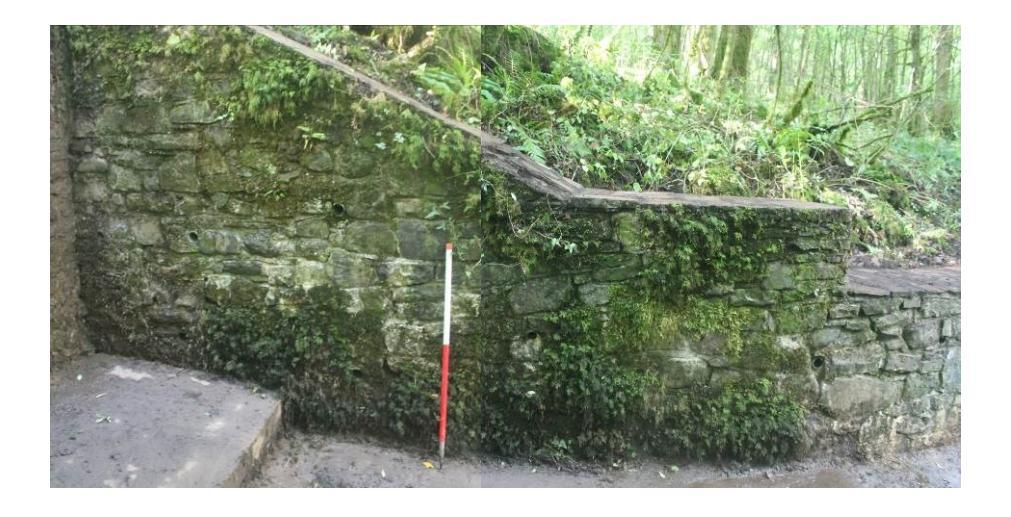
Photo 53: West wall at the third drop of the cascade

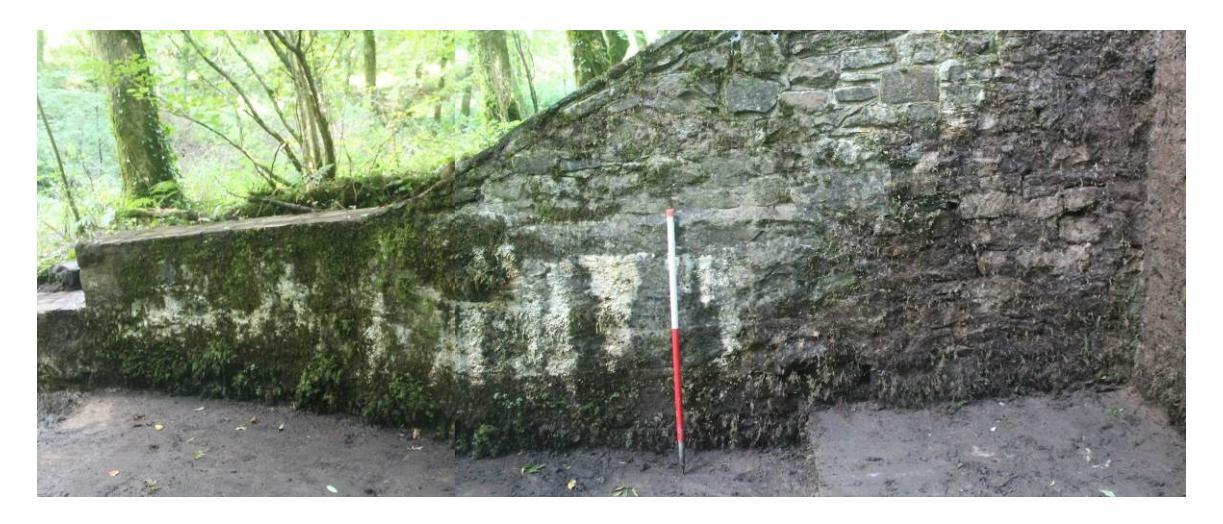
Photo 54: East wall at the third drop of the cascade

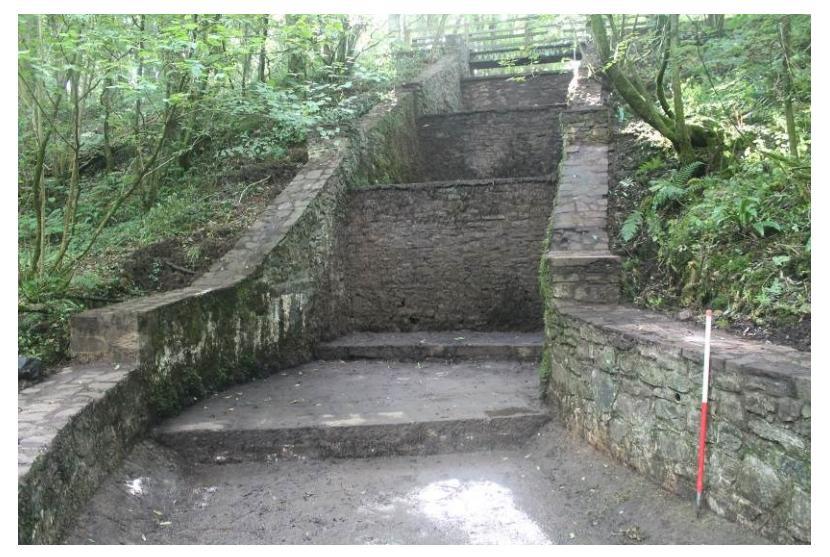
Photo 56: The cascade after rebuilding

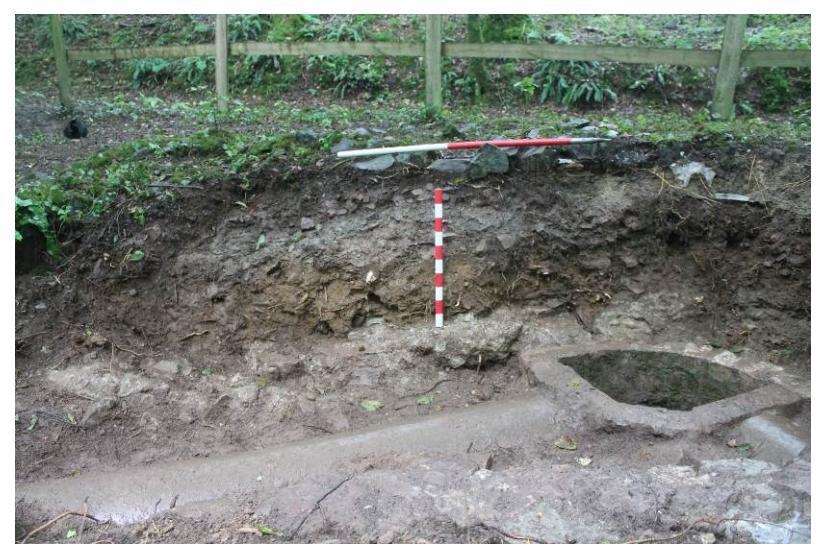
Photo 59: Track deposits (grey) in section

Originally the south side of the dam appears to have continued southwards, presumably until it eventually abuts solid bedrock on the natural valley side. The southern extent is, however, covered in a layer of yellow dam clay and two layers of stone chippings (Photo 59). These chippings are the remains of a metalled surface (Structure 24) leading on to the dam. The surface appears not to have continued across the top of the dam.

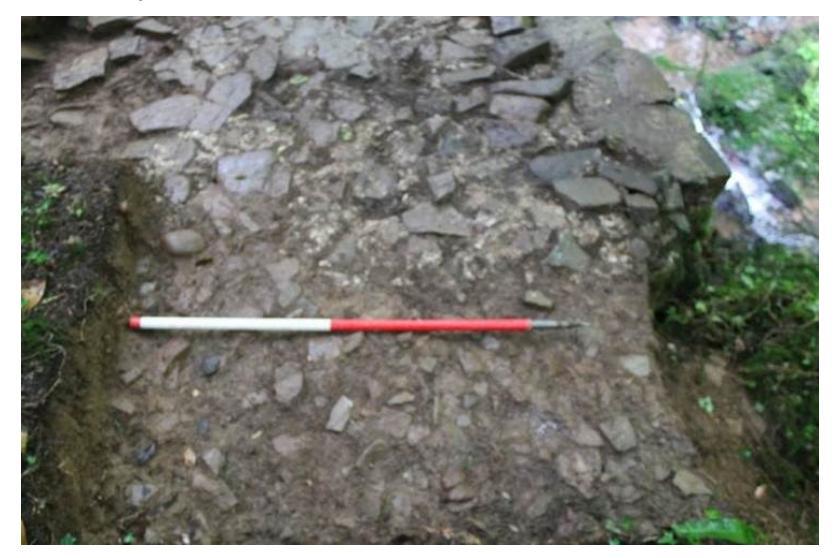
The point where the northern approach track meets the top of the dam was cleared of leaf litter (Photo 60). The track was found to be metalled with crushed stone running seamlessly onto the mortared slab stonework of the northern half of the dam. Part of the revetment wall flanking the approach path has collapsed.

Photo 60: Interface between the path and the top of the great waterfall on the north side. Looking south.

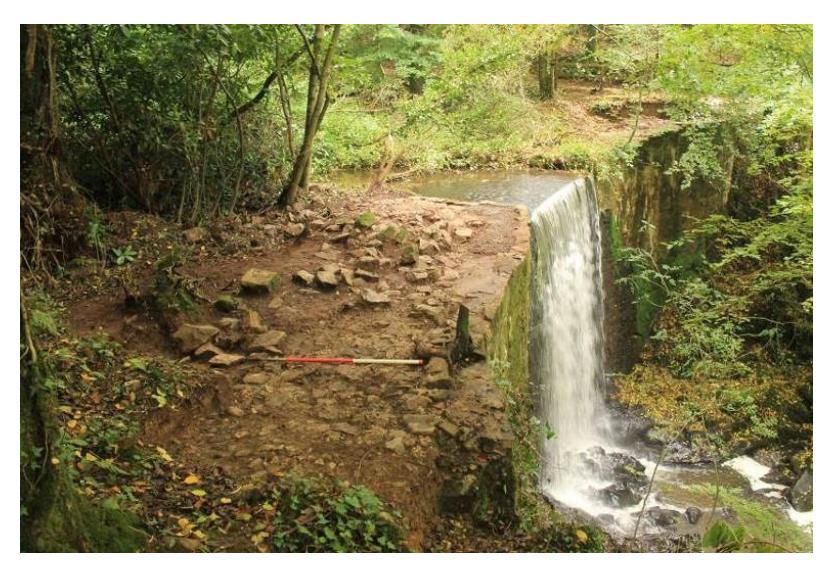
Photo 61: North side of the waterfall, looking south

The north side of the dam structure (Photo 61) shows evidence of several phases of alteration as a result of various repairs presumably undertaken at different times. Where there have been no repairs, the top of the dam is surfaced with flat stone fragments set in lime mortar (as on the south side). Coarse grey concrete on the north edge of the dam indicates a phase of repair. Grey cement on the northern edge indicates another repair. These patches may have capped exposed core work resulting from the removal of the equivalent parapet wall that survives on the south side. The random stone rubble in a clay matrix projecting above the level dam surface represents the backfill of a third repair which presumably removed material from the core of the dam perhaps to repair a leak or remove tree roots.

Possible evidence of two or three post pads was identified, but these were of different sizes and were not evenly spaced. Any other potential evidence for a possible bridge across the dam that may have existed previously was destroyed by the later repairs.

- Visible cracks and leaking suggest that the north side of the dam still requires substantial repair or rebuilding.
- It is possible that there was originally a bridge over the cascade spillway, but because only part of the west side of the dam was cleared of overburden, no evidence was revealed. On the east side, later disturbance may have destroyed any evidence formerly present.
- Further investigation of the flanking revetment walls (currently inaccessible) on the east and west sides of the dam may provide additional information as to whether the dam was originally symmetrical or not, and may even provide clues as to how it was bridged.
- The overflow pipe may only have had a temporary function. If it is to be retained and restored to function, it may be necessary to ensure that the right angle bend does not get blocked up with debris.

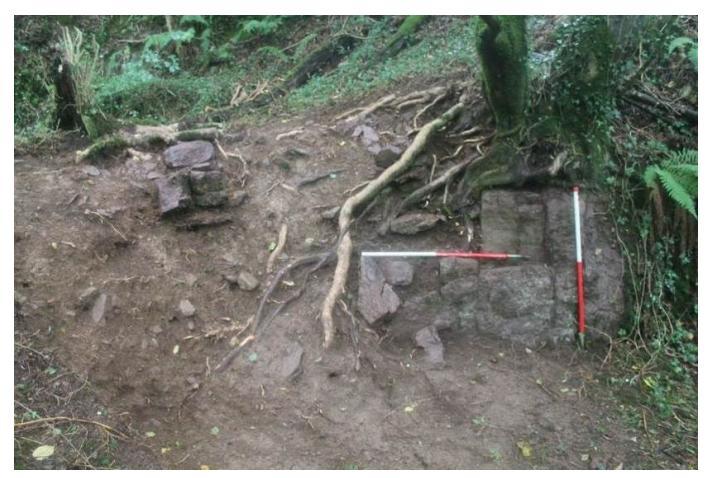
The supposed area of interface between the dam and the valley side/quarry was stripped of overburden. The quarried rock face was revealed (Photo 62), over and against which the dam appears to have been constructed (from clay and stone rubble). The quarry is therefore most likely to pre-date the construction of the dam. No evidence for a stone facing to the dam (on its lake side) was apparent. What appears in the photo like some coursed masonry is most likely just a fortuitous arrangement of stones.

Photo 62: Site 4A looking north

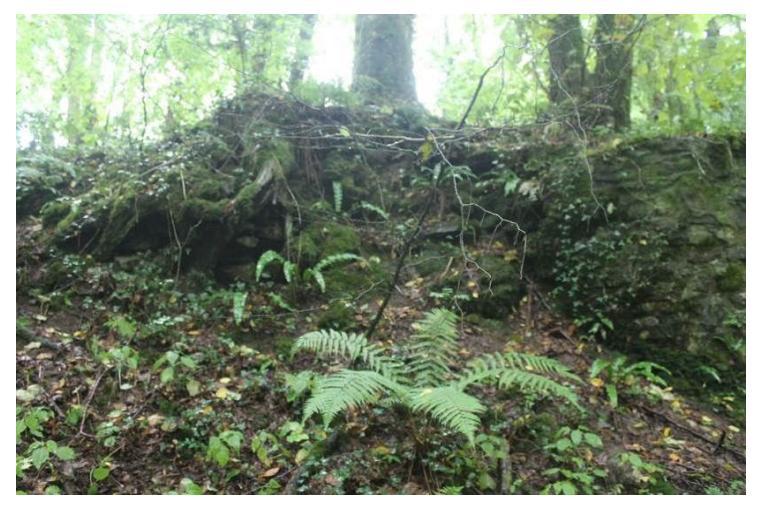
Investigation 4B shed no more light on the structure of the dam. Observations on the north side of the dam showed vestiges of stone rubble masonry (Photo 63) adjacent to, (and apparently behind), the rebuilt revetment walls on the north side of the watercourse. These may be vestiges of the current structures before they were restored, or perhaps more likely, vestiges of a masonry facing to the dam, or of an earlier water management structure (such as a cascade).

Photo 63: Stonework visible adjacent to the restored water management features may be vestiges of a masonry face to the dam, or the remnants of an earlier water management feature.

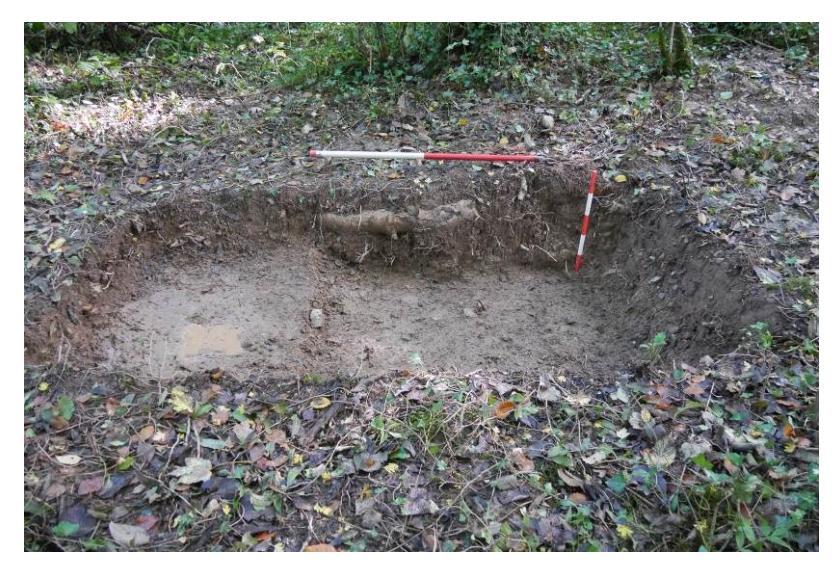
Photo 64: Investigation 4B

No evidence to clarify whether the existing land forms are the result of a bank being built up against the lake-side side of the dam was identified (Photo 64). It was difficult to estimate exactly where such an interface might be located, so it may be that the evidence sought did not fall within the excavated area. Furthermore since the whole landform is constructed from yellow clays, it is difficult to differentiate between potentially different deposits.

• If this dam is restored as part of the scheme, larger scale investigations (prior to or during construction works) would be needed to fully understand the sequence of features in this location.

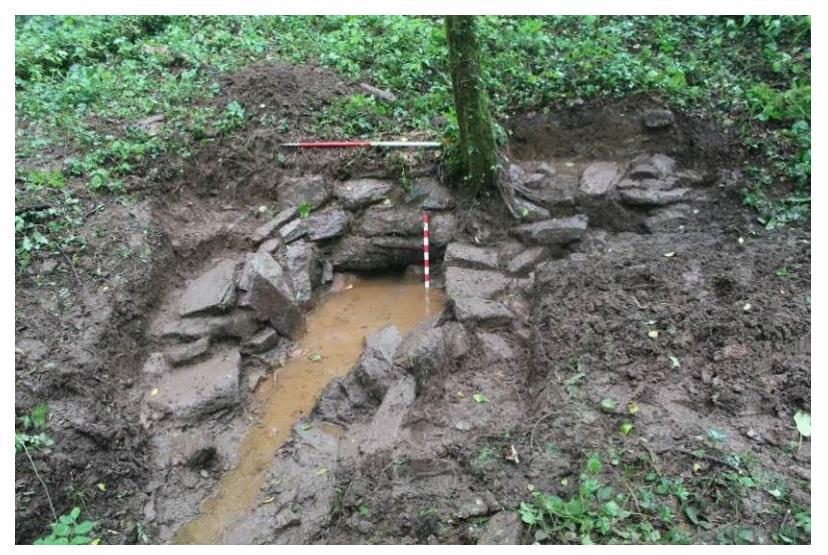
The removal of overburden revealed the remains of a stone-built culvert (Photo 65). The masonry consists of large undressed irregularly shaped stone. What survives of the walls revealed suggests they are irregularly coursed and clay bonded.

The culvert is constructed in a very different style to the known Paxton period culverts, and is most likely to be of earlier origin.

Photo 65: Culvert 4CS34, looking east

- Although the culvert appears to be of earlier origin, it need not suggest that the dam above it is of the same date.
- If this dam is restored as part of the scheme, larger scale investigations (prior to or during construction works) would be needed to fully understand the sequence of features in this location.

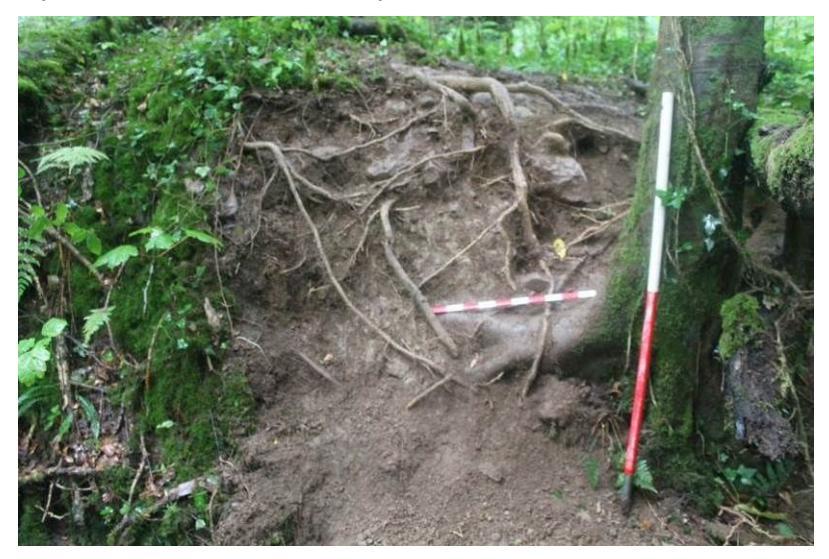
Due to the presence of myriad tree roots, only a small area was cleared of leaf litter etc. No evidence to suggest that this was a constructed landform was apparent (Photo 66). Although it is possible that the course of the river in this location has been engineered, it seems most likely that this bank is entirely natural.

Photo 66: Site 4D looking southwest

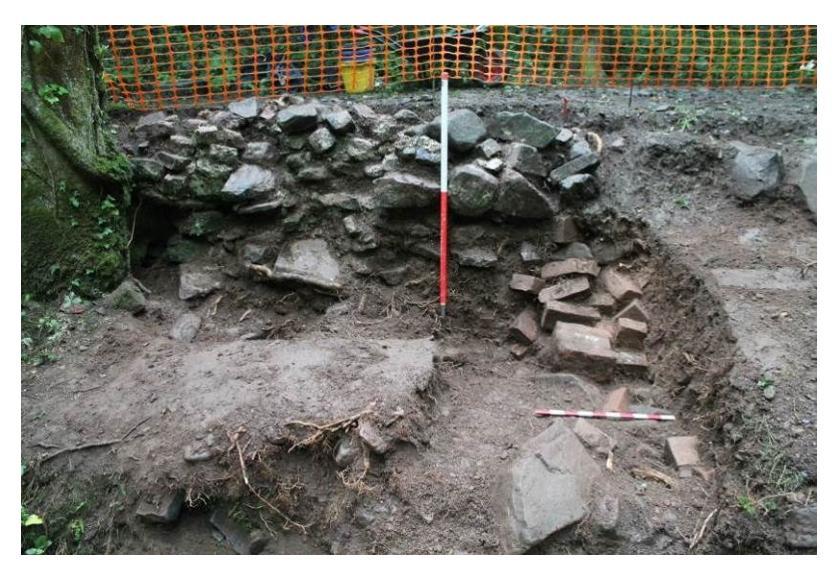
The remnants of both bridge abutments were investigated (Photos 70 and 71). On the north bank, adjacent to the modern path, vestiges of irregularly coursed rubble stone in a mortar matrix were revealed. Most of this is core work (the wall face having collapsed). The length of the stonework suggests that on this bank, the bridge abutment is incorporated into a bank-side revetment wall. The concentration of red brick in photo 70, corresponds with the west side of the bridge which survives on the southern bank bridge abutment. The remainder of the bridge abutment lies to the east (beyond the excavated area). The visible stonework is assumed to represent the southern side of abutment, minus its red brick facing.

Photo 70: East abutment

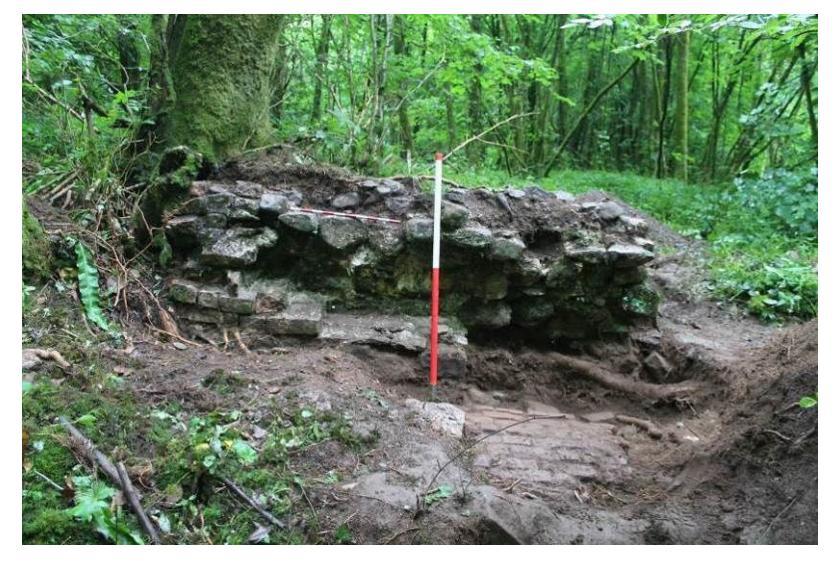
Photo 71: West Abutment

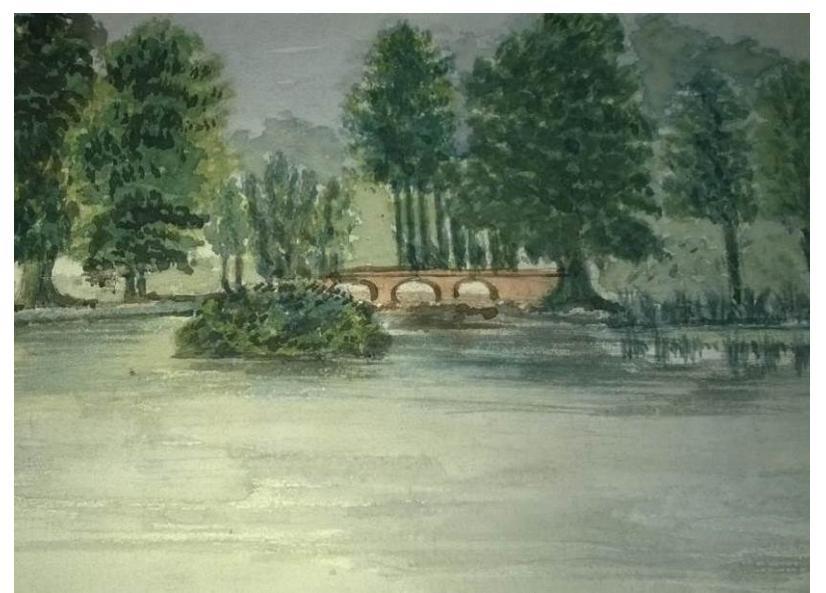
- **Plate 10:** This painting by Alice Abadam circa late 19th century titled 'The minnow Bridge Chalybeate Pond' is probably a depiction of bridge 6AS25
- Because the width of the watercourse has changed, and the bed of the river may have lowered, it is not possible to see if evidence survives of pier bases for the spanning arches.
- Major groundworks and waterflow management would be needed to try and find evidence of bridge piers.

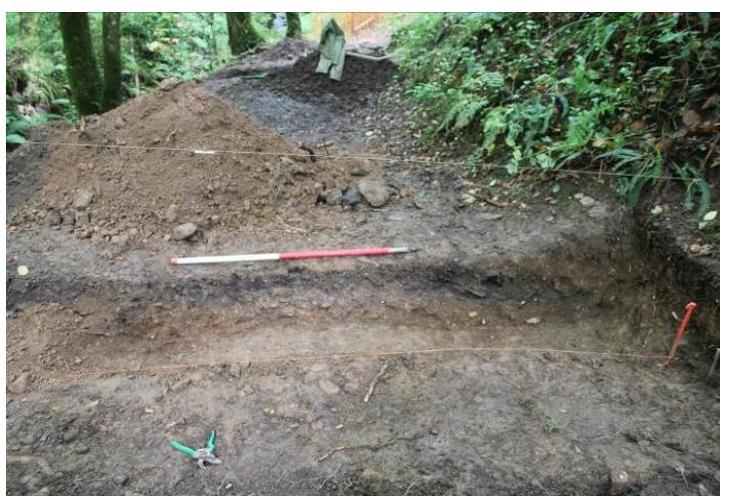
Two trenches were excavated across the pathway. In the western trench (Photo 73) clear evidence of a metalled carriageway surface was identified. The eastern trench was excavated to test the theory that this may have been the location of a footbridge across the river. No evidence of this was discovered, but the same metalled surface was revealed at the southern end of the trench a ceramic water/drainage pipe was identified in a cut backfilled with fragments of red brick (Photo 74).

Photo 73: Site 6C track surface, looking east

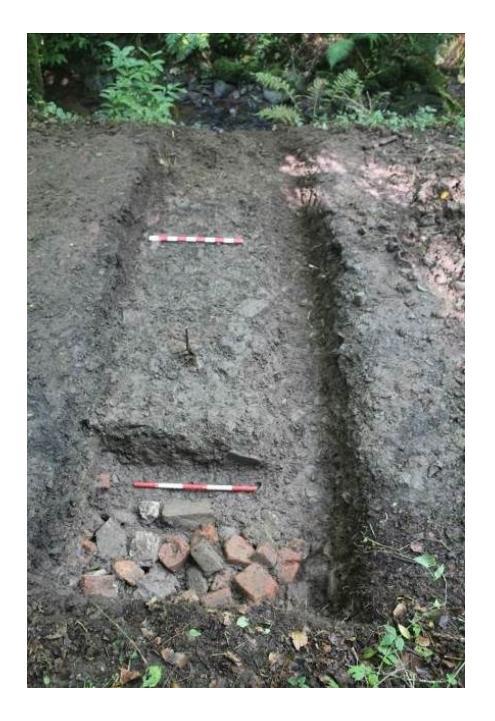
Photo 74: Site 6C track surface with brick filled pipe trench. Looking north

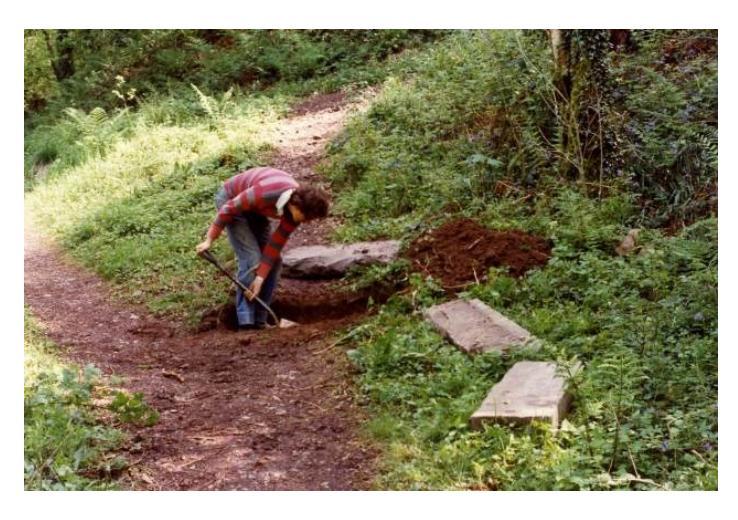
Although it was not possible to ascertain what paths if any led up to the top of the cascade, photographs taken in the 1980s when the modern paths were constructed do not suggest there were formal steps in these locations (Photos 75 and 76).

Photo 75: 1980s photograph of steps to top of the cascade under construction

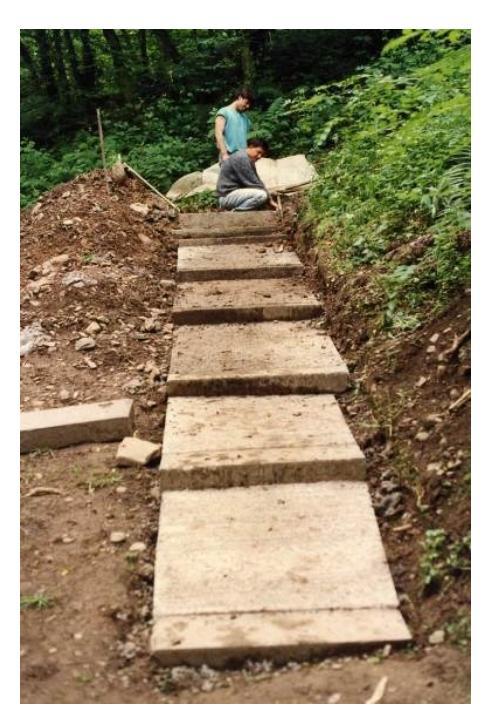
Photo 76: 1980s photograph of steps to top of the cascade under construction

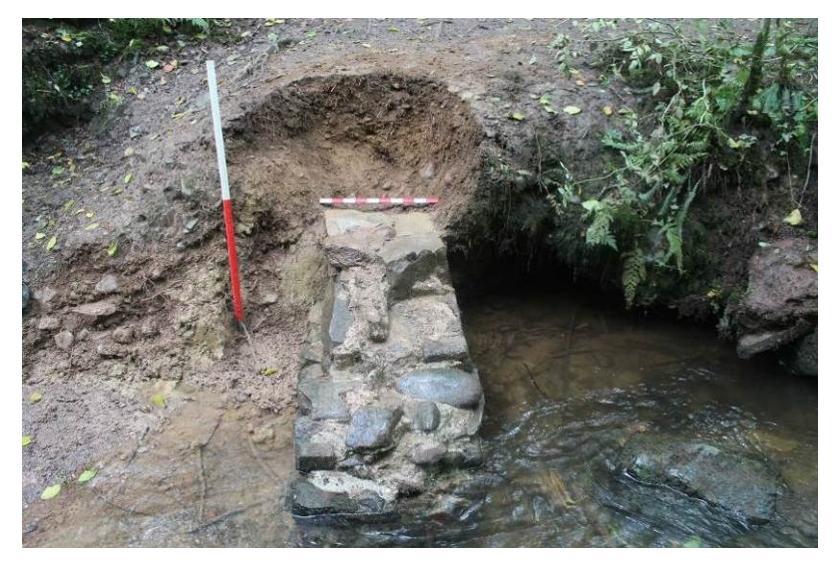
The masonry block (Photo 77) was cleared of overburden and its surviving extent established. The masonry seems unlikely to be a bridge abutment because it is so narrow. There was no evidence of a path surface associated with it.

Photo 77: Structure 30 looking south

• Restoration of this feature would re-establish the pool below the hidden waterfall to its intended height.

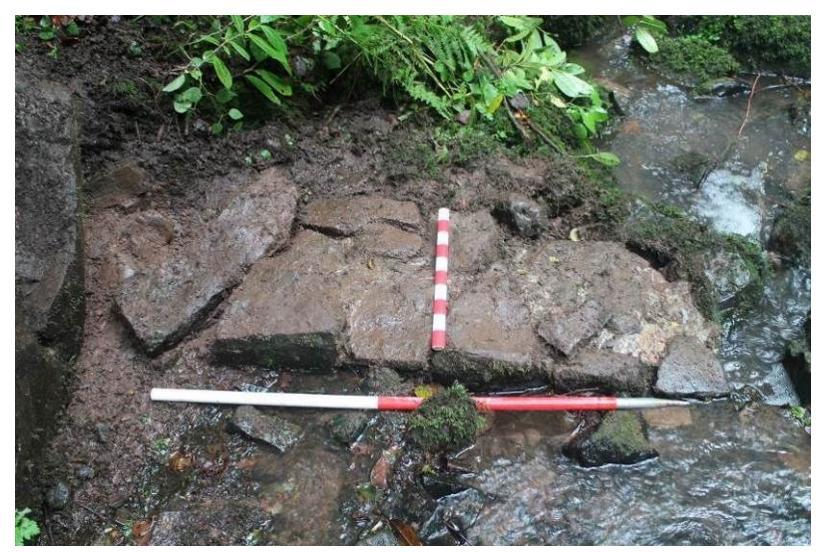
Photo 78: Structure 31 looking east

A second stub of mortared masonry (Photo 78) was located above the 'Hidden' waterfall. This is also likely to be the remnant of a small cascade to enhance the dramatic effect of this location (however, it does seem quite dramatic enough without it).

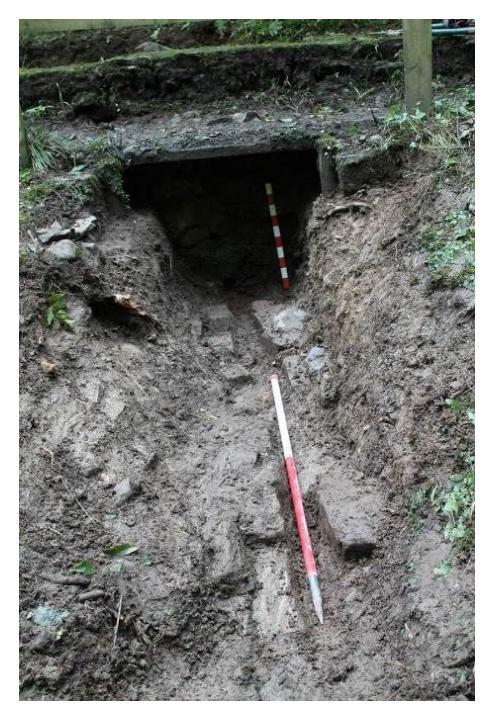
Photo 79: Drain leading from fountain, looking north

The existing structure appears to have been almost entirely rebuilt, to the extent that is not possible to know whether its present appearance differs from its original form. The existing fountain head is a modern facsimile. Beneath the wooden boards supporting the modern pathway, a mortared masonry wall face appears to be associated with the original structure (Photo 79). It is slightly differently aligned to the existing restored structure. An iron pipe exits from this masonry into a crudely constructed rubblestone drain that may formerly have held pipework.

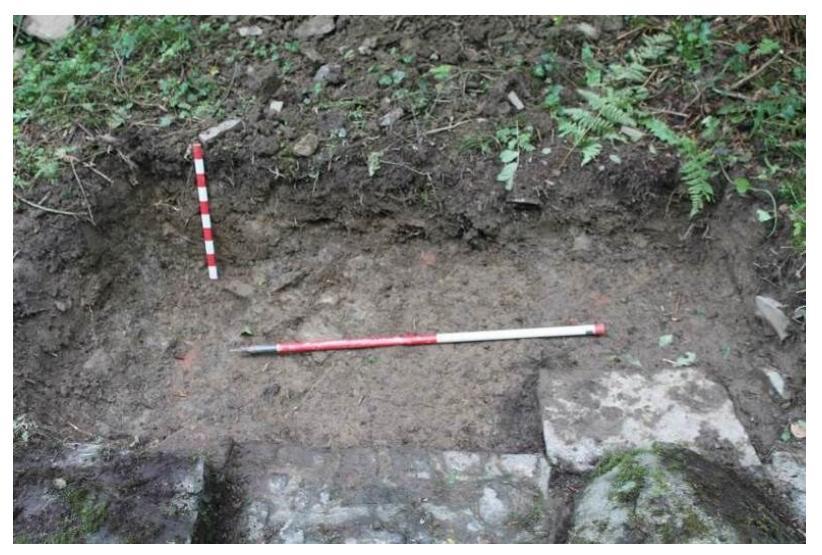
Photo 80: Investigation on north side of the fountain, looking north

Above the fountain feature, a small area was cleared to ascertain how the fountain was fed (Photo 80). It appears that a small reservoir behind the fountain was fed with spring water. The overflow from this, fed the fountain spout. No evidence of a pipe or conduit leading to the fountain was identified.

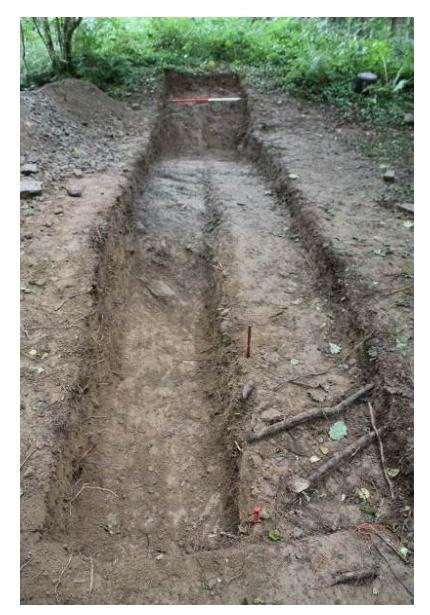
The carriageway in this location was found to be cut into the sloping shale bedrock on its north side (Photo 81). At the base of the cut, what was originally thought to be a wheel rut, now seems more likely to be a drainage gully. Two phases of compacted crushed stone surfaces were identified, each with evidence of wheel ruts and a distinct camber.

This carriageway appears to be very well engineered and constructed. Further south, where the same route was sampled in Trench 11A, it appears to be similarly constructed but not cur into bedrock.

Photo 81: 8DS14 looking west

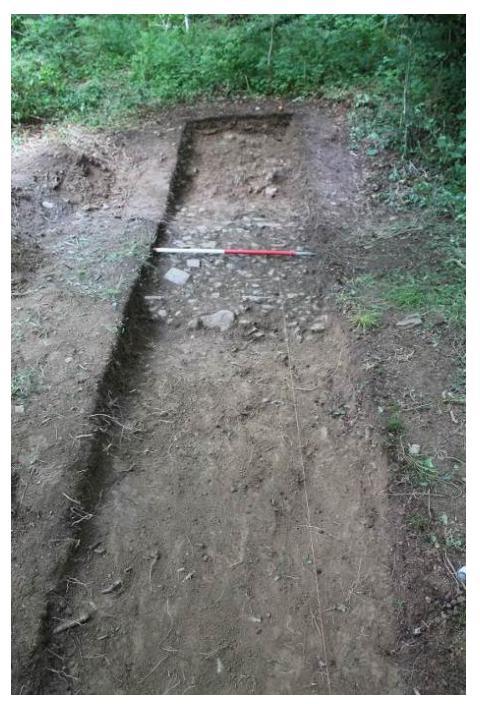
A second trench was opened to characterize the track thought to be associated with the nearby stone quarry (Photo 82). This track was also terraced into the sloping bedrock. The track also had a metalled surface with evidence of wheel ruts, but was generally less well constructed and using a coarser grade of crushed stone.

Photo 82: Structure 14: metalled track looking west

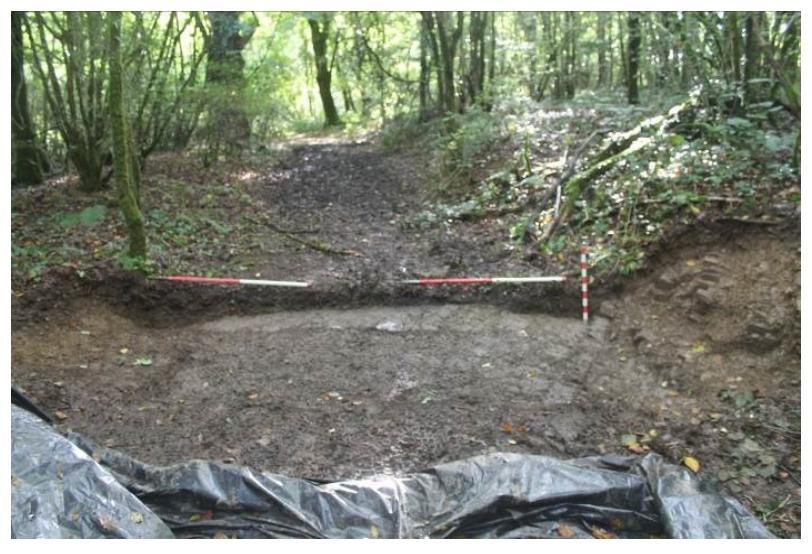
A third trench (Photo 83) was cut across the trackway to try and ascertain whether one of the routes was later than the other. This was found to be cut directly down onto bedrock, with remnants of a metalled surface above. It is most likely to be the same surface as carriageway structure 13.

Photo 83: Structure 32 Carriageway looking south

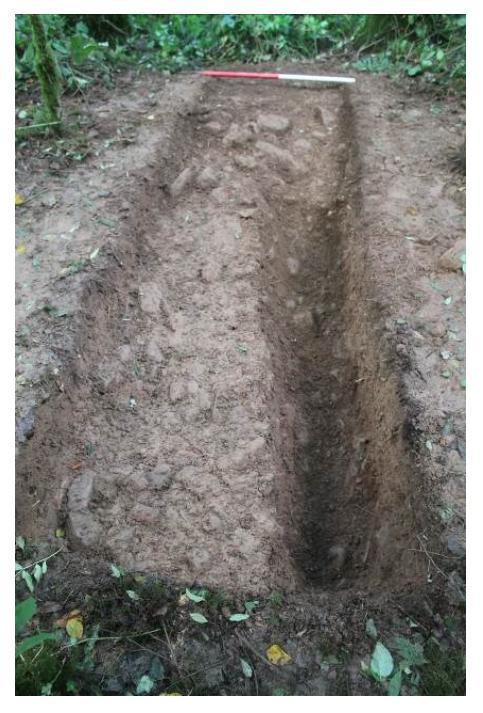
The trench could not be located in its intended position due to extreme waterlogging of the location. An alternative location on the top edge of the terrace above was excavated instead (Photo 84). A spread of cobbles of varying size in a clay silt matrix was revealed, but this appears to be a natural deposit rather than a constructed carriageway.

Photo 84: Site 8F. Looking east

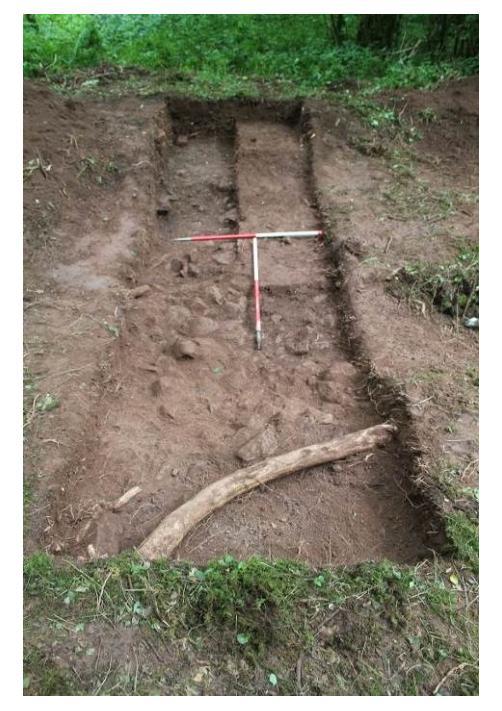
A trench (Photo 85) was opened between the two banks to ascertain their significance. The topsoil was a naturally deposited silt overlying medium sized river cobbles of various shapes and fairly mixed (not sorted) lying within a river-bed like gully between the banks. There is no evidence of the channel having been constructed or artificially cut into natural deposits. Basically the feature is a natural former stream course.

Photo 85: Site 8G looking south

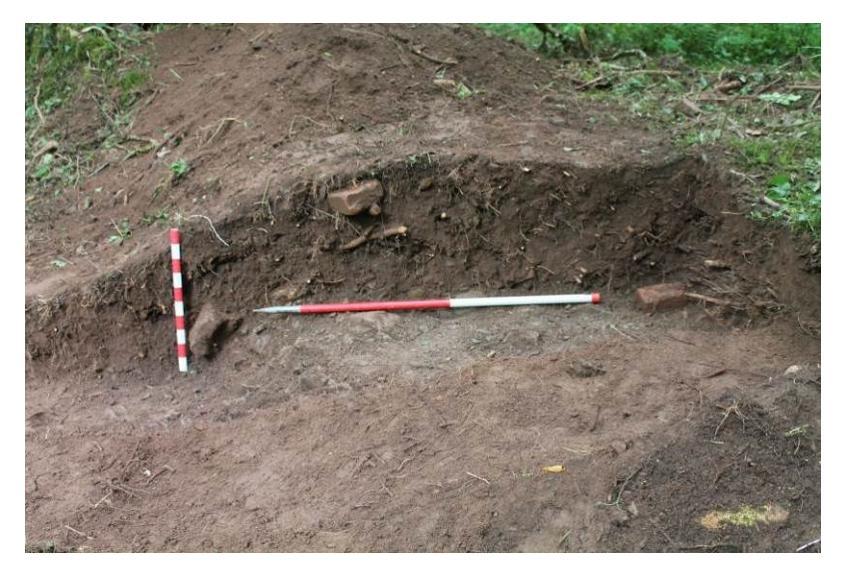
The uncompacted clay-silt bank material lies on top of naturally deposited river gravels and contains a few fragments of red brick (Photo 86), presumably derived from the nearby bridge. The character of the bank material suggests that they are not purposefully constructed (clay would have been a more effective material to line a water channel with). Instead, the banks appear to be a typical example of a 'levée', where the channel has broken its banks during a peak flood event. Silts (and brick fragments) within the flood water have settled out beside the main flow, eventually forming the banks which tail off more gradually away from the watercourse.

Photo 86: Detail of south bank of Levee, looking west

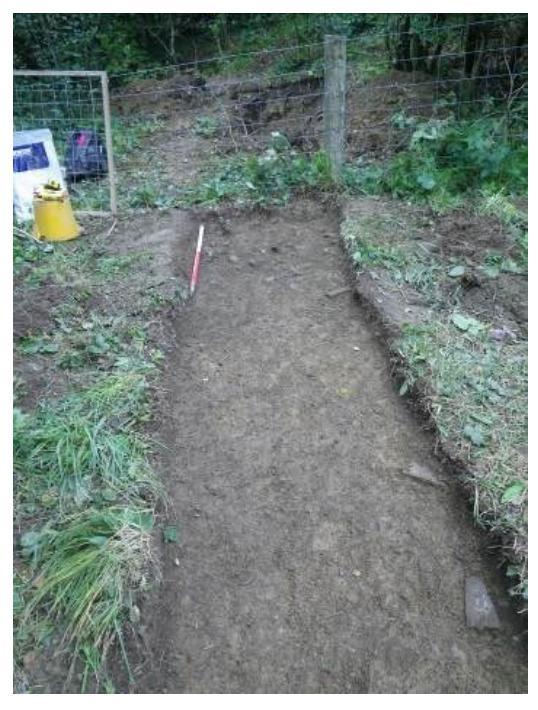
Remnants of what appeared to be a metalled surface were located at the eastern end of the trench (Photos 87 and 88), and presumably extended eastwards on the other side of the fence. This is in line with the carriageway leading up to the western end of the Llyn Mawr dam.

Photo 87: Structure 38: Trackway, looking southeast

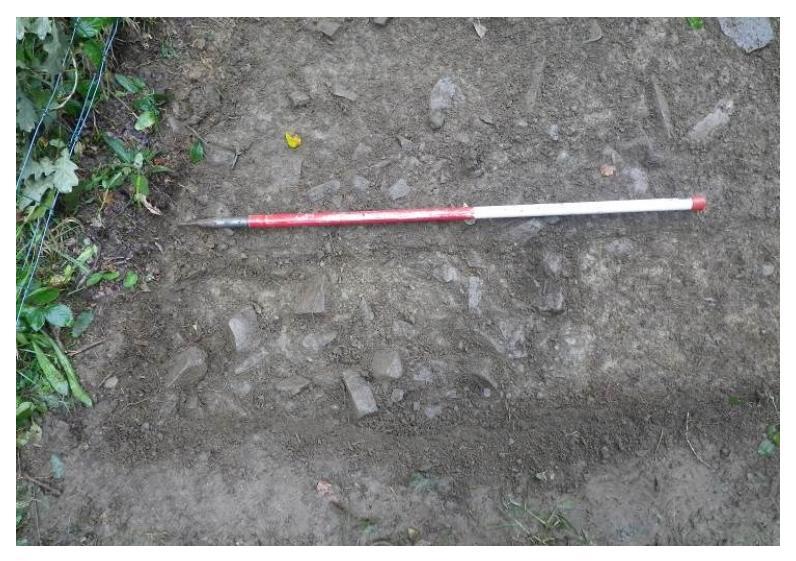
Photo 88: Trackway surface

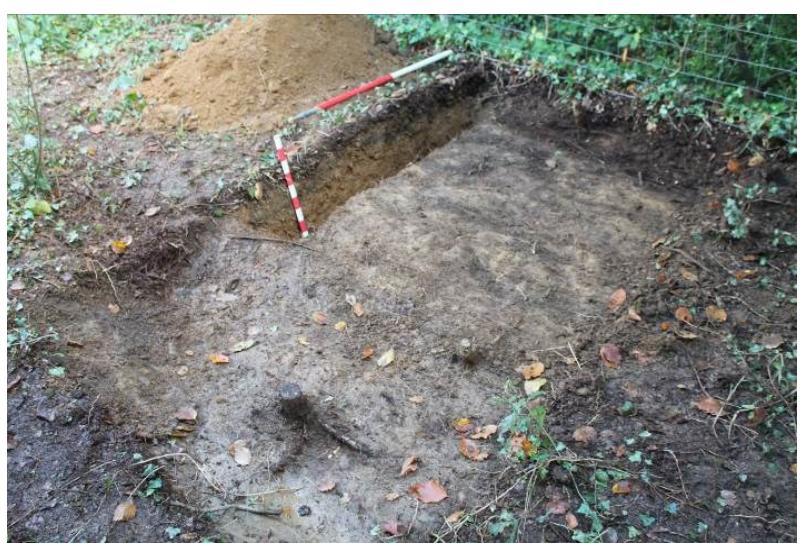
No evidence of a formally constructed or surfaced viewing platform was apparent within the excavated area (Photo 89).

Photo 89: Site 10B investigation

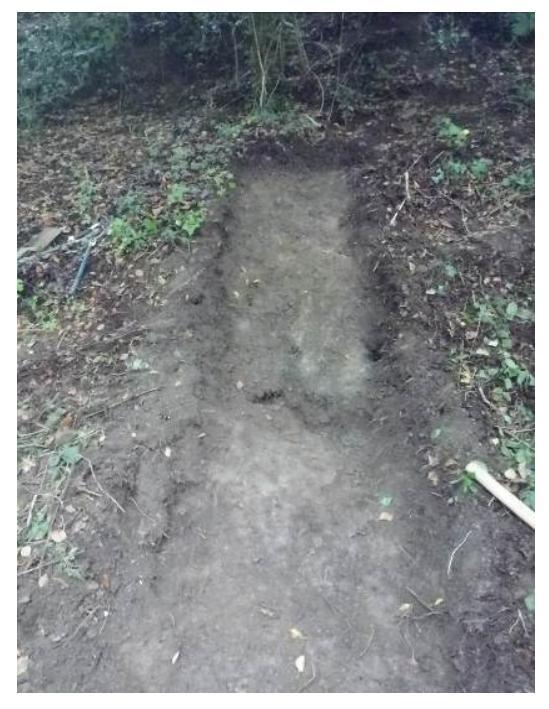
The soil was generally loose and very disturbed as a result of the badger activity. No significant features or deposits were identified (Photo 90), however, a few roof slate fragments were observed.

Photo 90: Site 10C investigation looking northwest

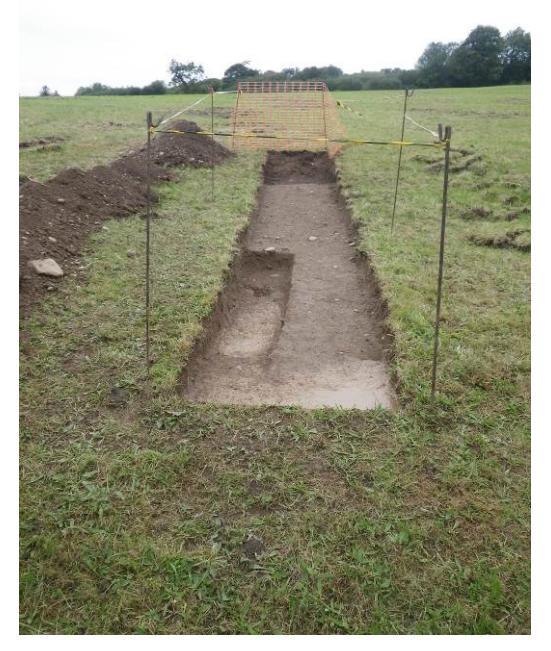
Although a linear feature was visible as a land form on the ground surface, no evidence of a constructed feature was apparent within the machine excavated trench (Photo 91). Occasional small to medium sized stones and pebbles may be remnants of a metalled surface but it is assumed that ploughing has effectively destroyed any metalled surface that may have existed. No evidence of wheel ruts or roadside ditches was observed.

Photo 91: Site 11A looking northwest

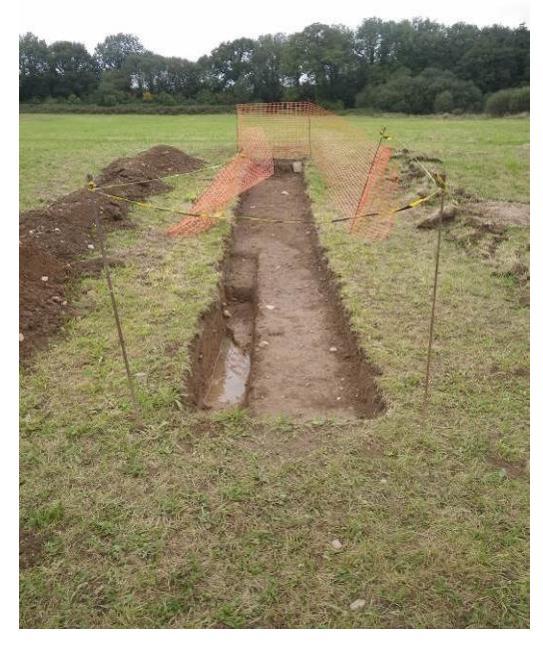
Although a linear feature was visible as a land form on the ground surface, no evidence of a constructed feature was apparent within the machine excavated trench (Photo 92). Occasional small to medium sized stones and pebbles may be remnants of a metalled surface but it is assumed that ploughing has effectively destroyed any metalled surface that may have existed. No evidence of wheel ruts or roadside ditches was observed.

Photo 92: Site 11B looking northwest.
