# **THE TYWI GATEWAY PROJECT – BISHOP’S PARK, ABERGWILI THE WALLED GARDEN: ARCHAEOLOGICAL INVESTIGATION 2017**

RHIF YR ADRODDIAD / REPORT NO. 2017/2  
RHIF Y PROSIECT / PROJECT RECORD NO. 110318

Chwefror 2018  
February 2018

Fran Murphy and Hubert Wilson

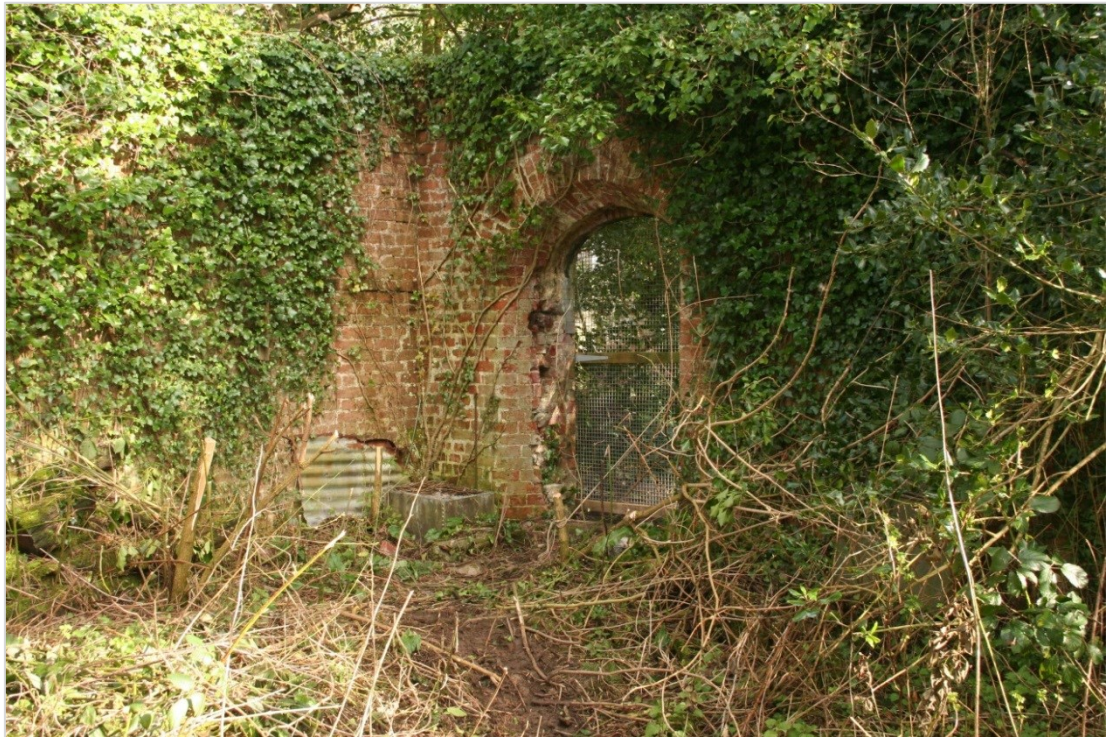
- 2.1.5 In recent years the walled garden has fallen into disuse and has become overgrown with small trees and shrubs, brambles and other vegetation. The walls were nearly completely covered in ivy (Photo 2).
- 2.1.6 Prior to the survey work that was undertaken by DAT in June 2016 the walled garden had been cleared of most of the shrubs and brambles and before the start of this investigation the walls had been cleared of ivy.

**Photo 2:** The northeast doorway into the walled garden at the start of the project.

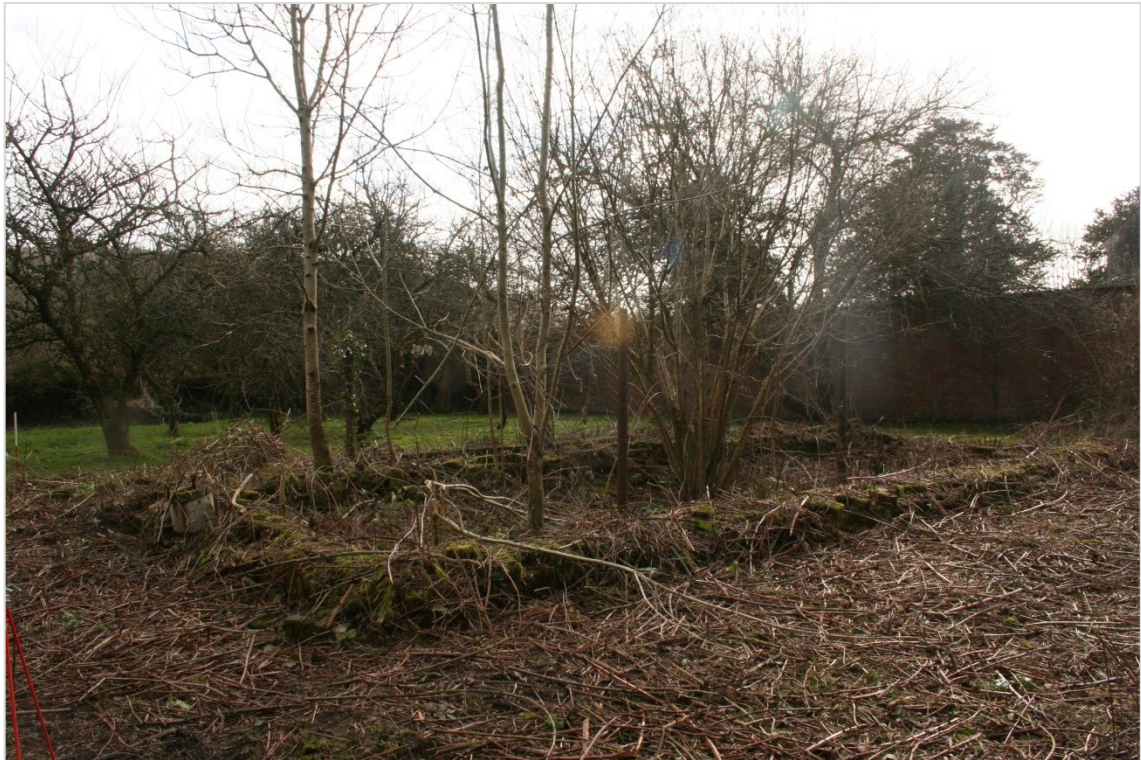
- 2.1.7 A number of structures were evident within the walled garden after the clearance, including the remains of at least 3 glasshouses (Photos 3 & 4). However, much of the garden was obscured by years of accumulated soil and decomposing vegetation (Photo 5).

**Photo 4:** The remains of one of the pair of glasshouses (Glasshouse 2) at the start of the project.

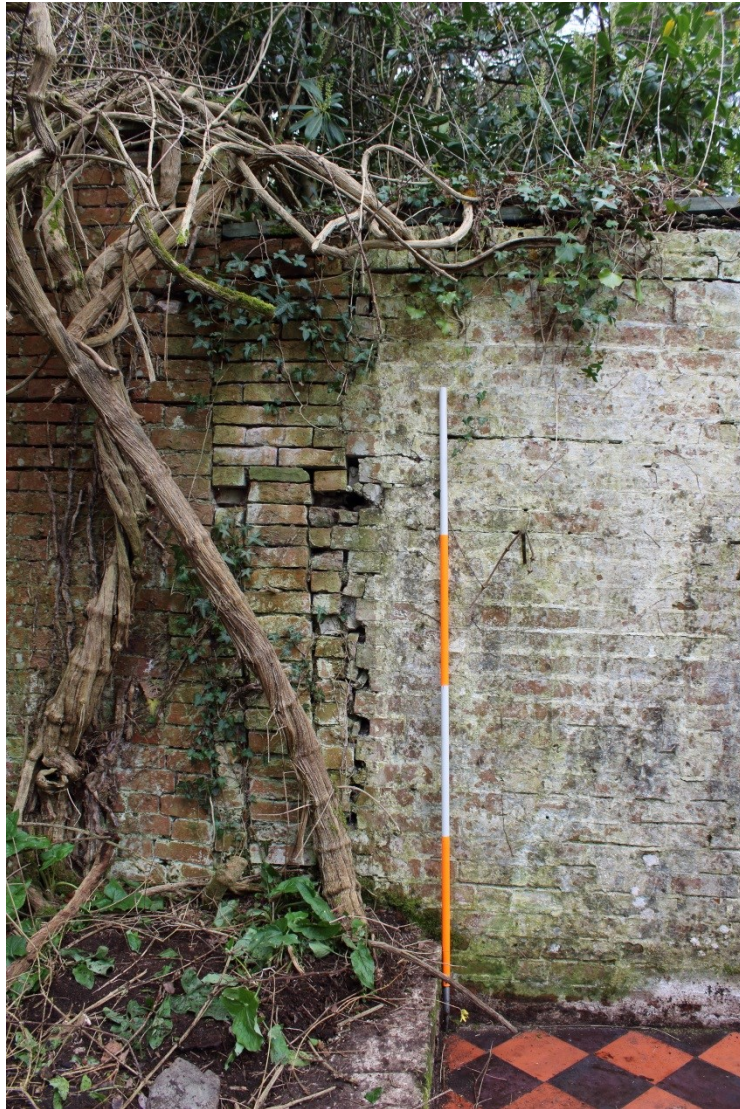
**Photo 11:** Evidence of a brick flue within the east wall at the north end of Glasshouse 1. 2m scale

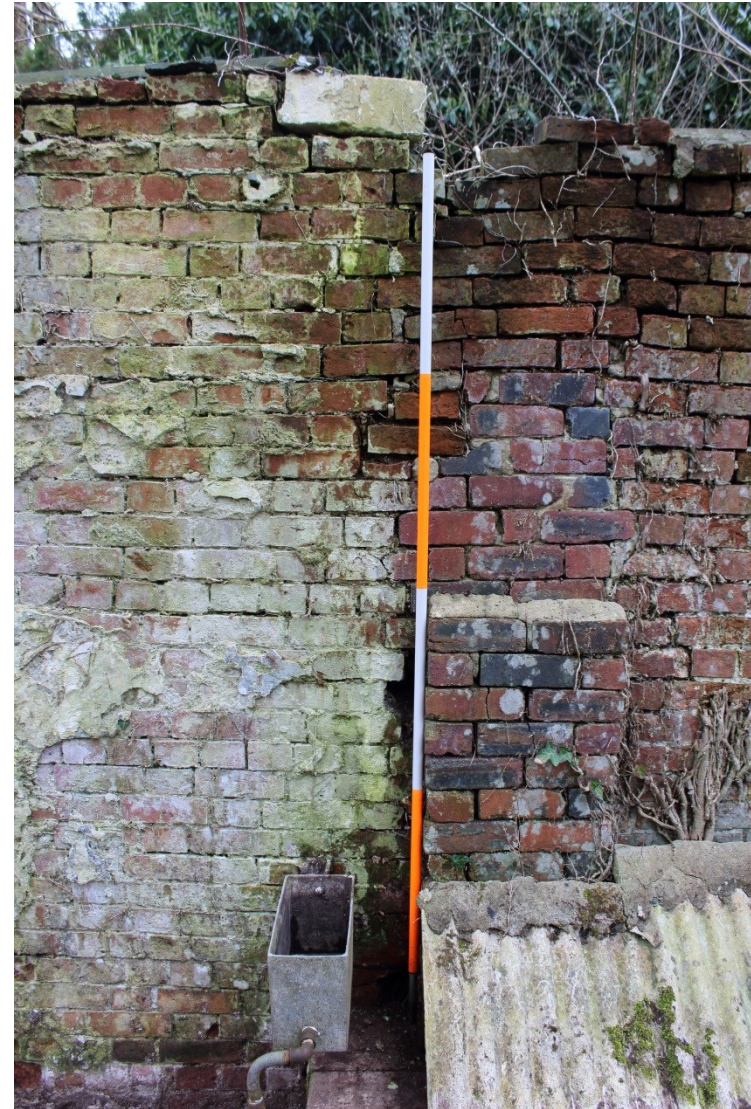
**Photo 12:** Evidence of a brick flue within the east wall at the south end of Glasshouse 1. 2m scale

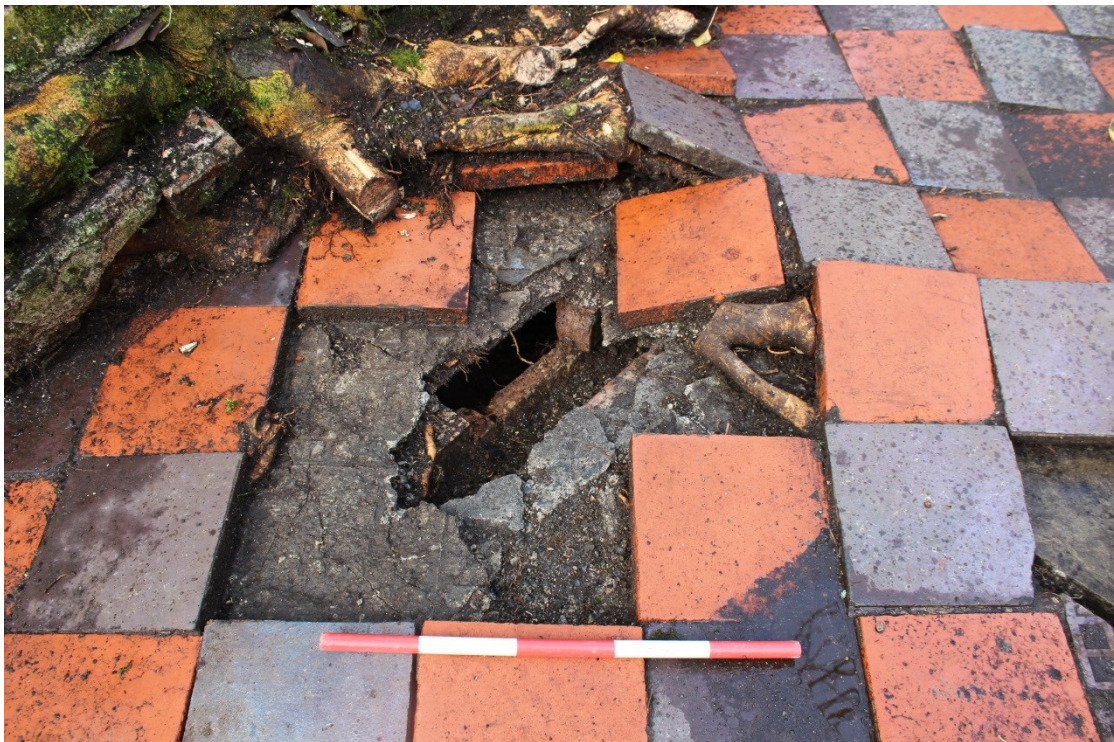
**Photo 14:** Photo showing the cavity below and brick supporting wall to the earlier stone floor. 0.5m scale

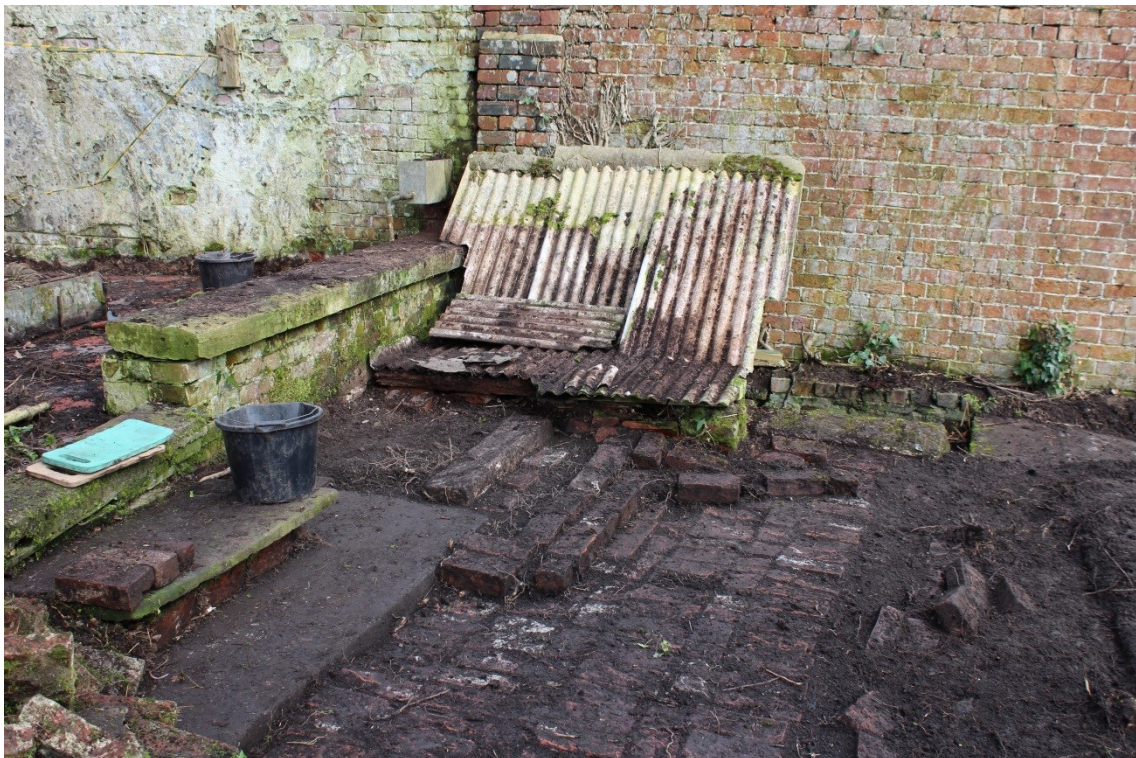
**Photo 18:** Photo showing the corrugated asbestos roof to the boiler house of Glasshouse 1. Looking east

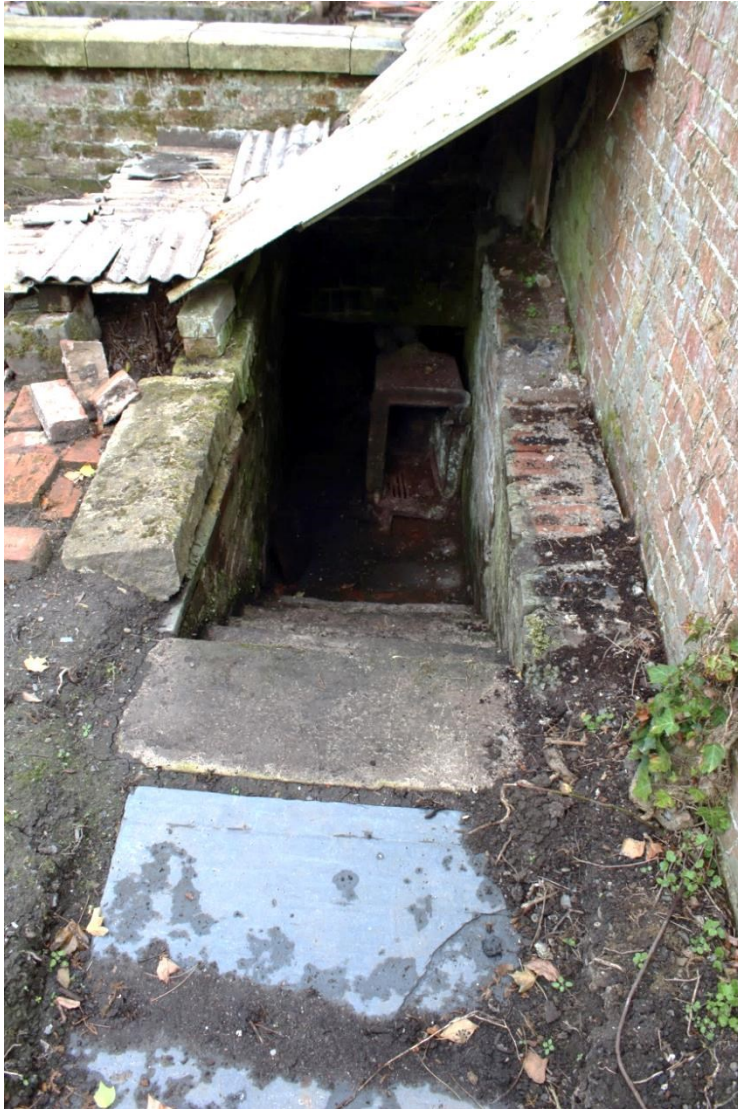
**Photo 19:** Photo showing the corrugated asbestos roof and steps down to the boiler house of Glasshouse 1. The small cast iron boiler can be seen at the bottom of the steps. Looking north.

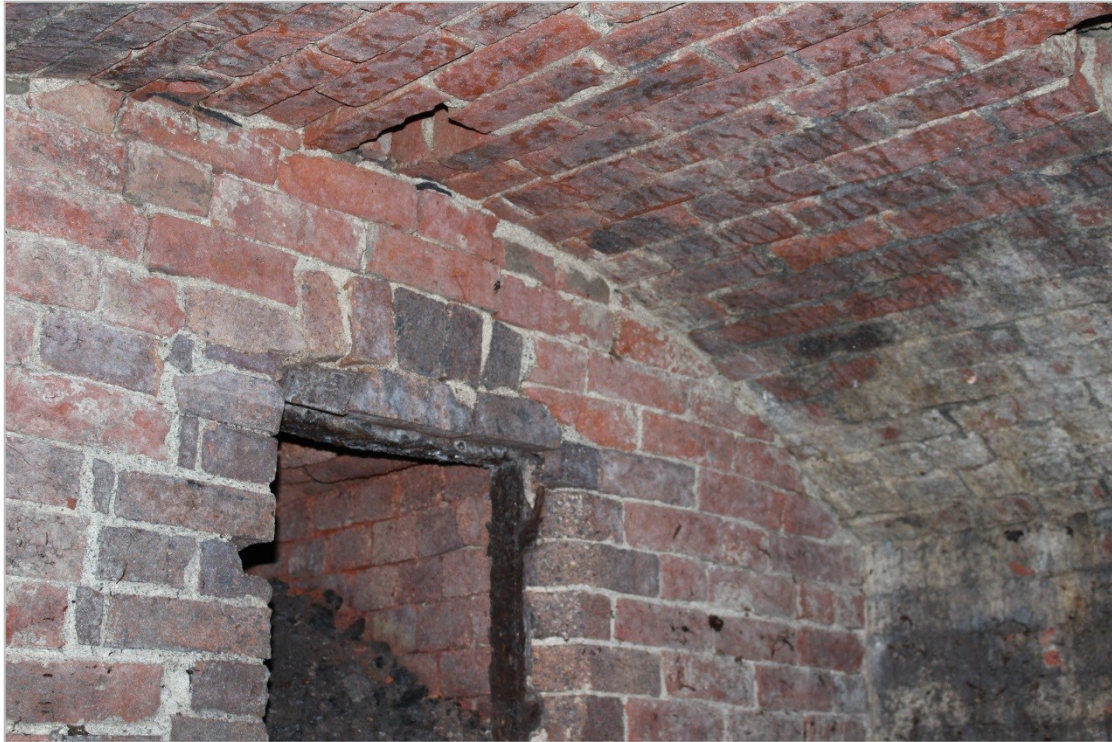
**Photo 21:** Photo showing the roof and west wall of the brick vaulted chamber of the underground boiler house to Glasshouse 1.

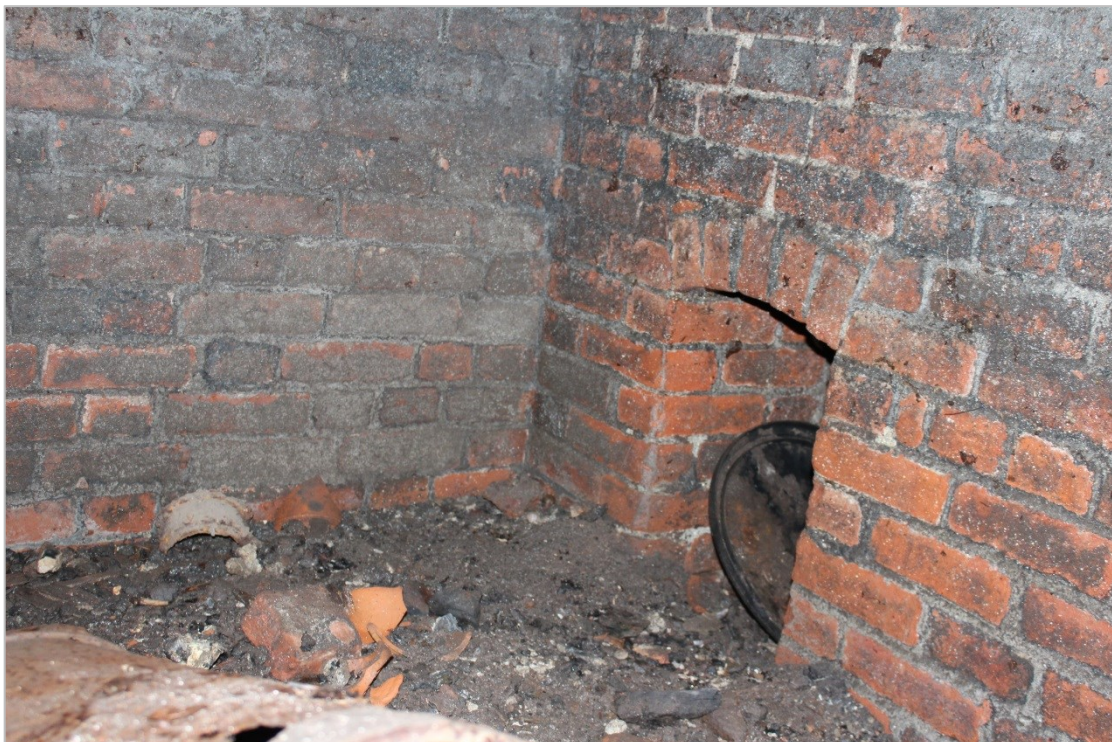
**Photo 22:** The east wall of the boiler house showing the bricked arched recess at floor level.

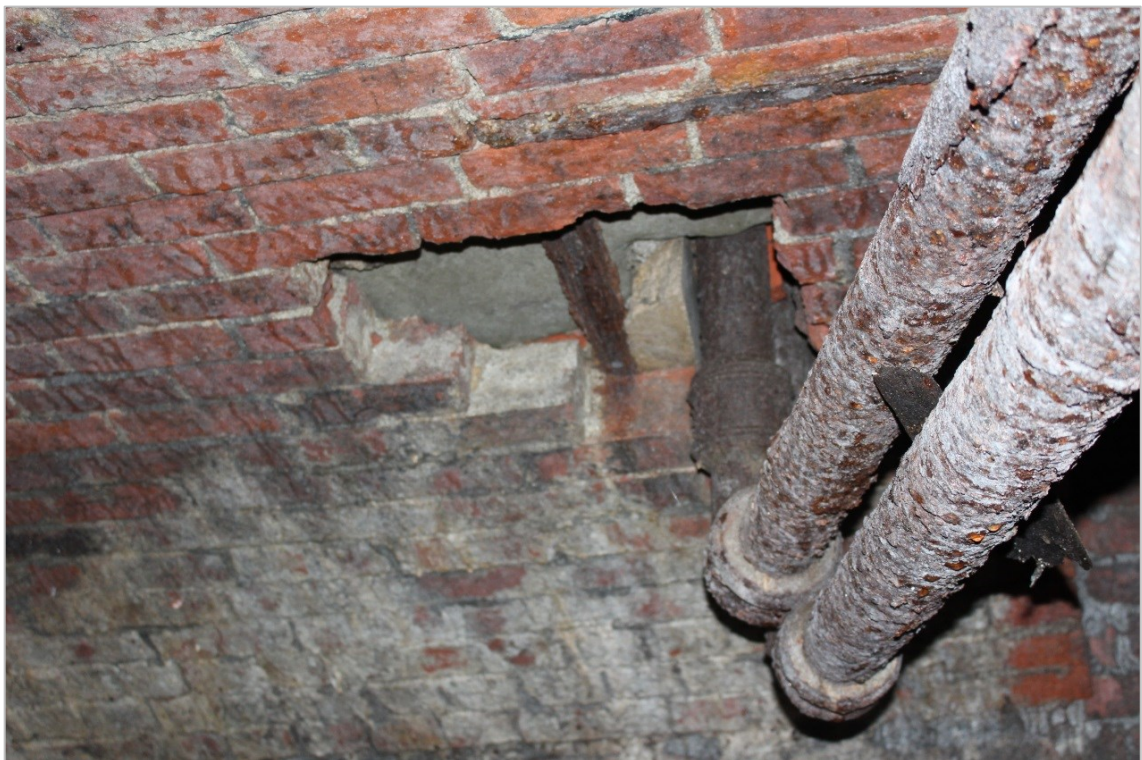
**Photo 25:** The two cast iron pipes running upwards to the glasshouse above through a hole made in the brick vaulted roof.

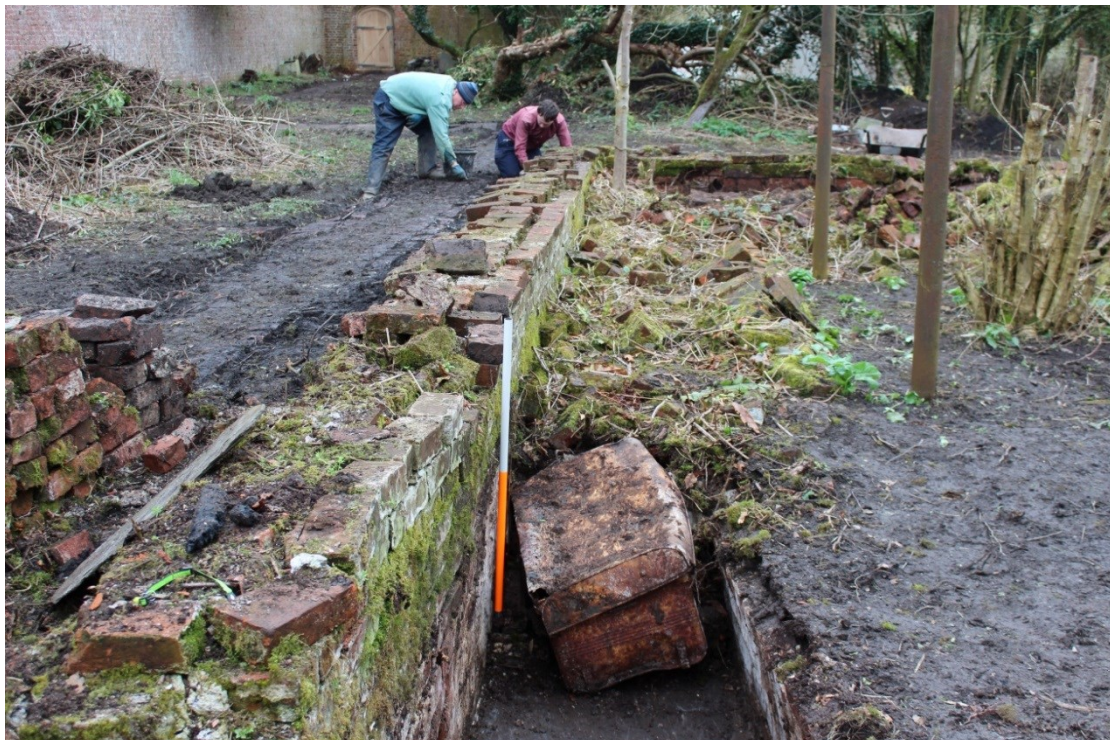
**Photo 31:** Partial excavation of the sunken path of Glasshouse 2 showing a dumped metal trunk. Looking northeast. 1m scale

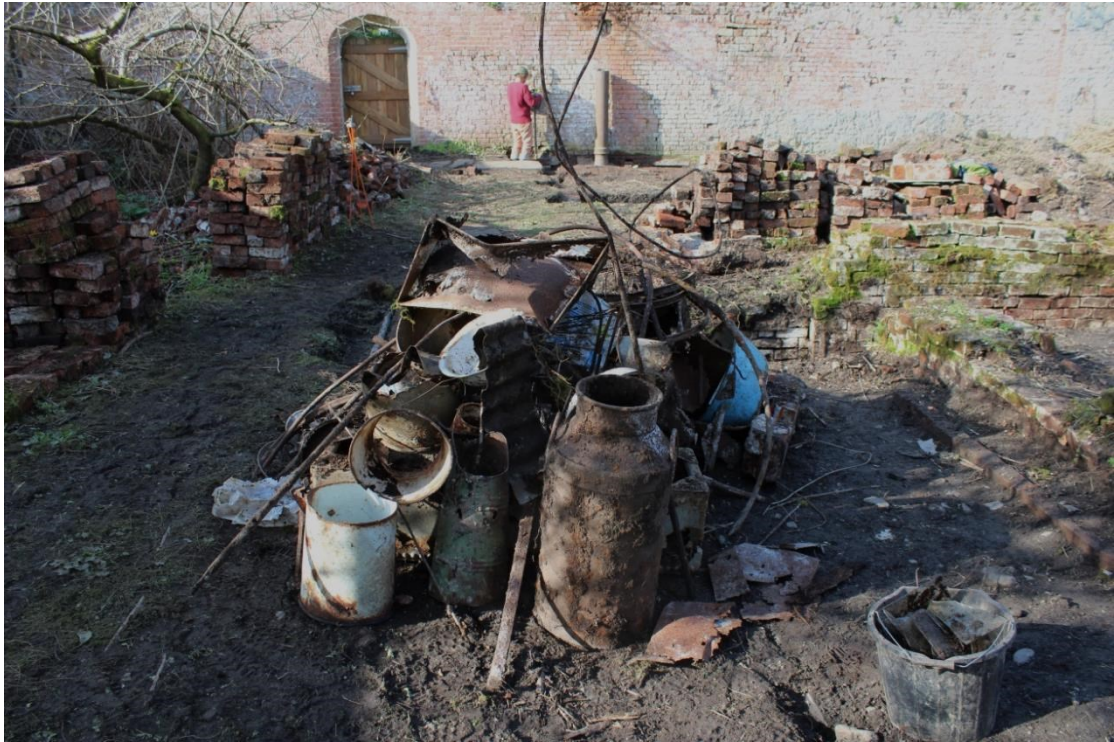
**Photo 34:** Some of the accumulated rubbish excavated from the sunken paths of Glasshouses 2 and 3.

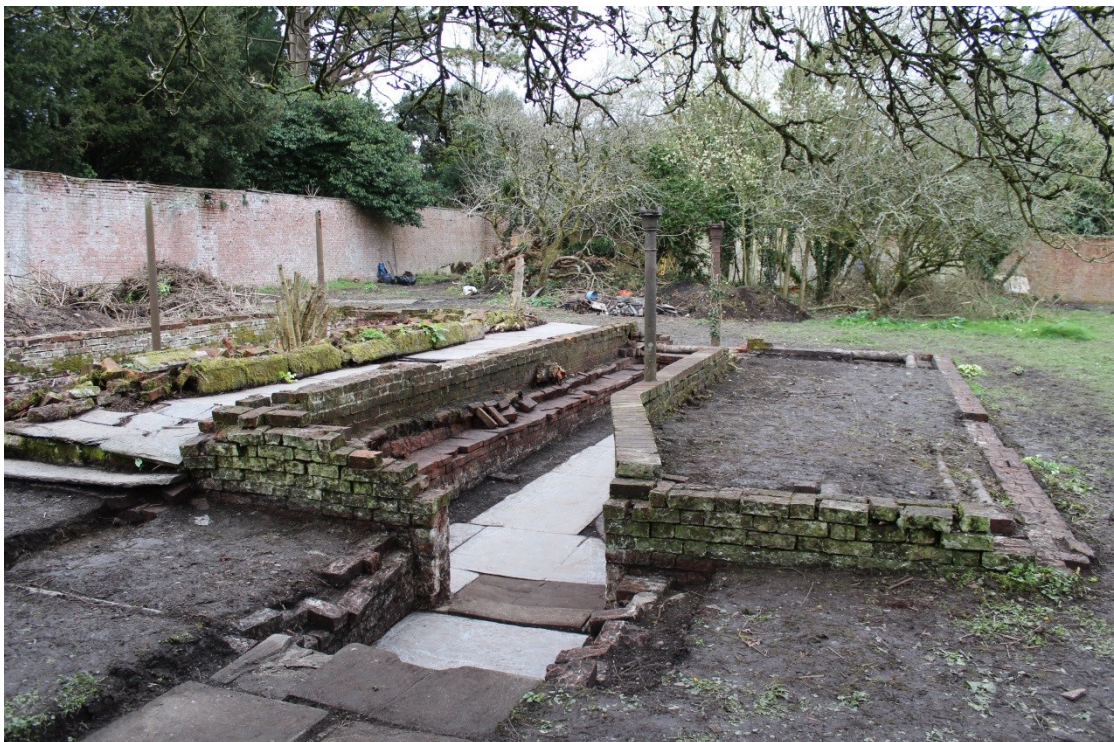
**Photo 35:** The cleared sunken path of Glasshouse 3. Looking approximately north.

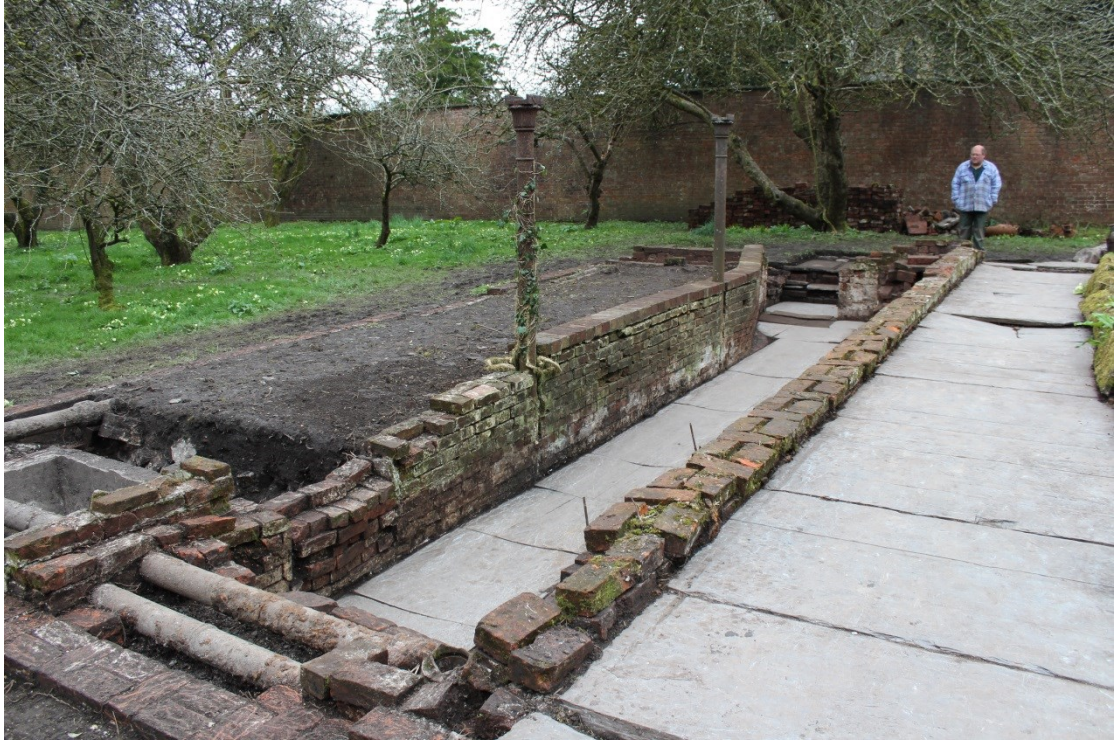
**Photo 36:** The cleared sunken path of Glasshouse 3 and the central suspended path. Looking approximately south.

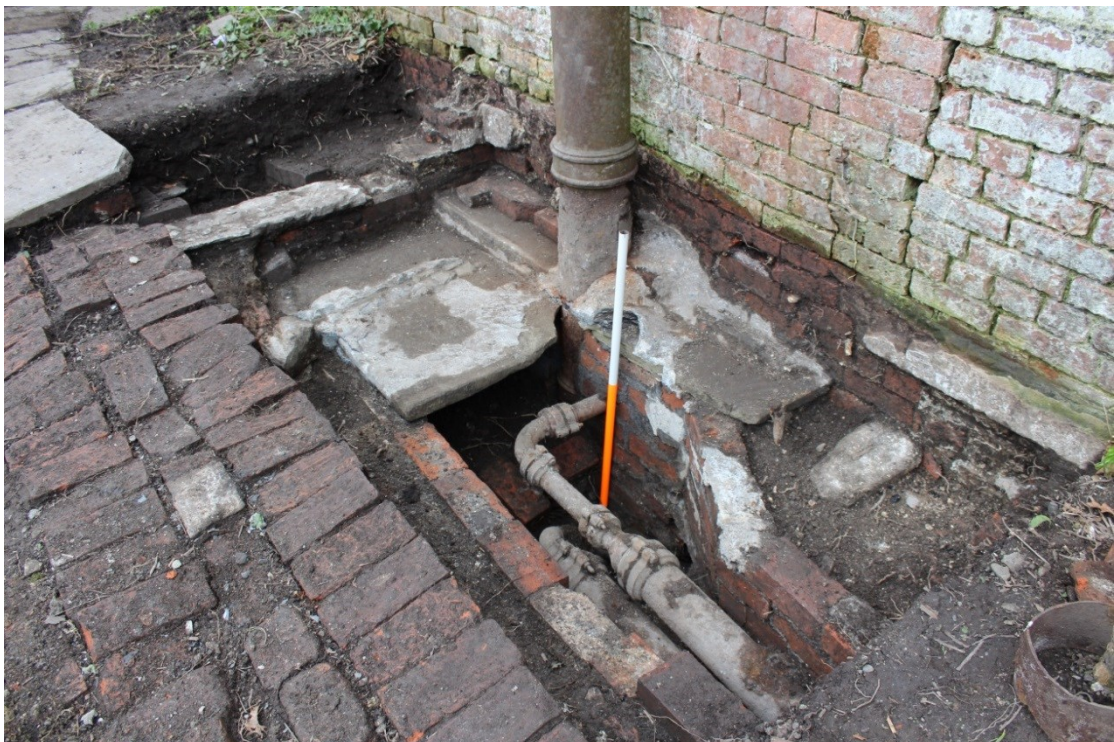
**Photo 37:** The two heating pipes reduced from 4" to 2" inch that then run under the north garden wall. Note the cast iron cylindrical flue. Looking west. 1m scale

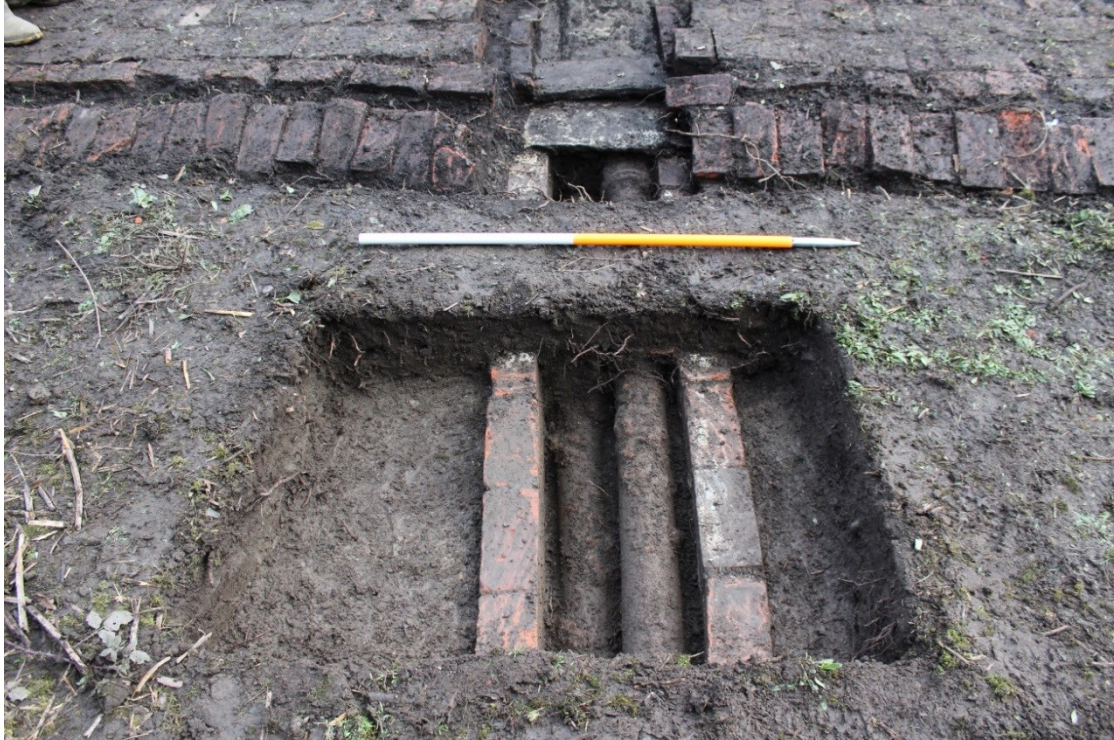
**Photo 38:** The two heating pipes running underground in a northwest direction from Glasshouse 2. They sit within an uncapped brick edged channel. Looking northwest. 1m scale

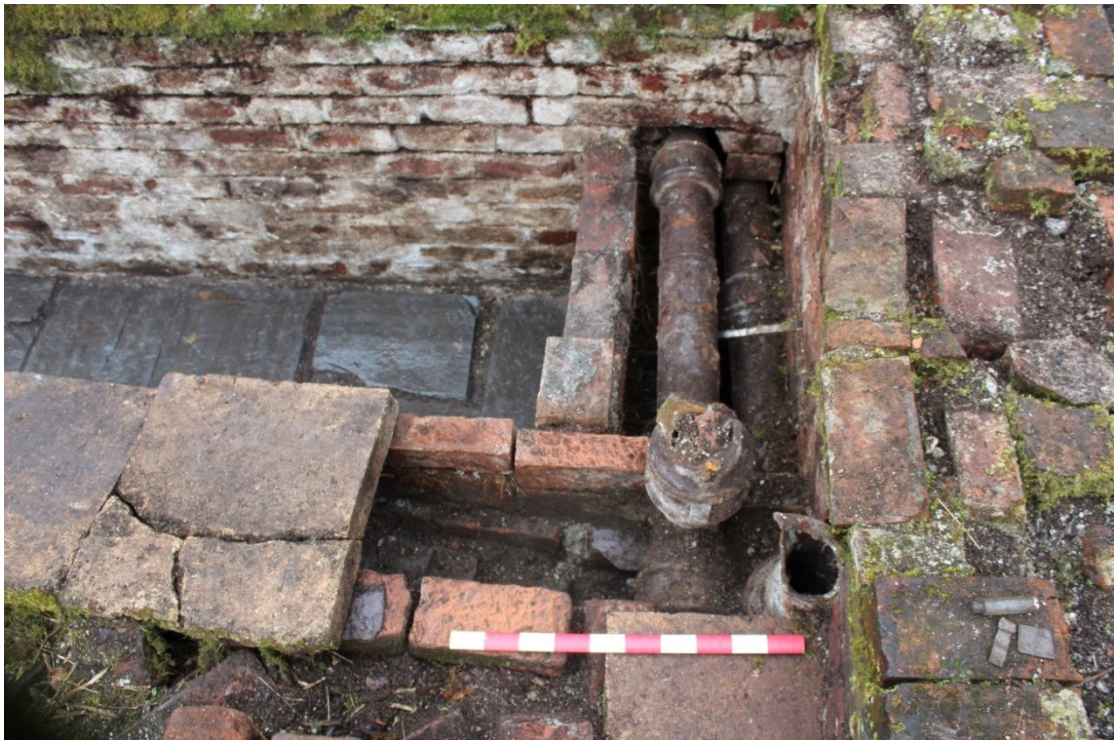
**Photo 39:** The east end of Glasshouse 2 showing the main heating pipes and the remains of the vertical feed and return pipes. Looking roughly northwest. 0.5m scale

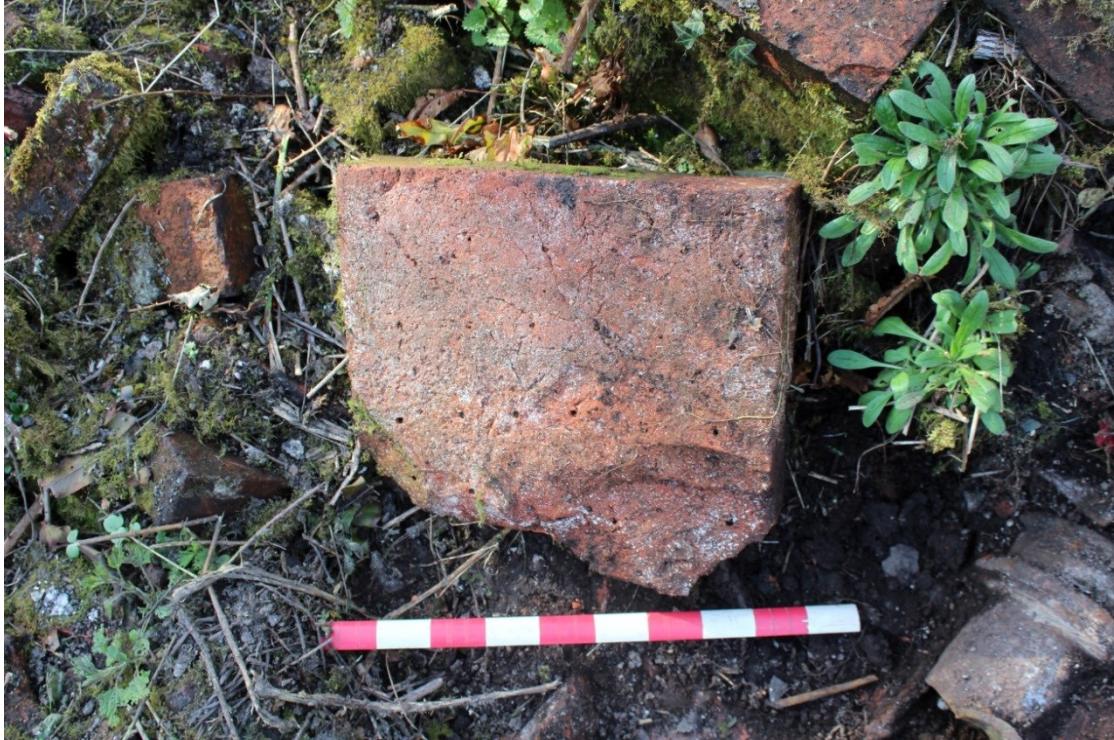
**Photo 40:** The perforated underside of one of the ceramic slabs on which the heating pipes were placed. 0.5m scale

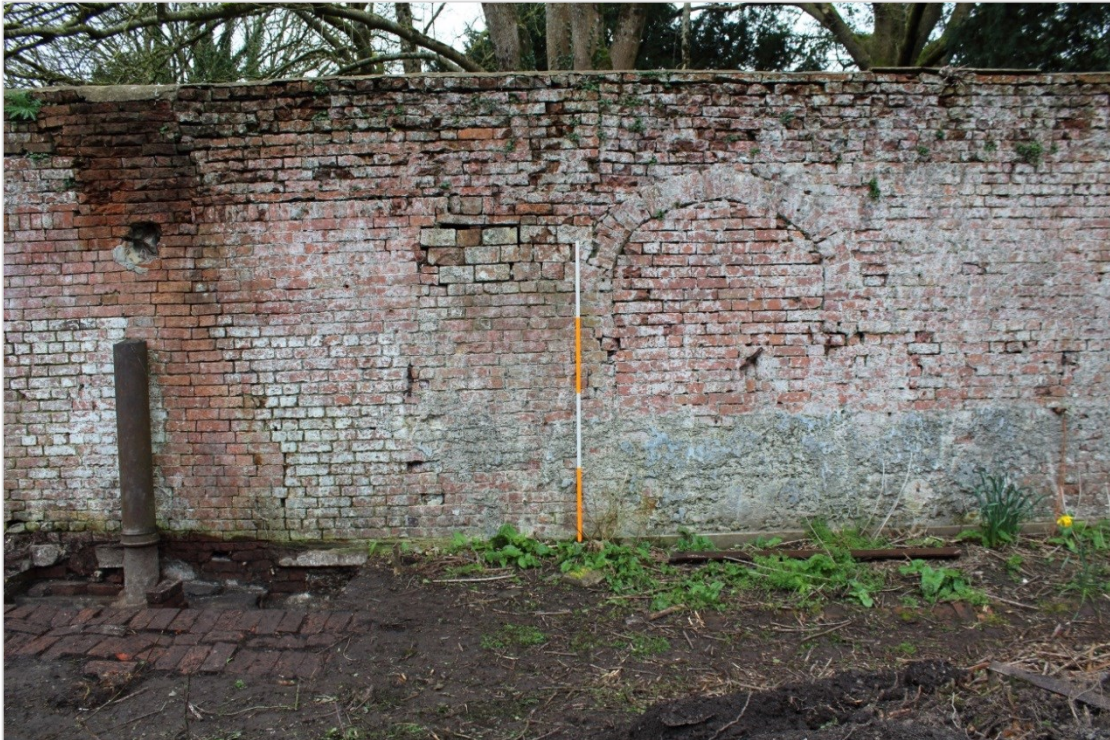
- 4.4.3 The full length of the extended Orangery as shown on the 1<sup>st</sup> edition 1889 OS map may be indicated by the positions of two internal brick flues within the north wall (Photos 42 & 48, Figure 8). This would indicate an approximate length of 17.60m. The two flues or chimneys appear to be for the internal heating of the south facing wall, similar to that recorded in the east wall of Glasshouse 1.

- 4.4.4 Evidence of a brick arched recess/door can be seen in the north wall (Photo 42). On the other side of the north wall the wall has been heavily repaired. It is possible that this recess or door sat centrally within the earlier (smaller) phase of Orangery as indicated on the 1843 estate map.

**Photo 42:** The south facing garden wall showing the blocked arched recess of the earlier Glasshouse 4. It also shows the cast iron cylindrical flue seen in Photo 41 and behind the reddened heat affected brick flue within the wall. 2m scale

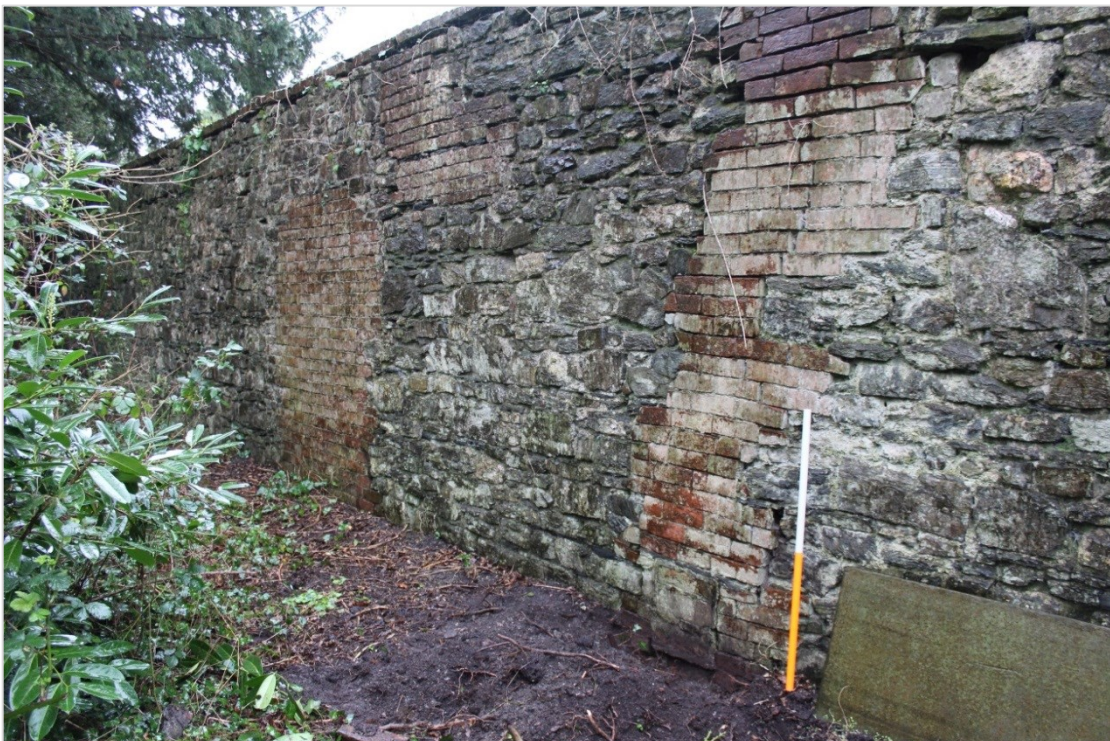
**Photo 43:** The north facing garden wall showing the other side of the heat affected brick flue seen in Photo 41. Note the blocked square hole at the bottom of the flue. 1m scale

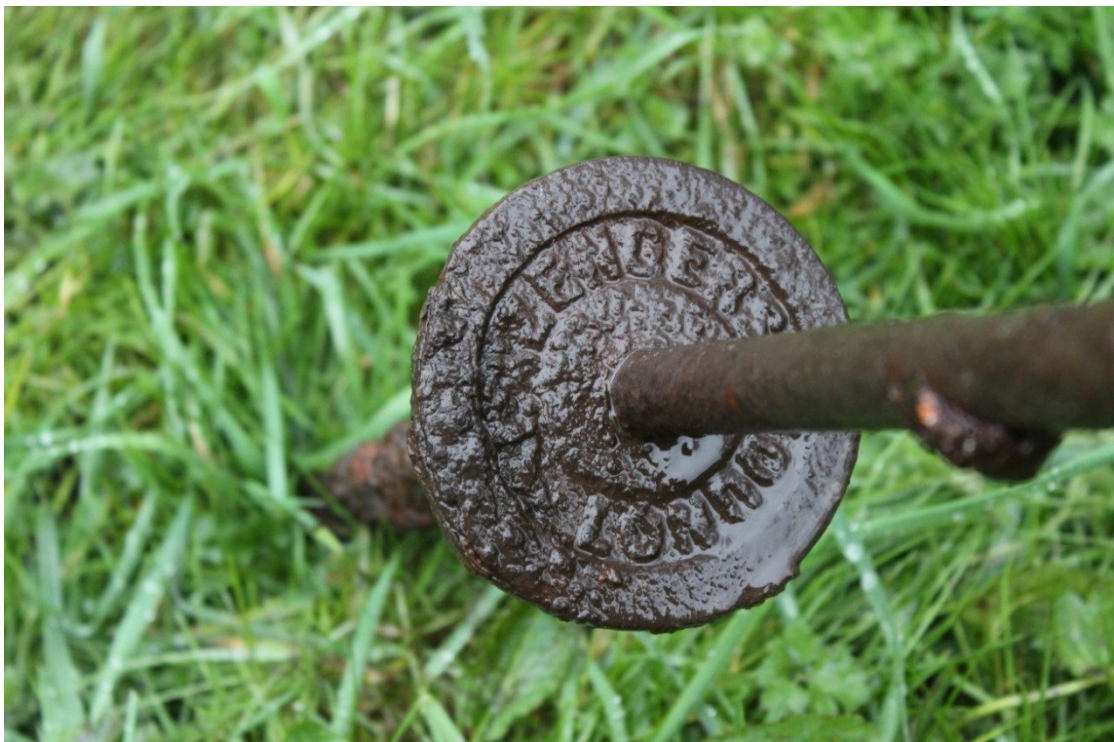
- 4.3.14 One surviving thin iron pipe from Glasshouse 2 was marked 'MESSENGER & CO LONDON' (Photo 45). This possibly formed part of a window ventilation system.

**Photo 45:** A thin iron pipe from Glasshouse 2 marked 'MESSENGER & CO LONDON'.

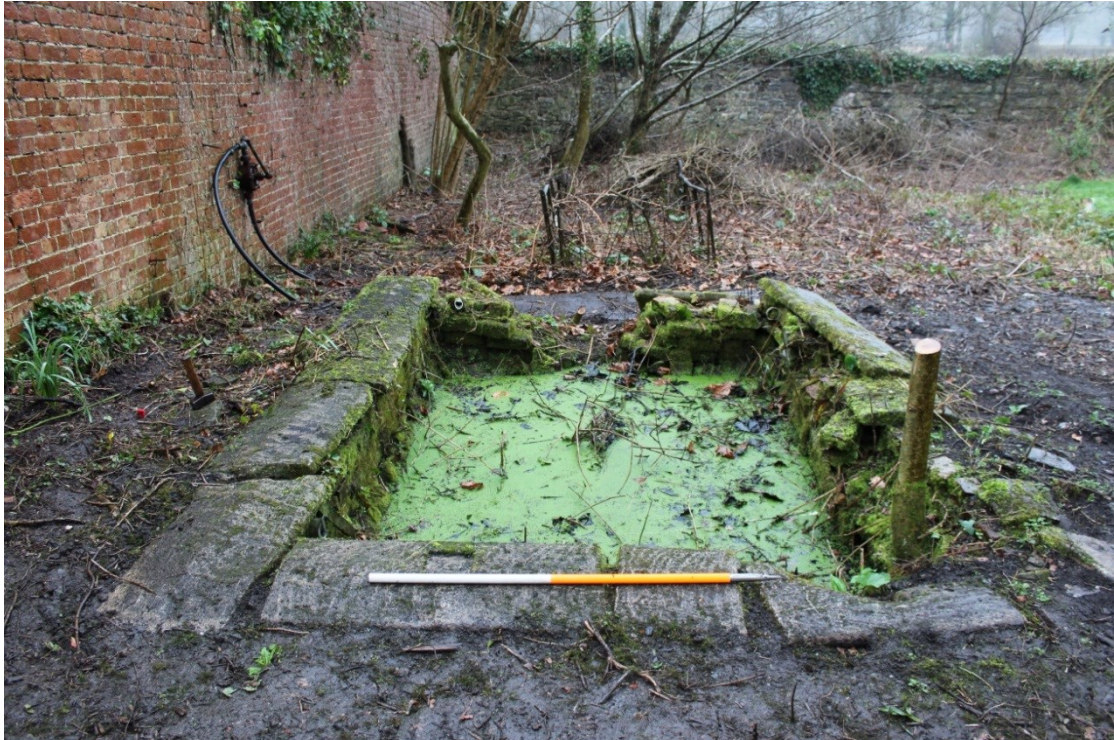
- 4.5.1 Other features recorded within the walled garden include a rectangular sunken pond known as the 'Dipping Pond' (Photo 49) that still contains water. Internally it measured 2.70m by 2.20m and was aligned northwest-southeast. Its edges were capped with coping stones, and at each corner were the remains of a broken lead pipe protruding out horizontally into the pond. The depth of the pond was estimated at just over 1.0m depth by pushing a ranging rod into the accumulated soil and leaf mould below the water until the rod hit a very hard surface, indicating a stone base. The pond appears on the 1843 estate map (Figure 13).

**Photo 49:** The 'Dipping Pond'. Looking southeast. 1m scale

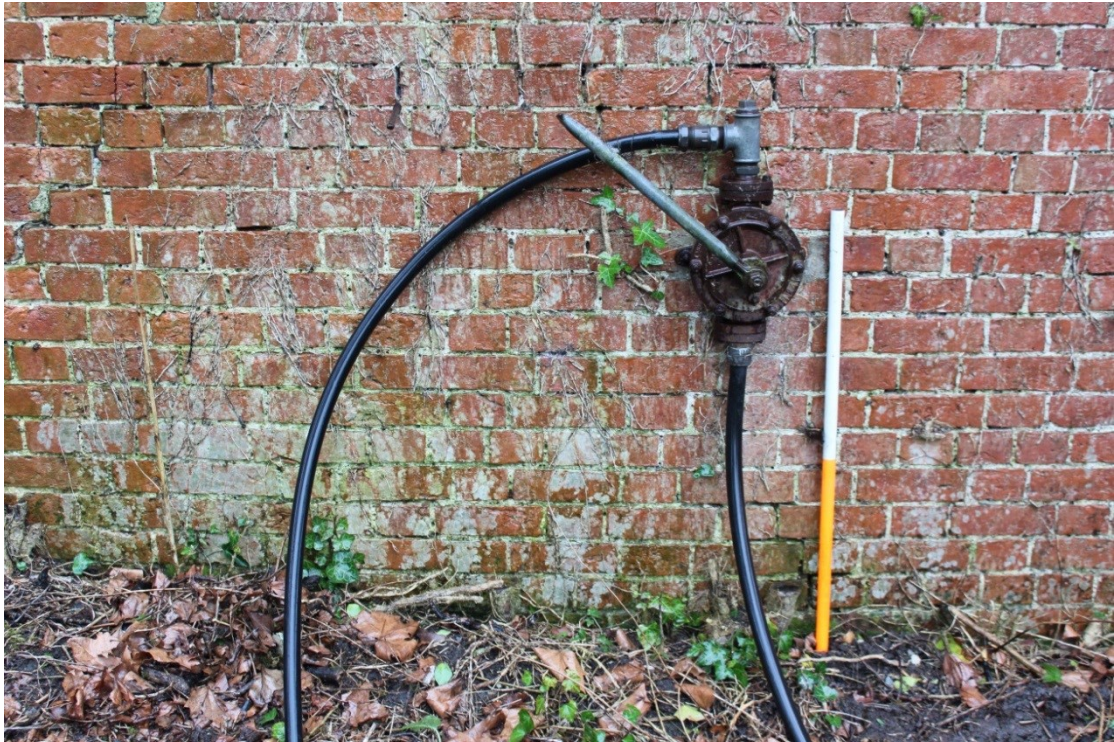
- 4.5.2 To the south of the Dipping Pond was a rectangular makeshift enclosure formed from old metal gates whose purpose is not known (Photo 50).
- 4.5.3 Fitted to the garden wall to the east of the Dipping Pond is a hand crank pump (Photo 51). Two polyurethane pipes are attached to it but they do not appear to connect to the pond.

**Photo 51:** The hand crank pump on the east wall of the walled garden. 1m scale

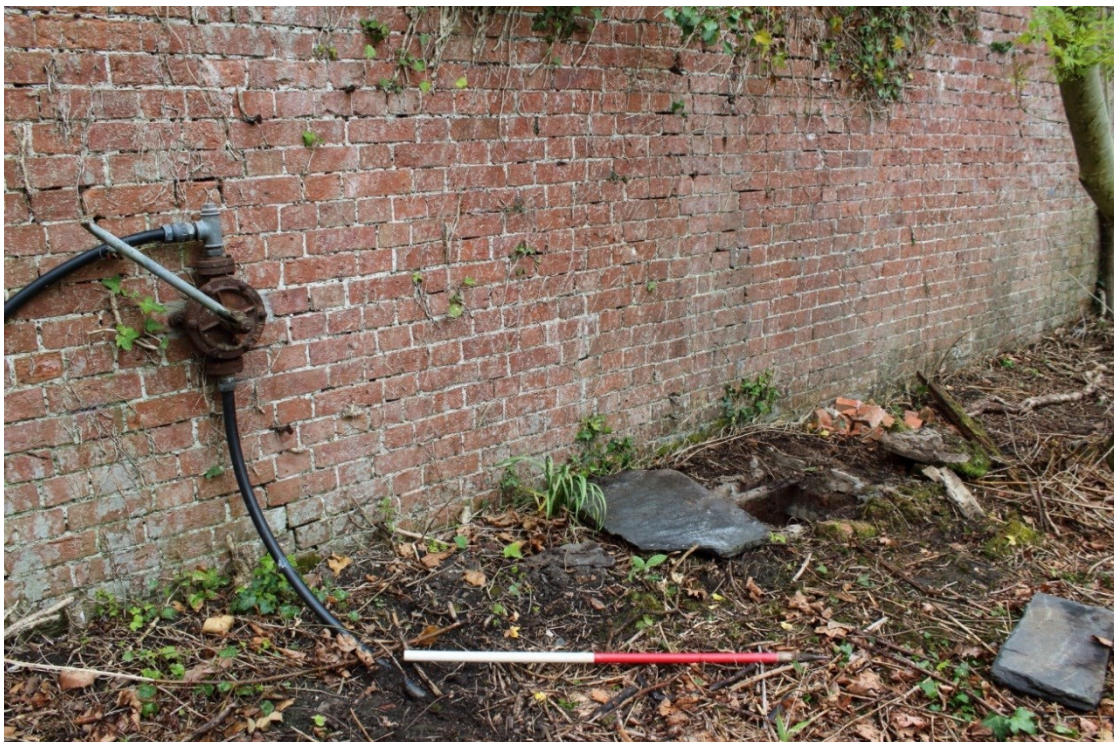
**Photo 52:** The hand crank pump with the opening to the cistern shaft to the right just after its covering of slabs was removed. 1m scale

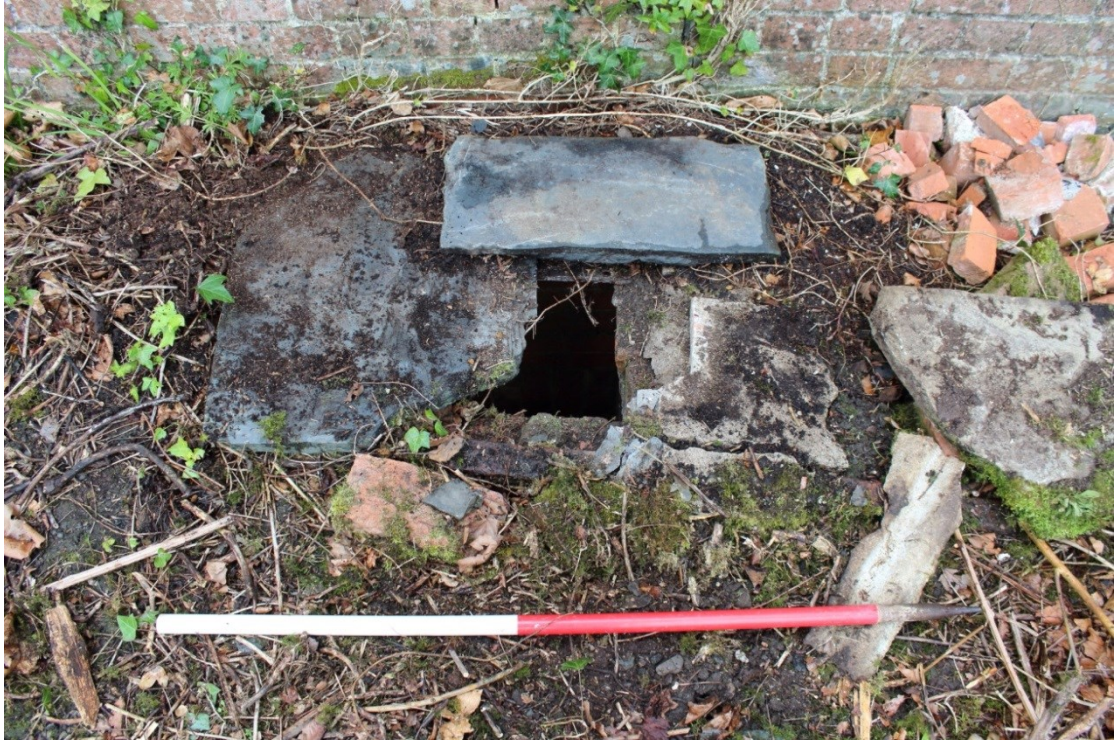
**Photo 53:** The opening to the cistern shaft when first exposed. 1m scale

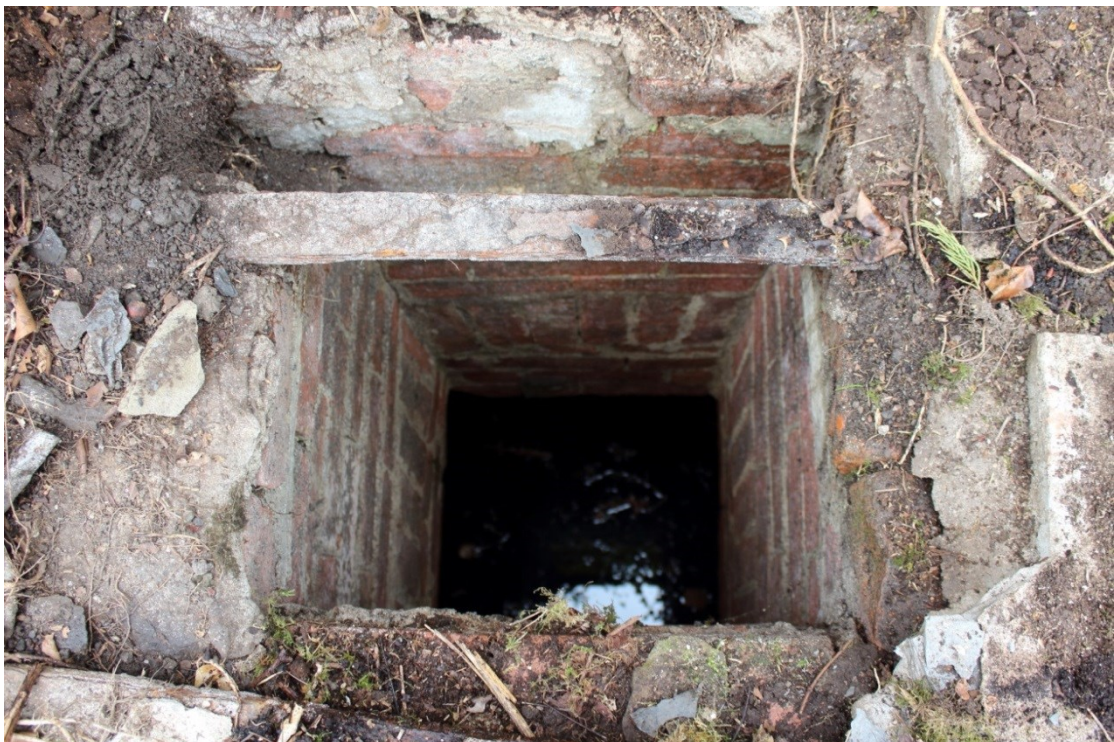
- 4.5.7 The brick built manhole entrance was around 0.70m square and around 1.1m deep to the opening of the cistern structure (Photo 54).
- 4.5.8 Water level was at 1.70m below ground surface.

**Photo 54:** The square brick shaft to the cistern showing water below.
