# **THE TYWI GATEWAY PROJECT – BISHOP’S PARK, ABERGWILI THE WALLED GARDEN: ARCHAEOLOGICAL INVESTIGATION 2017**

RHIF YR ADRODDIAD / REPORT NO. 2017/2  
RHIF Y PROSIECT / PROJECT RECORD NO. 110318

Chwefror 2018  
February 2018

Fran Murphy and Hubert Wilson

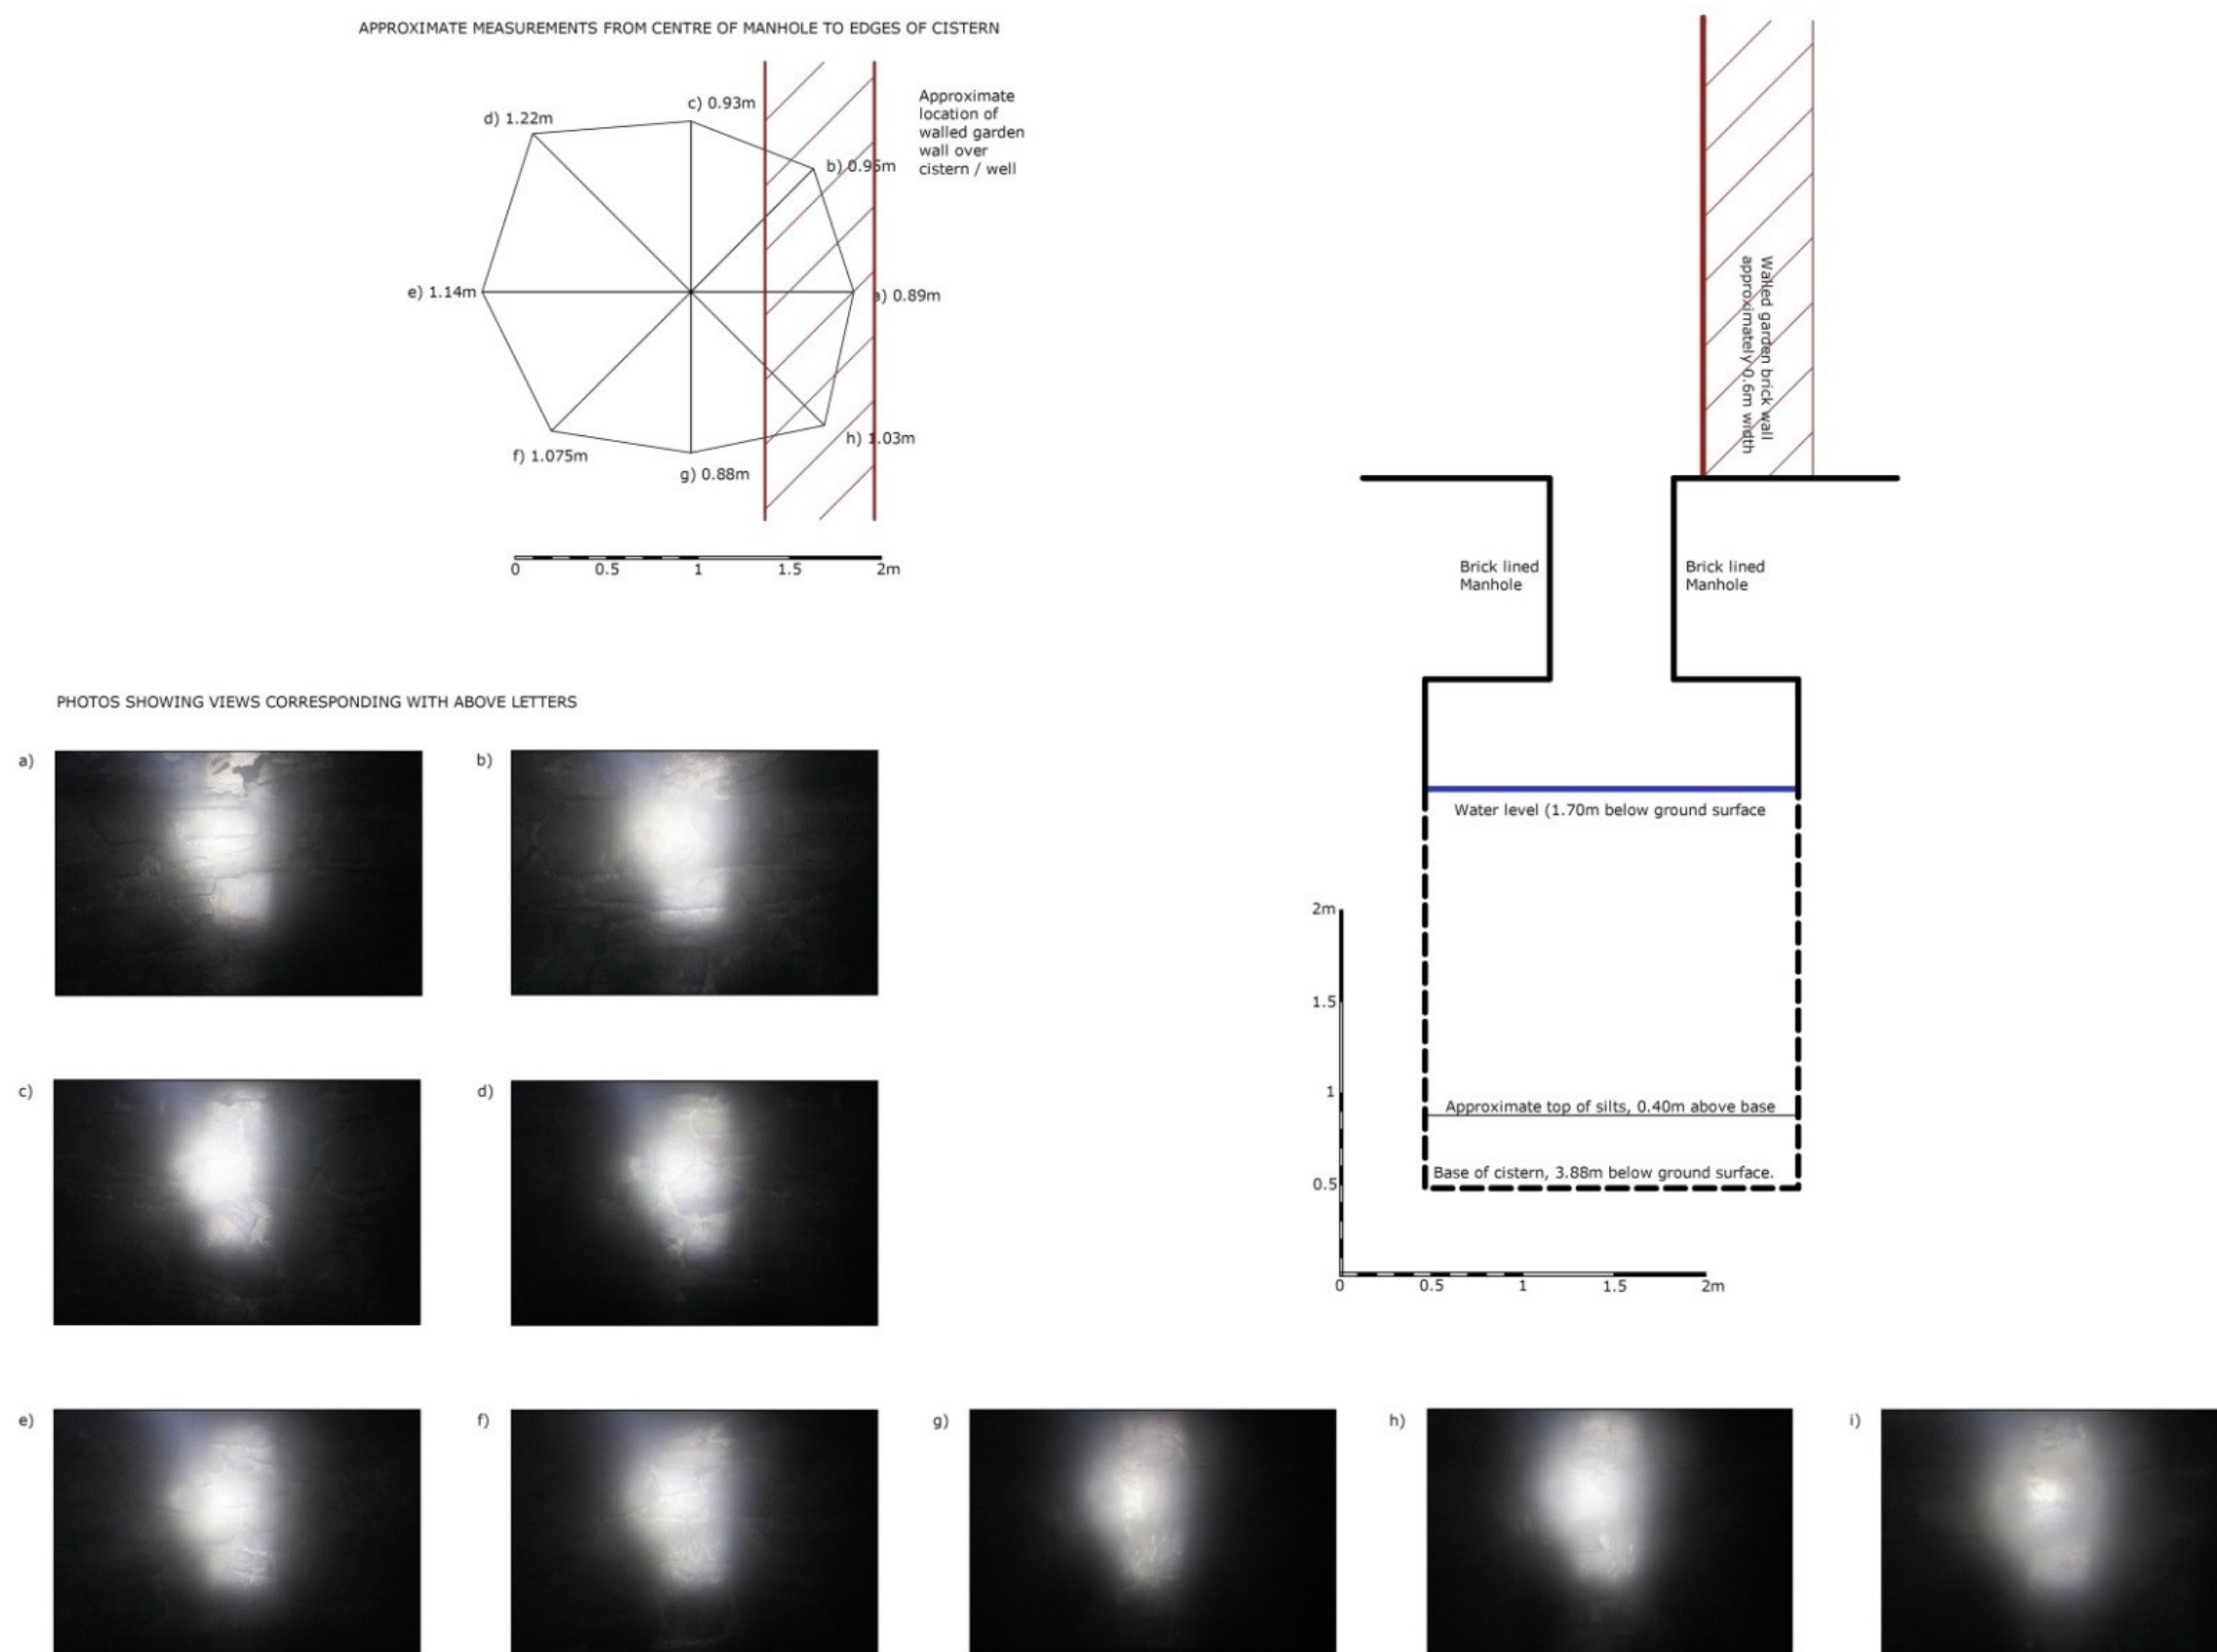
- 4.5.5 This shaft was further investigated in January 2018 using a camera on an extended pole and a distometer, and a rough plan and section through the cistern feature are shown in Figure 12. The photographs are also included but are limited in their usefulness.

- 4.5.10 No evidence of a water inlet or pipe within the walls above water level was seen.
- 4.5.11 The structure appears to be capped with rough concrete/cement (potentially with metal beams – but this could not be confirmed). The rough nature of the capping can be just seen at the tops of photos a) and b) in Figure 12.

- 4.5.12 The eastern wall of the walled garden (which is approximately 0.60m in width) partially runs over the open part of the cistern – with perhaps a maximum of 0.50m of the wall width over it and around 0.10m of its width presumable sitting on the walling of the structure at this point. Thus it is estimated that a maximum total length of 1.5m of the wall runs unsupported over the open part of the structure. There could be a maximum 1.1m deep foundation over it – probably supported on the capping of the structure.

**Figure 12:** Results of investigations into the cistern within the walled garden.

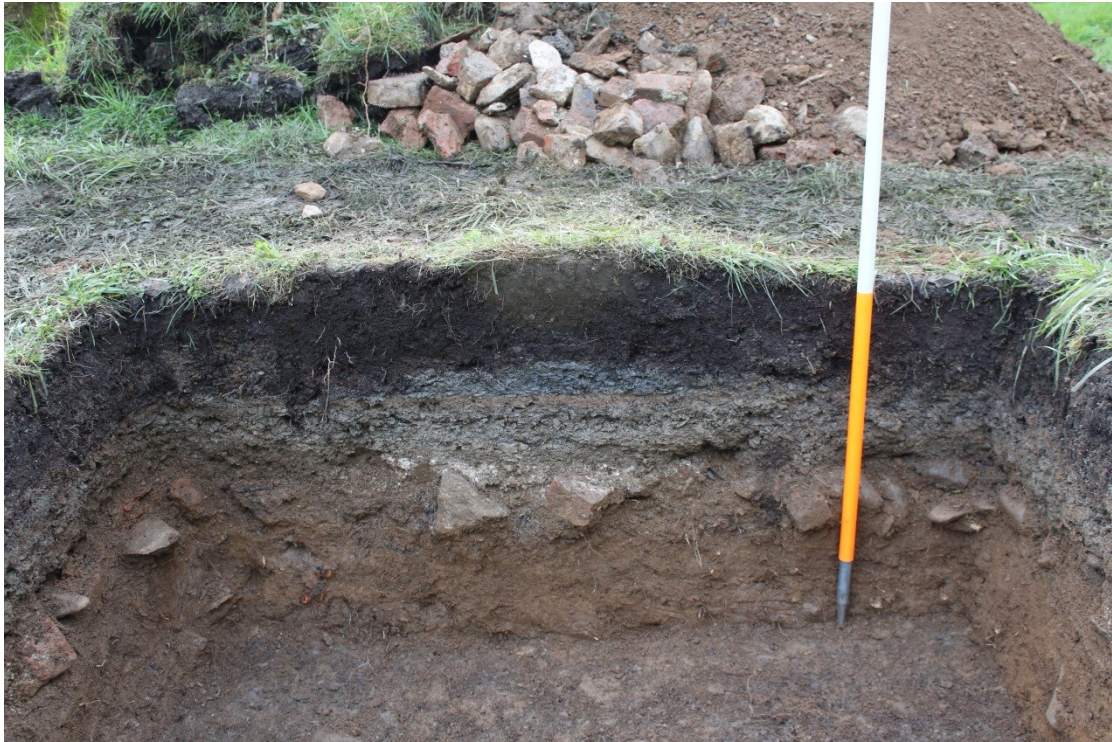
- 4.6.2 The paths were still visible on the ground as slightly raised linear banks.
- 4.6.3 The northeast facing section of the test pit was drawn and is shown in Figure 14 and Photo 56, both of which clearly show the build-up of path deposits.

**Photo 56:** The northeast facing section of Test Pit 1. 1m scale

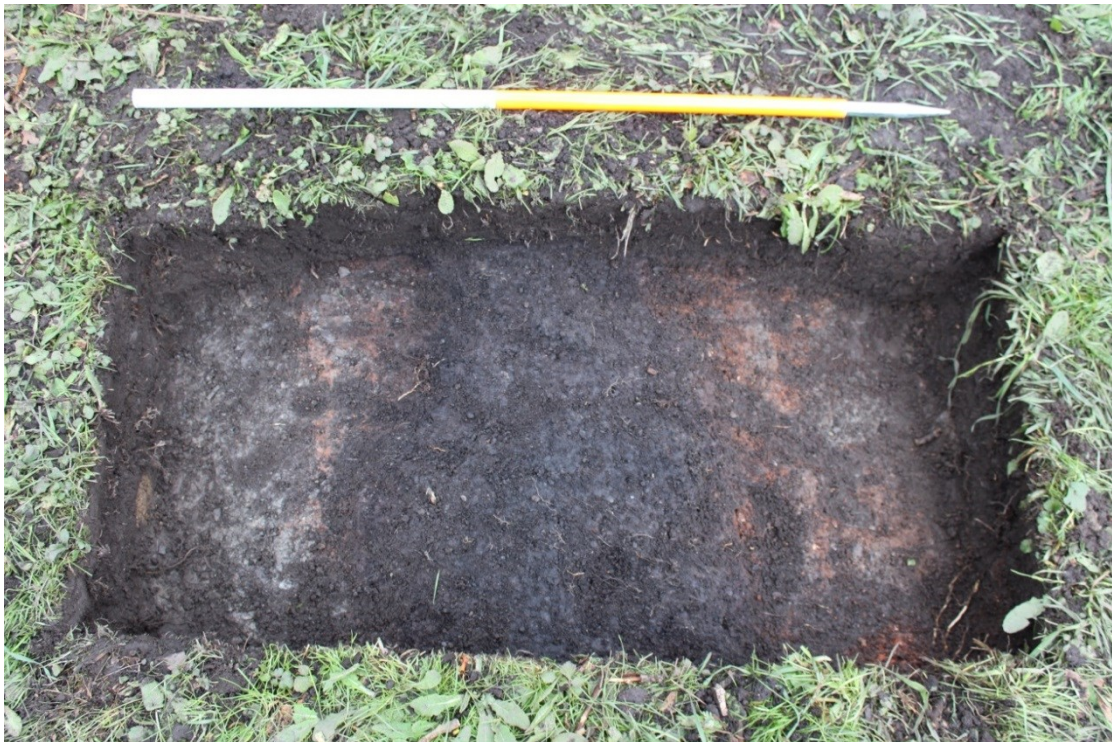
- 4.6.6 A 1m by 0.5m test pit was excavated across the path that led southwest from Glasshouse 1.
- 4.6.7 This path was still visible on the ground as a slightly raised linear bank and can be seen in the aerial photograph taken in the 1950's shown in Figure 7.
- 4.6.8 The test pit revealed the path to be formed from ash and clinker with an obvious camber (Photo 57).
- 4.6.9 It is probable that the ashes and clinker were a product from the boiler house of Glasshouse 1.

**Photo 57:** Test Pit 2 showing the remains of the cambered ash path. Looking southwest. 1m scale

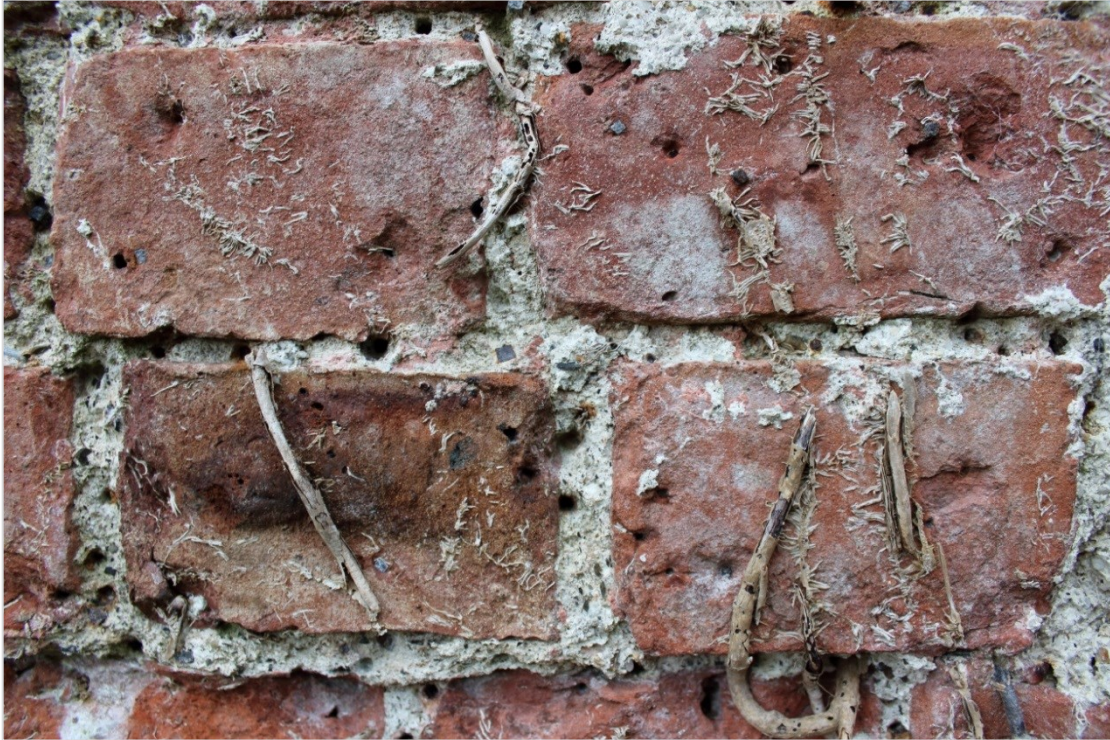
**Photo 62:** Close up of the some of the many small nail holes (some nails still *in situ*) within the south facing wall of the walled garden.

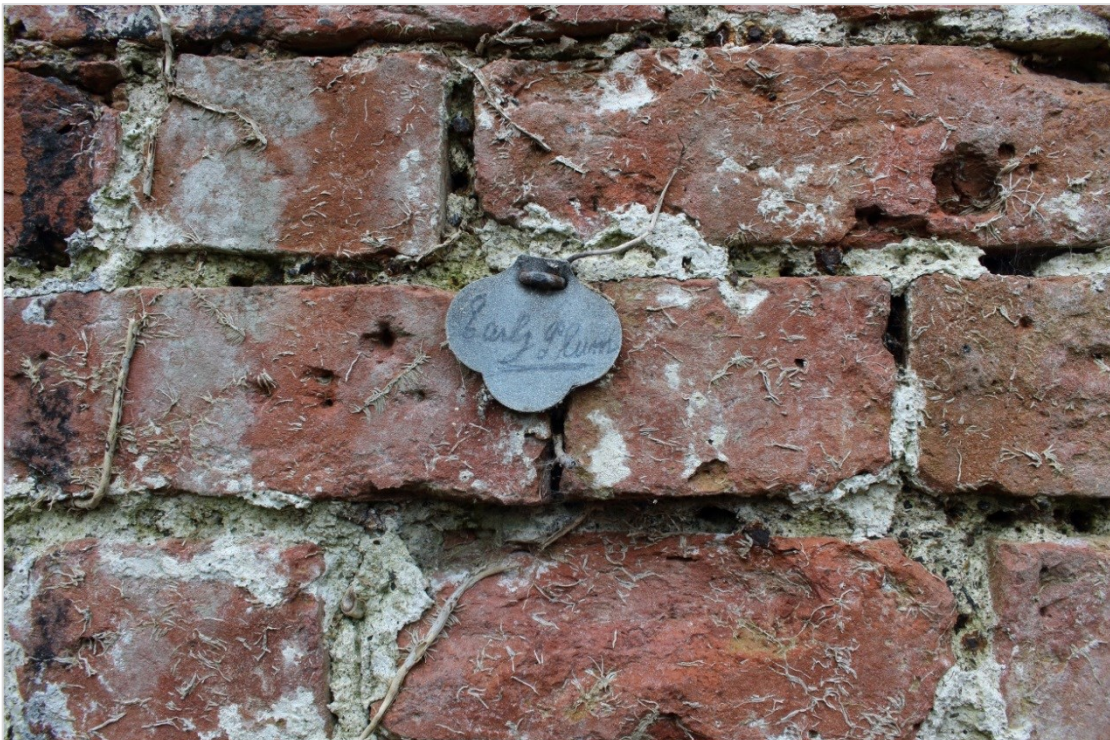
**Photo 63:** Close up of a small metal label with 'Early Plum' inscribed on it was found still attached to the south facing wall
