# CAREW FRENCH TIDAL MILL AND CAUSEWAY, CAREW, PEMBROKESHIRE (SN 04155 03831)

# ARCHAEOLOGICAL WATCHING BRIEF DURING REPAIR AND REMEDIATION WORKS 2017

RHIF YR ADRODDIAD / REPORT NO. 2017-72 RHIF Y PROSIECT / PROJECT RECORD NO. 111174

> Chwefror 2018 February 2018

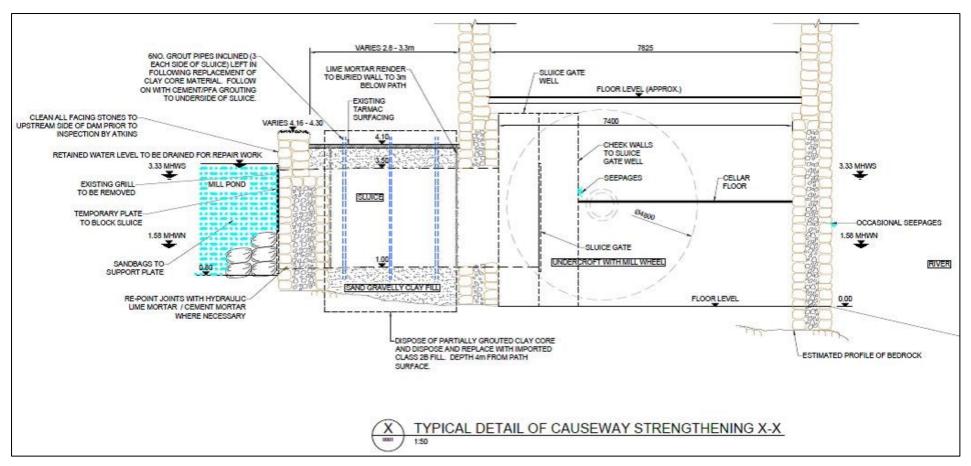
Figure 2: Section of eastern causeway wall and southern wheel sluice showing the proposed scheme of works (Reproduced courtesy of Atkins © Atkins Limited (2017)).

- 1.5 An archaeological watching brief is required during Phase 2 of the repair works which includes the excavation of a large test pit into the clay core of the causeway to inspect the base of the masonry walls and to determine the depth of water ingress. The test pit will be situated over the southern wheel sluice and will include the excavation of the core material encompassing the sluice (Figures 1 & 2). This test pit will measure approximately 4m in length and depth, and will

encompass the full width of the causeway, c.3m. Further intrusive probing works may also be necessary. The excavation will be undertaken by a mini-excavator or similar small tracked machine. A photographic record will be undertaken of the exposed masonry of the causeway and sluice during this stage. This test pit will be later refilled by imported clayey soil and the re-use of existing clay infill where possible.

- 1.6 Following the excavation of the test pit and inspections, the repair works include the lime mortar pointing of the external face of the causeway wall (eastern side), lime rendering of the external and internal Mill cellar and the crown of the southern sluice tunnel. These phases of work will not be necessary to watch.
- 1.7 This WSI details the methodology of the evaluation which will be undertaken and has been prepared in accordance with the *Standard and Guidance for an Archaeological Watching Brief* (CIfA<sup>3</sup> 2014).
- 1.8 Dyfed Archaeological Services area Registered Organisation with the Chartered Institute for Archaeologists (CIfA).
