CAREW CASTLE CAFÉ, CAREW, PEMBROKESHIRE 2018: ARCHAEOLOGICAL WATCHING BRIEF

SN06575 03775

DYFED ARCHAEOLOGICAL TRUST
RHIF YR ADRODDIAD / REPORT NO. FS18-010
RHIF Y PROSIECT / PROJECT RECORD NO. 112372

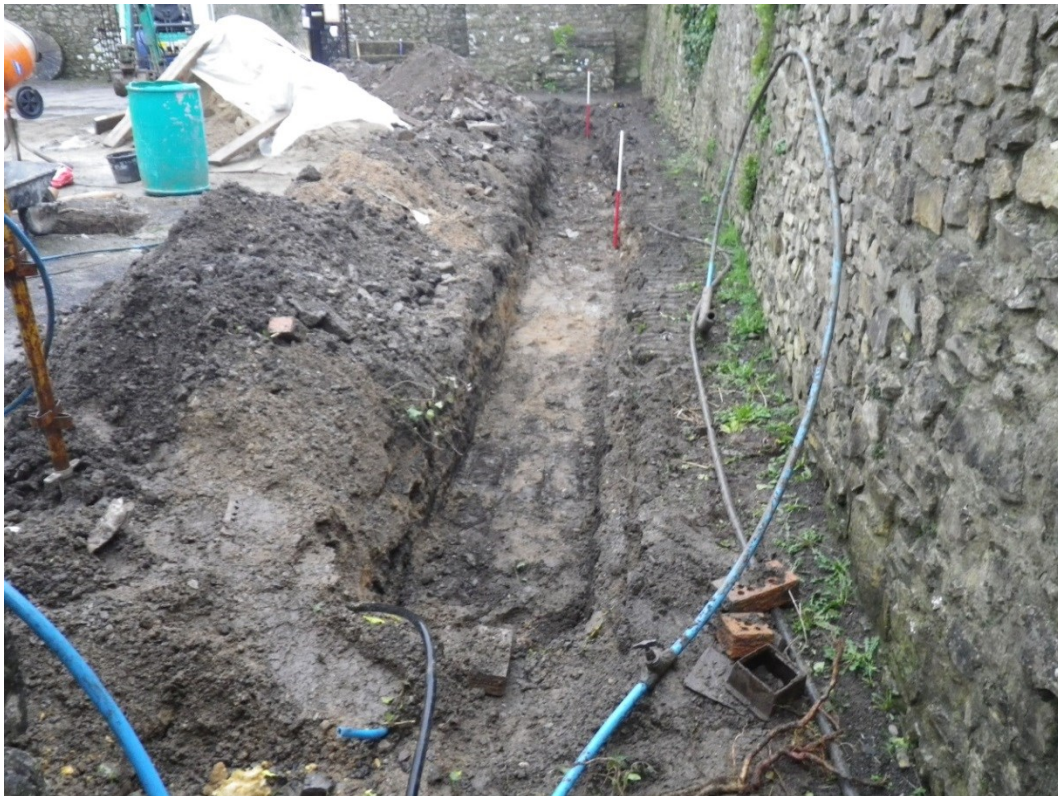
2.2.10.3 An electric and a BT service duct were inserted during this stage of works (as exposed during the 2018 watching brief), running along the southern edge of the walled garden from the rear of the new visitor centre. These appeared to follow almost the exact line of earlier electricity cabling and an earthing wire (as also noted in 2018). The observed works can be seen in Photos 1, 2 and 3. It would appear that the service run was excavated to a depth of less than 0.50m below ground level, exposing underlying sands and mortar to the west and dark soils to the east, with the former excavated area in the centre (as seen in the evaluation trench).

Photo 1: View east along service duct trench from adjacent to new visitor centre (2013)

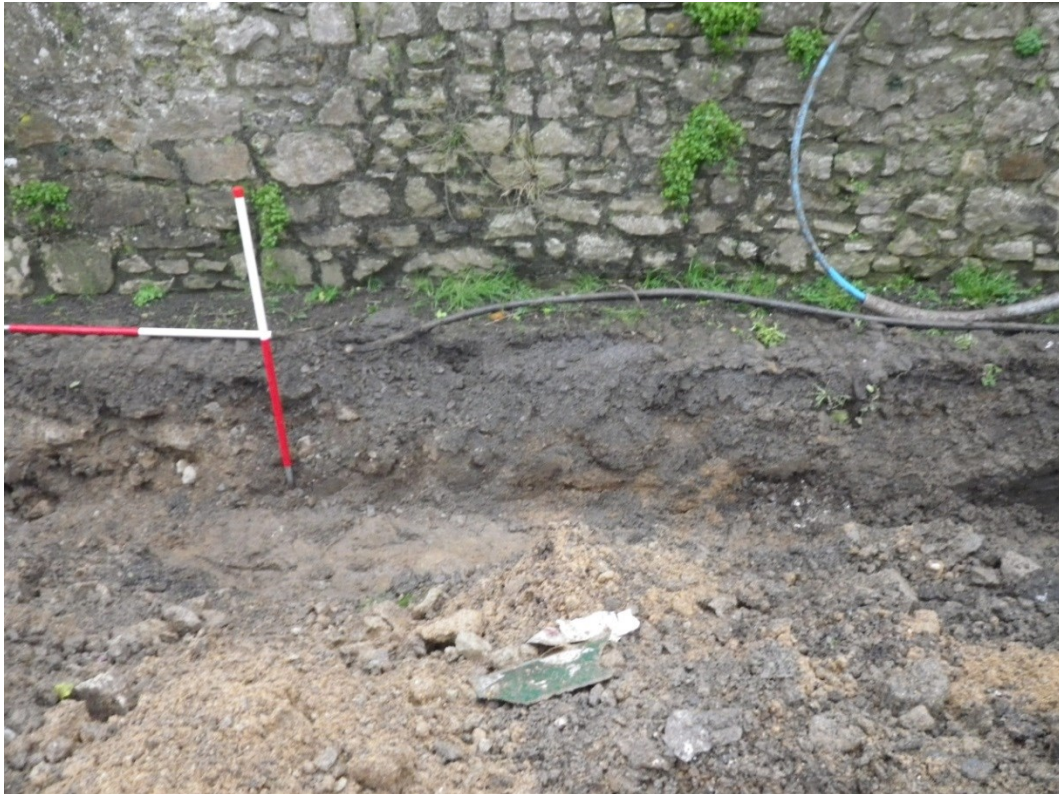
Photo 2: Example section through service duct trench along southern edge of walled garden, with wall behind (2013)

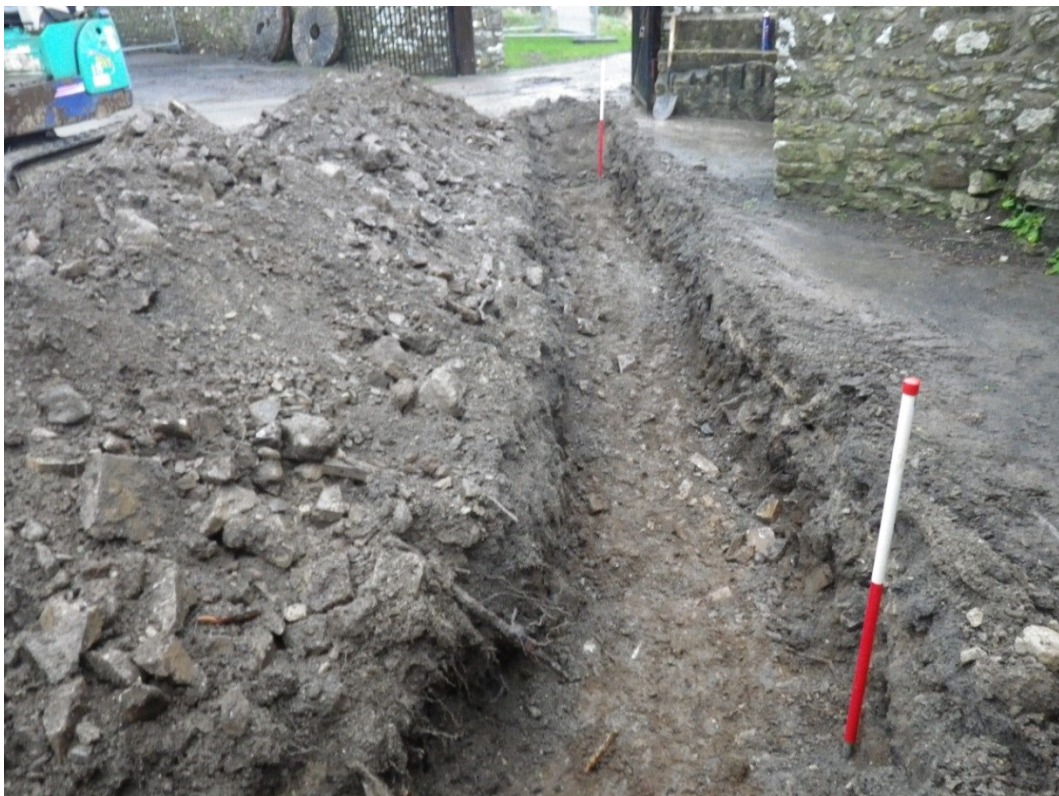
Photo 3: View northeast along service duct trench where it turned towards the eastern entrance to the walled garden (2013)

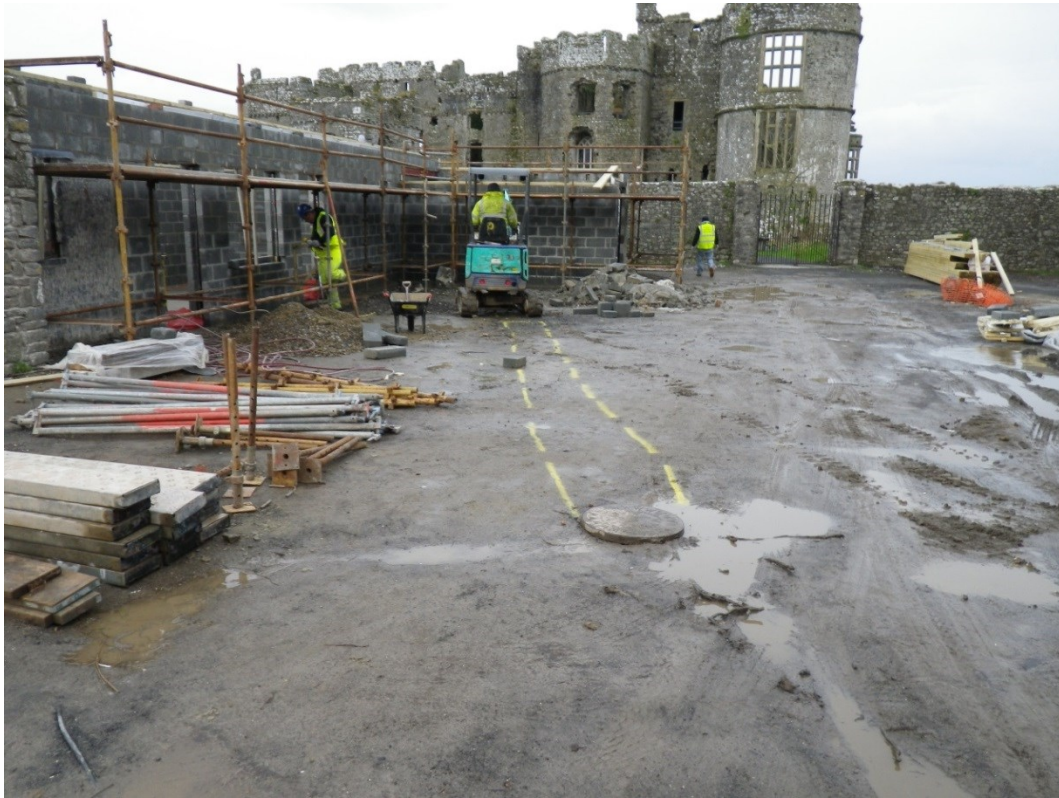
2.2.10.4 The alignment of the drain observed during the 2013 works is shown on Figure 5, which ran to the north of the new Visitor Centre connecting with an existing manhole (Photos 4, 5 and 6). The depth of the drain cut would appear to be around 0.70m deep. The base of the trench appears to have exposed dark silty soil, possibly remnants of garden soil from use of the walled garden. The photos do not indicate any significant archaeology being exposed, other than the garden soils. An existing electric cable can be seen cutting across the eastern end of the drainage trench.

Photo 4: View west across drainage trench leading to manhole at start of excavation, marked in yellow (2013)

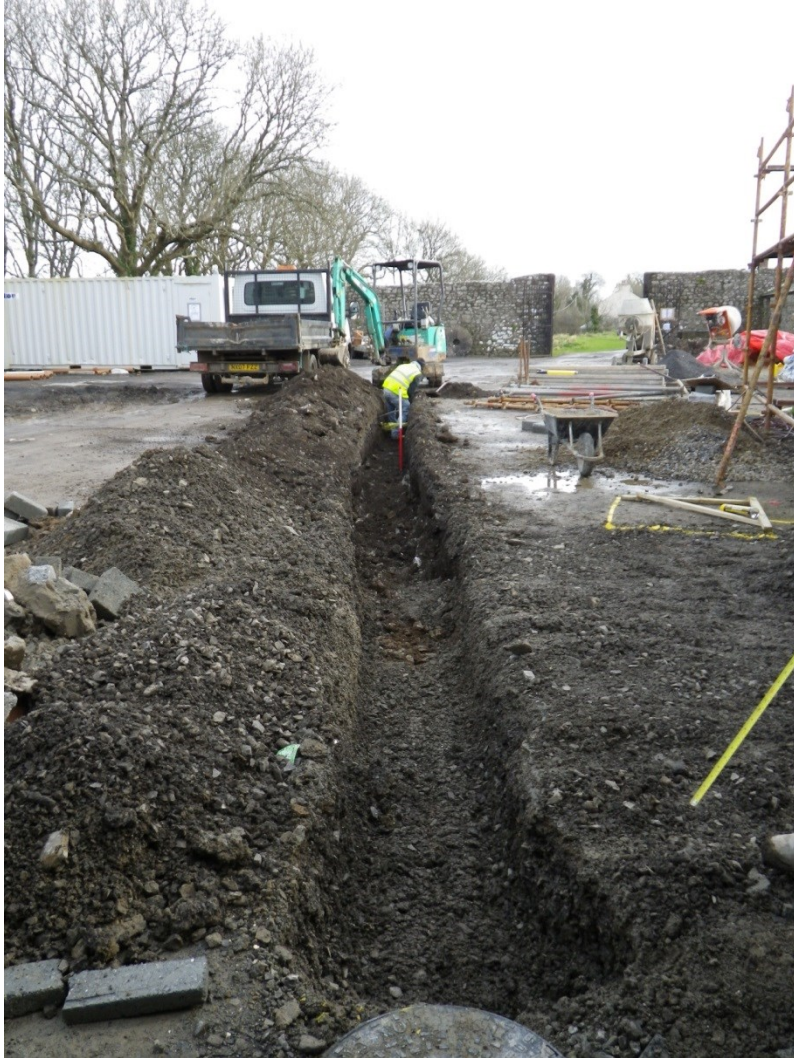
Photo 5: View east along drainage trench from visitor centre toilets towards existing manhole (2013)

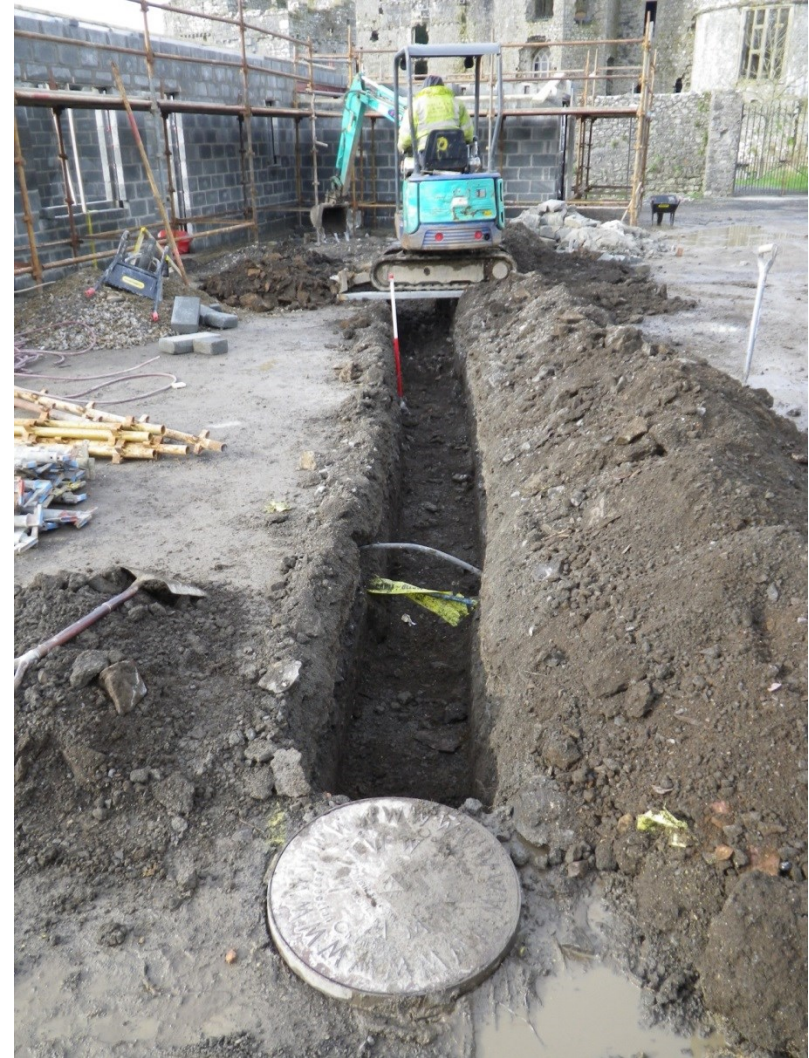
Photo 6: View west along drainage trench from existing manhole towards toilet block, with existing electricity cables visible crossing the trench (2013)

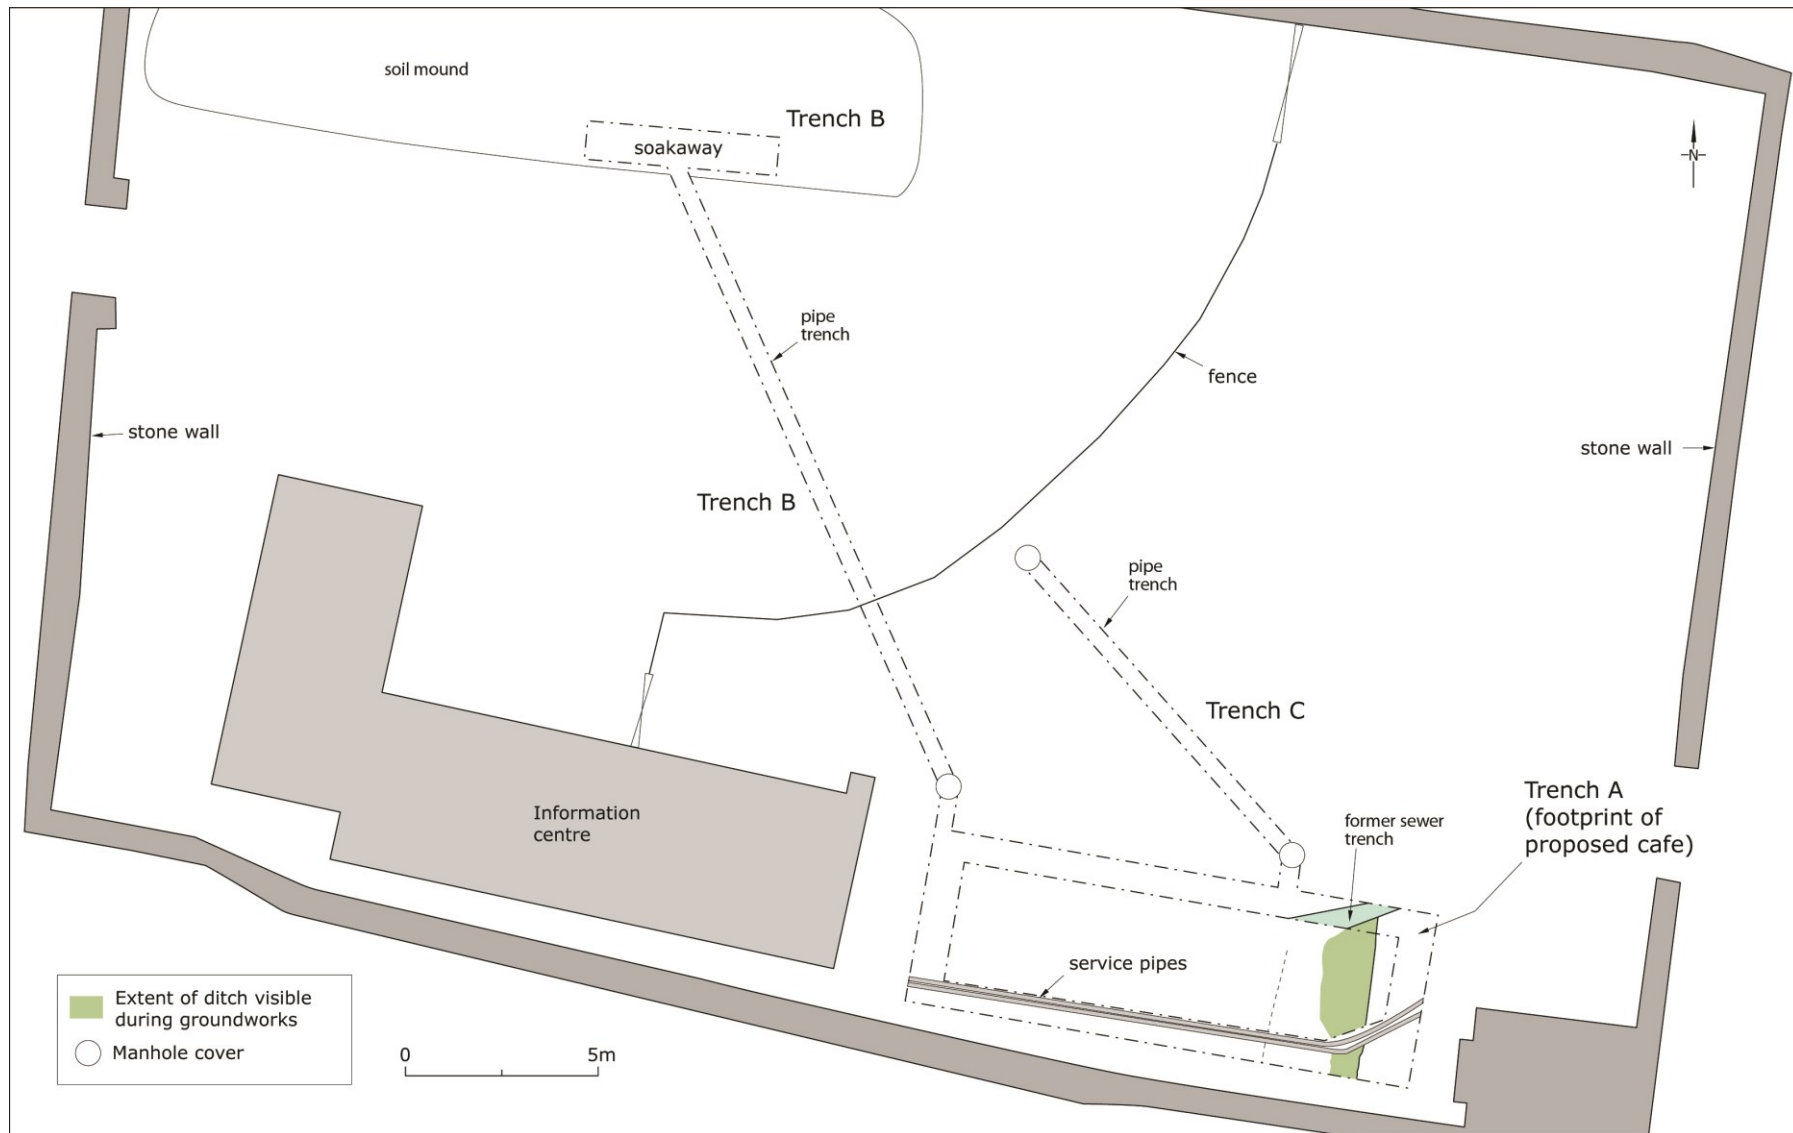
Figure 6: Plan of Trenches A, B, and C. Note extent of confirmed ditch fill with dotted line suggesting western edge.

- 4.1.1 The groundworks monitored during this watching brief are broken down into three parts for discussion; Trench A, which incorporates the footprint of the new café; Trench B, a drainage run leading northwest from the northwestern corner of the café to a soakaway; and Trench C another drainage trench which led from the northeastern corner of the café to a manhole to the northwest (Figure 6).

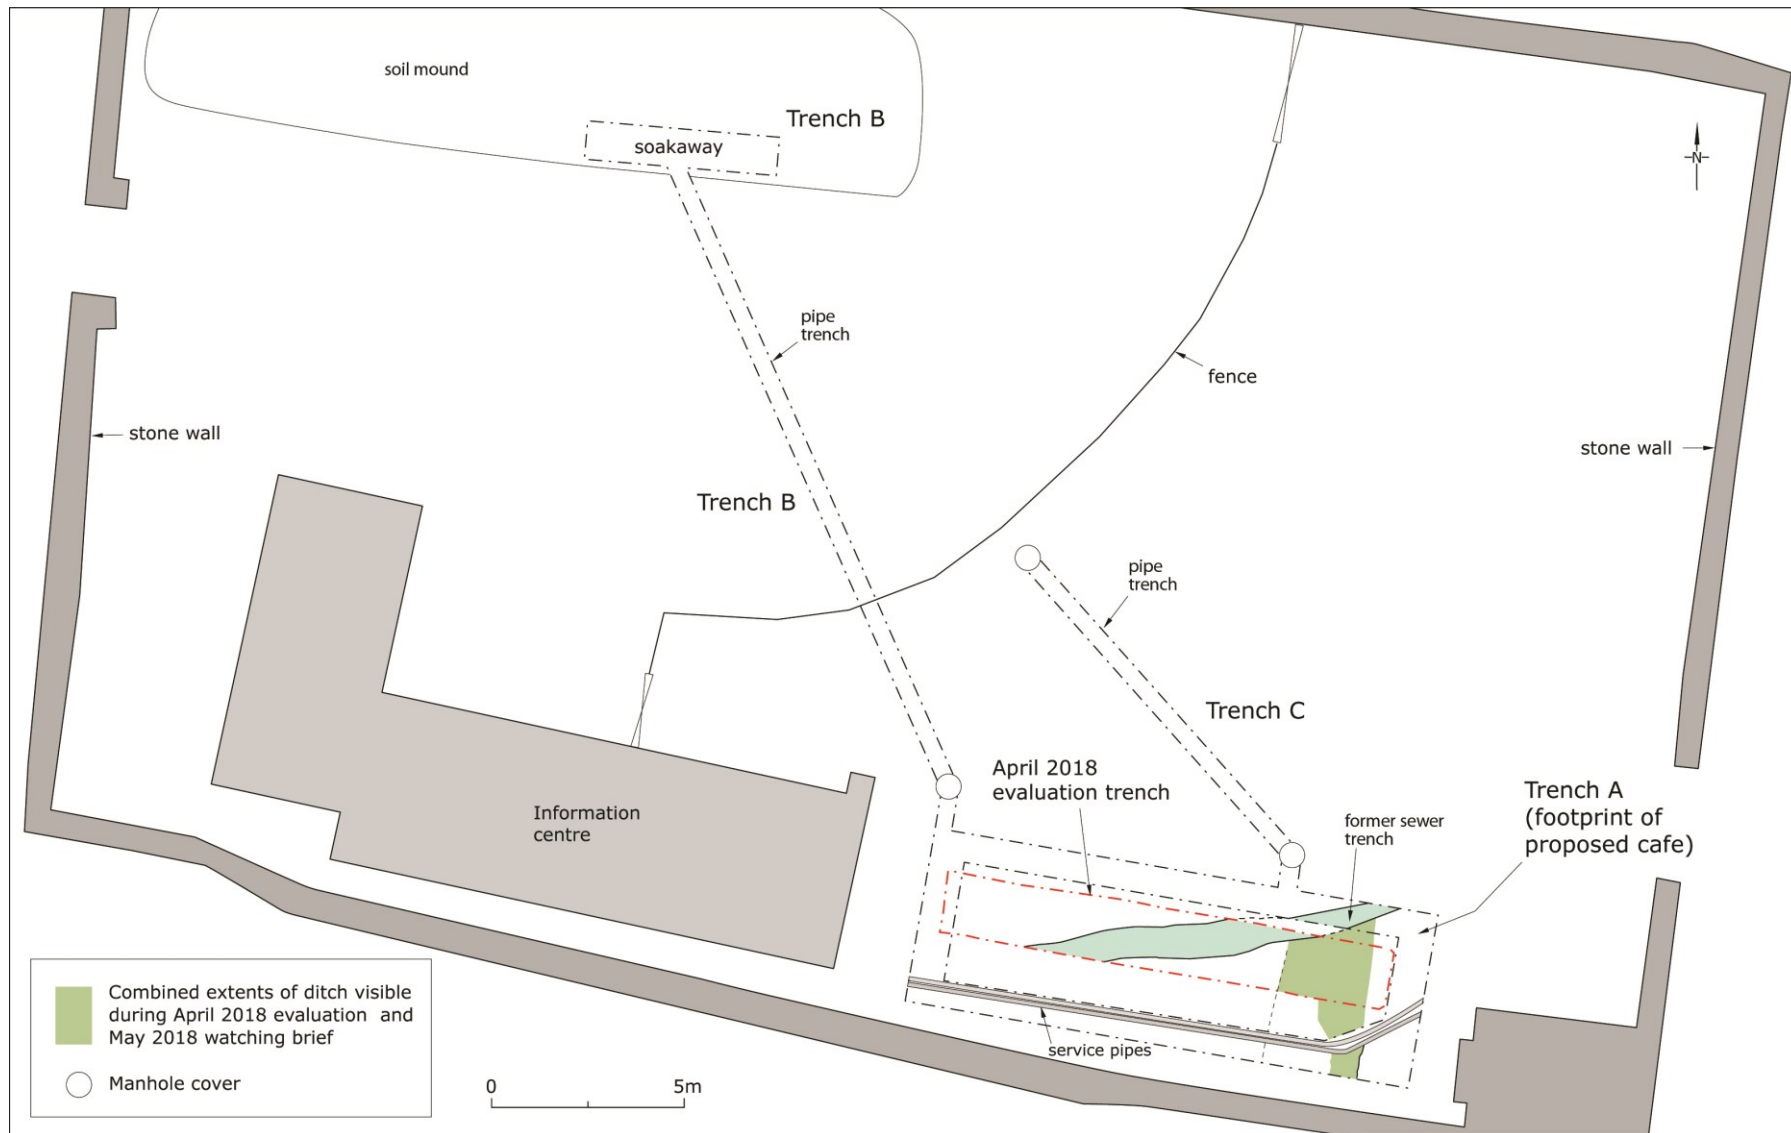
Figure 7: Combined Plan of April 2018 evaluation trench (Jenkins and Meek 2018) and May 2018 watching brief.

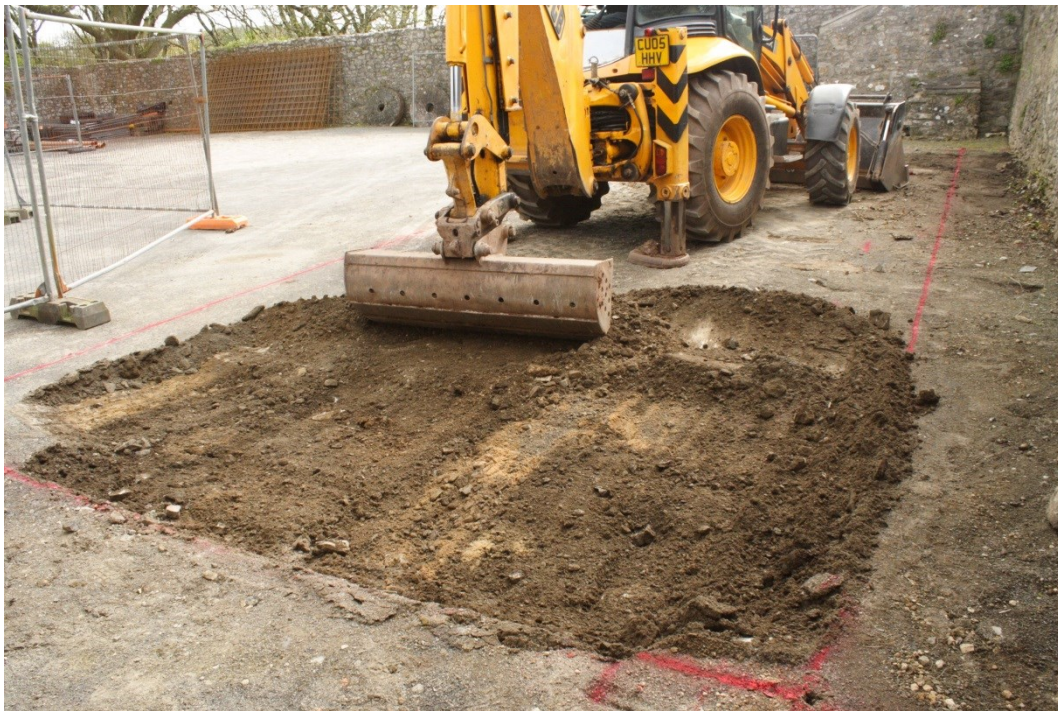
- 4.2.1 Trench A was initially excavated across the footprint of the café using a toothless bucket (Photo 10). The area excavated measured 13.25m x 4.55m with its longest axis aligned roughly east/west (Figure 6). The footprint lay between 0.65m and 0.72m north of the south wall of the walled garden. It lay around 1.85m east of the visitor centre and 1.5m to 2m from the building in the southeastern corner of the walled garden (Figure 6). The area was initially excavated to a depth beneath ground level of 0.275m at the western end and 0.40m at the eastern end of the footprint. The depth of material removed became gradually deeper to the east due to a slight rise in the ground level. A laser level was used by the site contractors to ensure a consistent depth across the footprint.

Photo 10: View northeast at commencement of excavation of footprint of café, extent marked by red lines

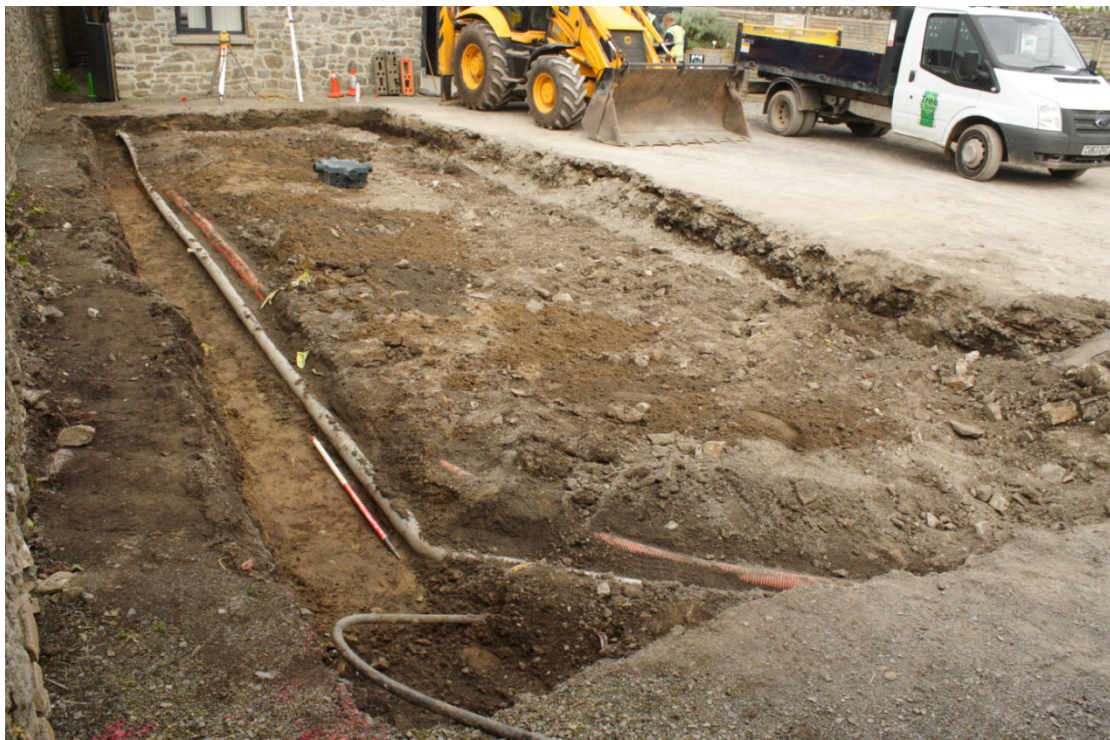
- 4.2.12 Two further areas of excavation were also carried out within the footprint of the building once formation levels had been reached (Photo 17). A radon gas mitigation chamber was dug into an area just west of centre within the building footprint, with an additional plastic pipe vent heading south to the walled garden wall. It was agreed with the site contractors that this would be located within the backfilled trench from the 1993 excavations. The depth of excavation for the radon gas mitigation system was less than 0.30m, with the venting pipe necessarily above the level of the existing service ducting.

Photo 17: View northwest across café footprint following site strip and excavation of perimeter 'toe' trenches, prior to radon gas mitigation and service duct installation.

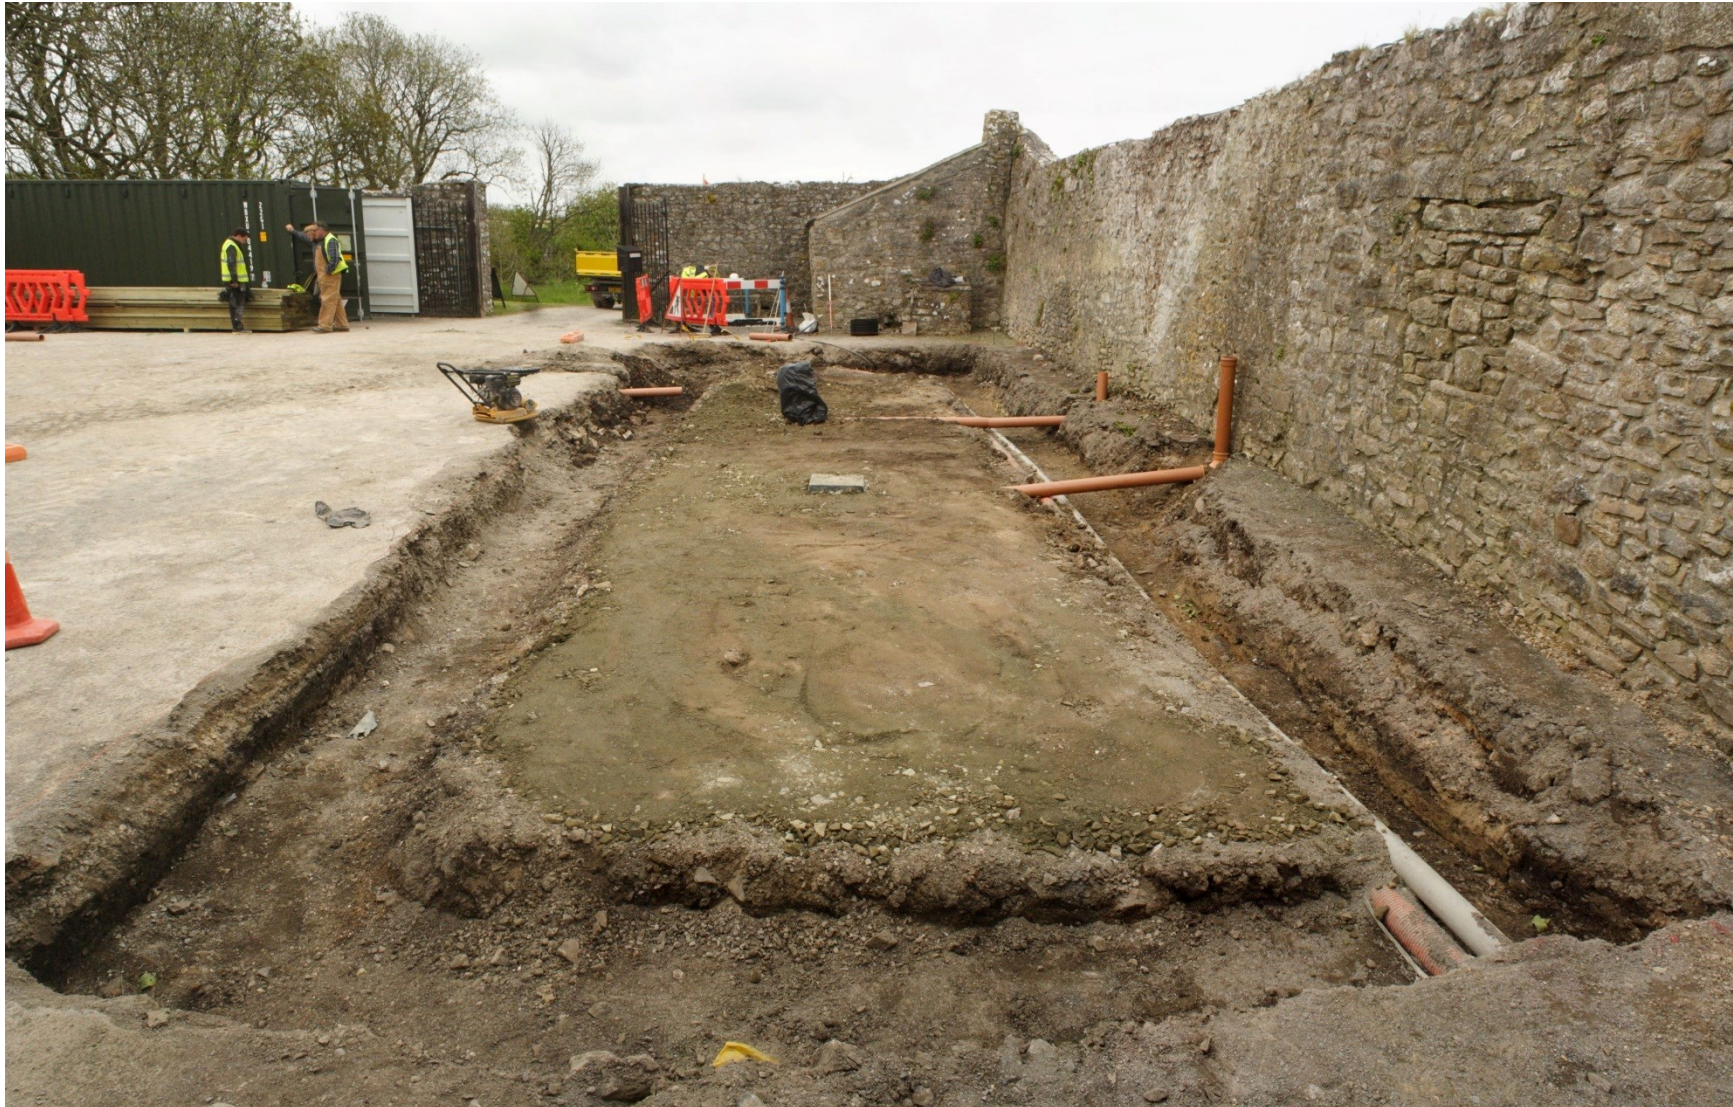
Photo 18: View east across the completed footprint for the new café building raft foundation, including radon mitigation system, service ducting and levelled material over central part of footprint

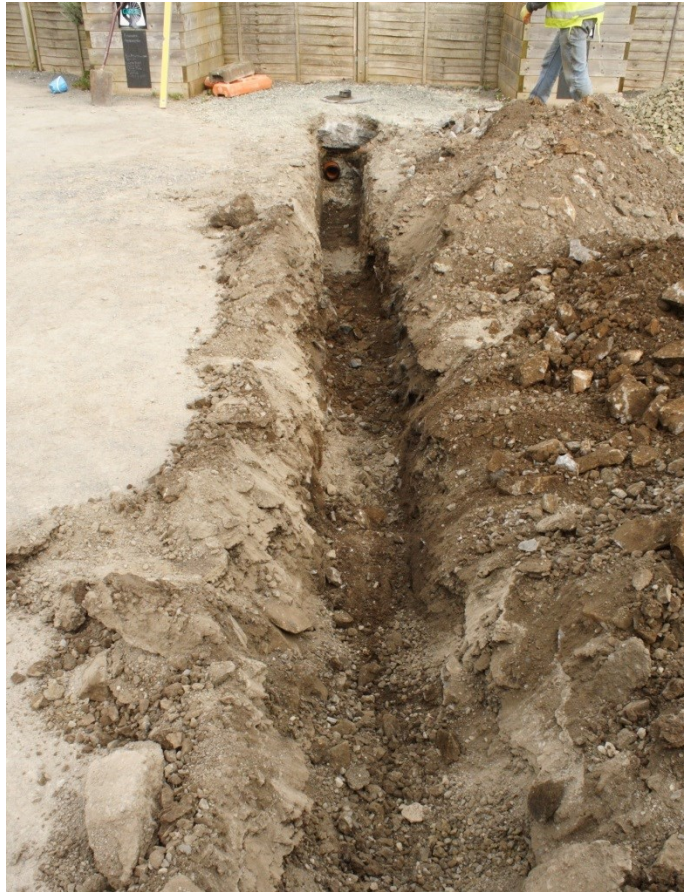
- 4.4.2 Much of the trench line crossed through previous excavations undertaken in 1993 which had been backfilled and significantly compacted. The rubble within the fill and compaction made excavation difficult and the toothed bucket created a ripped up and messy trench base. It is presumed that as the area had been previously excavated that these works will not have affected any undisturbed archaeological remains. Beyond the mid-point of this trench the base of pipe rose above 0.50m and therefore was above archaeological layers.

Photo 23: View northwest along drainage Trench C towards existing manhole
