CAPEL ERBACH: BUILDING RECORDING SURVEY 2019

RHIF YR ADRODDIAD / REPORT NO. 2019-09
RHIF Y DIGWYDDIAD / EVENT RECORD NO. 117056

CADW PROJECT NO. DAT 150

Chewfwr 2019
February 2019

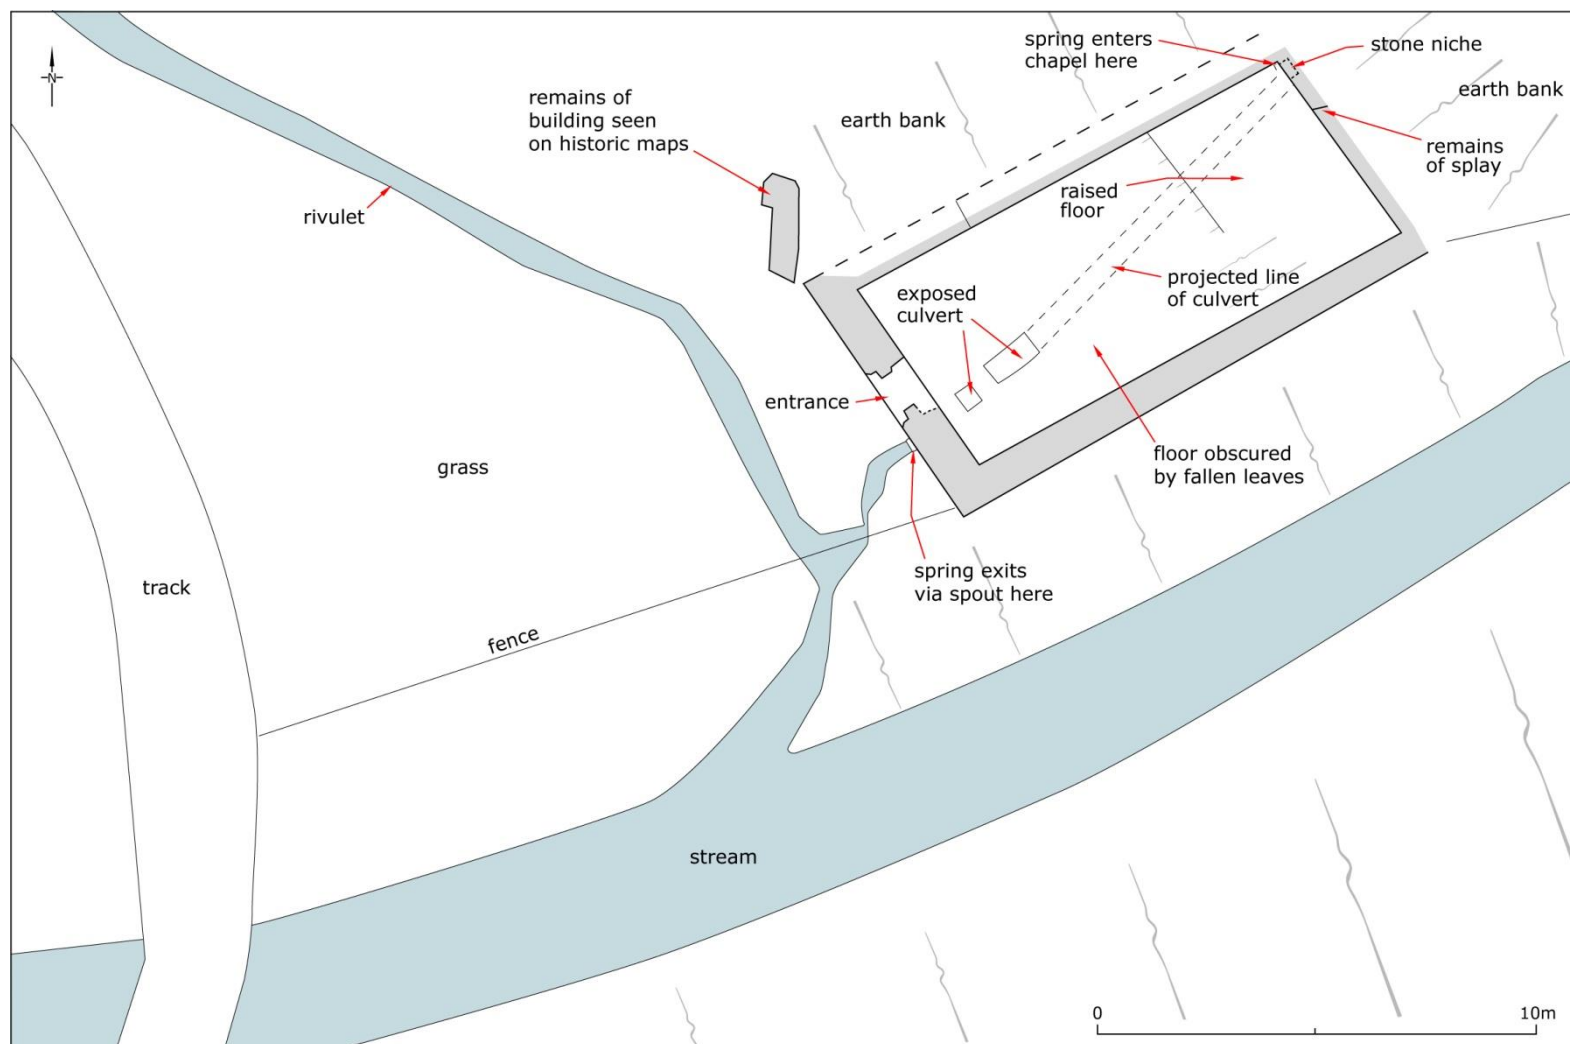
Figure 4: Plan drawing of Capel Erbach.

- 3.1.5 The floor of the chapel is covered in leaf mould, but evidence of a raised platform towards the rear of the chapel was visible. The spring enters the chapel in the northeast corner where it enters a stone lined channel below the floor level, with some exposed sections. It flows diagonally across the chapel towards the southwest corner where it leaves the chapel.

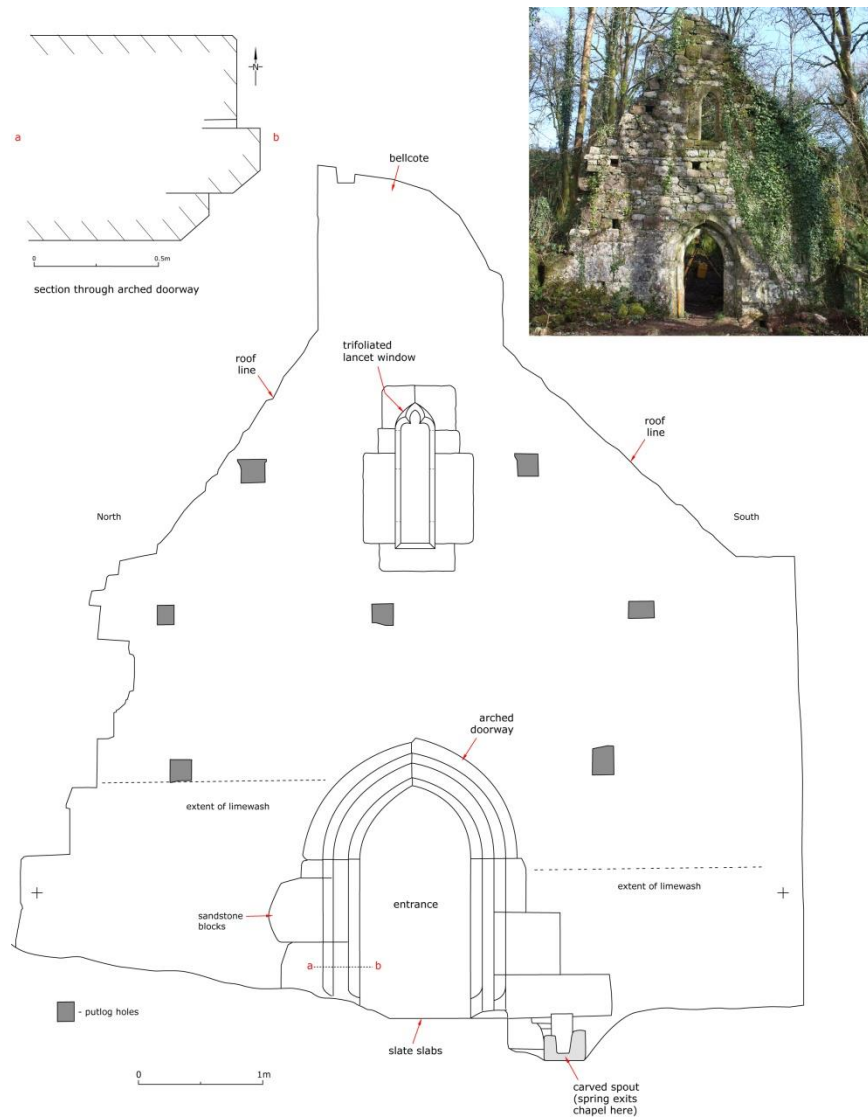
Figure 5: Western wall exterior

- 3.1.2 The western wall is 6.85m high and houses the bellcote, arched entrance doorway and the trifoliated lancet window. A small water spout emanates from the chapel to the right of the arched doorway (on the outside). To the left of the doorway (on the inside) the internal masonry suggests that there may have been a staircase which led to the bellcote.
- 3.1.6 Internally, above the door way, a large crack is beginning to form in the stonework and the arch is currently being held in place by acrow props (Seen in Photo 4).
