**SOUTH QUAY, PEMBROKE
NOS. 4, 5 & 6 CASTLE TERRACE,
NOS. 7 & 8 NORTHGATE STREET:
LEVEL 3
HISTORIC BUILDING RECORDING**

Prepared by Dyfed Archaeological Trust
For: Pembrokeshire County Council

REPORT NO: 2019/45

December 2019

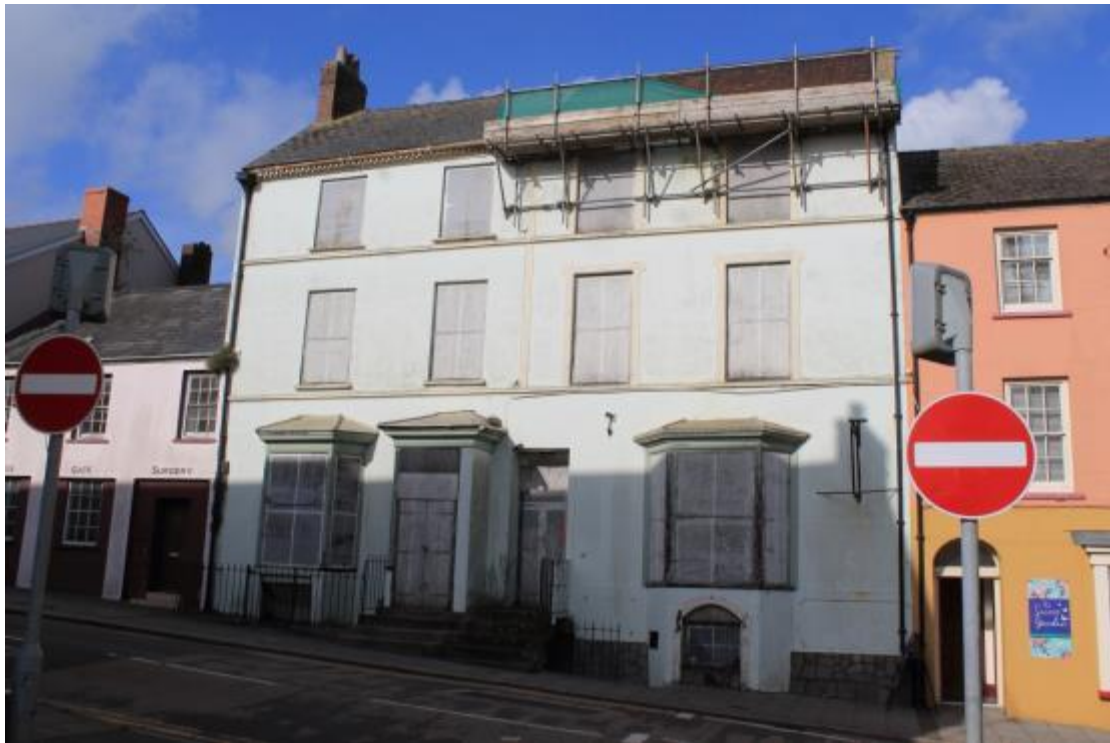
Photo 1: Southern facades of Nos. 4 & 5 Castle Terrace

- 4.2.8 The street-side façade thus originally comprised three bays, with a window either side of the central door (Photo 1). The painted stucco exterior is divided horizontally by moulded strings at each floor-level, above a moulded sill-course, and there is a dentil cornice-band beneath the overhanging eaves. A brick chimney stack occupies the west (end) wall, possibly secondary in this form?

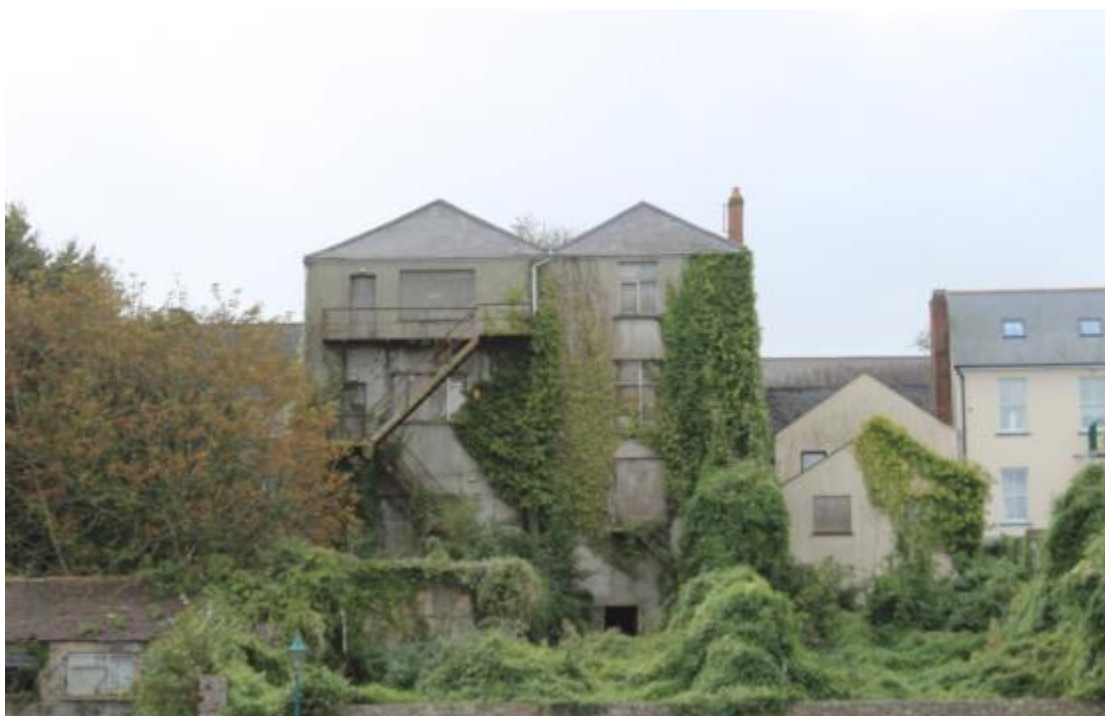
4.2.12 Behind the main street-side block lie two long, conjoined rear extensions, also of three storeys beneath a double-hipped slate roof, which were present by 1861 and were probably added when the building was divided (Photo 8).

Photo 8: Southern façade of Nos.4 & 5 Castle Terrace, viewed from South Quay car park showing rear extensions and hipped roofs

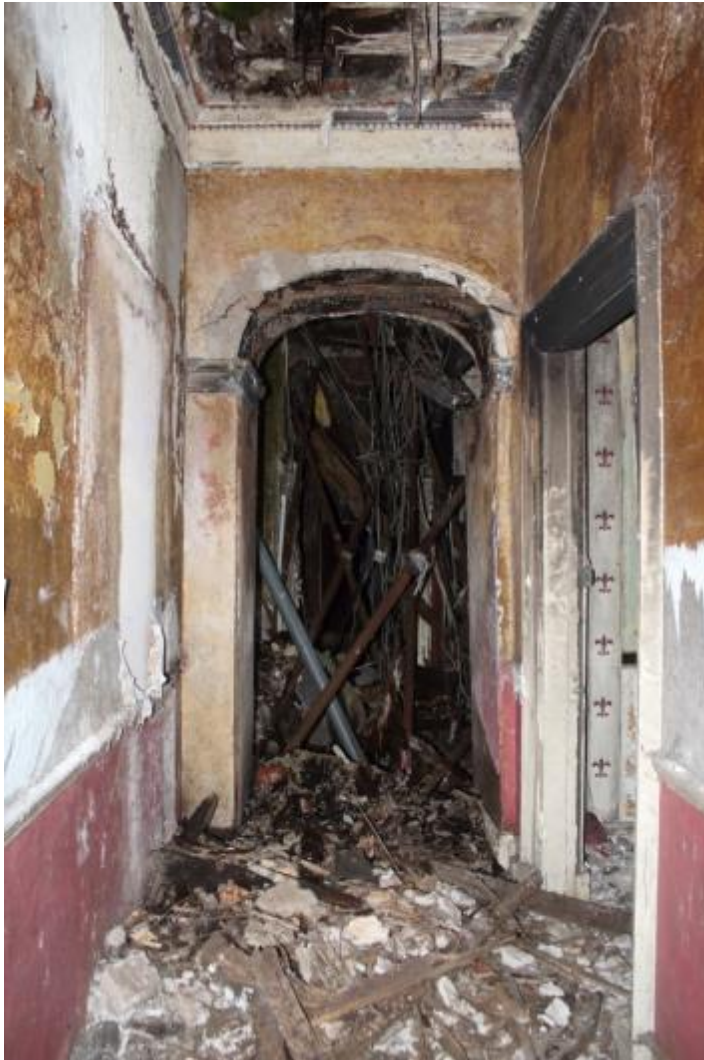
Photo 9: View north along central passage from original front door with collapsed area beyond

4.2.14 Internally, many of the fittings, and some of the floors and partitions, are damaged or lost. In No. 4, the central passage runs from the front-door through to the rear extension, which is accessed through an elliptical arch; the passage shows an original moulded cornice with anthemion ornament in the frieze and rosettes in the ceiling border, c.1800.

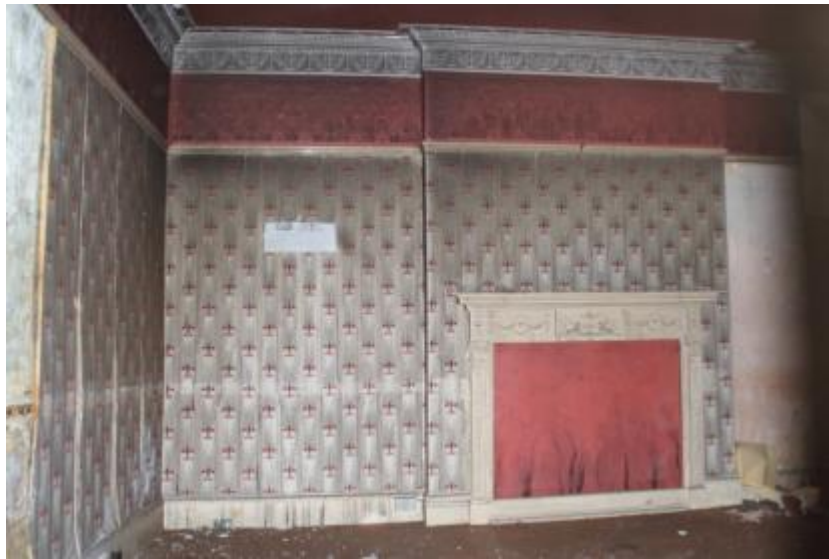
4.2.15 The front room is treated in the Adam manner. It is entered through a doorway with a moulded surround, and has a similar cornice (Photos 11 & 12). A contemporary timber, Adam-style chimneypiece occupies the east wall fireplace, with Ionic pilasters showing delicate neo-Classical ornament in pilaster panels (Photo 11). There is a plaster ceiling rose with anthemion surround. The reveals of the bay window show sunk timber panels (Photo 12). The upper floor rooms have been altered, and are now fire-damaged. The roof structure was not seen.

Photo 11: View east into southeastern room of No. 4 Castle Terrace showing fireplace

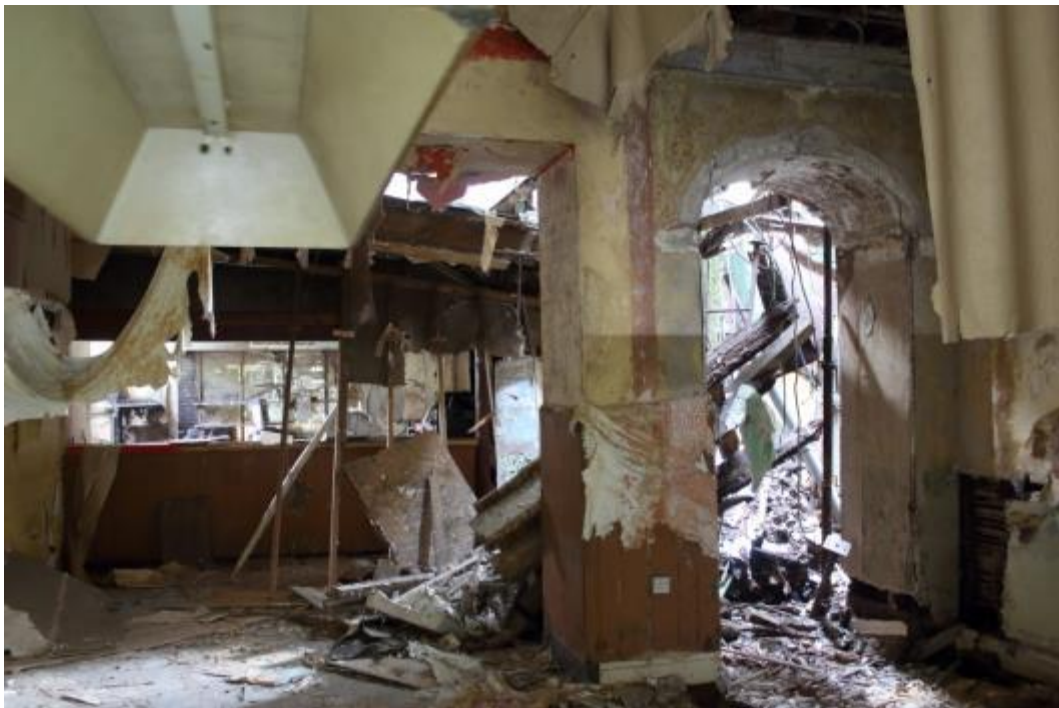
Photo 14: View north across southern room of No. 5 Castle Terrace, showing wide internal partition wall looking through to bar area and collapsed superstructure and roof

- 4.2.17 As noted above only the two entranceways and front room of No. 5 Castle Terrace could be accessed during this survey due to safety reasons. It was evident that the building fabric behind the front rooms was in a very poor state of repair and the majority of the fabric had been significantly compromised through damage and collapse. The width of the wall at the rear of the front room seen within No. 5 (Photo 14) could potentially indicate an earlier date reused in the later structure, but this is not possible to confirm until the building has been cleared of debris and made safe. Behind the single pile block on the street frontage, the remainder of the building superstructure is likely to date from the extension in the early 19th century. It is possible that earlier elements survive, but based on the state of collapse seen within the buildings, this could again not be confirmed until the area is cleared of debris and made safe.

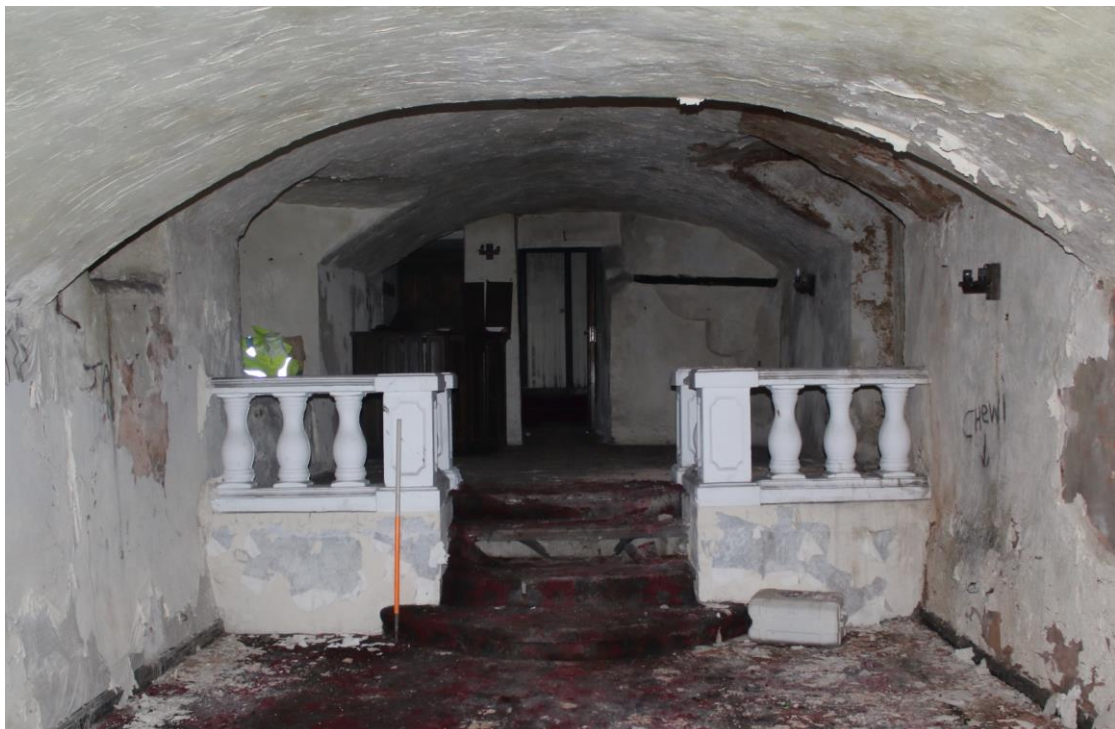
Photo 16: View south of central unit towards southern wall, showing change in floor level and modern steps and balustrades

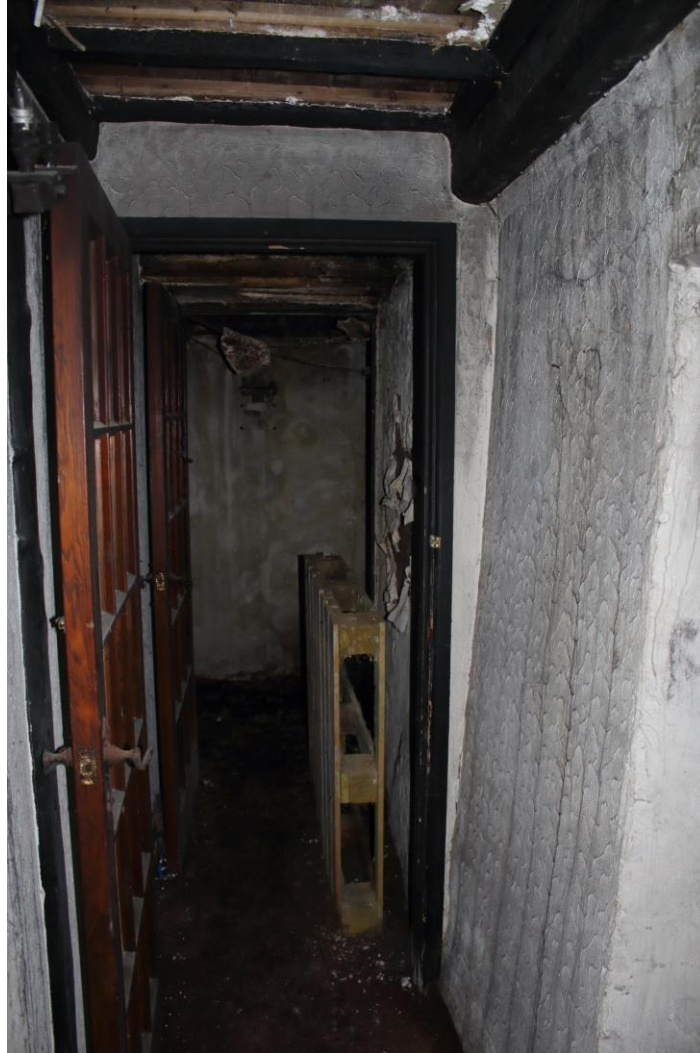
- 4.3.5.2 The south wall is substantially battered showing it to have been an outside wall, though lying 6.45m north of the current street frontage (see the southern unit, below) (Photo 17). The southwest corner shows substantial external quoining of early character, left exposed by the plaster.

Photo 17: View west along the front of the external face of the south wall of the central unit showing batter at base of wall (and doorway to corridor)

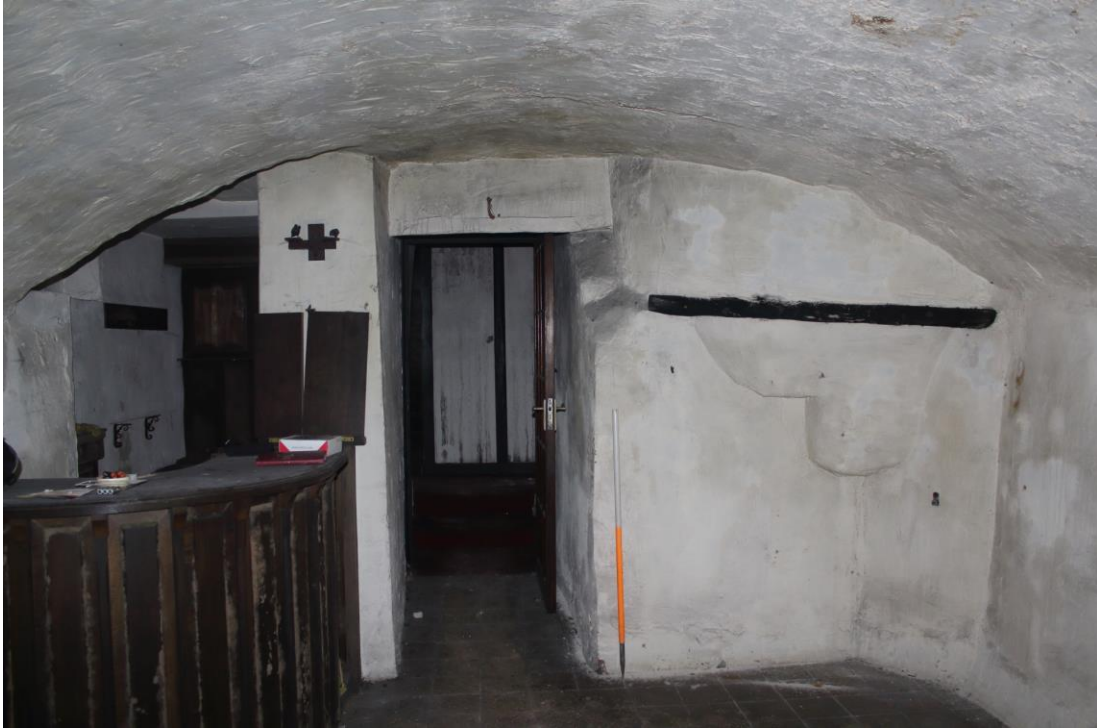
- 4.3.5.3 An entry (from the street side) lies centrally within this wall and may be original, cf. the end-wall entries in the ground floor at the Haverfordwest and Tenby Tudor houses, but it's very regular square head is probably a later alteration (Photo 18) – the present plaster finish apparently conceals a re-used section of roof-truss (Listed Buildings website, ID 6313), while the remainder of the original openings are segmental-headed. This wall is very thick at c.2.3m, and the entry is correspondingly long and slightly skewed, in a manner characteristic of medieval Pembrokeshire (Photo 18).

Photo 18: View of south wall of central unit of basement showing square headed entrance passage, corridor through wall (centre), squinch to west (right) and recess to east (left)

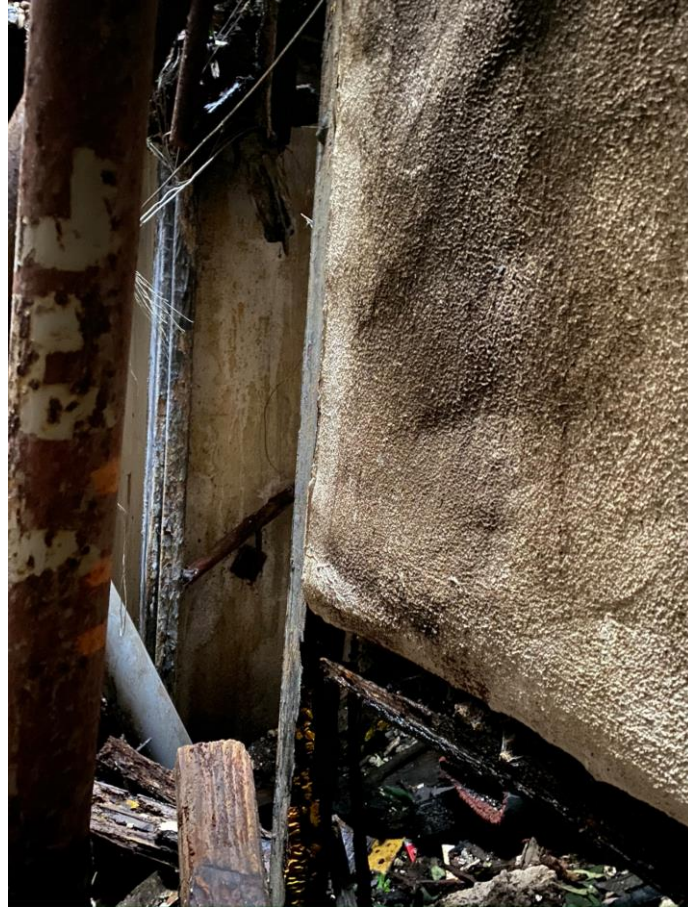
4.3.5.4 The thick south wall of the central unit appears to incorporate a passage, gallery or 'mural chamber' above the entry; this was inaccessible and could not properly be seen, but would appear to carry a modern stair to first floor level (Photos 19 & 20). The latter is carried over the internal, southwest corner of the building on a large, corbelled and rather amorphous squinch of convincingly medieval date (Photo 18); large squinches of this nature are another characteristic of medieval and early post-medieval Pembrokeshire, in both secular and ecclesiastical buildings (Day and Ludlow 2016, 68). A deep recess in the north (internal) face of this wall, leading off of the vaulted chamber east of the entry, has been much altered and its original nature can only be guessed at (Photo 18).

Photo 19: External view roughly north of the opening into the thick southern wall of the central unit

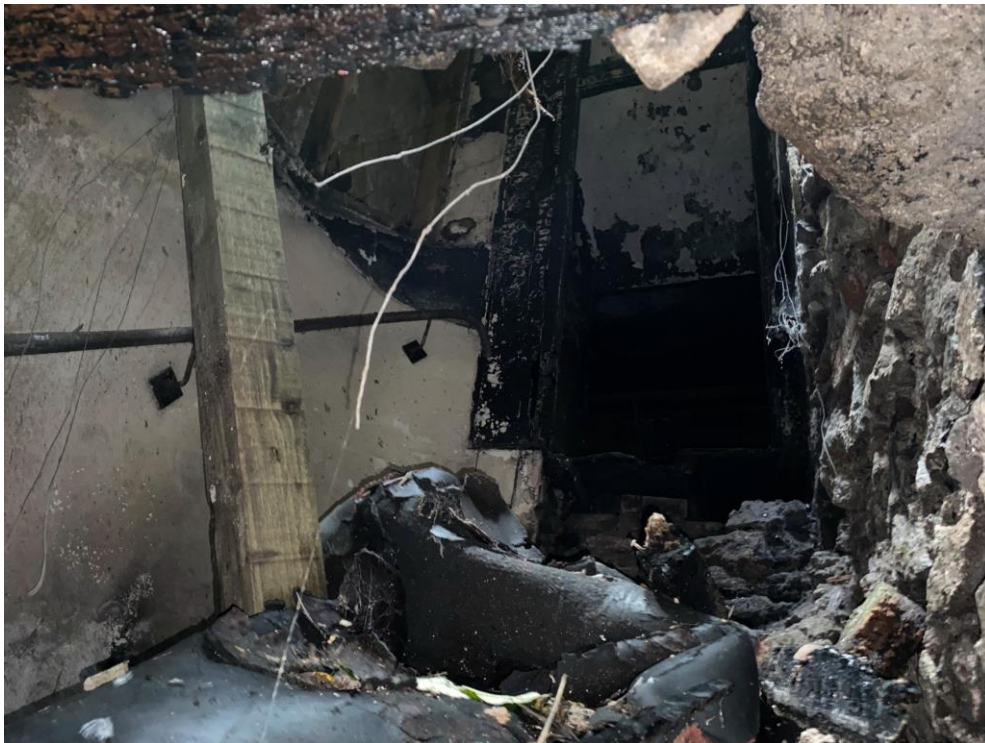
Photo 20: View inside the mural chamber within the thick south wall of the central unit of the basement, showing modern stair and collapse

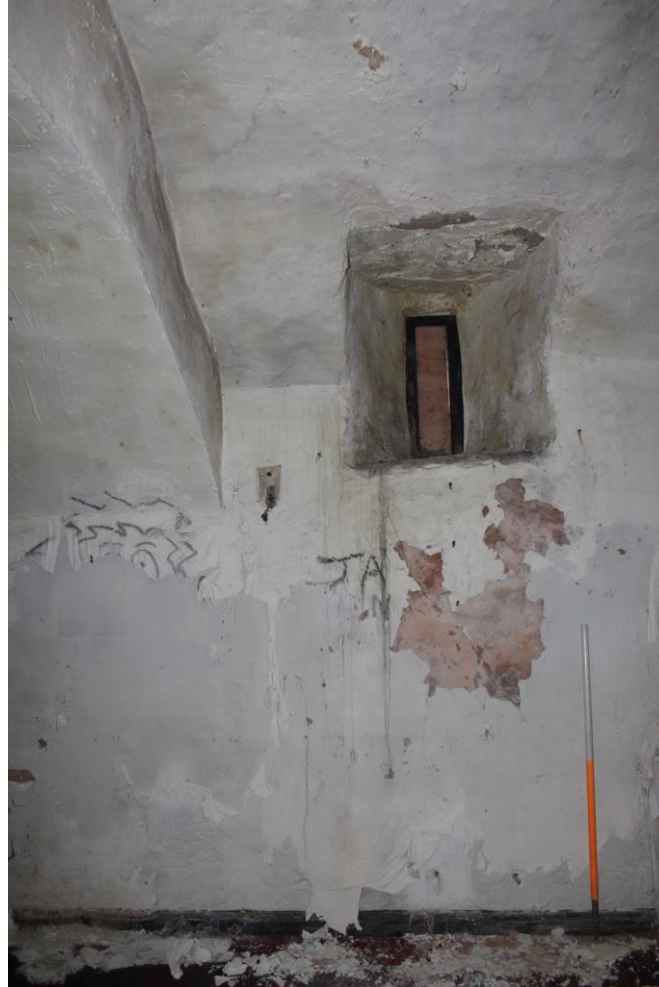
Photo 21: Viewing east of northern small, plain splayed opening in east wall of central unit of basement

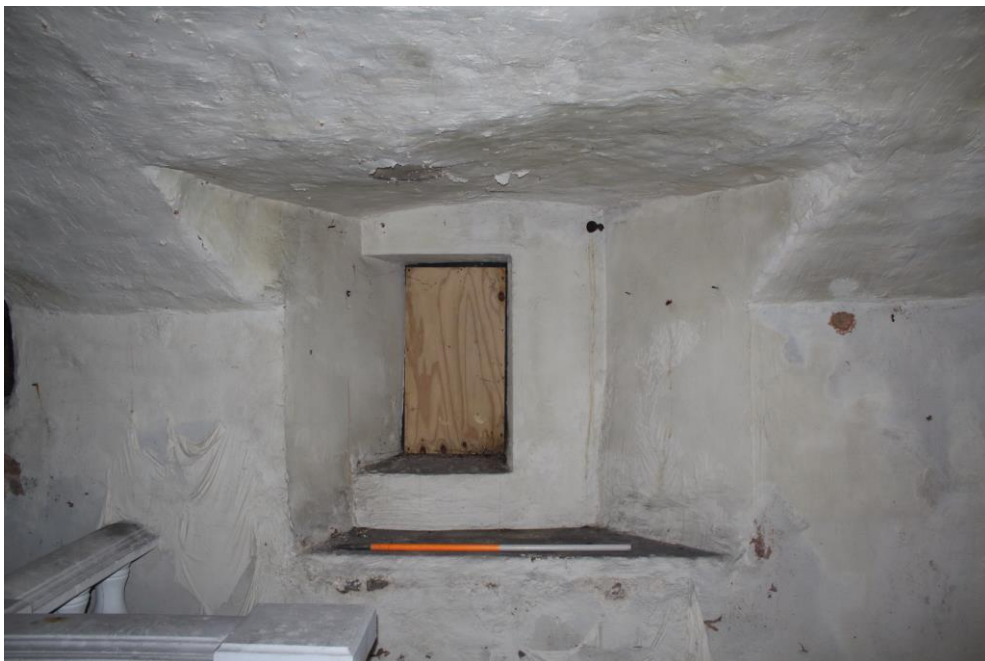
Photo 22: View east of larger splayed window in eastern wall of central unit of basement with lower sill and rectangular opening

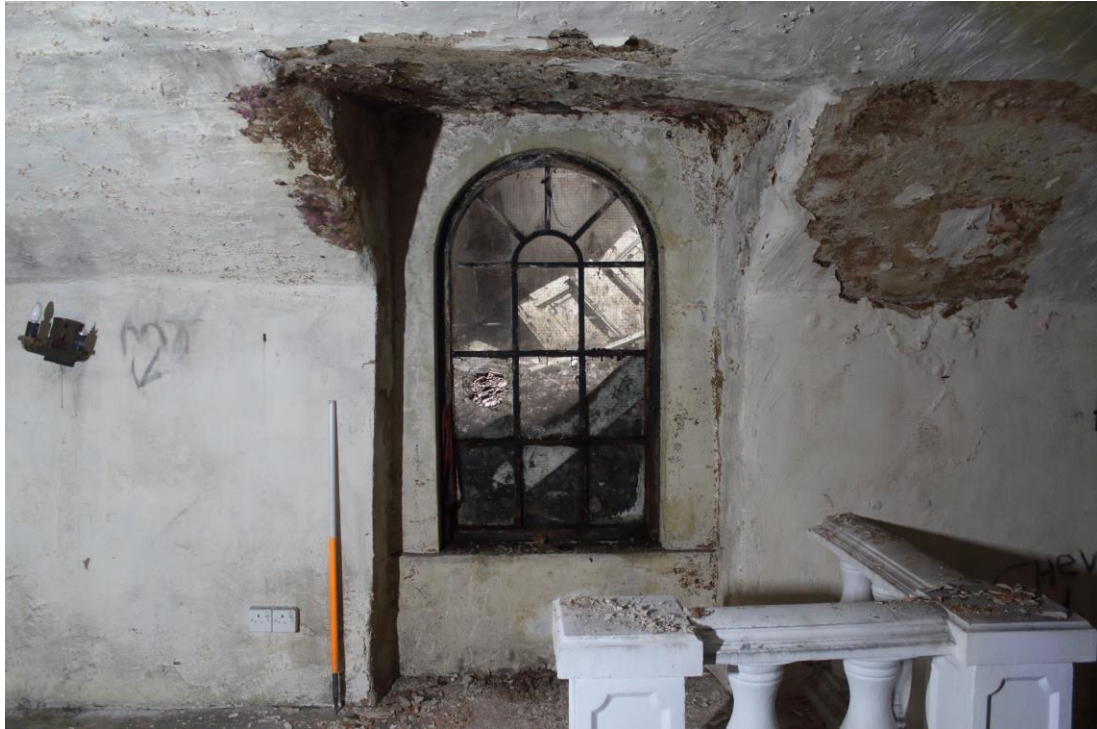
- 4.3.5.6 The west wall is pierced by a large, central opening descending to floor level, with a depressed segmental head that is groined into the vault (Photo 23). It is now occupied by a window of 'early Georgian' form, which appears to be of very recent insertion as this opening seems to be the doorway, showing a surround with a 'four-centred arched head' of late-medieval form, and splayed reveals, that is mentioned in published descriptions (Evans 1981, 3; Listed Building website; Lloyd *et al.* 2004, 338; Parkinson 1980; Parkinson 2000, 580; see below); this was not visible in 2019, the passage being choked with debris. It may represent an original second entry, from the alley in the gap between Nos. 4 and 5.

Photo 23: View west of doorway to corridor from central vaulted unit of basement, with modern 'Georgian' window insertion

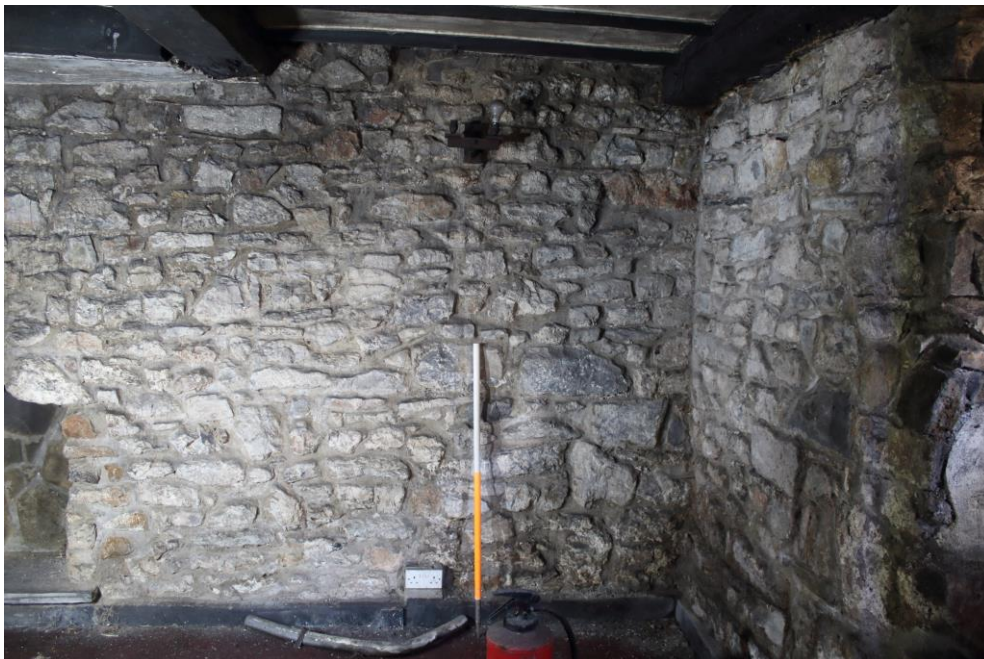
Photo 24: View east of eastern wall of southern basement unit showing the south wall butting against the east wall

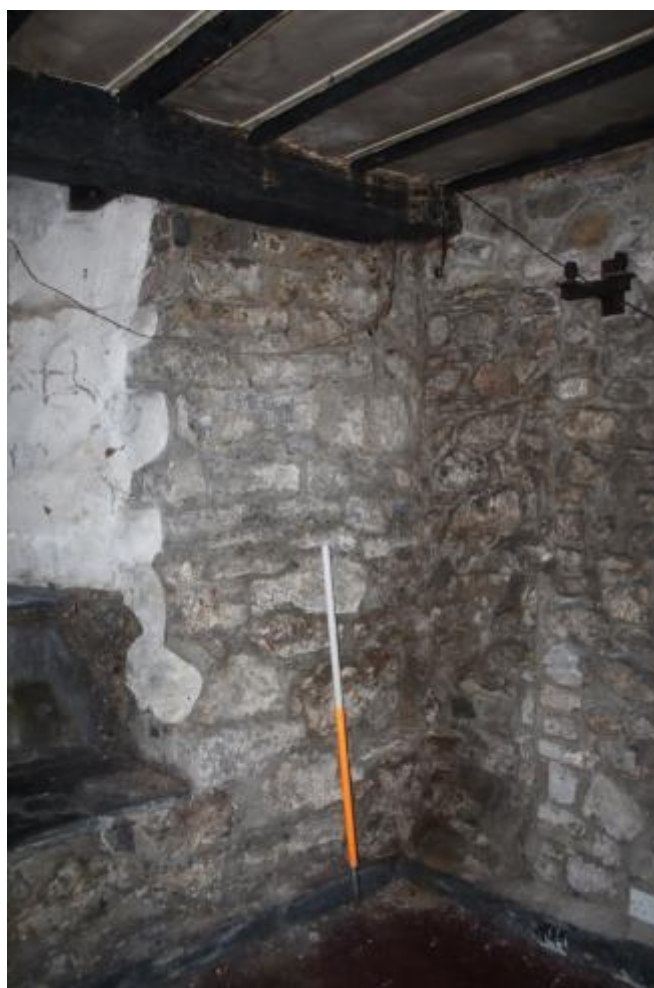
Photo 25: View southwest of corner of southern and western walls of southern basement unit showing bonded walls in the lower part and possibly butting above

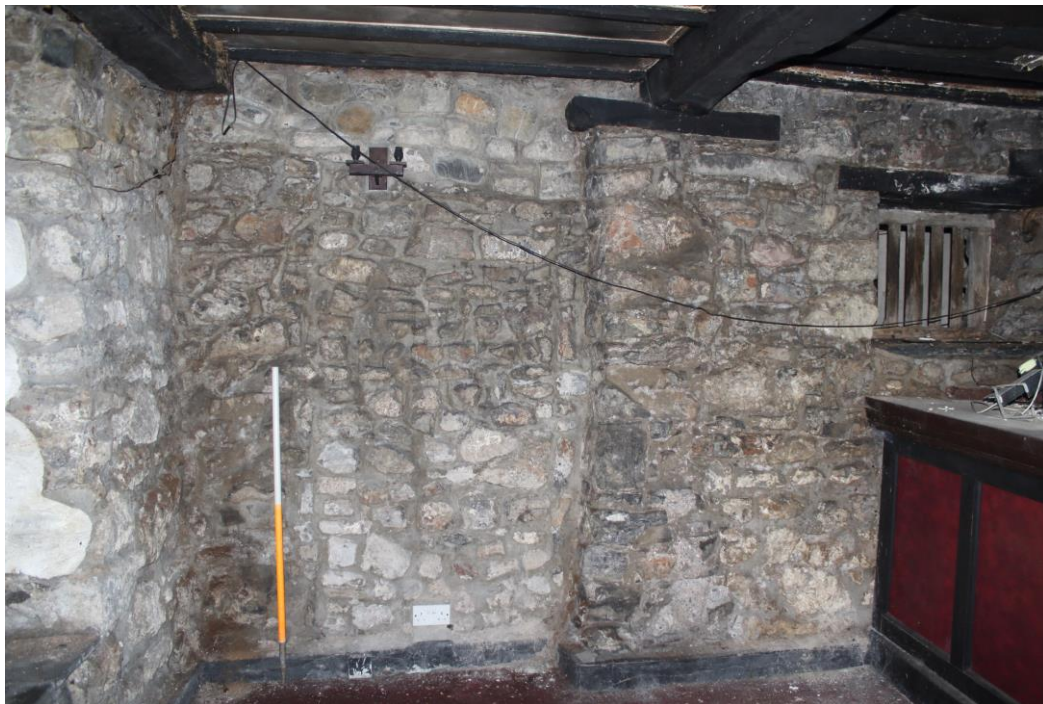
Photo 26: West wall of southern basement unit showing window light to left and blocked doorway by scale

4.3.6.4 To the south is a blocked doorway (Photo 26), probably square-headed but the lintel has been lost; a second doorway in this wall, hard up against the central undercroft south wall, is original but has been altered with the addition of a modern frame (Photo 17).

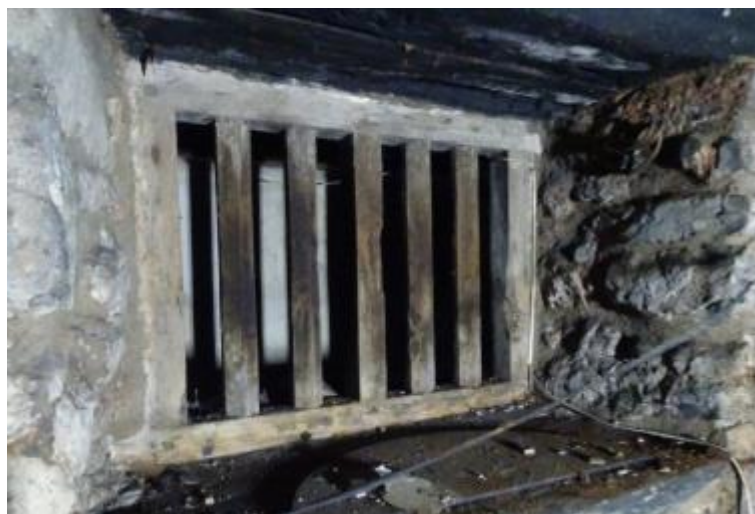
Photo 27: Detail of C16th-C17th unglazed timber framed window in west wall

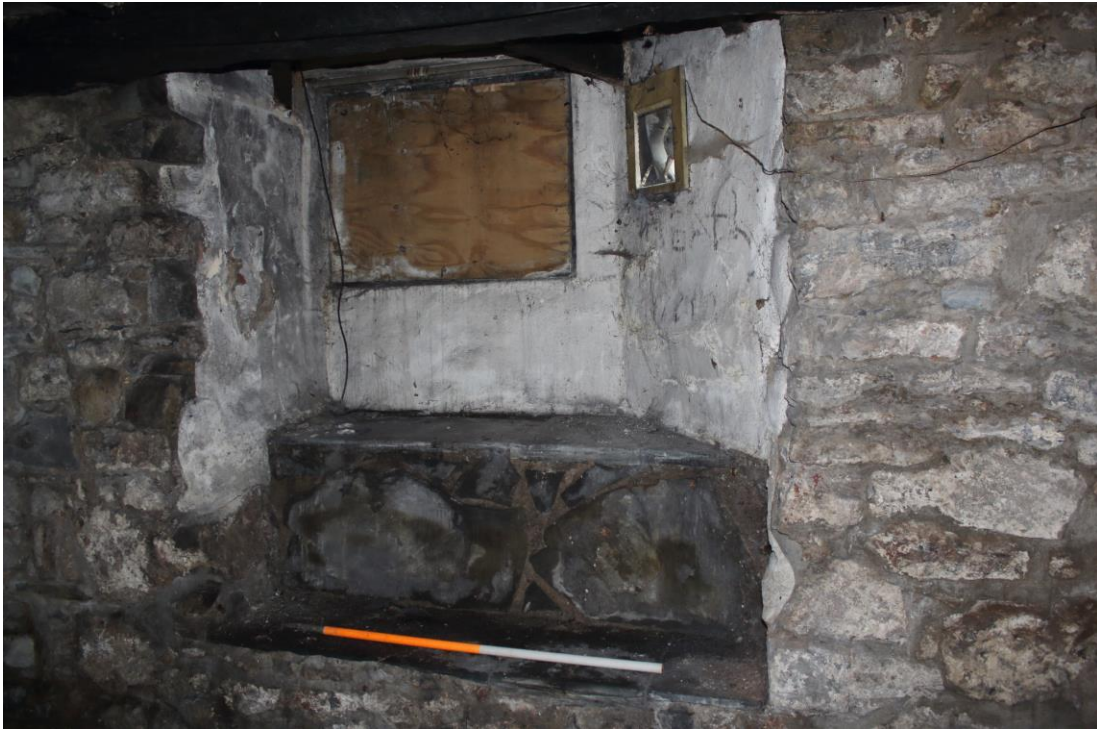
4.3.6.5 The south wall is now pierced by a wide, fairly tall light, more-or-less at external pavement level (Photo 28). It is now occupied by a square window, within and contemporary with the window-bay above ie. early twentieth-century, which externally has a rounded segmental head within a moulded surround. Internally, however, the western reveal is splayed, suggesting it may be an adaptation of an original light.

Photo 28: Window light in southern wall of southern basement unit roughly at Castle Terrace pavement level

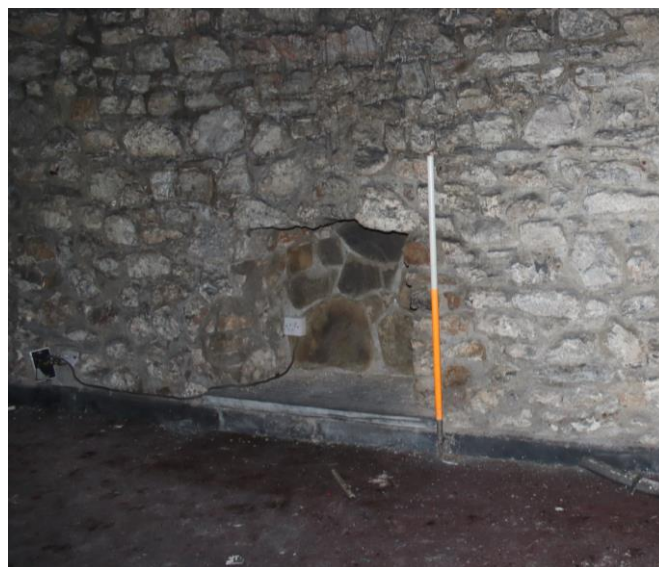
Photo 29: Detail of dummy fireplace in northern part of eastern wall of southern basement unit

4.3.6.6 The east wall shows a small, late twentieth-century dummy fireplace (Photo 29), while the north wall corresponds to the central undercroft's south wall.

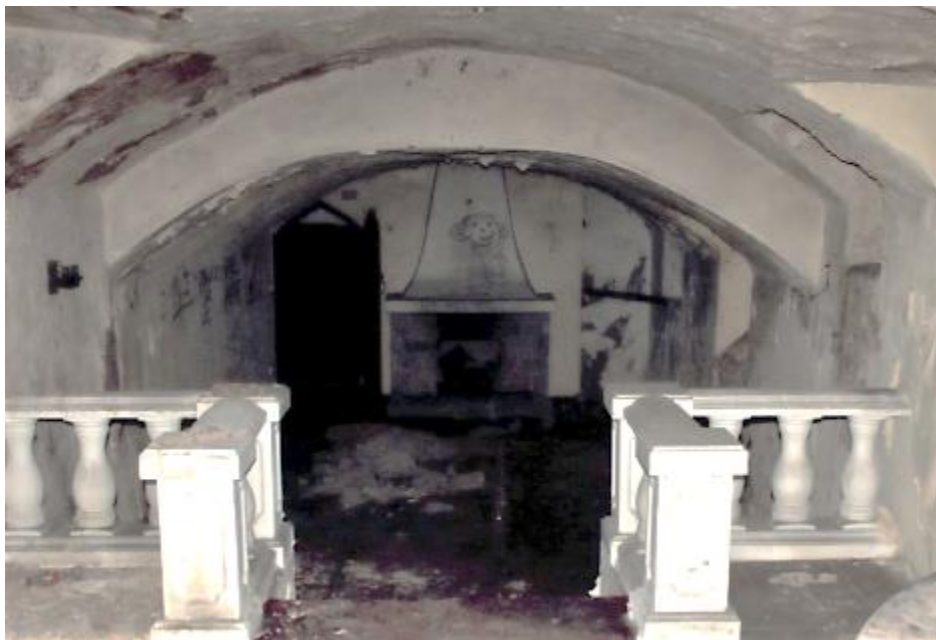
4.3.7.1 The central undercroft is now open to a second vaulted unit to the north, which has a similar masonry barrel-vault but at a slightly lower level (Photo 33). The floor is also c.0.65m metres lower. As in the central unit all visible walls, and the vault, lie beneath thick plaster which may conceal earlier finishes.

Photo 33: View north from central basement unit to northern basement extension, showing reduction in vault height

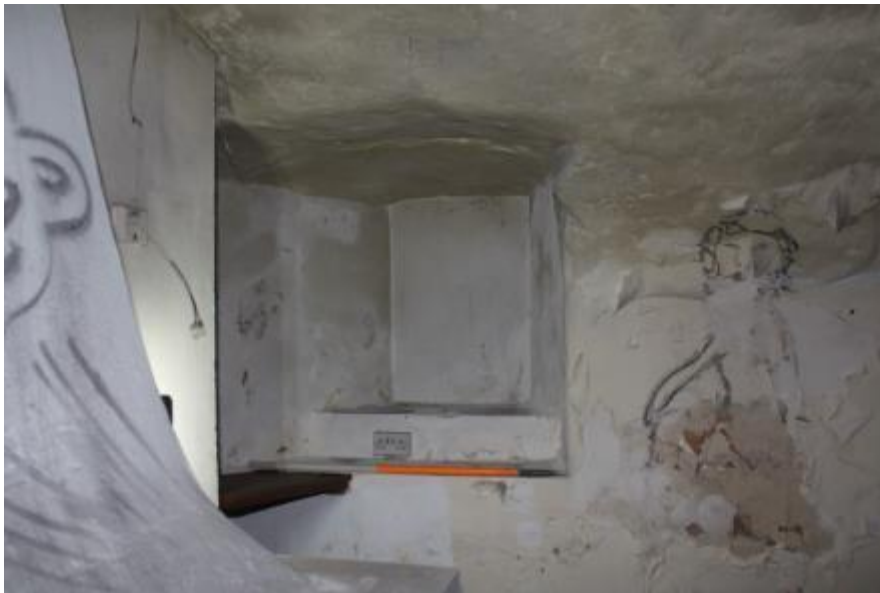
Photo 34: View east-northeast of northern light opening in eastern wall of northern basement unit

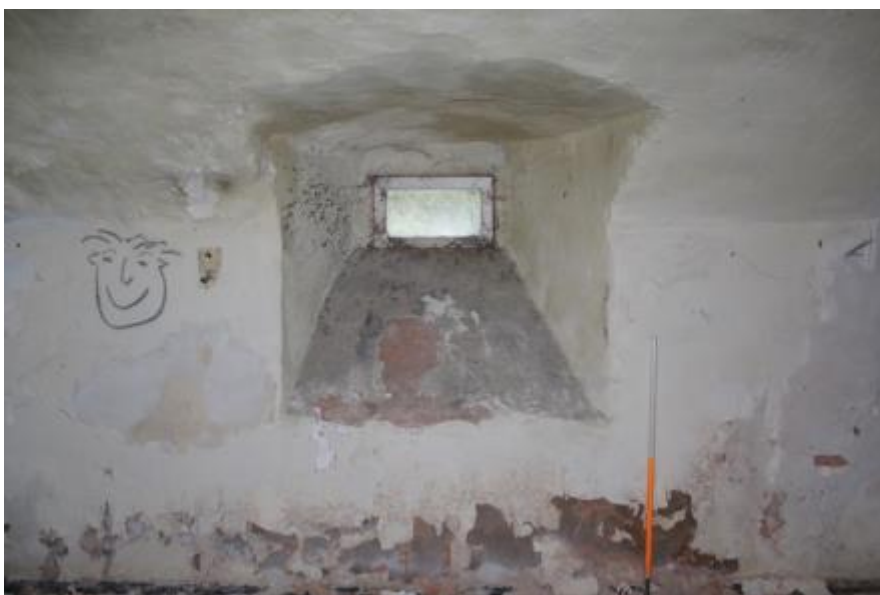
Photo 35: View east of southern light opening in eastern wall of northern basement unit with steep sloping sill

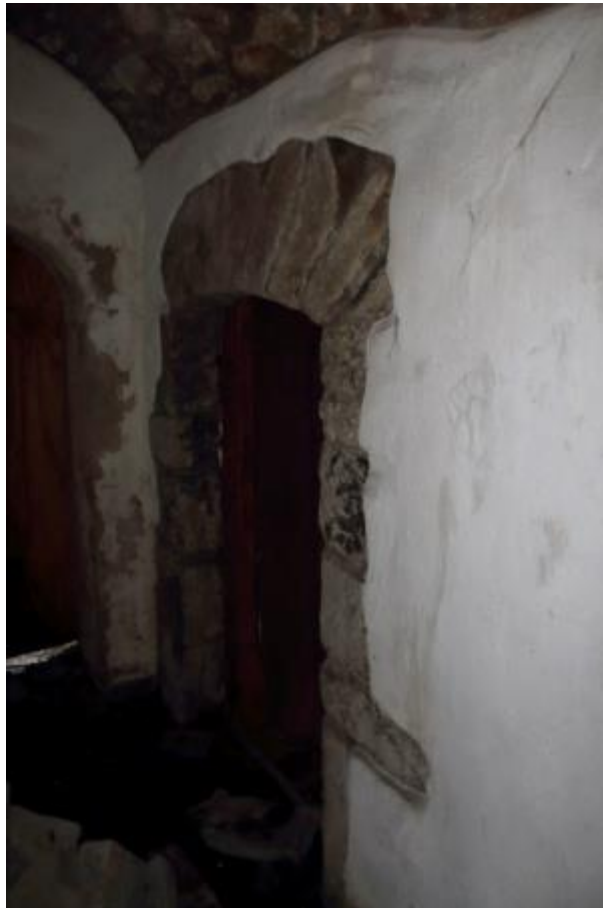
- 4.3.7.3 The west wall is a northward continuation of the line of the central undercroft wall, showing that Nos. 4 and 5 were still detached from each other when it was built. Towards its north end is a doorway with square reveals and a substantial segmental-headed surround, left exposed by the plaster, which shows large voussoirs (Photo 36). This is variously described as sixteenth-century (Parkinson 1980), or seventeenth-century (Parkinson 2000, 580). The latter date is favoured here, and the northern unit is regarded as an early seventeenth-century extension of the medieval undercroft, possibly pre-dating the southern unit.

Photo 36: External face of doorway into northern basement unit at its northern end with square reveals and a substantial segmental-headed surround

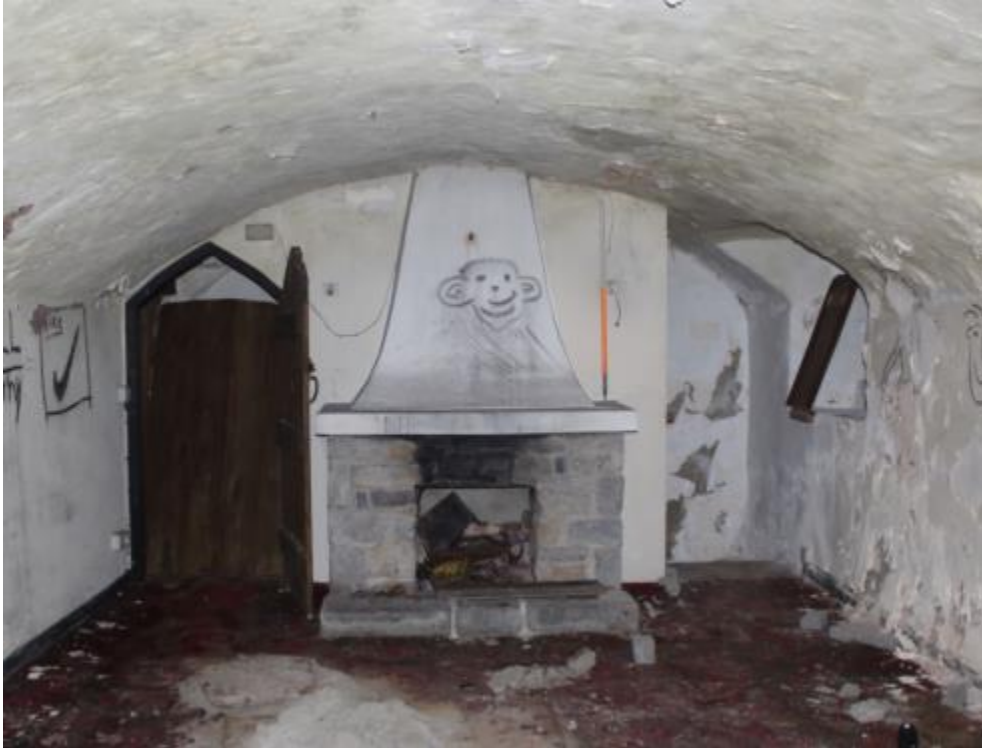
Figure 37: Northern end of northern basement unit showing modern fireplace, partition wall and doorway

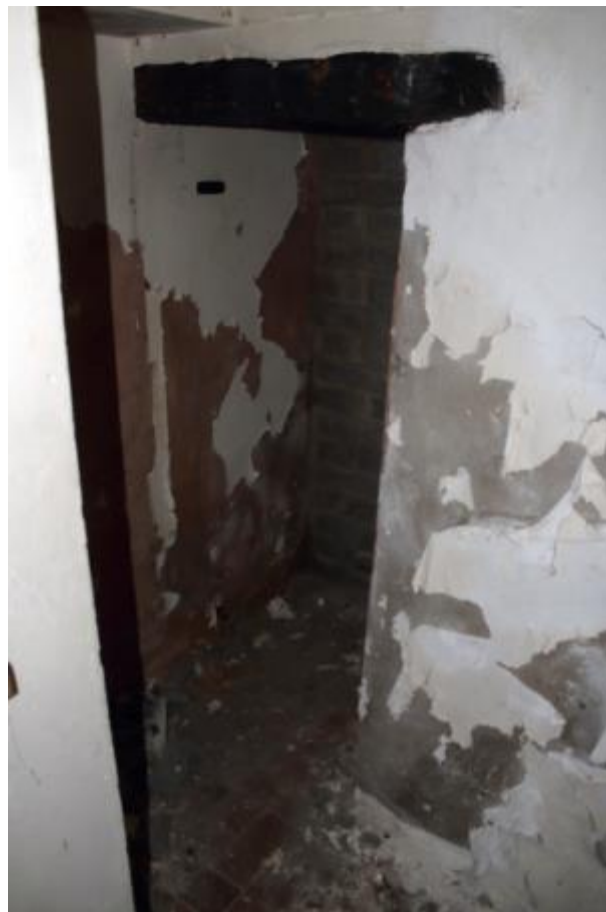
Figure 38: Northern end of northern basement unit showing blocked doorway on eastern side of northern wall, viewing northwest to show depth of opening

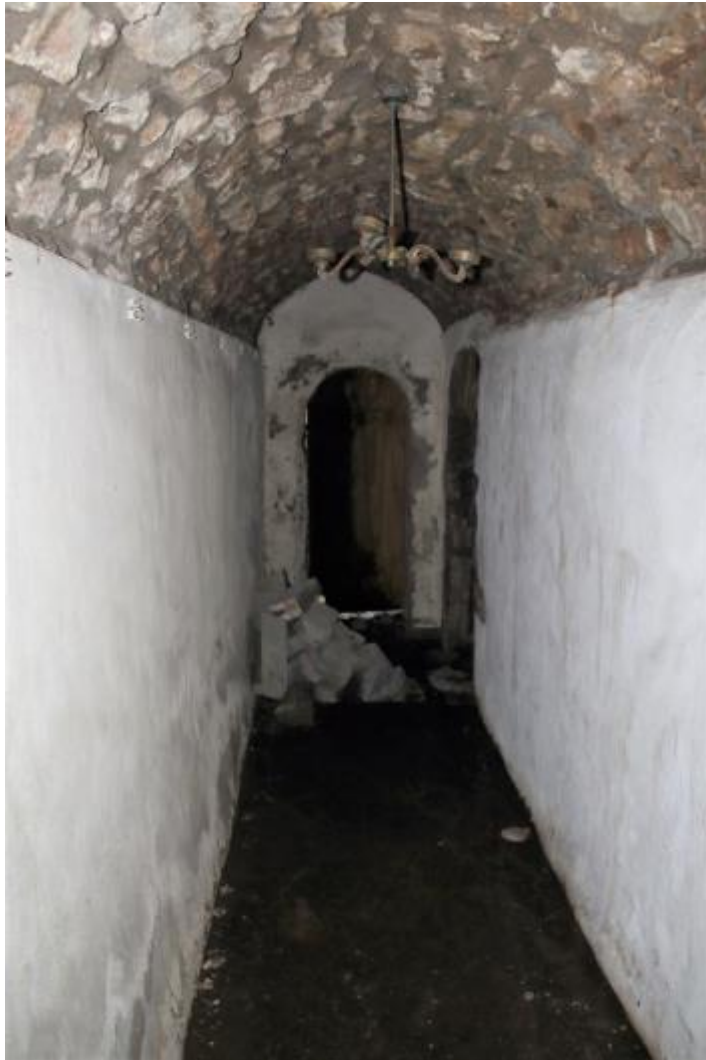
Photo 39: View north along vaulted passage adjacent to northern basement unit, with doorway into it to right

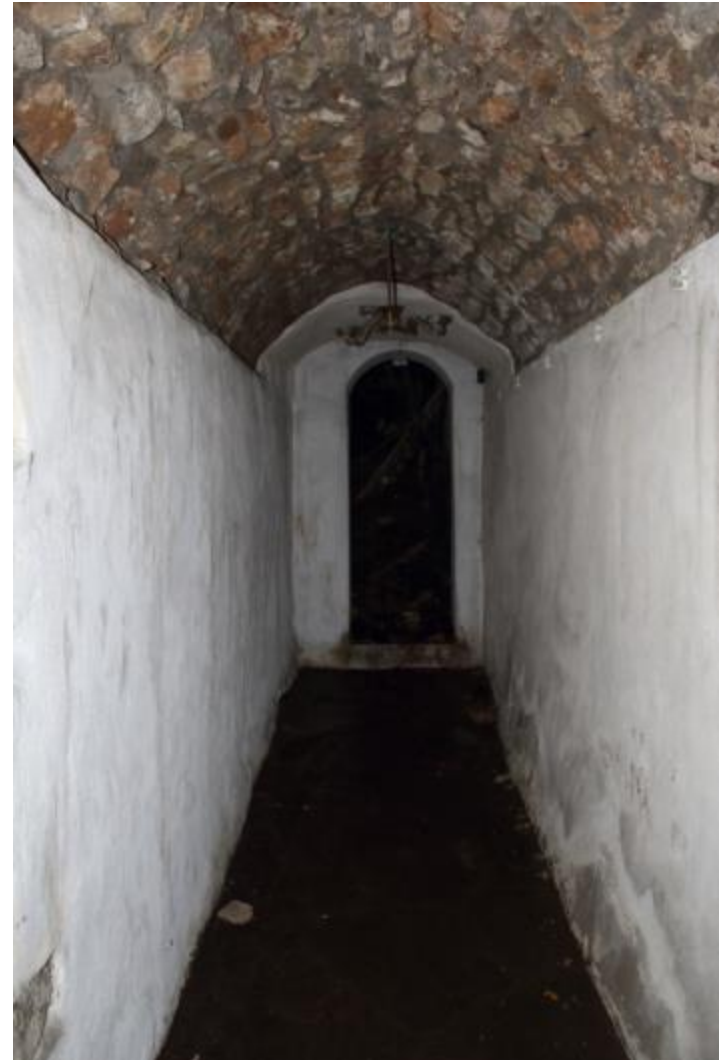
Photo 40: View south along vaulted passage adjacent to northern basement unit, leading to uncovered part

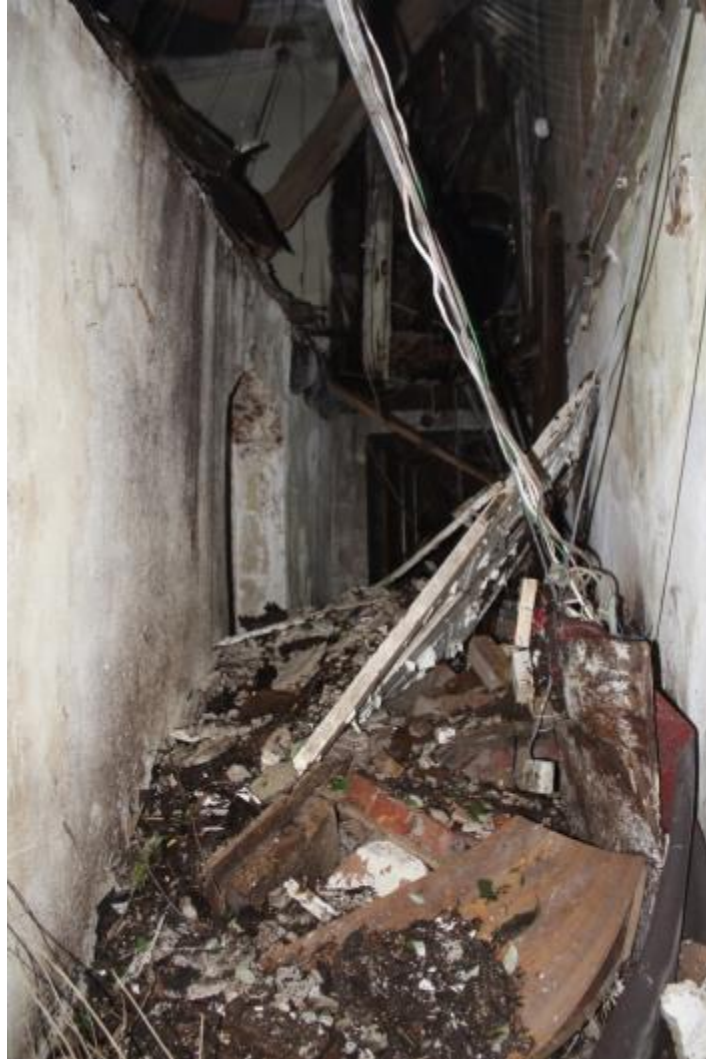
Photo 41: View south along uncovered passage way between Nos. 4 and No. 5 Castle Terrace, showing western wall of central basement unit to east (left) and doorway opening to No. 4 visible (with possible corbels to south) and collapse from structures above

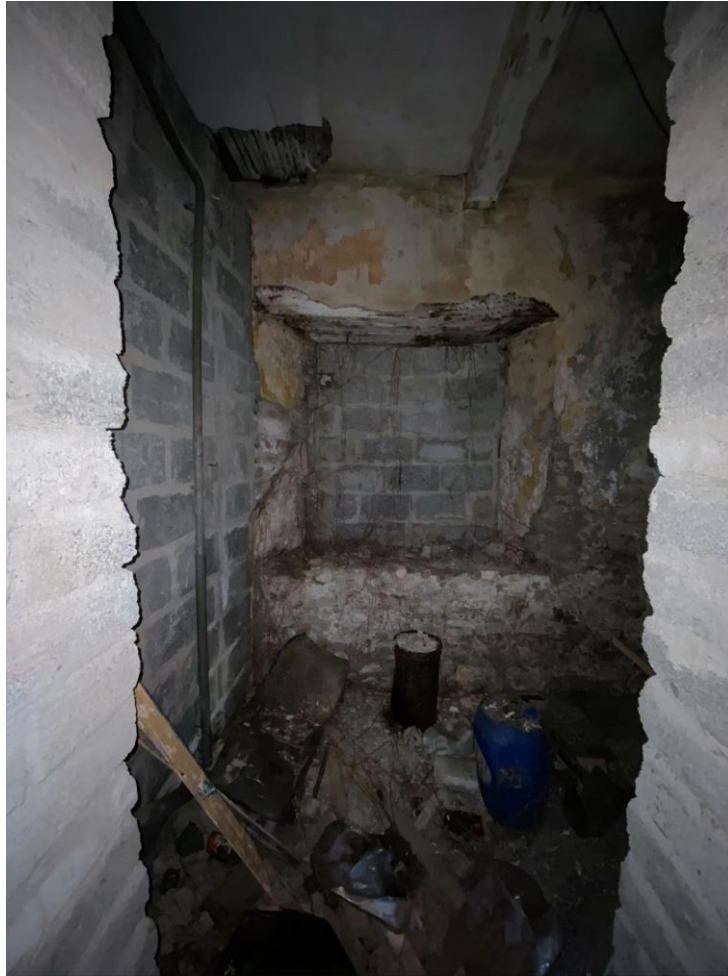
west wall, with a timber lintel, formerly opened onto the yard behind No. 6 Castle Terrace but is now blocked (Photo 42).

Photo 40: Large square window opening through western wall of northern room of basement of No. 5, viewing west through breeze block partition wall
