**SOUTH QUAY, PEMBROKE
NOS. 4, 5 & 6 CASTLE TERRACE,
NOS. 7 & 8 NORTHGATE STREET:
LEVEL 3
HISTORIC BUILDING RECORDING**

Prepared by Dyfed Archaeological Trust
For: Pembrokeshire County Council

REPORT NO: 2019/45

December 2019

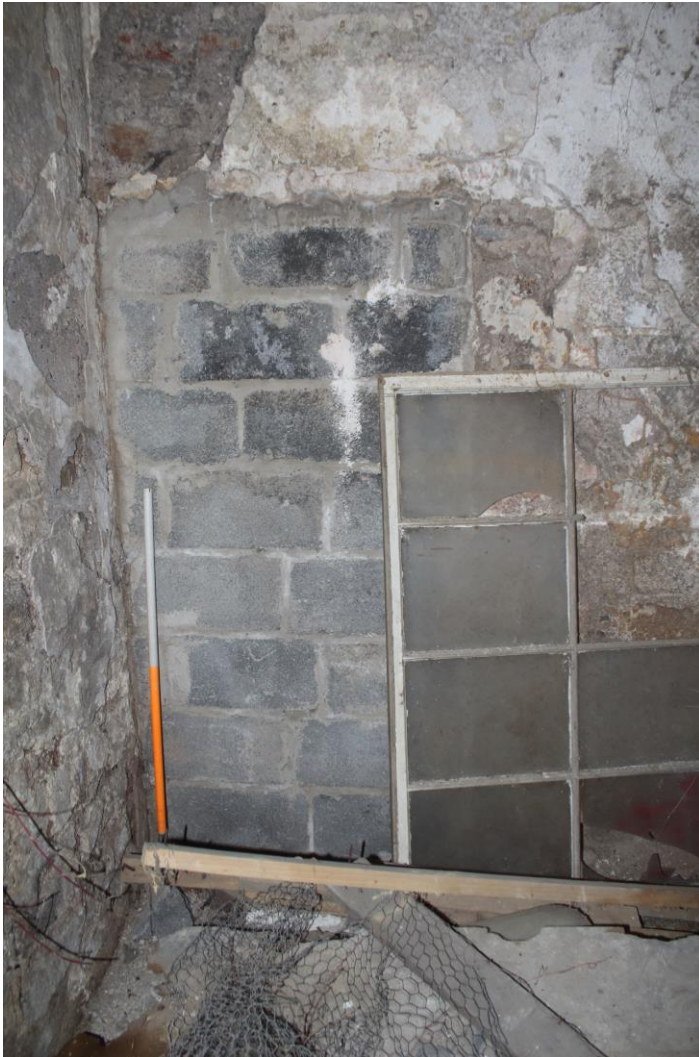
- 4.4.4 The north (rear) wall is pierced by two doorways, both with timber lintels (Photos 43 & 44). The western doorway is now blocked (Photo 43), but formerly led onto an annexe in the west half of the plot, now gone, with a window in its west wall like the one to its south and similarly blocked; the former annexe is shown on the 1861 OS map (Figure 12) but may not be contemporary with the main rear extension. The eastern doorway still accesses the back yard (Photo 44).

Photo 43: Blocked door way (breeze block) in northern wall of northern basement level of No. 5 Castle Terrace

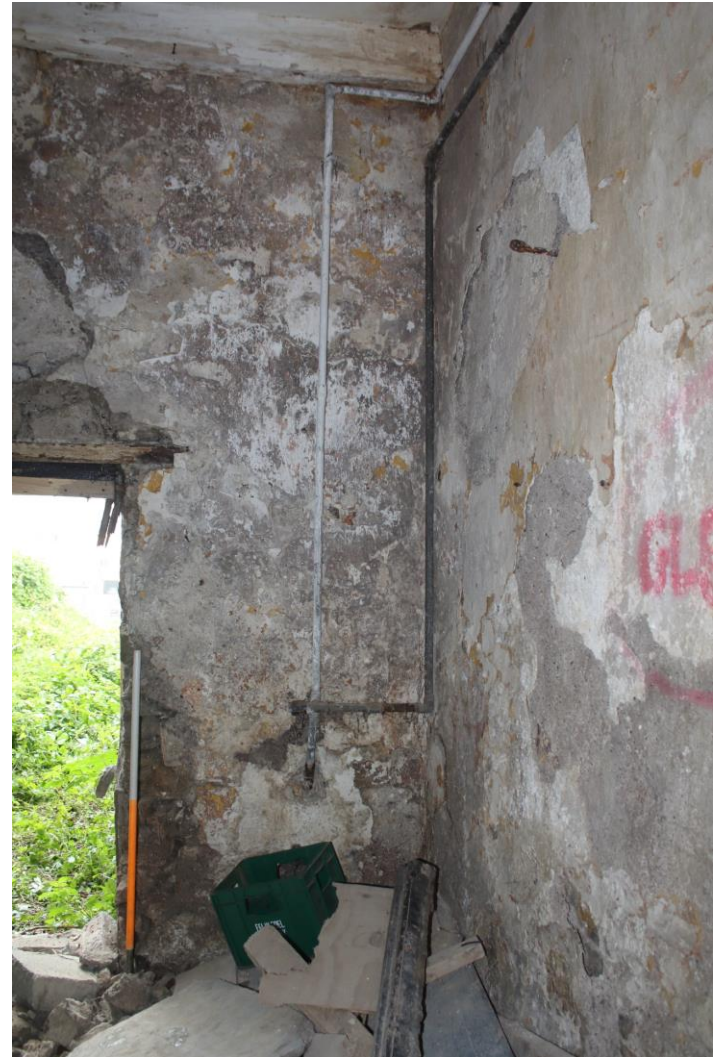
Photo 44: Existing doorway through northern wall of northern basement of No. 5, looking north along eastern side of room

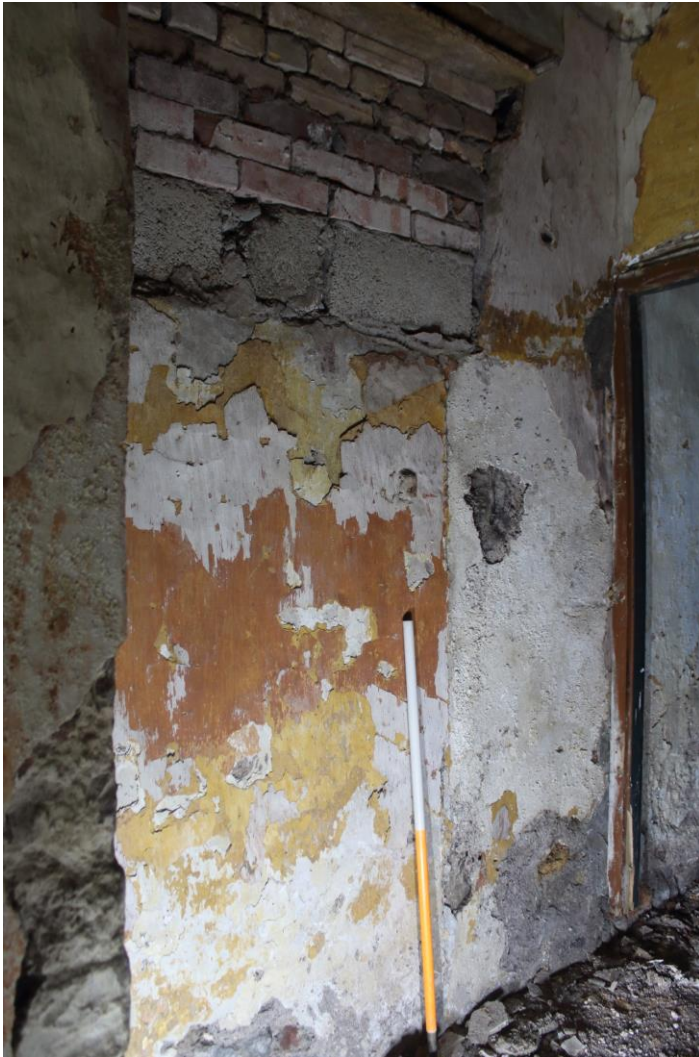
- 4.4.5 The east wall is represented by the pre-existing west wall of the vaulted passage in No. 4 (see above). Its inner face shows a right-angled return towards its south end, which lies opposite the southern end of the passage and may represent the northern reveal of a blocked doorway between the two (Photo 45). While no other evidence for this entry is now discernible, two connecting doorways are shown further south on engineer's plans (Figure 20), suggesting a link between the two properties was maintained after their division (see below, 'Discussion').

Photo 45: Blocked doorway at southeastern corner of northern basement level of No. 5, below breezeblocks, looking southeast

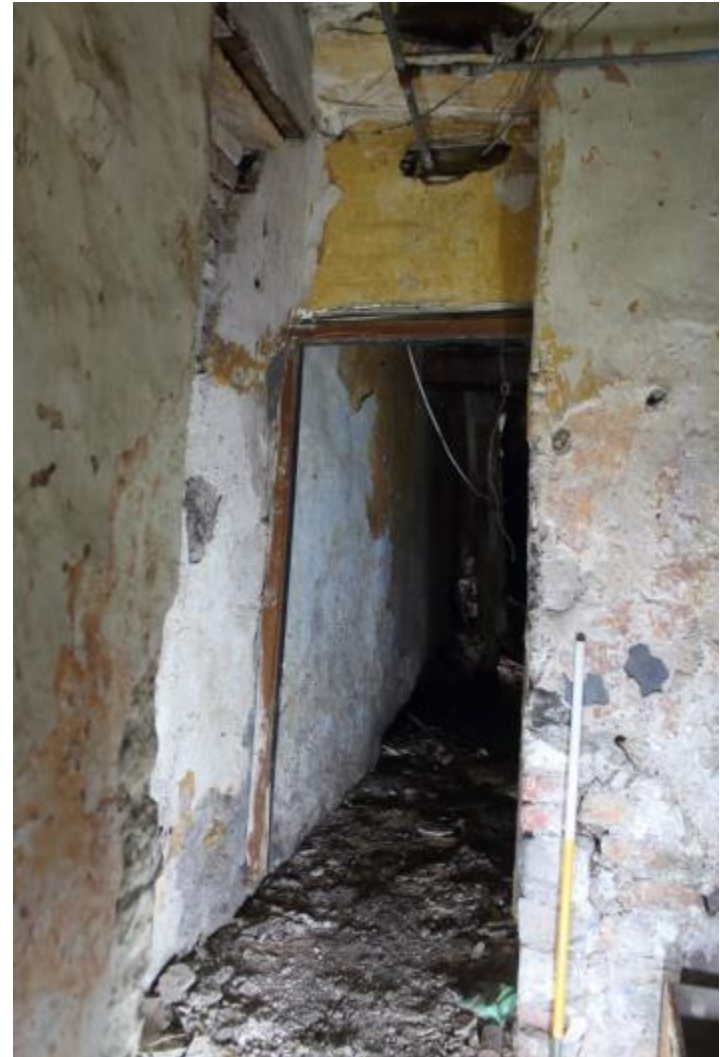
- 4.4.6 Due to access restrictions, the south wall was not clearly seen but incorporates an entry into the basement room to the south, opposite the external entry in the north (rear) wall (Photo 46).

Photo 46: View north showing entrance to southern basement level leading to collapsed area of building

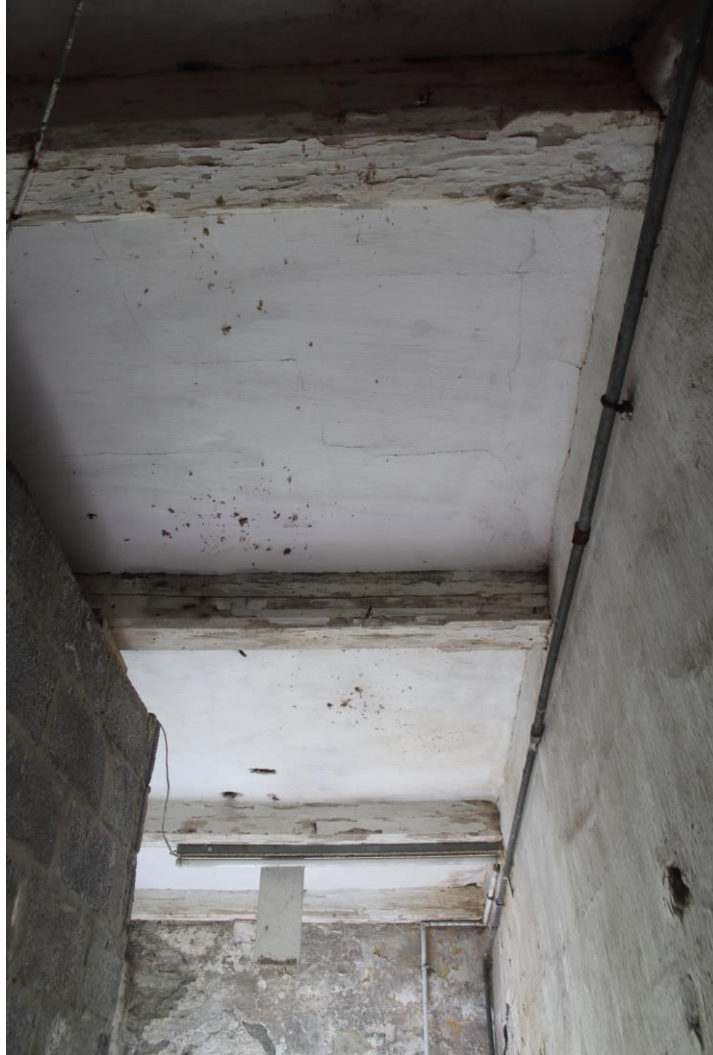
- 4.4.7 The timber ceiling is very high, and supported on very regularly-spaced, regularly-cut joists with chamfered corners, running from east to west, showing that they were intended to be left exposed (Photo 47). The chamfers terminate as run-out stops at their east ends, but not at their west ends where the termination is instead notched in at least one joist. It may be that the eastern side of the room was partitioned off to form a corridor, running between the doorways in the north and south walls, from which the joists would be more 'publicly' visible than on the western side.

Photo 47: View of ceiling along eastern side of northern cellar below the rear extension of No. 5 showing neat floor joists above with chamfered edges and stops

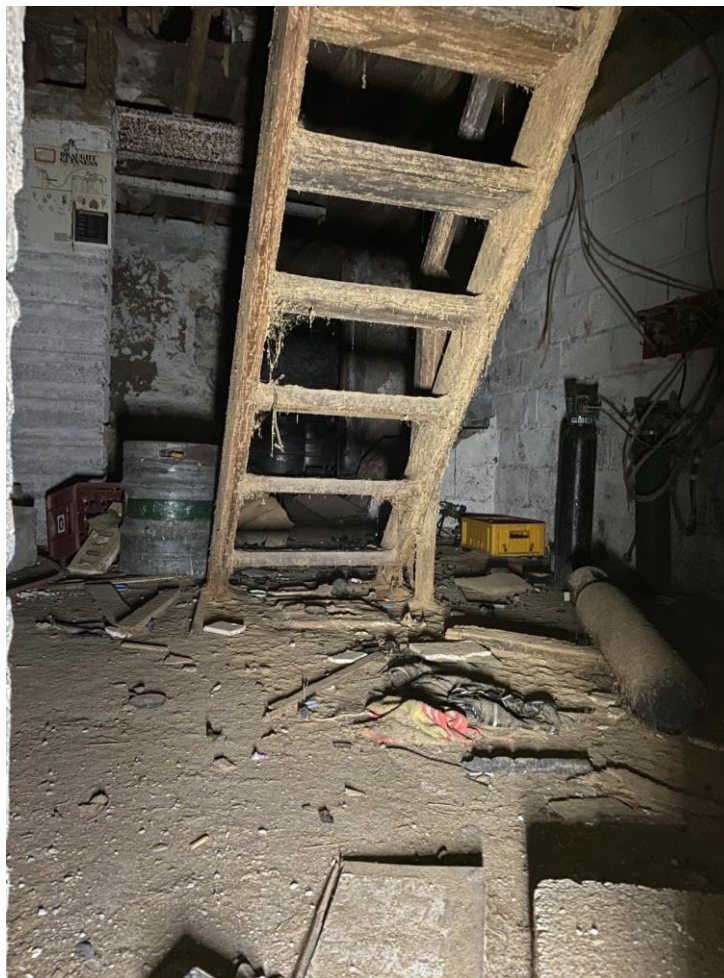
- 4.4.9 It was possible to view part of the southern part of the basement level below No. 5 Castle Terrace through a hole in a partition wall for a small rear stairwell leading to first floor. The southern cellar lay below the bar area of the first floor level (Photo 14) and was presumably used as a beer cellar. This is clearly evidenced by the remaining barrels, gas tanks, pipework, beer towels, crates and steps leading up to the bar area (Photo 46). The walls of this part of the cellar all appeared to have been rebuilt with breeze block, excluding the furthest south wall visible which could potentially be of stone but could not be confirmed).

Photo 48: View south through hole in partition wall into southern cellar area below No. 5 Castle Terrace

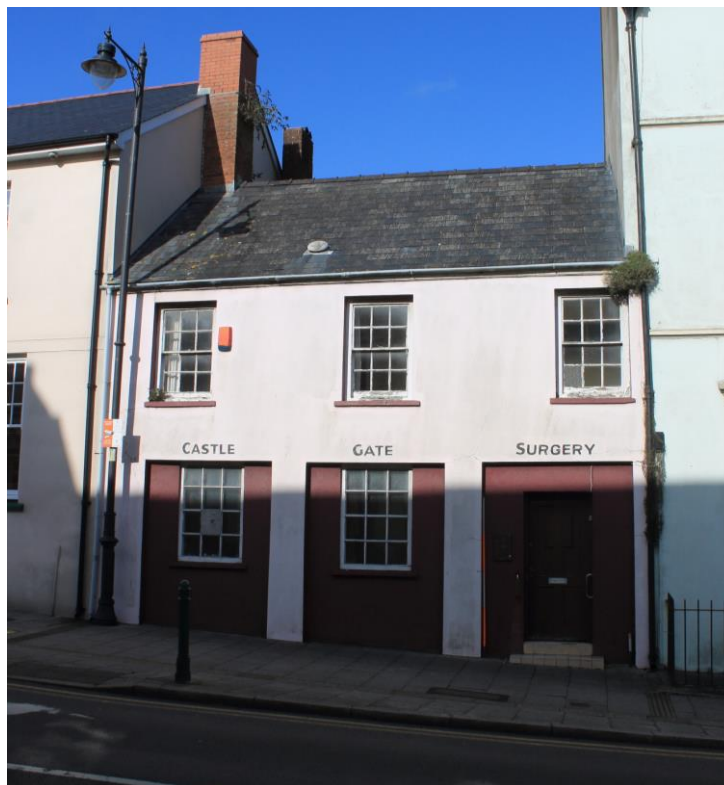
- 4.5.3 At ground-floor level, the front unit has a street-side facade of two square windows and a doorway, mid-twentieth-century in their present form, which occupy three areas of thin walling, recessed between thicker pilasters (Photo 49). It may be that a former 'arcade' is represented, possibly as a series of large glazed windows rather than openings and at least one old photograph does appear to show large shop-front windows, though like all views of Castle Terrace it is very oblique. These windows appear themselves have been an earlier twentieth-century modification of the original façade. The three sash windows at first floor may be survivals of an earlier façade.

Photo 49: Southern façade of No. 6 Castle Terrace viewing north

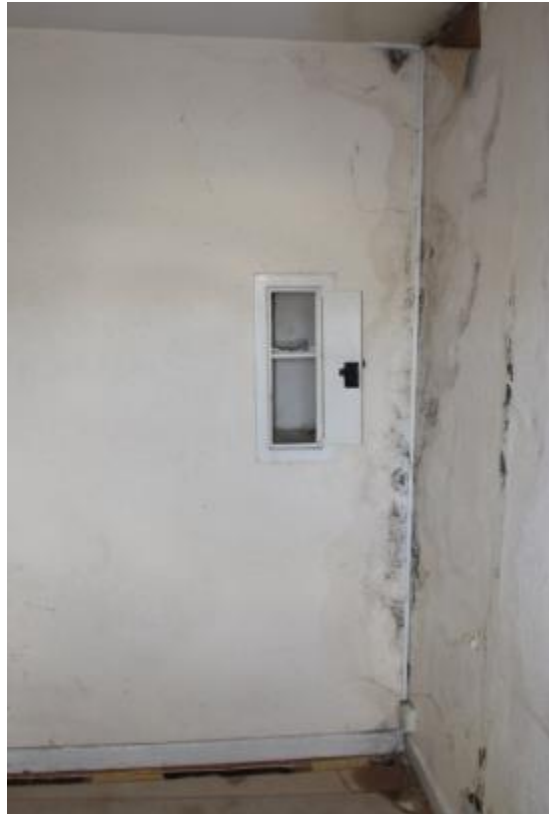
- 4.5.5 The southern part of the building (main south rooms at ground and first floor level) is divided from the rear unit by a thick wall, which is pierced by a small, narrow north-facing light, with splayed reveals (now converted into a cupboard) (Photo 50). The light is in the medieval tradition, and suggests that the wall itself belongs to a (broadly) late-medieval building, of at least two storeys, now represented by the front unit of the present building and thus lying parallel with Main Street: confirmation that this wall is medieval is furnished at basement level (see below).

Photo 50: Viewing south towards small cupboard with splayed interior on thick dividing wall of No. 6 Castle terrace suggesting the exterior opening of a medieval window light

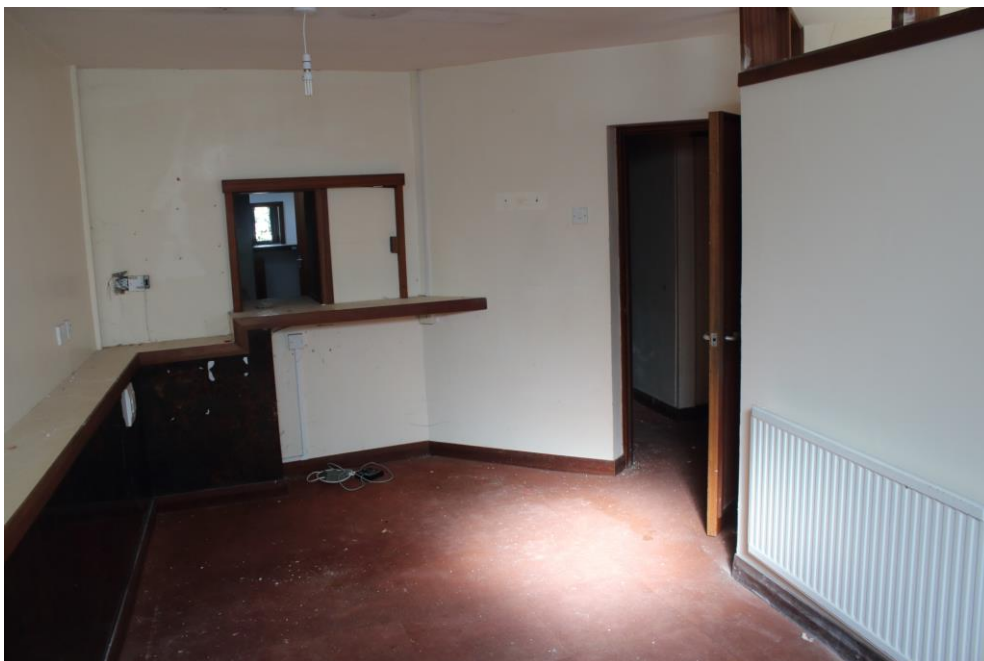
- 4.5.6 All other openings at first-floor level appear to be twentieth-century in their present form, along with the internal partition walls (Photo 51). There is an attic, through the door of which the A-frame roof-trusses were just visible; these are in somewhat poor condition and have been supplemented with secondary timbers over the course of the twentieth century.
- 4.5.7 There is an attic, through the door of which the A-frame roof-trusses were just visible; these are in somewhat poor condition and have been supplemented with secondary timbers over the course of the twentieth century (Photo 52).

Photo 51: Example of modern internal partition walls associated with adaptation of the building into a doctor's surgery, this a view south through the front office

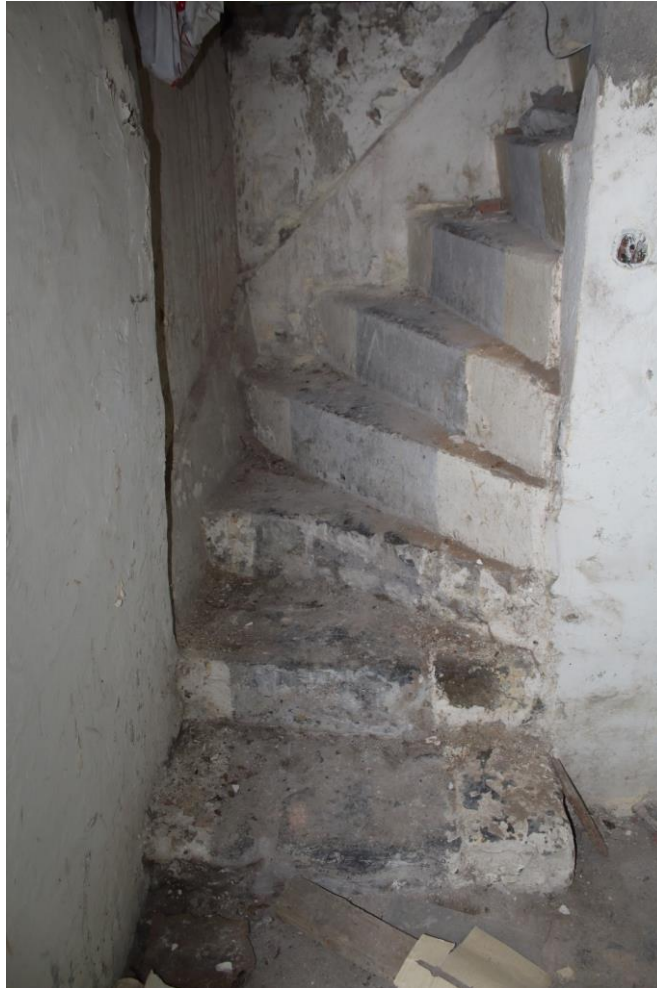
- 4.5.8 The basement is now accessed via a trap-door in the ground floor of the rear unit. This gives on to a dog-legged stair (Photo 53), with a half-turn, of shaley slate slabs, occupying the north wall of the front unit; this was, originally an external wall beyond which lay the back-yard. The overall arrangements here suggest that the stair may be an original feature ie. late-medieval, providing access between the building and its yard.

Photo 53: Dog-legged stair giving access to the basement level of No. 6 Castle Terrace, viewing south

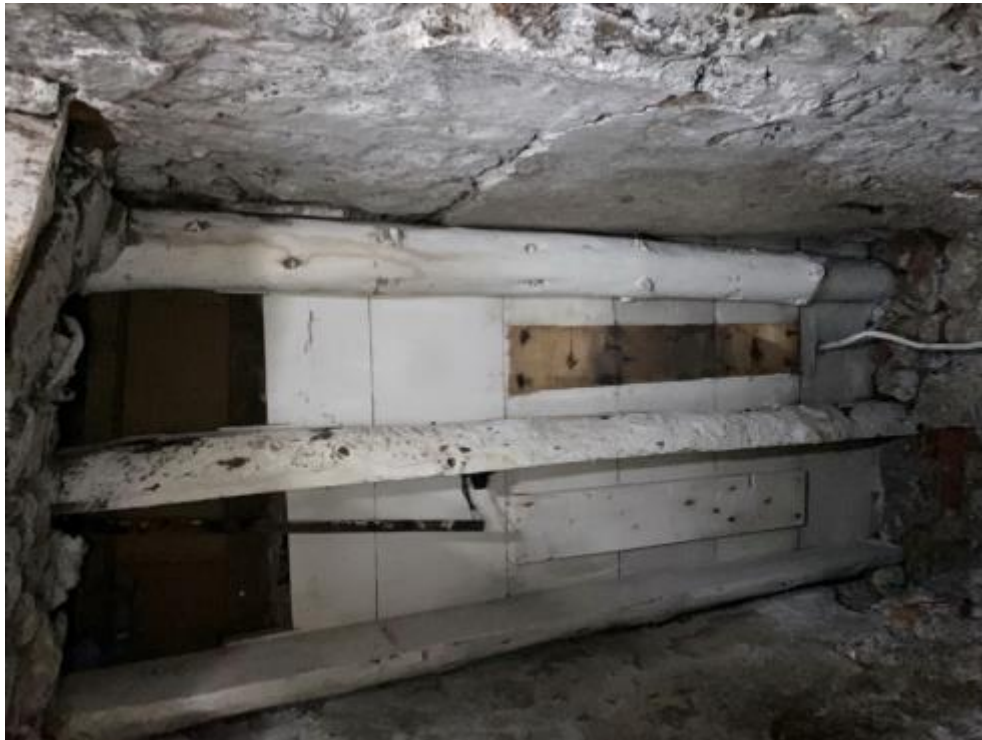
- 4.5.10 The recess entry gives on to a lintelled 'passage', c.0.8m long, that leads into the recess itself; it lies beneath the east-west limb of the stair. The recess lies aligned north to south at right-angles to the main building. It is c.0.80m wide and is not vaulted, instead having a timber ceiling which, in its present form, is of fairly recent date (Photo 55). The

Photo 55: View of roof structure above recess below outshut in No. 6 Castle Terrace, showing modern timber covering with north end to left

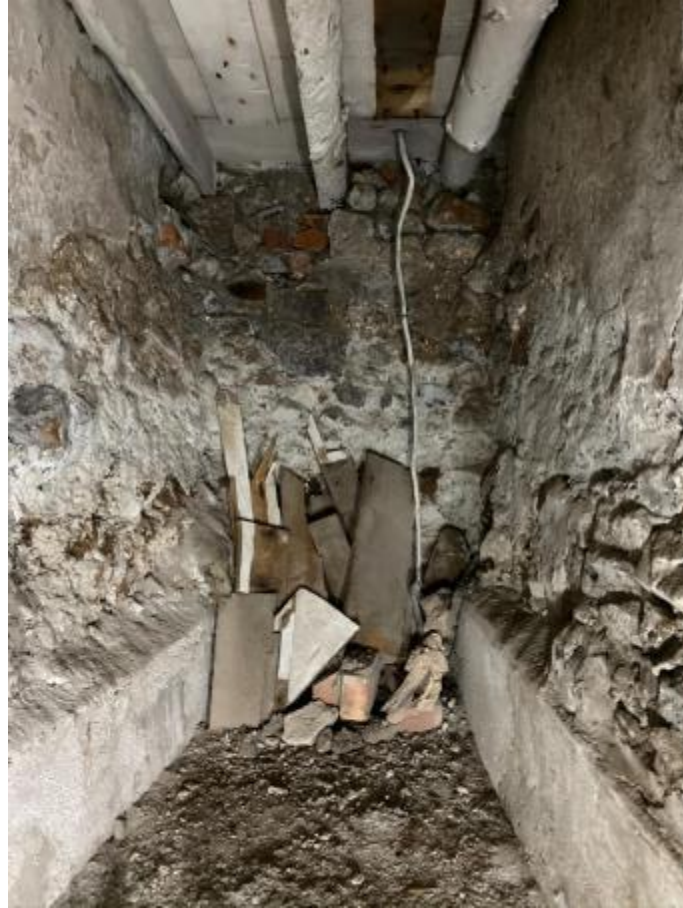
presence of bedrock at the bottom of its internal walls suggests the recess may have been adapted from a natural fissure (Photo 56). In more recent times concrete underpinning has also been inserted along its edges (Photo 54).

Photo 56: View south along recess to southern end showing bedrock at lower parts of sides with modern concrete underpinning

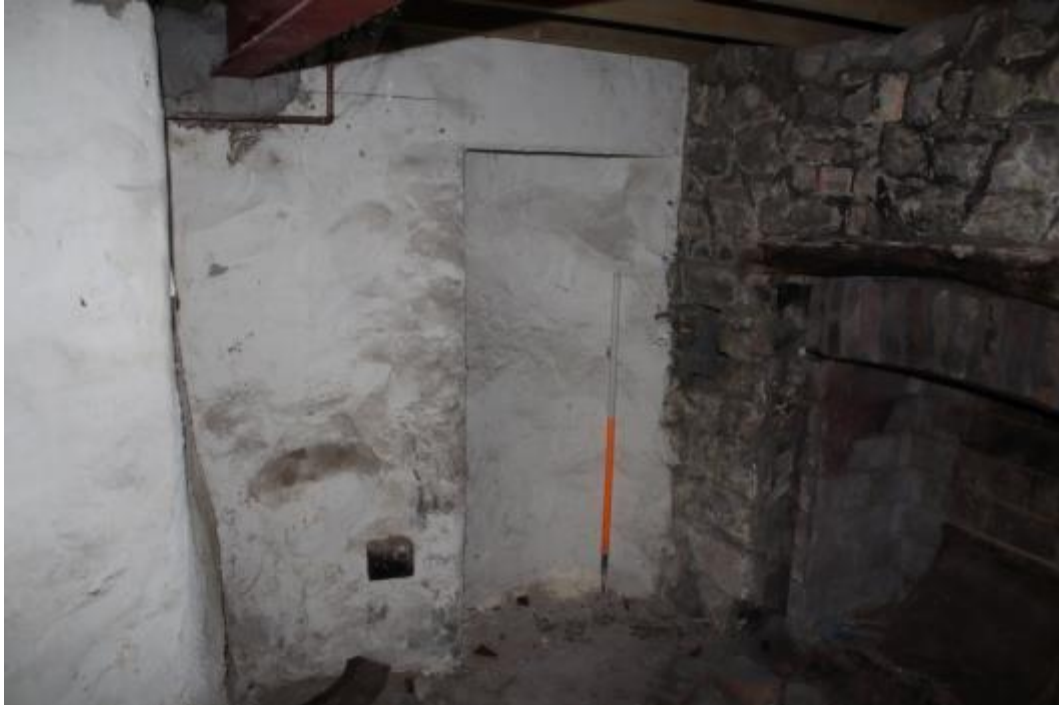
- 4.5.13 Lying in the same wall-face as the outshut, and immediately to the west, is a shallow 'alcove', with a square head and a semicircular back (Photo 57). This may have been secondarily cut into the wall-face, but it may be an original feature of unknown function; its location in an external wall-face would be unusual.

Photo 57: Alcove in northern wall west of outshut, with western wall of basement and later fireplace to right

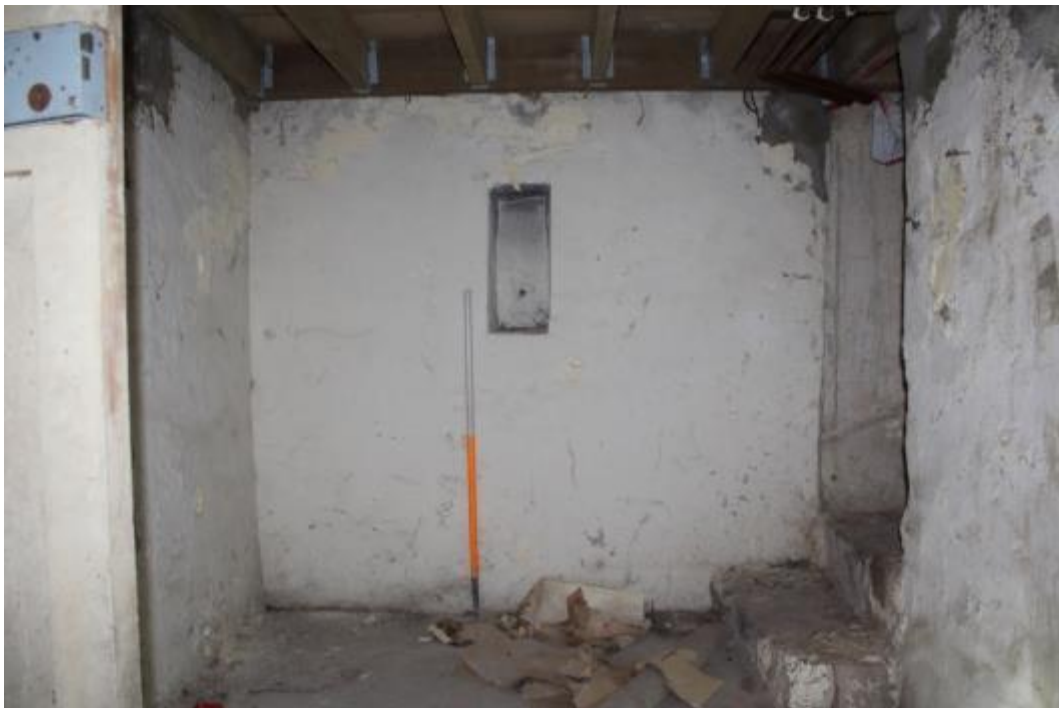
Photo 58: Eastern wall of basement below No. 6 Castle Terrace showing small alcove and stair access to south (northern wall is modern and of breezeblock)

4.5.14 As above, the basement side walls represent the east and west boundary walls of the burgage plot that No. 6 occupies, which here appears to have been an open yard during the medieval period. The east wall is very thick at basement level and it may represent another projecting medieval unit, extending further north than the stair outshut (Figure 21); the wall is now thinner at ground level, where its line is further to the east, but its original line here may have been truncated). There is a small square recess high up in this wall, of unknown function but perhaps confirming an early date for the wall (Photo 58).

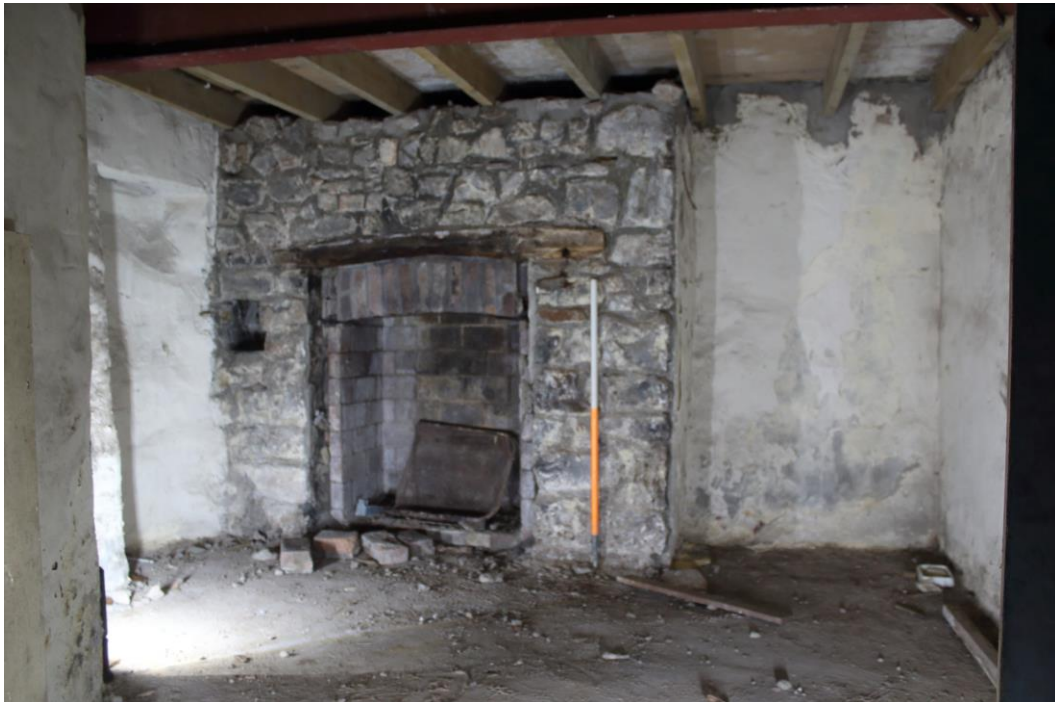
4.5.15 In the west wall is a fireplace of convincingly earlier post-medieval appearance, but perhaps made up from re-used materials after No. 6 was extended into the yard, with the addition of the rear unit, in the nineteenth century (Photos 57 & 59). All other features at this level, including the present walls and the timber ceiling, are nineteenth and twentieth-century.

Photo 59: View west of western wall of basement below No. 6 Castle Terrace showing later fireplace addition

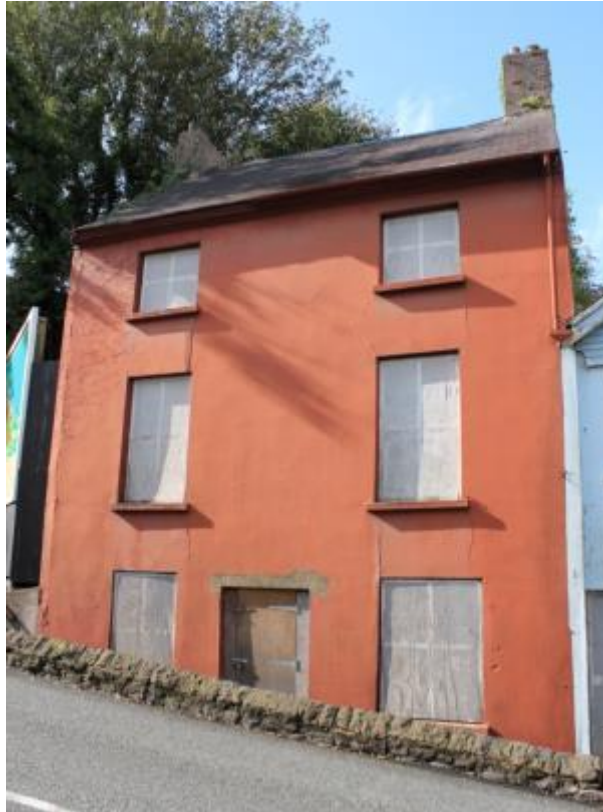
Photo 60: Eastern façade of No. 7 Northgate Street viewing west

- 4.6.2 The house is apparently of rubble construction, beneath thick external stucco incised to form mock coursing and now painted (Photo 60). It has a gabled slate roof with brick chimney stacks at both ends, the southern one now rendered. It is attached to the warehouse to the north, but the south wall was originally free of adjoining buildings: it shows a projecting chimney-stack, and is pierced by a basement stair-light which was blocked when Northgate Street was developed to the south of No. 7 in the mid-nineteenth century. This development is shown on the OS map of 1861 (Figure 12), but was demolished in the mid-twentieth century. Its detail shows that No. 7 was formerly a residence of some quality, belonging to one of Pembroke's 'middling' families; it may have been associated with the conjoining warehouse. It suffered a decline in status during the 20th century.

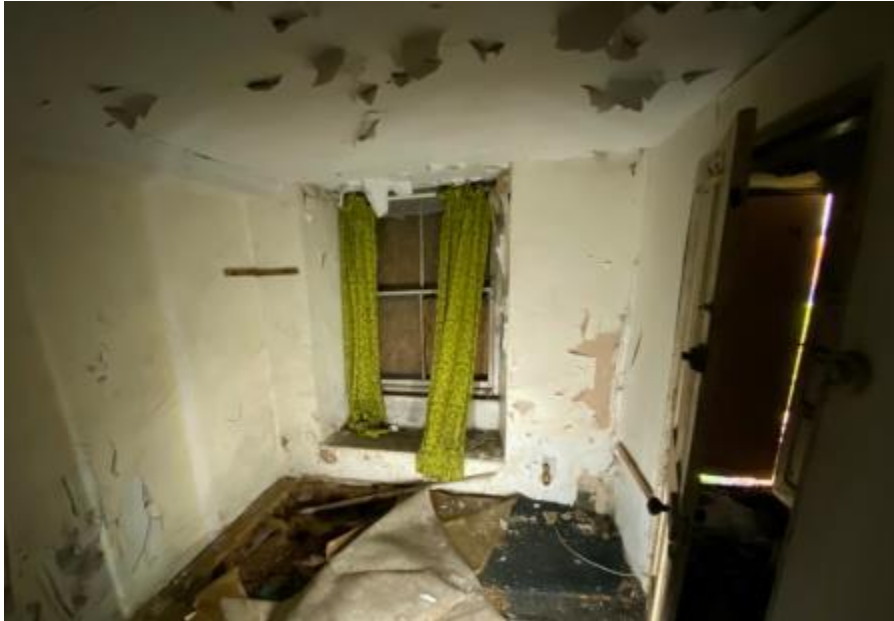
- 4.6.4 The plain, central doorway is flanked on each side by a square sash window without glazing bars (Photo 61). There are few other original

Photo 61: View east across ground floor northeastern room of No. 7 Northgate Street to sash window, with door to central passage

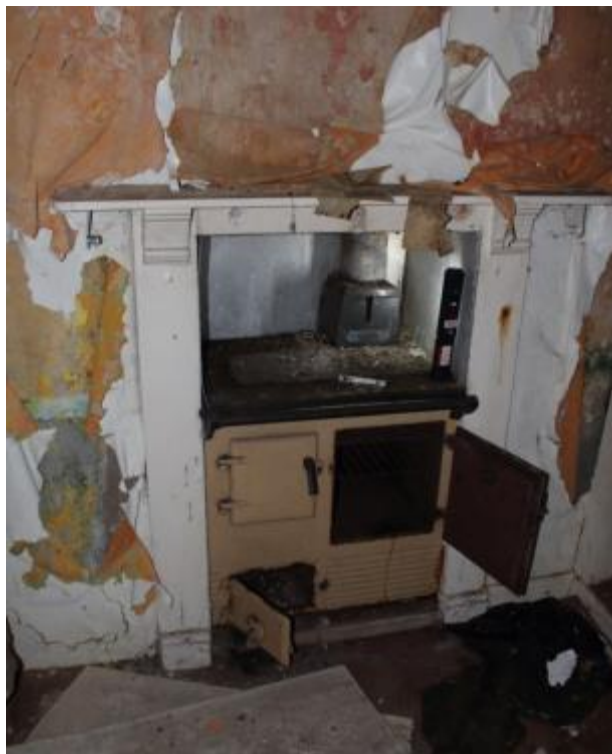
fittings at this level, and the present fireplaces are mainly late nineteenth-century. The northwest (rear) room was latterly used as a kitchen – reflecting its original function? – with an early twentieth-century range (Photo 62).

Photo 62: Range within northern wall of northwestern ground floor room

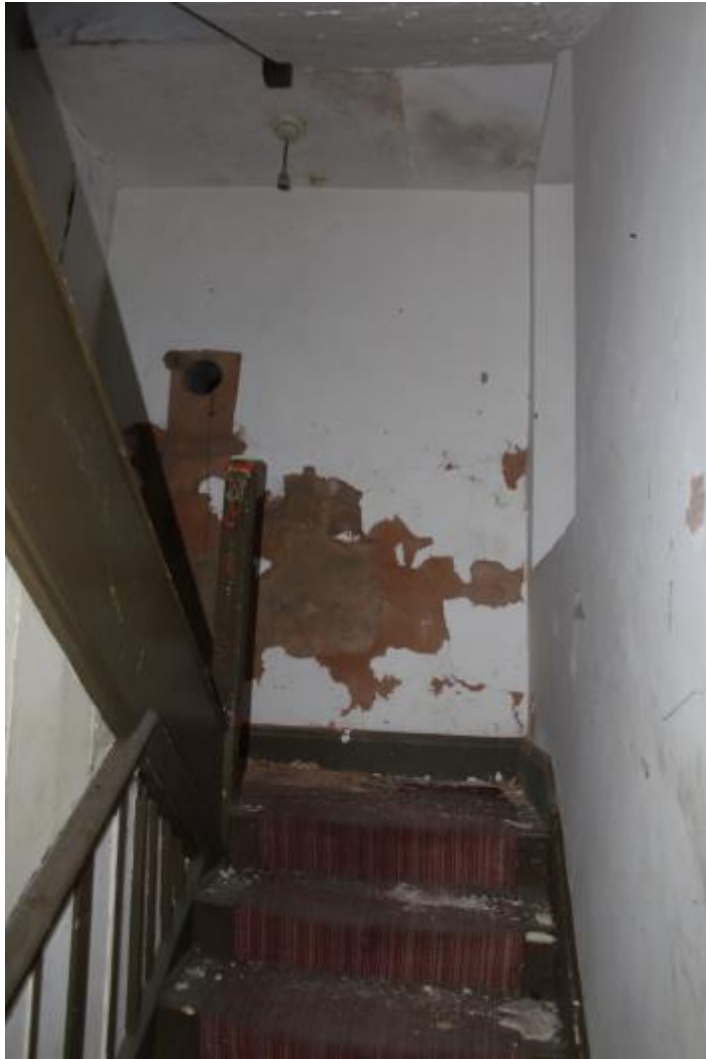
- 4.6.5 The stairwell occupies the southwest quadrant, leading off from the central passage; while the stairwell lights appear possibly to be original (Photos 63 & 64). The balustrade is late nineteenth - or early twentieth-century (Photo 63), while there is no proper landing on either of the upper floors. Did the stair originally lie at the rear (west) end of the passage?

Photo 63: View south up stairwell to half landing before first floor showing window opening to west (right)

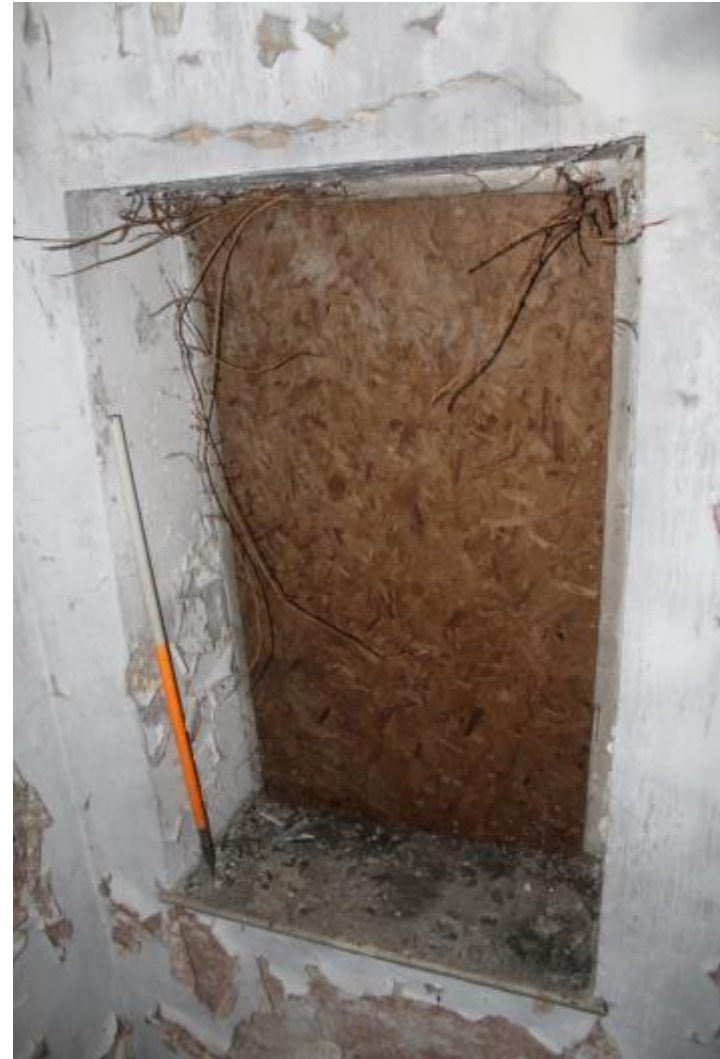
Photo 64: View west of west facing window light in stairwell at half landing before second floor level

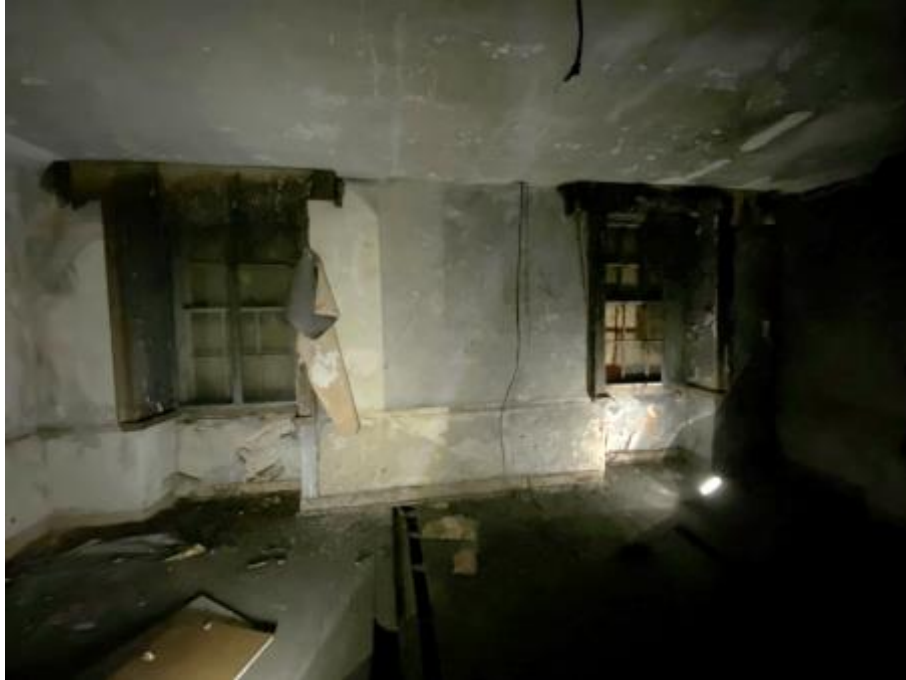
- 4.6.6 At first-floor level, the front half of the house is occupied by what was always a single, large room without evidence of subdivision. It is lit by two long, hornless 12-pane sash windows facing the street, with glazing bars (Photo 65). Too large and grand to have been a bedroom, it must have functioned as a reception room of some kind (dining room? ballroom?). This is borne out by the fine bolection mouldings in the door- and window-frames, and the panelled doors themselves, all original fittings of the early nineteenth century (Photo 66).

Photo 65: View of windows in eastern wall of first floor room

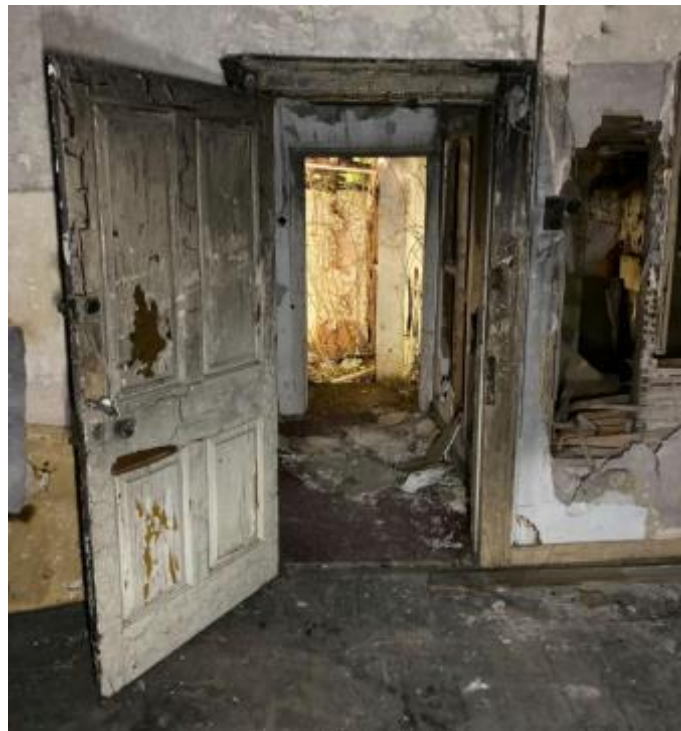
Photo 66: View west of panelled door and door frame leading from landing into large southern room at first floor of No. 7 Northgate Street

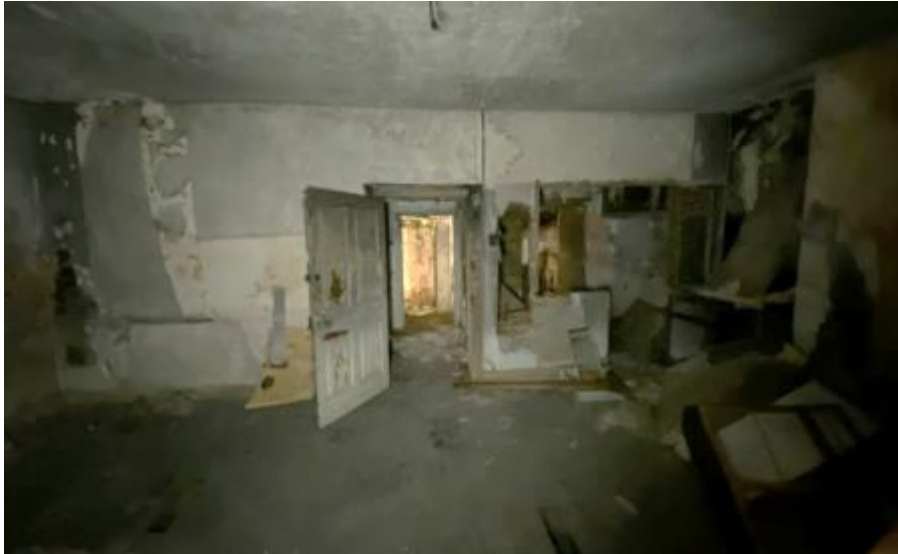
- 4.6.7 The rear half is occupied by the stairwell, and by a twentieth-century stud-wall subdivision (with early twentieth-century doors), which seems to have acted as a service area to the main room (Photo 67) – possibly reflecting an earlier arrangement? As on the ground floor, the present fireplaces are mainly late nineteenth-century. A blocked doorway leads from the first floor landing into this service room (Photo 68) but it is not known if a doorway originally led directly into the front room at first floor level.

Photo 67: Wide angle view across western side of front room at first floor level in No. 7 Northgate Street showing central doorway into room and modern stud wall to north (right) leading to former service room

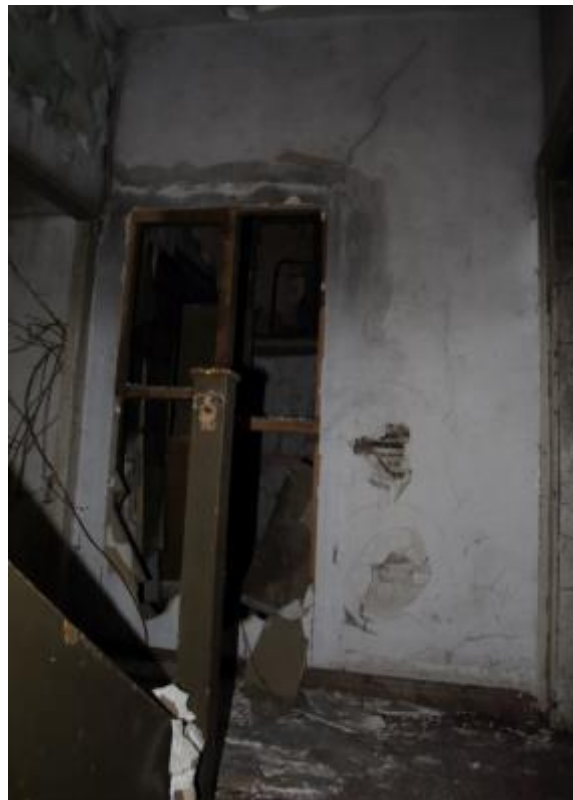
Photo 68: Blocked doorway on first floor landing into western service room

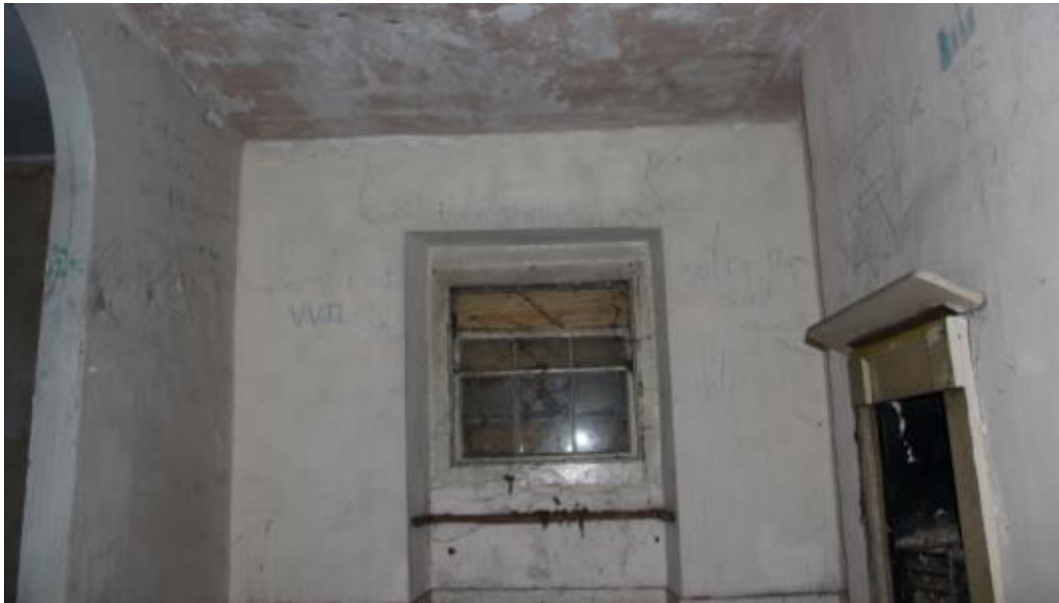
Photo 69: Southeastern window in eastern elevation of second floor room viewing east

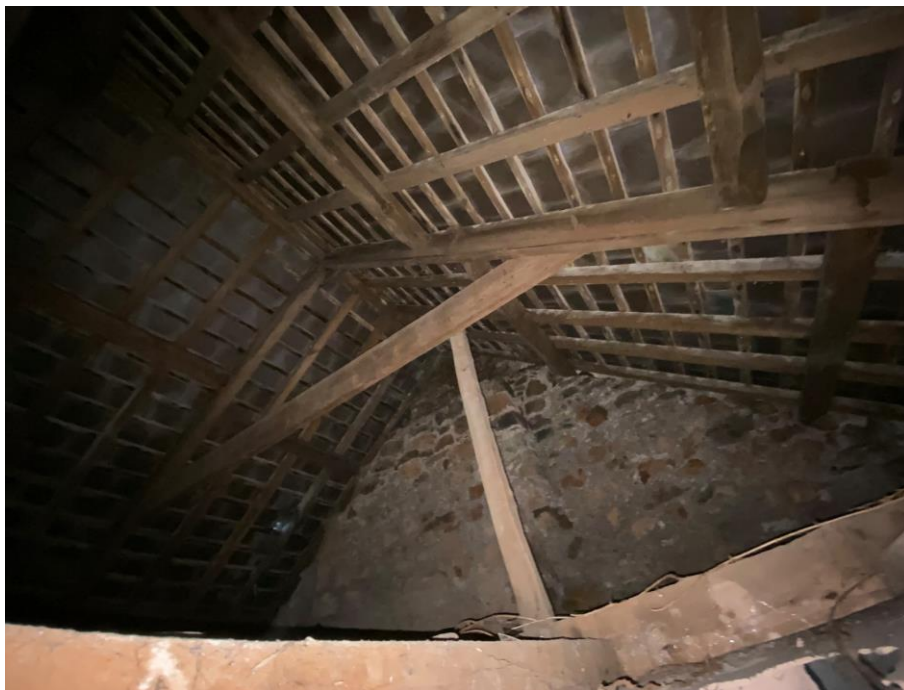
- 4.6.8 The second floor is now occupied by the upper part of the stairwell, and a series of bedrooms, the partitions between which do not appear to reflect the original layout (and which, in their present form, are later twentieth-century). Two square 6-pane sash windows, with glazing bars, face the street (Photo 69). The small windows, and the relatively low ceilings, suggest this floor was originally occupied by servant's bedrooms (as would befit the status of the house), but in the absence of any identifiable master-bedroom this remains uncertain; the function of the original rear extension is unknown, but it may be that the servant's quarters were instead located within it. The present fireplaces are again mainly late nineteenth-century. There is an attic, within which the pegged, A-frame roof-trusses were visible (Photo 70).

Photo 70: View southeast into roof space showing pegged trusses

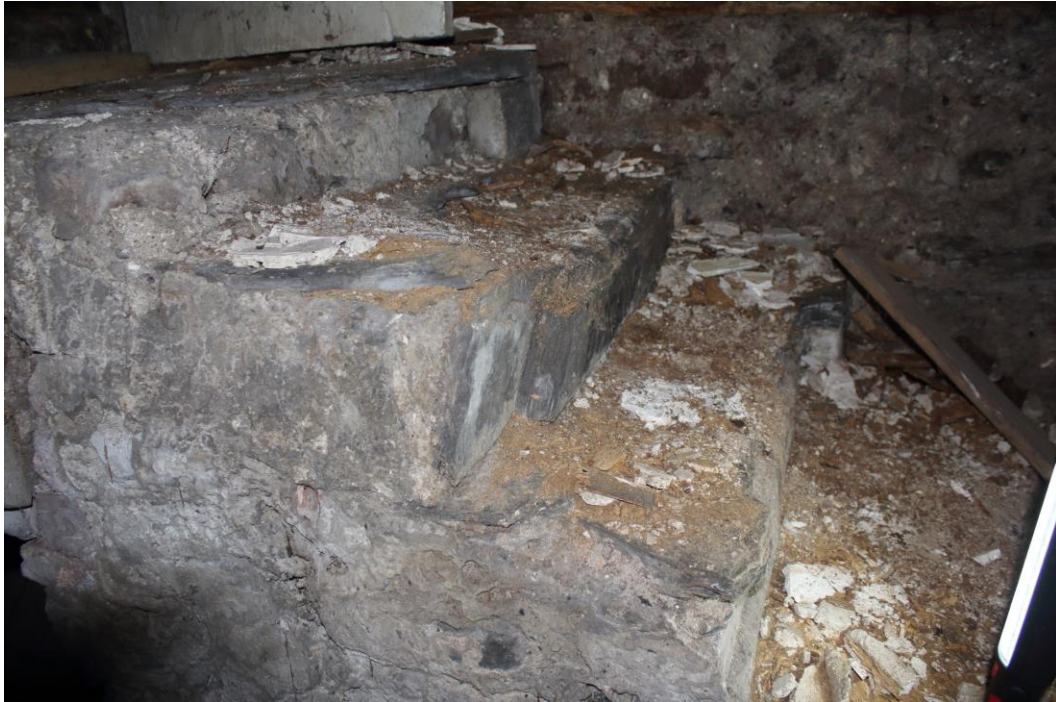
- 4.6.9 A cellar lies beneath the northern half of the house. It is entered from the central passage, via a stairway that lies within, and at the foot of the main stairwell – apparently in its original location, irrespective of the date of the present staircase above. The steps are of masonry, faced with shaley slate on both treads and risers (Photo 71), and make a full dog-legged turn to enter the cellar.

Photo 71: Detail of stone stairs with shale faced treads and risers leading down to basement level

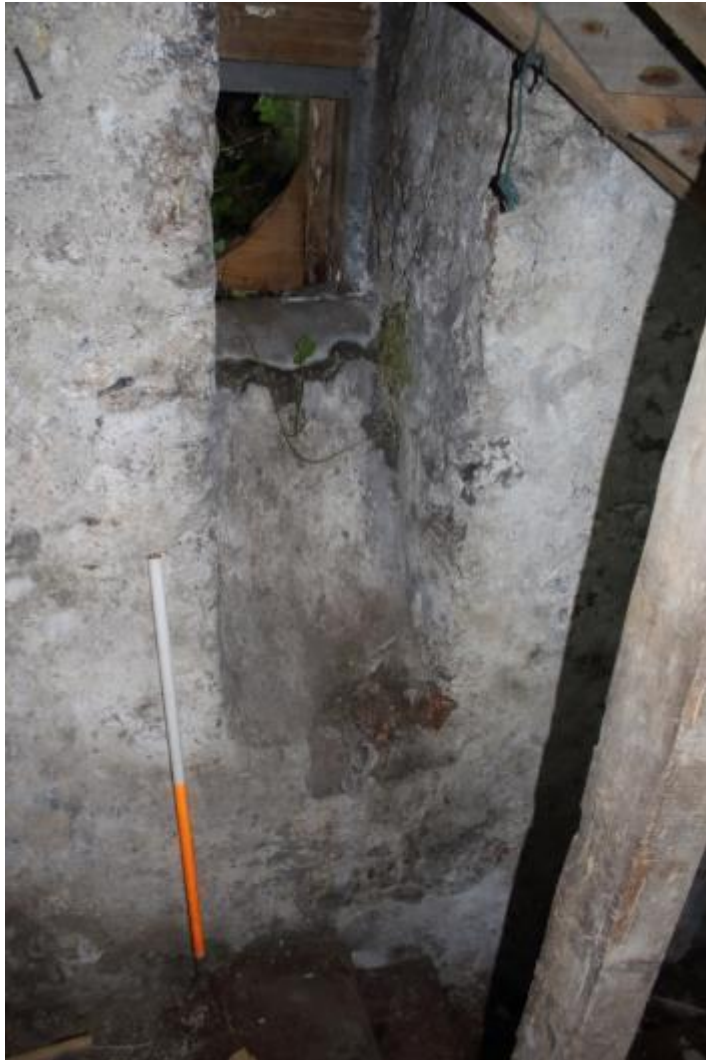
- 4.6.10 There is a deeply plunging stair-light to the west (Photo 72), while a similar light to the south was blocked when the neighbouring building was added in the mid-nineteenth century (Photo 73).

Photo 72: Deeply plunging stair light on western side of stairwell leading to cellar viewing west
