**SOUTH QUAY, PEMBROKE
NOS. 4, 5 & 6 CASTLE TERRACE,
NOS. 7 & 8 NORTHGATE STREET:
LEVEL 3
HISTORIC BUILDING RECORDING**

Prepared by Dyfed Archaeological Trust
For: Pembrokeshire County Council

REPORT NO: 2019/45

December 2019

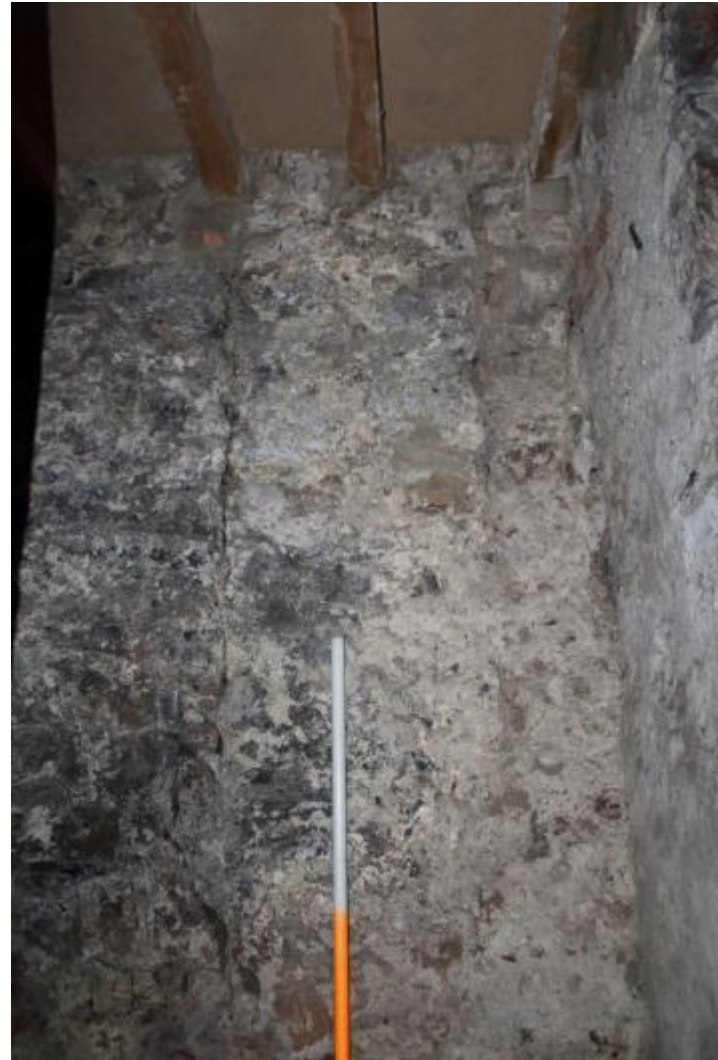
- 4.6.10 There is a deeply plunging stair-light to the west (Photo 72), while a similar light to the south was blocked when the neighbouring building was added in the mid-nineteenth century (Photo 73).

Photo 73: View south of blocked stair light on southern wall of stairwell leading to cellar

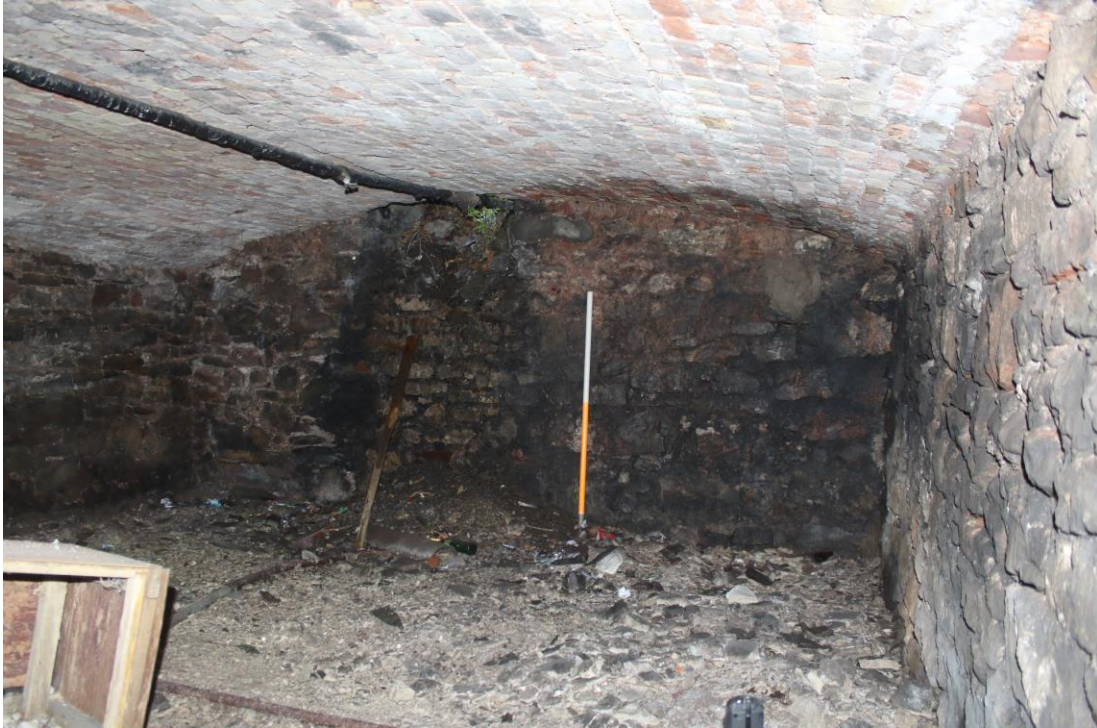
- 4.6.11 The cellar has a brick, segmentally-arched vault (Photo 74), groined over the entry, supported on masonry side walls whose mixed rubble suggests it was not sourced from the castle ruins. There is a coal-chute from the street, and a small light high up on the rear (west) wall. The floor of the cellar was revealed in one small area, showing that the apex of the vault was 1.5m high. The use of brick vaults on stone side-walls is known from the early nineteenth century at, for example, Carmarthen (Ludlow 2014, 149-50), and the cellar is therefore thought to be of one build with the rest of the house, which similarly appears to be of rubble construction.

Photo 74: View east across coal basement with brick vault in cellar below
No. 7 Northgate Street

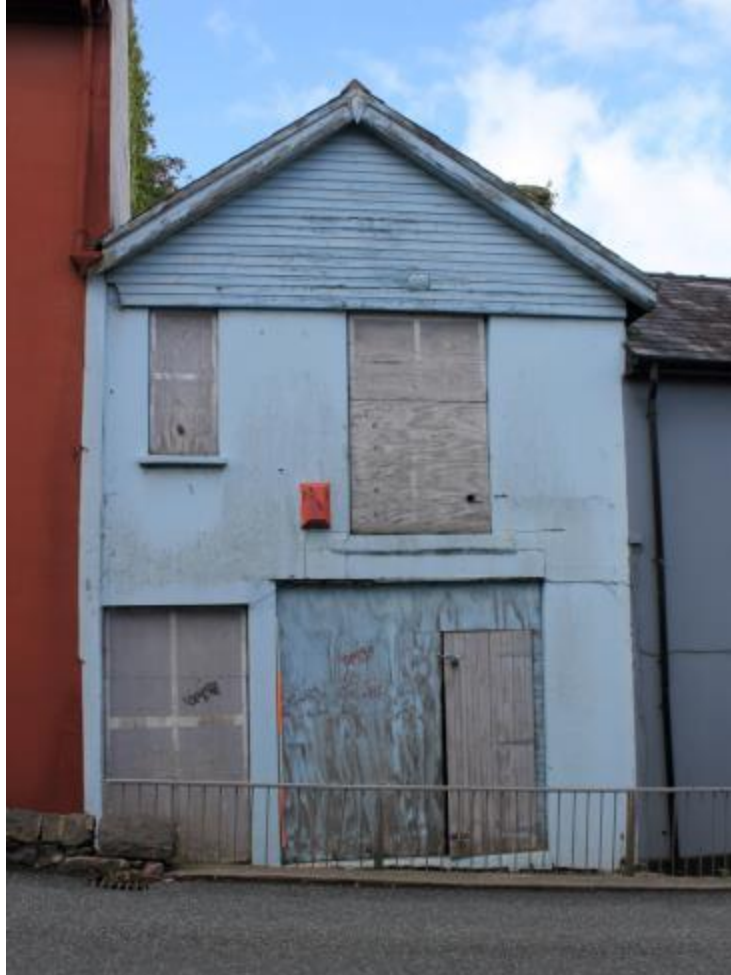
Photo 75: Eastern façade of No. 8 Northgate Street viewing west

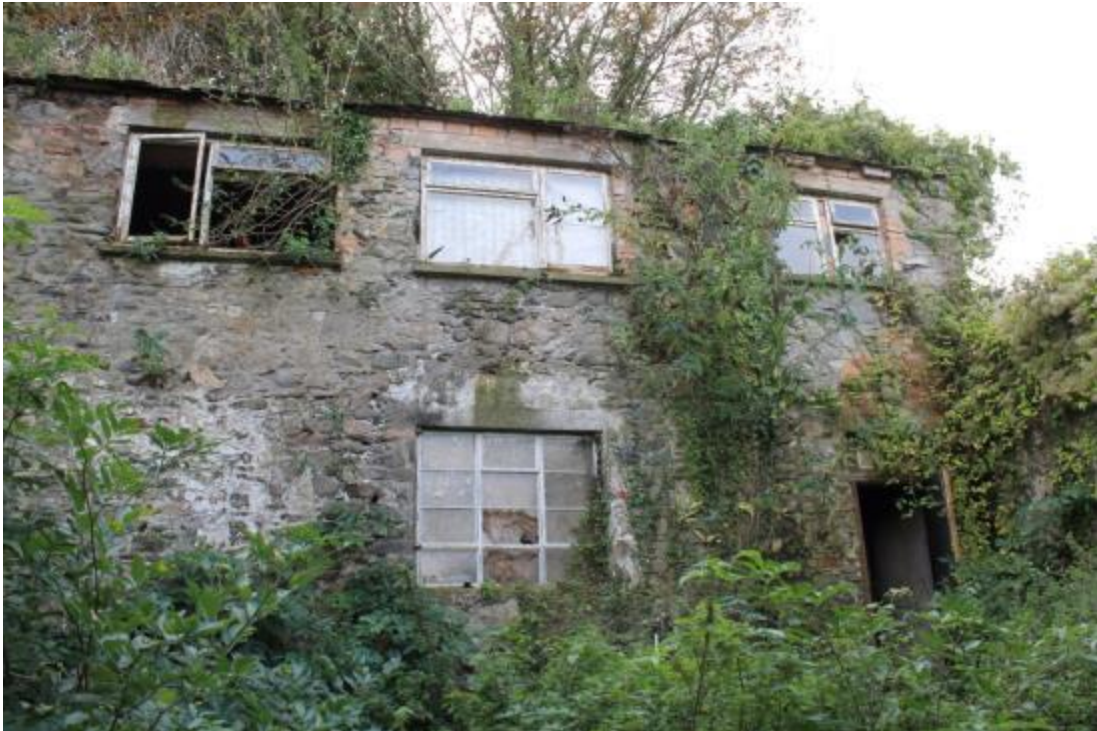
4.7.5 From the rear yard area it was possible to see part of the southern frontage of the building where it projected beyond the side of the adjacent outbuildings of the pub to the south (Photo 78).

Photo 78: View south of western part northern elevation of No. 8 Northgate Street from yard area

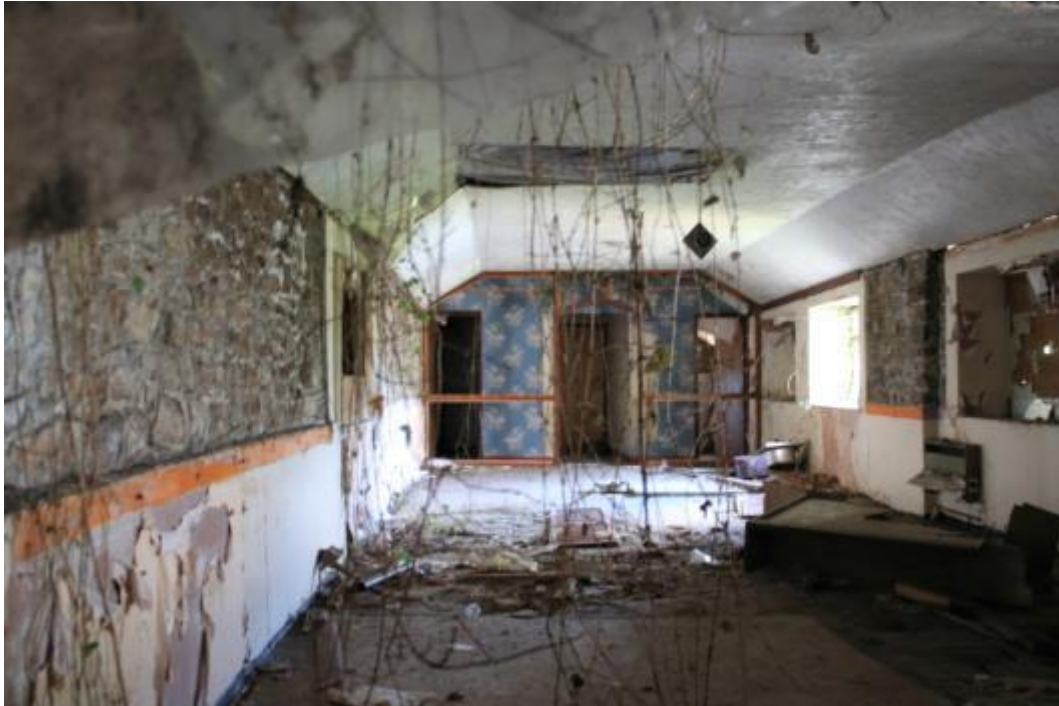
- 4.7.6 The upper floor was inaccessible due to structural instability but a view from the top of the stairs was possible (Photo 79). At the western end of the building at first floor level was an exit into the rear yard area of No. 4 Castle Terrace (Photo 80).

Photo 79: View west across first floor of No. 8 Northgate Street towards western end and doorway exit to garden of No. 5 Castle Terrace

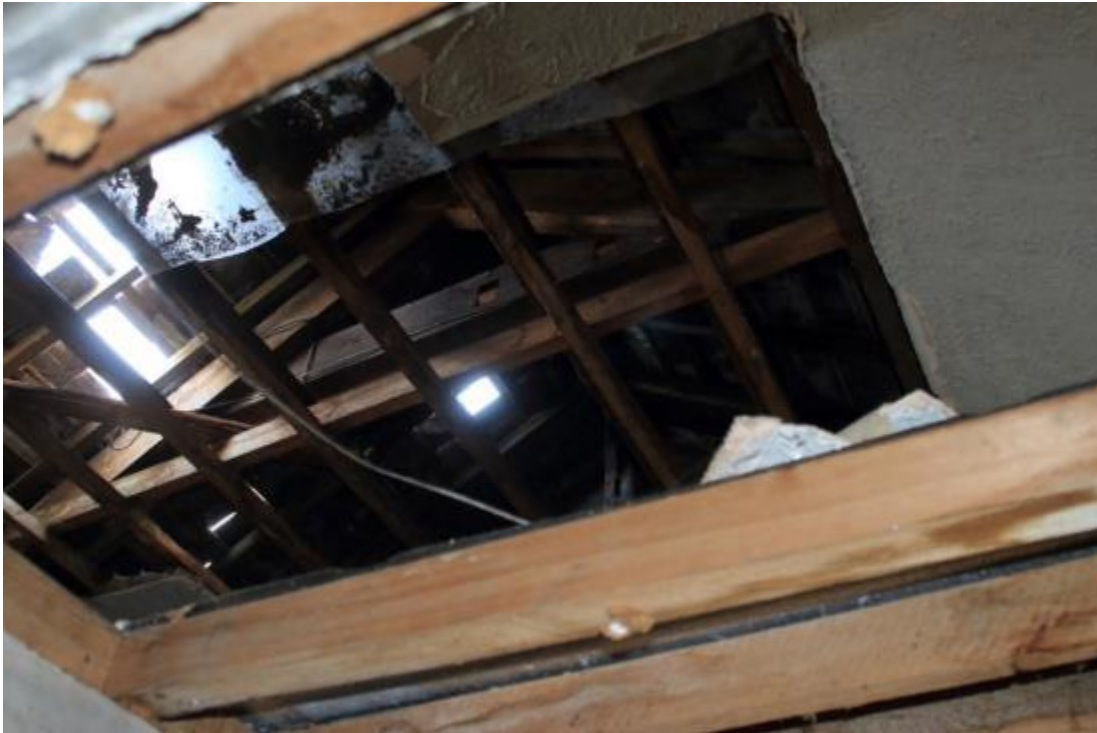
- 4.7.7 Little of the roof structure was visible, but the plain A-frame trusses would be consistent with an early/mid-nineteenth-century date (Photo 81).

Photo 81: View from stairs to A frame roof truss of No. 8 Northgate Street

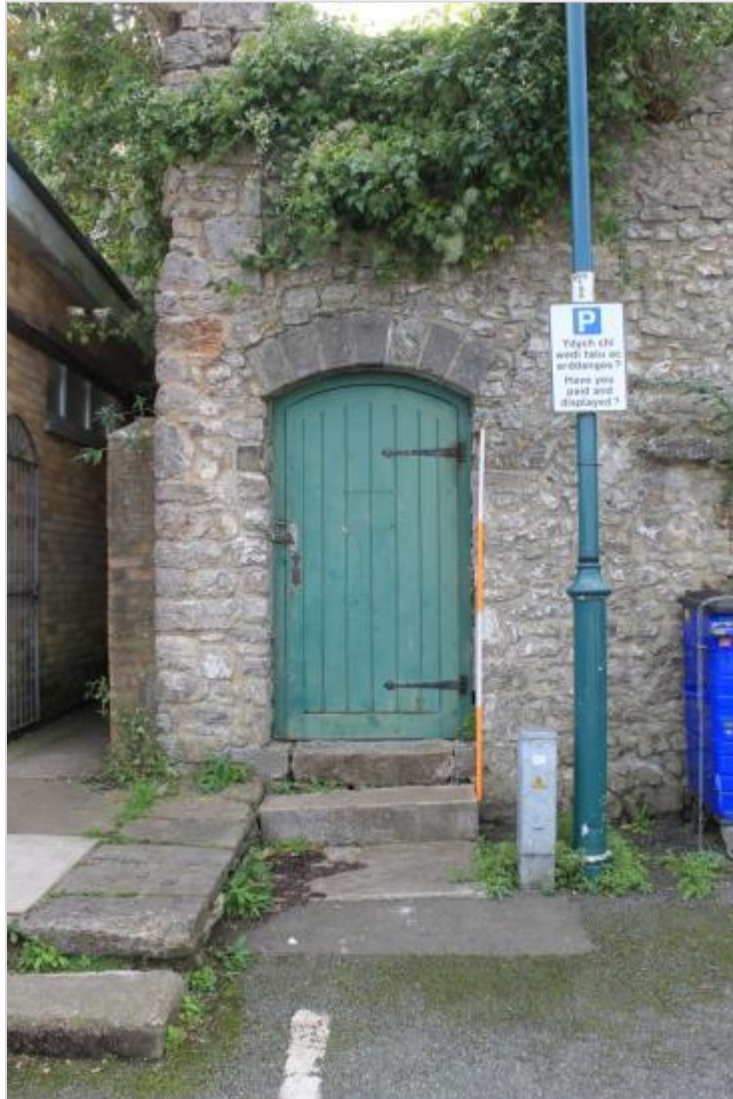
Photo 85: Entrance to No. 4 Castle Terrace from South Quay. The existing segmental head is a modern reconstruction.

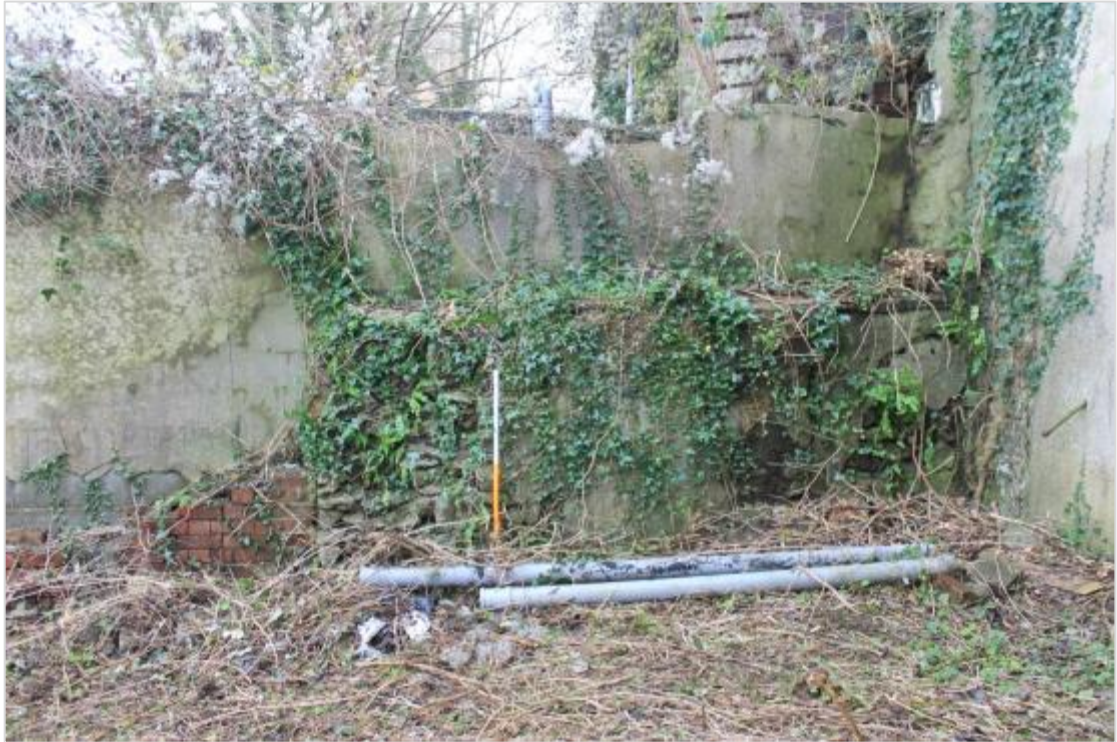
Photo 100: Remains of west elevation of No. 4 Castle Terrace. To the left of the 1m scale the stub of an east-west wall is visible (see Photo 98). 1m scale

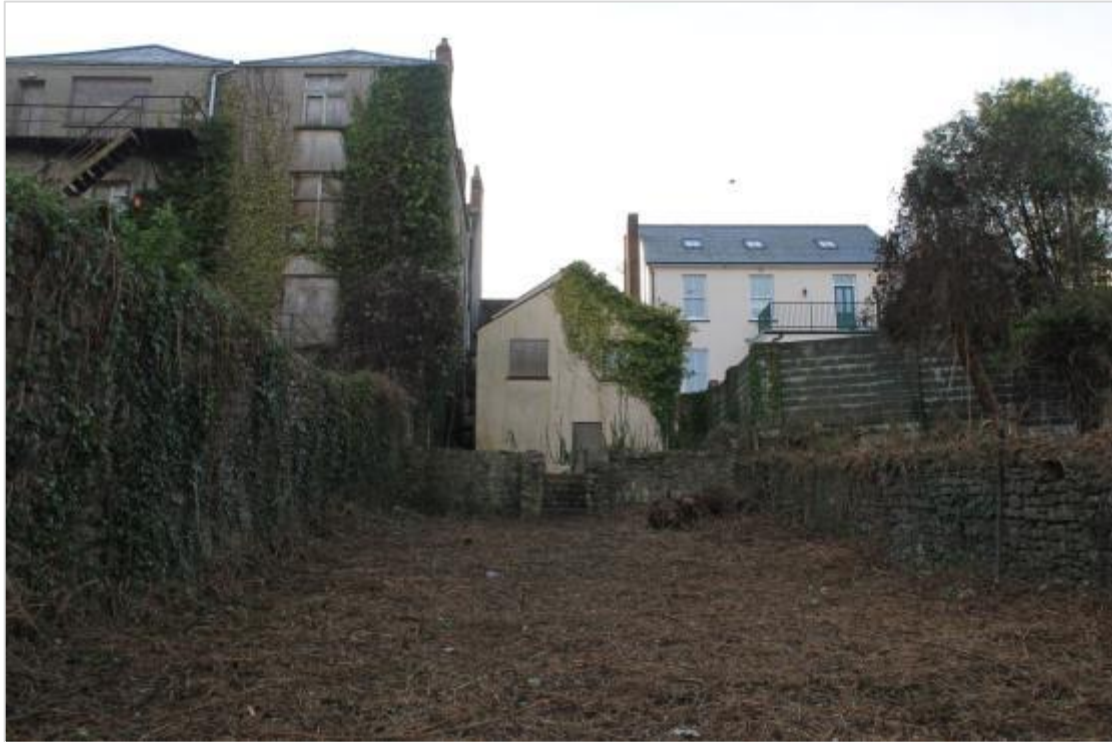
Photo 108: View south towards north elevation of Nos. 6 Castle Terrace

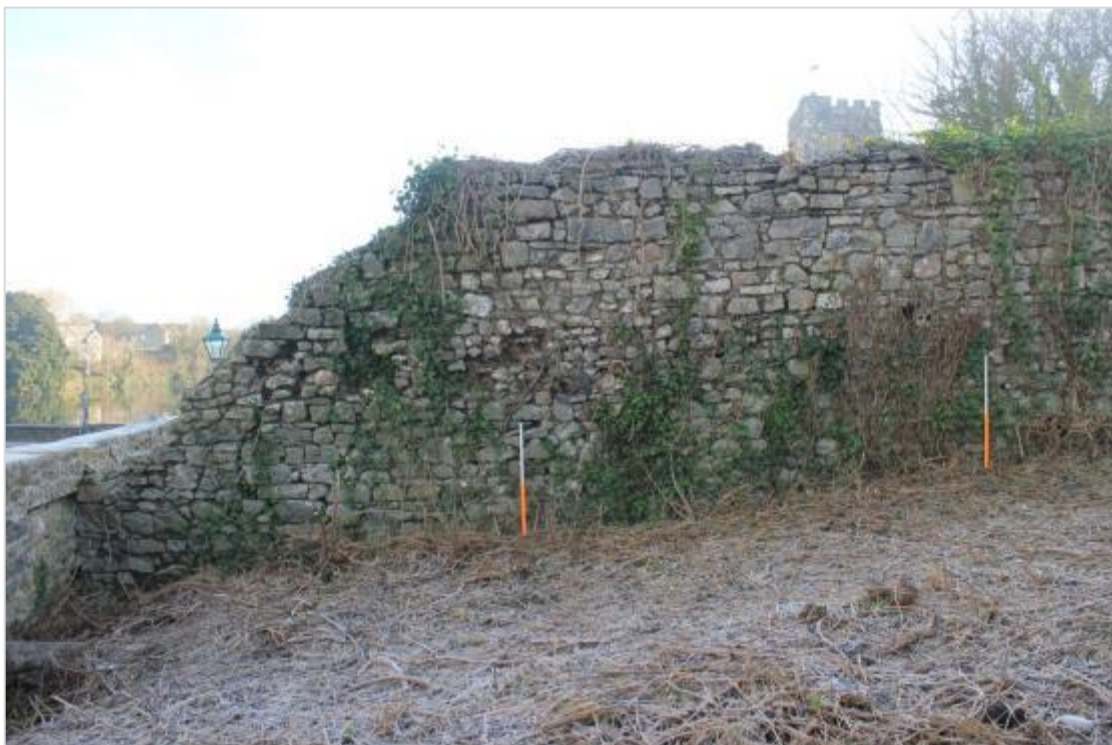
Photo 109: Northern end of west face of wall (PRN 115030) dividing burgage plots Nos. 5 and 6 Castle Terrace. 2 x 1m scale

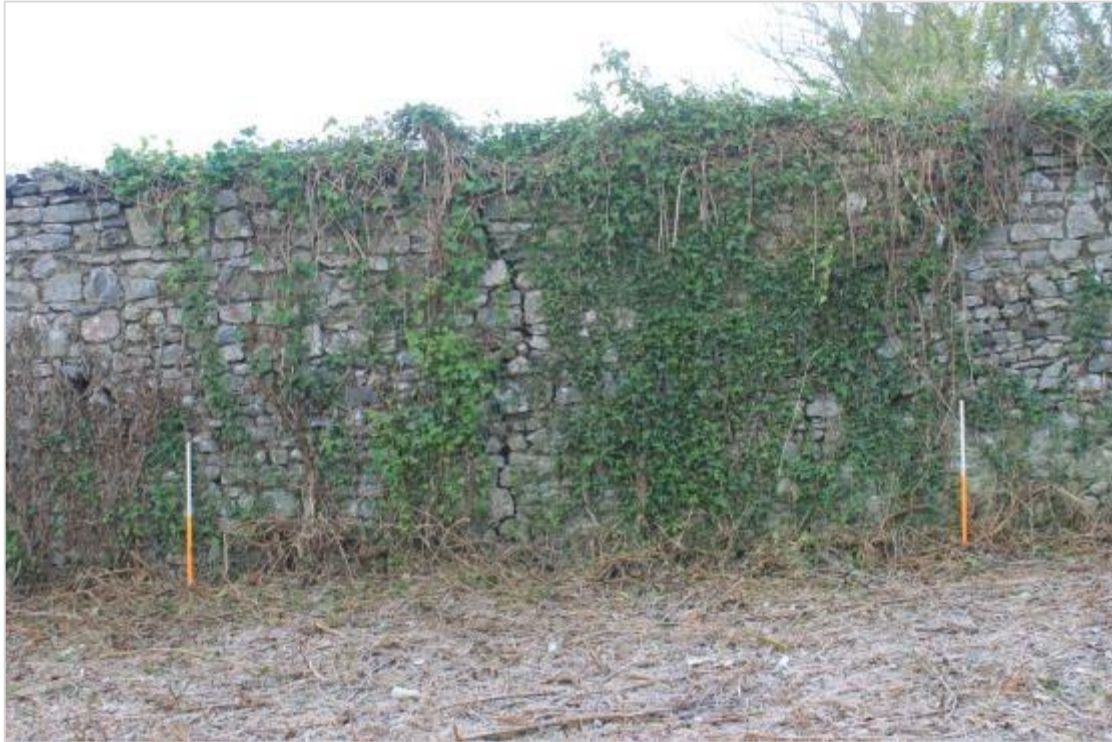
Photo 110: Middle section of west face of wall (PRN 115030) dividing burgage plots Nos. 5 and 6 Castle Terrace. 2 x 1m scale

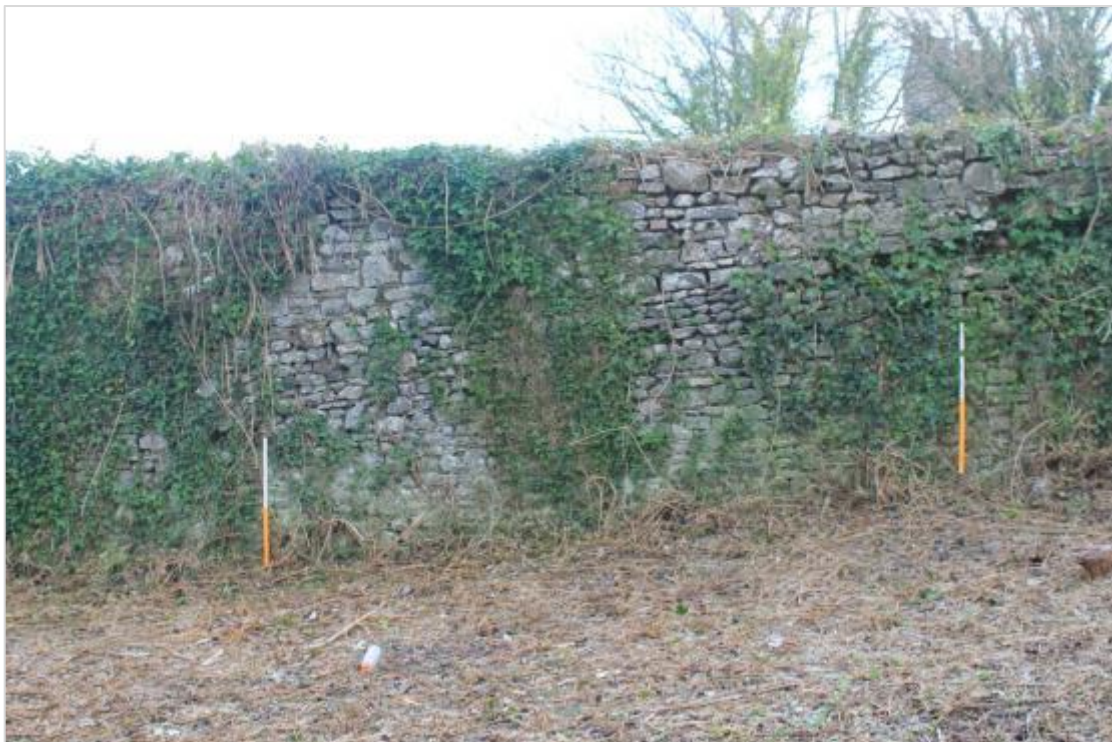
Photo 111: Middle section of west face of wall (PRN 115030) dividing burgage plots Nos. 5 and 6 Castle Terrace. 2 x 1m scale

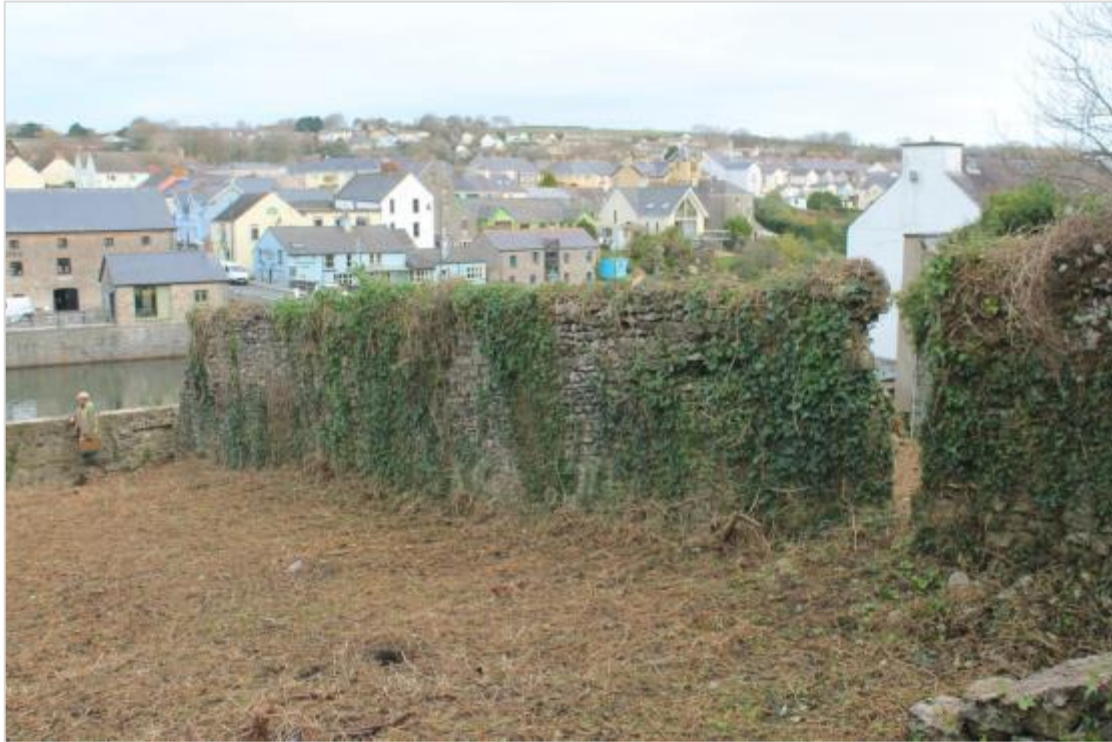
Photo 114: View north along wall (PRN 115030) dividing burgage plots Nos. 5 and 6 Castle Terrace

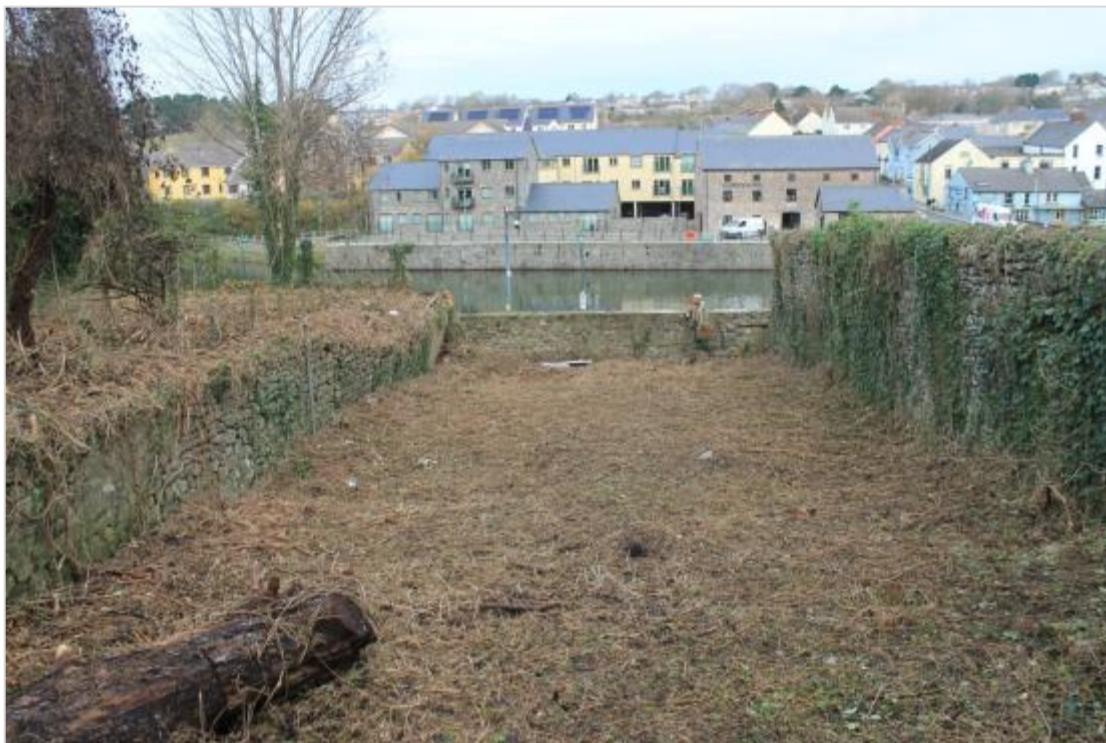
Photo 116: View north along burgage plot at No. 6 Castle Terrace

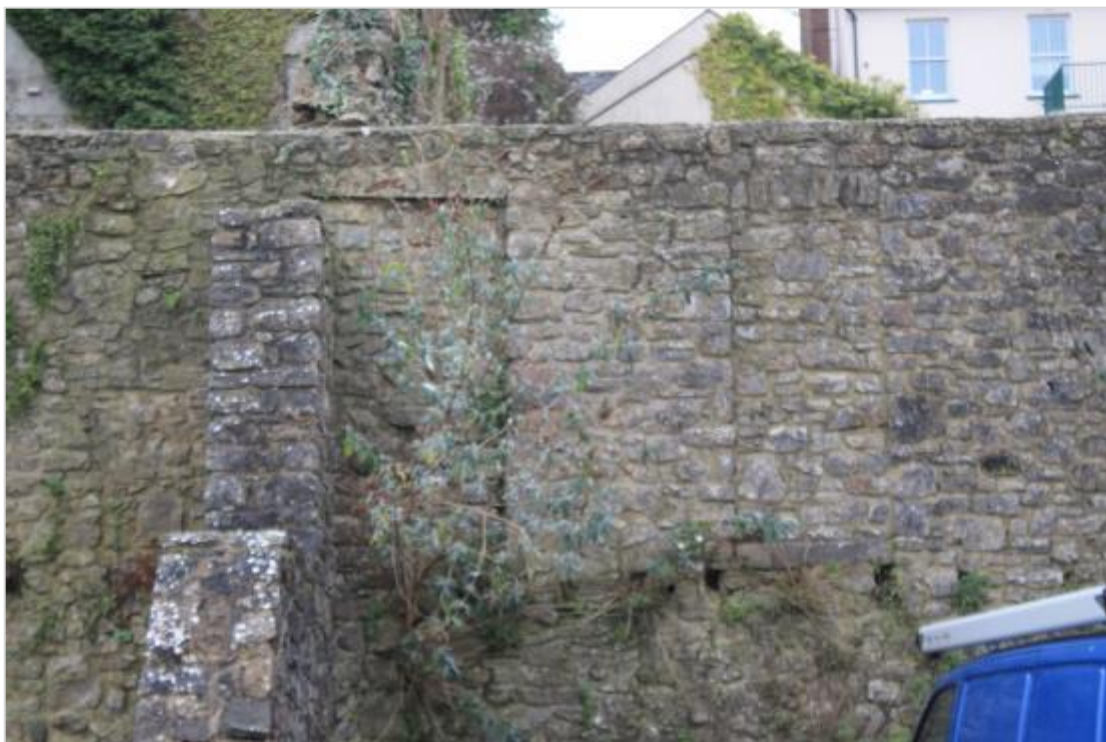
Photo 117: View south of blocked openings in section of quayside wall bordering north end of burgage plot at No. 6 Castle Terrace (the opening on the left can be seen in Photo 107)

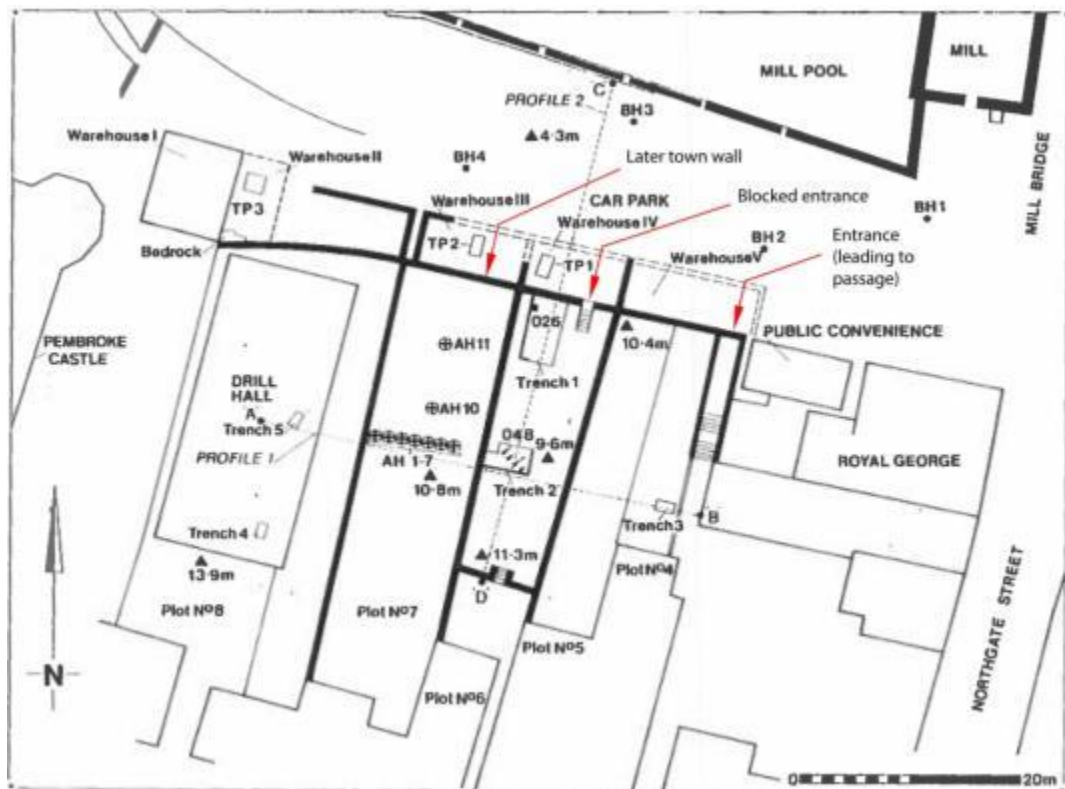
Figure 30: Pembroke quay and town wall, from Lawler 2001

- 6.3.5 A second entry through the wall is shown behind No. 6 on an archaeological plan of 2001 (Lawler 2001, Fig. 2) (see Figure 30), and may be roughly contemporary with the passage; it may be connected with the business undertaken in No. 6 (latterly a saddlery, see above). Neither access would be suitable for the conveyance of heavy merchandise being narrow, very sloping and featuring steep flights of steps, and showing a low vault behind No. 4: the solely private and pedestrian access that is suggested may confirm that the owners of Nos. 4, 5 and 6 had business interests at the quay.
