NATIONAL PARK CARAVAN SITE, SAGESTON, PEMBROKESHIRE HISTORIC BUILDING RECORDING (NGR SN 0532 0317)

REPORT NO. 2020-06
EVENT RECORD No.120803

March 2020

**NATIONAL PARK CARAVAN SITE,
SAGESTON, PEMBROKESHIRE:
HISTORIC BUILDING RECORDING**

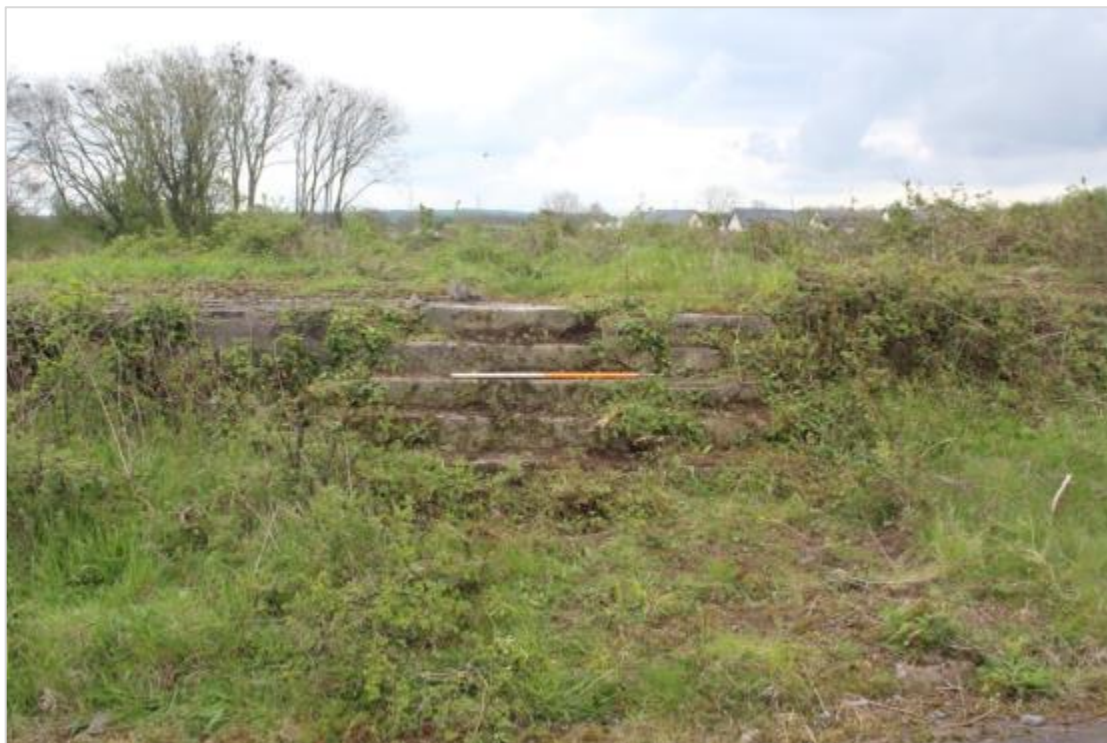
Photo 10: View east towards steps leading to Buildings 29 and 47.

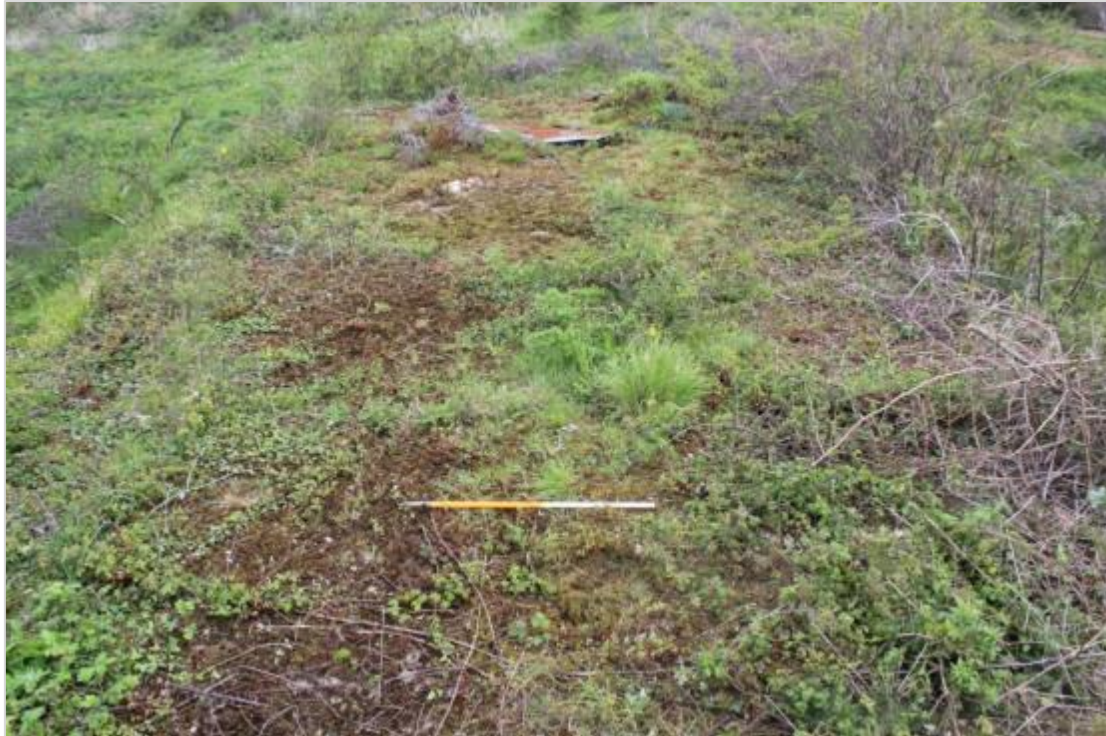
Photo 17: View east: Building 37 (Medical Inspection Block); concrete raft measuring c. 13.6m by 5.8m; vegetation covered with well delineated edges; has survived fairly intact; north face is c. 1m high with pilasters/butresses.

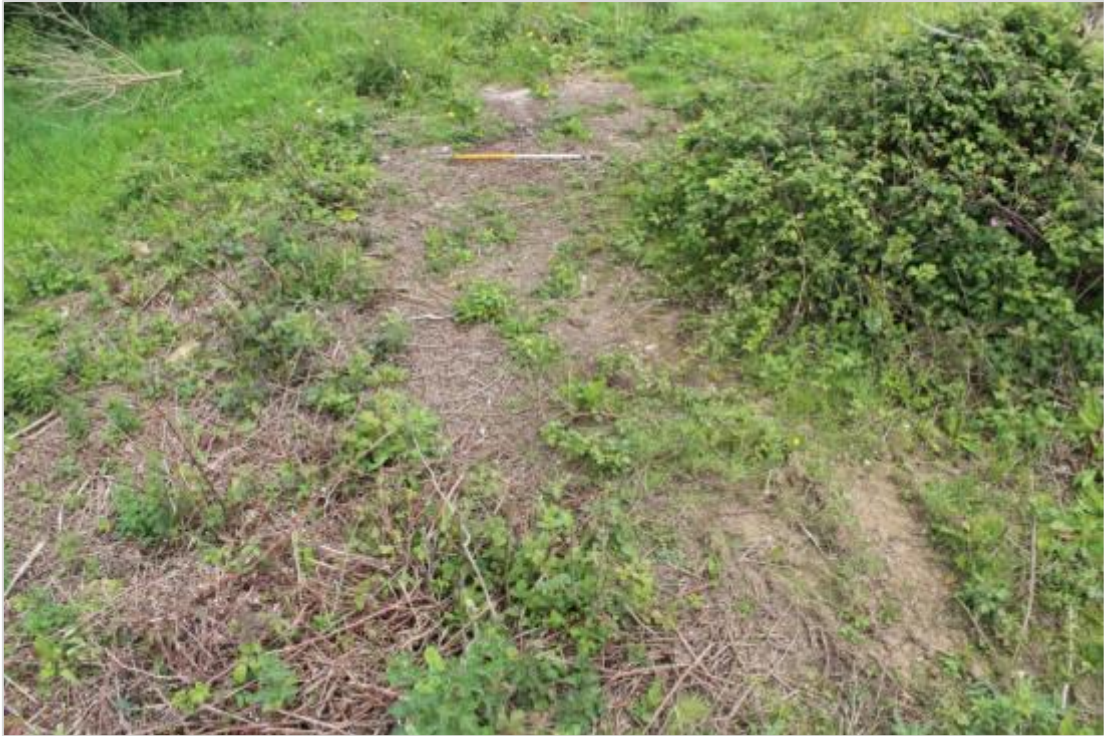
Photo 21: View east: Building 99 (not seen on 1946 plan and given arbitrary number); edges of concrete raft not clear; surveyable area measures c. 5m by 2.7m.

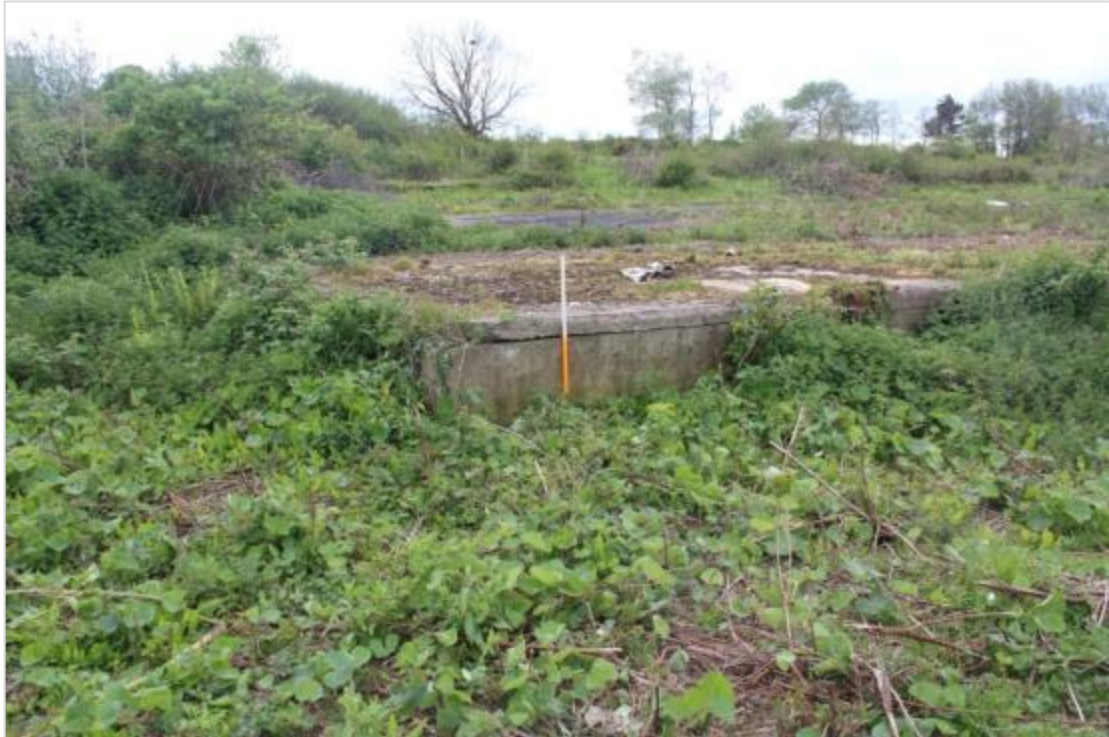
Photo 23: Northeast corner of Building 50.

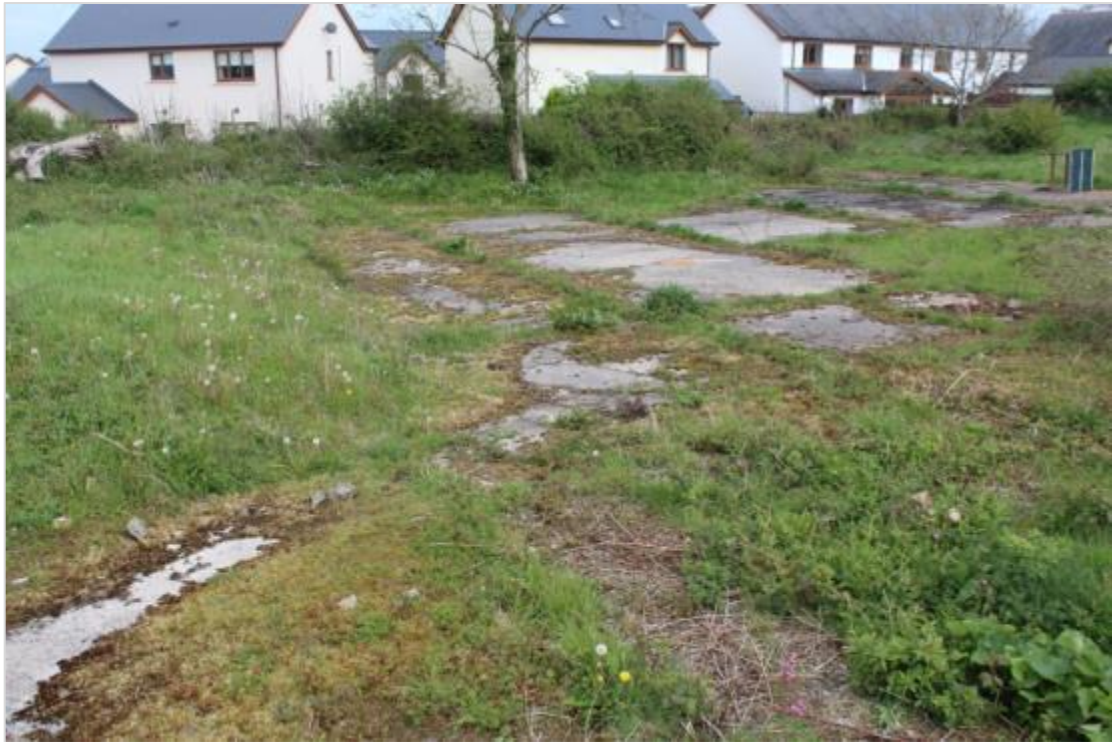
Photo 27: View southeast: Building 52.

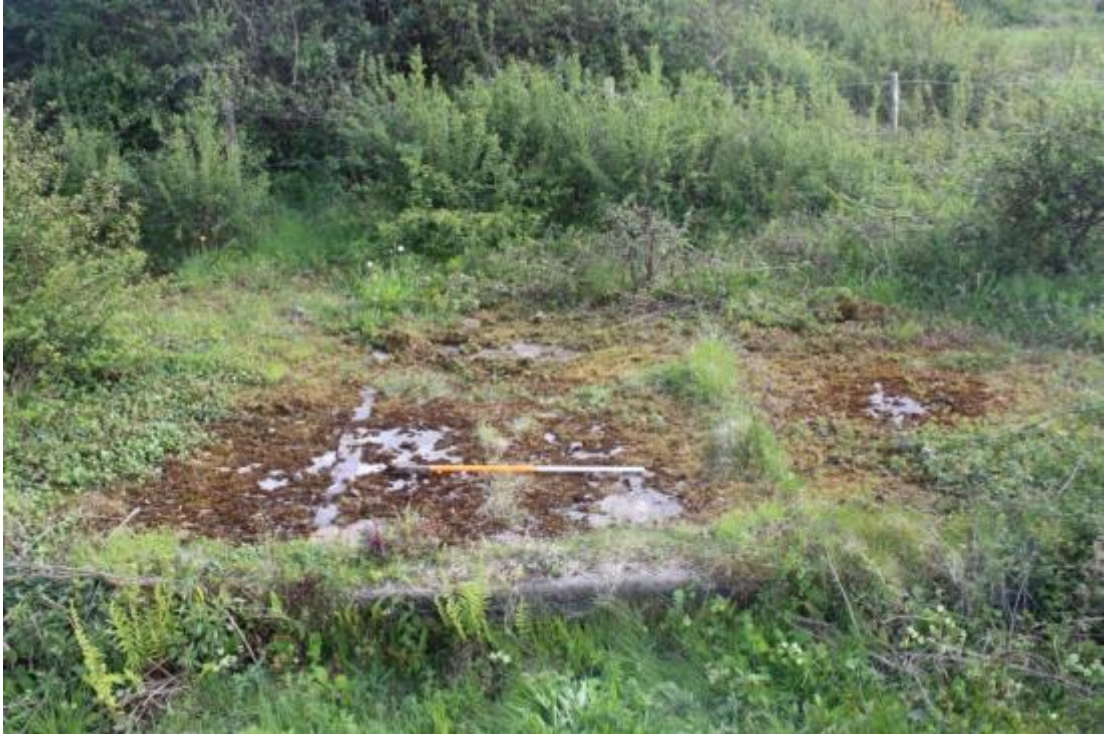
Photo 29: View south: Building 62 (Gas Defence Centre); concrete raft; observable area measures 7.6m by 3.2m; south and east sides under vegetation

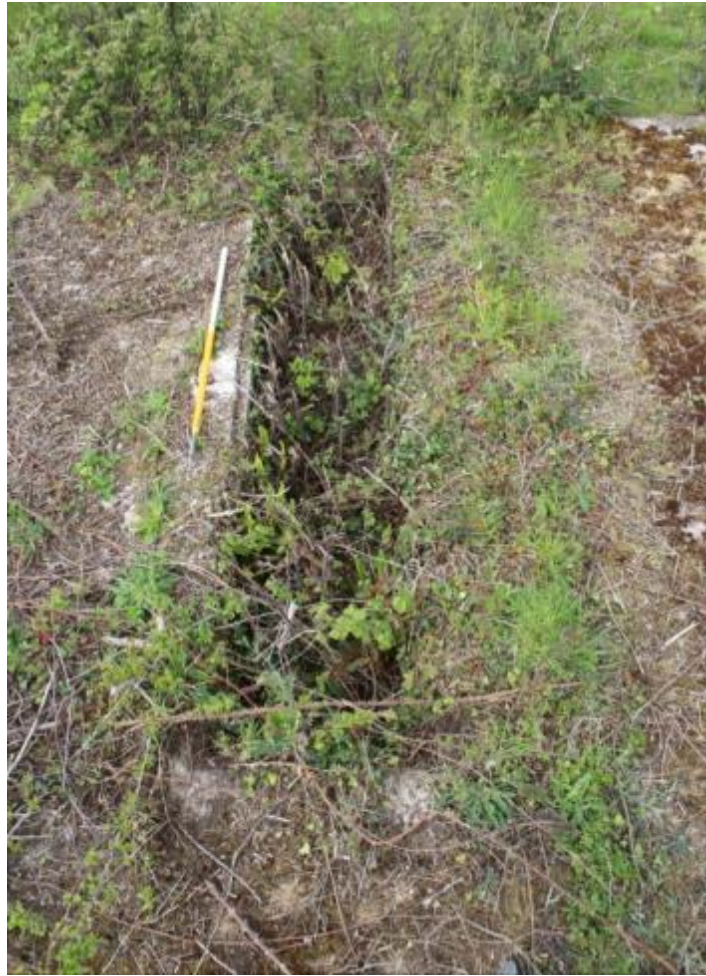
Photo 30: View east: Building 181 (Post Office); well preserved concrete raft measuring c. 10.9m by 4.7m; rectangular slot measuring 2.7m by 0.5 and 0.5m deep at roughly midway point.

Photo 31: View north: rectangular slot in floor of Building 181.

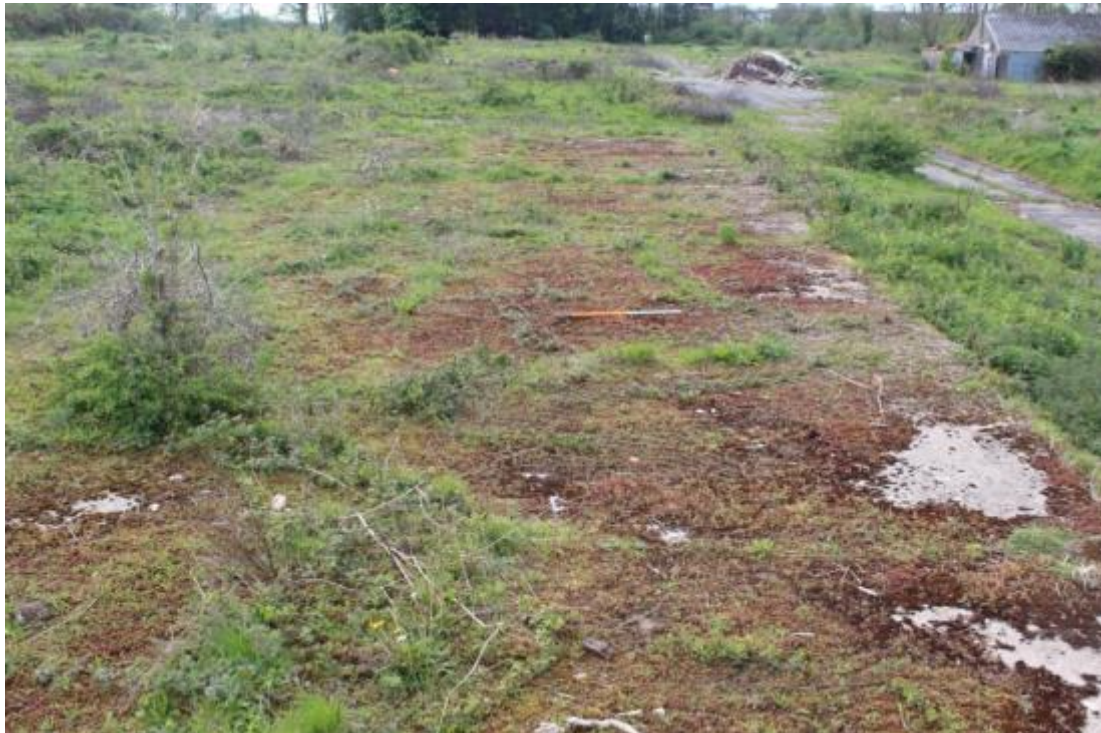
Photo 32: View west: Building 55 (PBX); intact, well-preserved concrete raft measuring c. 27.7m by 8.8m and 0.5m high on north side.

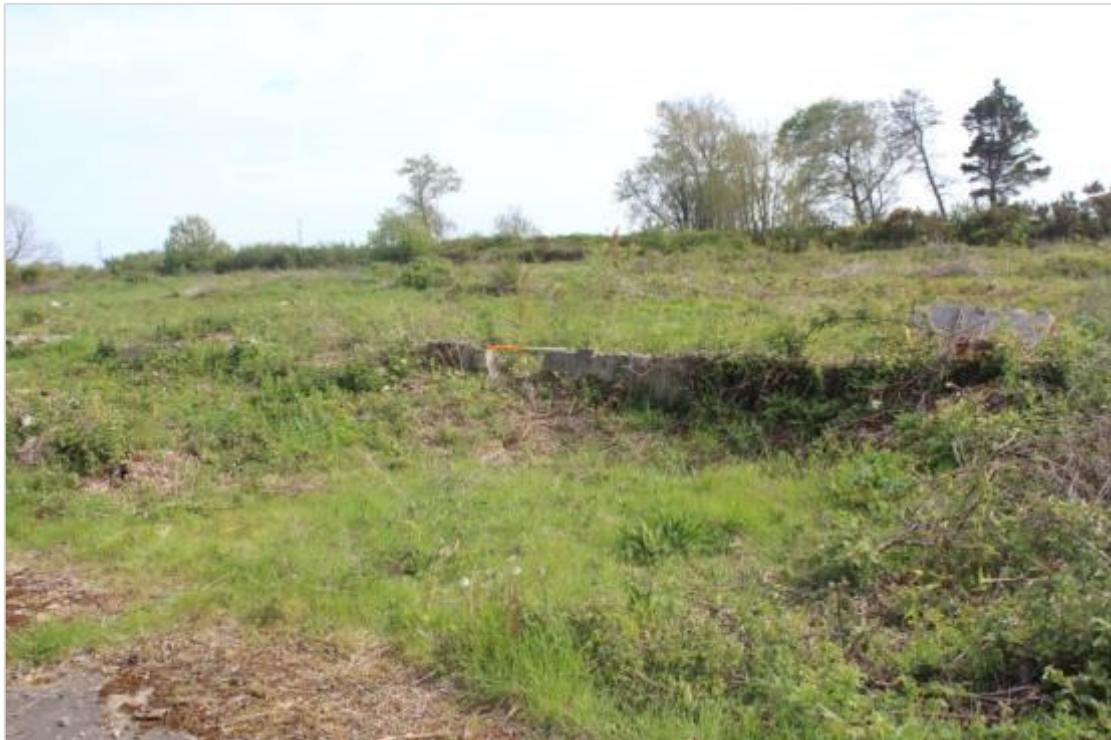
Photo 45: View west: Building 39 (Aircrew Intelligence – Barber and Shoemaker); well-defined north and west edges, rest is rubble strewn and grassed over; area roughly measures 29m by 7m.

Photo 46: North wall of Building 39.

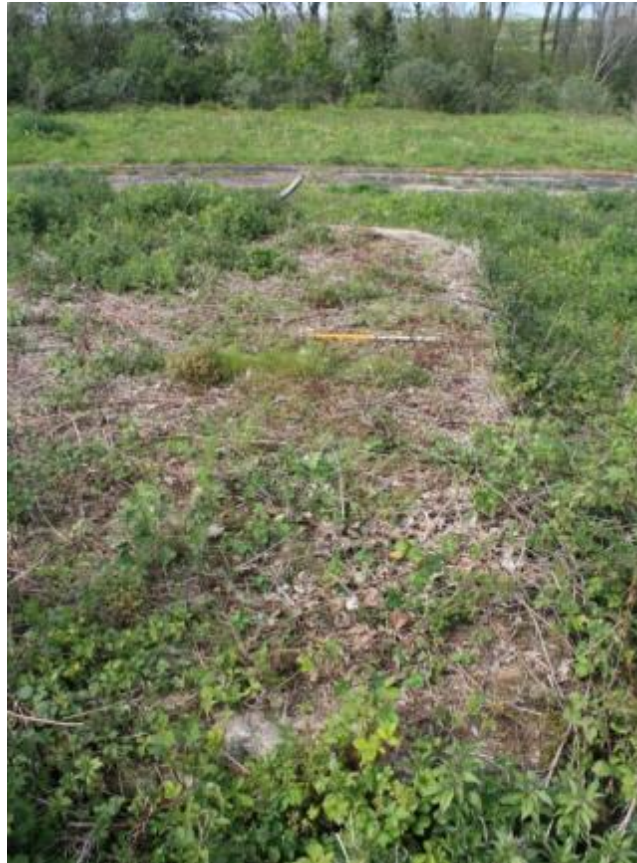
Photo 49: View north: Building 5 (Bath Block and Drying Room); only the northern half of the concrete raft remains; visible area measures c. 7.7m by 5.7m.

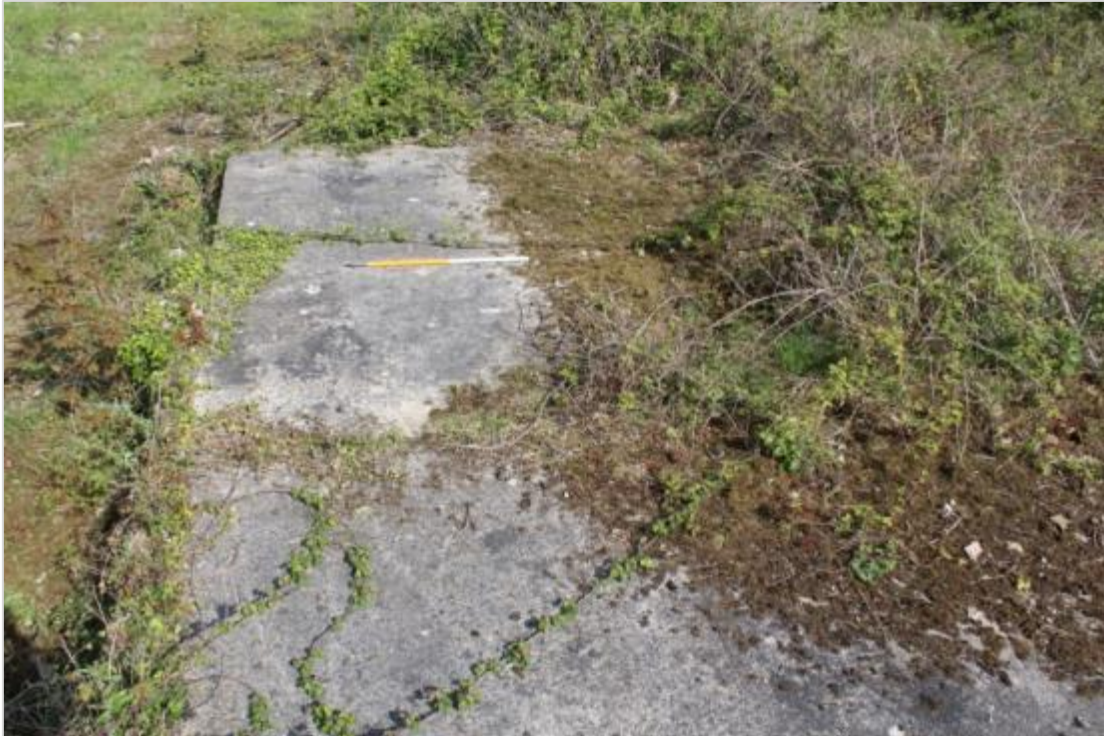
Photo 51: View east: Building 10 (Dining Room and Institute); northeast corner of concrete raft (west end); the majority of this structure has been truncated by the A477 bypass.

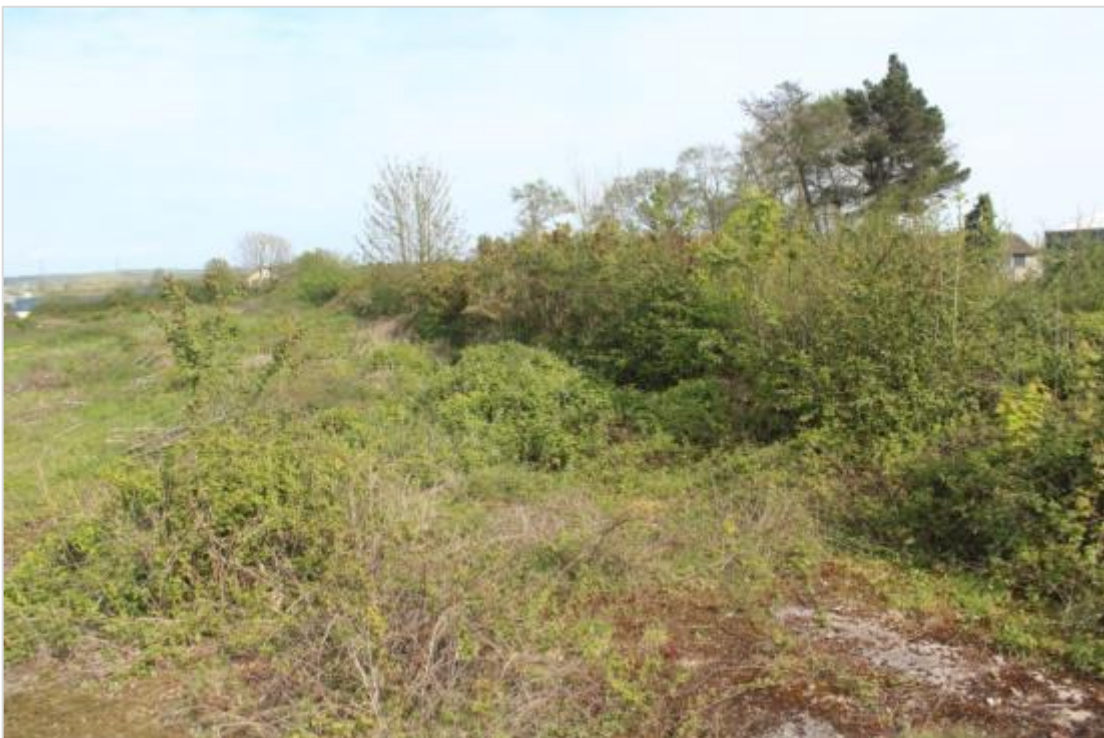
Photo 52: View east: Building 10 (Dining Room and Institute); eastern end of concrete raft; majority of structure truncated by A477 bypass.

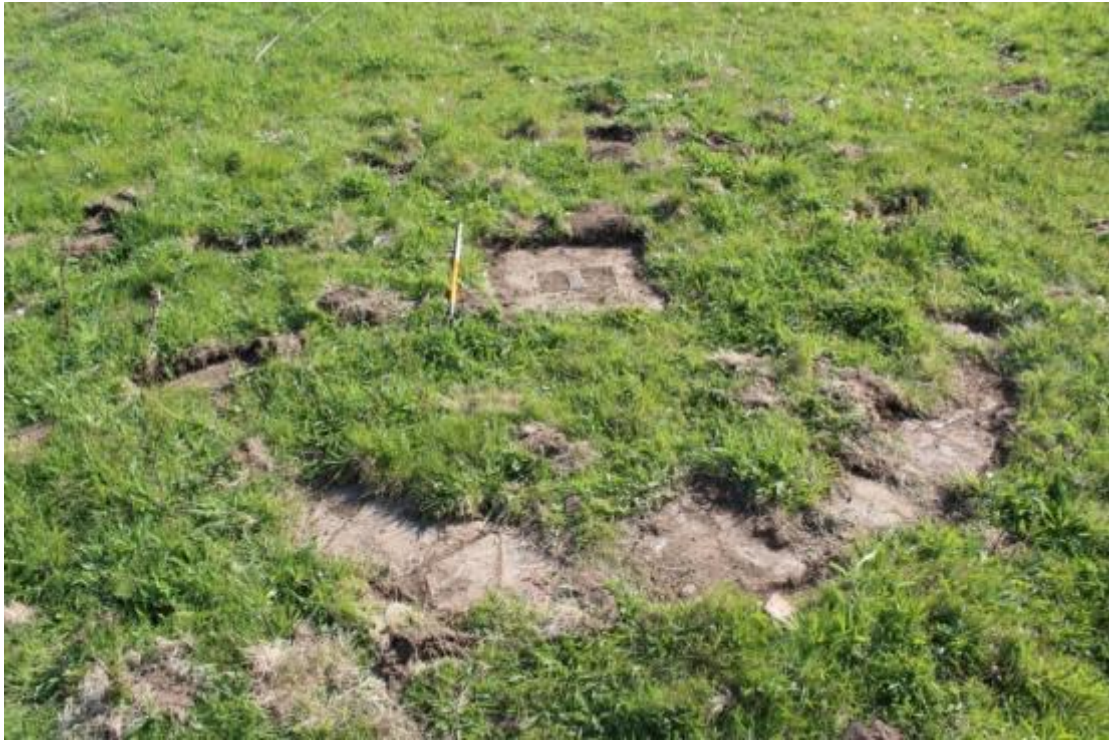
Photo 53: View south at partially uncovered flag plinth.

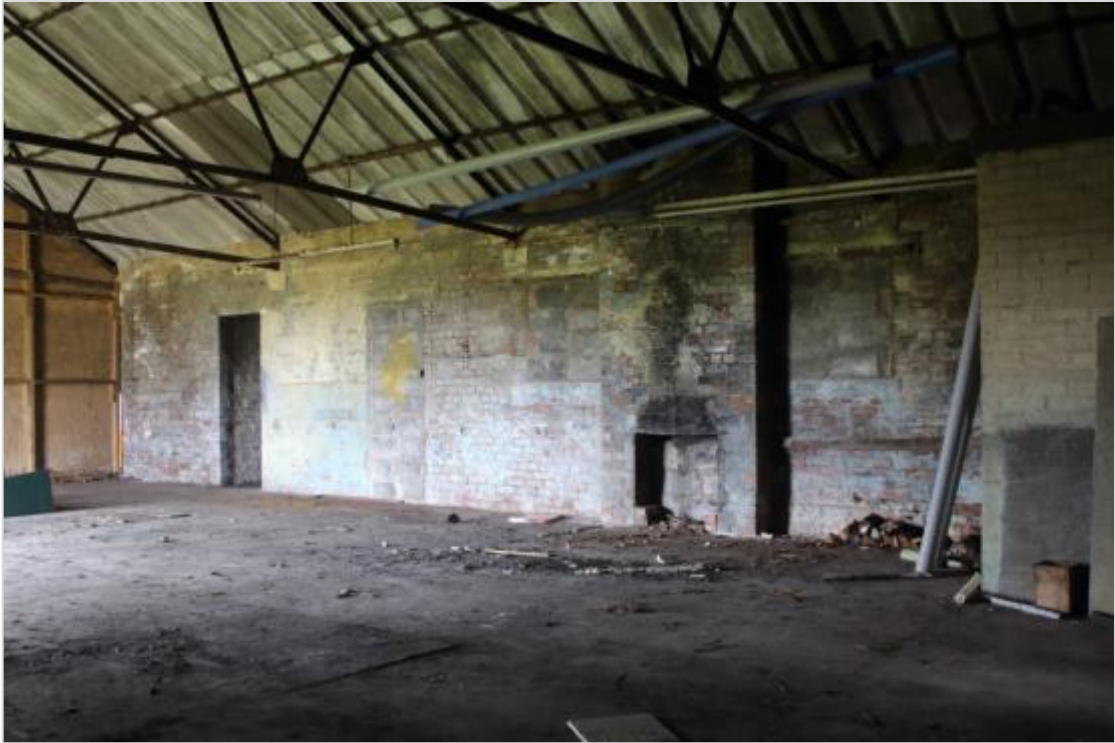
Photo 65: View southwest; oblique shot of west wall.

- 3.5 Access into the building is via one of two steel garage doors.
- 3.6 The interior consists of a main hall with a concrete floor, within which is a covered inspection pit. The hall contains two fireplaces (Photo 65); the fireplace associated with the chimney in the south wall cannot be seen from within the hall and is possibly situated in the garage at the south side of the building. At the north end of the hall a door opens into a small corridor. The wall and the floor of the room directly in front of this door has been removed (Photo 69), revealing a fireplace at the north end of the building.

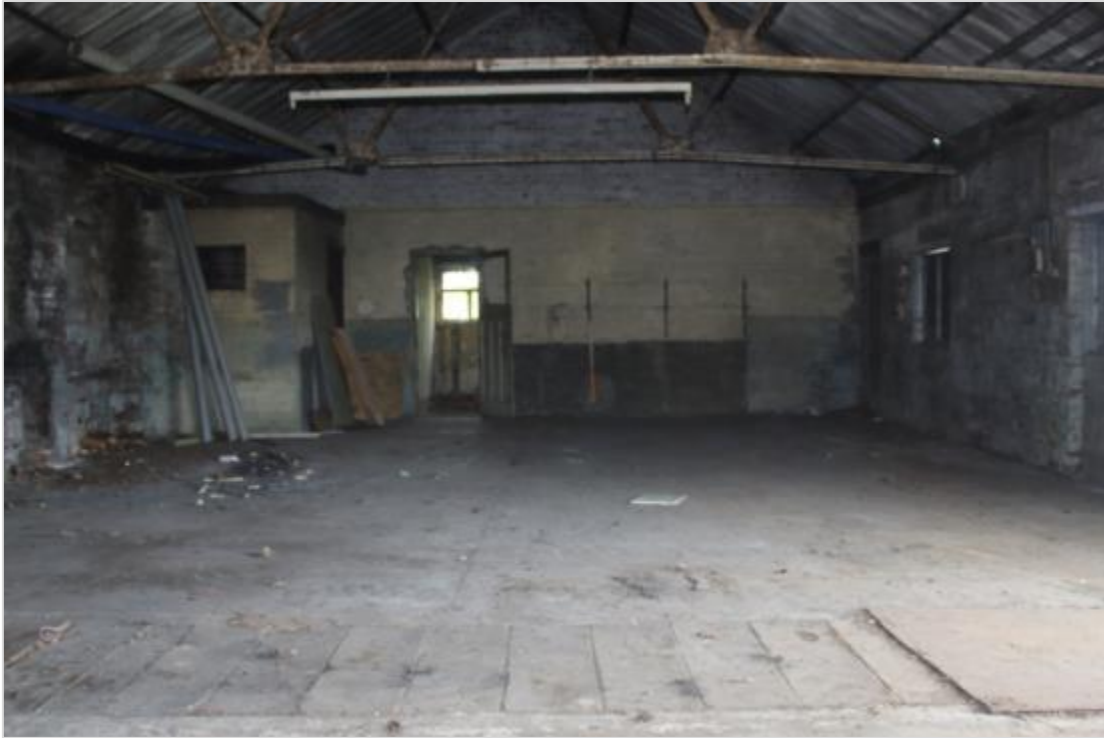
Photo 67: North wall of main room (door leads to two small rooms and toilet block).

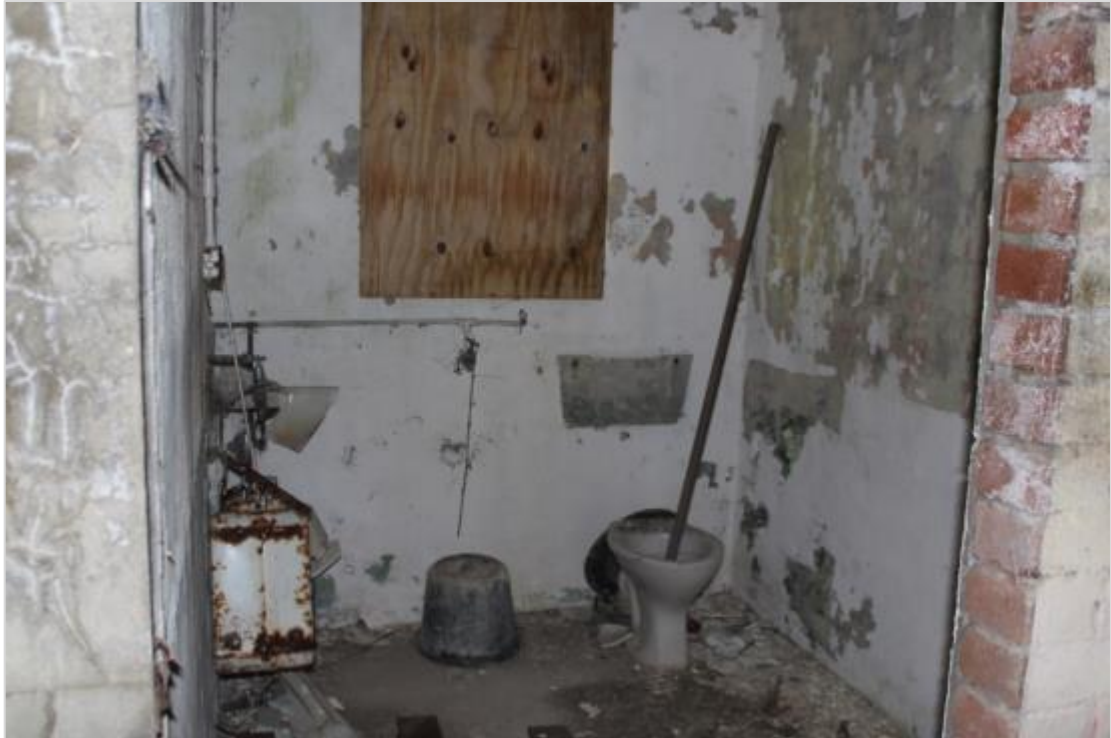
Photo 71: Toilet cubicle located at north end of building.

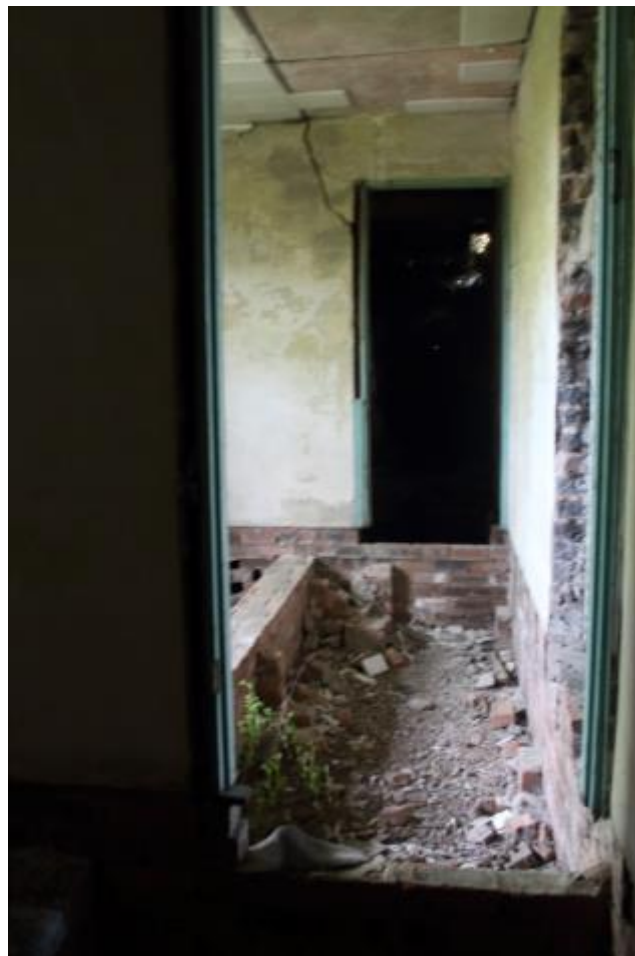
Photo 72: Corridor leading to toilet block from main room.
