YMCA, LLANELLI, CARMARTHENSHIRE

HISTORIC BUILDING RECORDING

REPORT NO. 2020-47
EVENT RECORD No.125512

September 2020

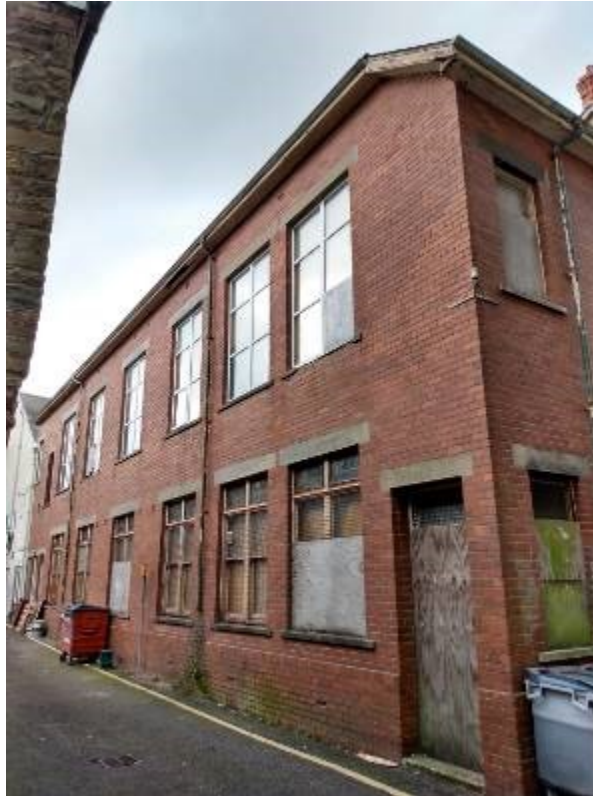
Photo 9: West facing shot of the rear elevation to the YMCA, showing the later mid-20th century extension.

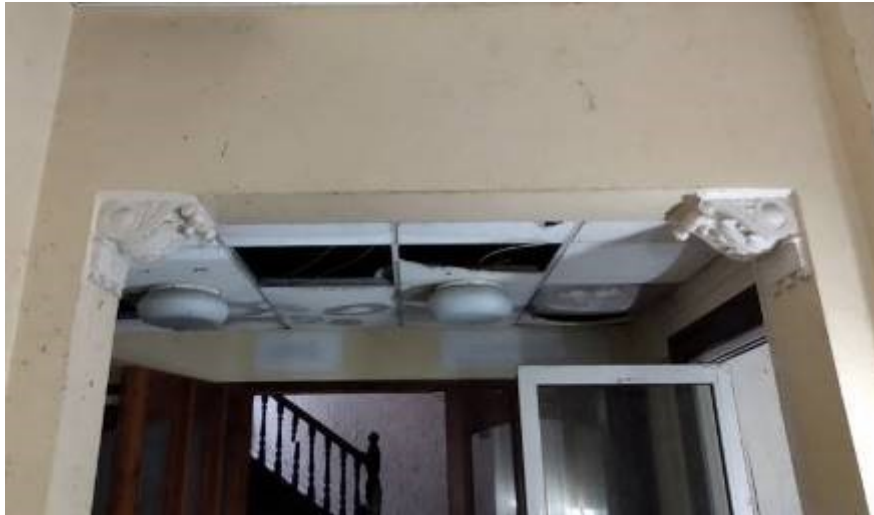
Photo 12: Southeast facing shot into the stairway hall, with original decorative corbels retained.

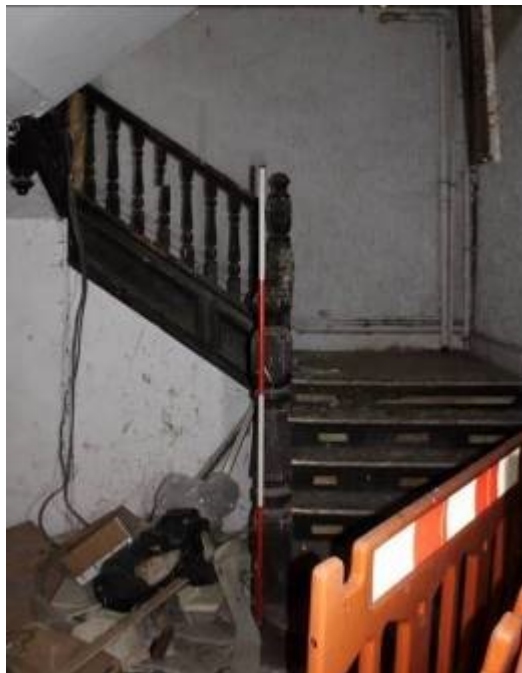
Photo 13: Southeast facing shot of the foot of the main stairs. 2m scale.

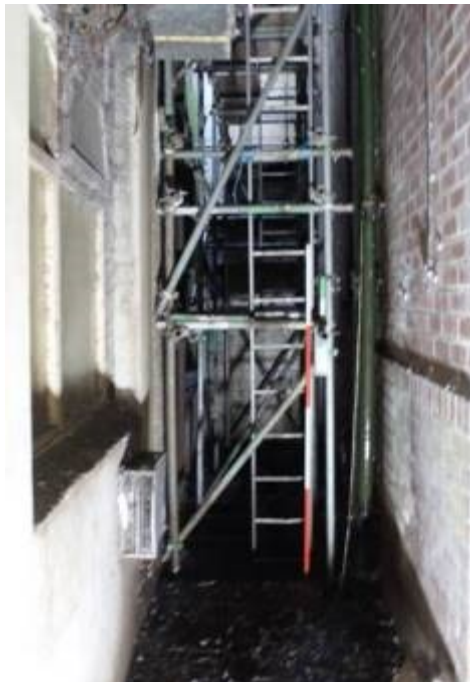
4.2.6 To the south of the kitchen lies a rear passage, which may have run between the original building and the later extension, although the eastern part of the passage has been incorporated into the extended building. At the western end the area is infilled with scaffolding, but natural light come in from corrugated plastic sheeting at roof level. A doorway opens to a rear access area to the southeast, along the south-western side of the building.

Photo 20: Northeast facing shot of formerly rear, now internal, passageway. Kitchen window visible on the left. 2m scale.

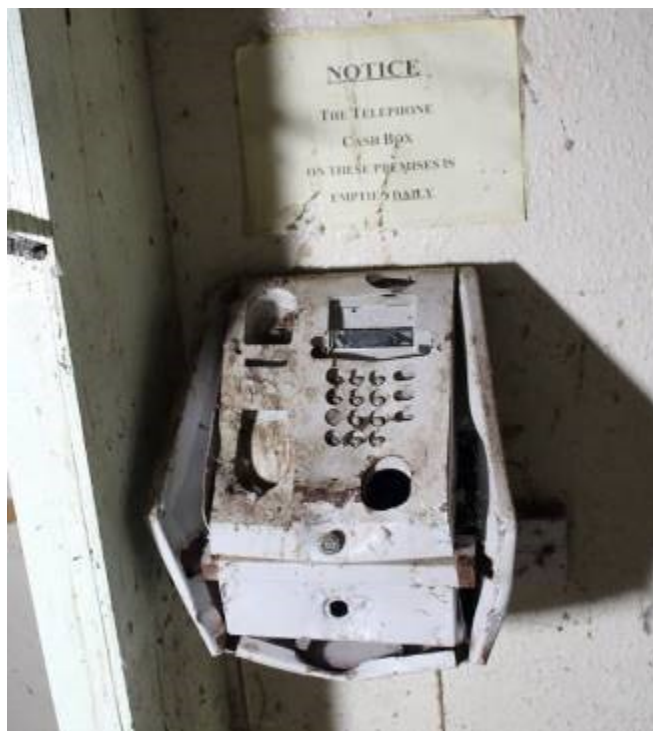
Photo 23: Payphone within the adjoining side room.

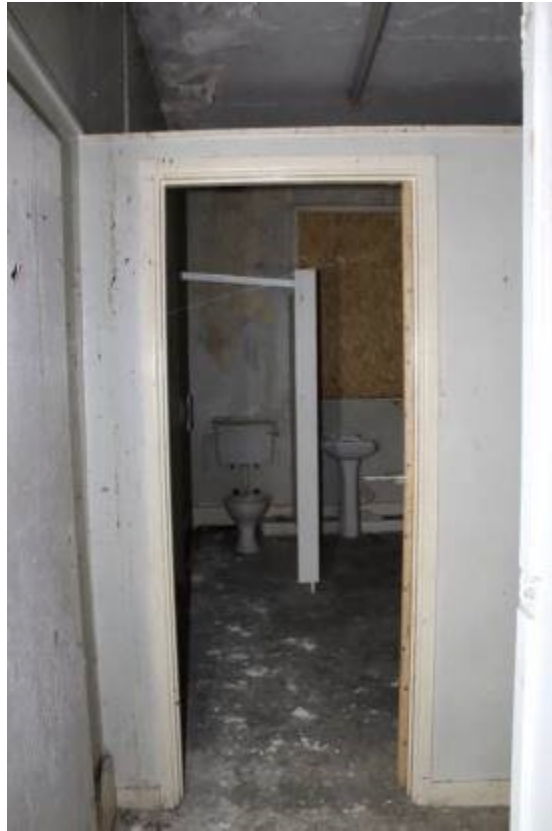
- 4.3.6 The space between the original building and rear extension contains WC units, with modern WC furniture in plain plastered rooms. A boarded window unit lies in the outer northeast wall.

Photo 41: WC unit contained in the infill between original building and later extension.

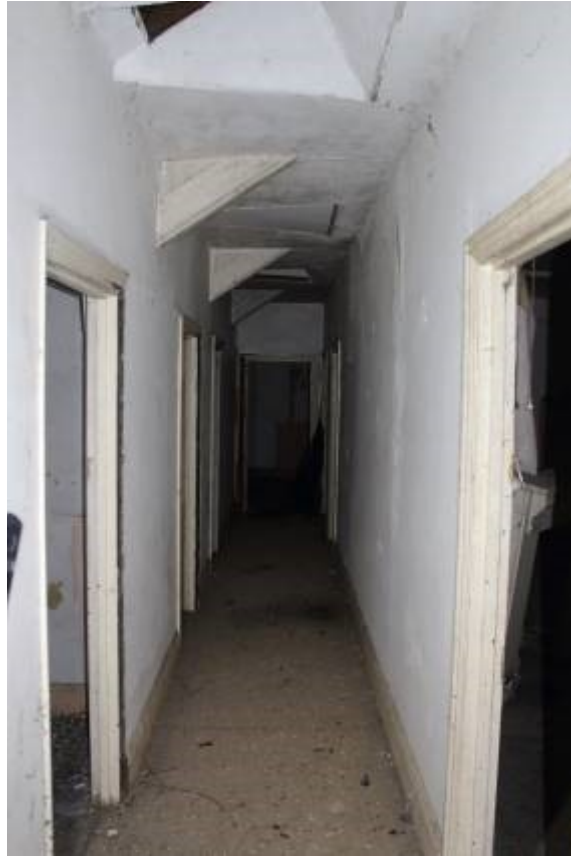
Photo 56: Southwest facing shot down the central 3rd floor corridor.

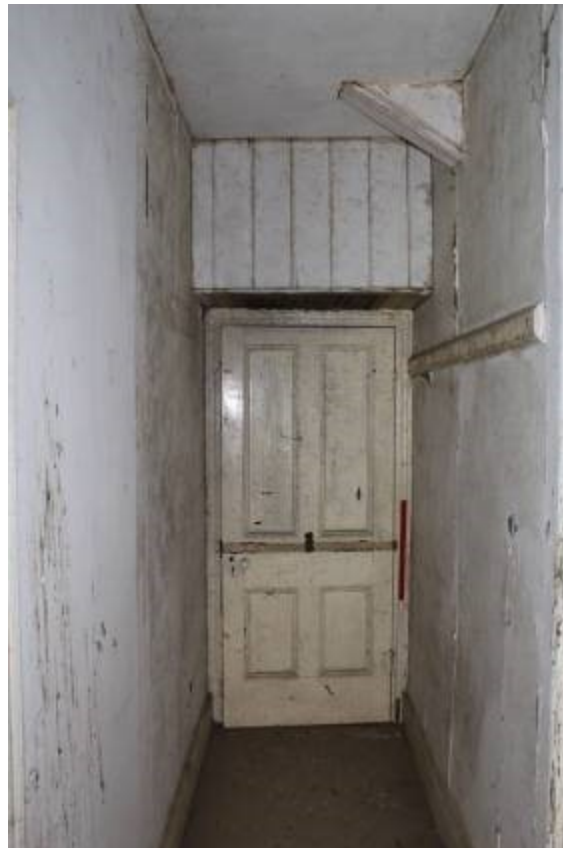
Photo 57: Northeast facing shot along the central 3rd floor corridor, showing the door enclosing the otherwise open dumbwaiter shaft. 2m scale.

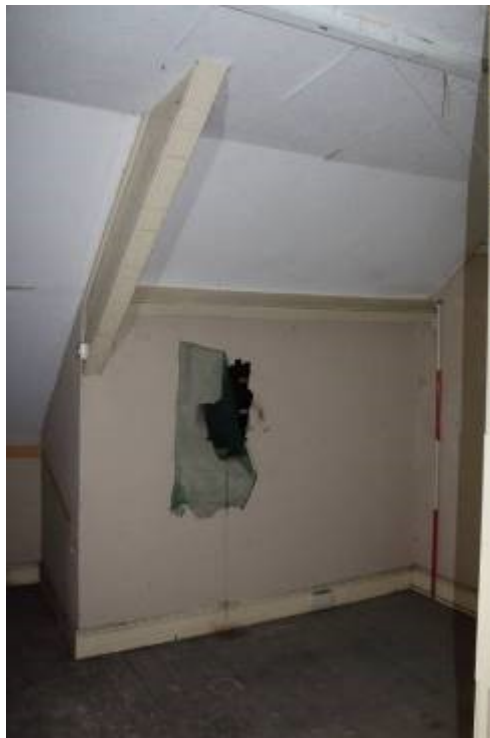
- 4.5.3 The northeast frontage room has a low skirting, plain papered walls, plain sloping ceiling with encased main rafters exposed.

Photo 59: Northeast facing shot of the 3rd floor northeast frontage room. 2 scale.

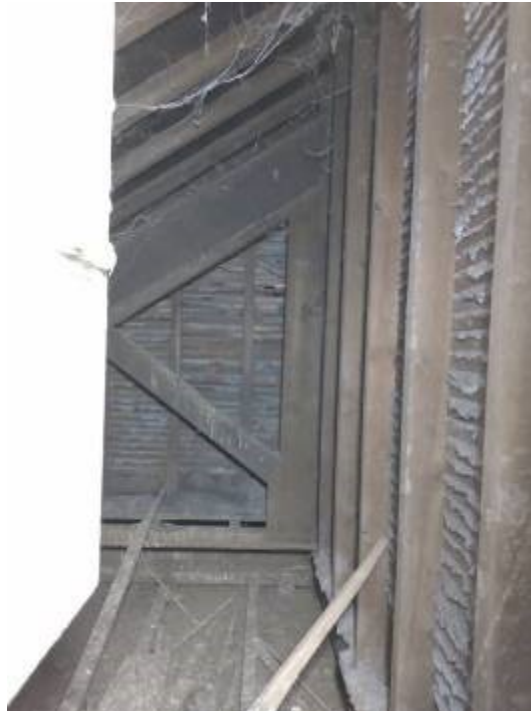
Photo 61: Northeast facing shot of the roof space accessible from the central frontage room.

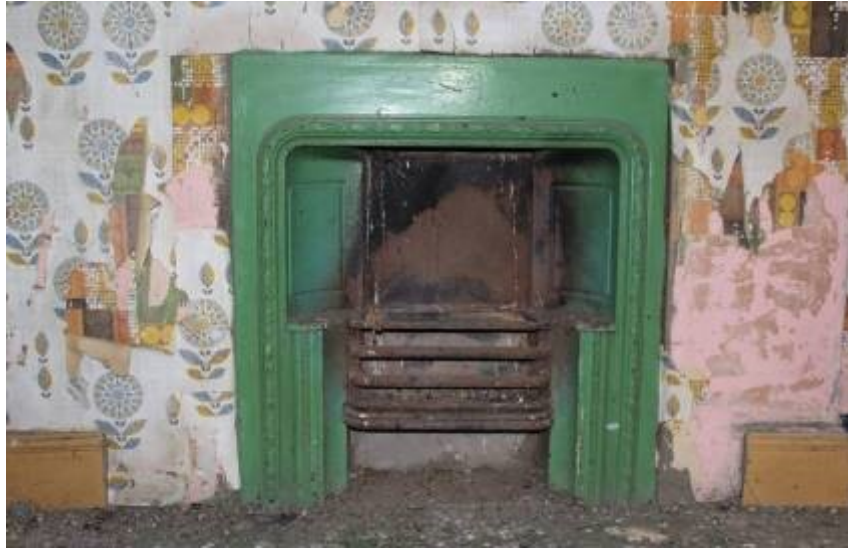
- 4.5.5 The southwest frontage room has a picture rail, and fireplace in the southwest wall, a small roof light block by the current roof covering. A cast iron fireplace sits within a green-painted cast iron surround with decorative band around the fireplace. An enclosed storeroom has been built into northwest side of the room. Wood boarding surrounds a fire escape in the western corner, which accesses an aluminium staircase to the flat roof of the fifth bay unit.

Photo 63: Detail of the fireplace in the 3rd floor southwest frontage room.

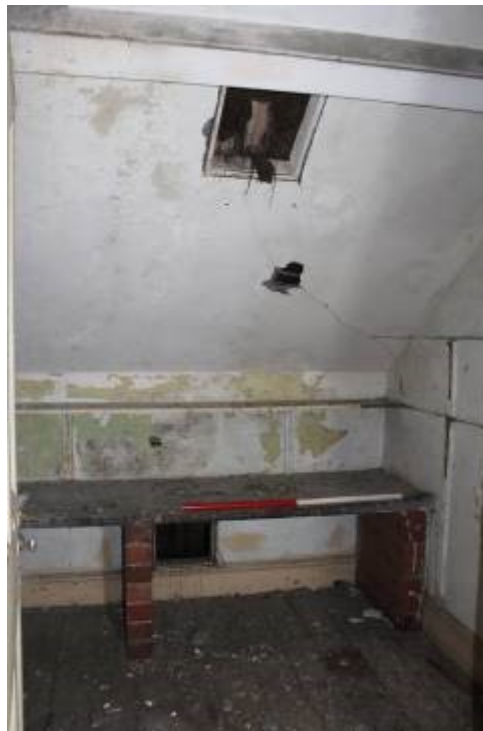
4.5.6 Five rooms of identical size line the southeast side of the building, all accessed via plain doors, subdivided by lathe and plaster walling, a plain sloping ceiling with small square roof lights in the slope, blocked by the current roof covering. Within the north-eastern room a slate bench sits on brick supports, lining the southeast wall, with a small square loft access below. The adjacent room has a taller loft access, with an oven lying on the otherwise featureless floor. The central room has no loft access, with airplane wallpaper on the walling, the images dating from the 1950s/60s. The two southwest units are combined into a single room, with a partial central division. The room is generally featureless other than a small water tank against the southwest wall.

Photo 64: Southeast facing shot of the 3rd floor rear room with slate shelf to the rear. 1m scale.
