**DYFED COASTAL PROMONTORY FORT  
ASSESSMENT 1993-1994  
D.A.T. P.R.N. 14798**

**March 1994**

**P. Crane BA (Hons)  
Dyfed Archaeological Trust Ltd.  
The Old Palace, Abergwili, Carmarthen,  
Dyfed SA31 2JR. Tel 0267 231667**

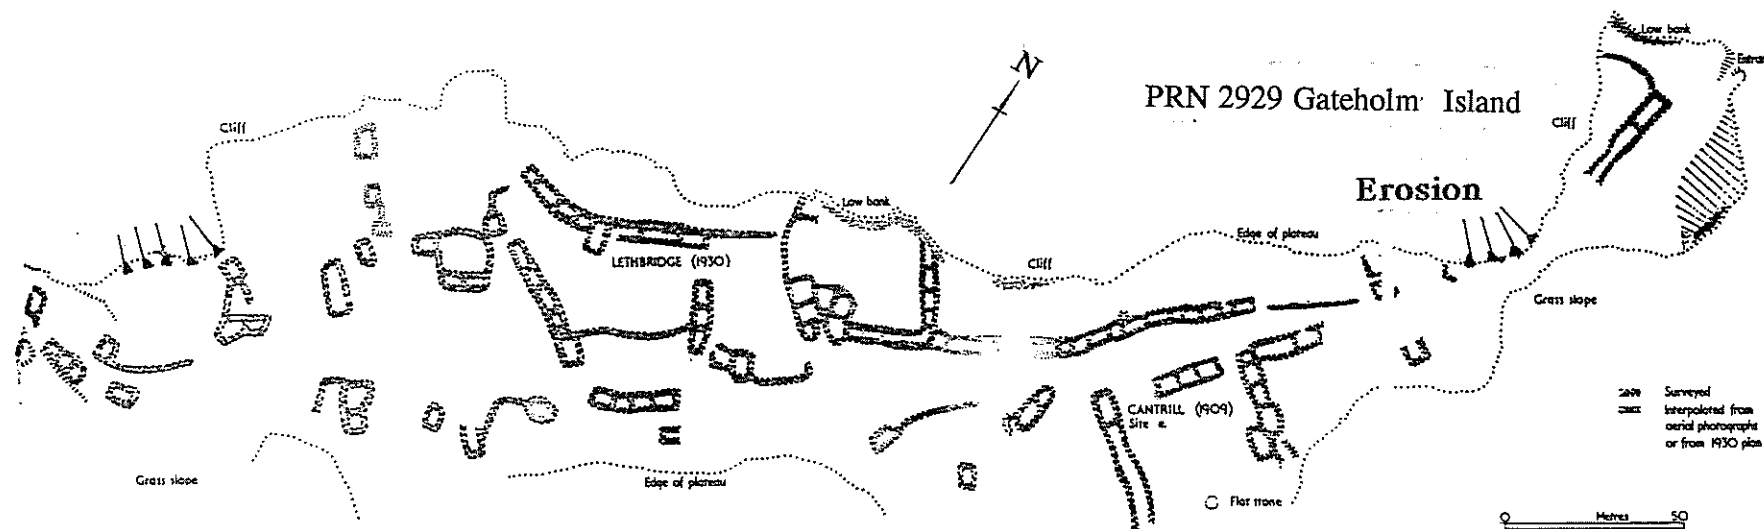
Figure 5

Notes: Still very good grass cover. No grazing, some bird burrow disturbance. Erosion confined to cliff edges especially on northern coast of island. Areas of major cliff erosion have been marked on the field map (Figure 5).
