# DYFED ARCHAEOLOGICAL TRUST LTD

## RUSTIC ALCOVE **HAFOD** CEREDIGION

ARCHAEOLOGICAL EVALUATION  
Project Record No. 32476  
MAY 1996

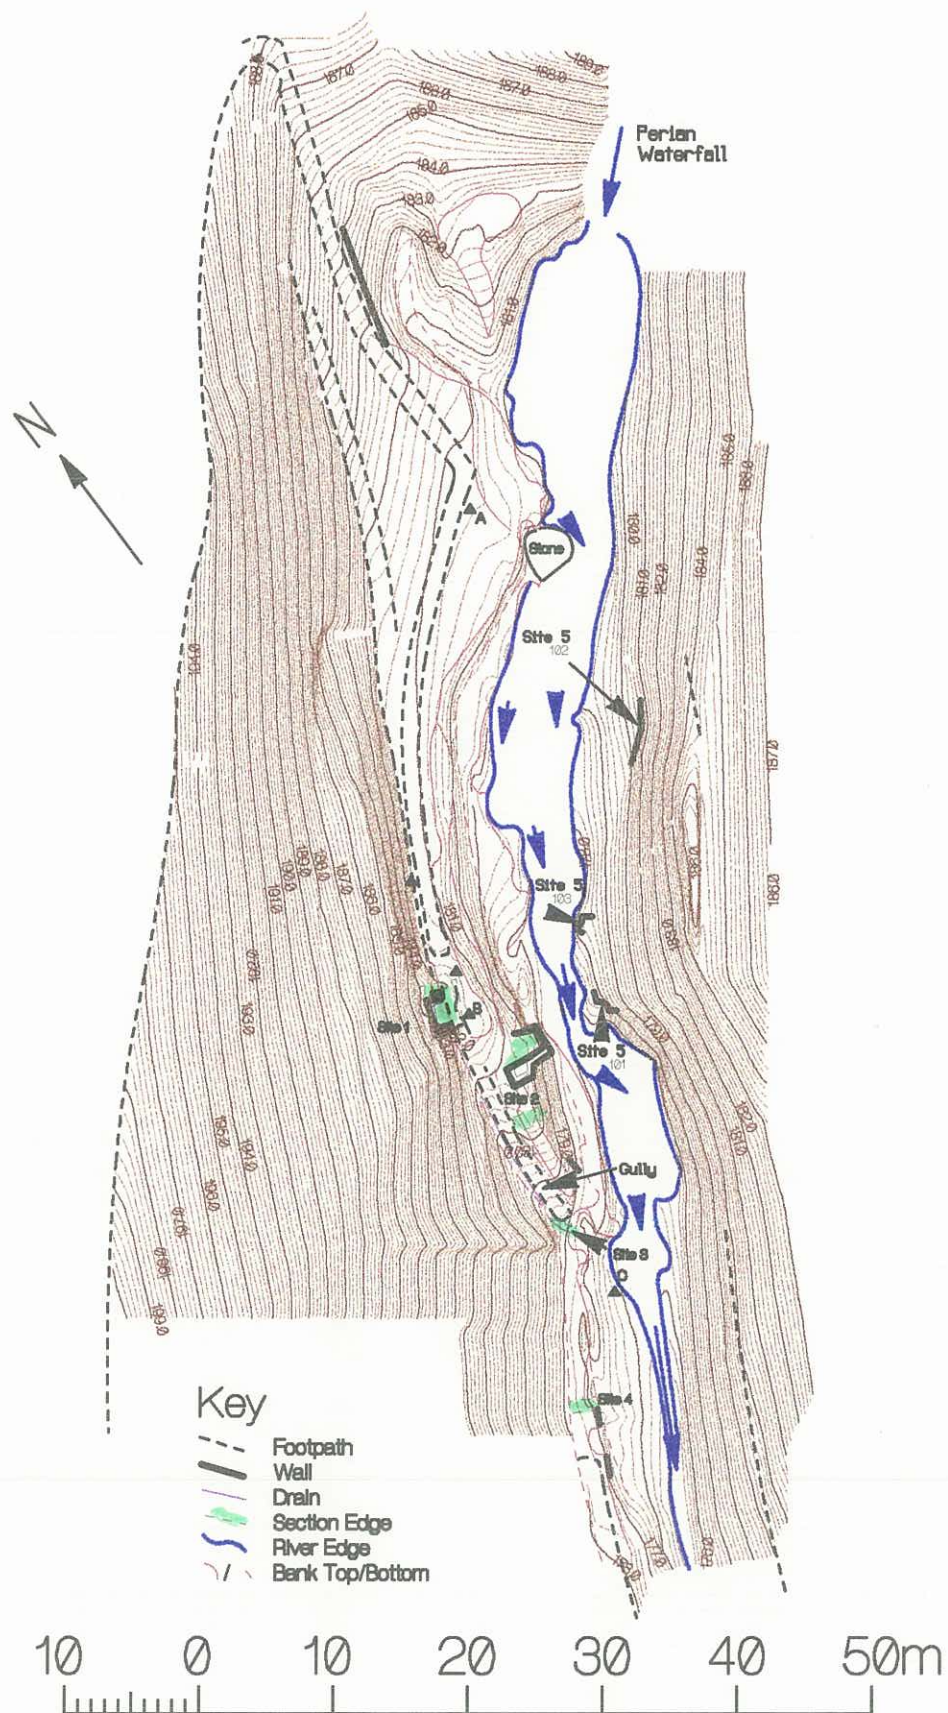
Figure 2

A bridge here is likely to have become redundant after the possibly later construction of the gullied part of the Ladies' Walk between Site 2 and Site 3 (figure 2). The reason for the construction of this gully walk could have been the unstable south eastern hillside, where there was evidence of several landslips, blocking the footpaths on that side.

- a. from the gazebo (Site 1) to the culvert of Site 3 and all of that segment from there out to the stream, including the bridge pier base of Site 2;
- b. on the opposite side of the stream, walls 101 and 103 and surrounding areas (figure 2);
- c. the area of the stream bed and adjacent banks from the waterfall down to the probable bridge at Site 2 (figure 1).

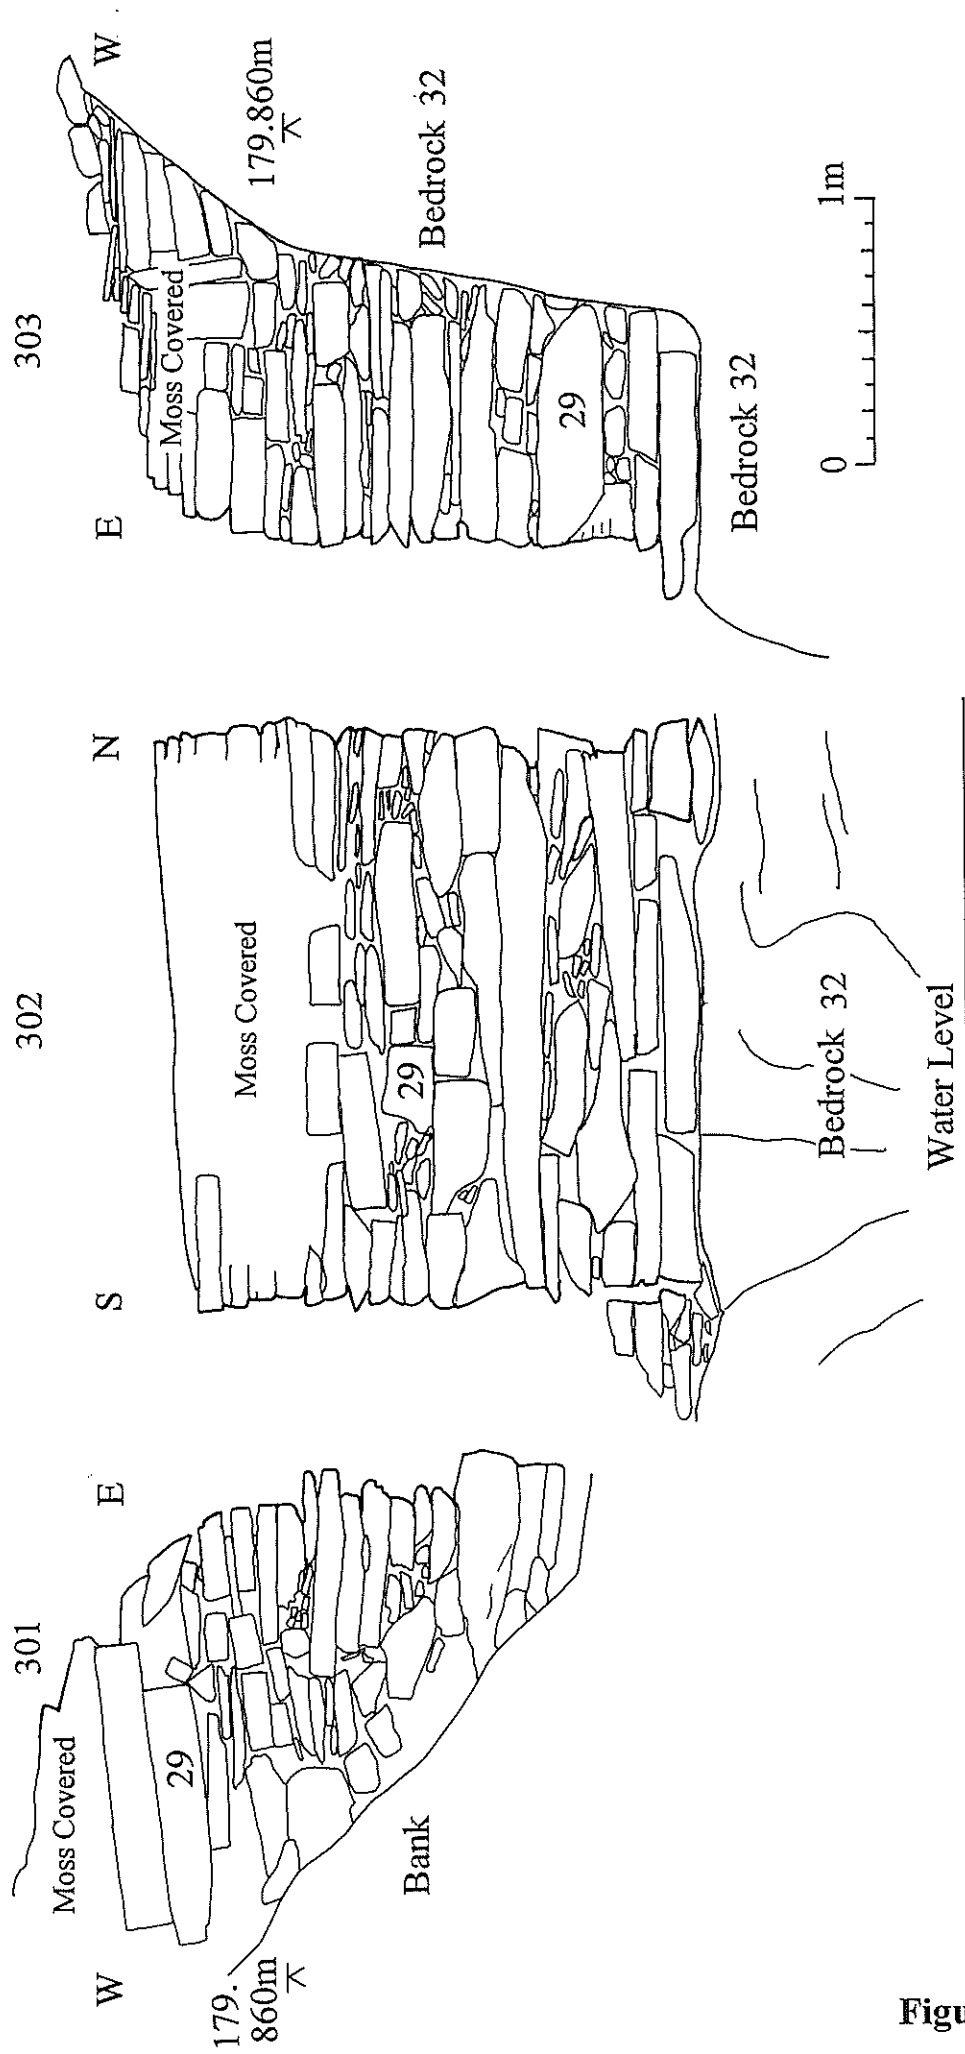
Figure 6

The earliest structure was that of a drystone pier 2.2m wide, 1.8m above the bedrock and projecting at least 1.6m out from the top of the stream bank (figure 10). It was constructed on bedrock which, in the area above the stream, appeared to have been cut to form part of the footings, and also into or on the natural clay bank/hillside material. There was no evidence for timber features in or on the surviving structure (figures 5 and 11). Stone by stone drawings (301-303, figure 6) were made of the elevations; moss cover was left intact where present.
