**HAFOD: CAE GWARTHEG FELLING  
(RECORD NO. 35850)  
ARCHAEOLOGICAL RECOMMENDATIONS**

**Report commissioned by: Forest Enterprise  
Report by: K Murphy BA MIFA**

HAFOD: CAE GWARTHEG FELLING (35850)  
ARCHAEOLOGICAL RECOMMENDATIONS

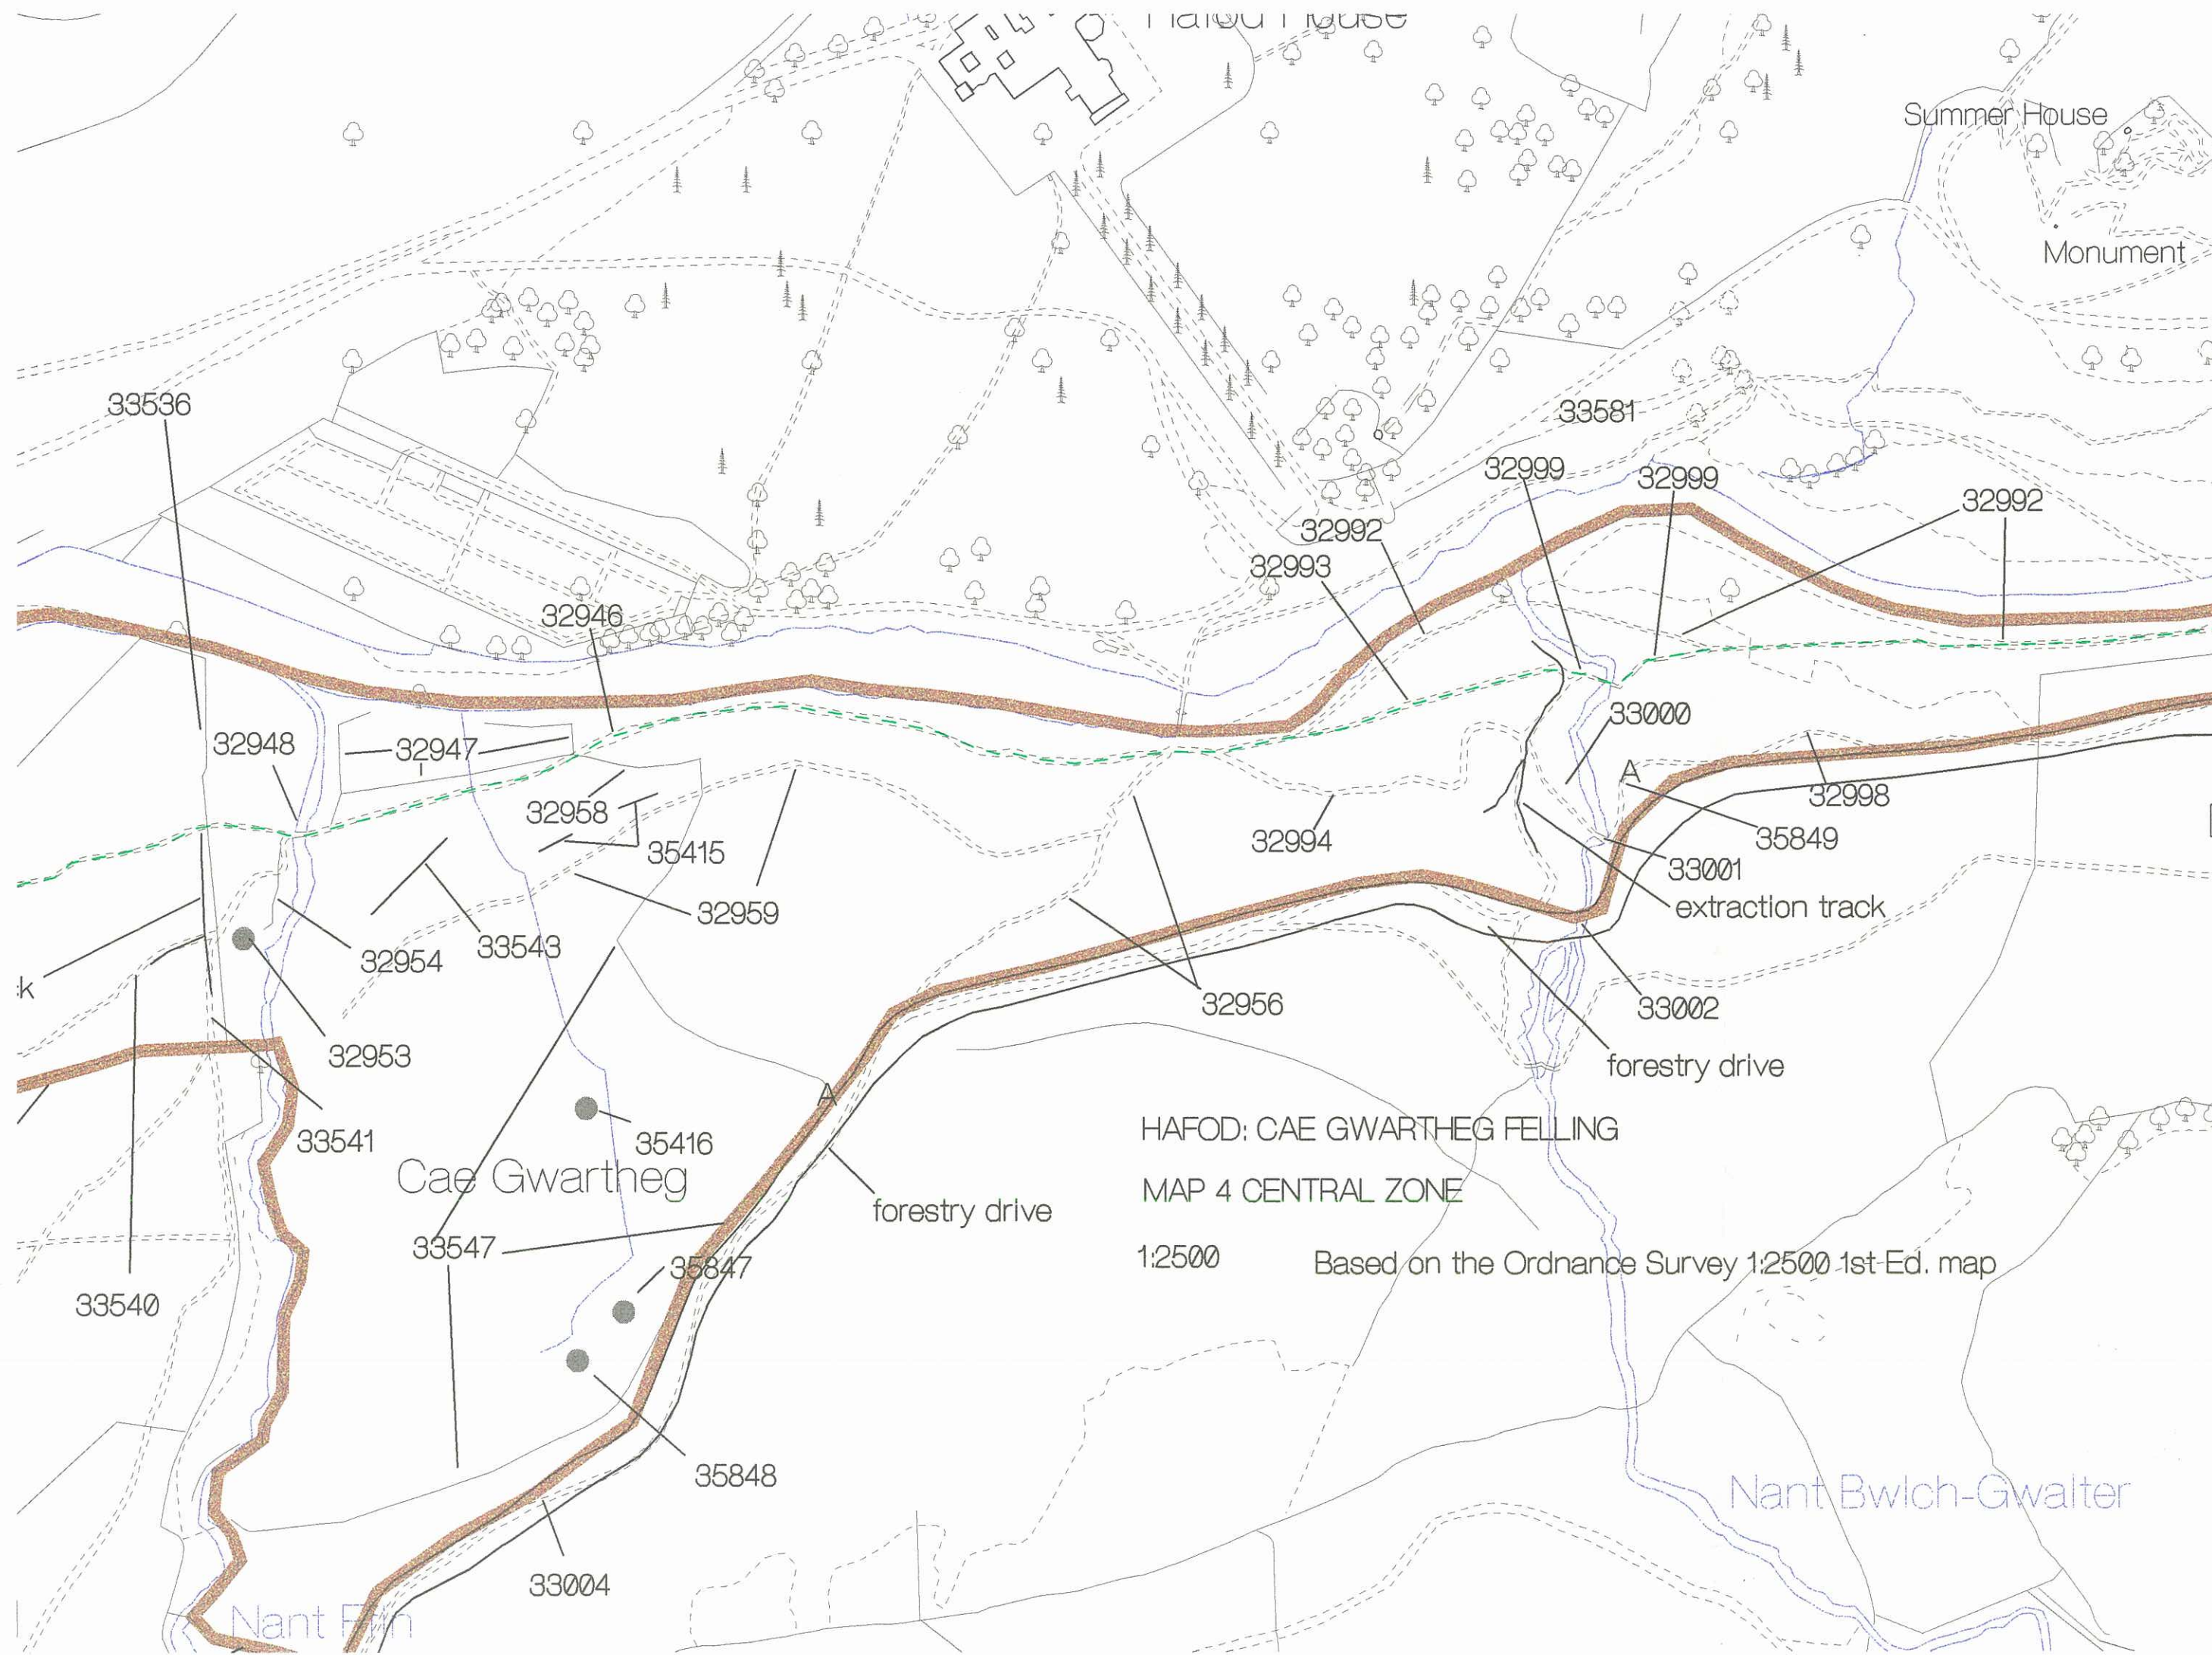
PHOTO. 44

**32997. Track** (Photos. 40, 42-44. 40 shows hollow-way and junction with path 32992, 42 & 43 the junction of this track and the forestry drive, 44 the causeway element of the track). This track is well-defined. At its eastern end it now runs down from a forestry drive and then along a low causeway with a steep drop on the northern side down to the flood plain of the Ystwyth. At its western end it runs in a slight hollow-way down to the flood plain to a fording place of the Ystwyth. This track forms part of the Hafod circular walk and is a public footpath. It is a robust element of the historic landscape.

*Recommendations:* If this track is to be used during felling operations, then action should be taken to prevent deep rutting by wheeled vehicles during wet conditions. Rutting could be a particular problem in the hollow-way where there is surface water. Here it is recommended that a hard-wearing surface is constructed.
