A PRELIMINARY SURVEY  
OF  
**HAFOD ICEHOUSE**  
RECORD NO. 26535

**REPORT NO. 35948**

Commissioned by: Hafod Trust

## **HAFOD ICEHOUSE (Hafod Archaeological Database No. 26535) A PRELIMINARY SURVEY**

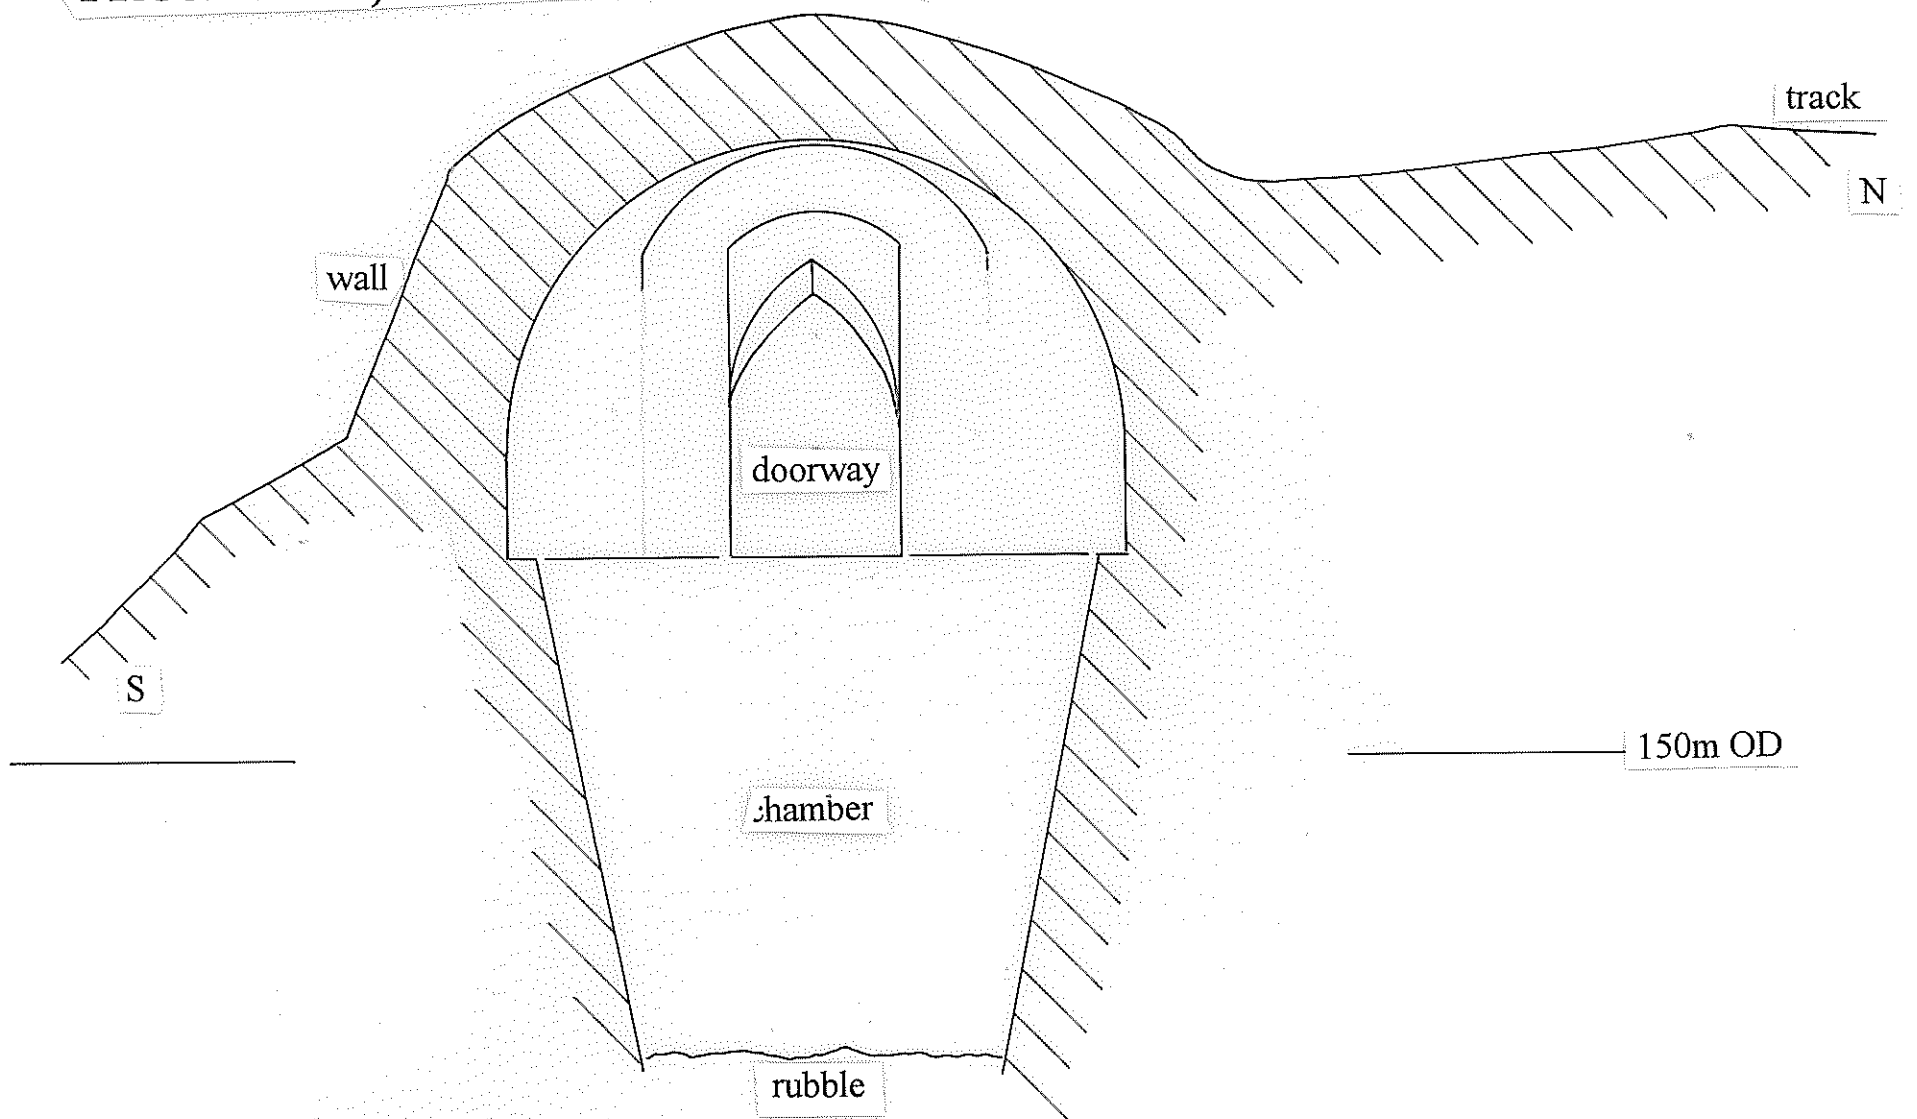
# EAST-WEST SECTION SHOWING DOORWAY (PROJECTED)

The interior of the chamber and dome of the icehouse is in very good condition. There is no evidence of root penetration from the shrubs growing above. It is built of coursed rubble. The chamber is cone-shaped, 3.35m diameter at the top narrowing down to c. 2.15m at the lowest visible point. Its depth down to rubble which fills its lower levels is 3.3m. This rubble is of unknown depth and presumably fills a sump and drain. The dome is 3.7m across at its base and is estimated to be semi-hemispherical in shape (it was not possible to conduct detailed measurements). Despite the step at the junction of the chamber and dome, there is no reason to suspect that they were not of one build.

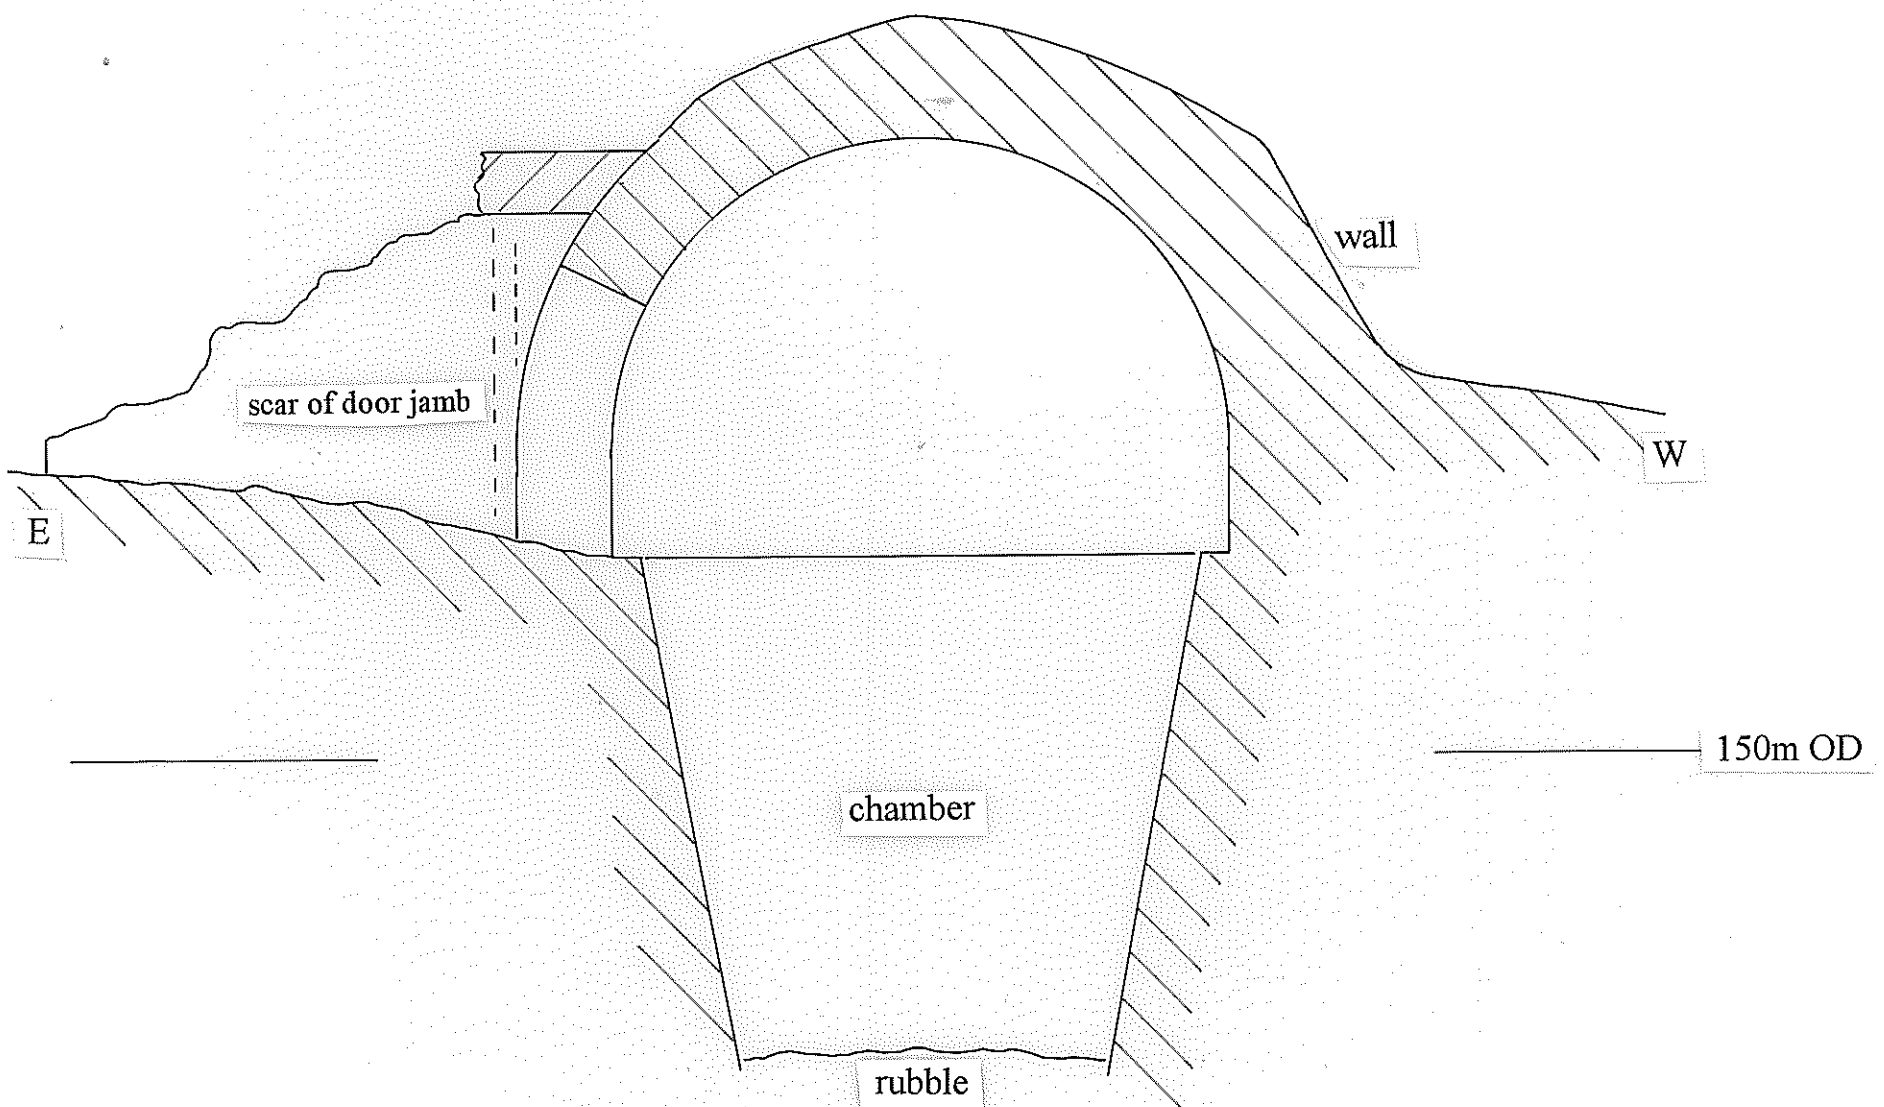
## NORTH-SOUTH SECTION

The icehouse entrance passageway is in a very poor state of repair: the stone vaulting has collapsed apart from a c. 1m section adjoining the icehouse's dome, much dilapidation has occurred to the stone-built side walls (the north wall in particular) and rubble has accumulated in the passageway. Nevertheless, it is possible to detect the original plan. The passageway was 3.9m long, 1.1m wide, 1.9m high and built of coursed rubble. A mortar scar of a removed door jamb is visible adjoining the chamber. The walls of the passageway are butt-joined onto the masonry of the chamber, but this is probably a reflection of the building technique employed rather than of chronological significance.

**Short term:** to prevent further decay to the passageway, repointing of the side walls is required.
