BURRY PORT HARBOUR

AN INITIAL ARCHAEOLOGICAL ASSESSMENT

PART 2 - ILLUSTRATIONS

Project Record No. 36920

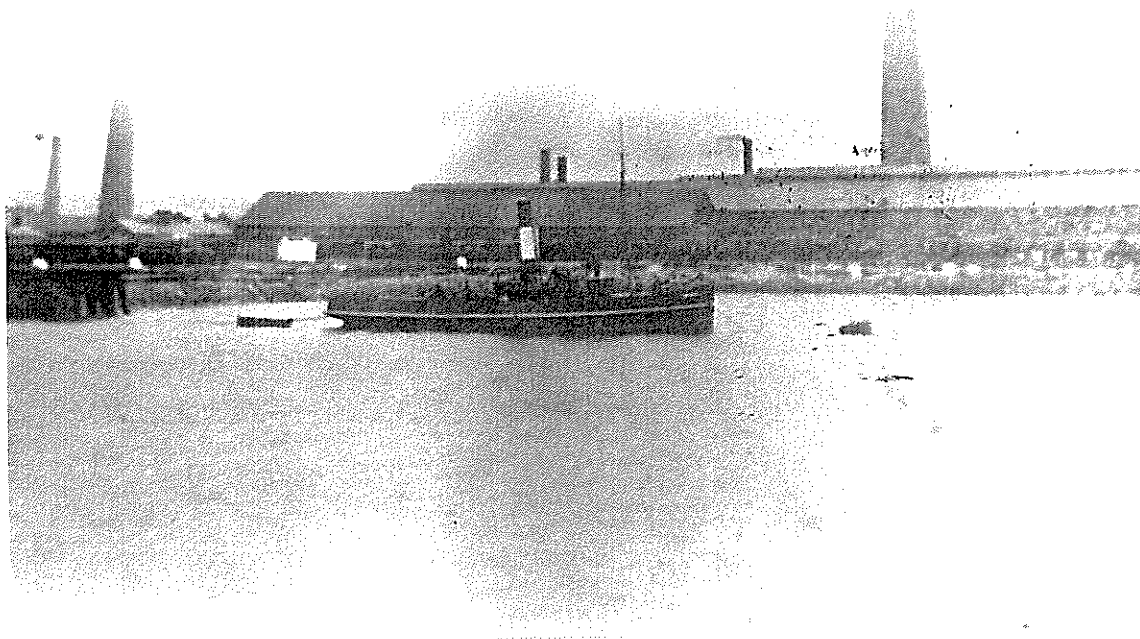
Plate 1. The east side of the Outer Harbour c.1900 (from a private photograph collection of J. W. Williams, Harbourmaster, Burry Port).

The original stacks are said to have been very small and according to Thomas, 1937, 15-16, the setting out of new large stack was commenced; however, there is an 'old record of a high chimney bearing the date 1847' (National Monuments Record). The stack was 60ft square at the base, on a 30ft thick concrete bed on which a stone course was laid and then the stack itself, which was 280ft high, of Bridgewater bricks lined by New Lodge Colliery fireclay bricks (Thomas, 1937, 15-16). It was completed in 1852 and was the 'highest stack in the kingdom', still a prominent landmark in 1937 (*ibid.*), and is shown in Plate 1.

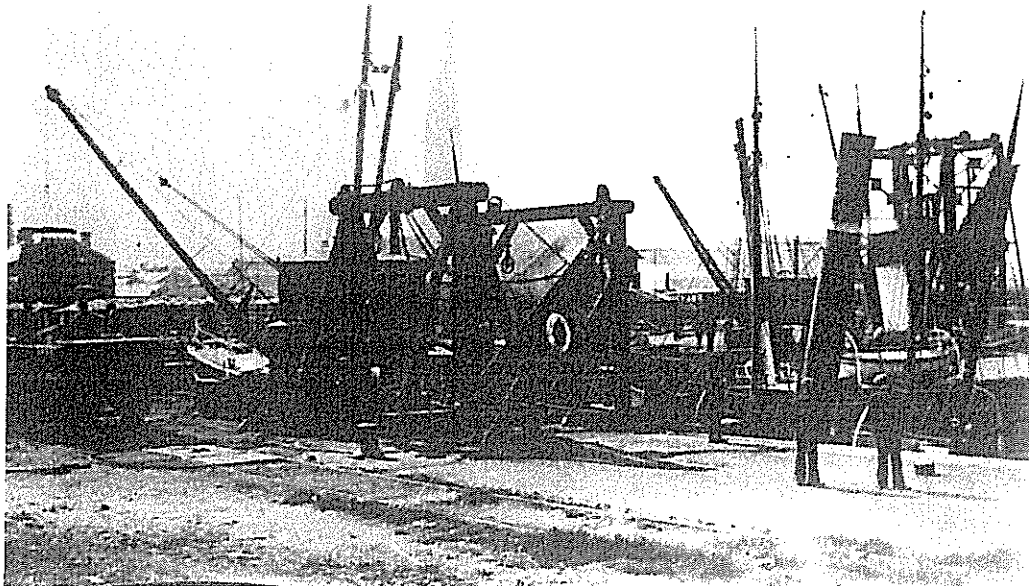
Plate 3. Timber wagon-tipper at Burry Port harbour c.1900 (reproduced from Nicholson, 1991).

Timber coal-wagon tippers were installed at the dock in 1840 (Nicholson, 1991, 132). These were supplied by harbour railway lines and physically tipped the coal-wagons up, emptying their cargo into the vessels at the harbourside below (Plate 3). Both the 1855 and c.1864 maps (see above) depict two projections, clearly representing coal-tippers, on the east side, and one on the north side of the dock. The rail supply network is unfortunately not fully shown, but a line appears to run, from the east, up to the lock. Both maps also clearly show the lock gates in the chases that exist today. The massive battered sea-wall that lies at the base of the harbour walls is also suggested, and thus appears to be an early addition, though secondary (see below). The Ordnance Survey 1:10560 of 1880 shows the East Dock is in more-or-less its final form, and the battered sea-wall is clearly depicted. Coal-tippers are shown as in 1855 and c.1864, but there were, in addition, two on the dividing quay on the west side; the harbour railway lines to each tipper are clearly shown. The label 'WHARF' lies on the east side; however, no line is shown crossing the central 'island' to the west side of the harbour. Three timber tippers, two on the west side and one on the east, were still present in 1900 (Nicholson, 1991, 132).

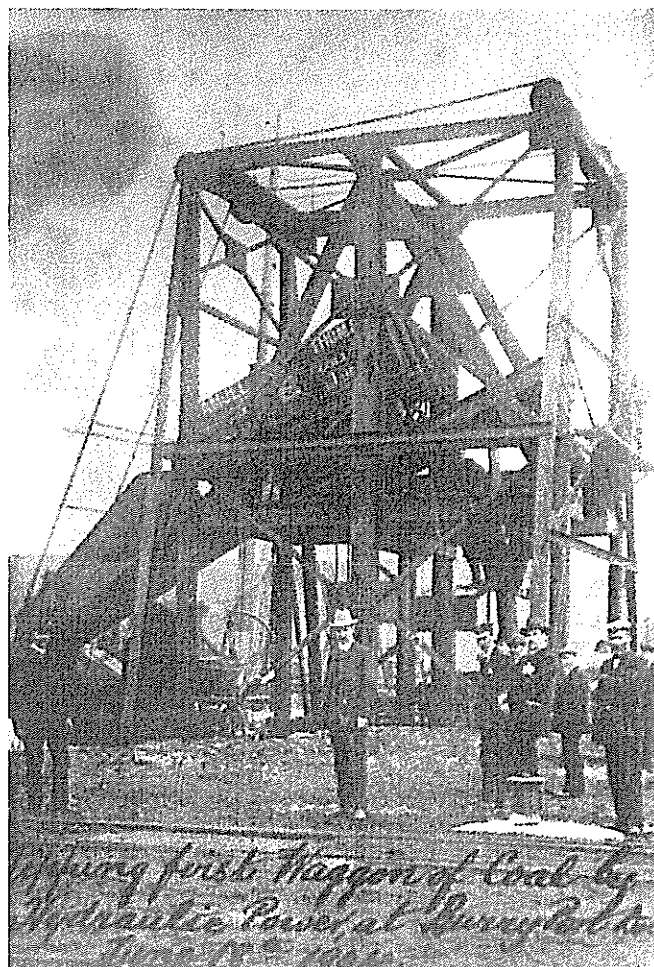
Plate 4. Hydraulic hoist at Burry Port harbour (reproduced from Nicholson, 1991).

The tippers were replaced, in 1904, by two hydraulic steel hoists (Plate 4), one on each side of the East Dock and powered by a contemporary generating plant (Nicholson, 1991, 136). They were made by Tunnett and Walker & Co. of Leeds, who also installed a turntable, weigh-bridge, hydraulic capstan and a hydraulic crane of both sides of the dock (*ibid.*). The dock was dredged in the same year, when the battered base may have been concreted and the massive apron, that was discovered beneath the silt of the Outer Harbour in 1947-8, was laid up to the lock gate (*ibid.*). New lock gates were fitted in 1905-6 (*ibid.*), allowing ships of up to 1800 tons to enter (Kelly, 1926, 151).
