YSTRAD EINION LEAD MINE, CEREDIGION

Report on Archaeological Recording by Dyfed Archaeological Trust during a Derelict Land Reclamation Scheme .

Report by H. J. James
& D. H. Phillips

June 1994.

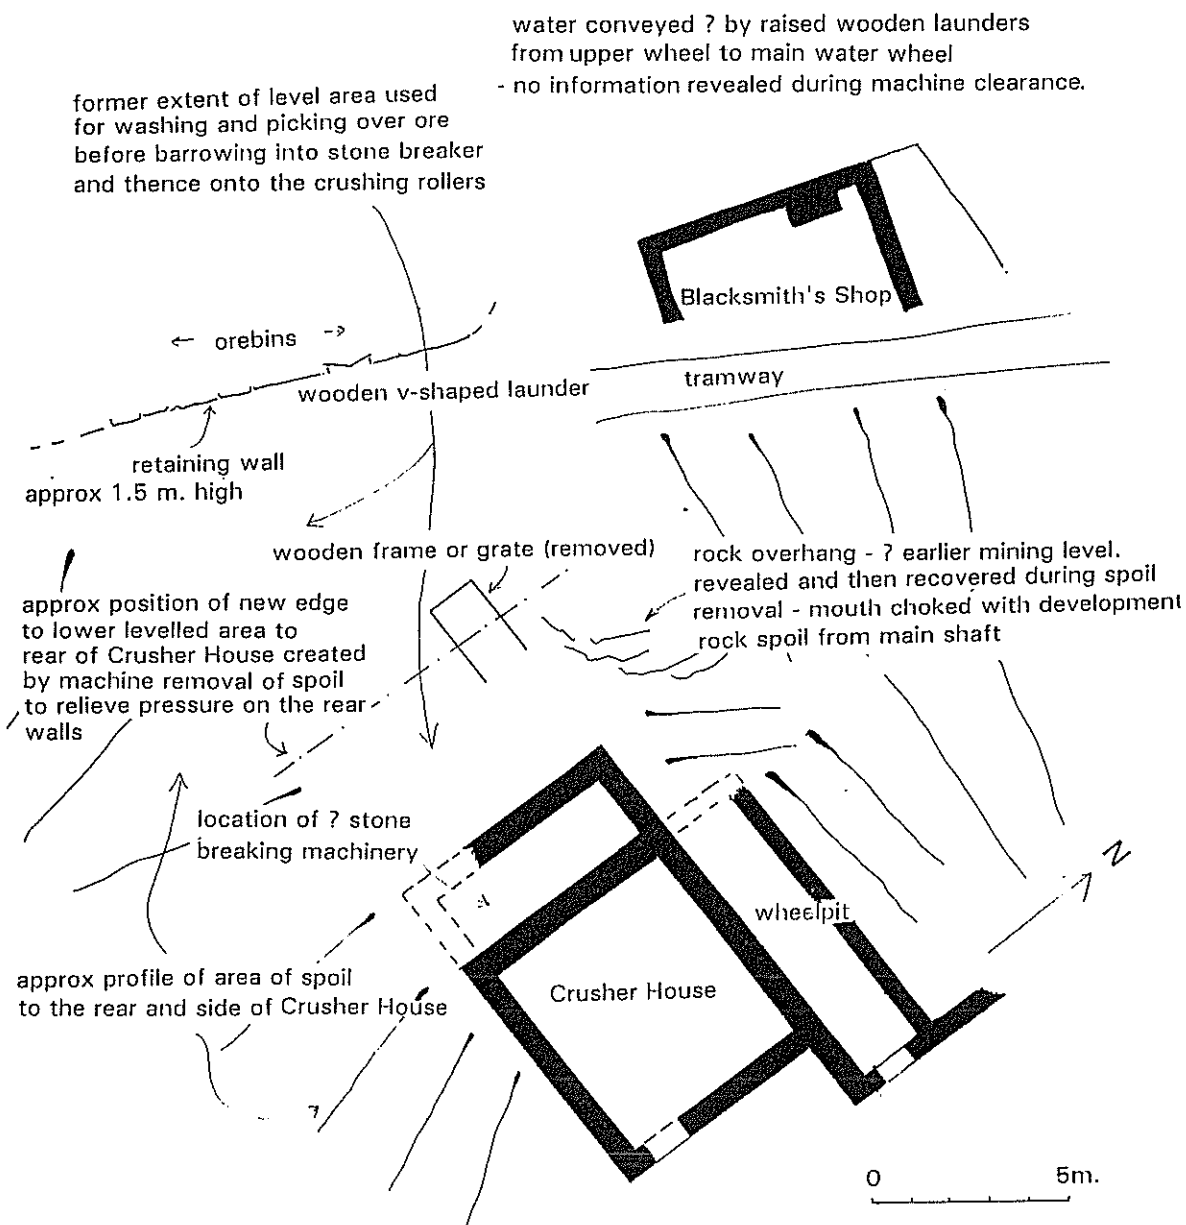
Fig. 9. Annotated plan (1:200) of area between the Orebins and the Crusher House. Block outlines of buildings taken from DCC's 1:200 site plan, all other information by DAT following on-site survey and recording.

3.3.2. The revetment wall in front of the ore-slides or bins was of two phases of build (see Film D' 12 & 13). This has been described above in the opening descriptive section. In front of the revetted face of the oreslides and the 'v' shaped wooden launder piercing the walling was a levelled rectangular terrace accessed on its northern side by the tramway and bounded on its southern side by the steep, unstable slopes of a spoil tip. The terraced working area has now been cut back a little and the area in front of it now been regraded to a more stable angle. It is now bounded to the south by flights of wooden steps to give access to the main shaft from the forestry road on the southern side of the mining complex. Plate 1a shows part of the area prior to consolidation works, with part of the wooden frame or grate in place. rectangular wooden frame.

3.3.3 In front of the terrace was an unstable area of stone tip which was piled up against the rear wall of the annex to the crusher house. The elevation (Fig. 10 S.W. elevation) shows the profile of this tip before removal. Part of the tip had been removed when Trust archaeologists arrived on site. In order to prevent any damage by heavy plant operating in the confined space of the upper ore-processing terrace from the tramway, it was decided to continue removal of stone from the south east and construct a ramp of spoil to allow access for a machine to that point and not the upper terrace or tramway - both areas likely to contain buried features. Scheme engineers also wished to remove more stone from the rear of the building to relieve pressure on the rear walls. Virtually all the stone was removed and the slope cut back into soft clay. A hitherto unknown rock overhang with a descending opening choked with spoil was revealed - all seemingly development rock similar to that below the main shaft. It was decided to go no further down than the surface levels thus reached. It was difficult to distinguish subsoil clay from redeposited material but it was evident that the consolidated

level created by the clearance and restoration scheme must still be on material redeposited against the rear of the building since the base of the wall and its foundation trench were not reached.

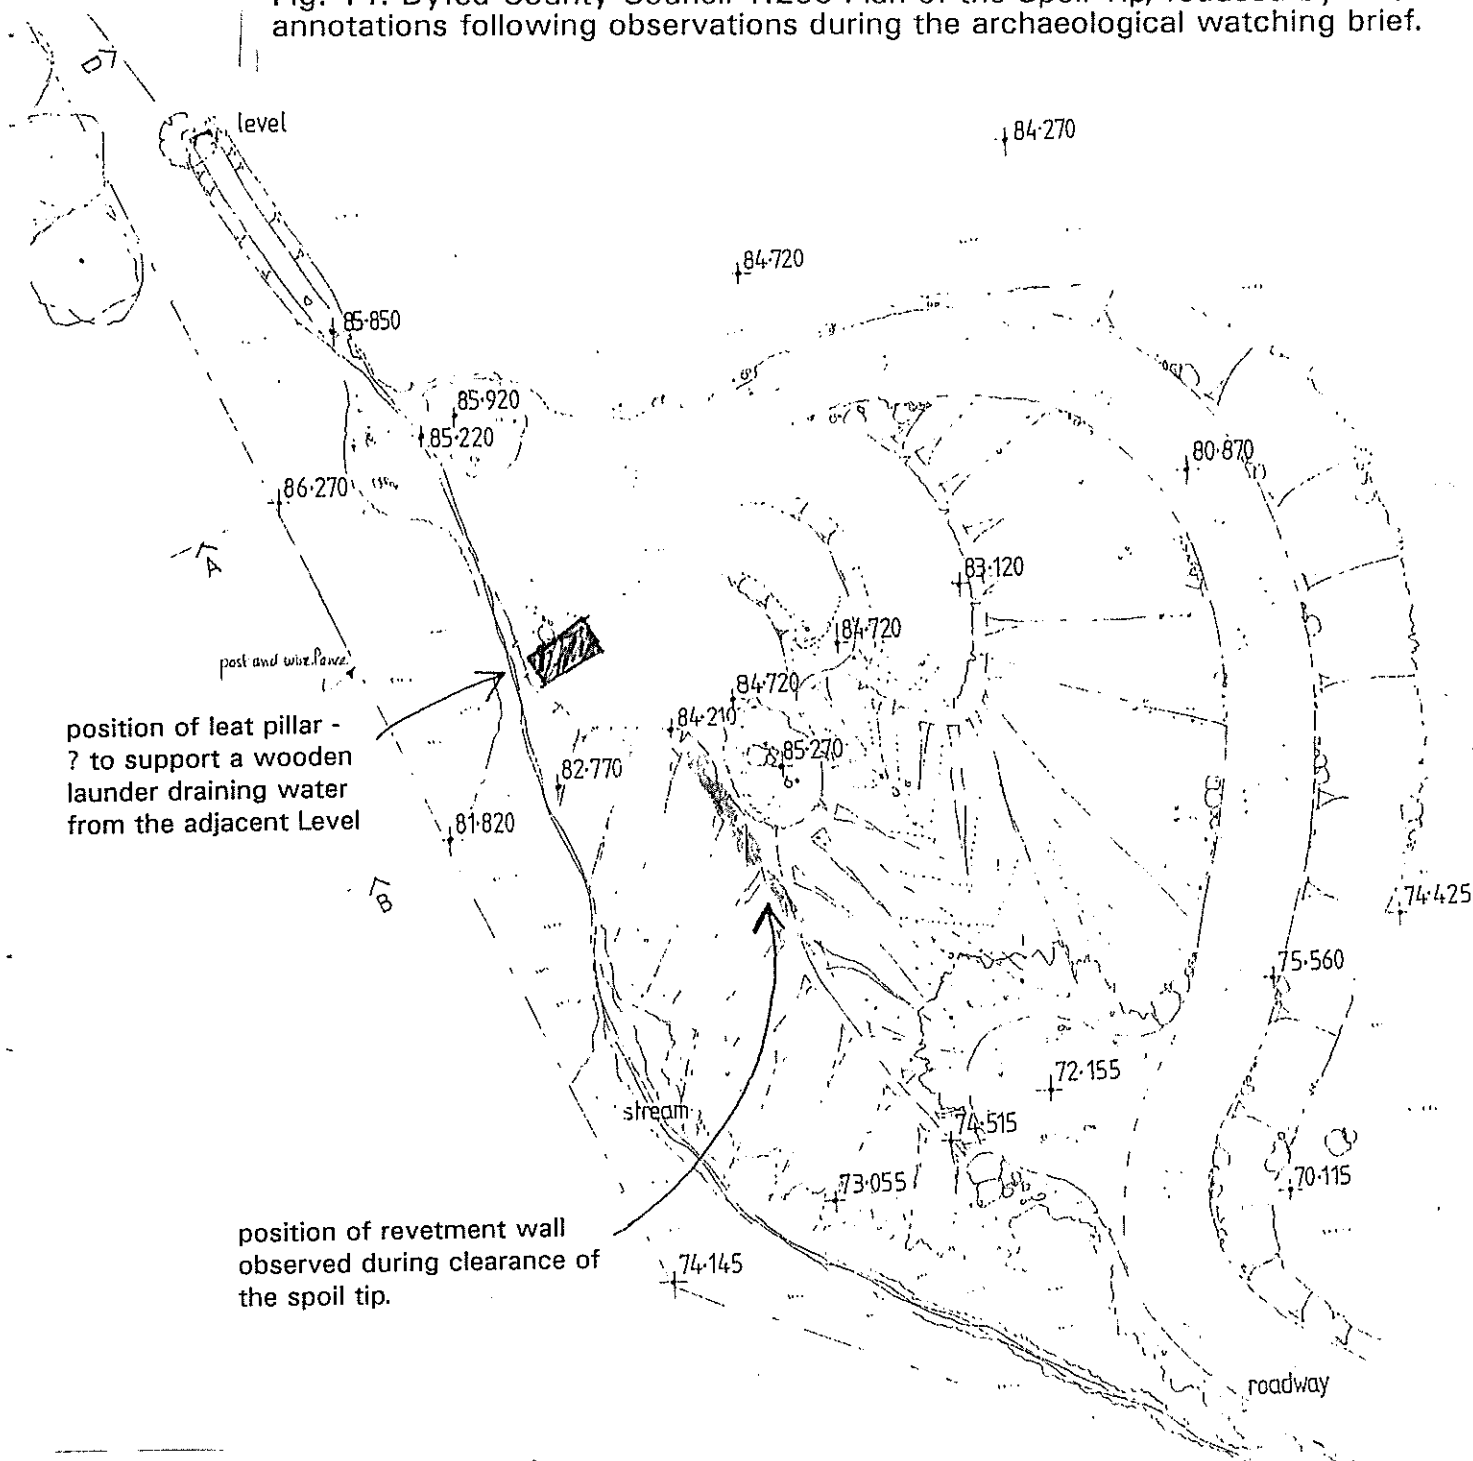
Fig. 14: Dyfed County Council 1:200 Plan of the Spoil Tip, reduced by 50% with annotations following observations during the archaeological watching brief.

3.7.1 A large spoil tip at the mouth of the Deep Adit level was sited some 100m. north of the ore processing areas (see Fig. 14 7 Plates 4a & b). It was noted in May 1993, during R. Protheroe Jones' rapid survey of the site, that the toe of this coarse development rock tip had already been quarried away for use as hardcore. The Reclamation and Consolidation programme required the spoil from the tip for infilling the settlement tanks prior to laying down the membrane and also for surfacing the access tracks (later to be used as footpaths). The spoil tip had been revetted on its south eastern side by dry stone retaining walls and it was agreed at the preliminary site visit to undertake a day's rapid investigation, by machine, of the tip to look for and record any other structural evidence. In the event this was not done, but it was clear from watching spoil removal that the only structural elements in the tip were the side retaining walls. Due to a modification of the scheme for encapsulating the slime pits, it was not necessary to remove the whole of the tip. Sufficient therefore remains to indicate its former extent and the retaining walls and traces of a wooden launder and leat pillar have been preserved.

3.7.2 The water issues from the tunnel like entrance to Level 3 and was possibly culverted before being discharged down the side of the Spoil Tip and thence to enter the R. Einion. Today the water takes a ragged course down a channel alongside the remains of the spoil tip. The 1st and 2nd editions of the O.S. 1:2500 maps (see Fig. 4) both show a length of causeway abutting the Spoil Tip from the south east. This cannot at present be traced and its purpose remains uncertain. Possibly the length closest to the tip now lies below the wide, metalled modern access track but where this diverges from the original causeway line the area is covered in impenetrable tree growth. The short length of tramline issuing from Level 3 out onto the Spoil Tip shown on the first edition, allowing easier exit and disposal of development rock spoil from the level, was obviously out of use by 1905 and is not shown on the 2nd edition. A piece of tramline was recovered during clearance.

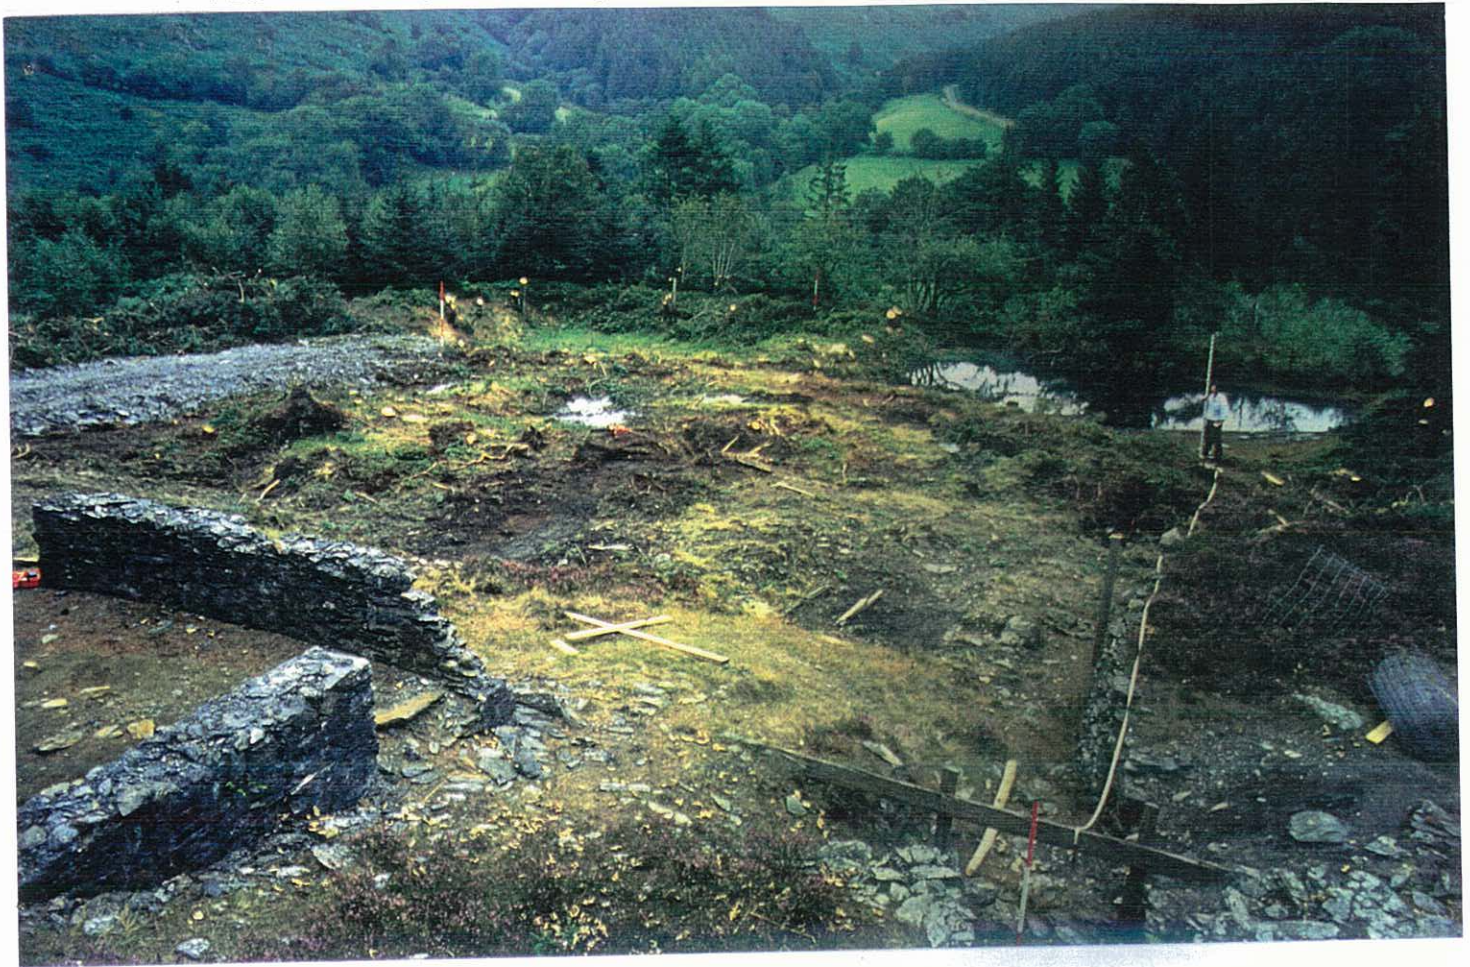
Plate 3a: Planning the slime pits after tree clearance, August 1993. Viewed from the jigger floor, tape lies along the tailrace of the lowest waterwheel.
