# **Marloes Court Farm W/13/3283**

## **Tir Gofal Farm Visit Historic Environment Report**

Report No. 2002/99

Marloes Court Farm  
Tir Gofal Farm Visit Historic Environment Report

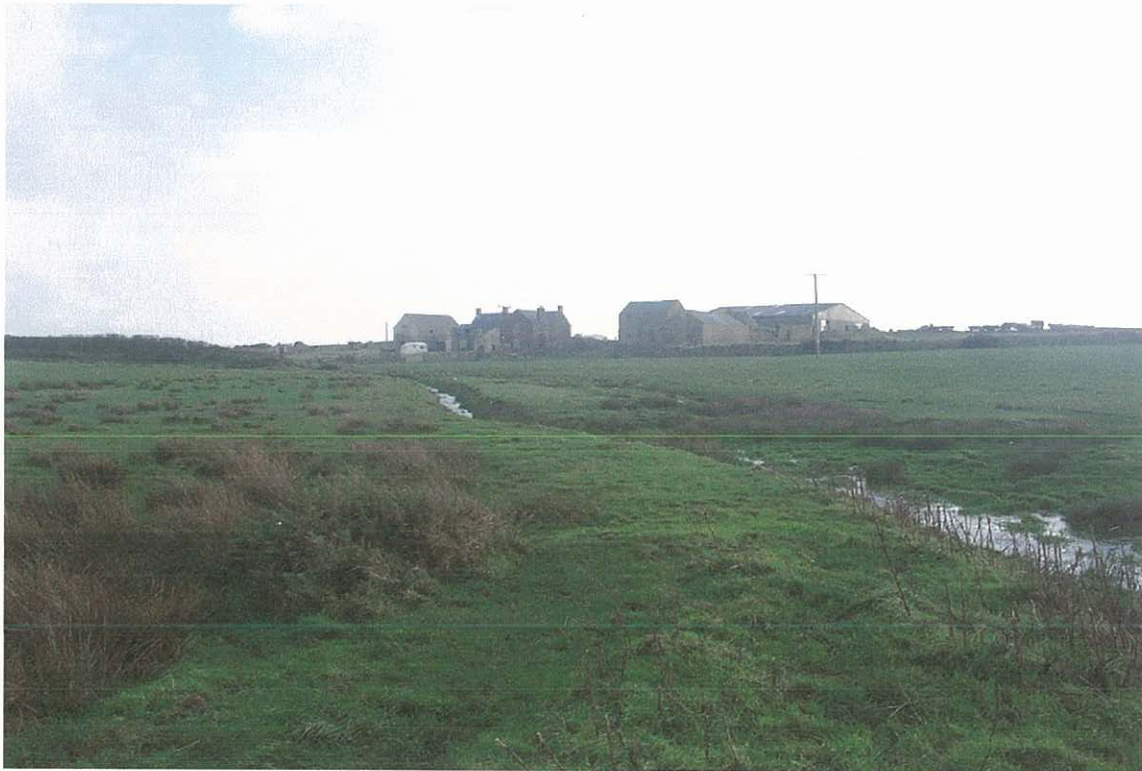
**Little Marloes Farmstead**

There are two main areas of concern at Marloes Court Farm. The first of these is the farmstead at Little Marloes which is currently in fair condition, though largely unused. The other includes the military remains at RNAS Dale.

This building is no longer inhabited, but still appears to be in fair condition. Ideally this building should be brought back into use before any structural damage is caused by weather and disuse. If this is not possible, the building should be maintained in a stable and weatherproof condition, and any future repairs carried out using appropriate traditional materials.

Other buildings within the farmstead should be maintained in a stable condition. Ideally the buildings would be brought back into use before significant structural damage occurs through weather and disuse.
