TIR GOFAL MANAGEMENT PLAN: HERITAGE MANAGEMENT INFORMATION (Call Out)

Prepared for: Castell Martin

Tir Gofal Reference No: W/11/0525

Report Number: 2005/116 Project Record Number: 45905

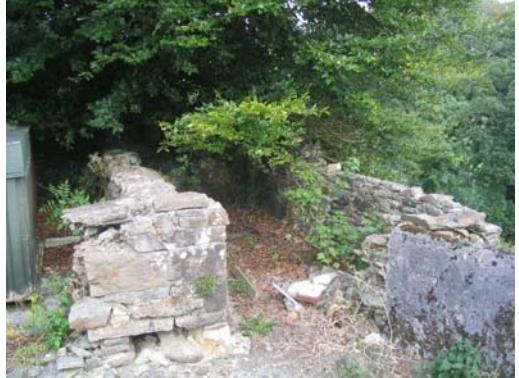
Both gable-ends of the building have long narrow ventilation slits. At the western end the slit is at ground floor level, whilst the eastern end has a ventilation slit at second story level in the gable. The difference in height may have been to accommodate two small walled enclosures, which are attached to the east end of the building. Although now reduced to low walls, a row of projecting flat stones at first floor level on the eastern gable-end suggests that the enclosures were formerly roofed. These enclosures appear to be the remnants of former pigsties.

Two small walled enclosures at the eastern end of the northern outbuilding

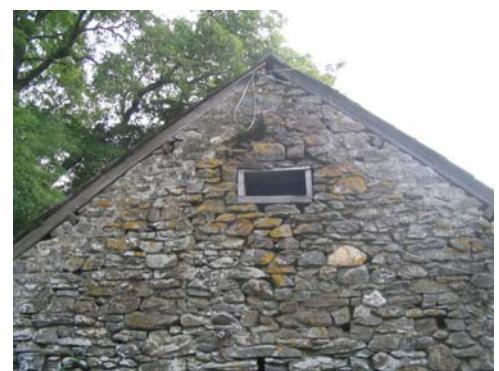
The western gable has a further small, rectangular opening above the ventilation slit, at second story level. This is not easily interpreted, but may represent a crude opening to allow owls into the barn to kill vermin.

Small opening in the western gable, which may be an owl-hole
