# **Llwynfedw W/11/4056**

## **Tir Gofal Farm Visit Historic Environment Report Call Out**

Report No. 2004/20

Llwynfedw  
Tir Gofal Farm Visit Historic Environment Report  
Call Out

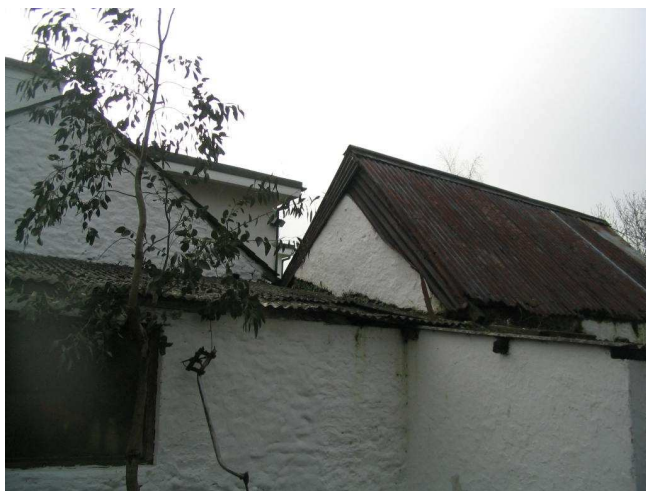
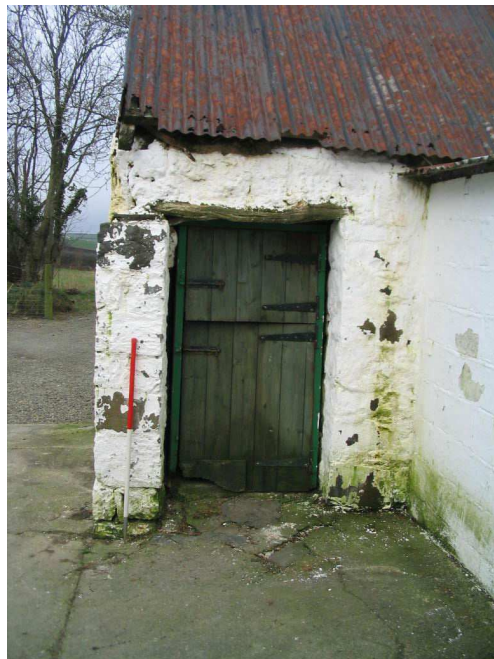
*Northeast elevation (above)  
Southwest elevation (below)*

This wall is in good condition. A modern lean-to style shed is against part of it. The only area of concern is at the north end, where water has been running down the wall face. It has brought off some of the whitewash and will soon start to erode the clom if the problem is not addressed.

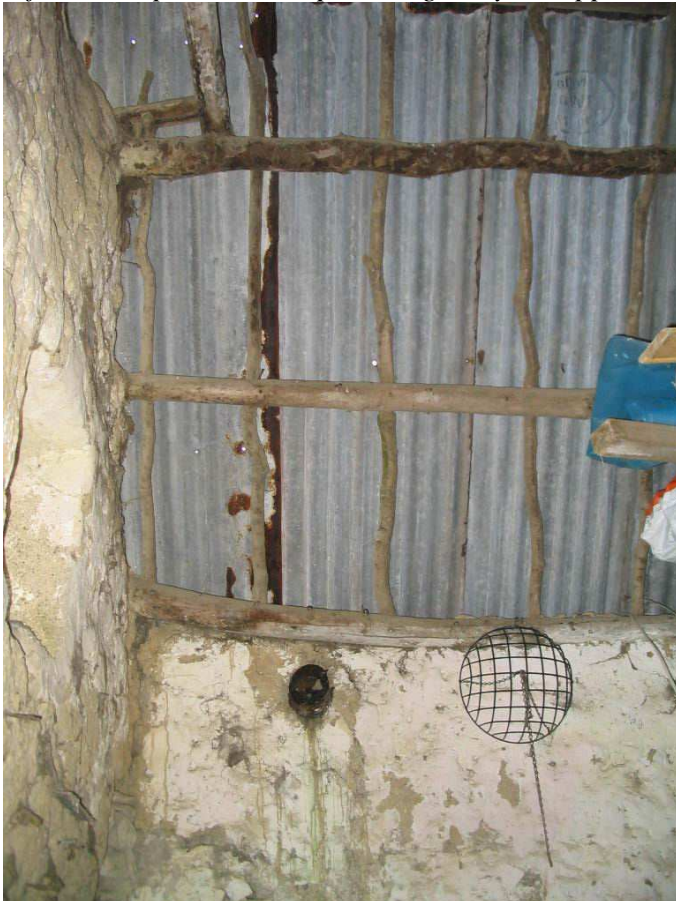
*Below: Roof structure showing purlins made of whole branches set into the top of the wall. The rafters are spaced wide apart, originally to support thatch rather than slates.*

The roof timbers appear to be sound, and are of considerable interest. They should be disturbed as little as possible during any works on the building. Where necessary, they should be repaired and retained but if replacement is unavoidable, the replacement should be in the same style. If the roof is replaced with corrugated iron, it should be ensured that the overhang on the roof is large enough to prevent any water from running down the exterior of the walls. It is beyond the scope of this report to give detailed advice on thatching, but a list of contacts has been provided in the appendix, and more advice may be available from them.
