Cwmgelli-fach W/12/3986

Tir Gofal Farm Visit Historic Environment Report

Report No. 2004/43

REPORT NO. 2004/43 PROJECT RECORD NO. 48485

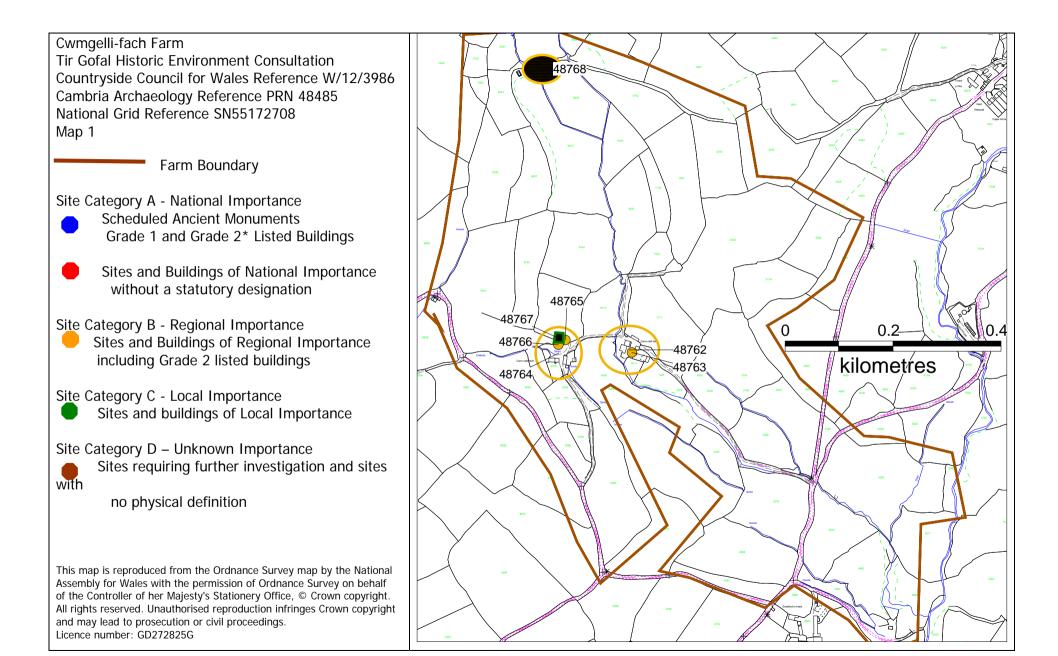
The barn is in good condition. The roof along with the other corrugated iron roofs on the farm, is regularly tarred and is in good condition too. The doors to the barn are missing and the stable door to the west is also rotting at its base.

Prn 48766 – the barn at Cwmgelli-fach, left - the large barn doors are missing and right - showing a detail of the stable door to be repaired

It is hoped that through the scheme, the barn doors can be replaced / repaired. As with all works on traditional buildings there should be an emphasis on repairs to the original rather than replacement or renewal. Hence the stable door, which appears to be original, should be repaired, it should be possible to splice in a new piece of wood at the base of the door. In addition any original door furniture (hinges, latches) should be maintained or reused. New doors will have to be made up for the double entrance for the barn and these should be of a traditional design - like those that survive in the barn at Cwmgelli-fawr, Prn 48762.
