RHIF YR ADRODDIAD / REPORT NO. 2005/2  
RHIF Y PROSIECT / PROJECT RECORD NO. 53031

## BUILDING RECORDING AT FLIMSTON FARMHOUSE CASTLEMARTIN RANGE, PEMBROKESHIRE DECEMBER 2004

Duncan Schlee

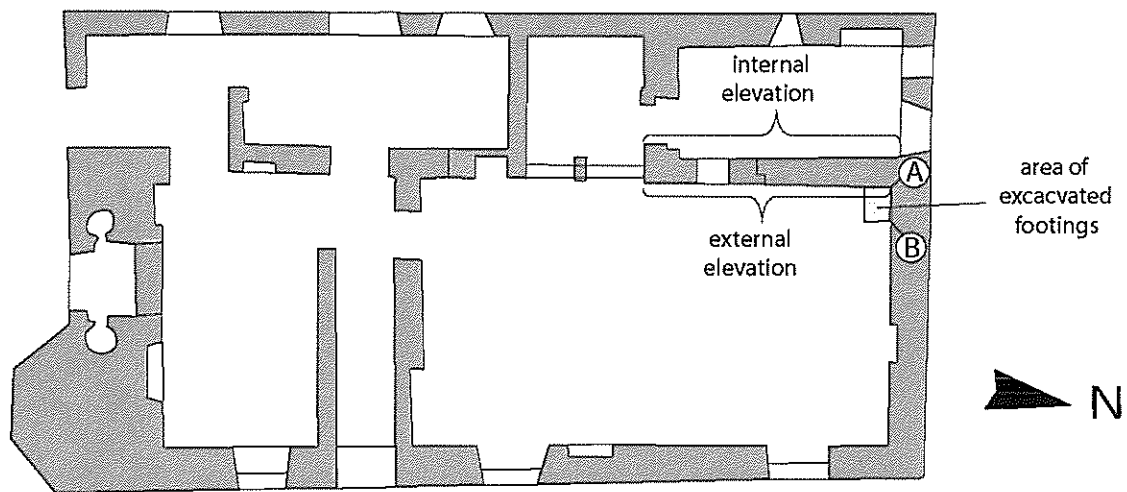
**Figure 1 :** Plan of Flimston Farmhouse showing location of excavation and elevations

The excavation of a small trench 0.50m long, 0.40m wide and 0.50m deep, for a concrete footing for a prop against the north wall of the building, revealed a sequence of deposits (figure 2). These are difficult to interpret due to the restricted size of the hole and its location (figure 1). Dwarf walls, capped with slate and built against the earlier masonry to support later plank floors, made it difficult to ascertain the stratigraphic relationships between the deposits and the masonry. The most significant deposit was at the bottom of the excavation where a clay layer containing plentiful charcoal fragments was encountered (see photo 6). This deposit may represent the floor level of the original building, although further excavation would be required to confirm this.
