HAFOD: PROPOSED FELLING ARCHAEOLOGICAL RECOMMENDATIONS

November 1997

**Report commissioned by: Forest Enterprise
Report by: K Murphy BA MIFA**

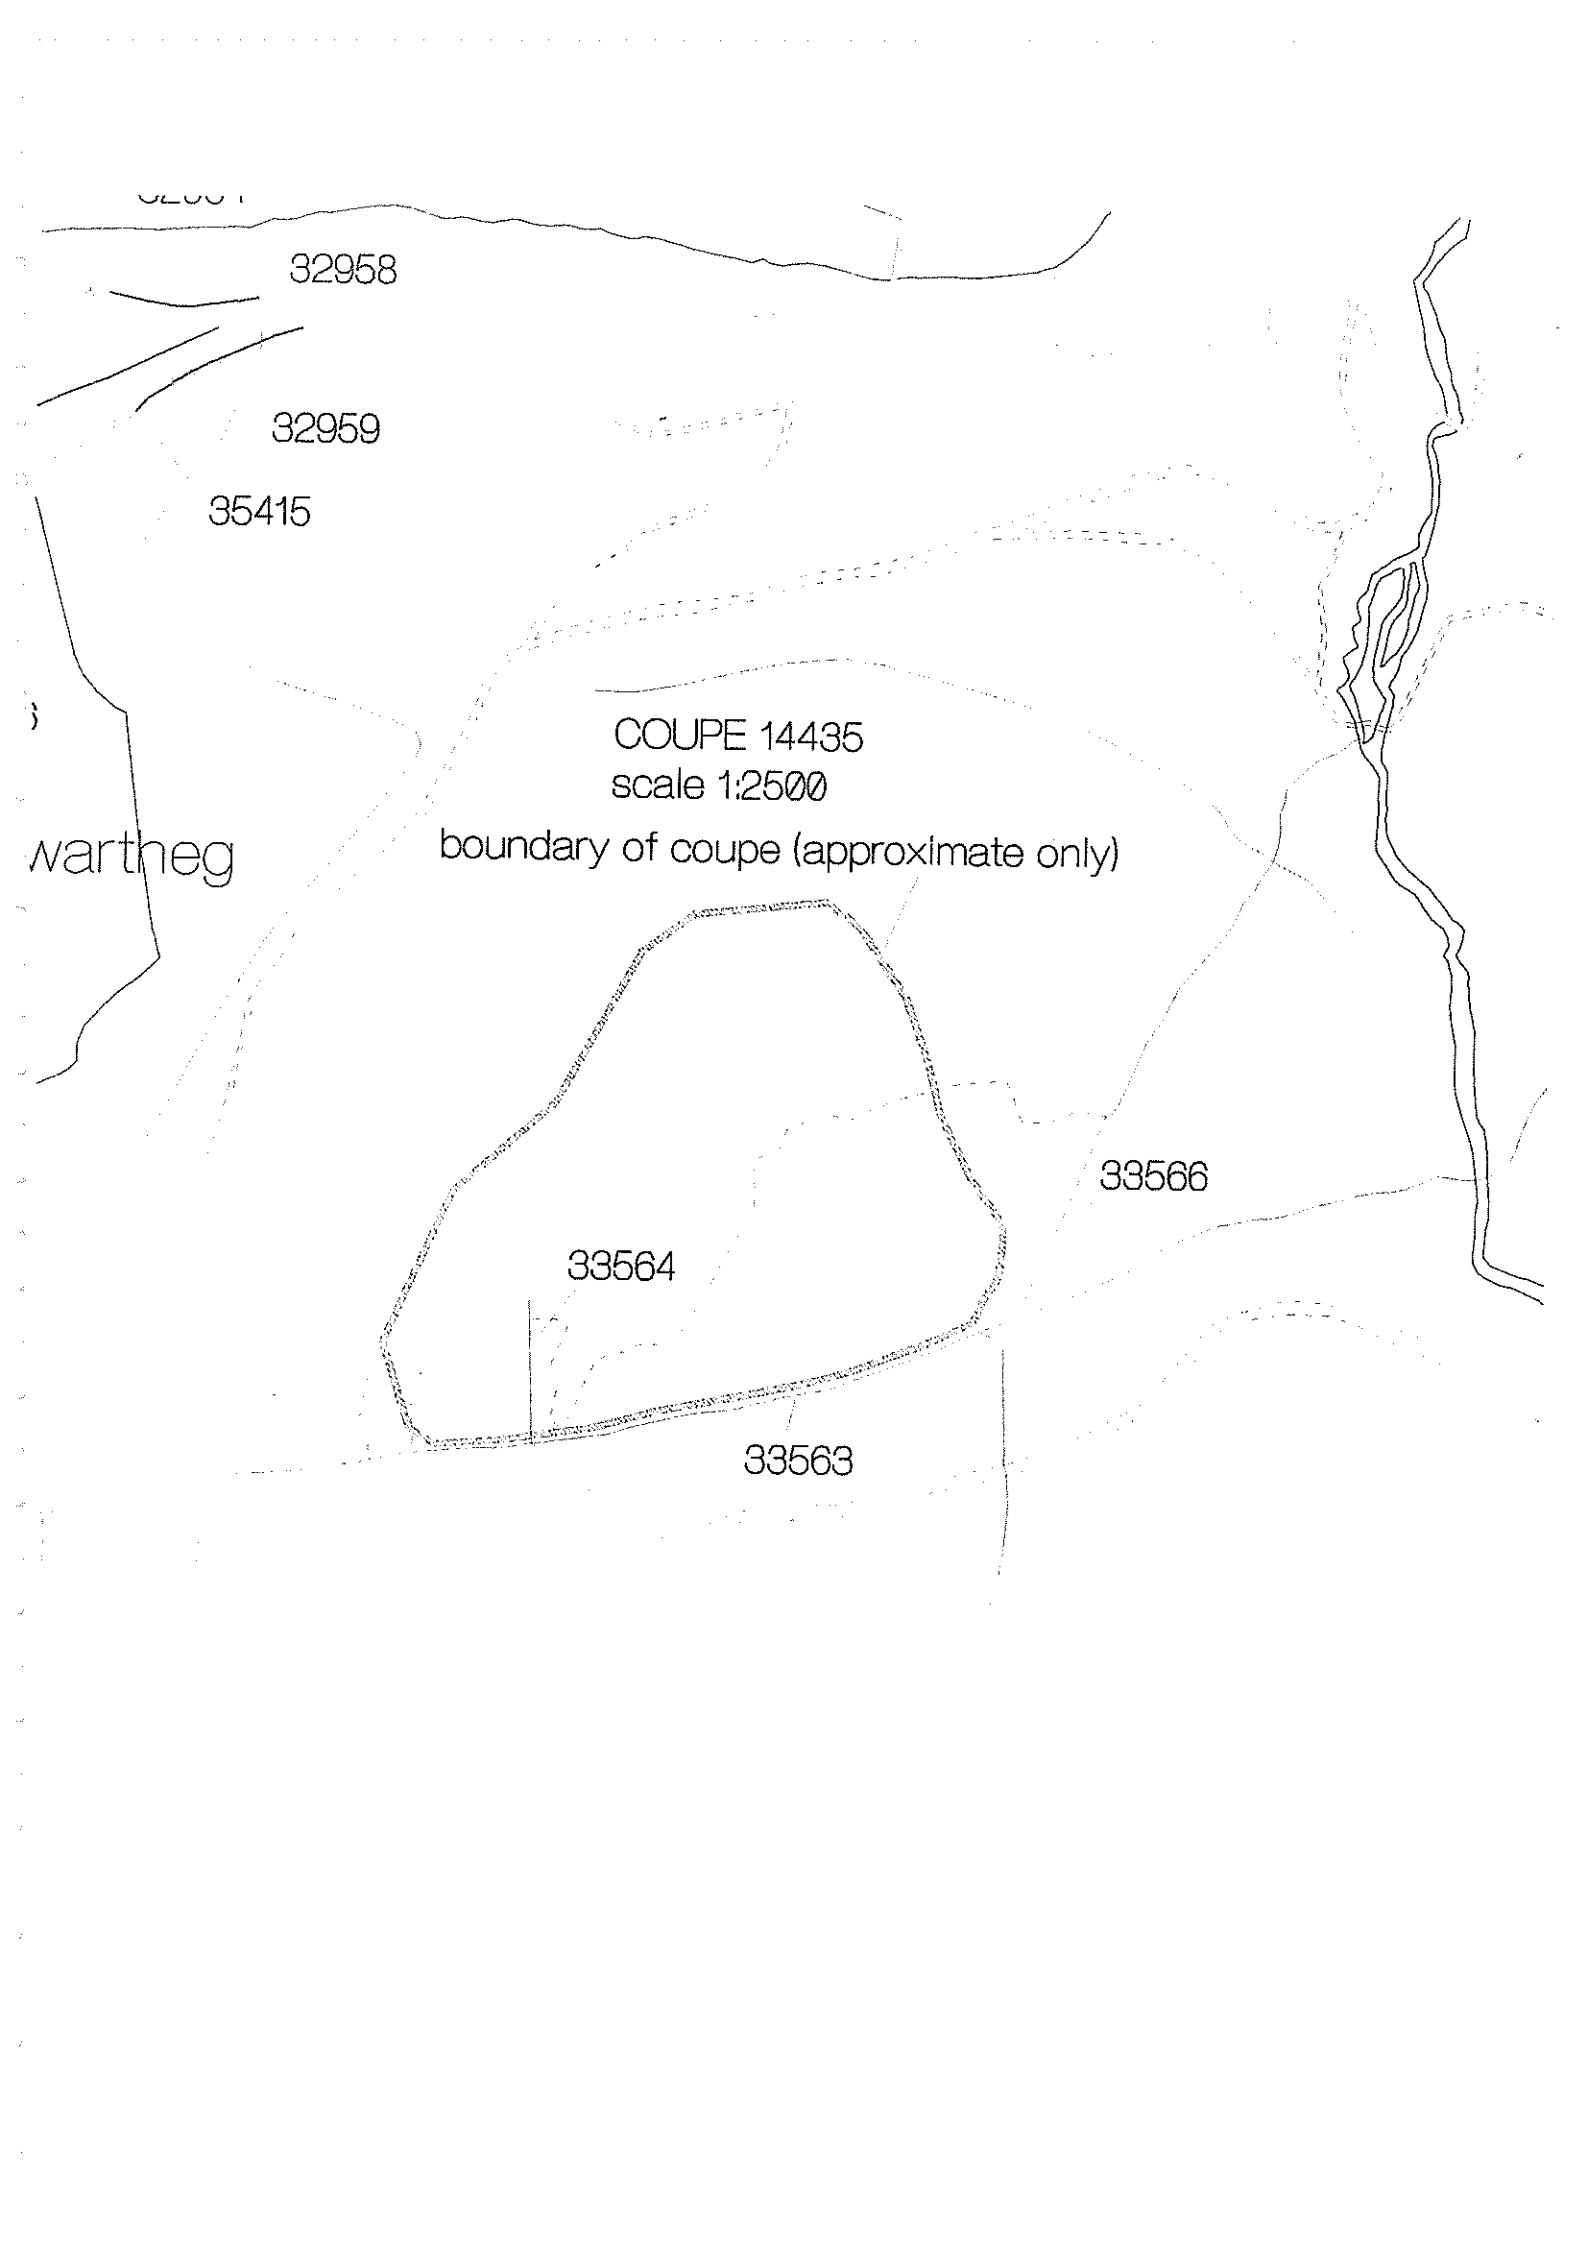
Photo. 12

33563. Wall (*Photo 12*). A long dry-stone boundary wall with broad-leaf trees planted at regular intervals alongside. The wall is in good condition and survives to full height with intact cap-stones. There are a few short stretches of partial collapse. This wall was built by Thomas Johnes. It is the best surviving of his estate walling at Hafod.

Recommendations: None

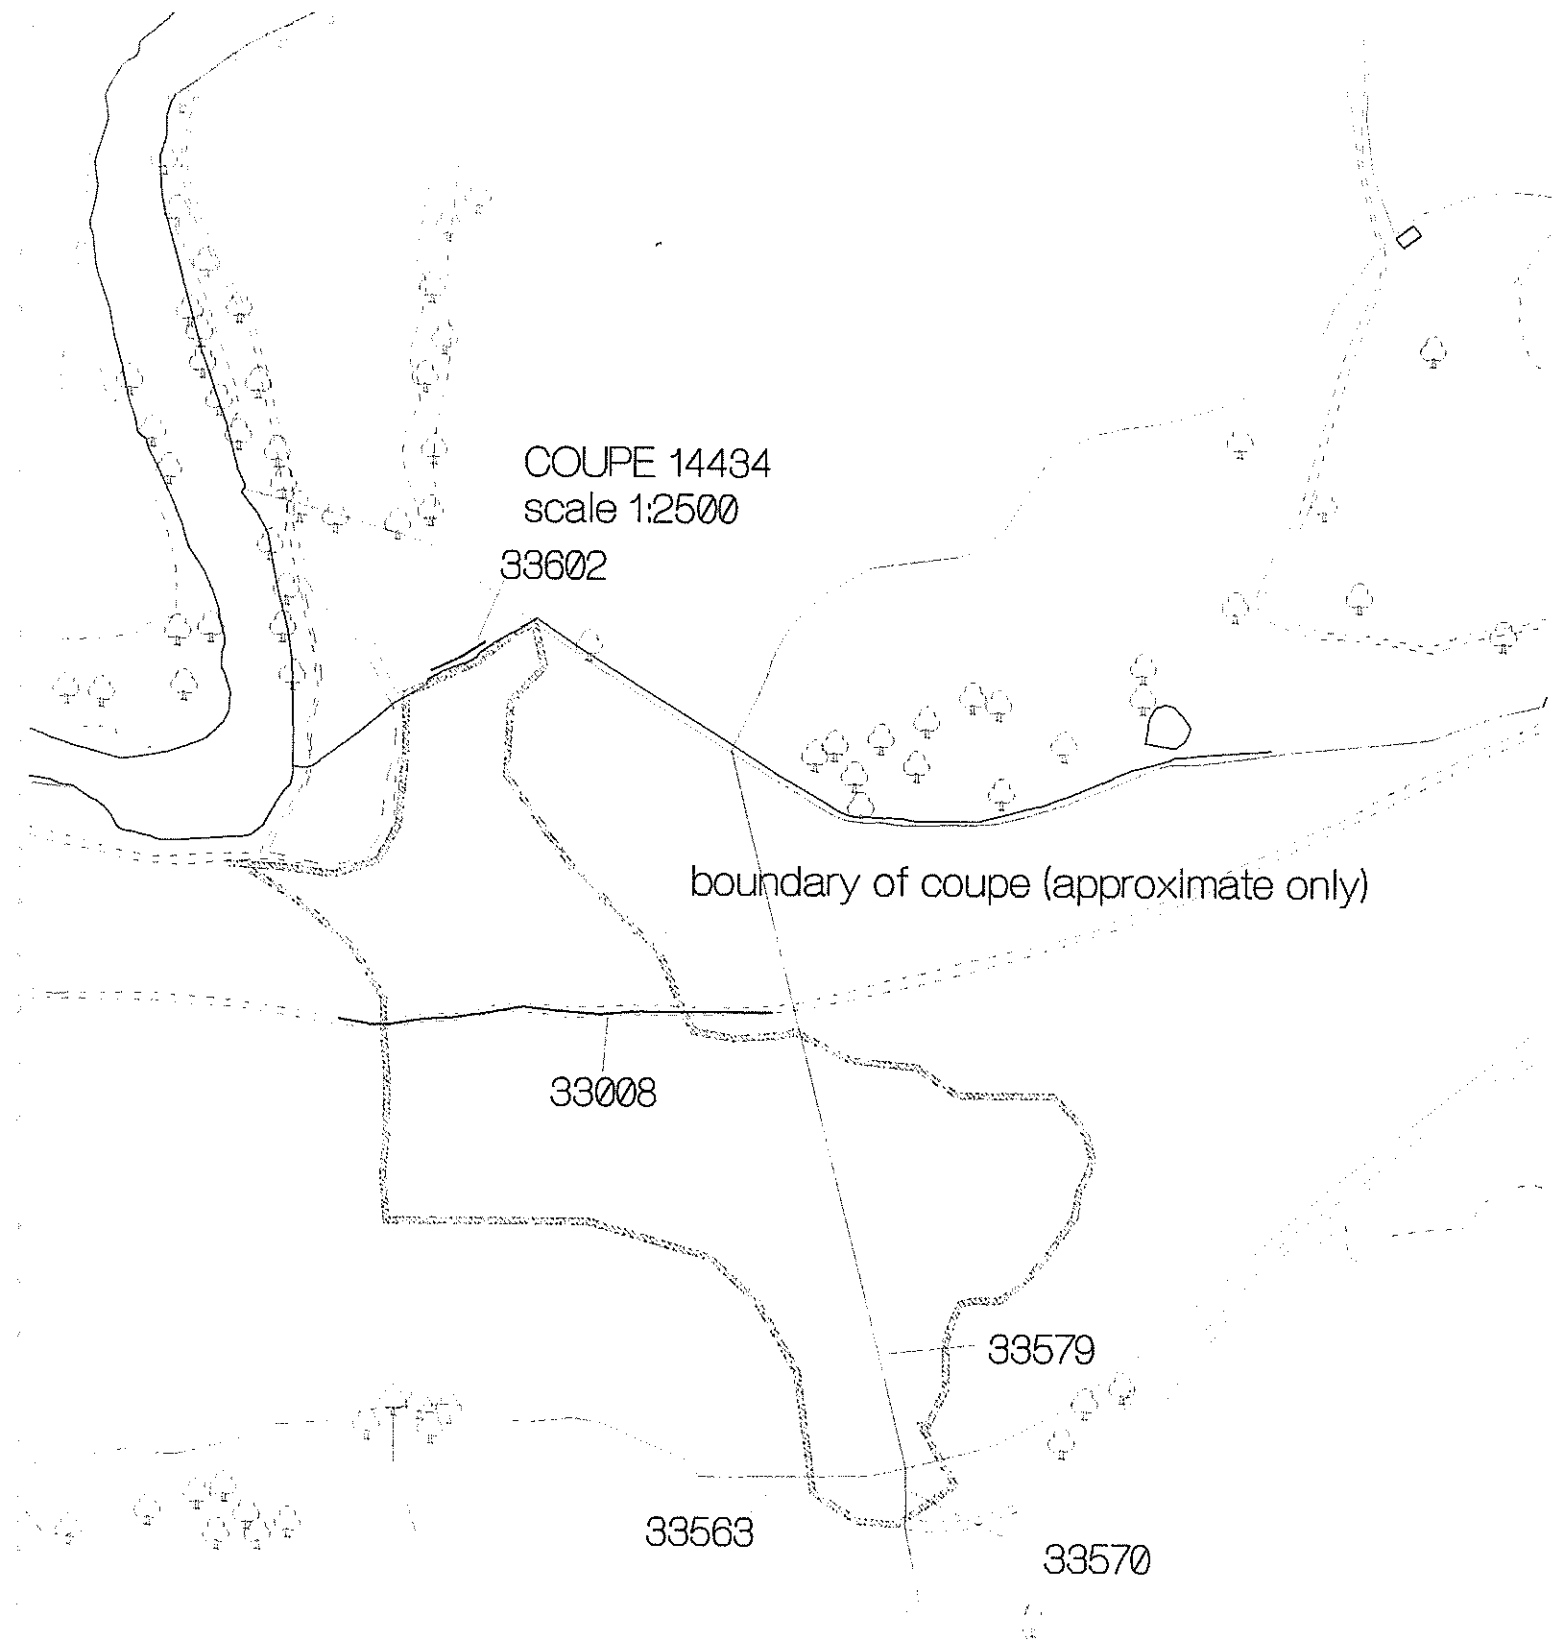
Photo 13

33008. Gentleman's Walk (*Photo 13. The terrace of the walk looking west*). The Gentleman's Walk which crosses this coupe from east to west is located on a distinct linear terrace some 2m wide mid-way up a very steep slope. This walk is an important element in the Hafod landscape. It must not be damaged.
