FENTON HOME FARM, CRUNDALE, HAVERFORDWEST, PEMBROKESHIRE

**BUILDING RECORDING,
OCTOBER 2005**

RHIF YR ADRODDIAD / REPORT NO. 2005/120
RHIF Y PROSIECT / PROJECT RECORD NO. 55439

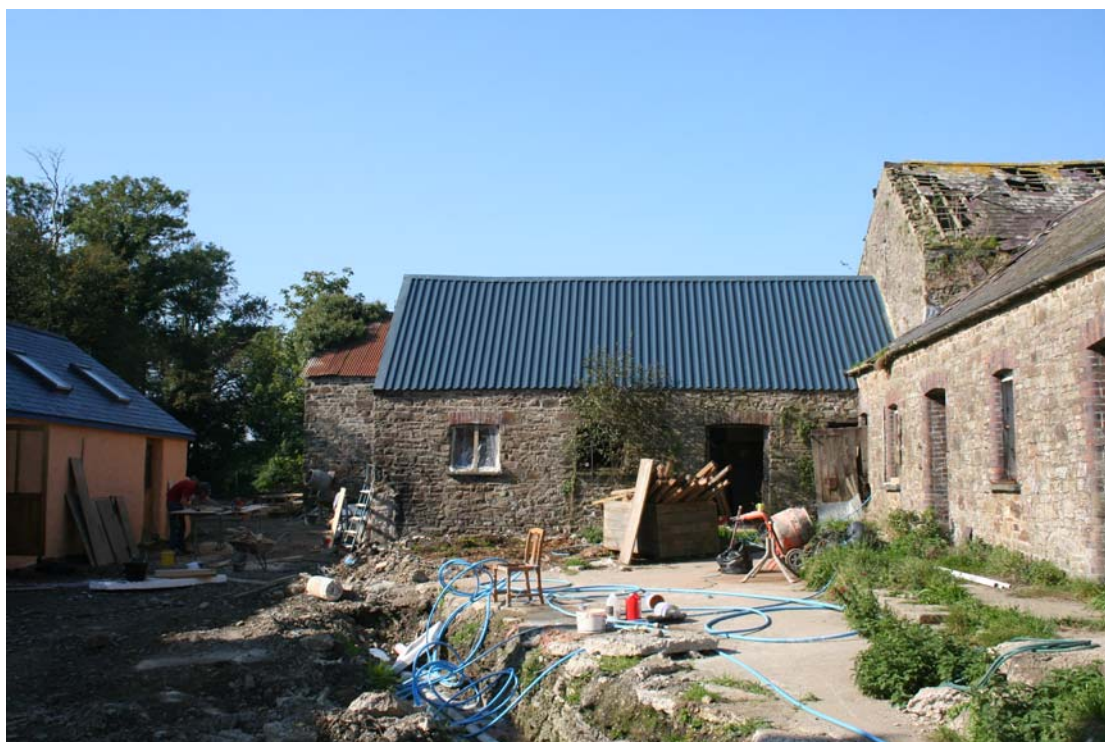
Fig. 14 - Building F from east, Building G to right

Both buildings may have been barns. They had not been affected by the 2005 development, and were in fair condition, but under a heavy growth of ivy.

Building G had not been affected by the 2005 development. It was in good condition retaining some fittings. It comprises four bays, defined by two windows and two doorways in the south wall. Its proximity to the farmhouse suggests that it may have been a stable from the first, with a loft that was lit by an original window high in the east (end) wall. The ground-floor window in the same wall is a later insertion, from Phase 3, with a red-brick surround and segmental yellow-brick head. The north wall is blind, and shows the remains of a whitewash finish relating to a later lean-to that was built against it. The lean-to appears to have belonged to Phase 3 (see Building E) but is now gone, and is represented only by its roof crease, visible on the east wall of Building E, and by the stump of its north wall at the northwest corner of Building H (see below).

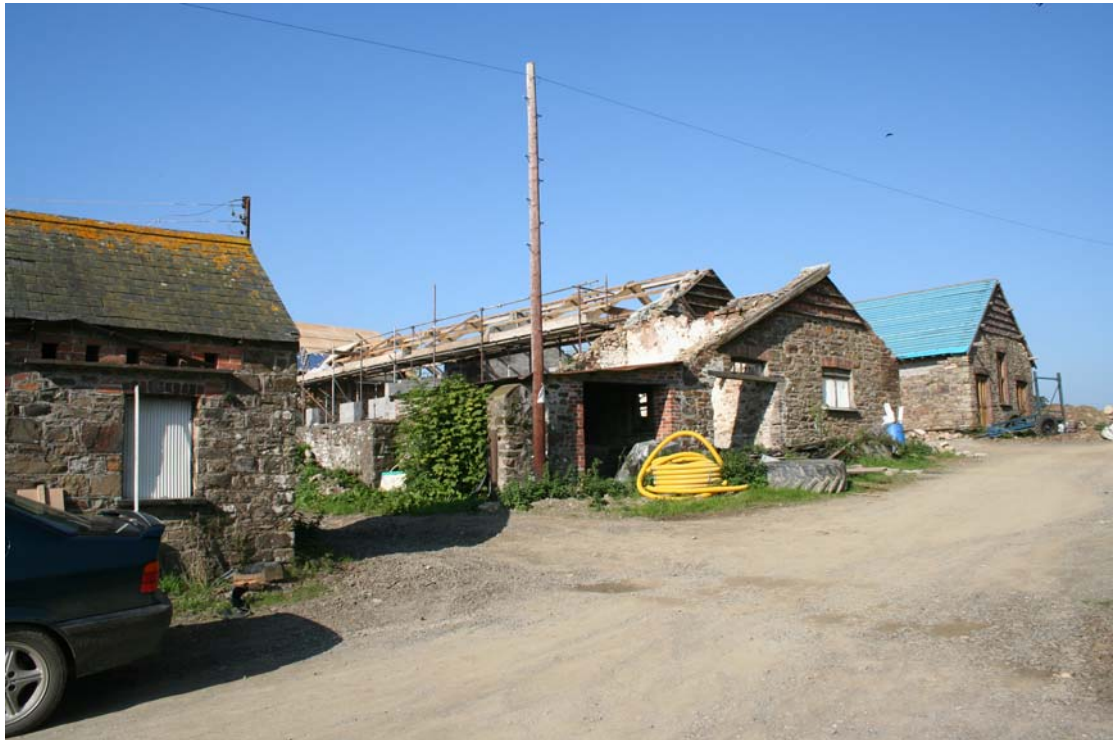
Fig. 15 - Looking northwest towards Buildings I, D and A

Building I had not been affected by the 2005 development, and was in fair condition. Its original purpose is not known; it may always have been used for storage. However, a concrete hard stand south of the building, in the angle with Building H, features the remains of brick divisions built against the south wall,

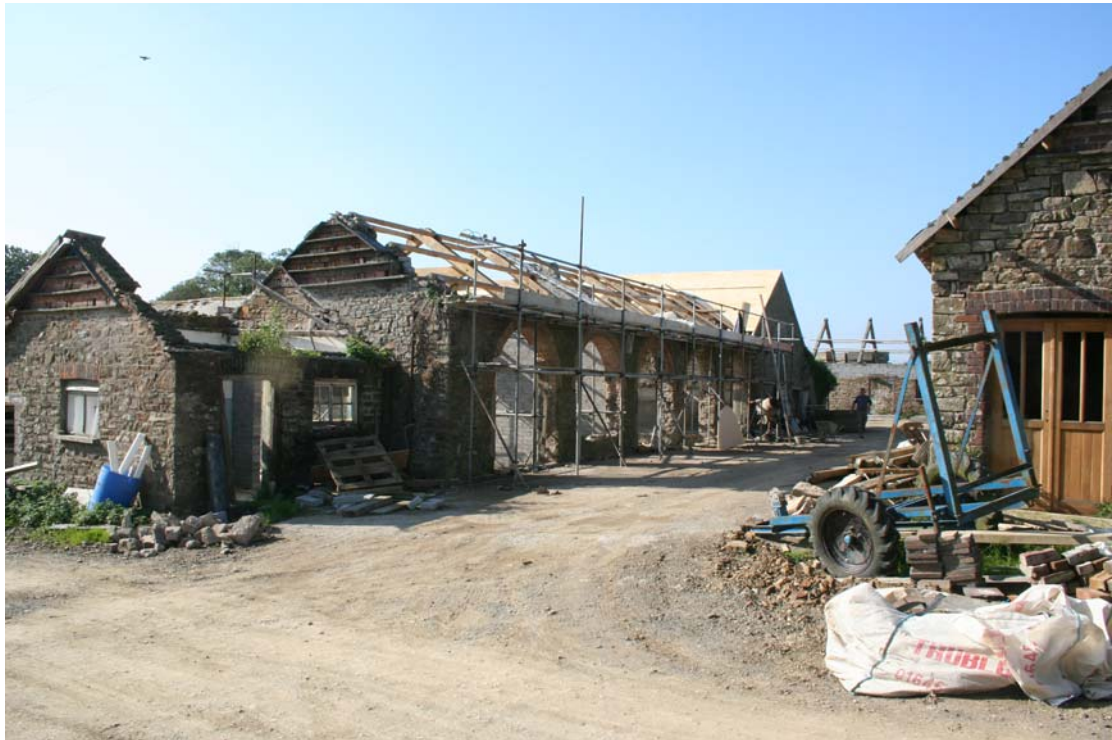
Fig. 17 – Buildings C and D from northeast, Building A to right

Building D has been much altered, both during 2005, and earlier. Its south wall had entirely gone, having been removed sometime prior to 2005 and replaced by an open side, the roof eaves being supported on an iron joist (now gone). By October 2005, a number of breeze-block partitions and pillars had been built, replicating the spatial division of the building. The roof, formerly gabled, had been taken off and the floor covered with a concrete screed.
