PRICASTON FARM CASTLEMARTIN STANDING BUILDING RECORDING

RHIF YR ADRODDIAD / REPORT NO. 2009/4
RHIF Y PROSIECT / PROJECT RECORD NO. 94314

January 2009

PRICASTON FARM, CASTLEMARTIN STANDING BUILDING RECORDING

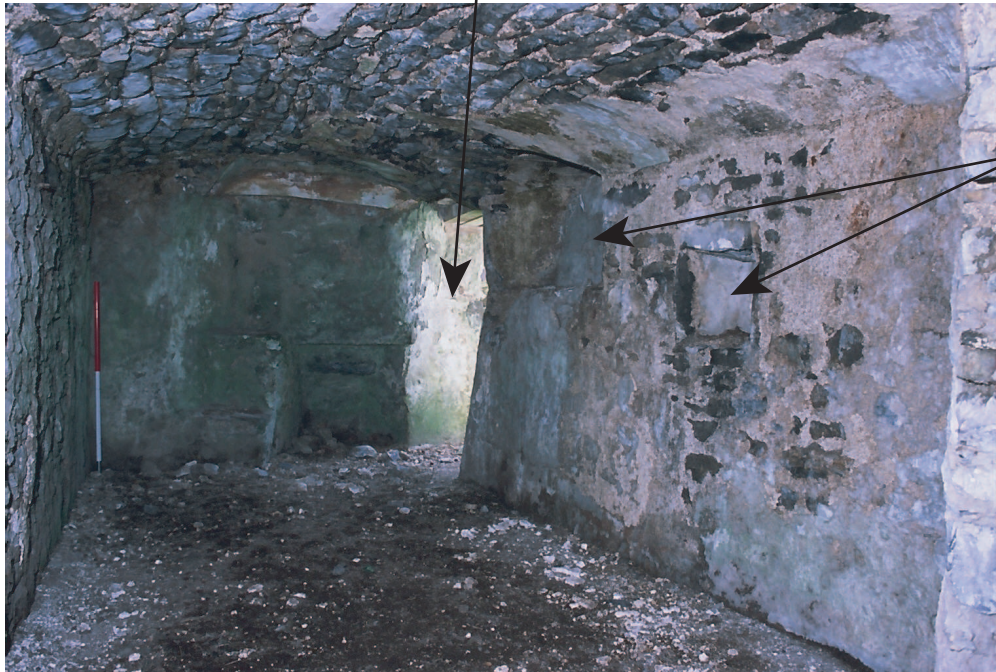
The northwest service room has two square niches in the northwest wall, which may indicate the location of former openings - the larger of the two seems likely to be a former window as the vault has been constructed to accommodate it - however plaster on the other side of the wall obscures their position and the smaller one may be a cupboard recess built for the purposes of holding a light (Plate 6). At the west end of this room a doorway has been broken through the wall at an angle to gain external access, the angle being squewed to avoid the southwest wall of the 19th century kitchen

Plate 6: Northwest service room
Wessex Archaeology

Blocked
opening

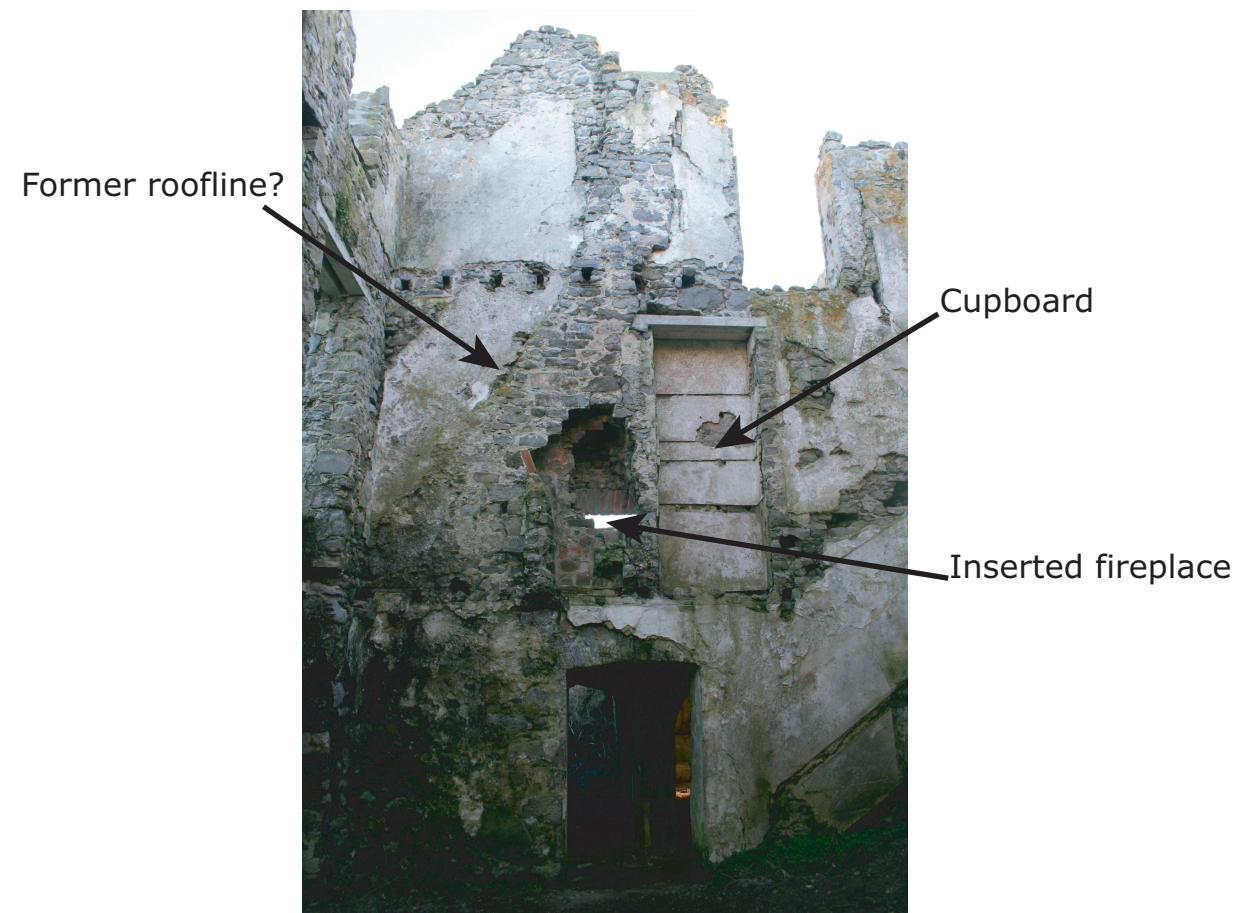
At first floor level of the hall there remains the vestiges of a fireplace at the southwest end, with one remaining brick surviving from the arch. Adjacent to the fireplace on the west side is a full-length cupboard internally faced with plaster showing the scars of shelving (Plate 8).

Plate 8: Southwest wall of hall

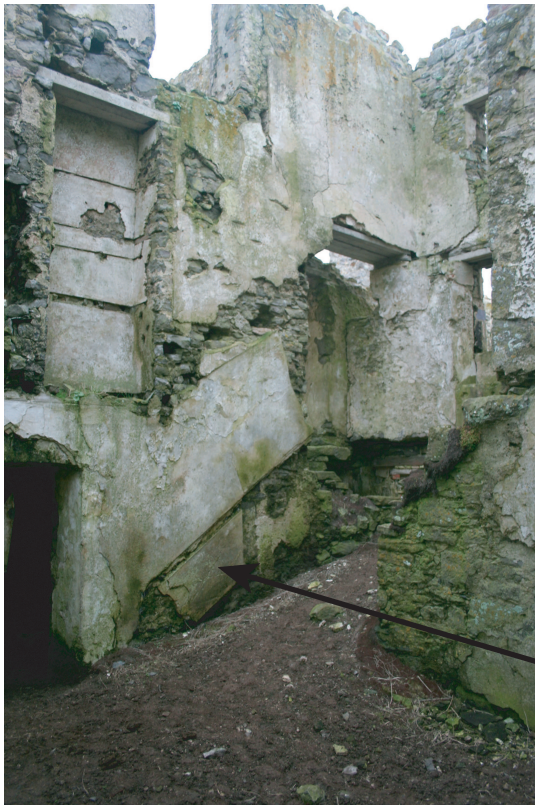
The northwest wall has a stair rising from the southwest corner, with access to the solar being gained by a series of semi-circular stone steps rising to the southwest and forming part of the cross passage roof (Plate 12). These steps have also given access to the first floor above the kitchen range behind the solar.

Scar of
Chippendale
balusters

Plate 12: Stair tower in
southwest of hall
Wessex Archaeology

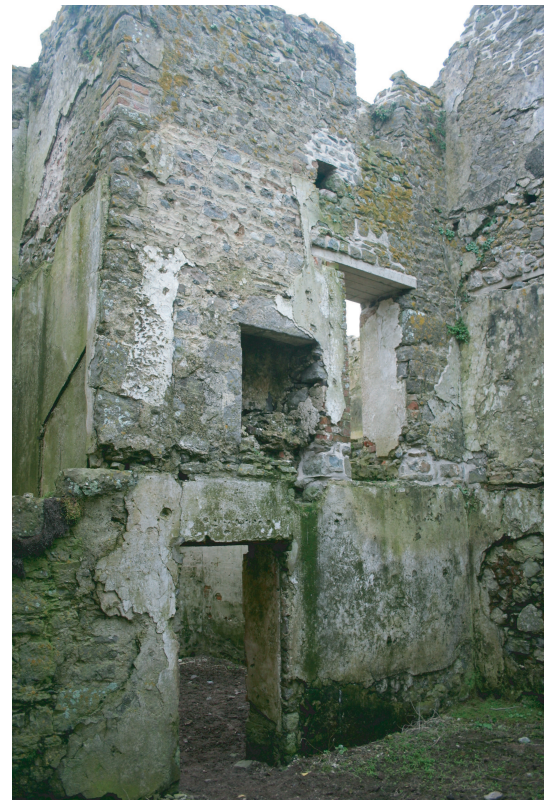
A fireplace in the northwest wall of the first floor is constructed with a large stone lintel over (Plate 13). To the north of it a doorway has been inserted into the room above the dining room.

Plate 13: Northwest wall of hall
showing fireplace on 1st floor

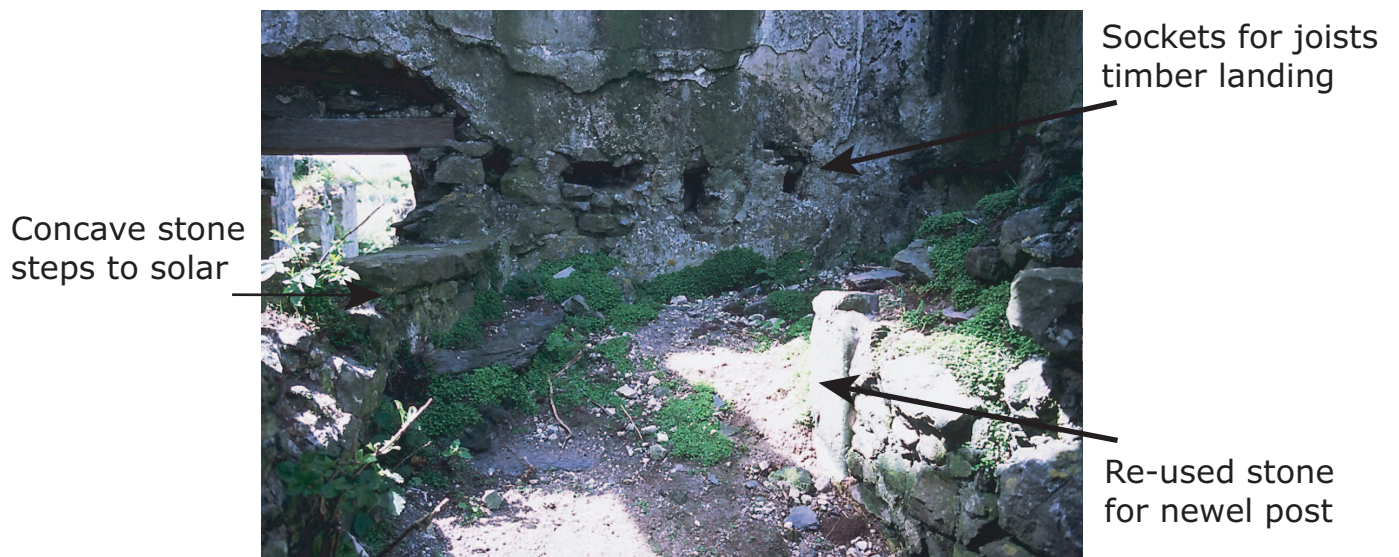
The stairs dogleg within a stair tower projecting to the northwest of the hall, giving access to the first floor. A reused stone forming a newel post has been noted in the Wessex report (Plate 14), which would suggest that the stair to the first floor is a secondary material (Wessex 2003; 3.2.14).

Plate 14: Stone steps in the stair tower
Wessex Archaeology

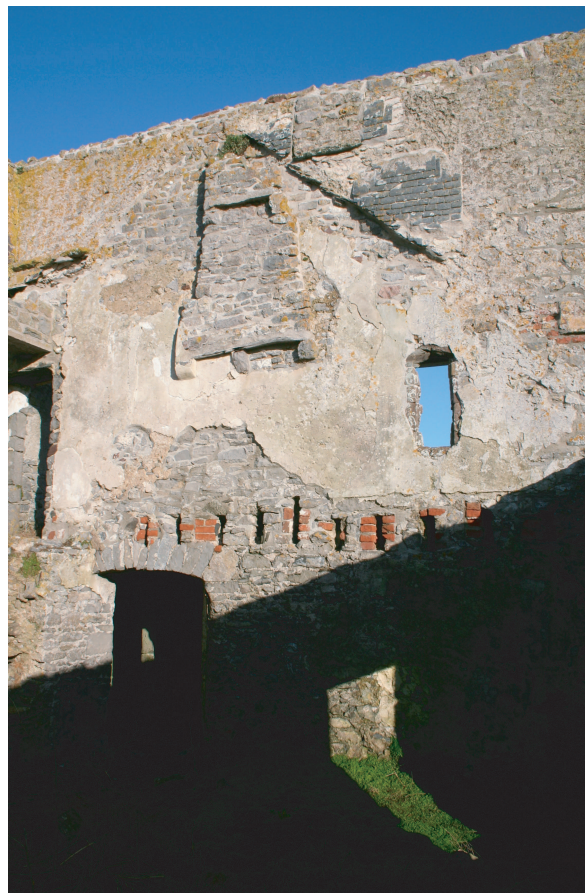
There was a fireplace in the northwest lateral wall of the solar (Plate 15 & 16), for which the corbelled chimney can be seen on the other side of the wall, this has latterly been blocked and a brick semi-circular niche formed partly in its place.

Plate 16: Exterior of northwest wall of the solar showing corbelled chimney

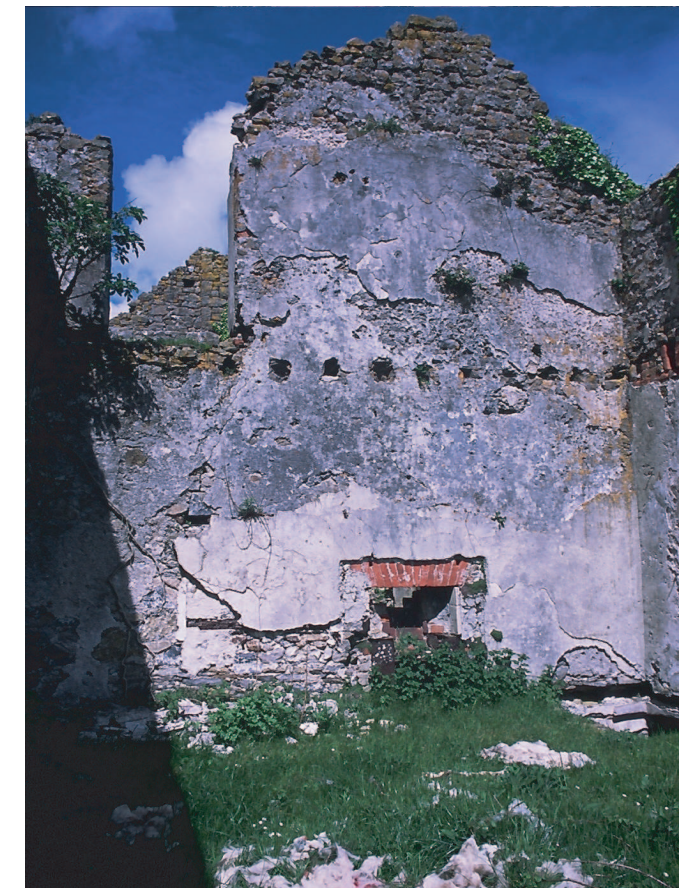
In the northeast wall a small cast iron hob-grate fireplace has been inserted and backs onto the fireplace in the first floor of the adjoining hall (Plate 17).

Plate 17: Hob-grate fireplace in northeast wall of solar
Wessex Archaeology

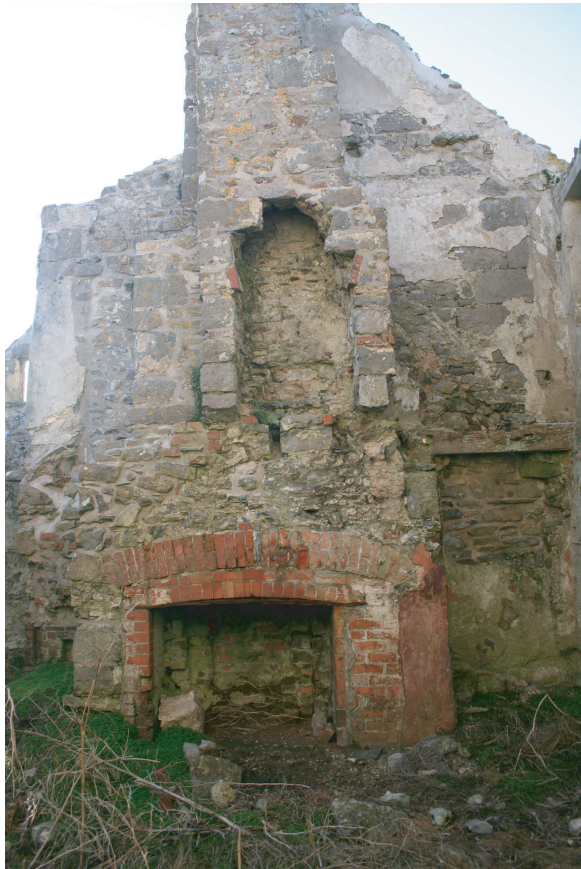
Plate 20: Northwest wall of the kitchen showing fireplace and chimney inserted into tower
Wessex Archaeology

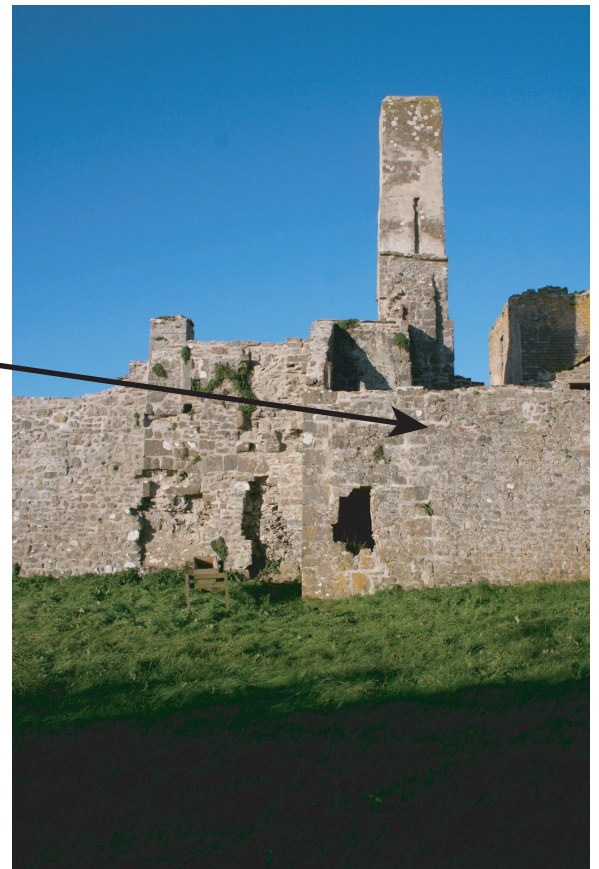
Vertical
straight-
joint

Plate 21: Southwest wall of tower

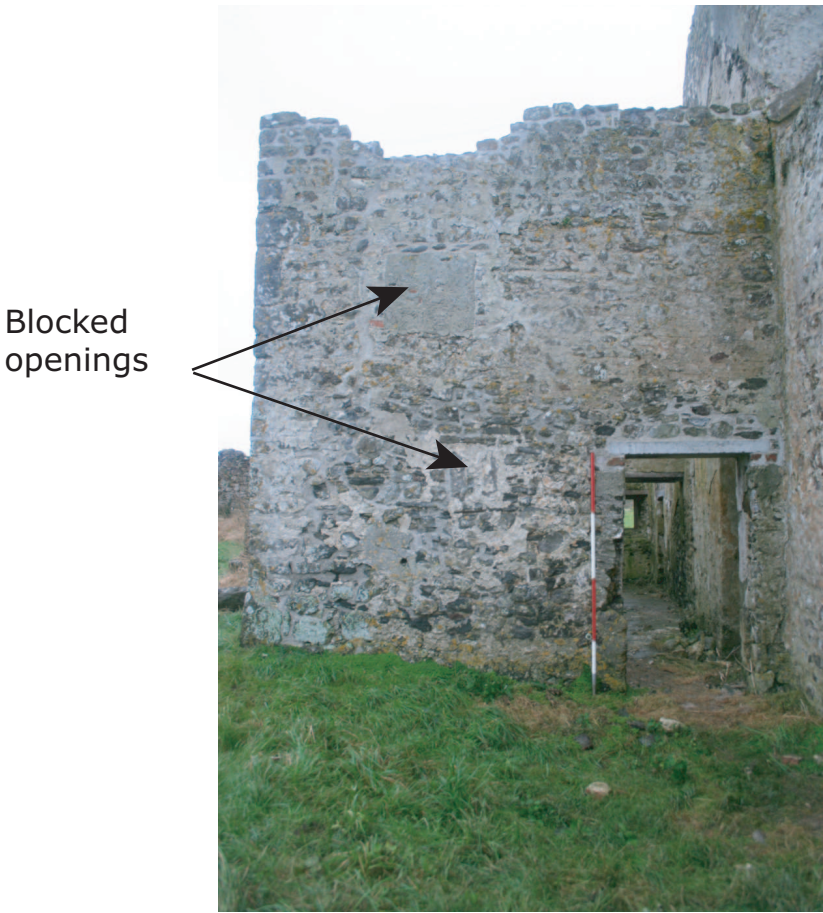
Plate 30: Northwest wall of northeast range

Straight joint

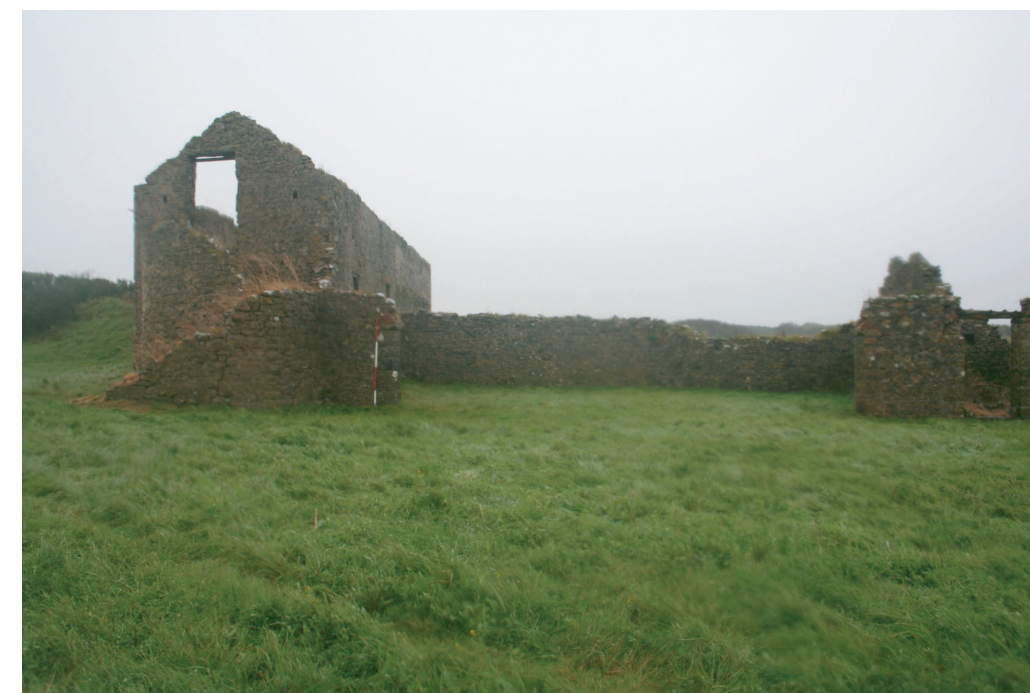
Plate 46: Cartshed (A4), northwest wall

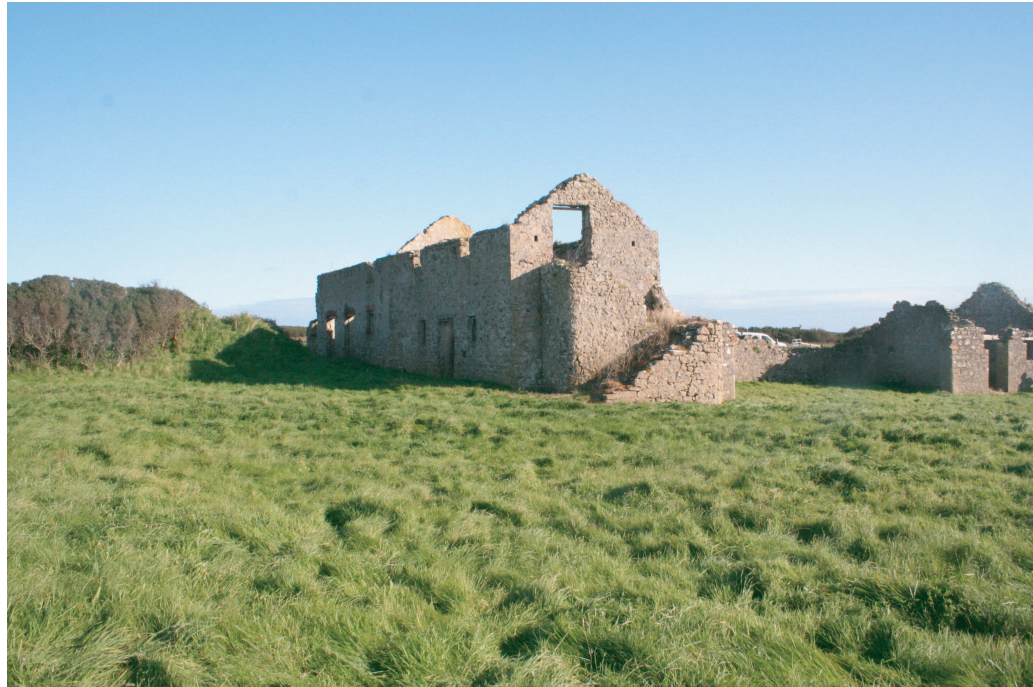
Plate 47: Stable range (B), view from the northwest

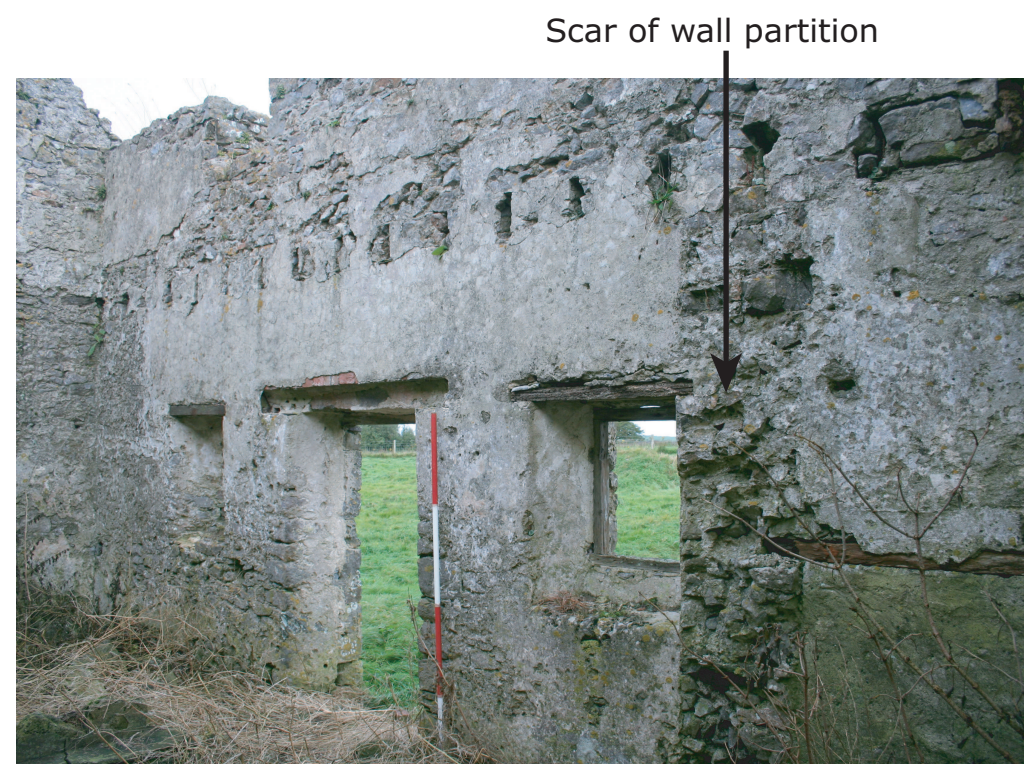
Plate 48: Stable range (B1), north wall

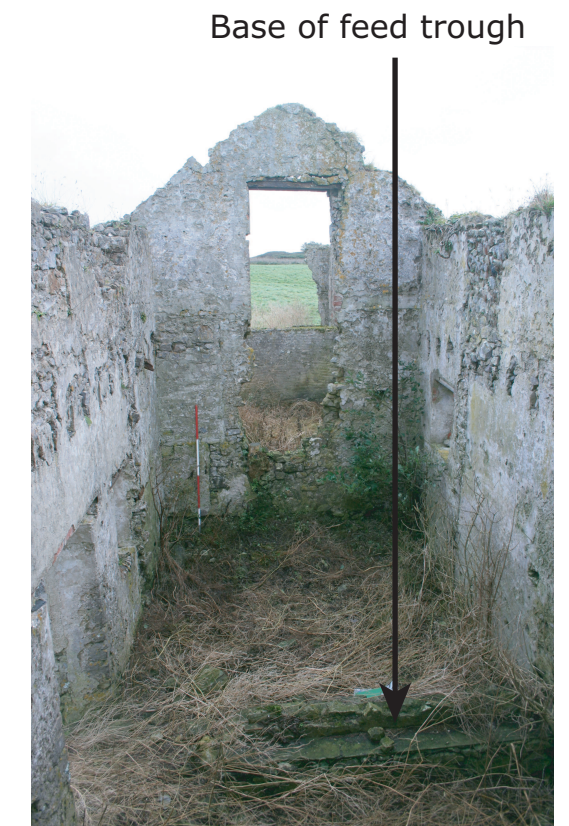
At first floor there are modified openings; in the south wall a small window now blocked mostly with brick to the west, to the east is a doorway blocked with rubble stone. In the north wall are two square window openings. Opposite the door and extending three quarters of the width of the building is a stone plinth, apparently a base for feed troughs (Plate 49). The layout of this building suggests that in its latest form it was a stable.

Plate 49: Stable (B1), looking east

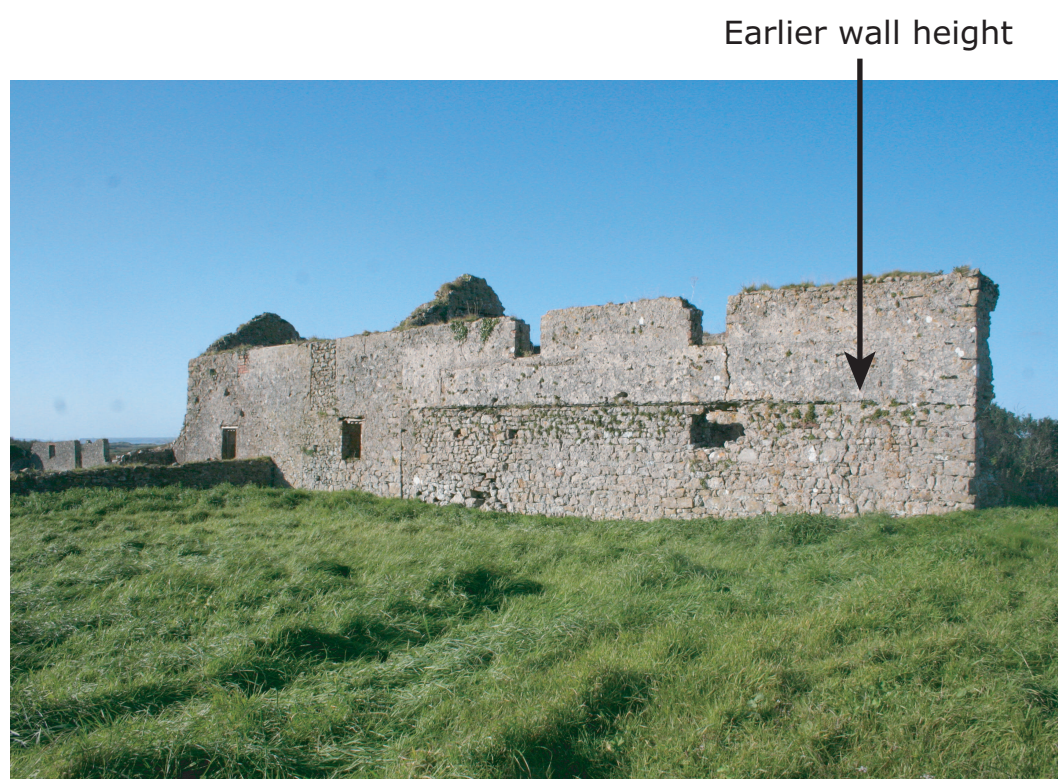
To the east are two rooms which (B2 & B3) which have clearly been built as a single one storey building with a stone partition wall which rises only to door head height (Plate 50). Brick arched window and door heads characterise this section of the building (Plate 51). The central room (B2) has a single doorway and a window in the north wall. Along part of the southern wall is a stone built plinth; the base of a feed trough. At first floor level there are openings in north and south walls. The arrangement of feed trough and openings suggests that this was also stabling for horses and probably a loose box.

Plate 50: Stable range (B), south wall

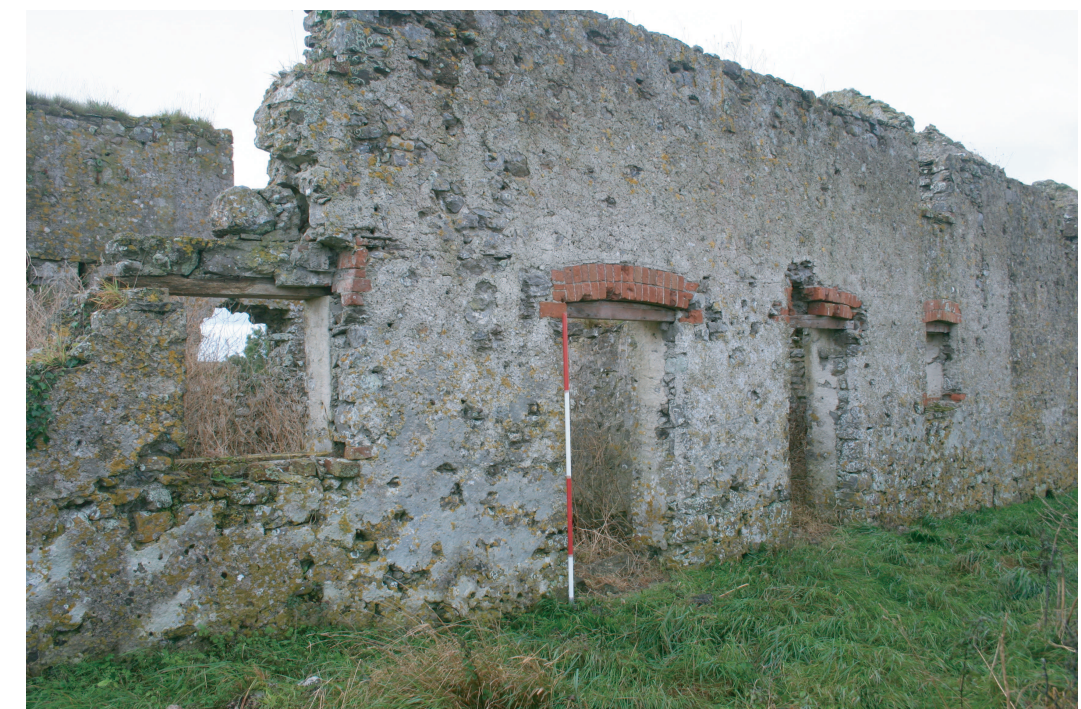
Plate 51: Stable range (B2 and B3), north wall

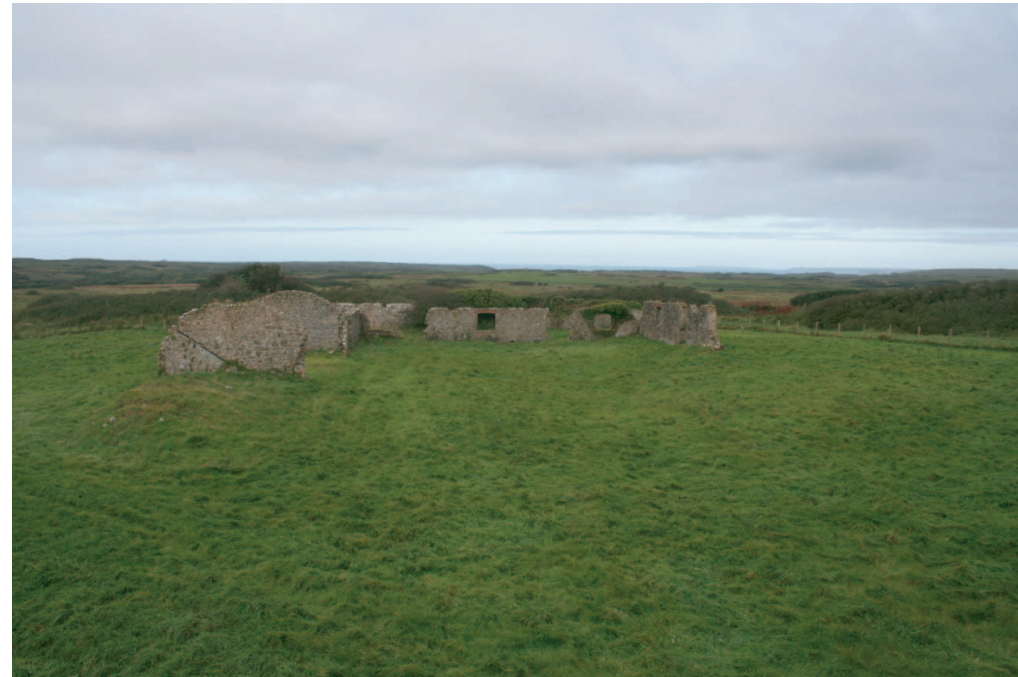
Farm building range C comprises a three sided courtyard complex (Plate 52). The whole complex appears of similar build, with little evidence of alteration or modification. The courtyard is constructed in rubble stone with brick arched door- and window-heads similar in type to that seen in the eastern, later part of stable range B.

Plate 52: Courtyard of cowsheds (C), view from the east

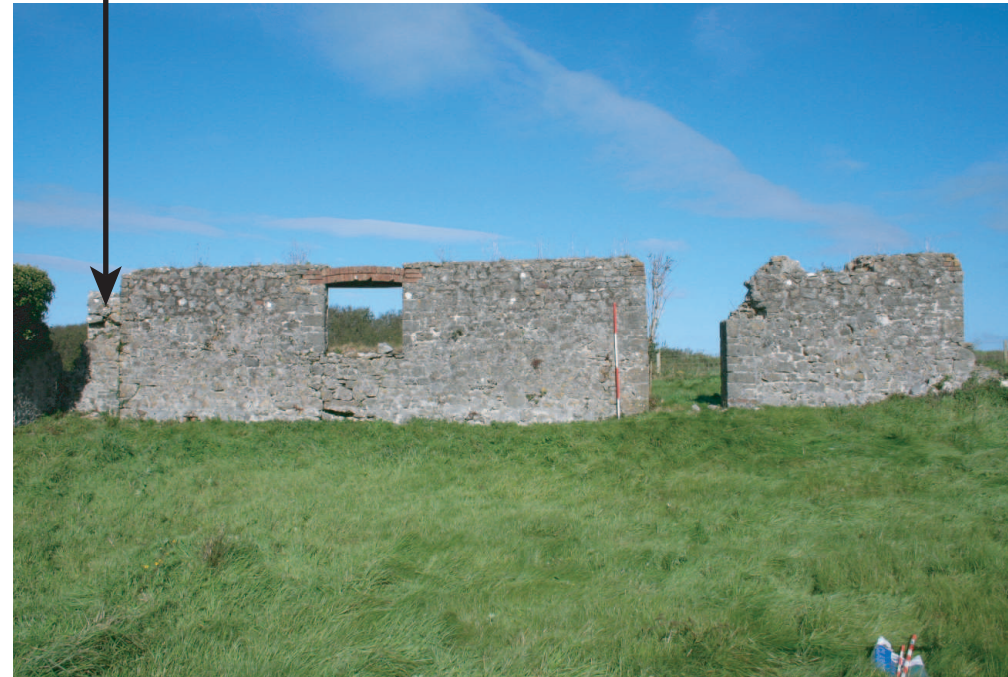
Of the north range (C1) only the southern wall survives in which a doorway and window remain. At the eastern extent of the wall are the remains of a further window jamb, beyond which the wall has collapsed (Plate 53). At its western end a small section of earlier wall survives contained within the masonry, on a different axis to the current building (Plate 54). This would appear to be the trace remains of a building recorded on the 1st edition Ordnance Survey map. Of the northern wall and east gable end, no upstanding masonry remains; only a stone embedded in the turf indicates the position of the back wall.

Earlier section of walling

Plate 53: Cowshed range (C1), south wall

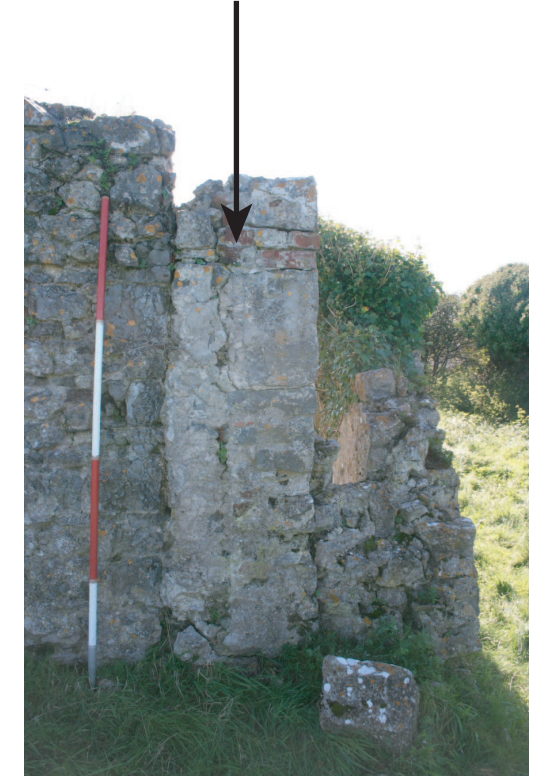
Section of earlier walling

Plate 54: Northwest corner of courtyard (C1), looking south

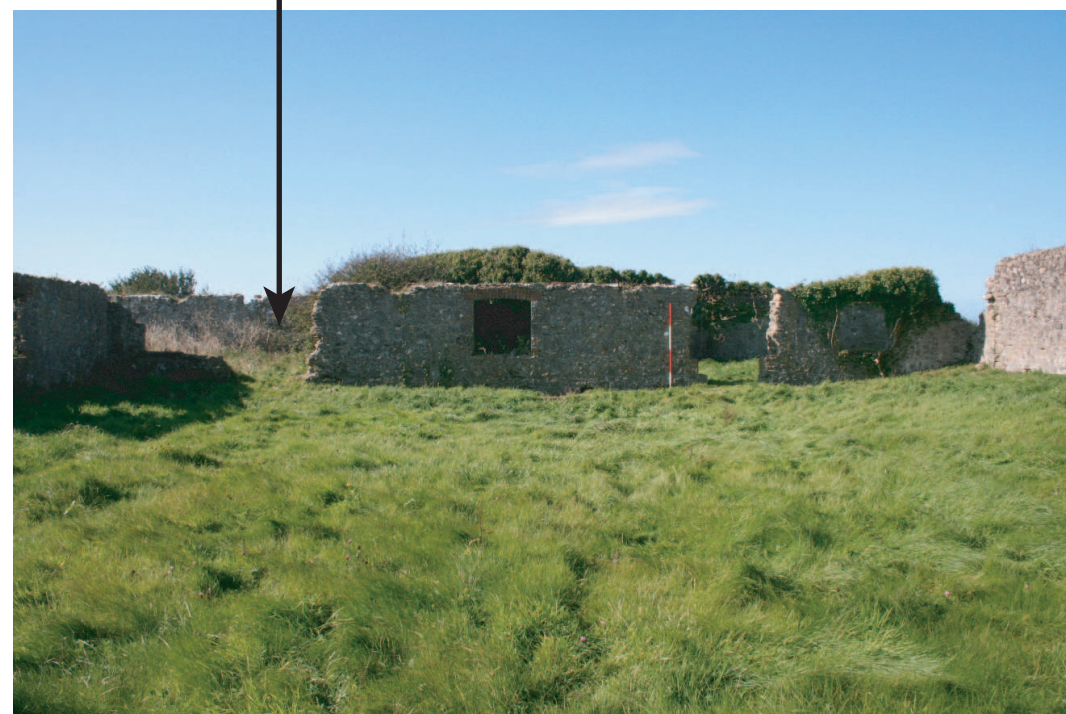
Of the western range (C2) a single doorway and three windows survive in the east wall, a second doorway probably stood in the gap where the wall has collapsed (Plate 55). The rear back wall has two high window openings, dressed in brick and largely obscured in ivy growth.

Former doorway

Plate 55: Cowshed (C2), east wall

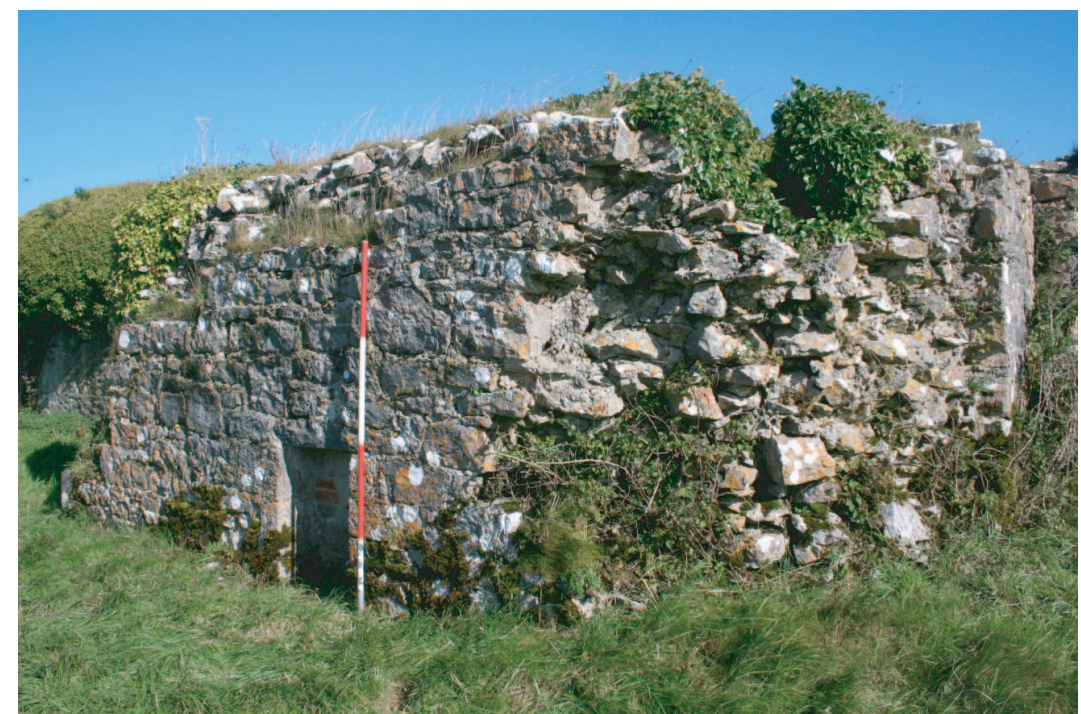
To the rear of this range, built up against the west wall is a stone built water tank (Plate 56).

Plate 56: Water tank on west side of cowshed (C2)

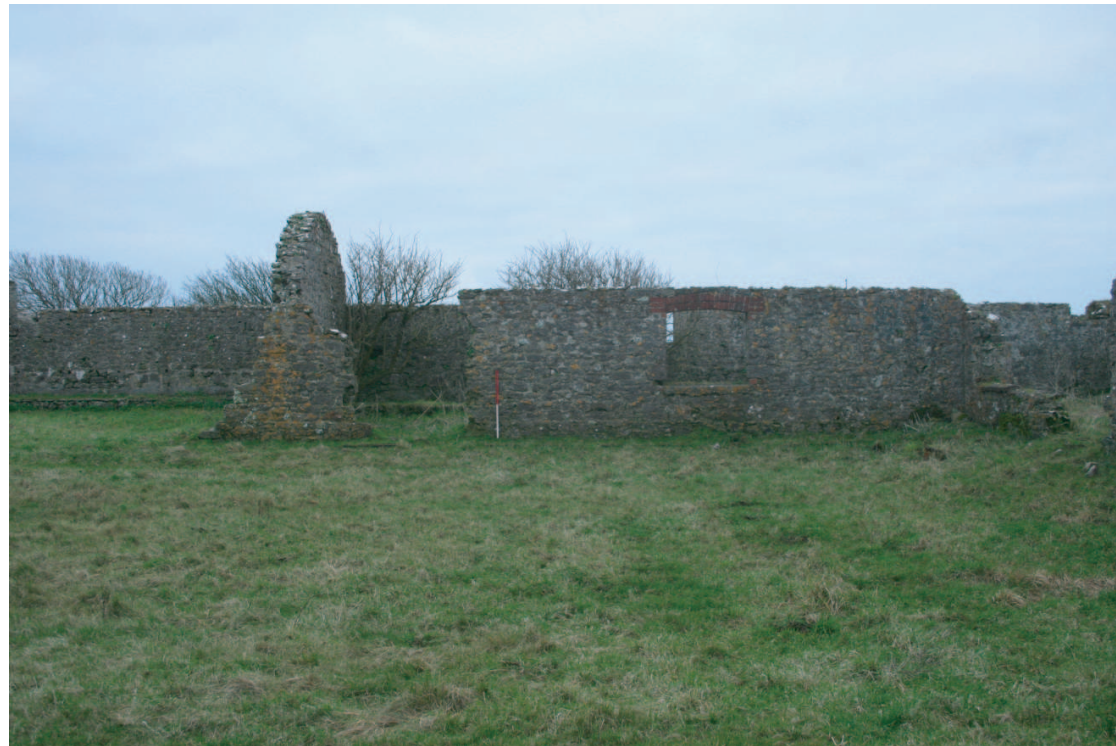
The southern range (C3) extends part way along before a stone partition wall divides this range in two (Plate 57). A doorway and window opening lie in the north wall, two window openings are situated in the south wall. A masonry plinth which denotes the line of a manger lies parallel with the back, south wall, indicating the survival of a feed passage. The stone partition wall is not keyed into the lateral stone walls, beyond which is a further cow shed, C4, which has no upstanding remains of the front, north wall (Plate 58). Against the southern wall, flush up against it is a plinth for housing a stone manger. The east gable wall retains the earlier wall line of a low single pitch roof and a low yard wall extending to the front, characteristic of pigsties (Plate 59). This courtyard range is clearly depicted on the 2nd edition Ordnance Survey map.

Plate 57: Cowshed range (C3), west end, north wall

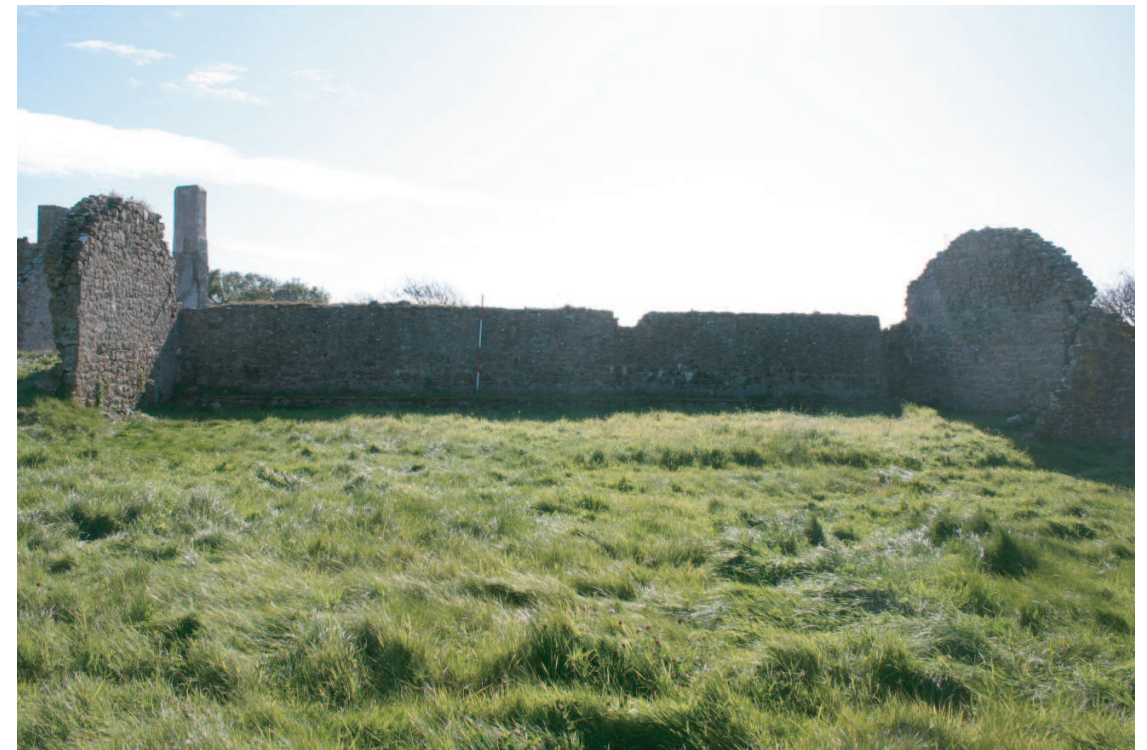
Plate 58: Cowshed range (C3), east end, south wall

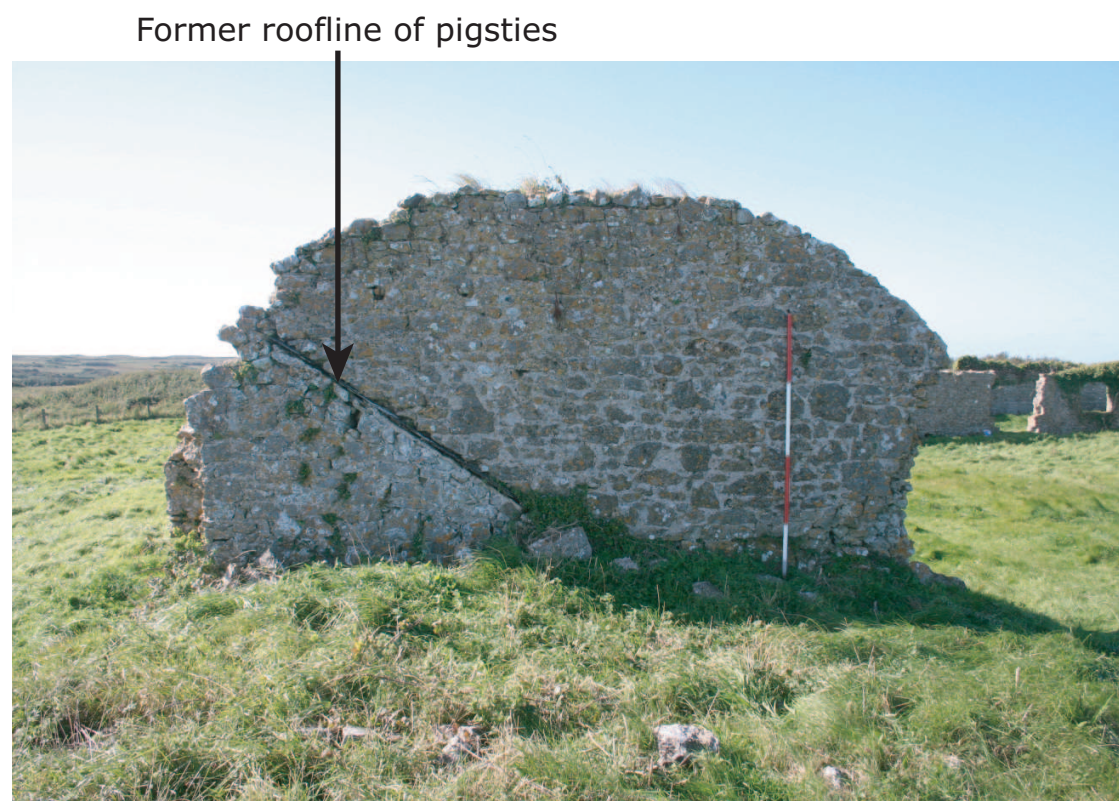
Plate 59: Cowshed (C3), east gable wall

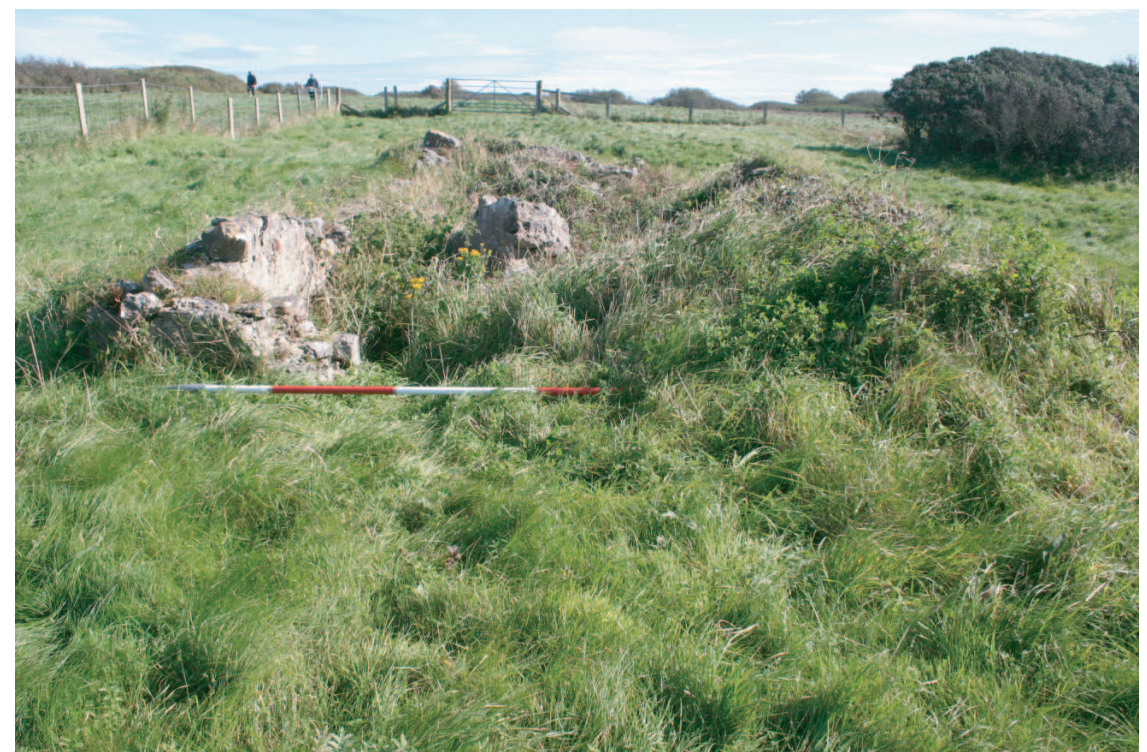
Farm building D consists of the ruins of a single rectangular small building lying detached from the other ranges (Plate 60). The form of the building is only just discernable amongst the stone tumble which covers the area. A doorway is evident in the west gable wall, in the northern corner.

Plate 60: Remains of farm building (D), west end

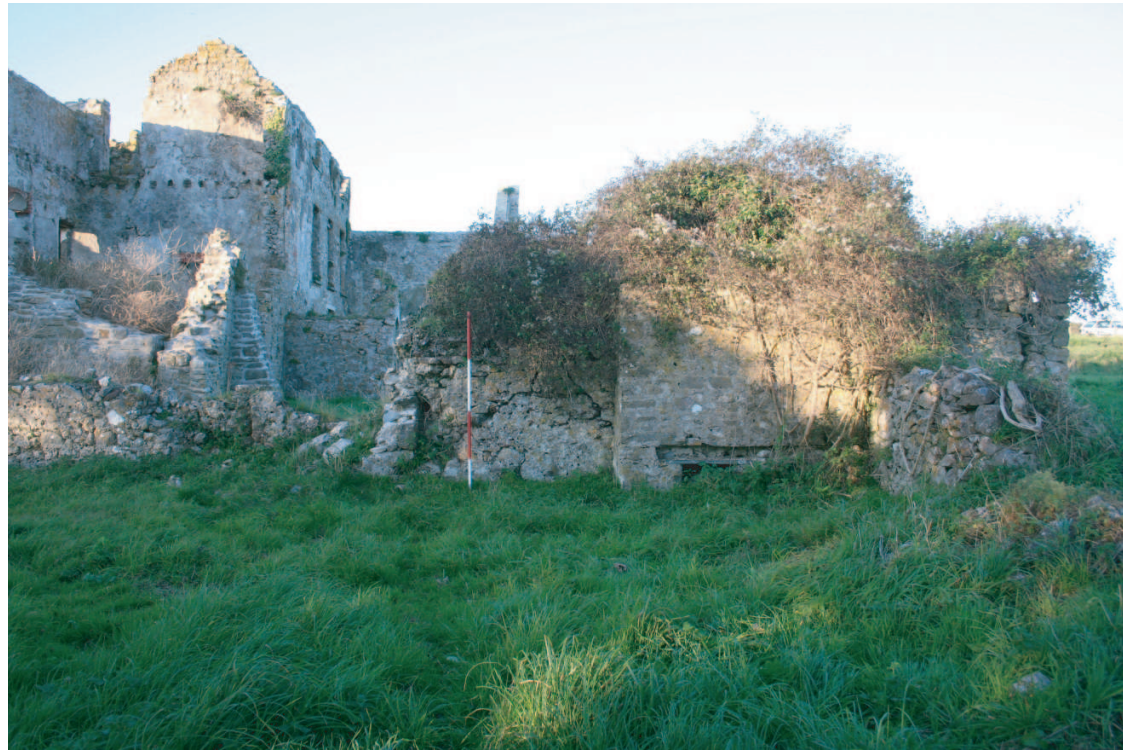
Projecting to the southeast of the farmhouse is an enclosure wall which runs from the southwest wall of the farmhouse. Built within this enclosure wall is a circular outside oven and beyond are outside latrines (Plate 61 & 62).

Plate 61: Oven range and latrines, view from the south

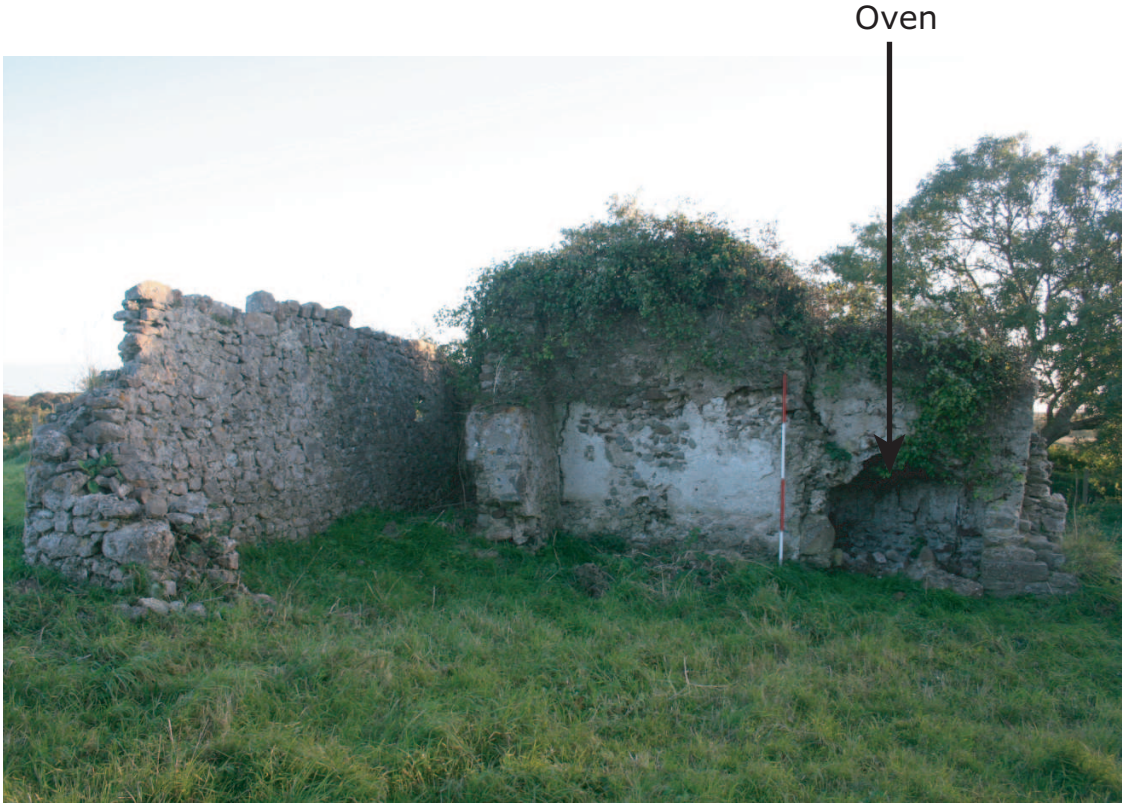
Plate 62: Oven and latrines, view from the north

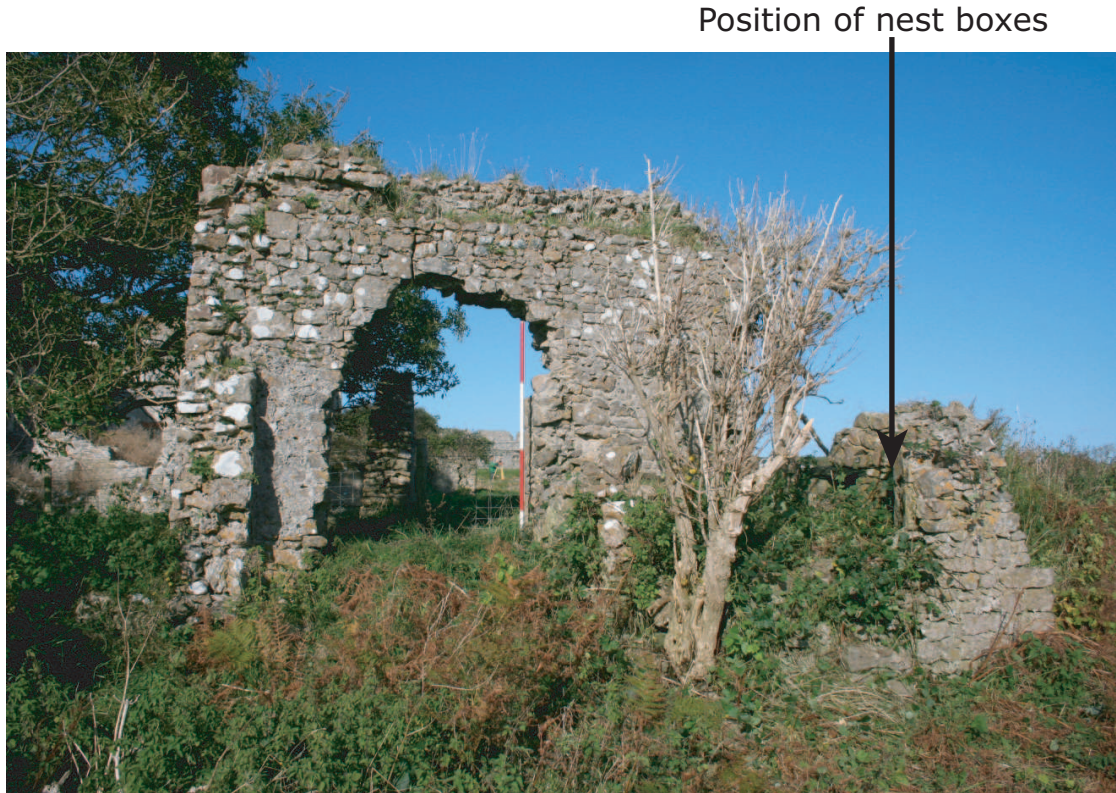
To the south of the complex, lying just outside the southern boundary of the current enclosure stands the ruins of a structure which incorporates two rows of nesting boxes. An arch of masonry represents the remains of a gateway, though none of the jambs or dressings survive (Plate 63). To the east, and projecting to the south is a small building with the remains of a window splay in the south wall and a doorway in the corner of the east wall. Along the internal faces of the east and west walls are nesting boxes; 0.35m wide, 0.4m deep and 0.4m high, constructed with a slate capping stone over (Plate 64).

Plate 63: Gatehouse / fowlhouse
